**TAILINGS AND PRODUCTION ROCK SITE  
2013 ANNUAL REPORT**

**Hecla Green Creek Mining Company**

**April 15, 2014**

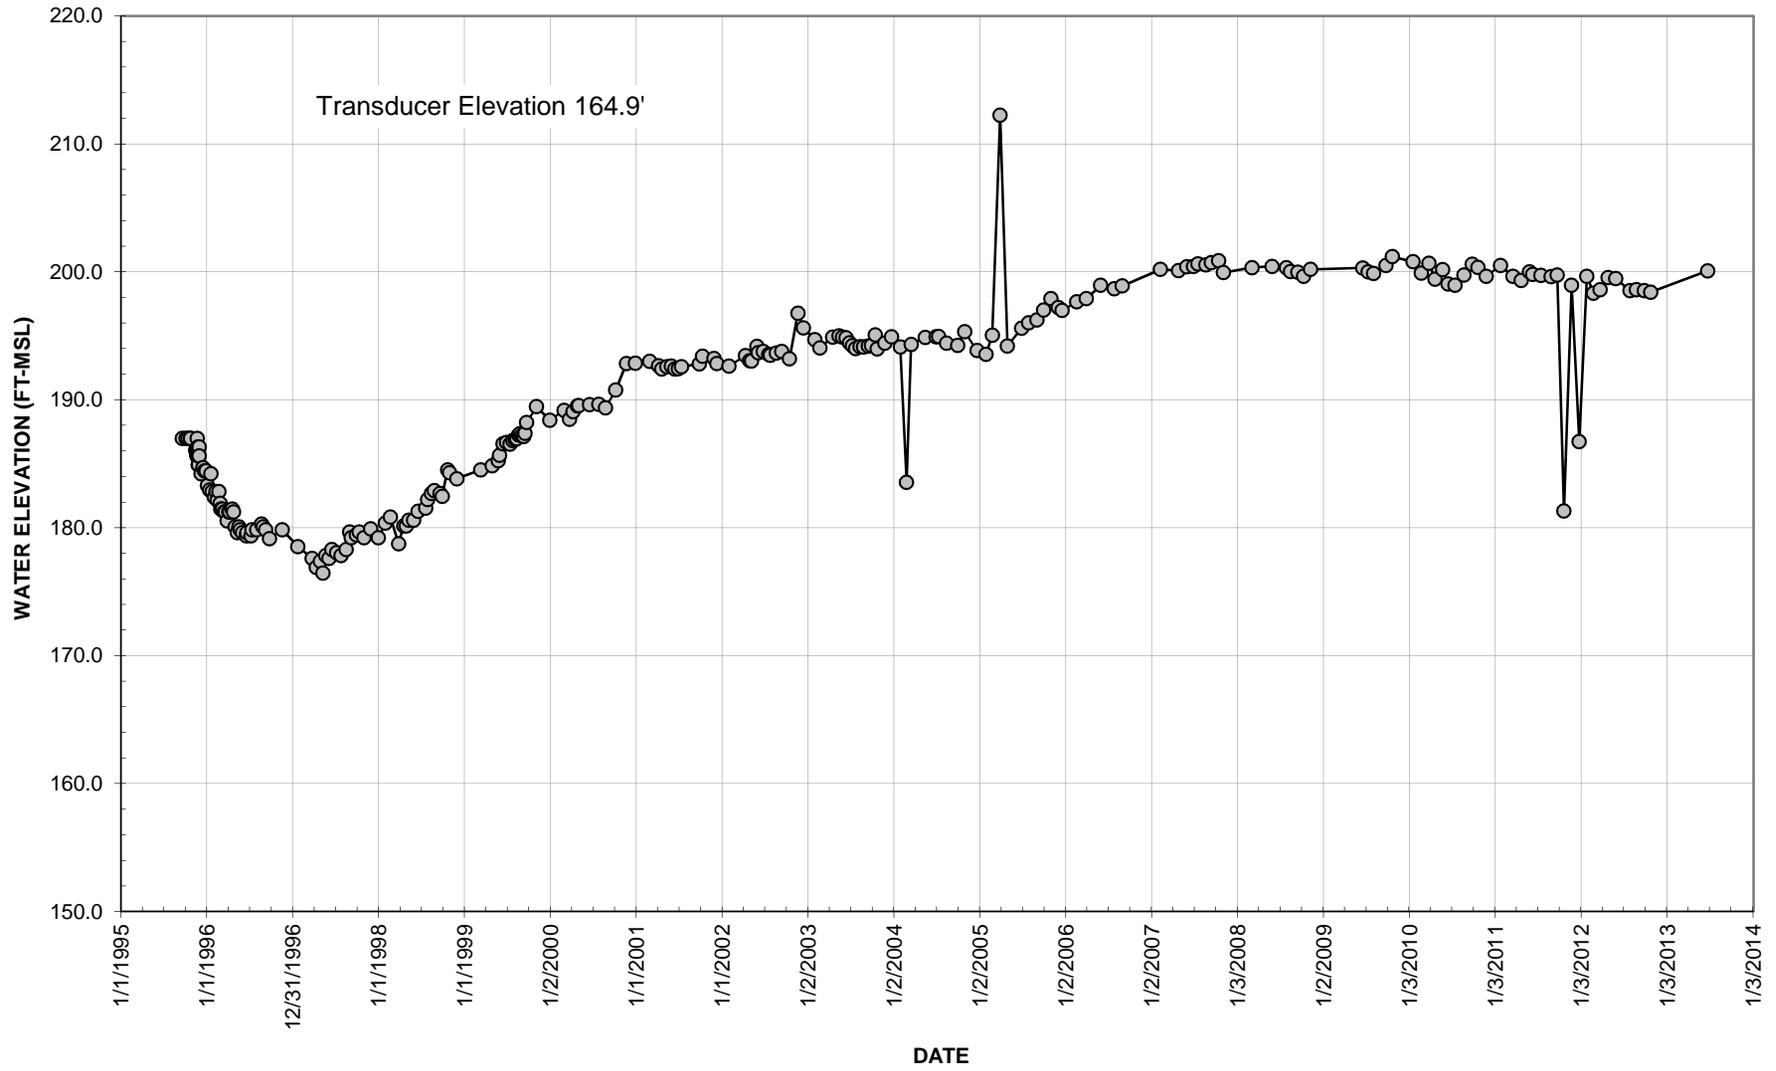
Figure 2.6 Water Level Data for Piezometer 50

In February of 2013 an approximate 25 foot increase in estimated water elevation was observed for Piezometer 51 (Figure 2.7). This was likely a field error because a concurrent rise was not observed for its companion instrument (Piezometer 50, Figure 2.6). Pneumatic piezometers are susceptible to freezing and can give errant readings if ice accumulates in the tubing.

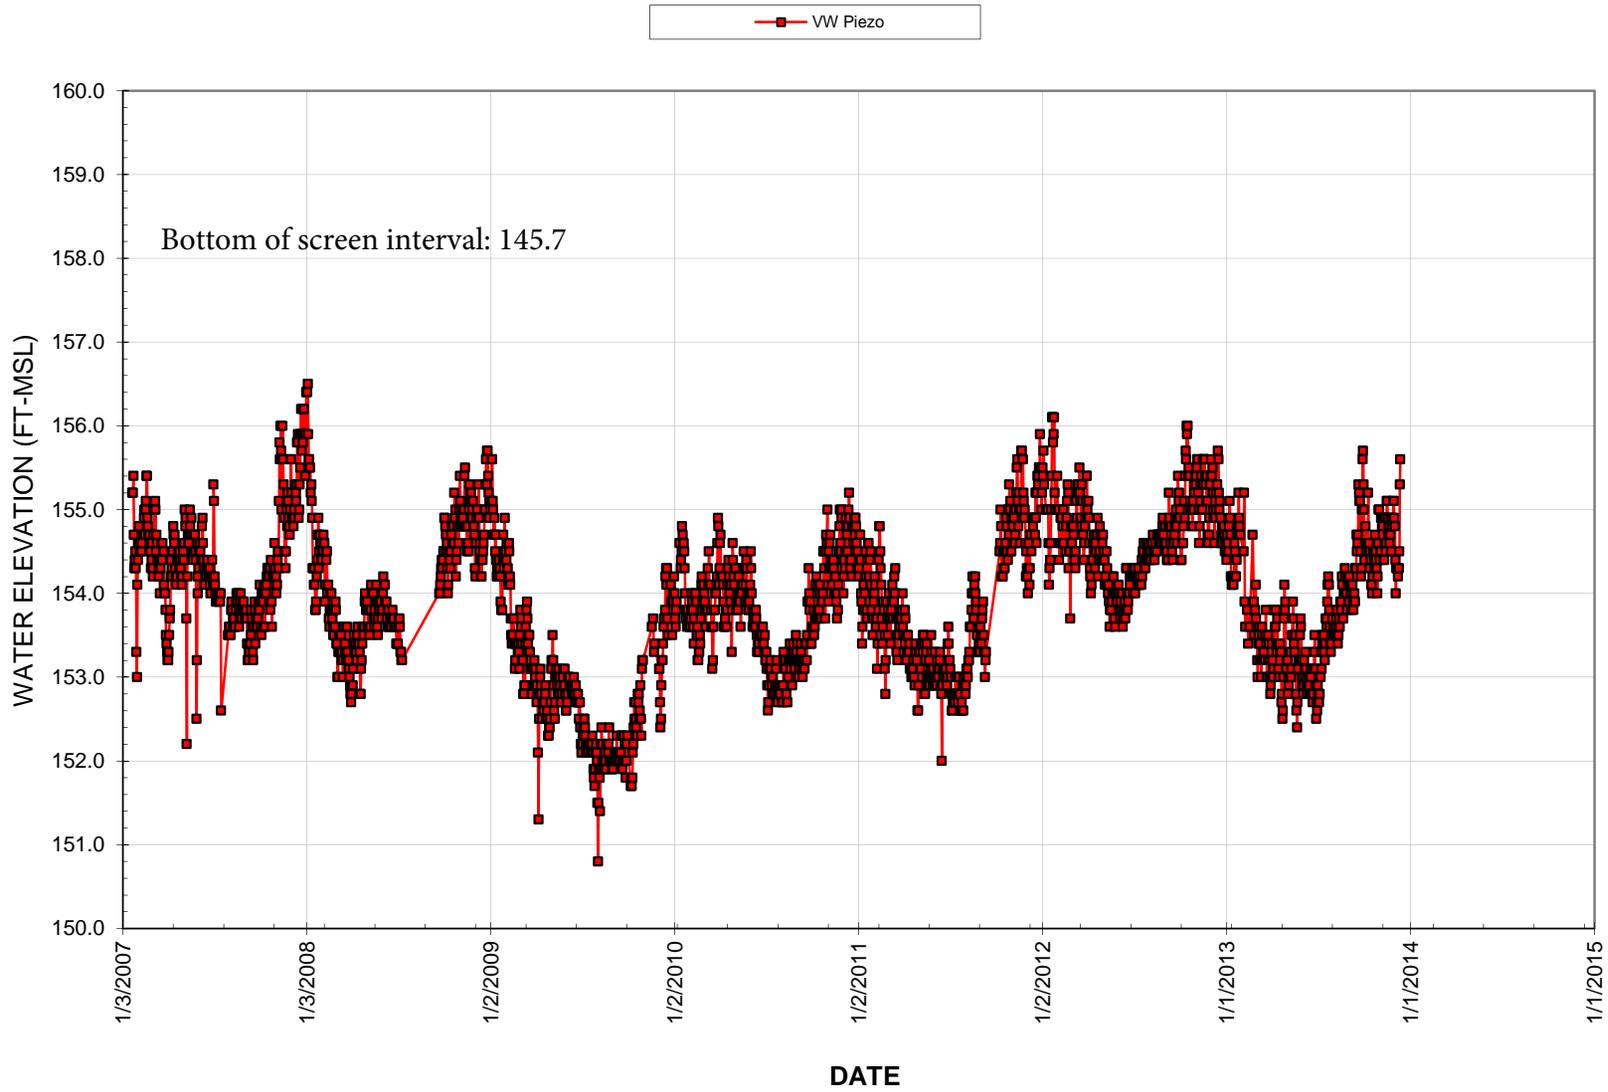
Figure 2.12 Water Level Data for Standpipe Piezometer PZ-T-00-02

The data from standpipe and pneumatic piezometers completed above the blanket drain (Piezometer 76, PZ-T-00-01, PZ-T-00-02, PZ-T-00-03 in Figures 2.10, 2.11, 2.12, 2.13) indicate that saturated conditions can develop above the unsaturated underdrains to a thickness of approximately 12 feet. This is consistent with the low permeability of the tailings and the uncapped condition of the pile. Covering the pile will help minimize the saturated zone in the pile. This was demonstrated by the over 10 foot decrease in the water table that occurred from 1995 to 1997 when the pile was covered (see Figures 2.1 to 2.7). Water levels have rebounded to, and in some cases above, 1994 elevations in most areas. Areas where water levels exceed their 1994 values are areas where the pile is considerably thicker than it was in 1994. The increase in water levels observed in PZ-T-00-01 (and to a lesser extent in instruments nearby) from 2005 to 2007 is likely a result of new tailings placement in the area and staged decommissioning of Wet Well 2.

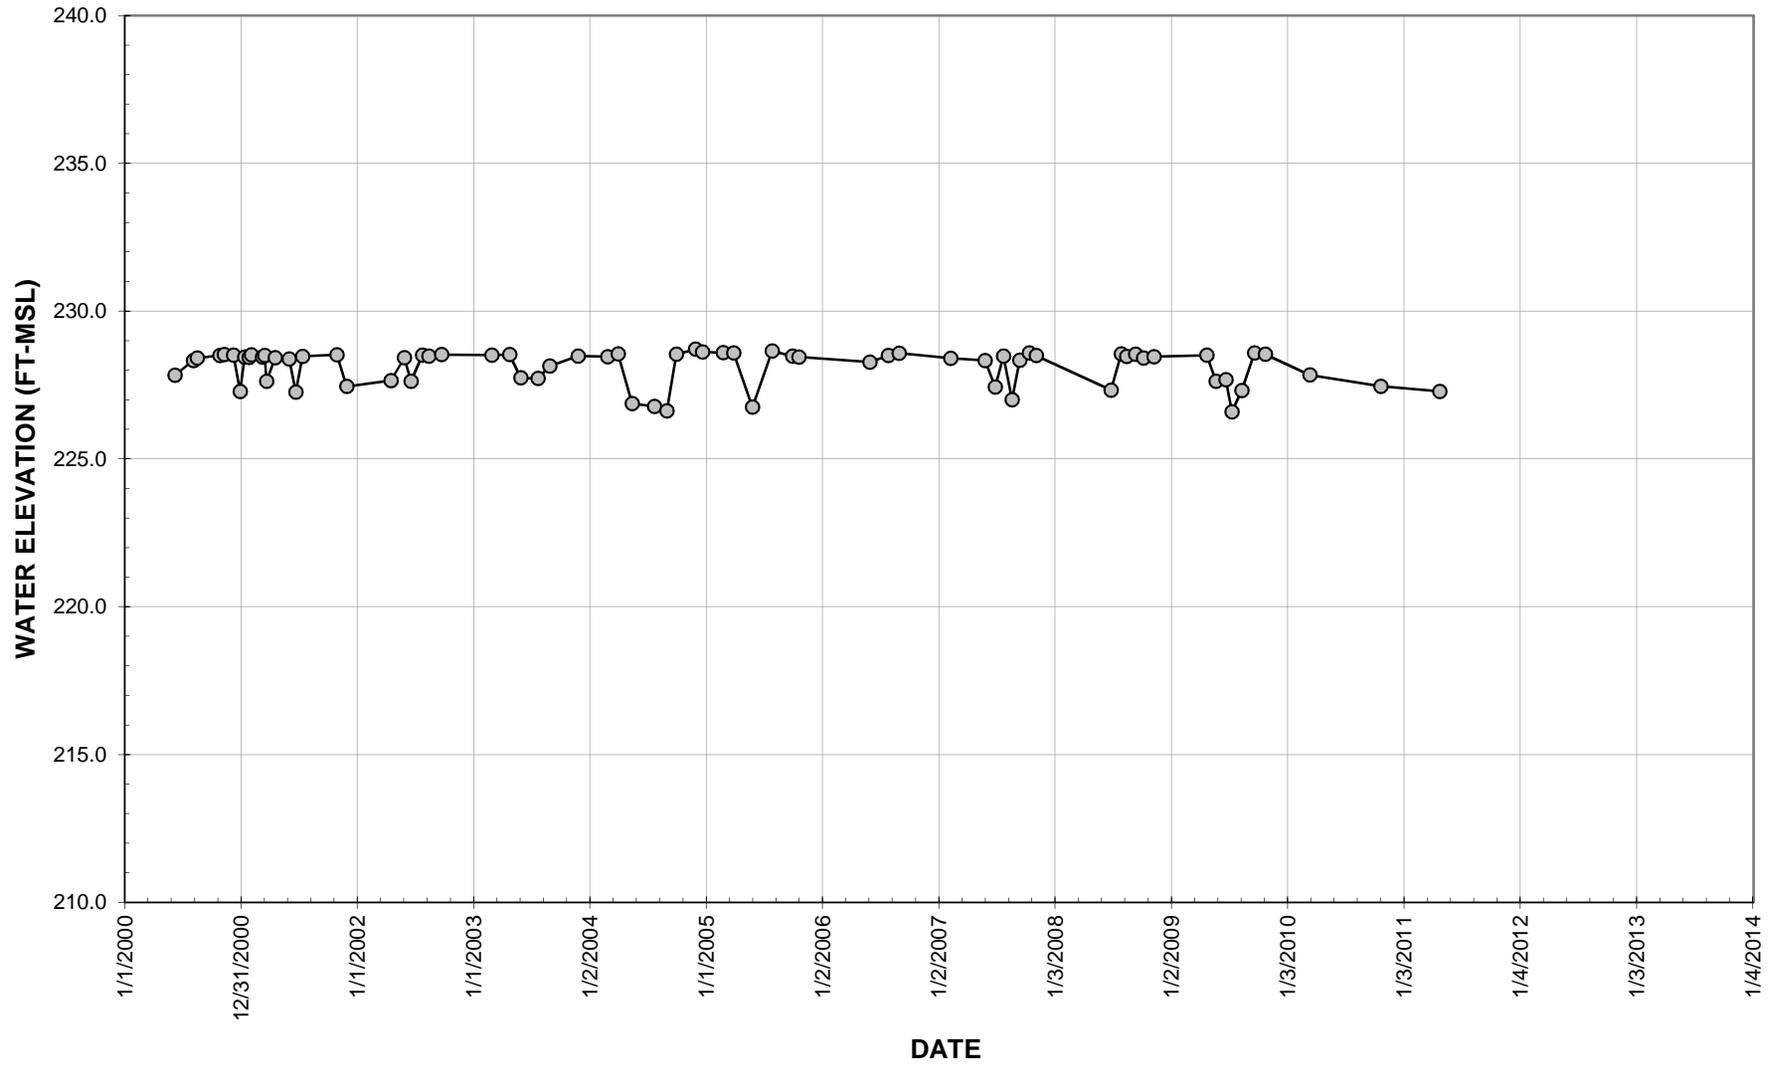
Figure 2.15 Water Level Data for Well MW-T-00-003A

Water levels in four wells completed east and west of the pile are shown for comparison in Figures 2.15 to 2.18. The eastern wells, MW-T-00-03A (Figure 2.15) and MW-T-00-03B (Figure 2.16), are completed in the shallow sands 12 and 17 feet, respectively, below ground surface. The figures for these wells show that the water elevation in shallow completions in native materials can be readily influenced by abnormal weather conditions. Wells MW-T-01-03A and MW-T-01-

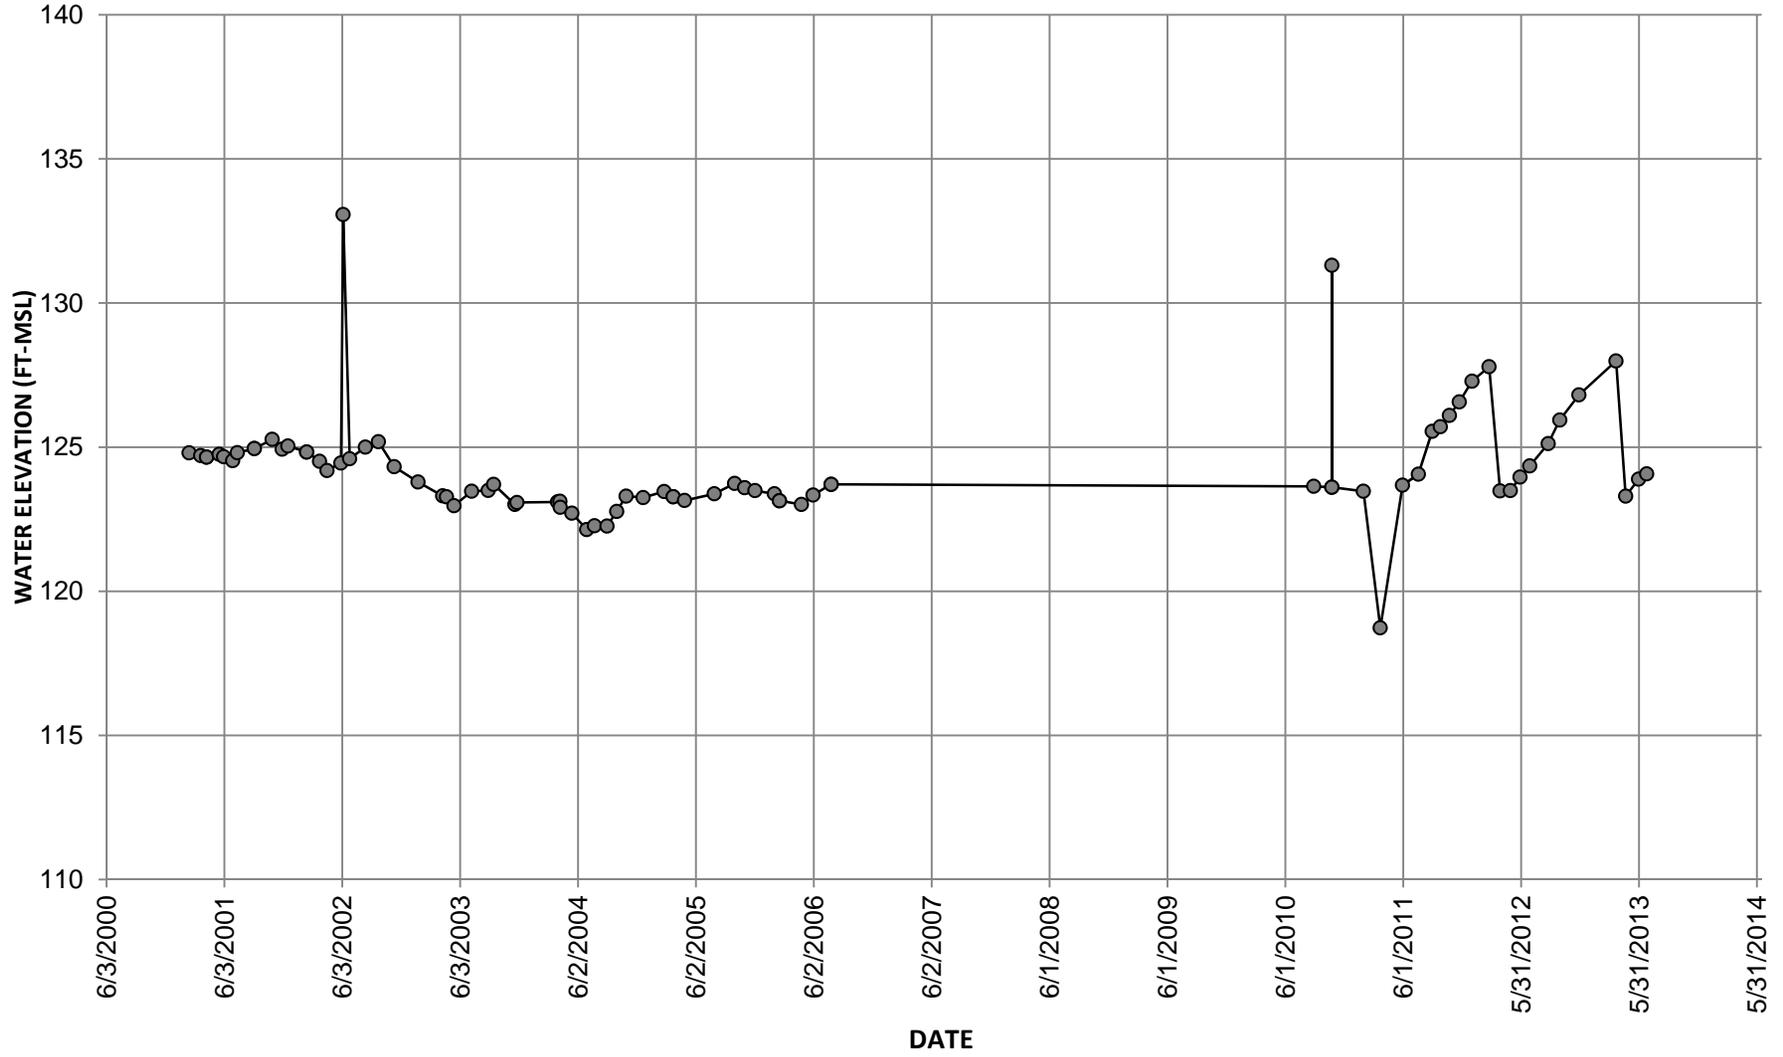
Figure 2.17 Water Level Data for Well MW-T-01-03A

03B are installed west of the pile. Their water levels are shown in Figures 2.17 and 2.18, respectively. MW-T-01-03A is completed in bedrock to a depth of 20 feet and MW-T-01-03B is completed in clayey silt to a depth of 12 feet. These wells show similar water level fluctuations with weather conditions as the two eastern wells. However, the water level in MW-T-01-03B shows a larger differential than MW-T-01-03A because silts and clays hold more water in tension, so a small increase in water content causes a large change in head. The ground surface elevation is 134 feet in the proximity of these two wells. Both MW-T-01-03A and MW-T-01-03B were damaged by bears in 2006 and attempts to recover them were not successful until 2010. A rapid decrease followed by a gradual increase to levels above recent historical values occurred in MW-T-01-03A in 2011. In 2012, the level decreased to levels seen in the past. The cause for the change is not known at this point, however this type of behavior has been documented in the companion well (MW-T-01-03B).

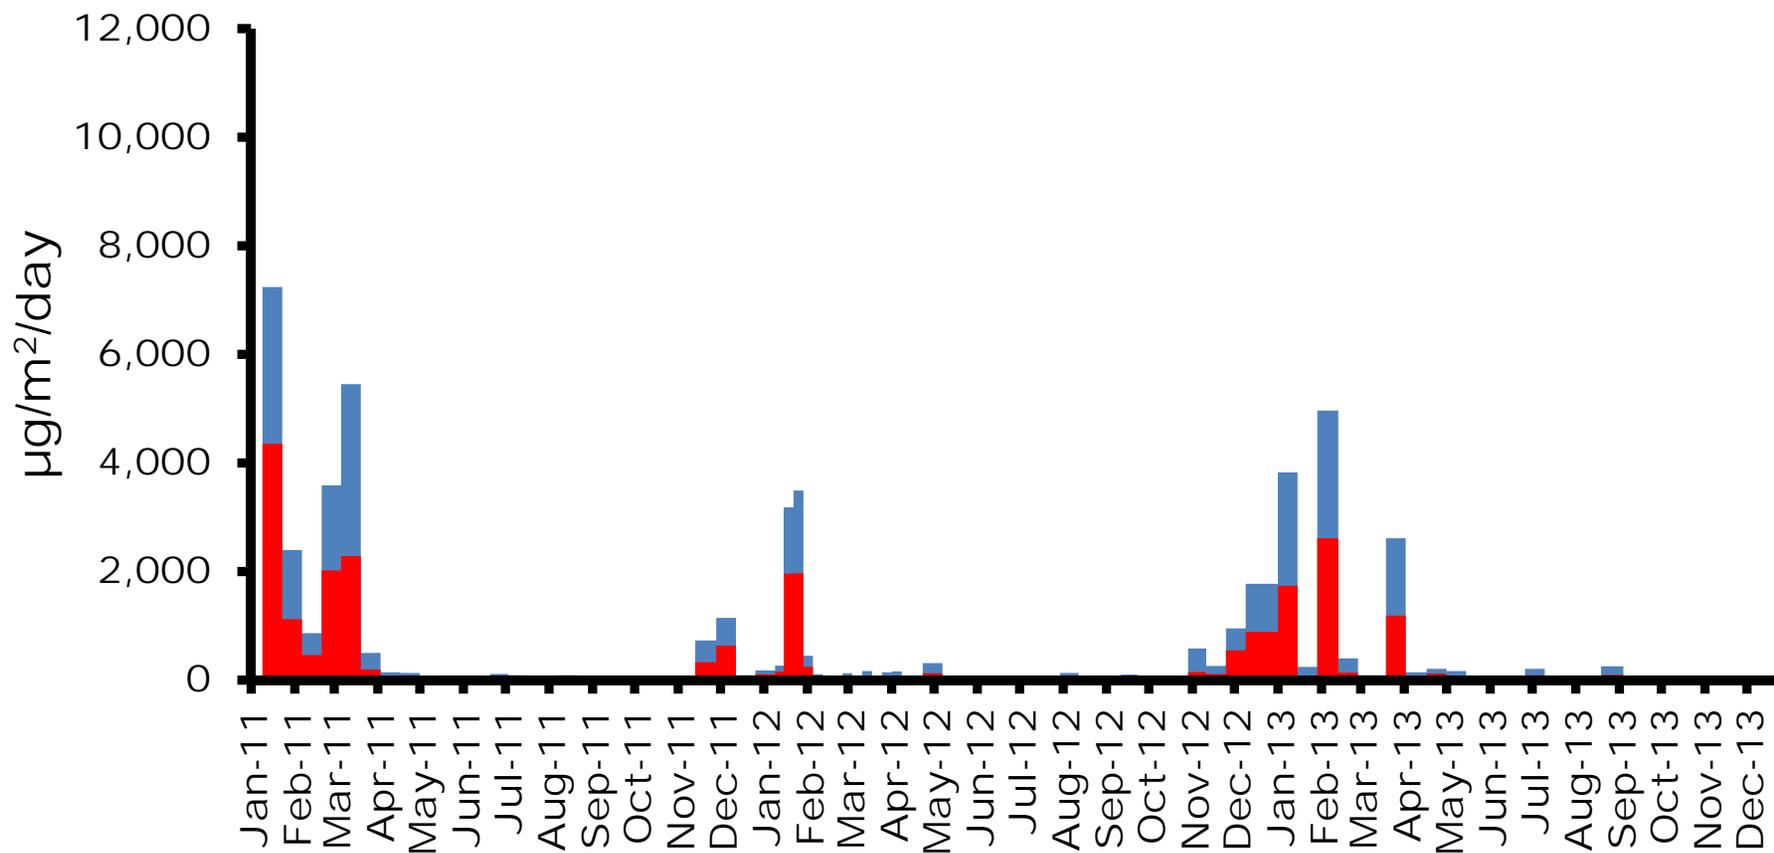
FIGURE 2.37

This data supports and verifies the statements made previously about the seasonality (winter) of this issue (Figure 2.37): it occurs under cold dry desiccating conditions with moderate wind speeds from the north or northeast. Out of the five ADP systems deployed in 2011, three received a higher rate of loading than the other two; they were ADP systems in the west, southwest, and south. Out of these three systems the southwest had the highest yearly accumulative lead load of 95,882 ug/m<sup>2</sup>/year and the west system with accumulative lead load of 94,468 ug/m<sup>2</sup>/year. The system to the south accumulated a lead load of 67,031 ug/m<sup>2</sup>/year (Table 2.9). This lower load may reflect that the ADP system here is farther away from the pile than the other two. Overall, 2013 presented more lead dusting than 2012 and less lead dusting than 2011.

Approximately 93% of the load collected was deposited in 148 days out of the 377 days that were monitored. This period consisted of two sub-periods that were from 1/2/2013 – 4/3/2013 and 11/18/2013 - 1/11/2014. These results were very similar to those obtained for the previous years (2011-2012). There was an increase in the lead loading in 2013 at each monitoring location. Results were consistent with past years except for the lead loading increase in the southwest which was nearly three times the amount of 2011 and 2012 results. Another difference is the least amount of lead loading occurred in the south as shown in Table 2.9a. Lead and zinc daily loading from 2011 through 2013 is shown in Figure 2.37.

Average **lead** and **zinc** daily loading of the ADP on the western side of the tailings disposal facility over a 3 year period.

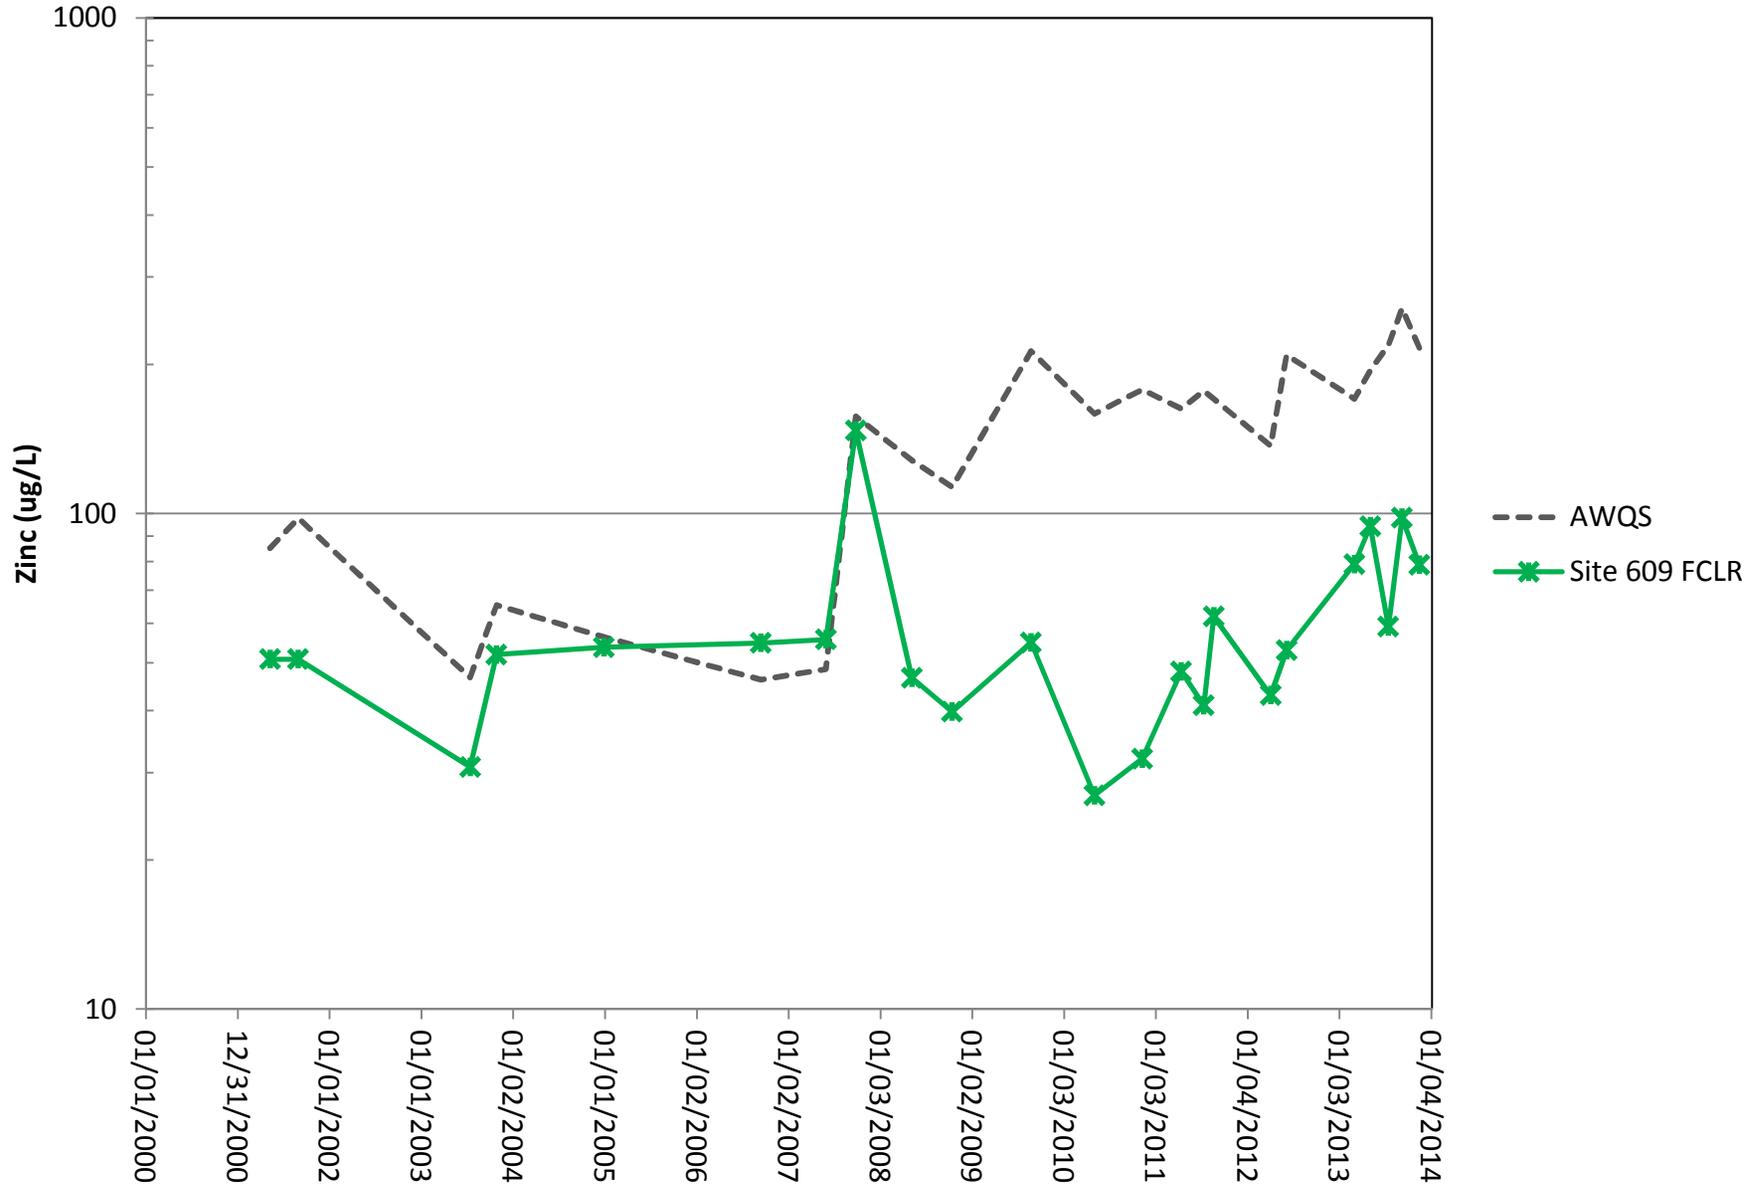
Figure 2.40 Site 609 Zinc Concentrations

- Site 609 is an appropriate monitoring site for tracking all facility related influences to Further Creek. Figures 2.40 and 2.41 show the concentrations of zinc and lead at Site 609. The increase in zinc and lead concentrations at Site 609 in 2011 and 2013 may be result of lower than average precipitation and deposition of dust from placement activities

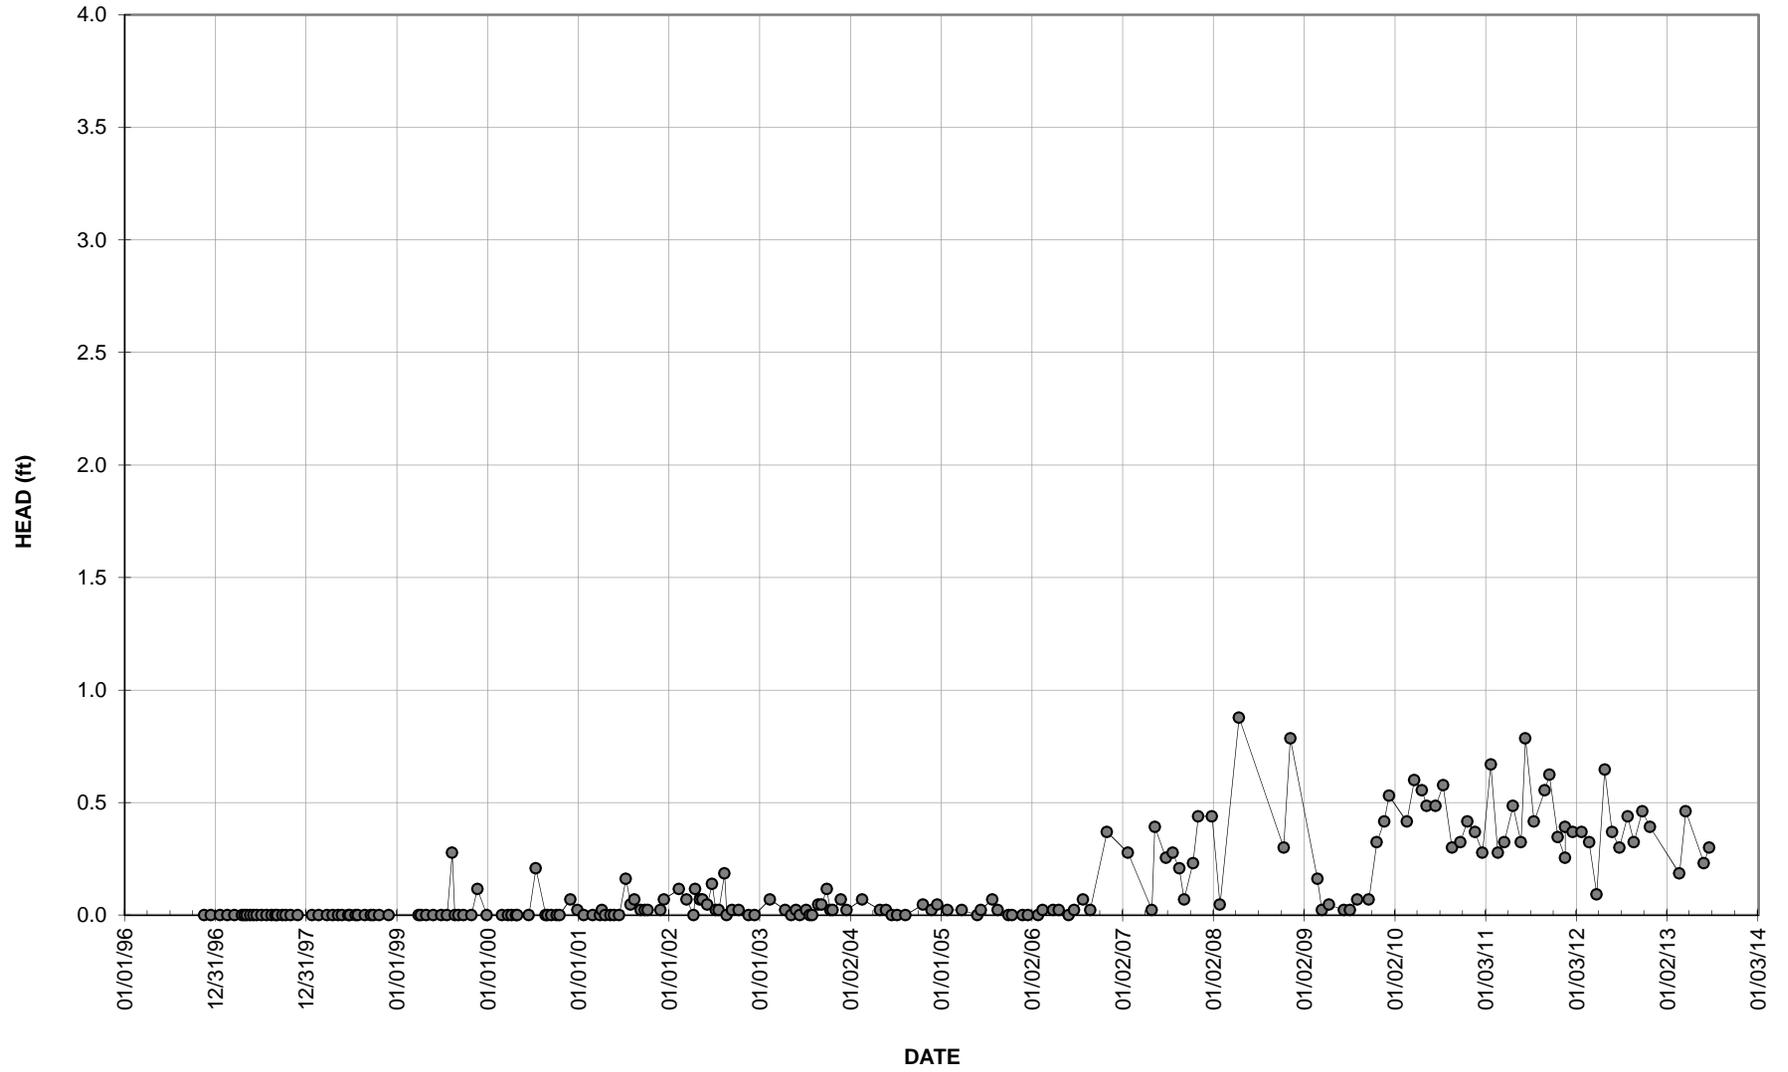
Figure 3.1 Pressure Data for Piezometer 52

Well and piezometer water level data are provided in Figures 3.1 to 3.12. The lack of significant pressure in piezometers installed close to the base of Site 23 (piezometers 52-55, Figures 3.1 to 3.4) demonstrates that the pile remains free draining. This is consistent with the construction of a network of finger drains under the pile and a blanket drain at the pile toe. Comparison of historic versus modeled flow from the finger drains and the curtain drain indicated they are performing as designed and as necessary (EDE 2004). The lack of pore pressure at the toe indicates that pile stability has been maximized. The inferred water table is 30 to 60 feet below the base of the production rock pile material up-slope of the Site 23 active placement area and 5 to 20 feet below the base of material placed in Site D and the toe of Site 23, respectively (see also Figures 3.5 to 3.12). Observations from wells completed in the colluvium below the sites indicate that perched water tables and braided flow paths exist beneath the site (e.g. compare Figure 3.6 and 3.7). This unit also shows large (up to 10 feet) fluctuations in head levels, which are consistent with perched, confined conditions and channel-like flow. There is a distinct seasonal pattern to the water level fluctuations beneath Site 23/D, particularly in the alluvial sands (Figures 3.9 and 3.11).

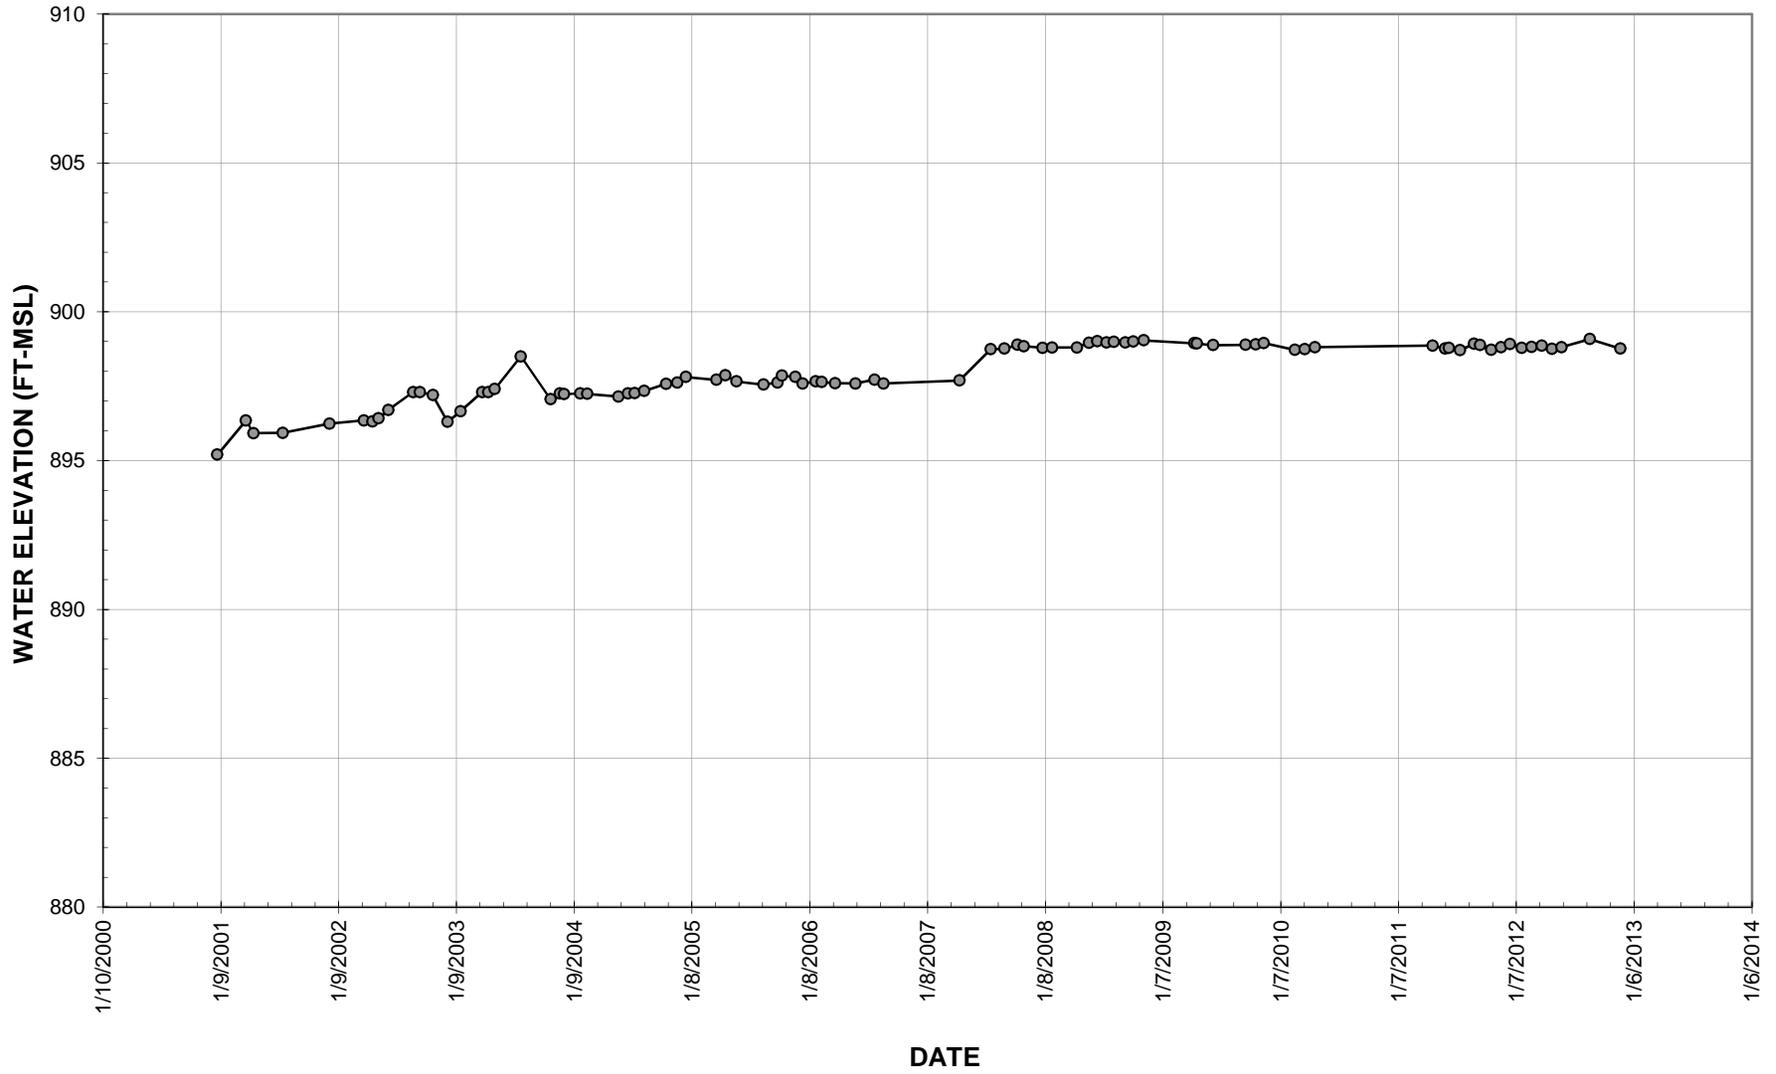
Figure 3.8 Water Level Data for Well MW-23-98-01

The silty/clay till that underlies the colluvial unit impedes downward flow and has an upward hydrologic gradient caused by its confining the more permeable bedrock below it. MW-23-98-01 (Figure 3.8) is completed in the till unit and indicates a water table near the top of the till, which is approximately 100 feet below the existing topographic surface. Alluvial sands occur between the colluvial unit and the silt/clay till near the toe of Site 23 and under Site D. Data from MW-23-A4 and MW-D-94-D3 (Figures 3.9 and 3.11) indicate that the sands are saturated. A curtain drain installed in between Site D and Site 23 in 1994 collects water that flows at the base of the colluvial unit and the top of the alluvial sands (see as-built and sections). This drain helps reduce pore pressures in the foundation of Site D, as well as capturing infiltration waters from Site 23.

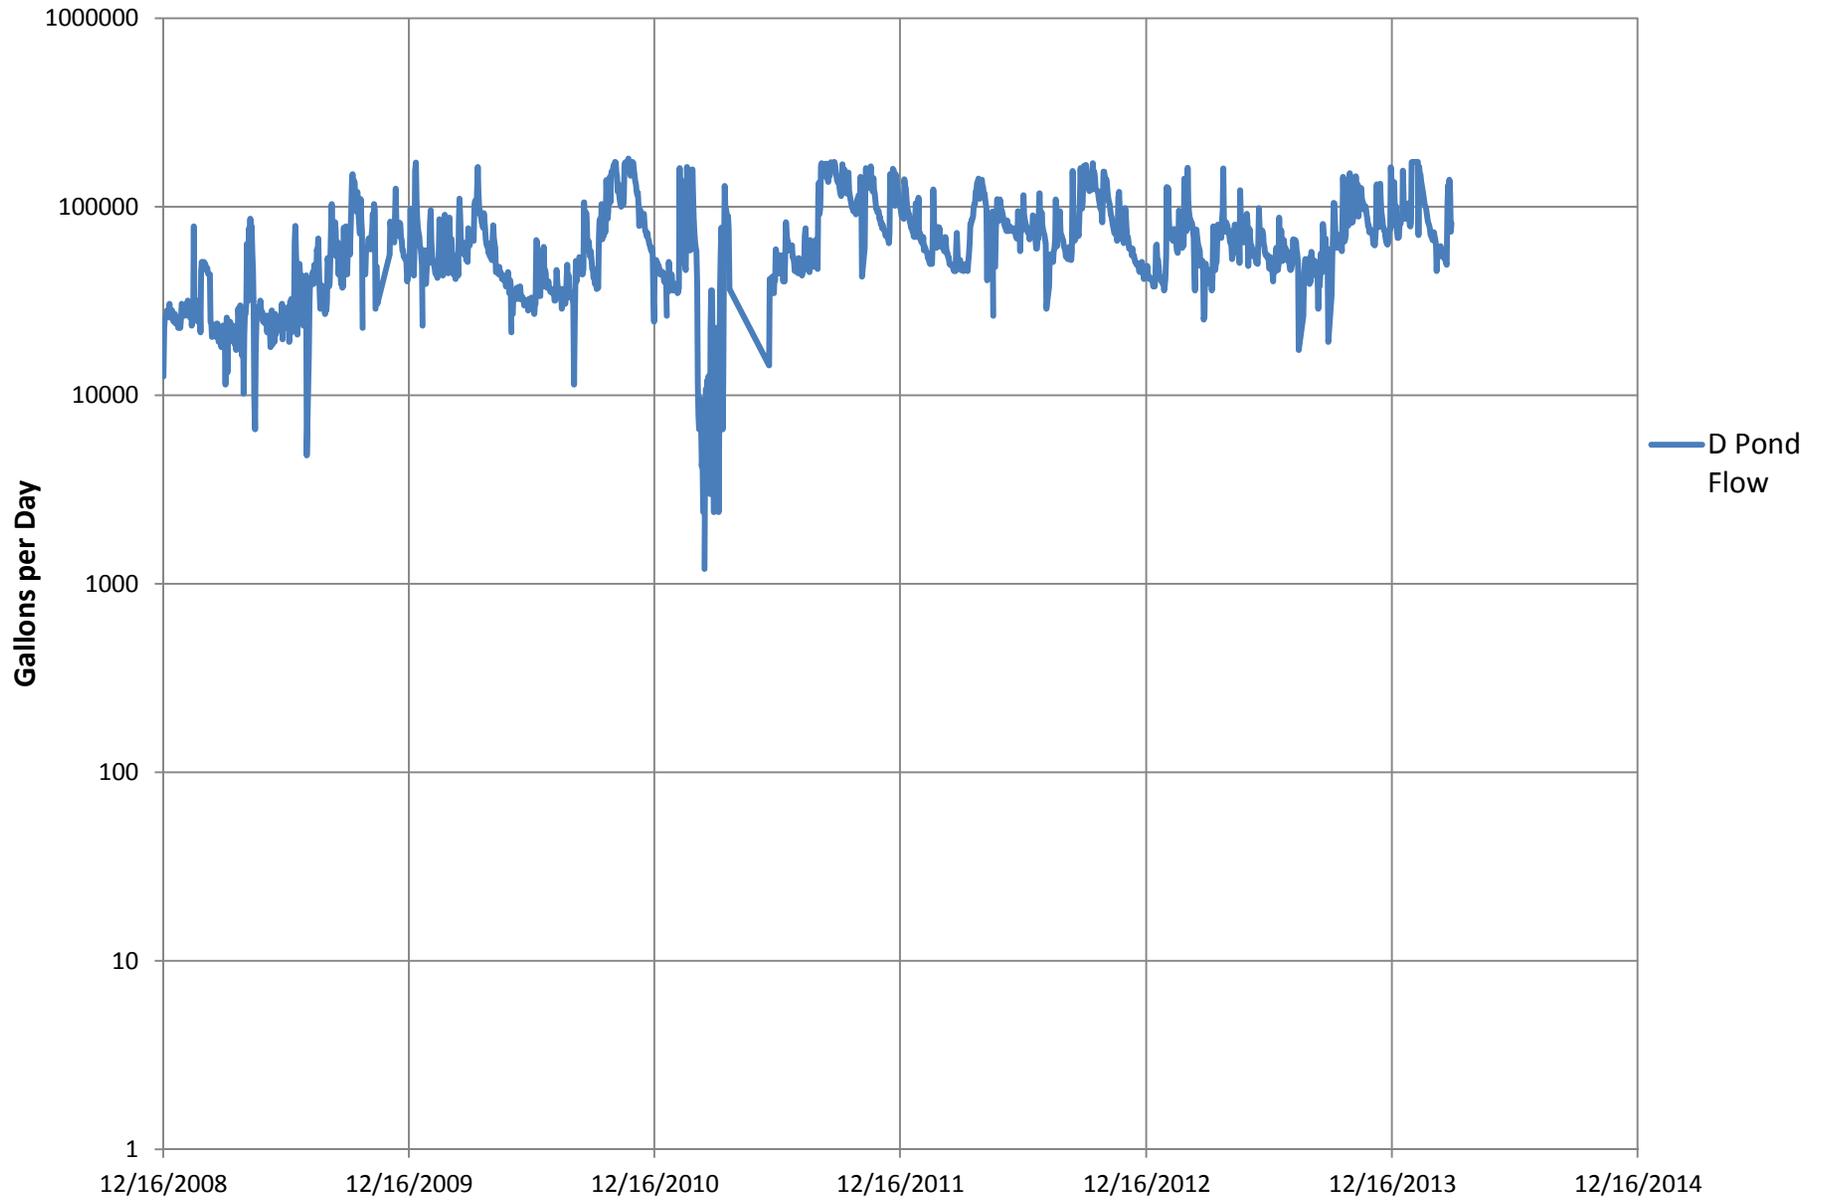
FIGURE 3.13 Pond D Flow Data

Flow data for Pond D are shown in Figure 3.13. The data used for the figure is calculated from a flow meter that records instantaneous flow every 5 minutes. The data logging will be programmed and edited to record more frequently and improve accuracy in 2014.

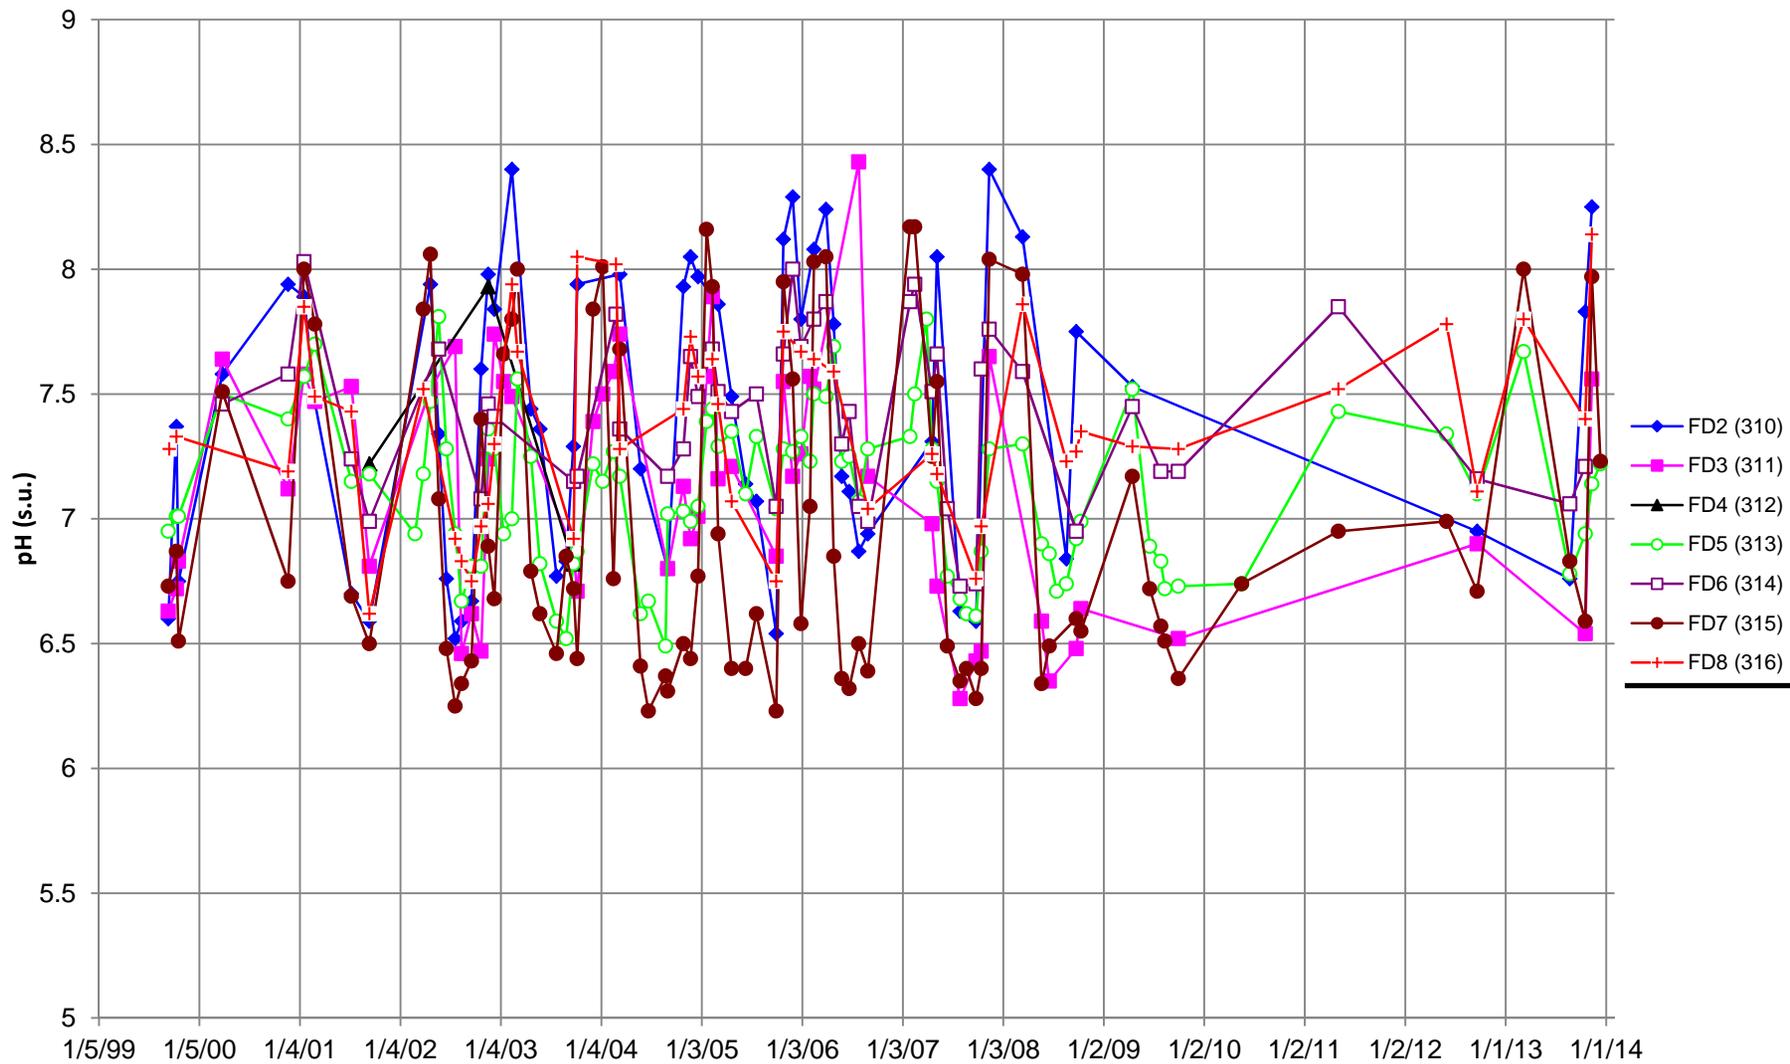
Figure 3.14a GREENS CREEK SITE 23/D INTERNAL MONITORING SITES:

Figure 3.14a shows the pH of waters collected from Site 23 Finger Drains 2 through 8, and Figure 3.14b shows the pH of monitoring wells MW-23-A2D, MW-23-A4, MW-D3 and Pond D (see as-built in Appendix 2 for locations). Monitoring of pH at these sites was not conducted in 2013. The lower pH values (generally pH 6.0 to 7.0) were recorded in MW-23-A4 and MW-D3, both of which are completed in alluvial sands beneath Site 23 and Site D, respectively. MW-23-A2D, which screens colluvium upgradient of Site 23, typically has the highest pH (generally pH 7.0 to 8.5). The Site 23 finger drains fluctuate at values between those of the monitoring wells. Figures 3.14a and b suggest that waters from different foundation units have different pH values and that Site 23 and Site D contact waters and the materials with which they are in contact exhibit sufficient buffering capacity to prevent acidification of site drainage in the near term. Seasonal fluctuations are apparent in the finger drains with highest pH values occurring in winter months and lower pH in mid to late summer.
