**TAILINGS AND PRODUCTION ROCK SITE  
2013 ANNUAL REPORT**

**Hecla Green Creek Mining Company**

**April 15, 2014**

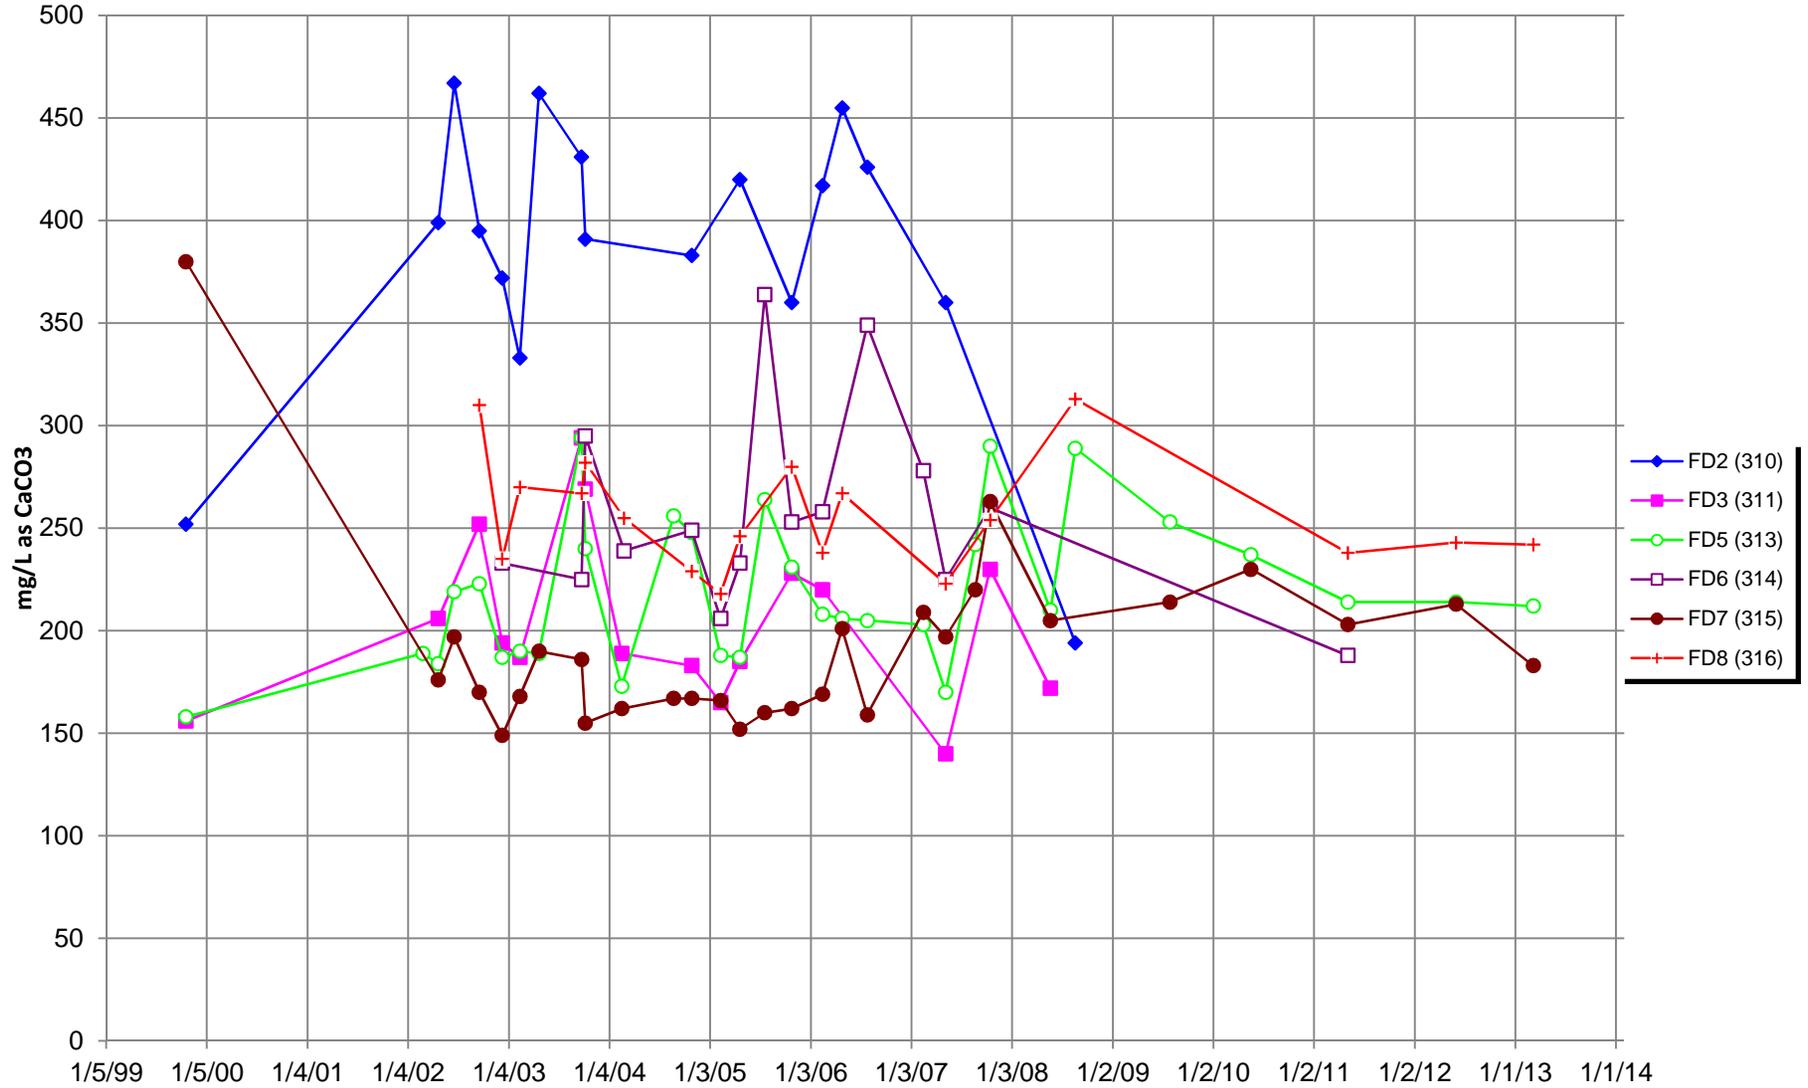
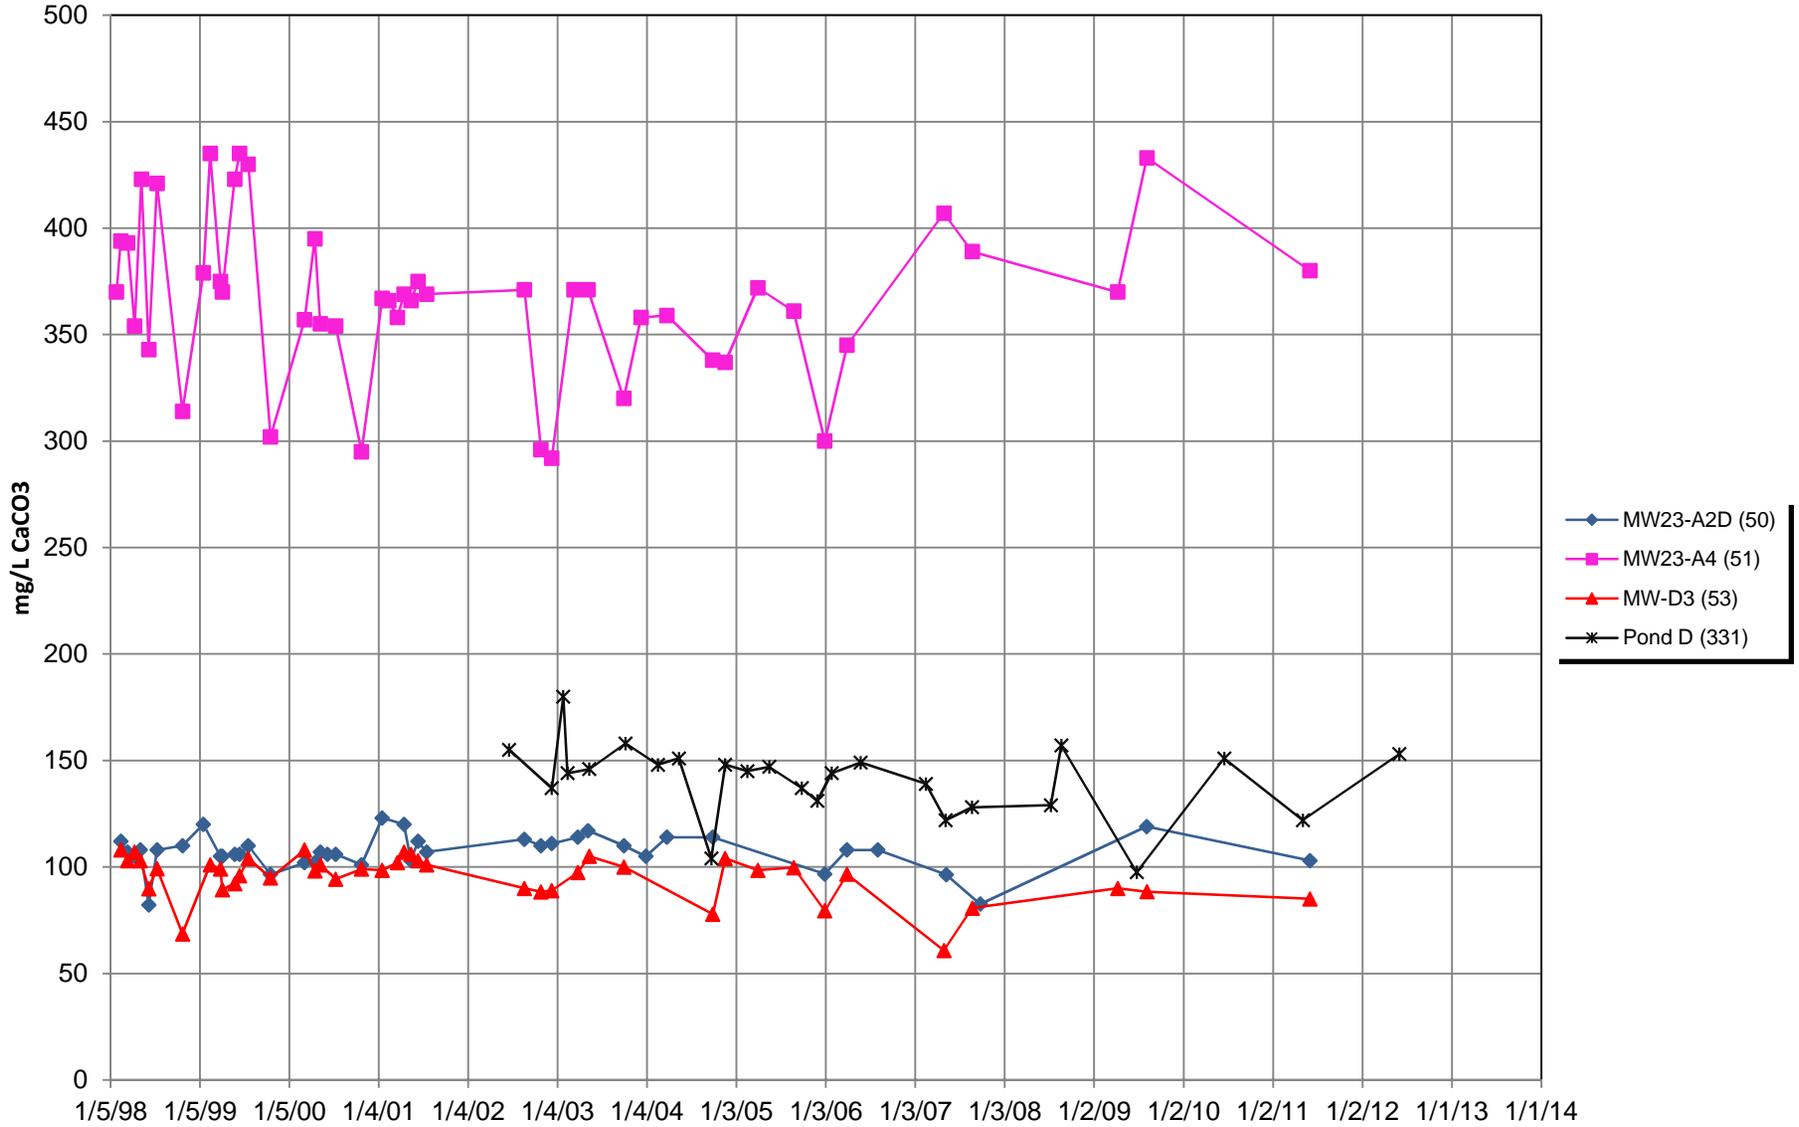
As with pH, high alkalinity values (Figures 3.15a and b) indicate that the waters are well buffered. Fluctuations in alkalinity correlate with those of other parameters, such as hardness (Figures 3.16a and b) and conductivity (Figures 3.17a and b), and also appear to be seasonal. Carbonate minerals in the production rock contribute to the high alkalinity of the drainage from the finger drains. Alkalinity is lowest in samples with the highest groundwater component (e.g. the monitoring wells, Pond D, 23FD-5 and 23FD-7). Calcium and magnesium are the primary contributors to hardness (Figure 3.16a) and reflect dissolution of carbonate minerals, such as calcite and dolomite. Carbonate dissolution neutralizes acidity formed by sulfide oxidation, which is also the source of sulfate shown in Figure 3.18a.

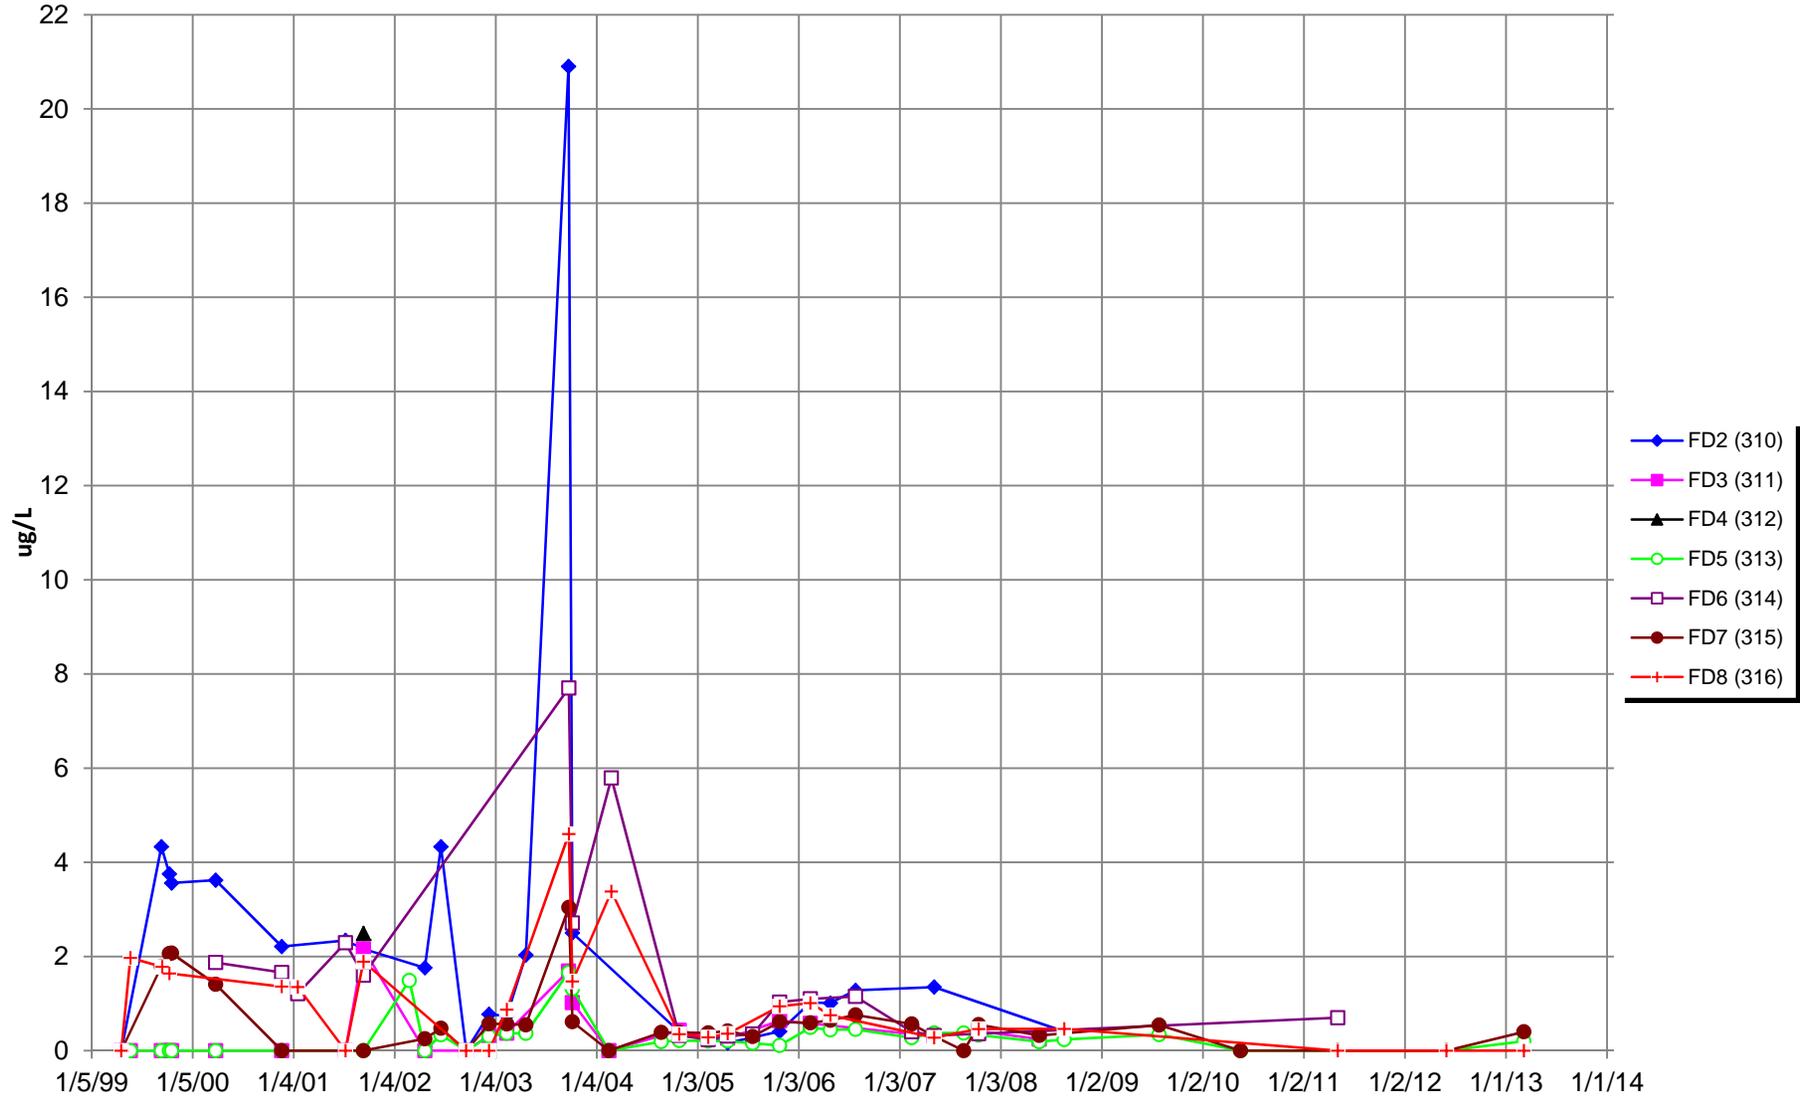
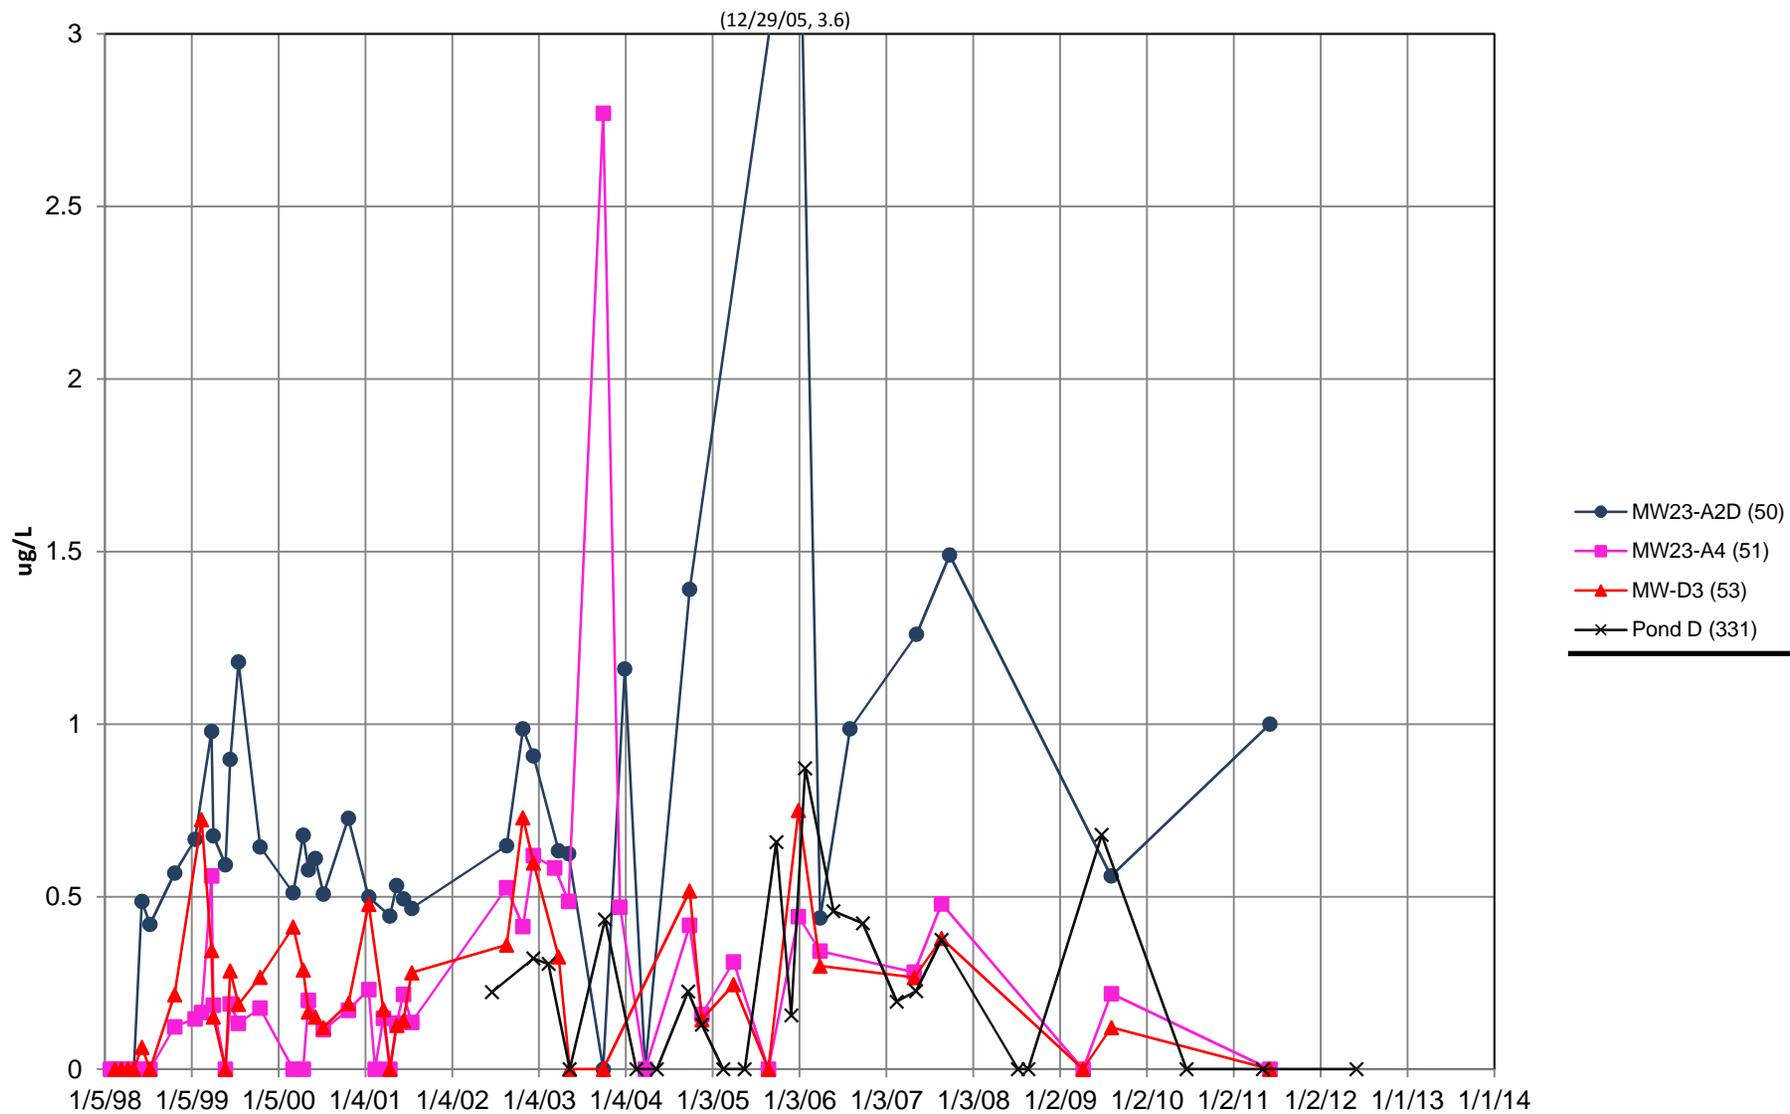
**Figure 3.19a GREENS CREEK SITE 23/D INTERNAL MONITORING SITES:  
FINGER DRAINS ARSENIC DATA**  
(Non-detectable analyses plotted as zero)

Arsenic data are presented in Figures 3.19a and b and are generally quite low. All finger drains and MW-23-A4 experienced increases in their arsenic concentrations in September 2003, with subsequent decreases back down to historical levels in October. The flows in the finger drains positively correlate with these changes. Fluctuations in arsenic values in 23FD-2 can be attributed to changes in redox conditions. Low arsenic and iron (Figures 3.25 a and b) concentrations indicate that these metals are precipitating as oxyhydroxides on rock surfaces in the pile.

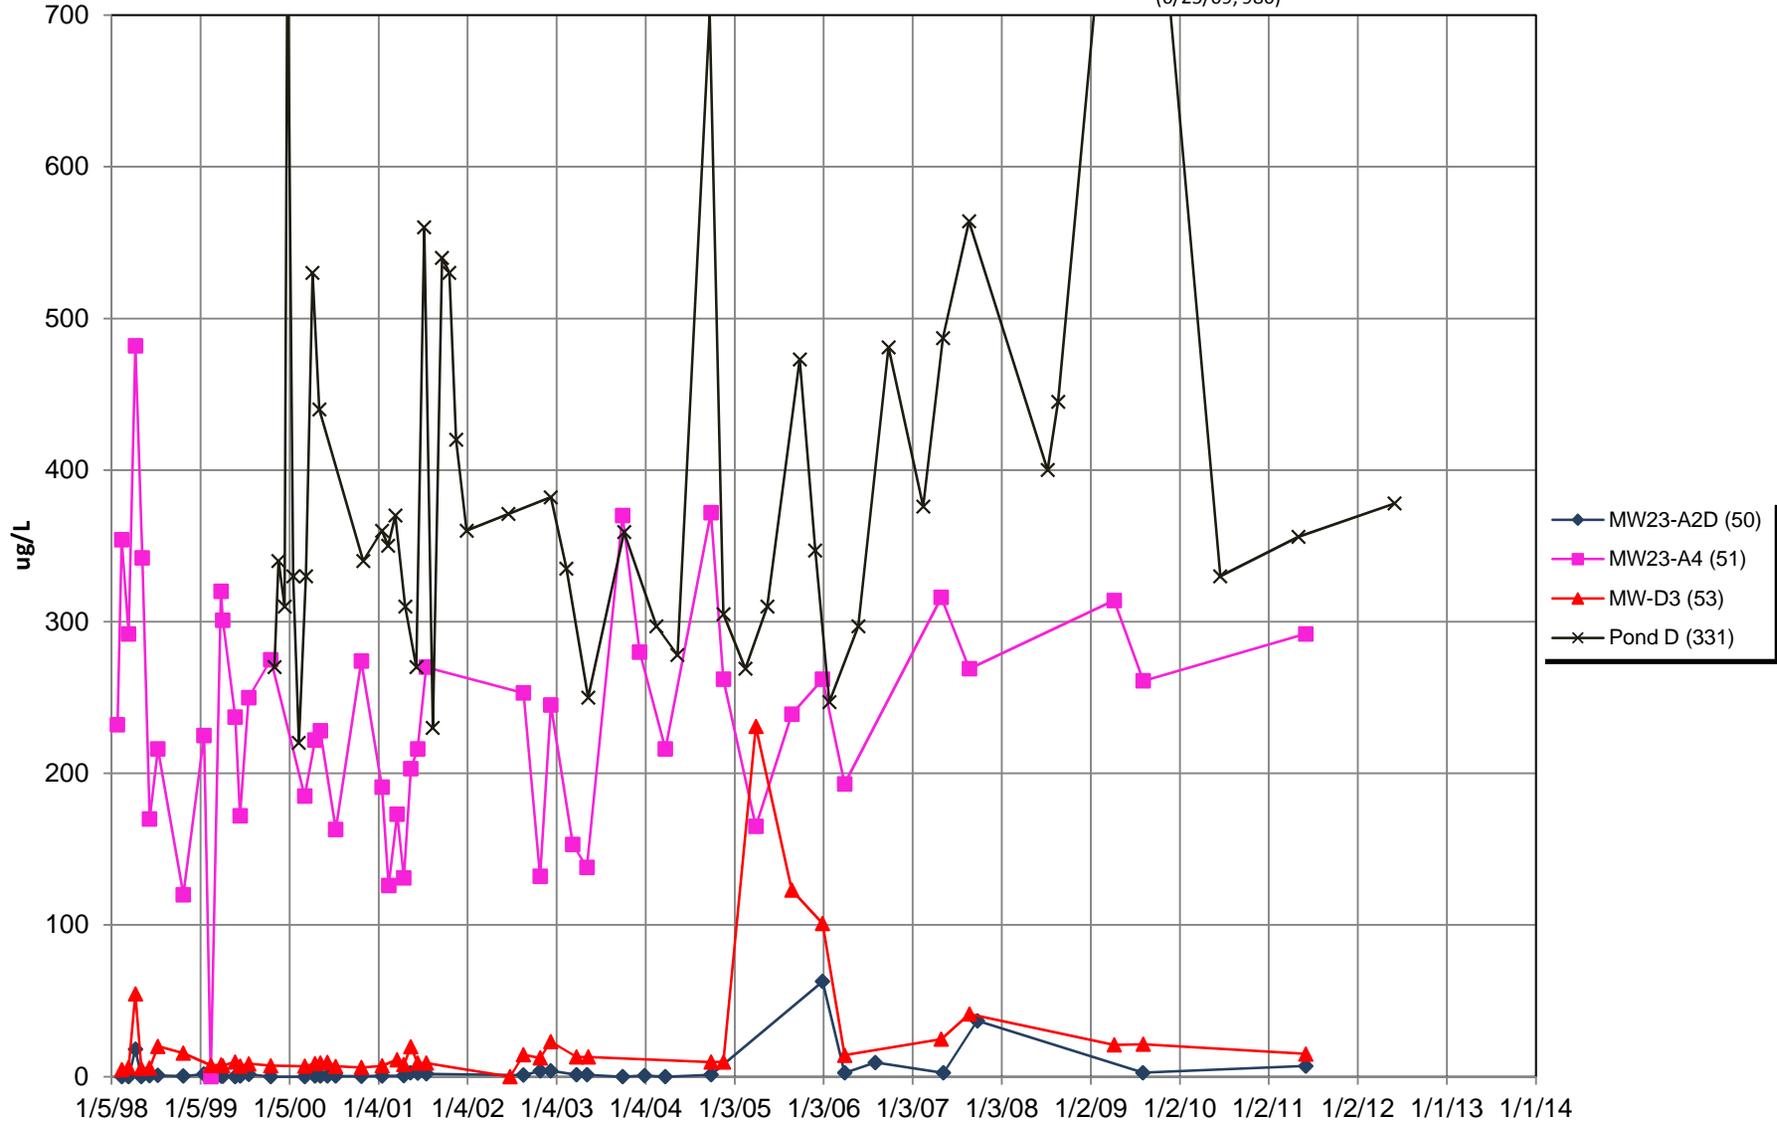
**Figure 3.20b GREENS CREEK SITE 23/D INTERNAL MONITORING SITES:  
GROUND WATER - ZINC DATA  
(Non-detectable analyses plotted as zero)**

Figures 3.20a and b show the concentration of zinc in the internal monitoring locations at Site 23/D. Zinc levels appear to be controlled by seasonal conditions. Zinc concentrations in the range of 20 to 70 mg/L are consistent with laboratory kinetic weathering tests performed on samples of argillite and serpentinite (Vos 1993). The zinc concentrations recorded for Pond D are generally below 0.9 mg/L and reflect contributions from several source waters. Pond D receives water from Site D surface runoff, seeps on the slope and at the toe of the site and the effluent from the curtain drain that HGCMC installed between Site D and Site 23.

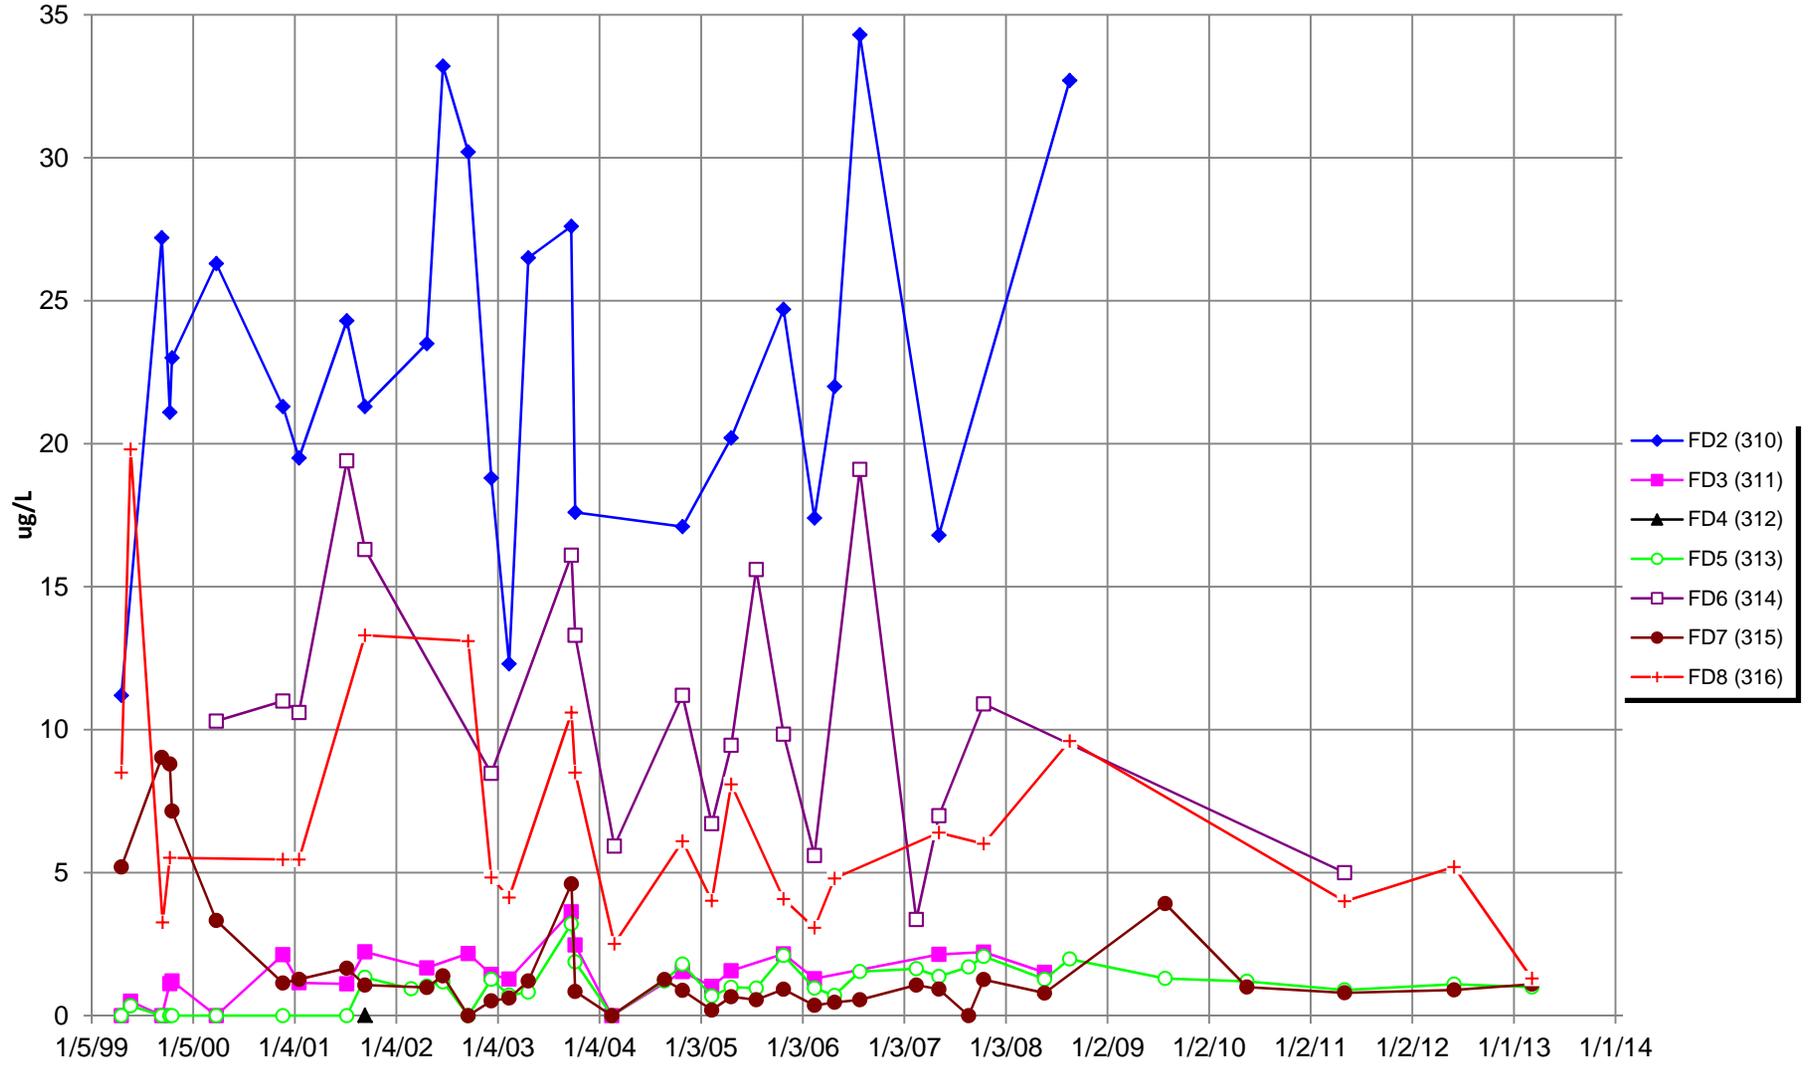
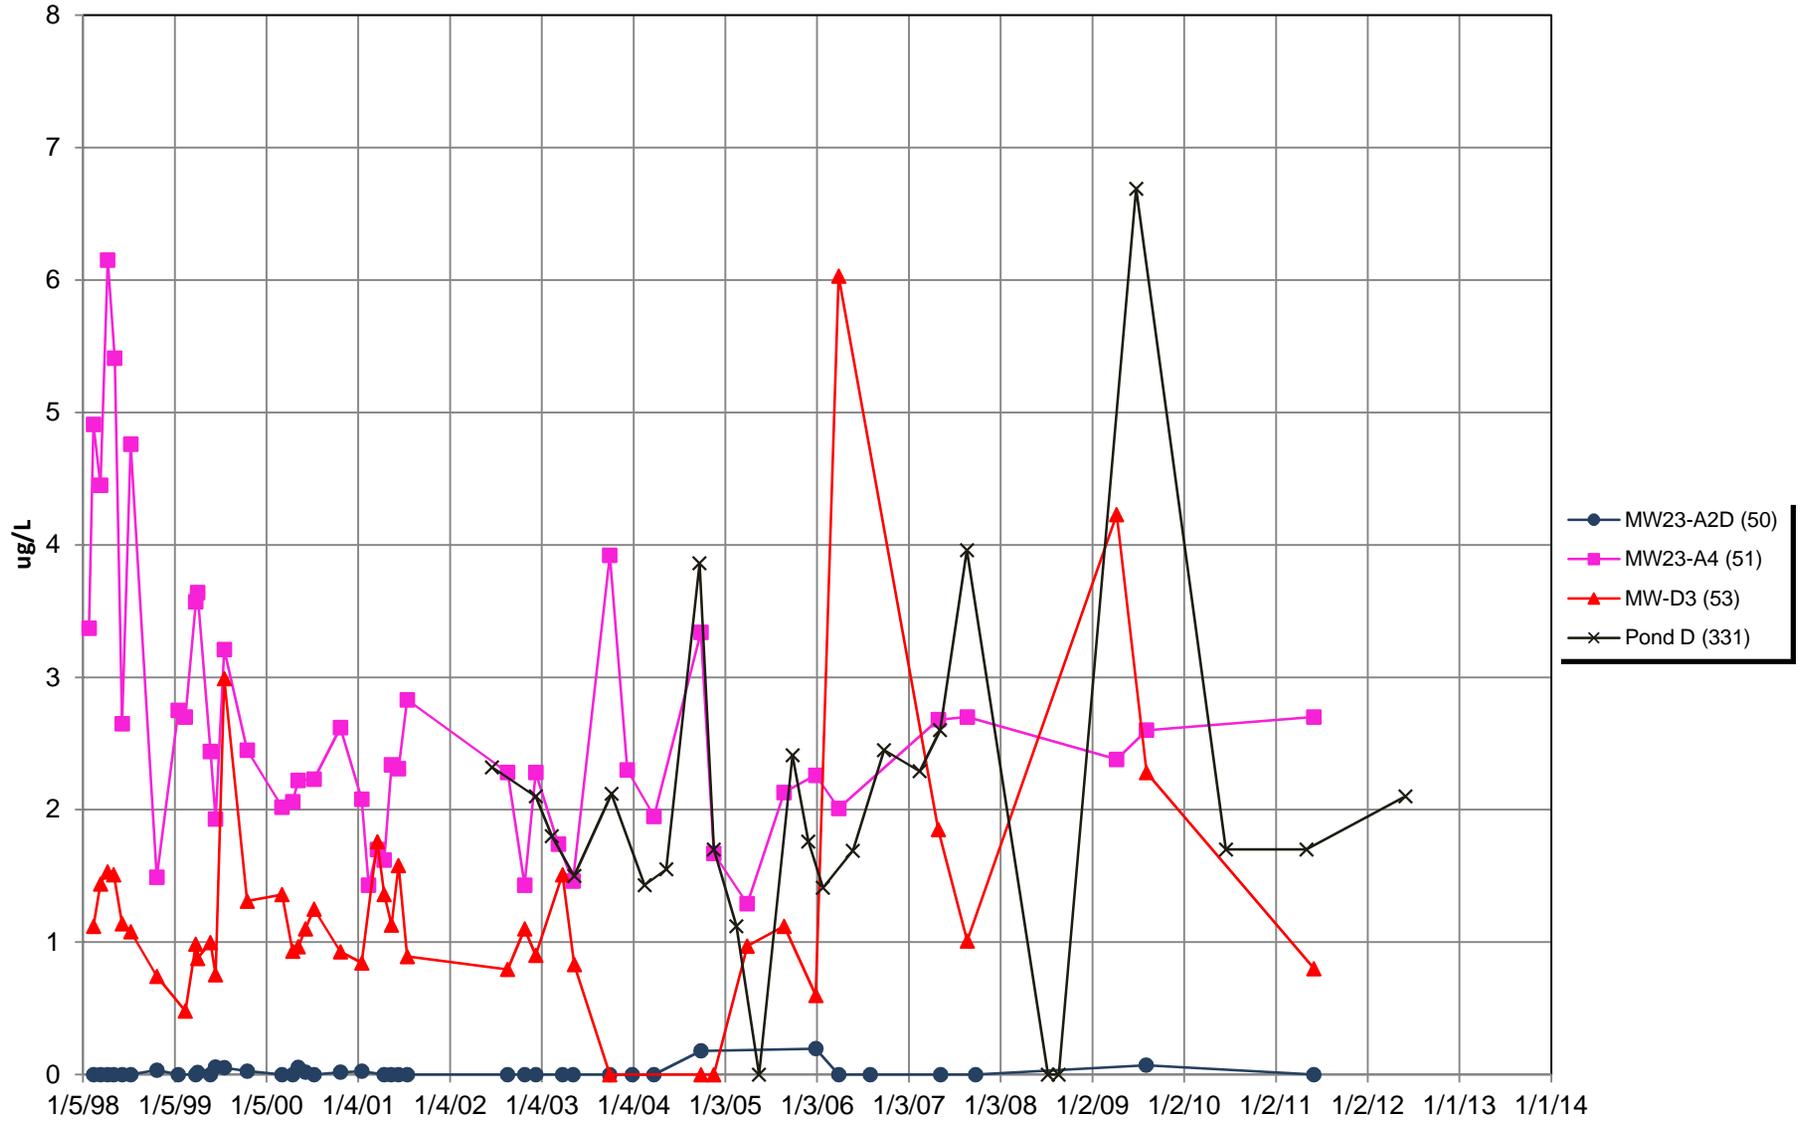
**Figure 3.21a GREENS CREEK SITE 23/D INTERNAL MONITORING SITES:  
FINGER DRAINS - CADMIUM DATA**  
(Non-detectable analyses plotted as zero)

Cadmium concentrations (Figures 3.21a and b) correlate well with those of zinc for the internal monitoring sites although at much lower values (0 to 35 ug/L).

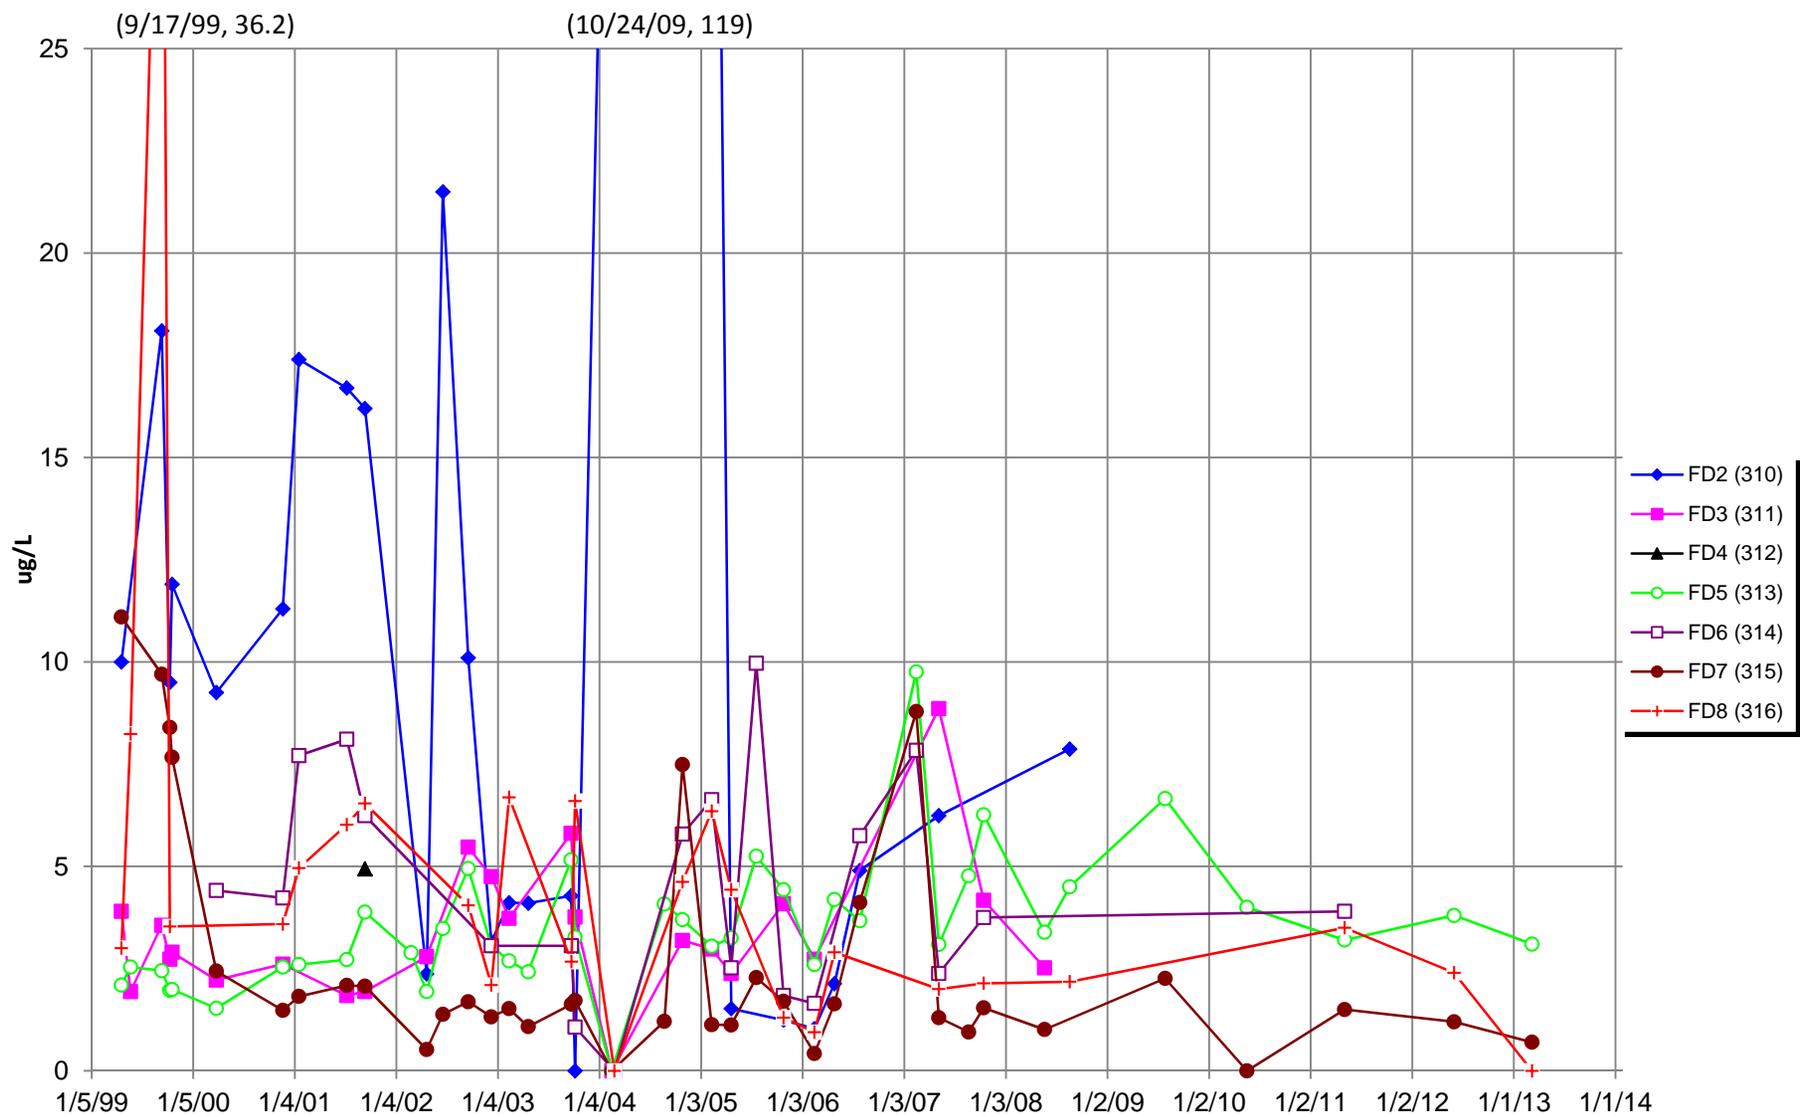
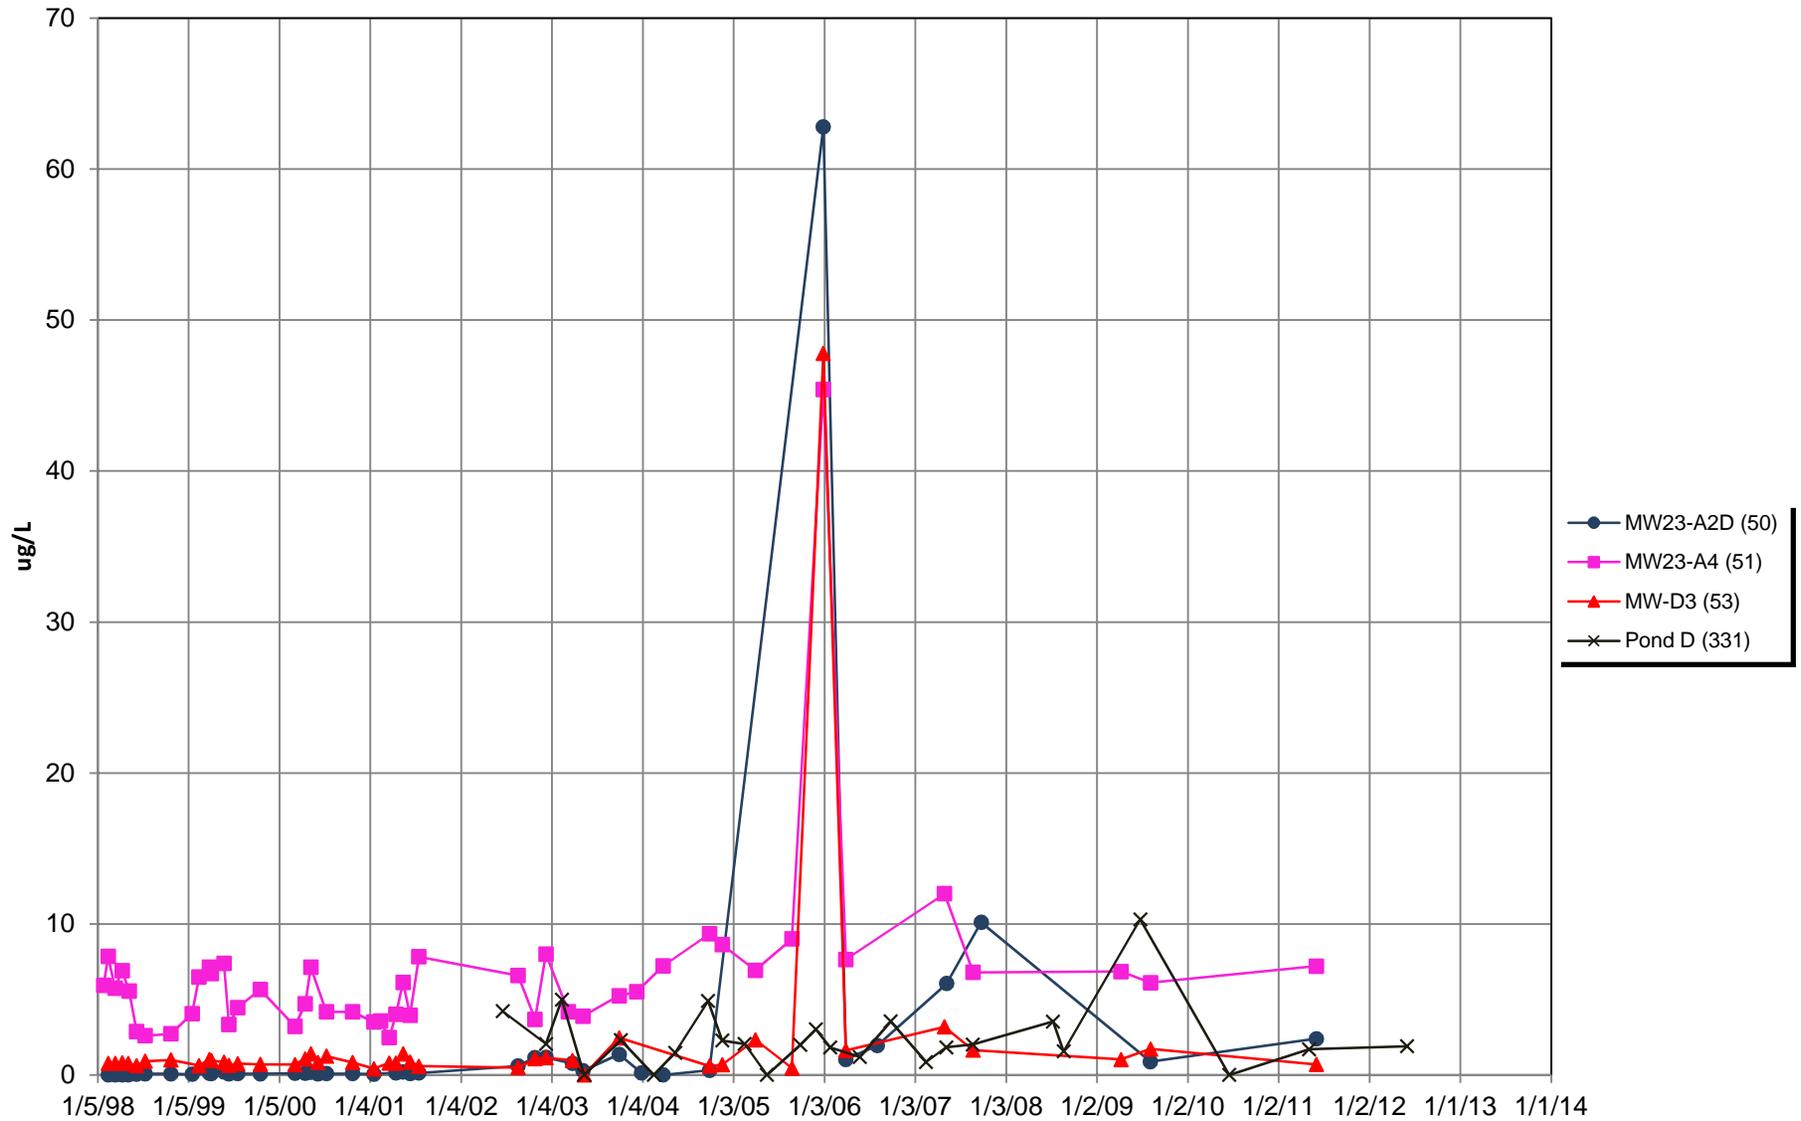
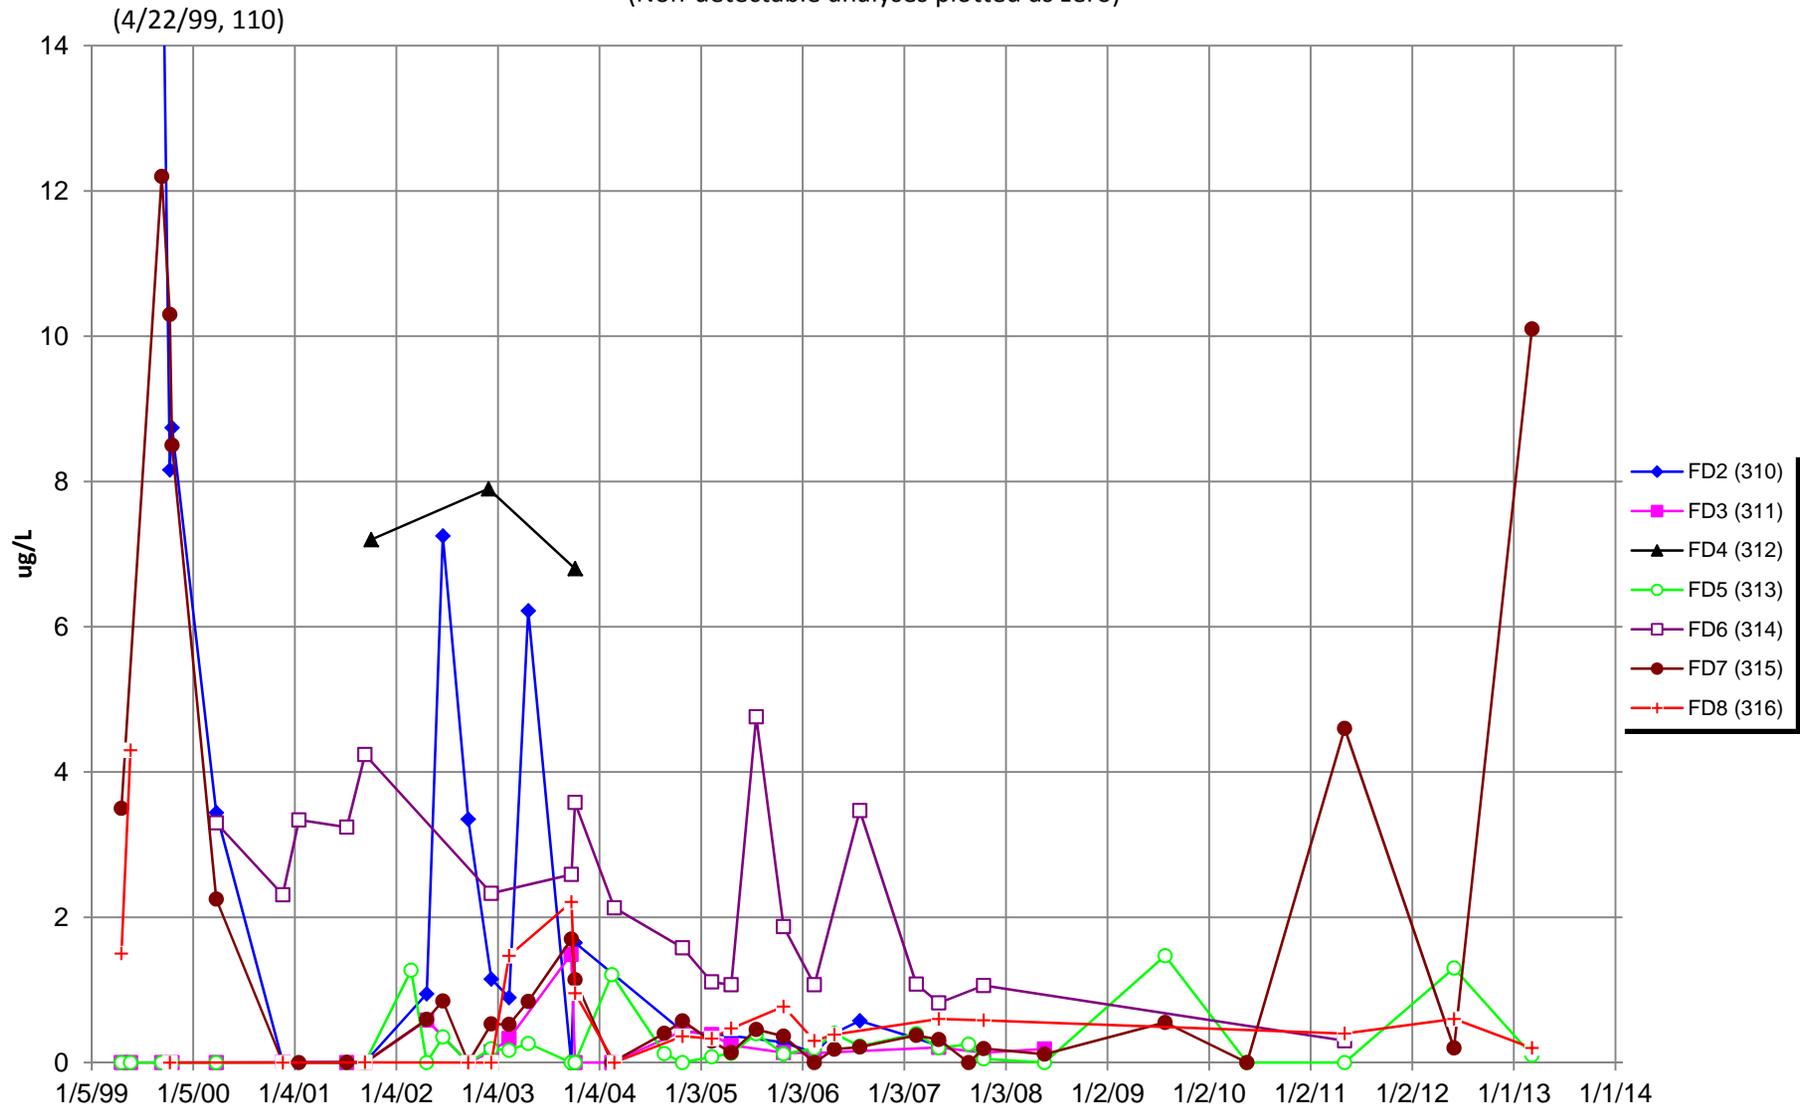
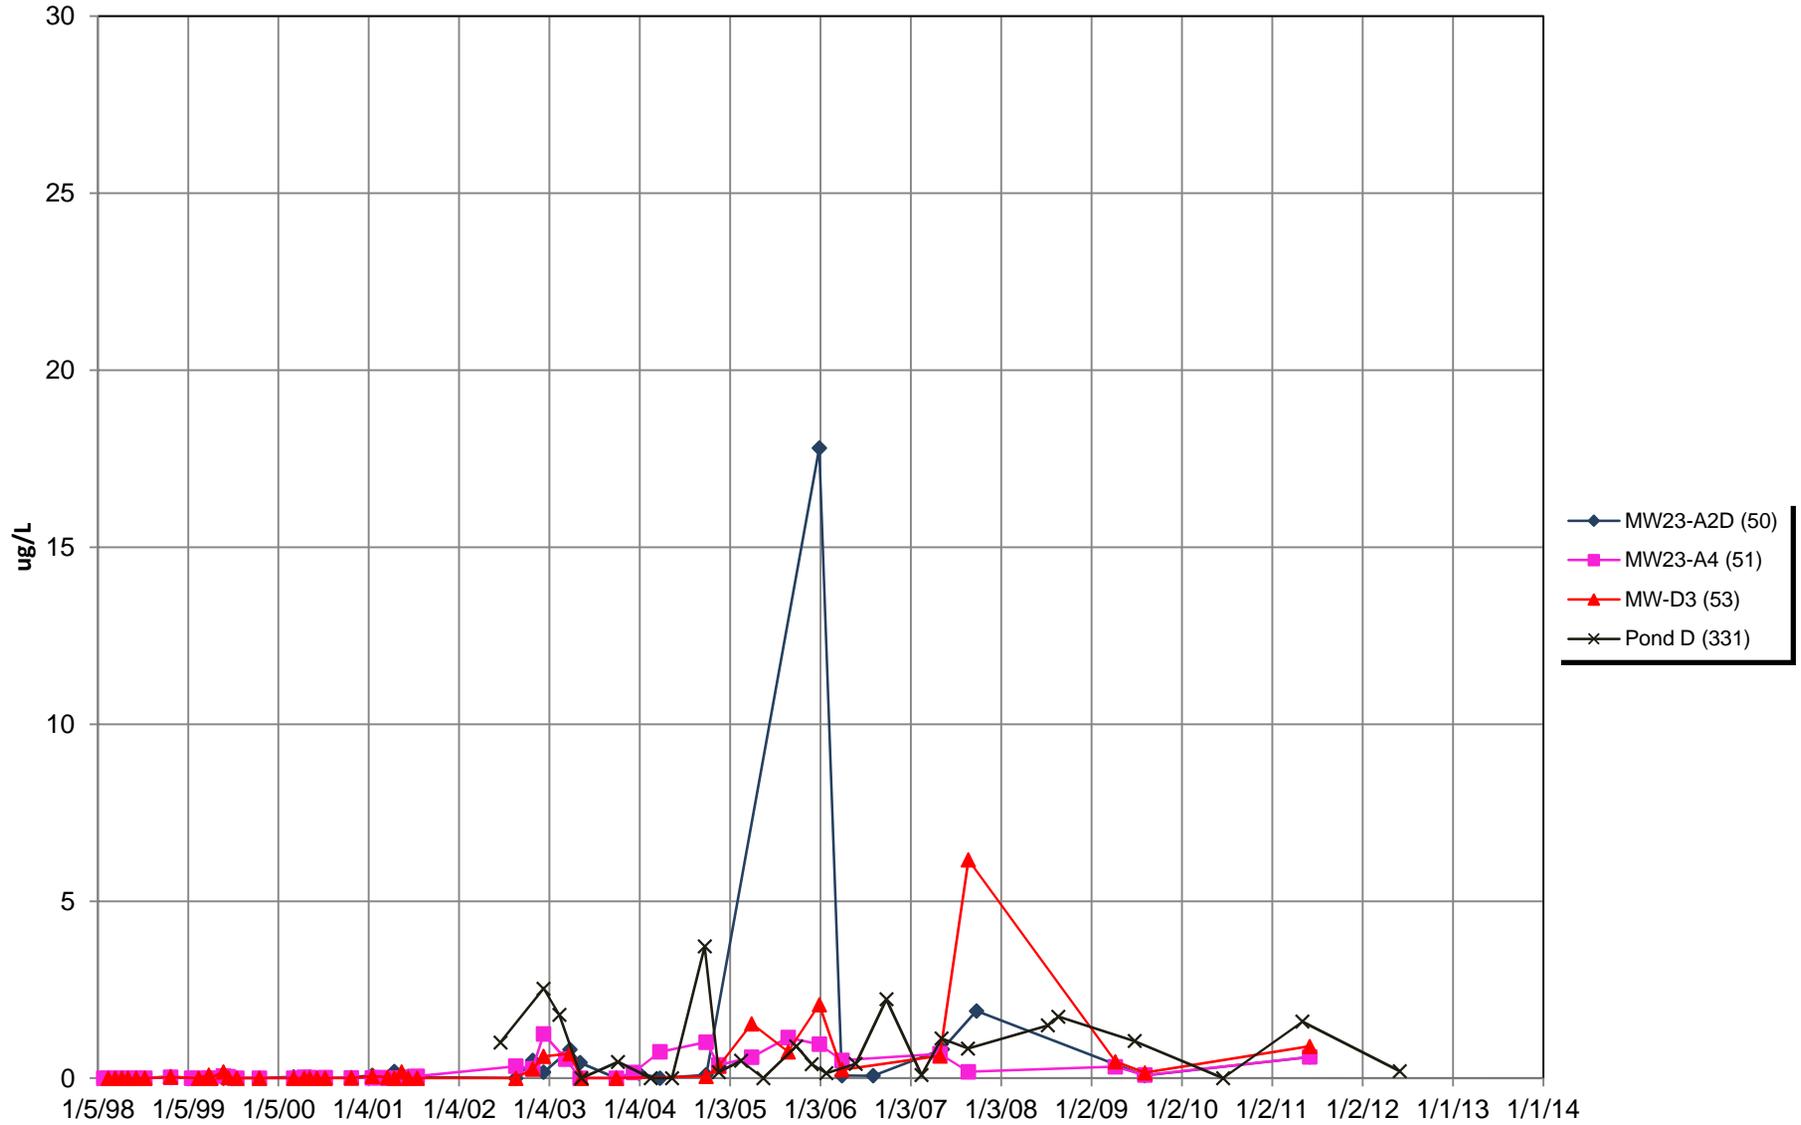
The concentrations of copper and lead (Figures 3.22a and b and 3.23a and b) are considerably lower than that of zinc in the Site 23/D internal monitoring sites. Both of these metals show the same general trends as zinc although 23FD-7 lead levels have increased recently but still remain below zinc levels and Alaska water quality criteria. The nickel concentrations presented in Figures 3.24a and b support the observation that the drainage from 23FD-2 is different than that of other drainages. It is possible that the material that supplies water to this drain has a greater proportion of serpentinite, which was shown to produce higher zinc and nickel concentrations than other rock types such as argillite and phyllite (Vos 1993). What appeared to be a linear increase in nickel concentrations in 23FD-2 prior to 2002 now appears to be decreasing or at least cyclical. The December 2005 sample from MW-23-A2D was an order of magnitude higher than
