**TAILINGS AND PRODUCTION ROCK SITE  
2013 ANNUAL REPORT**

**Hecla Green Creek Mining Company**

**April 15, 2014**

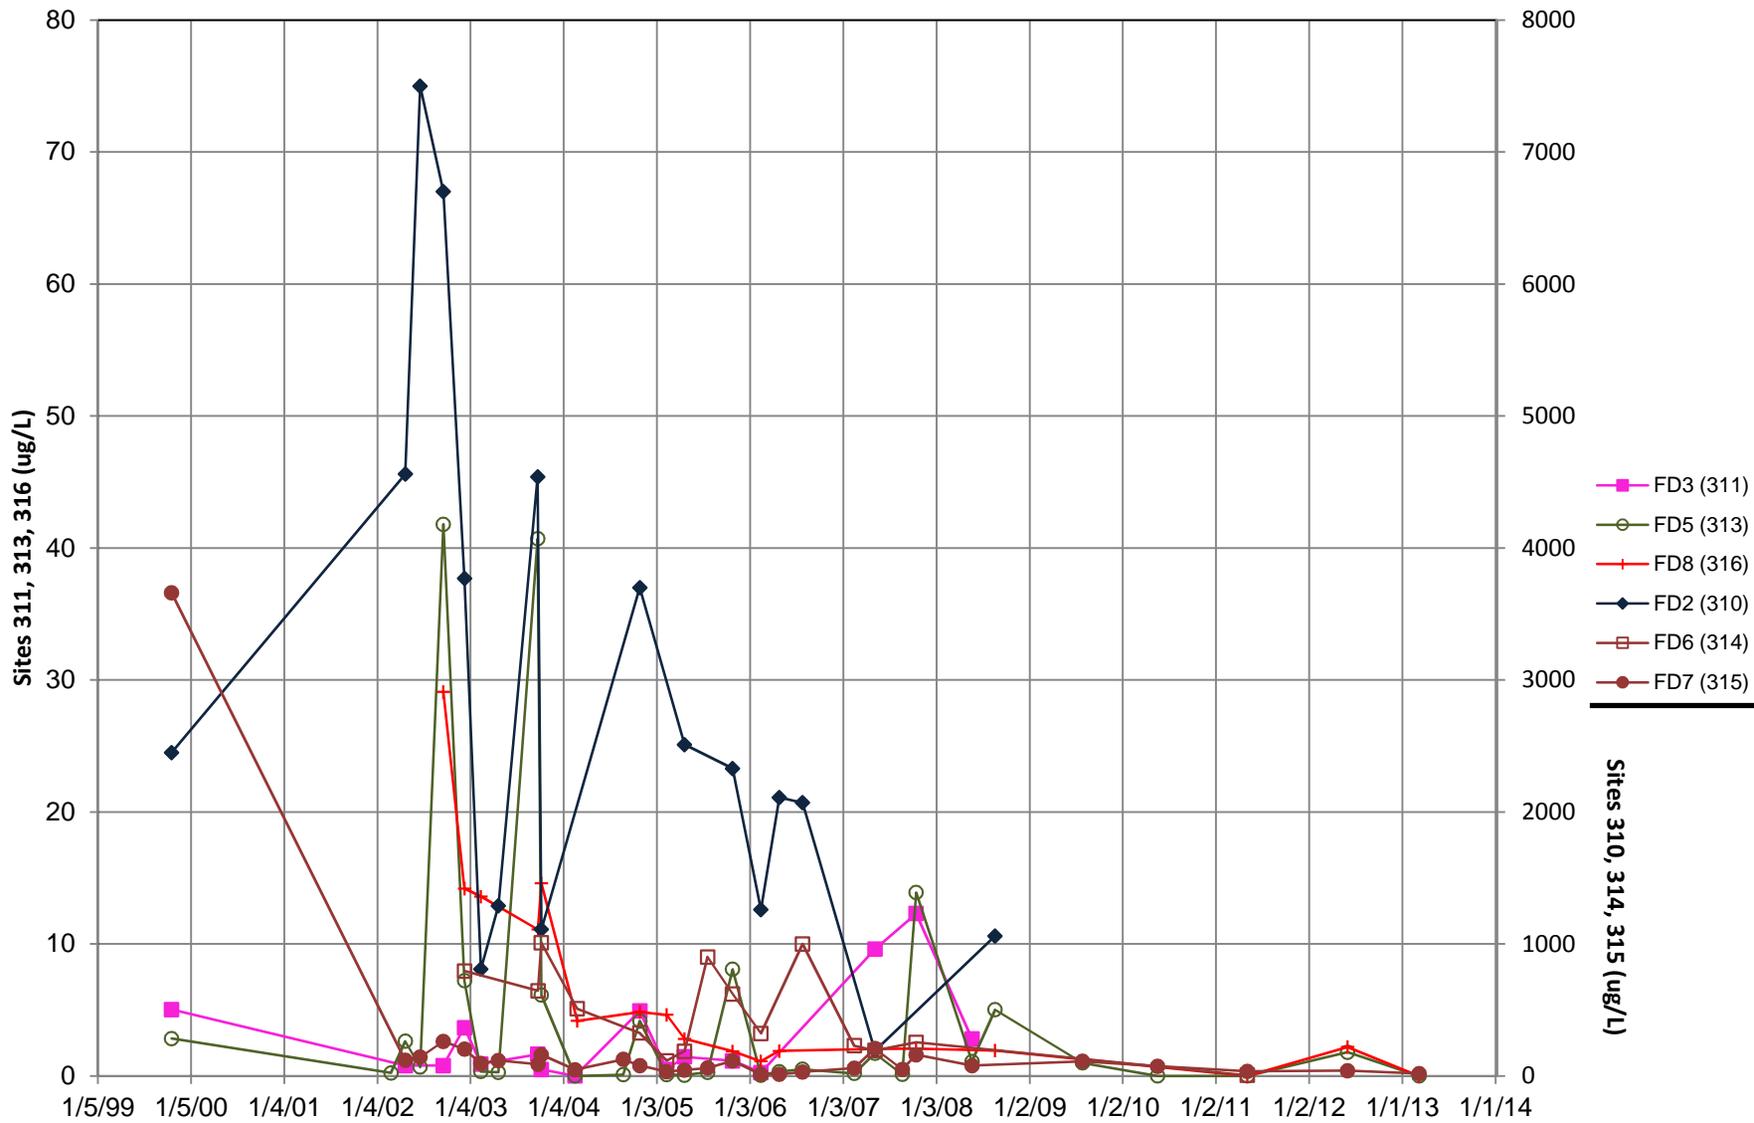
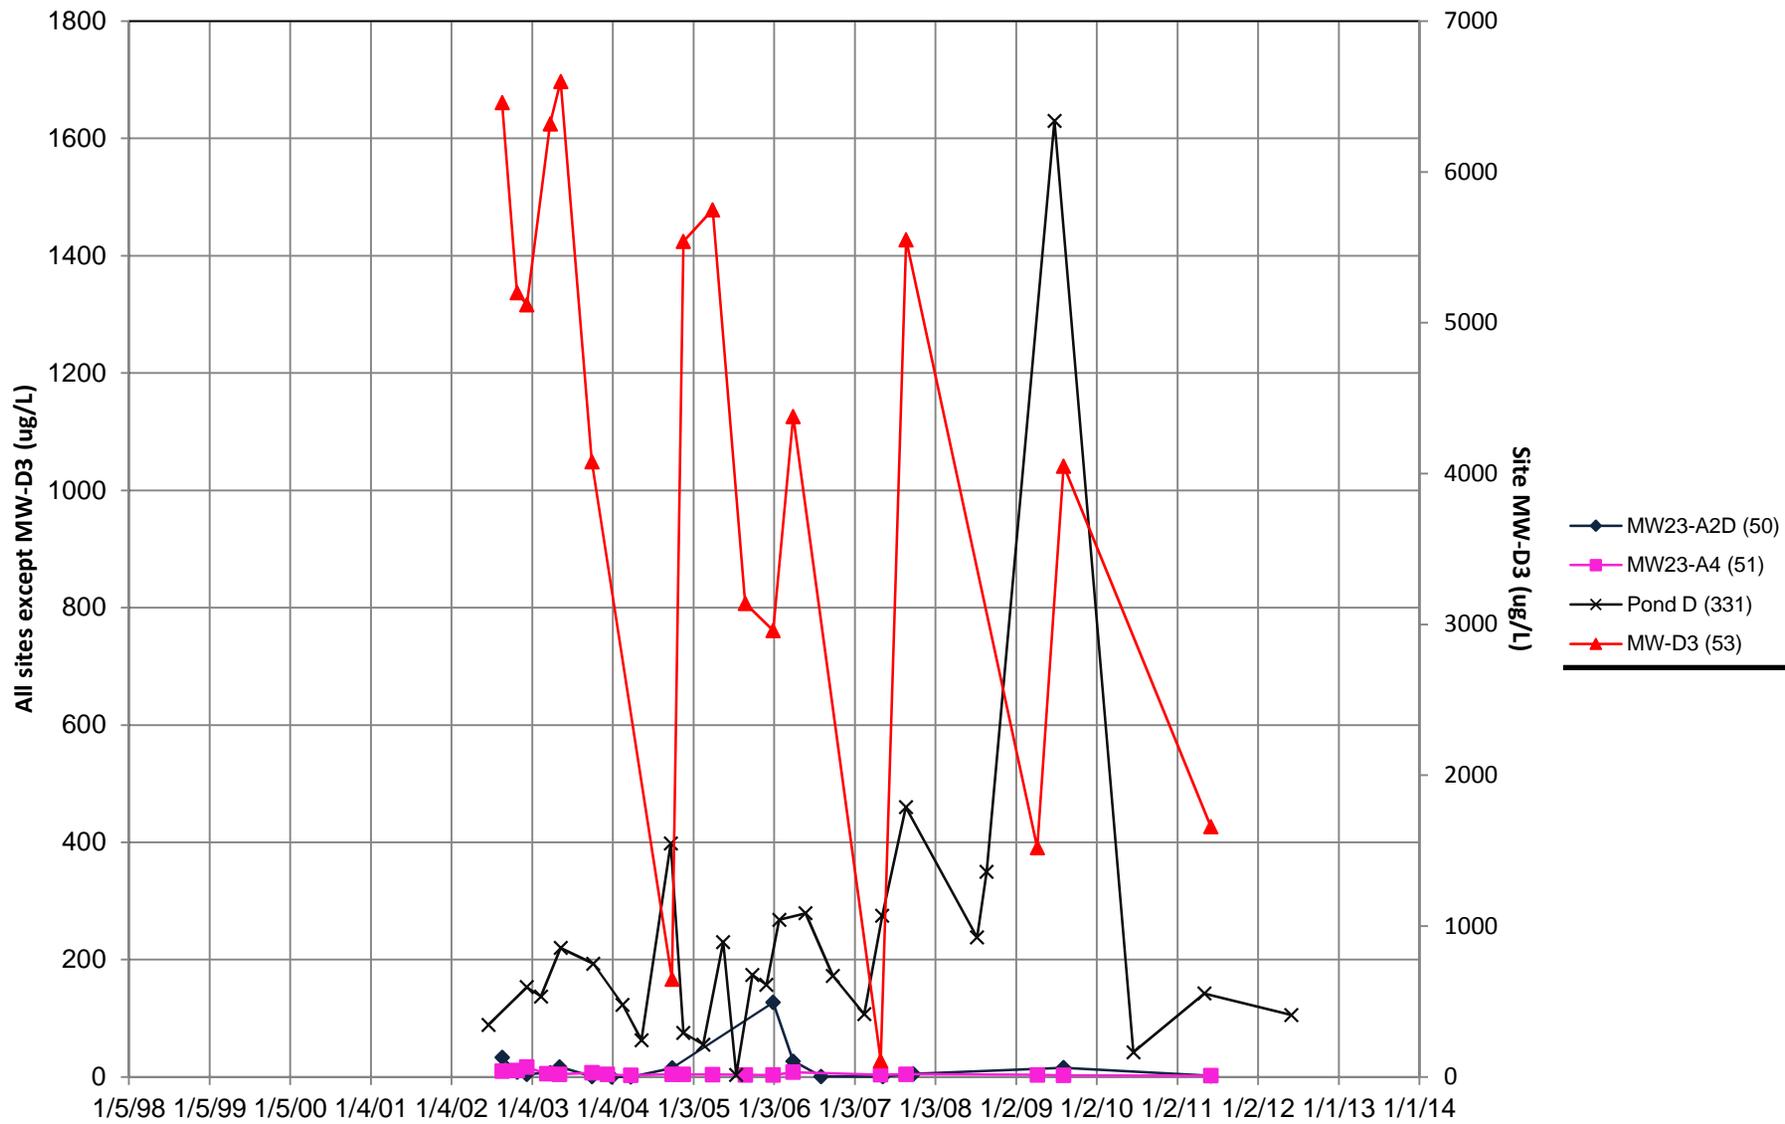
**Figure 3.26a GREENS CREEK SITE 23/D INTERNAL MONITORING SITES:  
FINGER DRAINS - MANGANESE DATA  
(Non-detectable analyses plotted as zero)**

Manganese concentrations (Figures 3.26a and b) are generally less than 50 ug/L for MW23-A2D, MW23-A4, and three of the finger drains (23FD-3, 23FD-5 and 23FD-8). The other three finger drains (23FD-2, 23FD-6 and 23FD-7) and MW-D3 and Pond D have elevated manganese concentrations, indicative of the different redox conditions. Precipitation/dissolution of iron oxyhydroxides and manganese oxides controls the concentrations of iron and manganese in these waters.

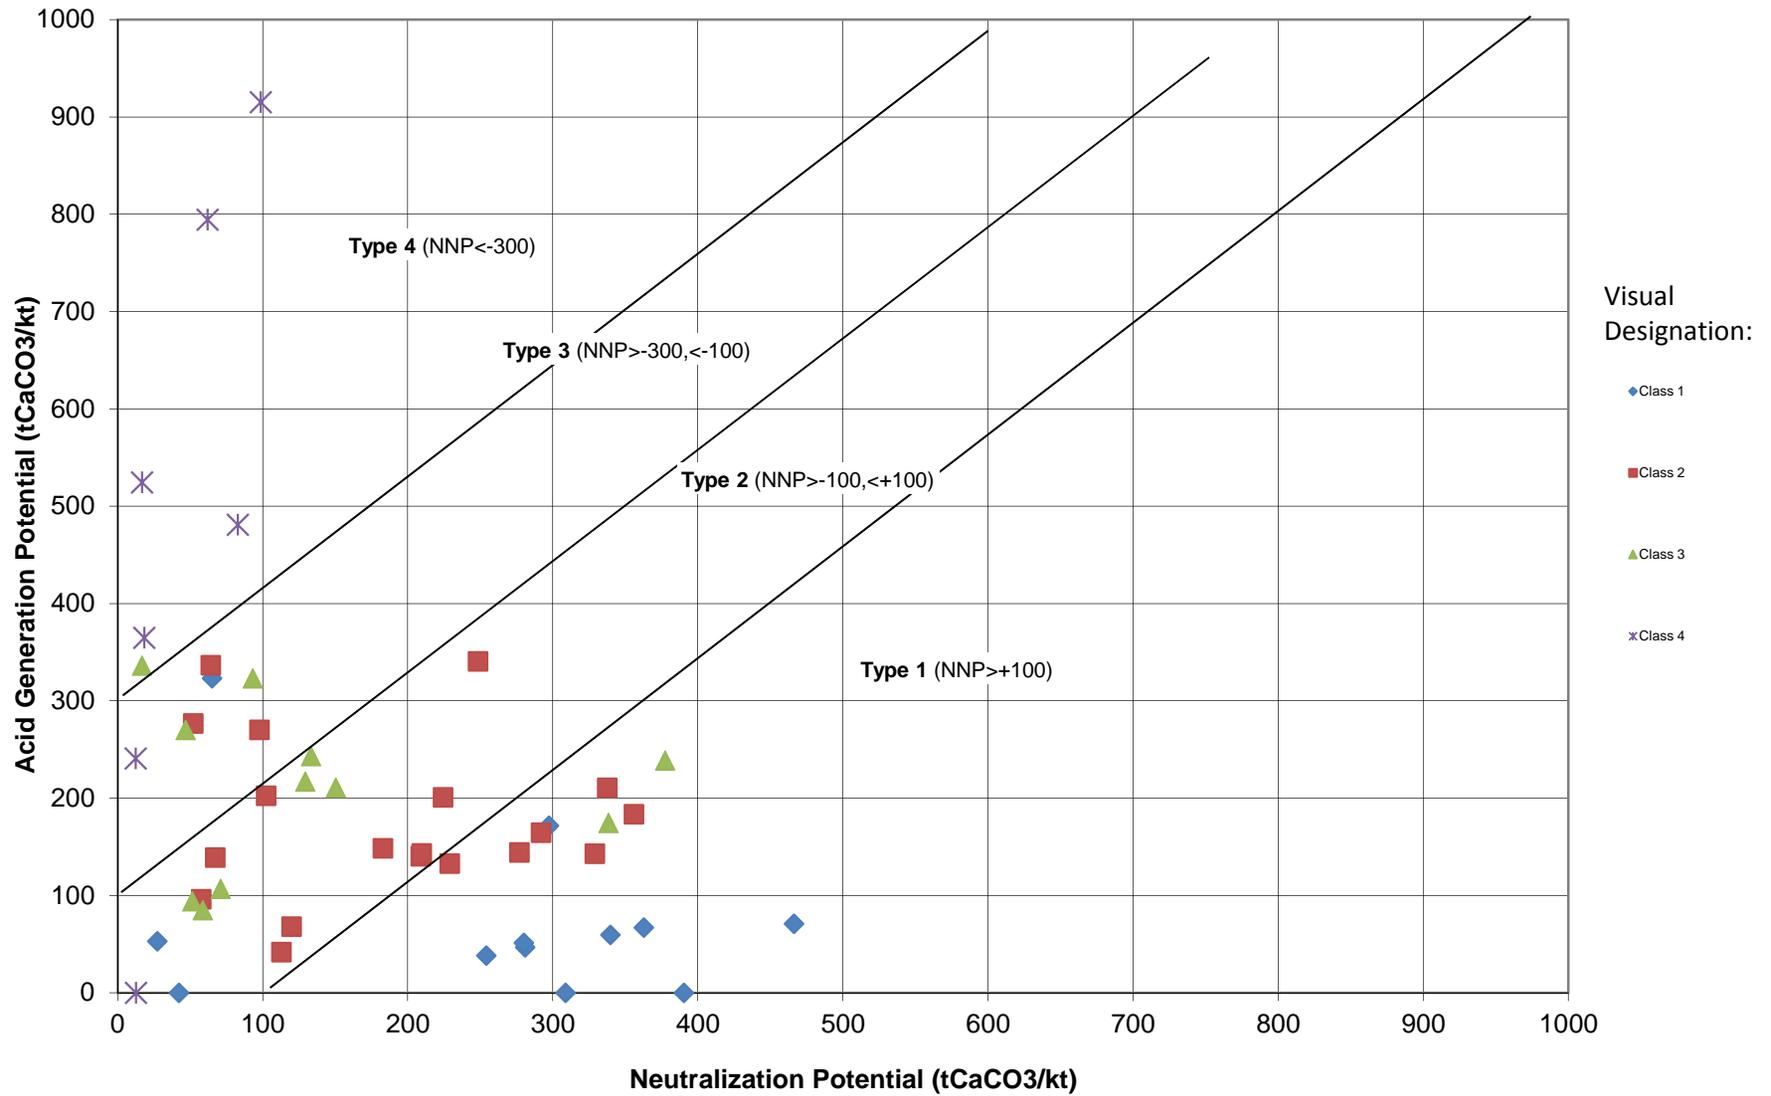
FIGURE 3.28 2013 ABA DATA FROM UNDERGROUND RIB SAMPLES

Acid base accounting (ABA) results from 49 underground rib composites collected in 2013 are presented in Table 3.3 and Figure 3.28. Class 1 rib samples had an average neutralization potential (NP) of 260 tons  $\text{CaCO}_3/1000\text{t}$ , which is equivalent to about 30% carbonate. The Class 1 samples had an average acid potential (AP) of 73 tons  $\text{CaCO}_3/1000\text{t}$ , which produced an average net neutralization potential (NNP) of 186 tons  $\text{CaCO}_3/1000\text{t}$ . Class 1 production rock does not have the potential to generate acid rock drainage; however, HGCMC recognizes the potential for metal mobility (primarily zinc) from this argillite rock. HGCMC has long-recognized this characteristic of Class 1 production rock and handles the material accordingly by placing it in controlled facilities, such as Site 23 and the tailings area.

Figure 3.28 compares actual class designation based on ABA analyses to the results of visual designation use underground to classify the production rock. Of the 49 composites, visual classification assigned 7 samples (14%) to a lower, less conservative class. Twenty eight (57%) of the composites were assigned to the appropriate class and 14 (29%) to a higher, more conservative class. These data represent an 86% success rate for the visual classification program.

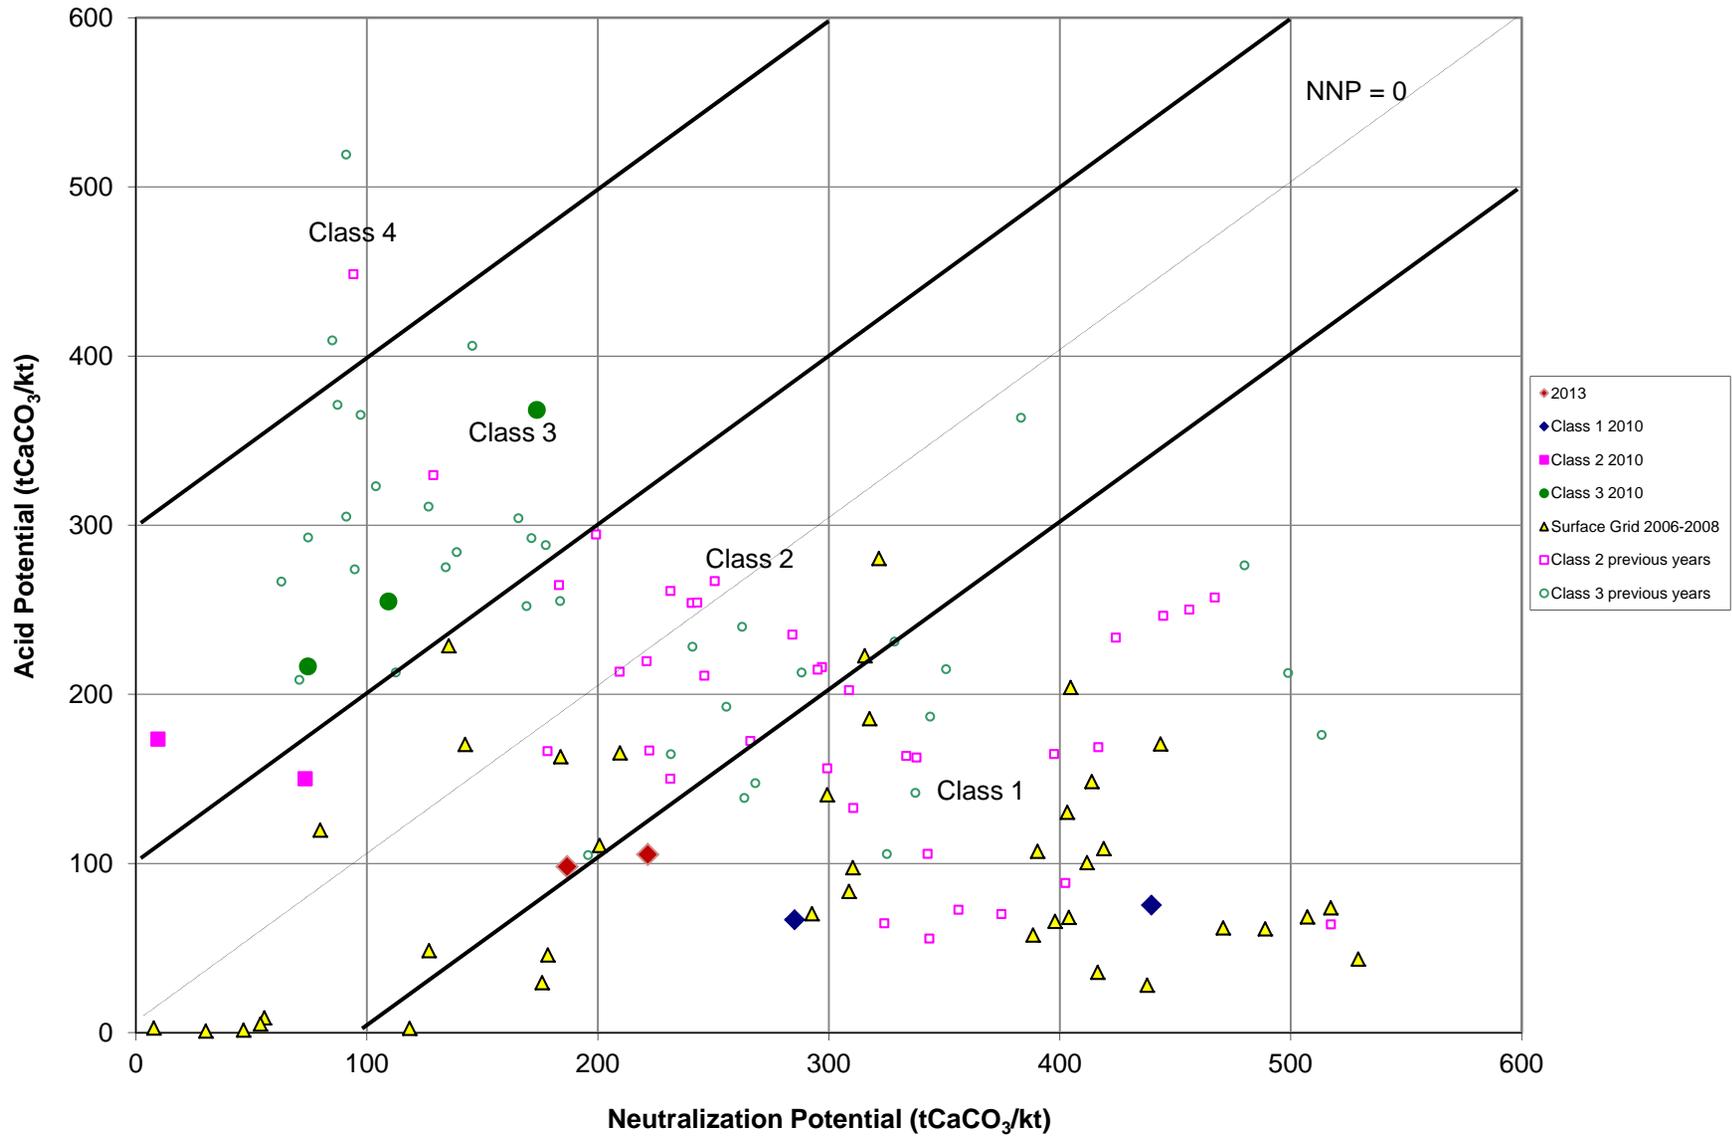
FIGURE 3.29a SITE 23 ABA DATA

No ABA Site 23 active placement composite samples were collected from the pile in 2013. 2010 ABA composite results from the Site 23 active placement areas are shown in Figure 3.29a. Active placement area ABA results from previous years as well as the 2006-2013 grid data are also shown on Figure 3.29a. Paste pH sample results are shown in Figure 3.29b. The AP to NP distribution in the Site 23 samples differs from that of the underground rib samples. The Class 2 and Class 3 stockpile areas are frequently empty except for a safety berm, which is constructed of Class 1 rock in the absence of other material. It is probable that several of the samples included this berm material. The grid sampling is also skewed toward higher NNP values because most of the outer surface of the pile is covered with Class 1 rock.

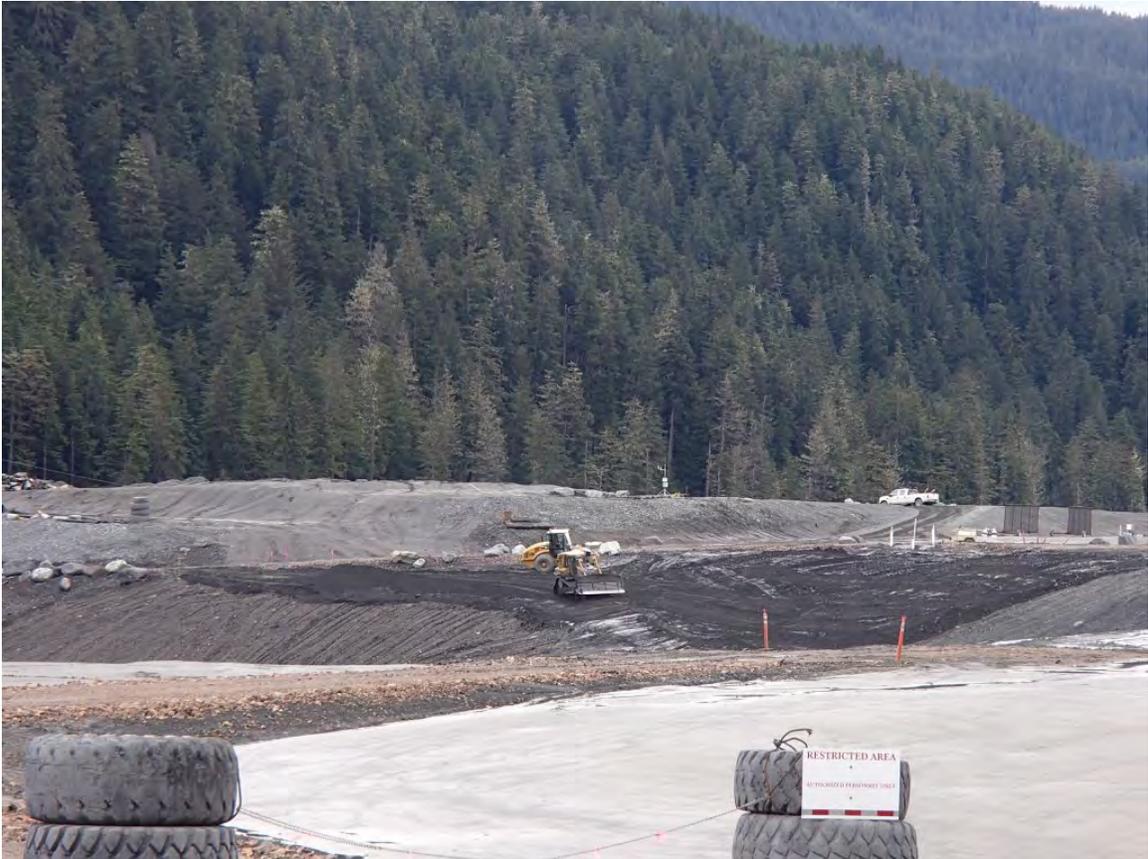
Photographs are presented in Figures 2.38 to 2.39 (Appendix 4). Figure 2.38 is a photo of the northwest area in the fall of 2013 with recently placed tailings, and Figure 2.39 is an aerial photo of the Tailings Facility in September 2013.

Figure 2.38 TDF northwest area in the fall of 2013 during tailing placement

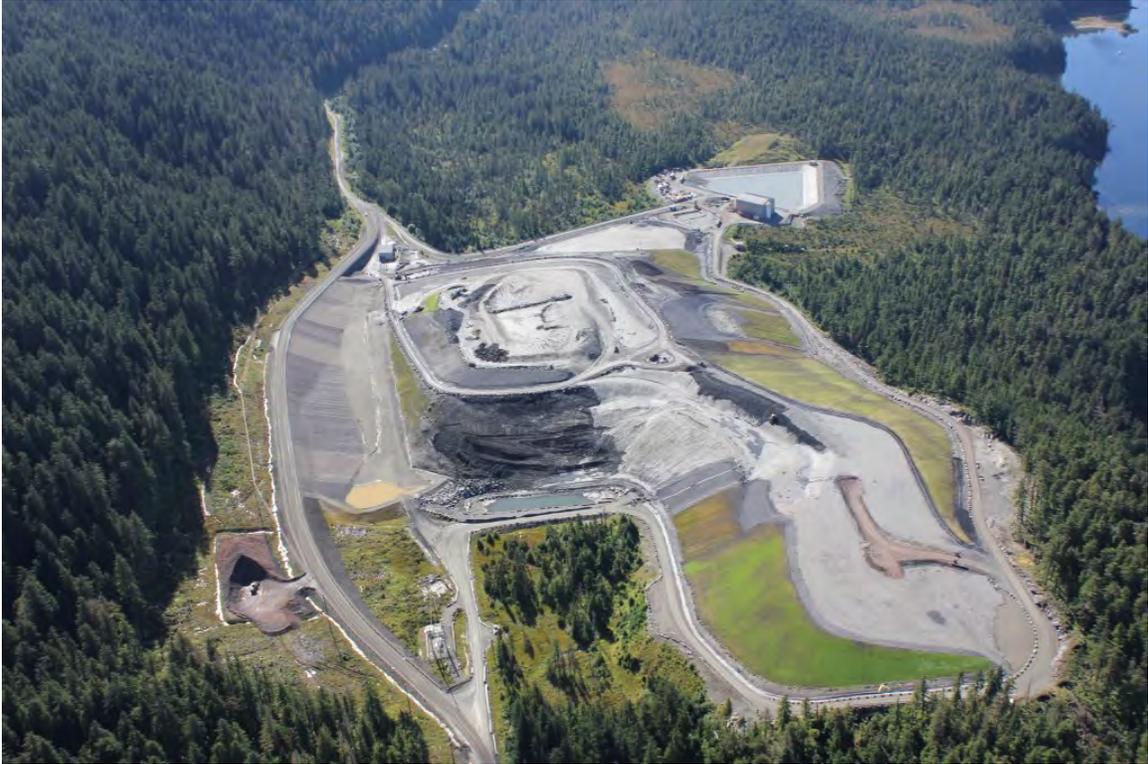
Figure 2.39 Tailings Aerial Photo September 2013

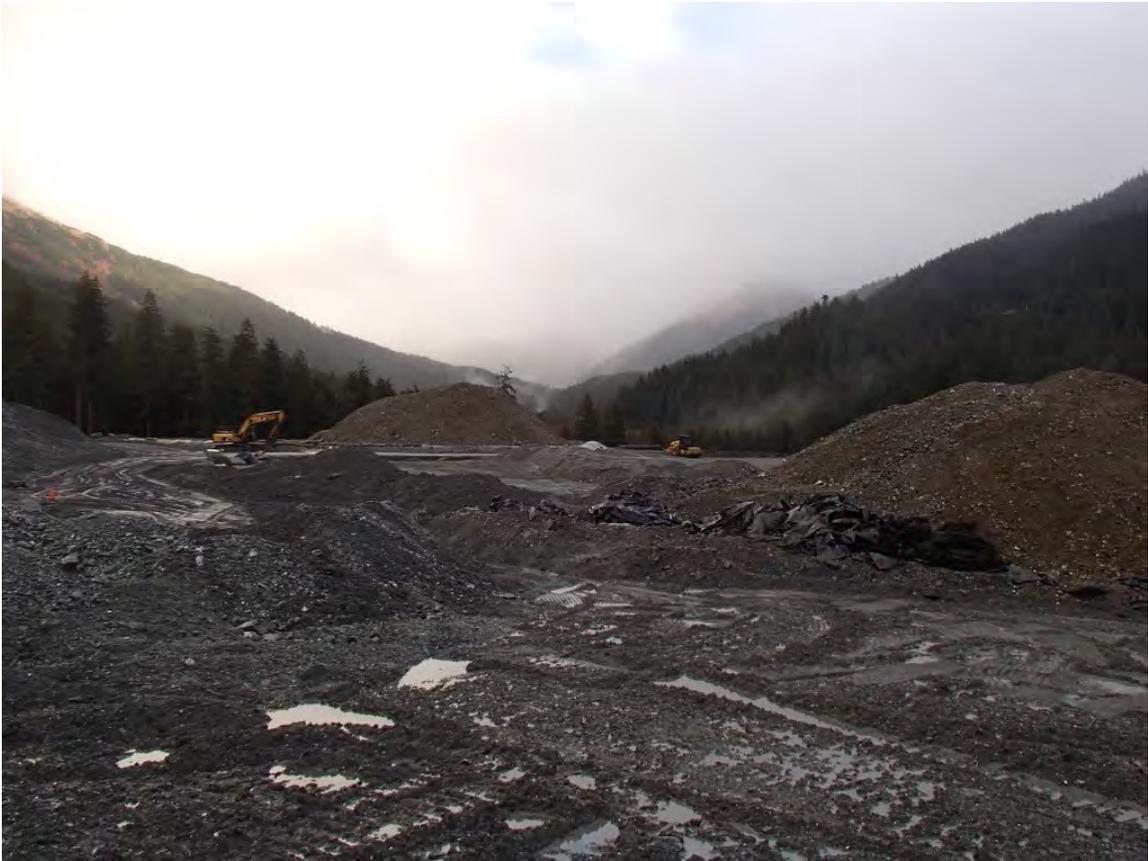
Figure 3.34 shows a photo of Site 23 in October 2013 with a pile of 1350 reclamation material placed on the eastern- pad. An aerial photo of Site 23 in September 2013 is shown in Figure 3.35.

Figure 3.34 Site 23 - October 2013 Reclamation material pile from the 1350 on the far (east) end

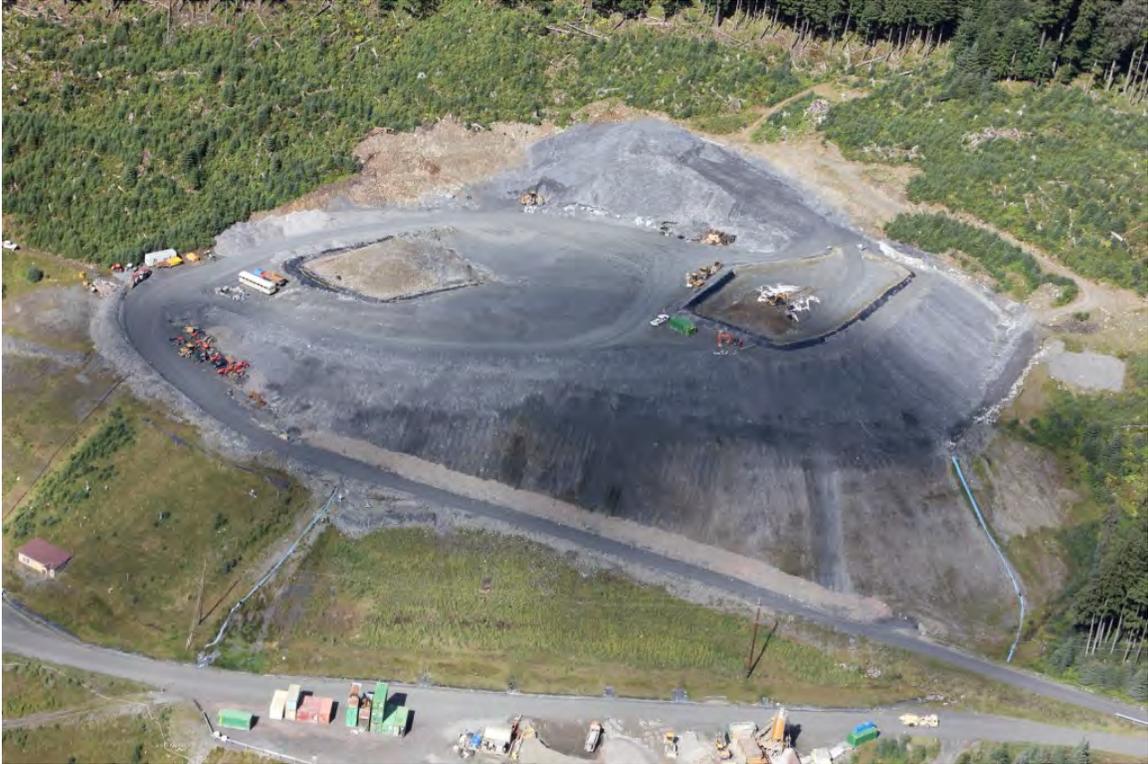
In 2008, HGCMC received approval from ADEC to construct an interim disposal area for waste rock to be backfilled underground (see photo Figure 3.35). A 25,000 cubic yard capacity area was constructed to aid in concurrent reclamation efforts and can potentially be utilized on a continual 12-month schedule. This was a large increase over the previous 920 remuck bay which had a

Figure 3.35 Site 23 Aerial Photo (oblique north view) Temporary Disposal Area- September 2013
