**ACTIVE TAILINGS AND PRODUCTION ROCK SITE
2016 ANNUAL REPORT**

Hecla Greens Creek Mining Company

April 15, 2017

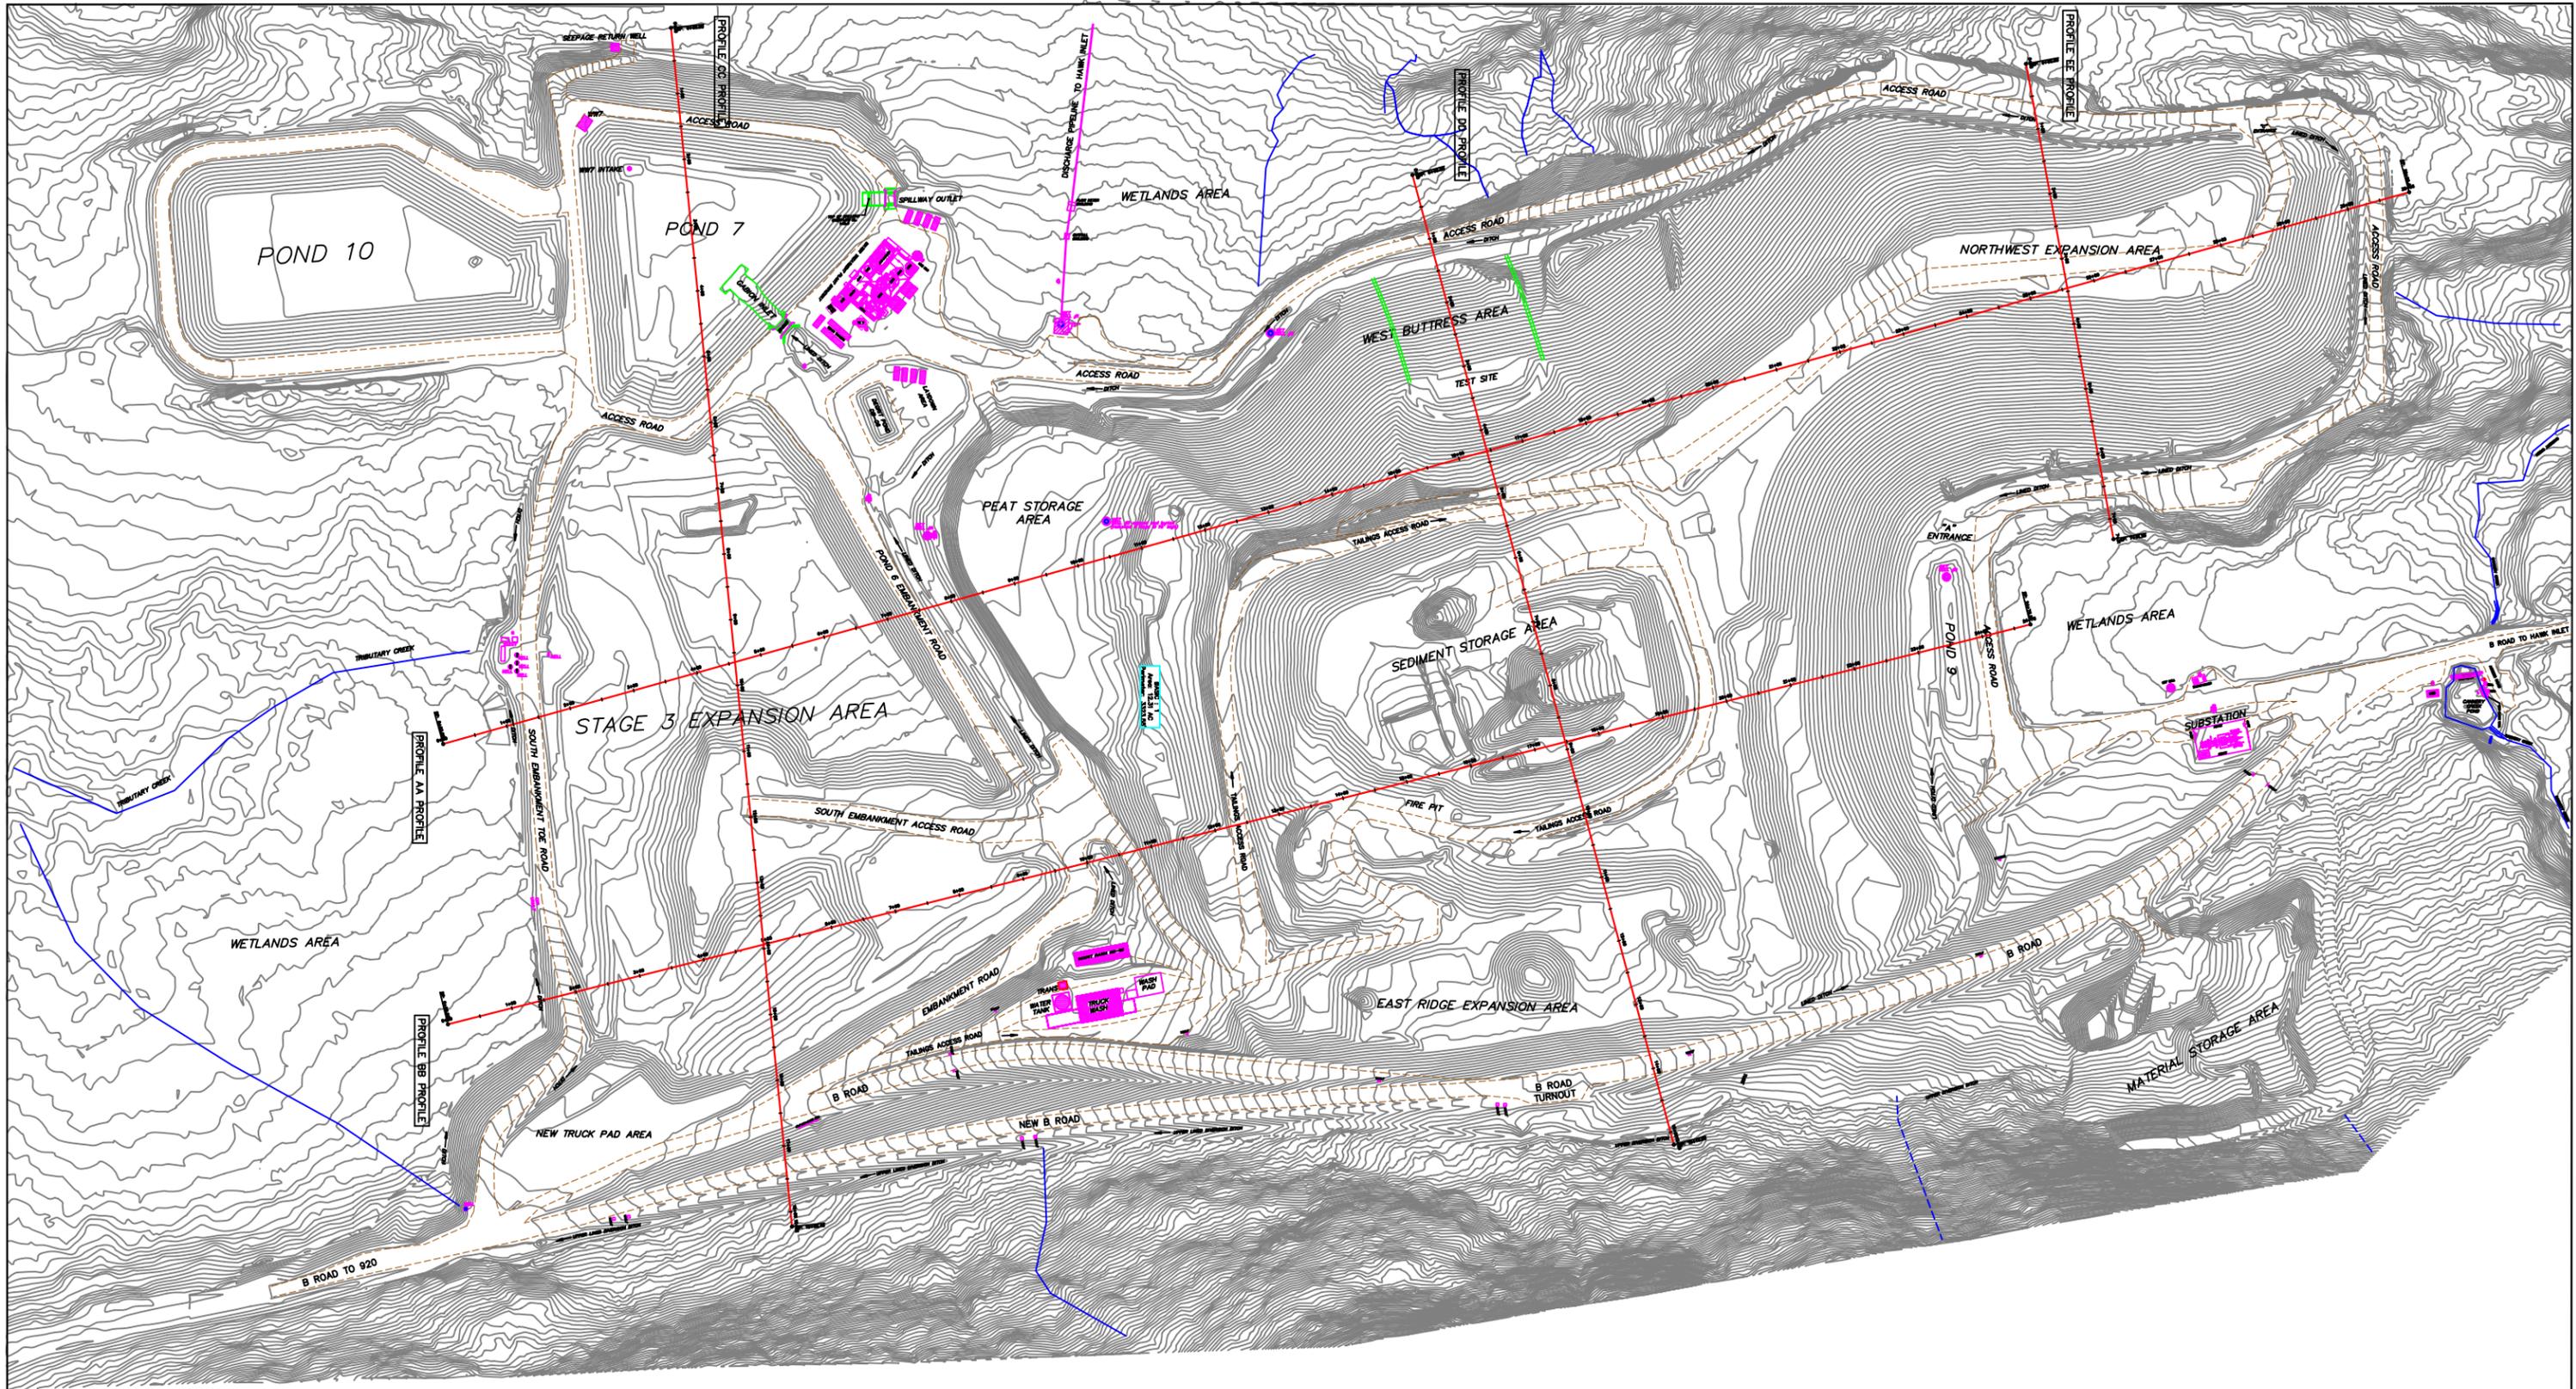
TDF Layout

The Tailing Facility as-built is shown in Attachment G. The maximum saturated thickness (approximately 35 feet) occurs near the center of the main portion of the pile. However, this elevated water table level does not extend close to the down-slope toe of the pile. The foundations of the West Buttress and southern portion of the pile are well drained, as indicated by typically consistent unsaturated conditions in the blanket drains and at the base of the West Buttress (piezometer 74 in Attachment D). Low head elevations near the pile toe maximize the pile's geotechnical stability. Intermittent head increases in the foundation drains are localized and of short duration and should not have an adverse effect on pile stability.
