**TAILINGS AND PRODUCTION ROCK SITE
2008 ANNUAL REPORT**

Hecla Greens Creek Mining Company

April 15, 2009

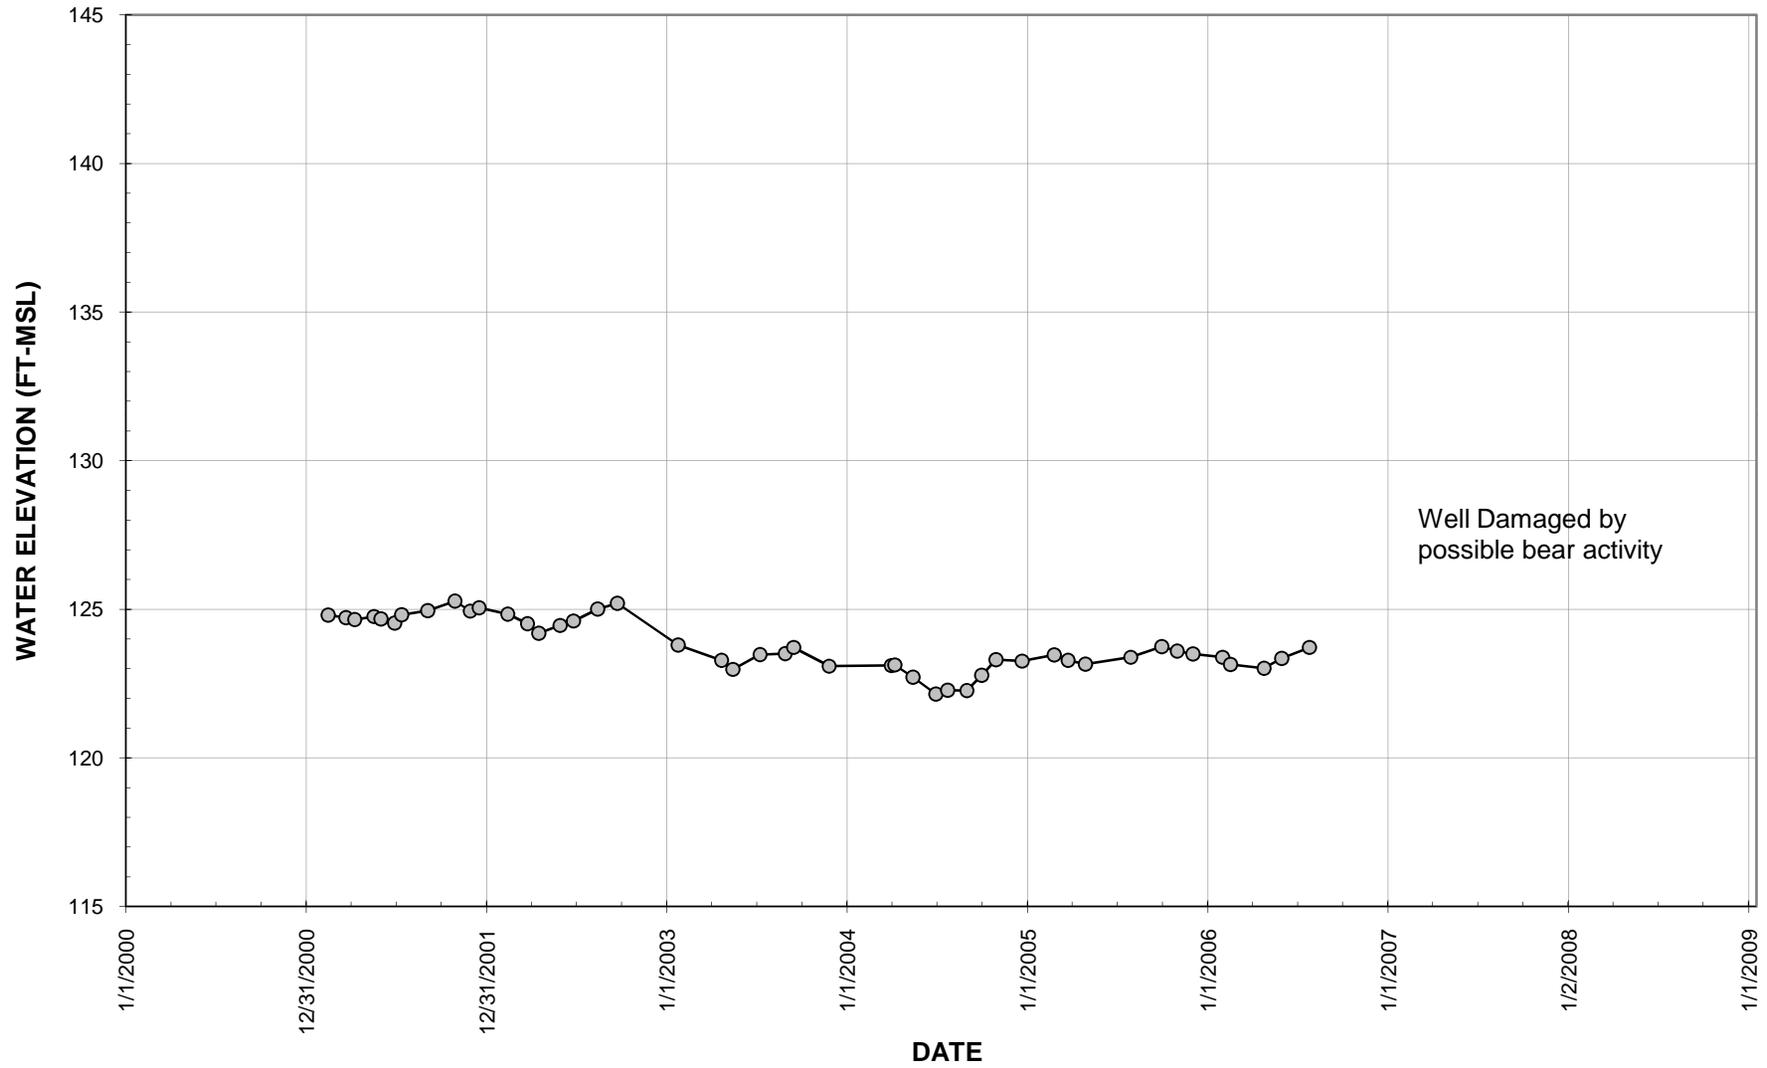
Figure 2.17 Water Level Data for Well MW-T-01-03A

Water levels in four wells completed east and west of the pile are shown for comparison in Figures 2.15 to 2.18. The eastern wells, MW-T-00-03A (Figure 2.15) and MW-T-00-03B (Figure 2.16), are completed in the shallow sands 12 and 17 feet, respectively, below ground surface. The figures for these wells show that the water elevation in shallow completions in native materials can be readily influenced by abnormal weather conditions. Wells MW-T-01-03A and MW-T-01-03B are installed west of the pile. Their water levels are shown in Figures 2.17 and 2.18, respectively. MW-T-01-03A is completed in bedrock to a depth of 20 feet and MW-T-01-03B is completed in clayey silt to a depth of 12 feet. These wells show similar water level fluctuations with weather conditions as the two eastern wells. However, the water level in MW-T-01-03B shows a larger differential than MW-T-01-03A because silts and clays hold more water in tension, so a small increase in water content causes a large change in head. The ground surface elevation is 134 feet in the proximity of these two wells. Both MW-T-01-03A and MW-T-01-03B were damaged by bears in 2006 and attempts to recover them have not been successful.

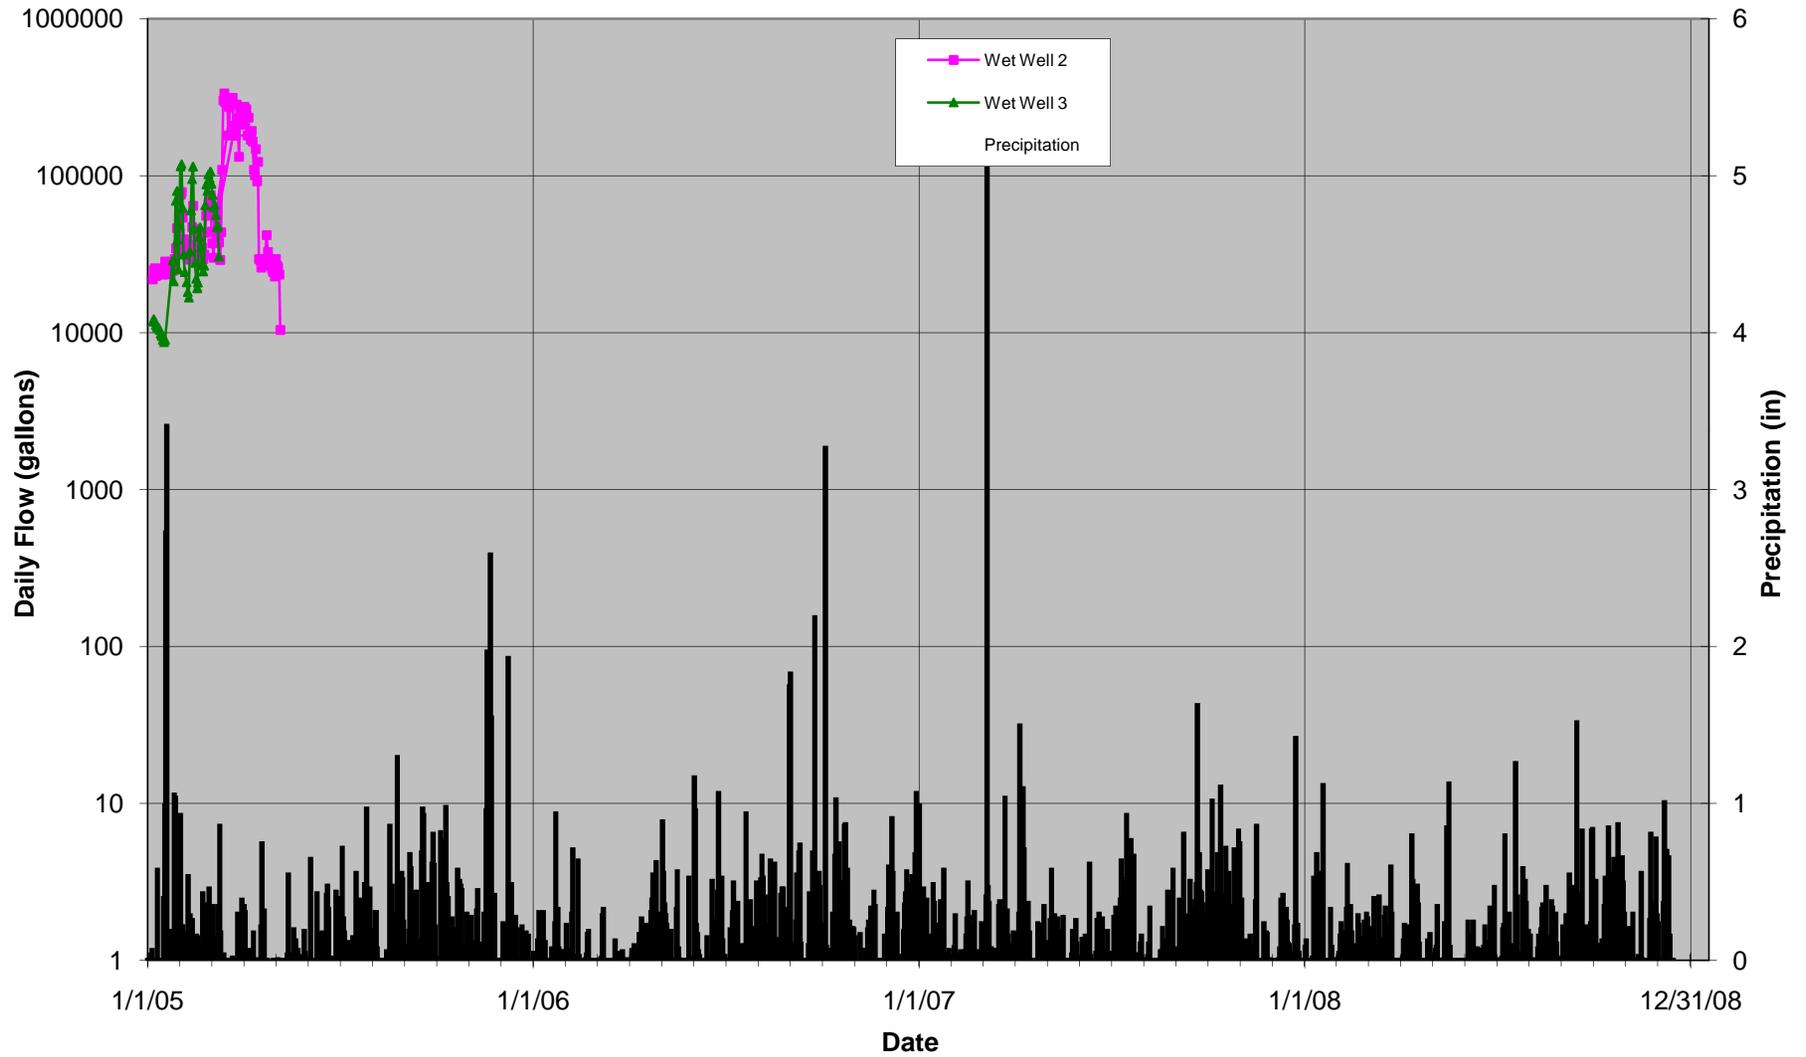
Figure 2.19 Tailings Area Wet Well Flow Data

Precipitation and temperature data are presented in Table 2.4. June was the driest month with 2.8 inches of precipitation. July and August were the warmest months while December exhibited the coolest temperatures. Flow data from Wet Wells 2 and 3 are presented with the precipitation data for 2005 – 2008 in Figure 2.19. The wet well flows respond relatively quickly to precipitation

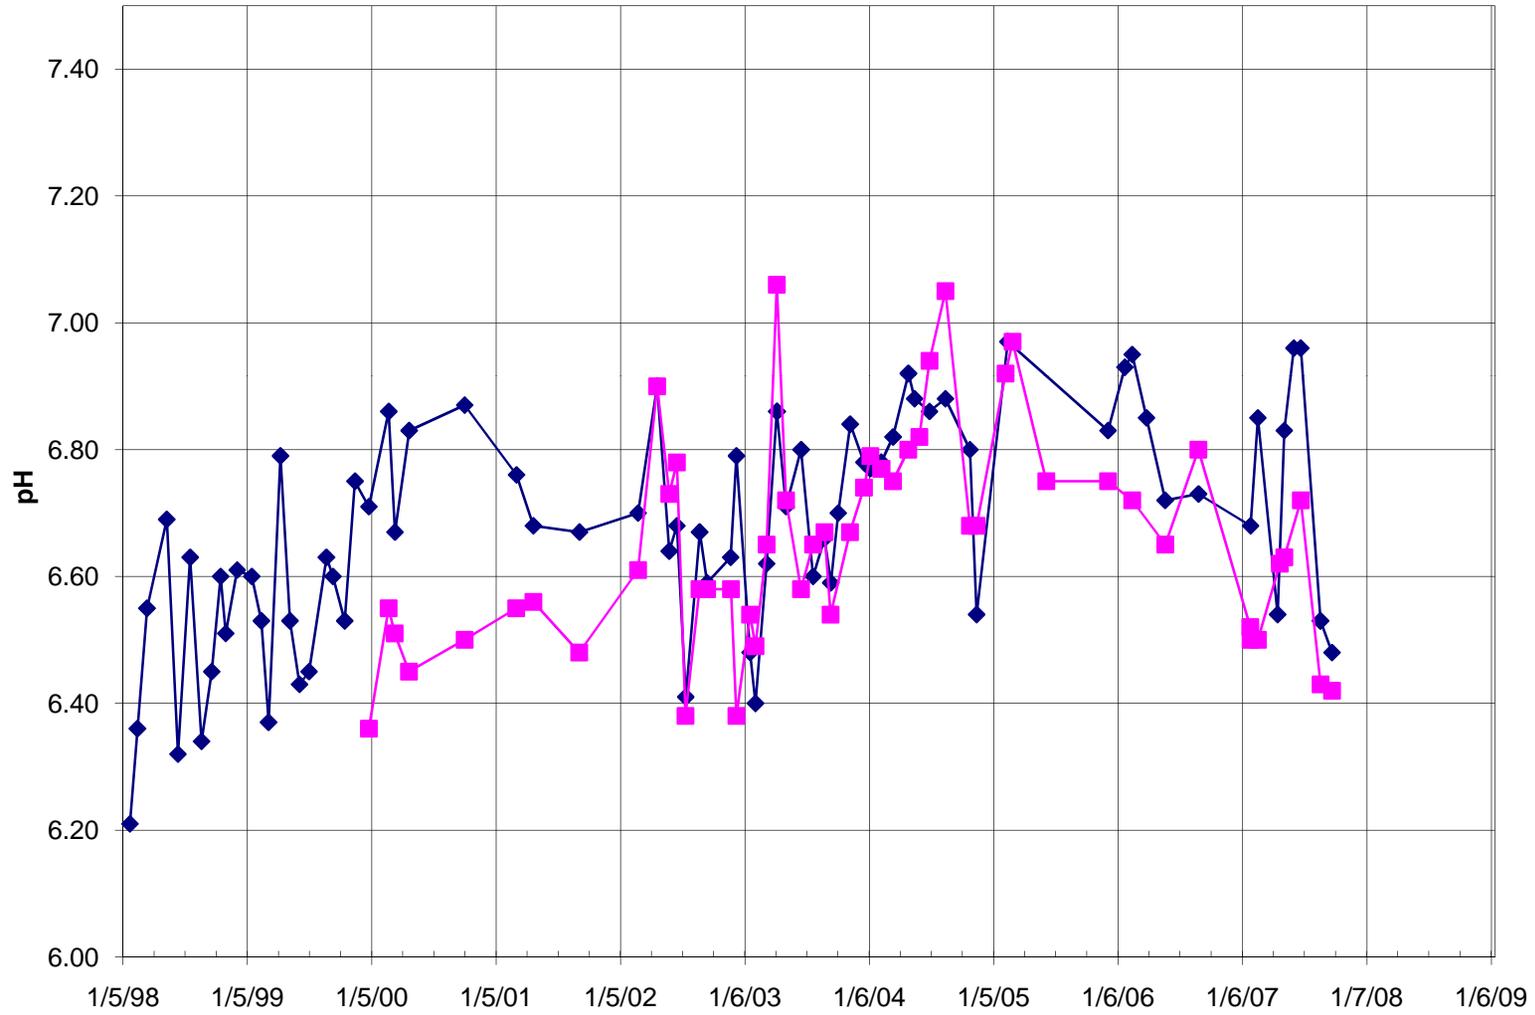
**FIGURE 2.20a GREENS CREEK TAILINGS AREA INTERNAL MONITORING SITES:
WET WELLS - pH DATA**

Most values of pH remained between 6 and 8.5 for all internal monitoring site samples in 2008 (Figures 2.20a, b and c). PZ-T-00-01, PZ-T-00-2 and PZ-T-00-3, which screen the lower ten feet of the tailings pile, have the highest pH of the internal monitoring sites. This is likely a result of microbial sulfate reduction and equilibration with carbonate in the saturated zone of the pile. The wet wells produce water with slightly lower pH (generally between 6.5 and 7), reflecting minor influences from groundwater (organic acids) and oxidized surface waters (acidity from thiosalt, sulfide and iron oxidation). The suction lysimeters all have pH values between 6.87 and 8.03 with the exception of SL-T-02-06 in 2006 and 2007 which showed pHs of 8.87 and 9.3, likely a result of sulfate reduction.

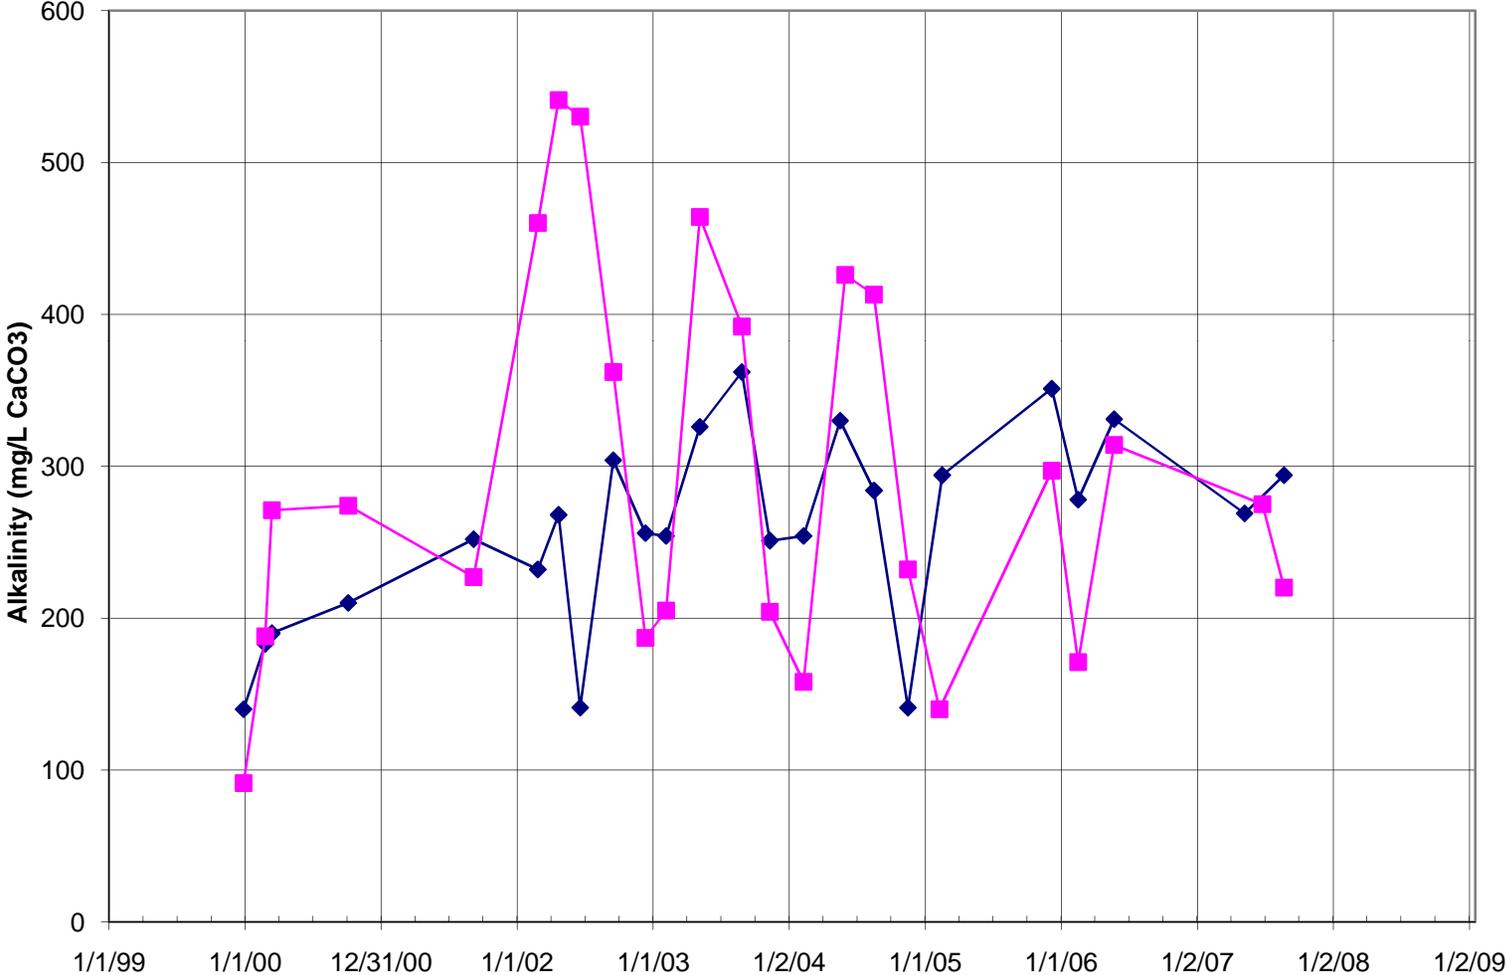
**FIGURE 2.21a GREENS CREEK TAILINGS INTERNAL MONITORING SITES:
WET WELLS - ALKALINITY
(Non-detectable analyses plotted as zero)**

Alkalinity data are presented in Figures 2.21a, b and c. Alkalinity generally ranges between 150 and 600 mg/l CaCO₃ within the tailings pile waters, consistent with buffering from carbonate minerals and the products of microbial sulfate reduction. The fact that these internal waters are near-neutral to alkaline and continue to show substantial alkalinity indicates that the buffering capacity of the tailings is sufficient to prevent acidification of site drainage in the near-term (at least tens of years) even though portions of this material have now been in place at this site for approximately 20 years.

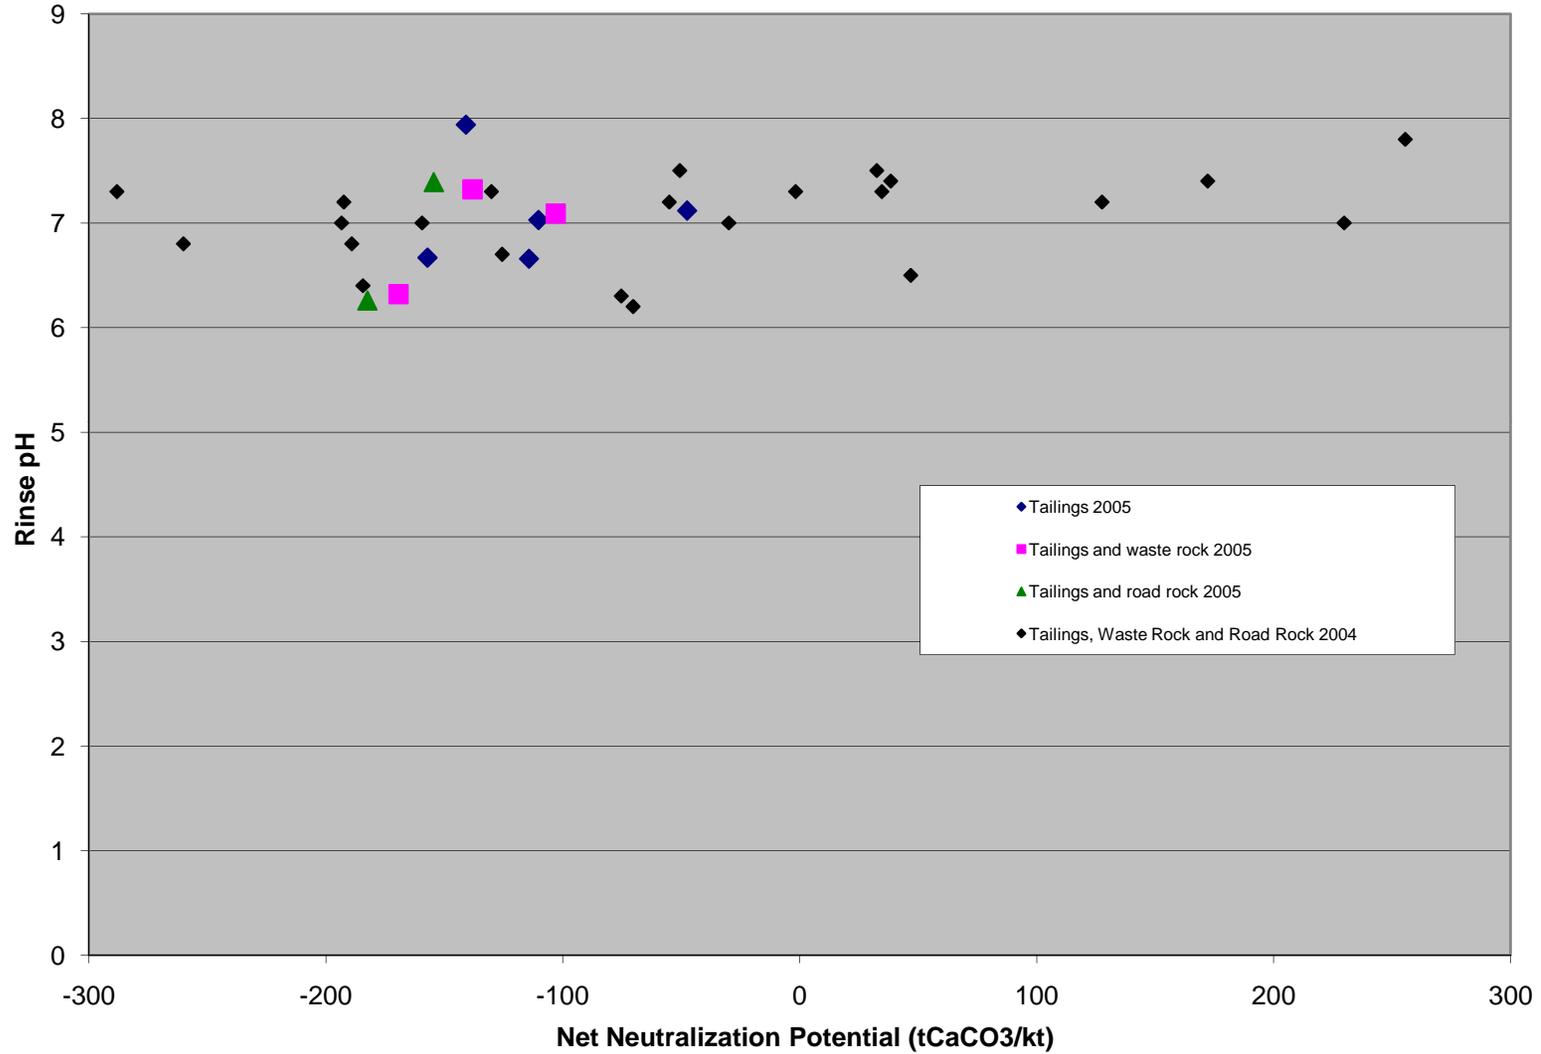
FIGURE 2.34 TAILINGS FACILITY PH VERSUS NET NEUTRALIZATION POTENTIAL

Figure 2.34 shows the relationship of pH to net neutralization potential for the same suite of 2005 samples shown in Figure 2.33. Rinse pH is a measure of the pH of a one-to-one mixture of “as received” fines and water. The rinse pH of all of the tailings samples are above 6.0, indicating that the exposed surfaces of the tailings pile remain well buffered. 2004 data is shown for reference.

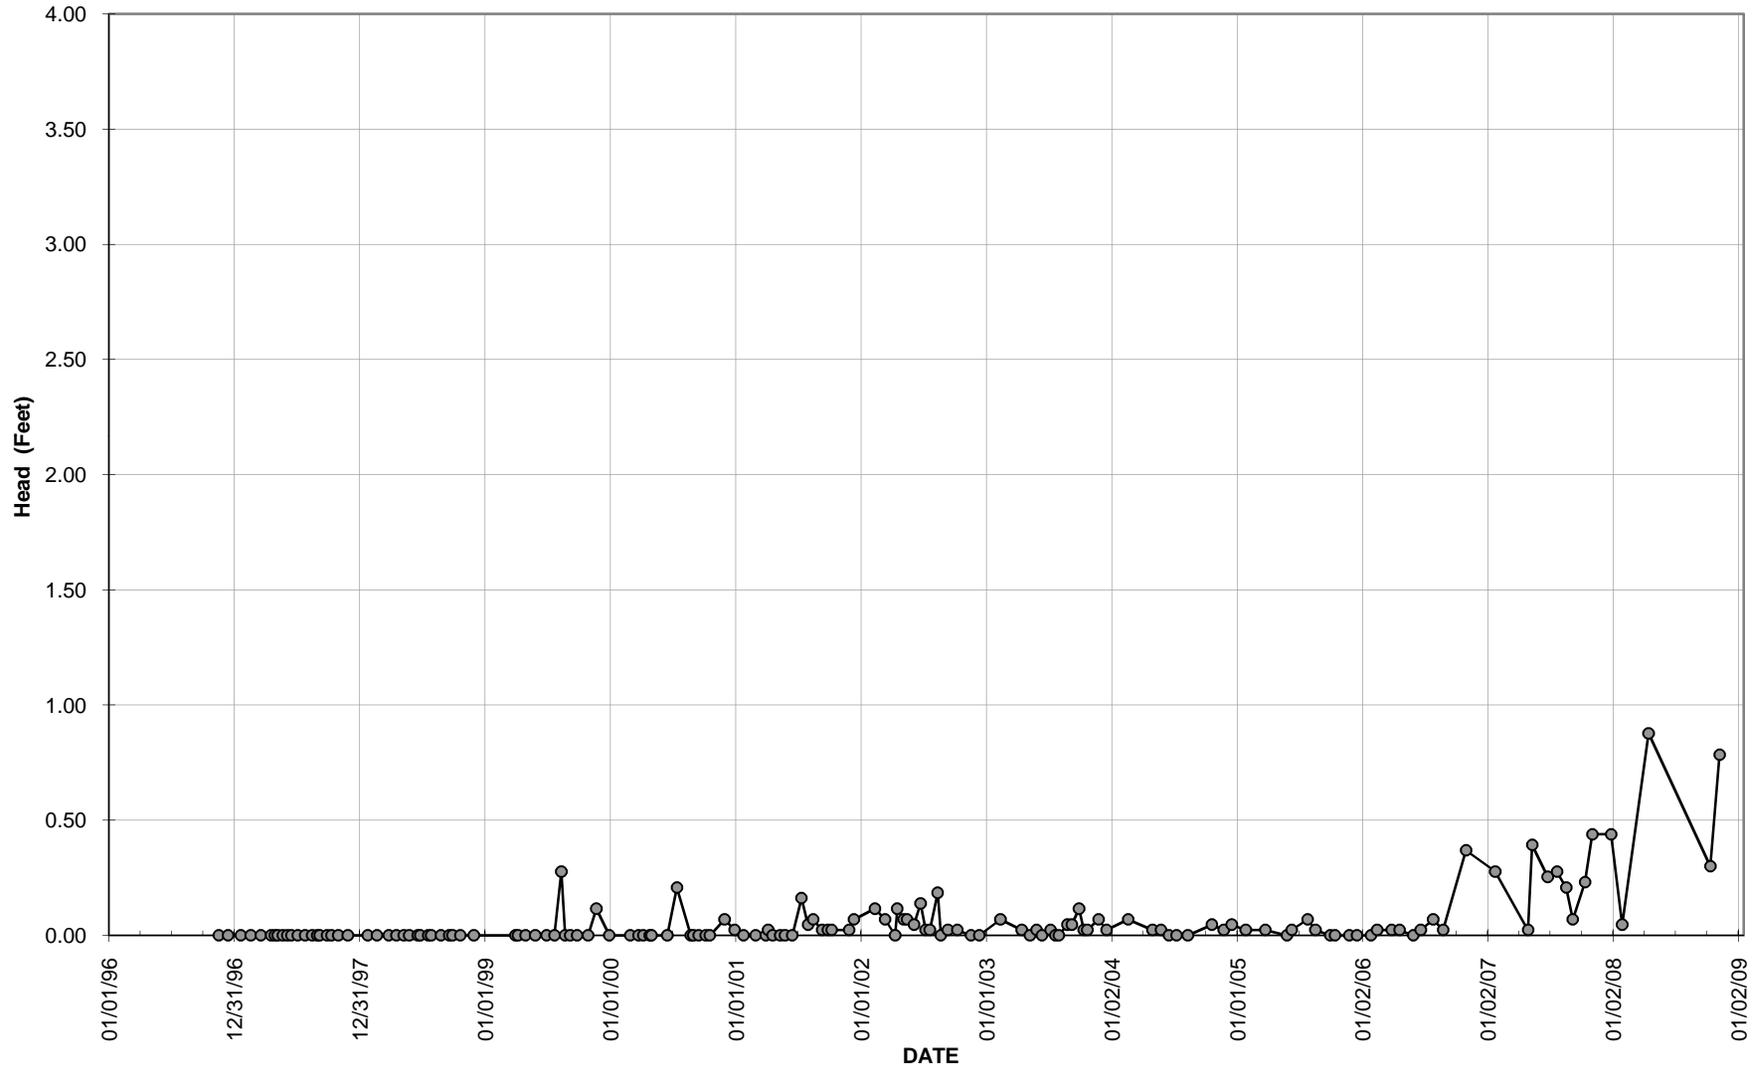
Figure 3.1 Pressure Data for Piezometer 52

Well and piezometer water level data are provided in Figures 3.1 to 3.12. The lack of significant in piezometers installed close to the base of Site 23 (piezometers 52-55, Figures 3.1 to 3.4) demonstrates that the pile remains free draining. This is consistent with the construction of a network of finger drains under the pile and a blanket drain at the pile toe. Comparison of historic versus modeled flow from the finger drains and the curtain drain indicated they are performing as designed and as necessary (EDE, 2004). See Appendix 2 for piezometer and finger drain locations. The lack of pore pressure at the toe indicates that pile stability has been maximized. Water levels from several monitoring locations are shown in Appendix 2. The inferred water table is 30 to 60 feet below the base of the production rock pile material up-slope of the Site 23 active placement area and 5 to 20 feet below the base of material placed in Site D and the toe of Site 23, respectively (see also Figures 3.5 to 3.12). MW-23-00-03 data showed an atypical drop in water elevation in August 2007. However, data collected before and after that date are within the historical data range. Observations from wells completed in the colluvium below the sites indicate that perched water tables and braided flow paths exist beneath the site (e.g compare Figure 3.6 and 3.7). This unit also shows large (up to 10 feet) fluctuations in head levels, which are consistent with perched, confined conditions and channel-like flow. There is a distinct seasonal pattern to the water level fluctuations beneath Site 23/D, particularly in the alluvial sands (Figures 3.9 and 3.11).

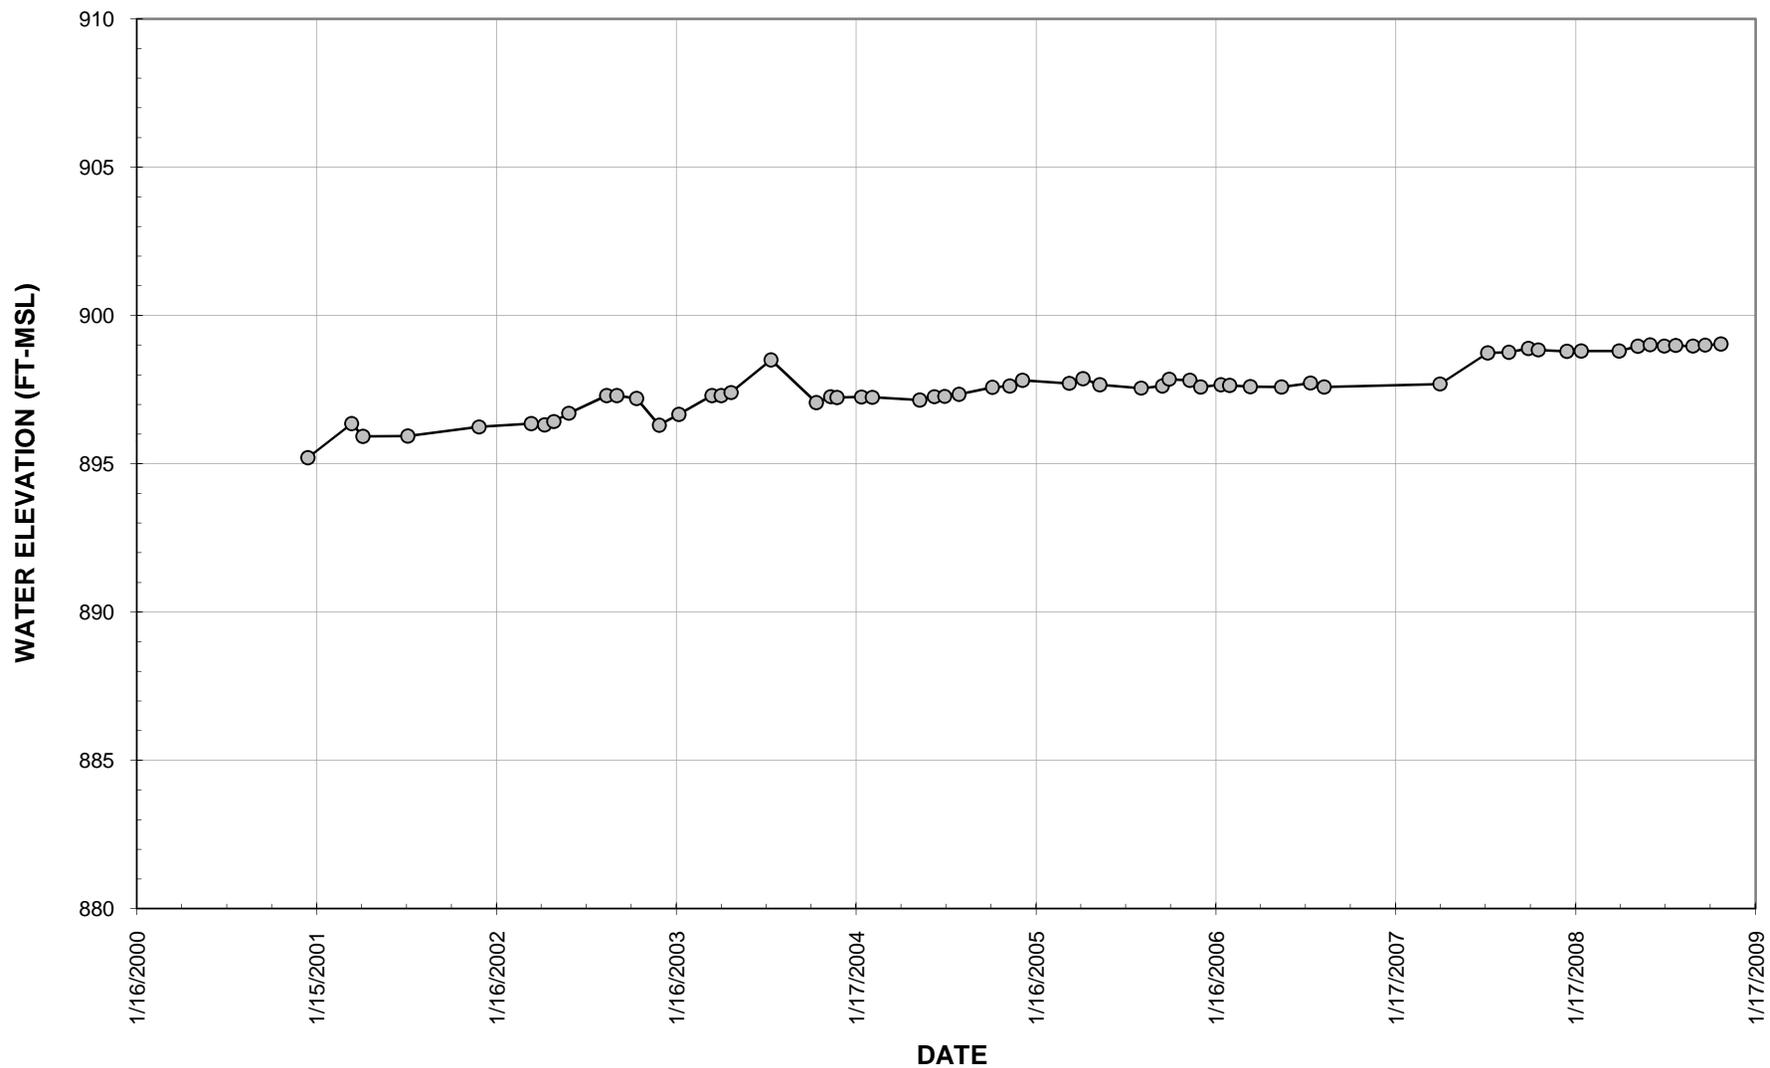
Figure 3.8 Water Level Data for Well MW-23-98-01

The silty/clay till that underlies the colluvial unit impedes downward flow and has an upward hydrologic gradient caused by its confining the more permeable bedrock below it. MW-23-98-01 (Figure 3.8) is completed in the till unit and indicates a water table near the top of the till, which is approximately 100 feet below the existing topographic surface. Alluvial sands occur between the colluvial unit and the silt/clay till near the toe of Site 23 and under Site D. Data from MW-23-A4 and MW-D-94-D3 (Figures 3.9 and 3.11) indicate that the sands are saturated. A curtain drain installed in between Site D and Site 23 in 1994 collects water that flows at the base of the colluvial unit and the top of the alluvial sands (see as-built and sections). This drain helps reduce pore pressures in the foundation of Site D, as well as capturing infiltration waters from Site 23.

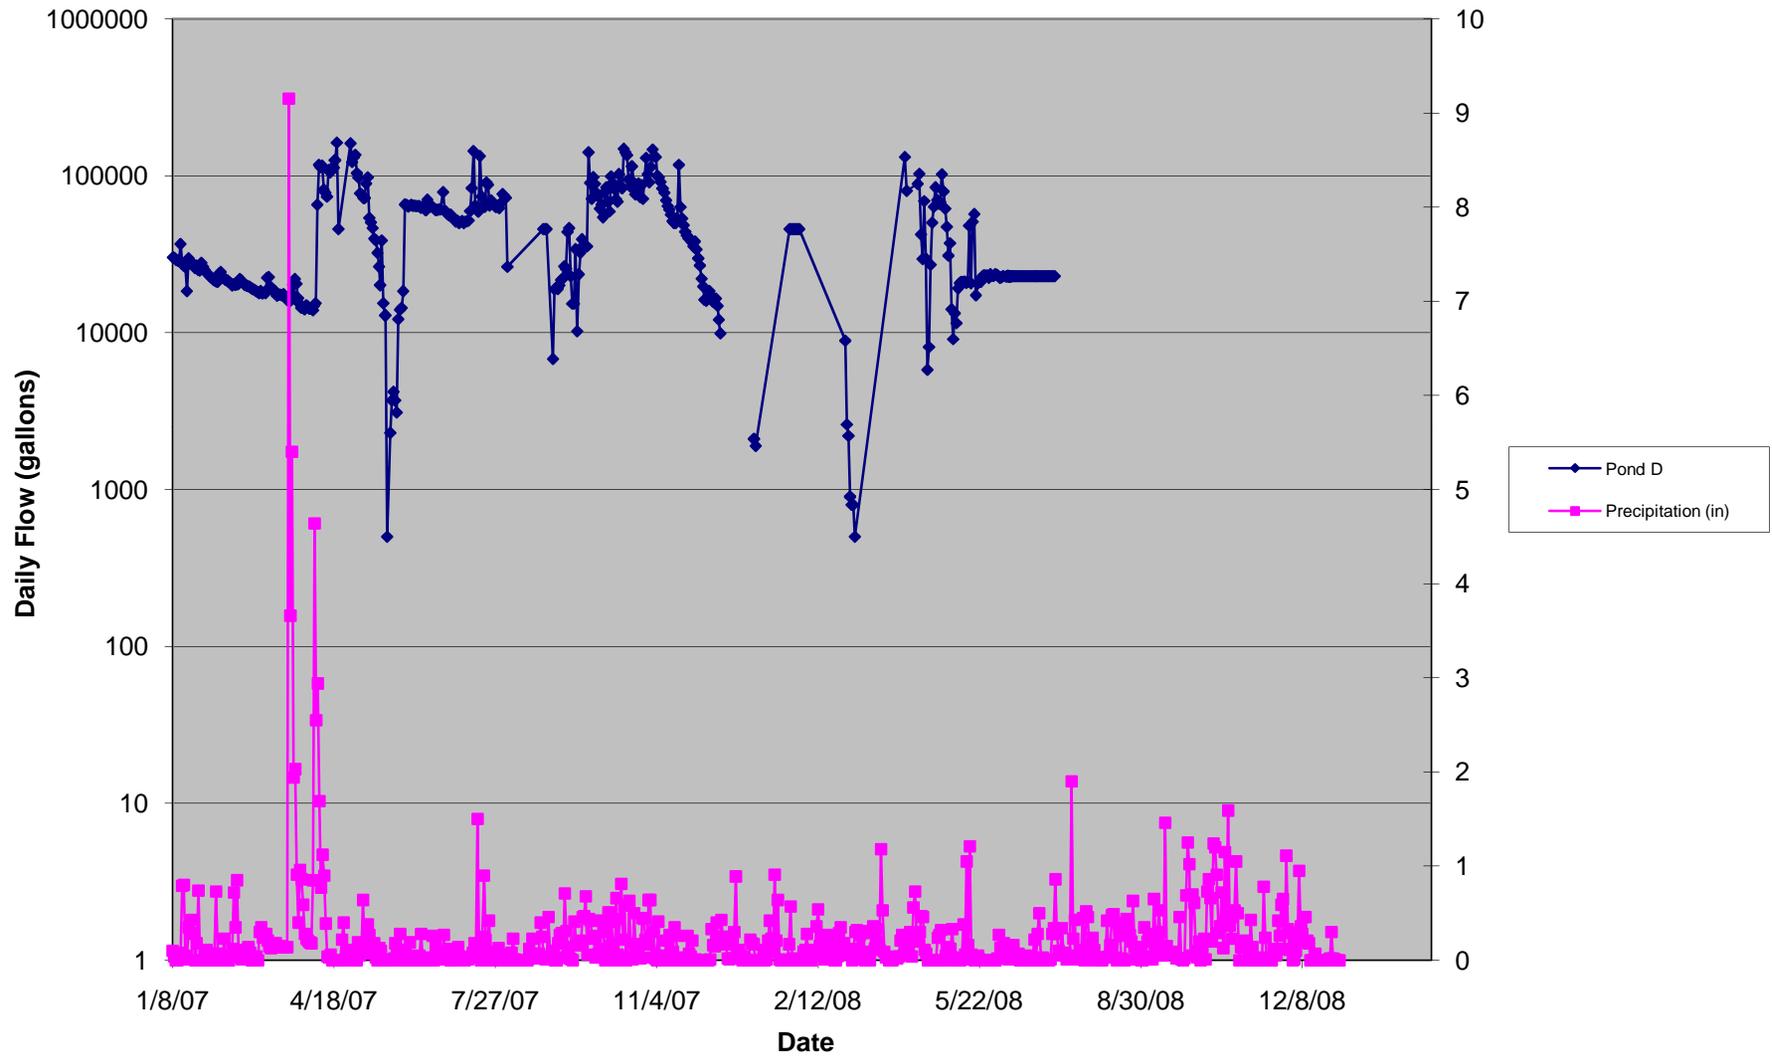
Figure 3.13 Pond D Flow Data

Flow data for Pond D are shown with precipitation in Figure 3.13. The Pond D flow meter was not operating from July - December of 2008 due to changes in pumping/piping as noted above. Once all equipment is in place and operating, flow measurements will resume.

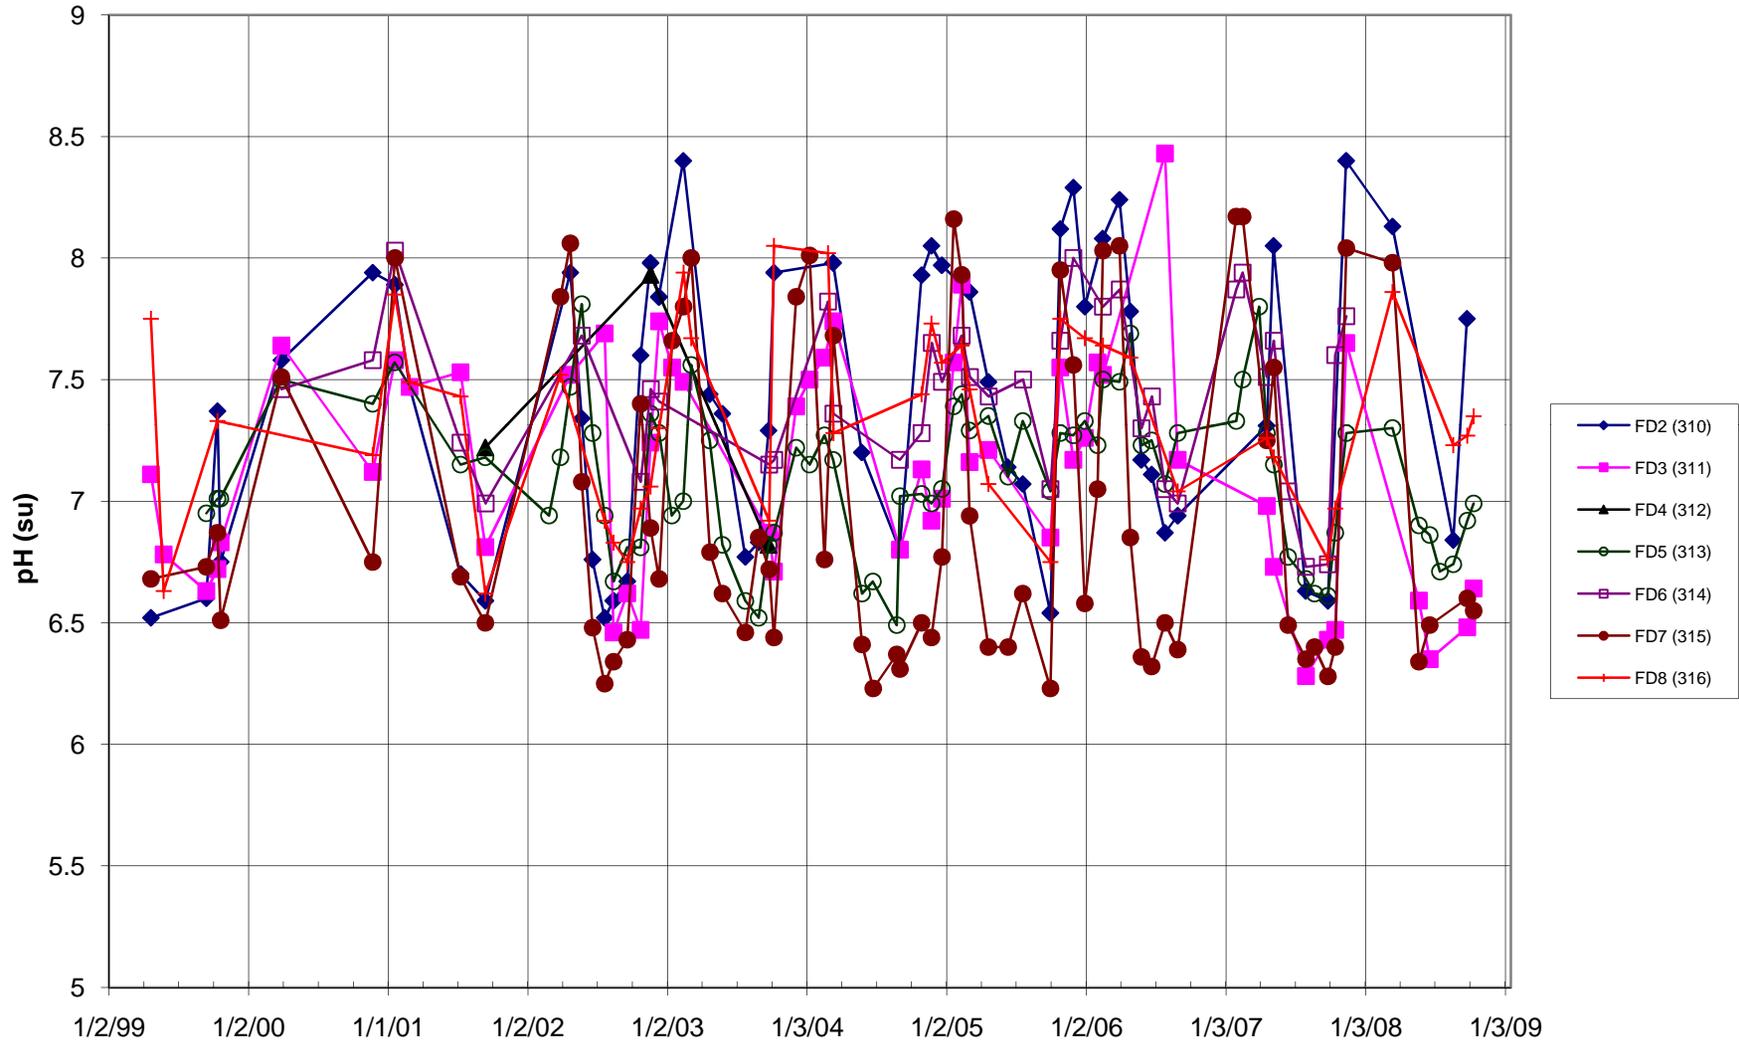
**FIGURE 3.14a GREENS CREEK SITE 23/D INTERNAL MONITORING SITES:
FINGER DRAINS - pH DATA**

Figure 3.14a shows the pH of waters collected from Site 23 Finger Drains 2 through 8, and Figure 3.14b shows the pH of monitoring wells MW-23-A2D, MW-23-A4, MW-D3 and Pond D (see as-built in Appendix 2 for locations). Values of pH were between 6 and 8.5 for all internal monitoring site samples in 2008. The lower pH values (generally pH 6.0 to 7.0) were recorded in MW-23-A4 and MW-D3, both of which are completed in alluvial sands beneath Site 23 and Site D, respectively. MW-23-A2D, which screens colluvium up-gradient of Site 23 typically has the highest pH (generally pH 7.0 to 8.5). The Site 23 finger drains fluctuate at values between those of the monitoring wells. Figures 3.14a and b suggest that waters from different foundation units have different pH values and that Site 23 and Site D contact waters and the materials with which they are in contact exhibit sufficient buffering capacity to prevent acidification of site drainage in the near term. Seasonal fluctuations are apparent in the finger drains with highest pH values occurring in winter months and lower pH in mid to late summer.

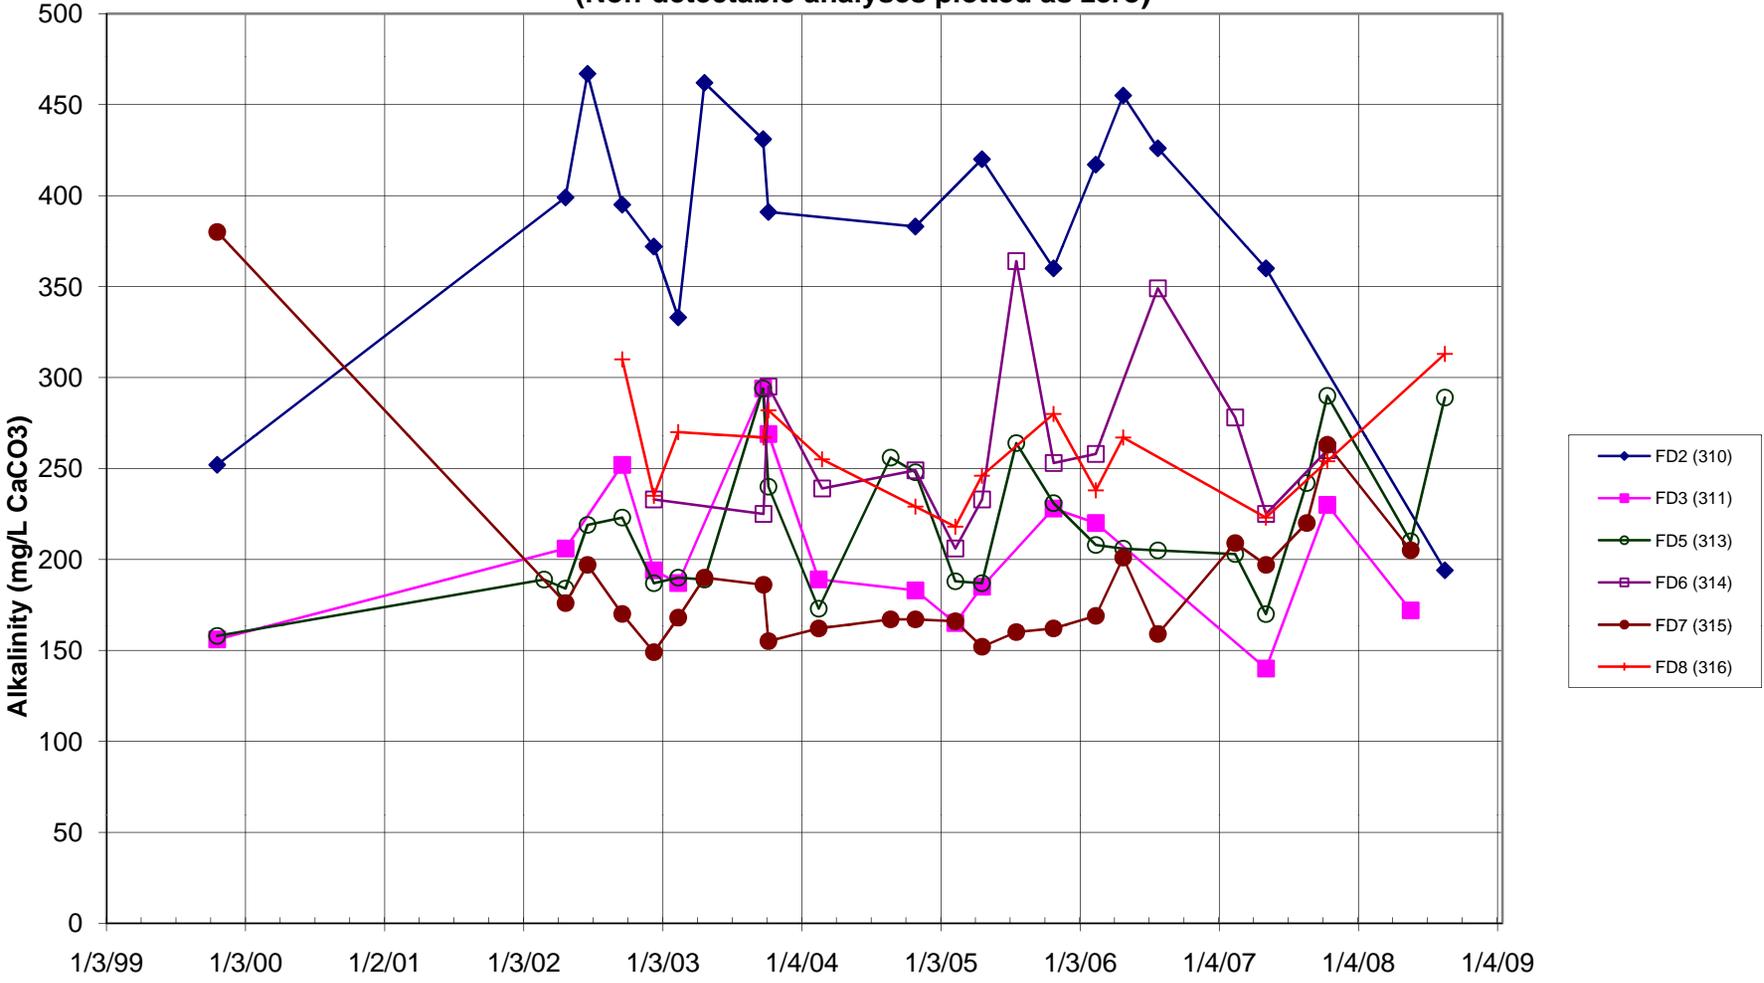
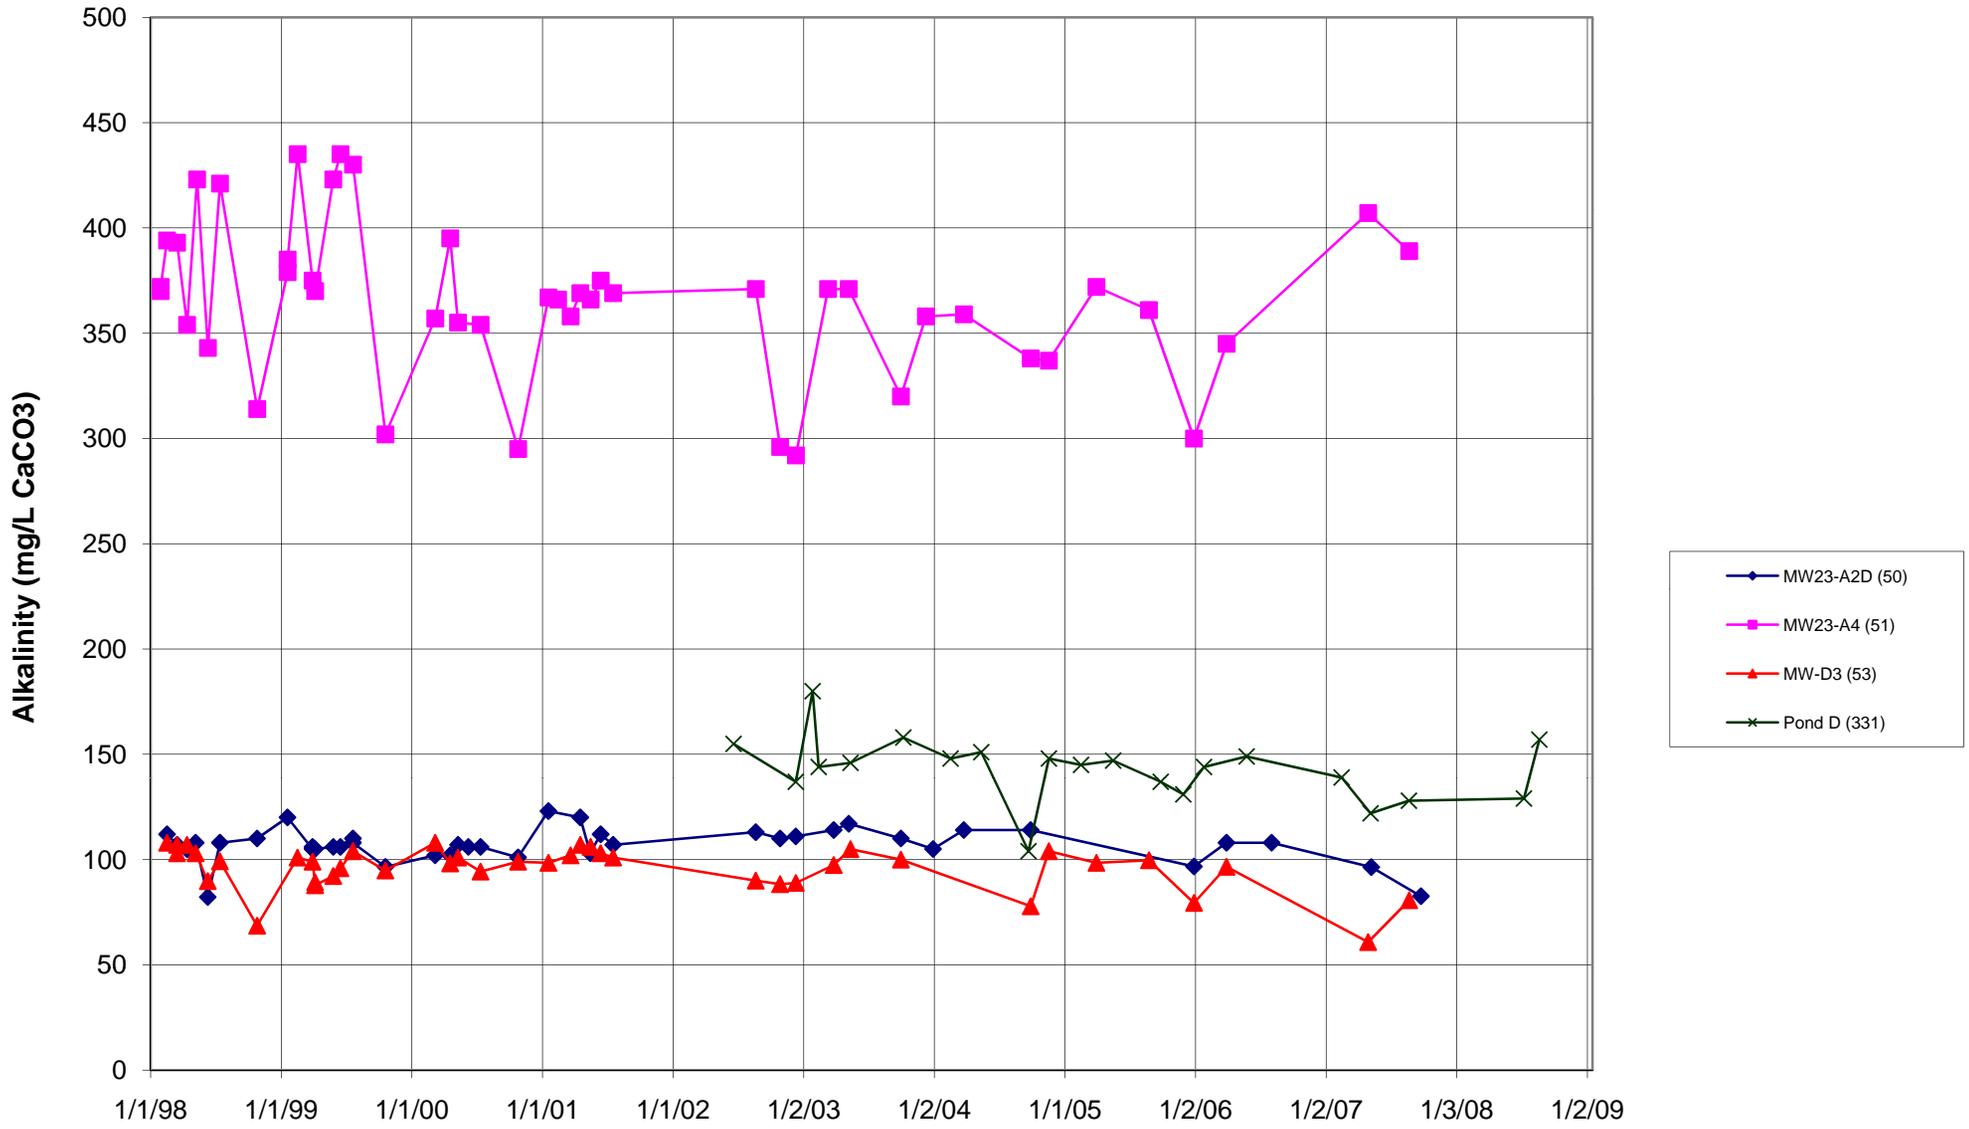
As with pH, high alkalinity values (Figures 3.15a and b) indicate that the waters are well buffered. Fluctuations in alkalinity correlate with those of other parameters, such as hardness (Figures 3.16a and b) and conductivity (Figures 3.17a and b), and also appear to be seasonal. Carbonate minerals in the production rock contribute to the high alkalinity of the drainage from the finger drains. Alkalinity is lowest in samples with the highest groundwater component (e.g. the monitoring wells, Pond D, 23FD-5 and 23FD-7). Calcium and magnesium are the primary contributors to hardness (Figure 3.16a) and reflect dissolution of carbonate minerals, such as calcite and dolomite. Carbonate dissolution neutralizes acidity formed by sulfide oxidation, which is also the source of sulfate shown in Figure 3.18a.
