**TAILINGS AND PRODUCTION ROCK SITE
2008 ANNUAL REPORT**

Hecla Greens Creek Mining Company

April 15, 2009

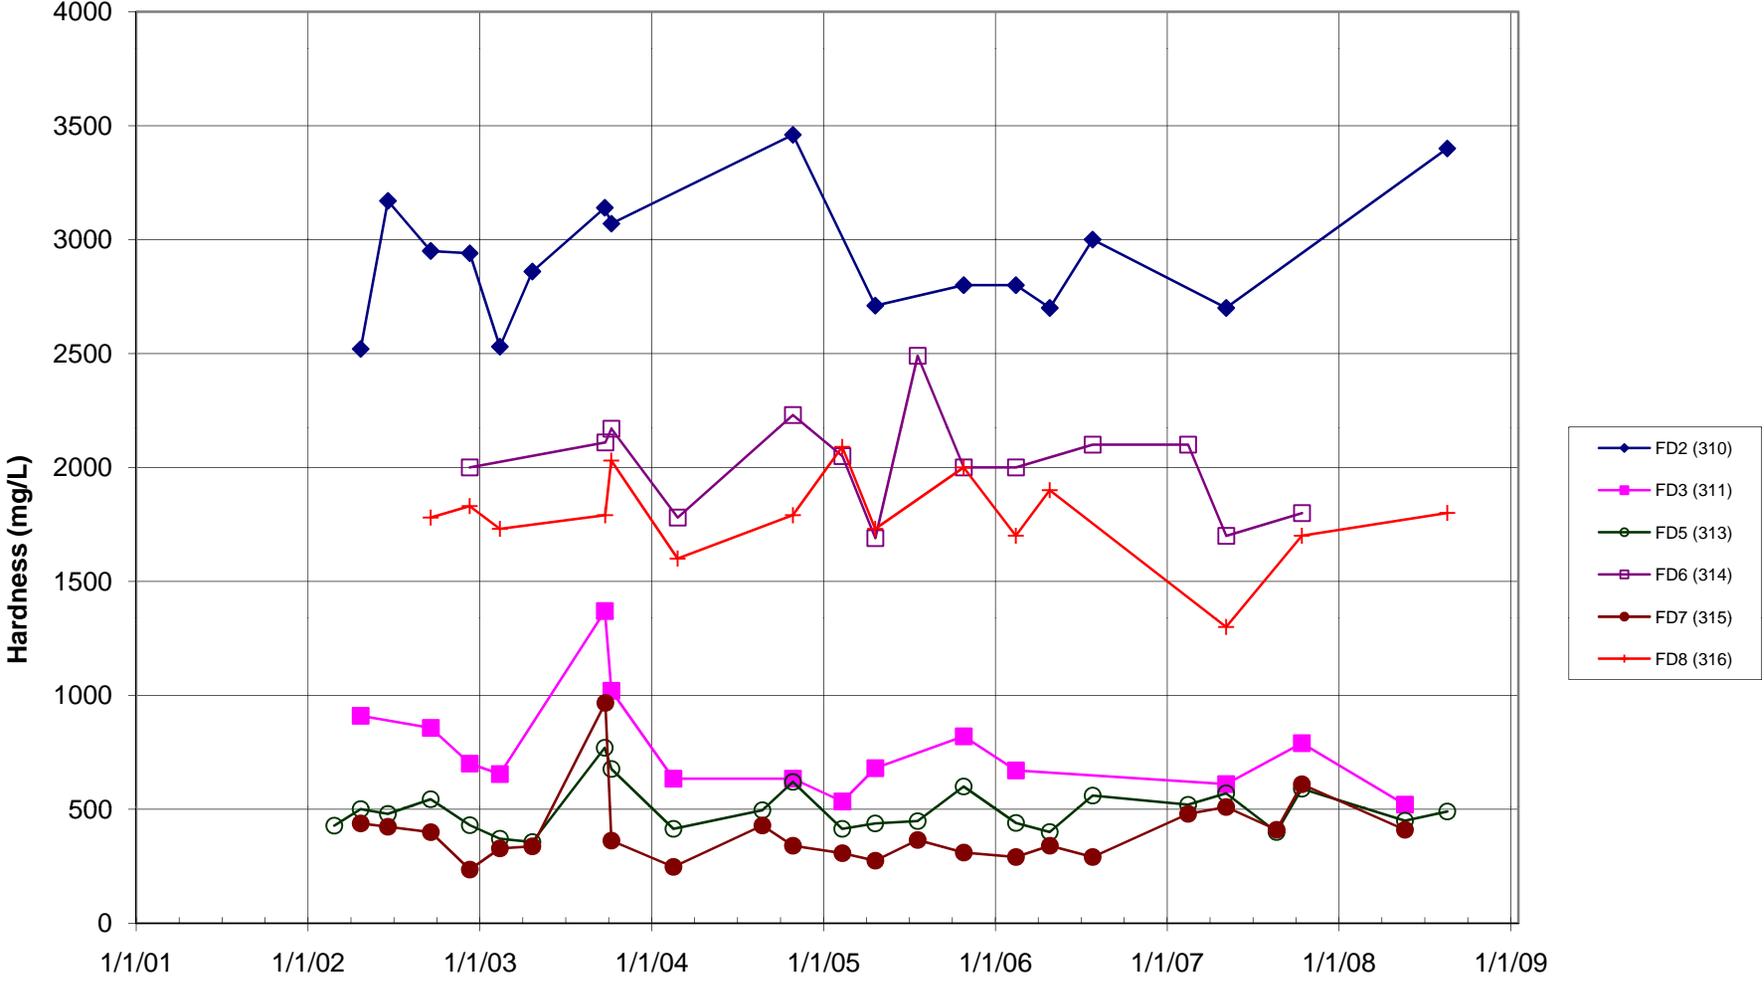
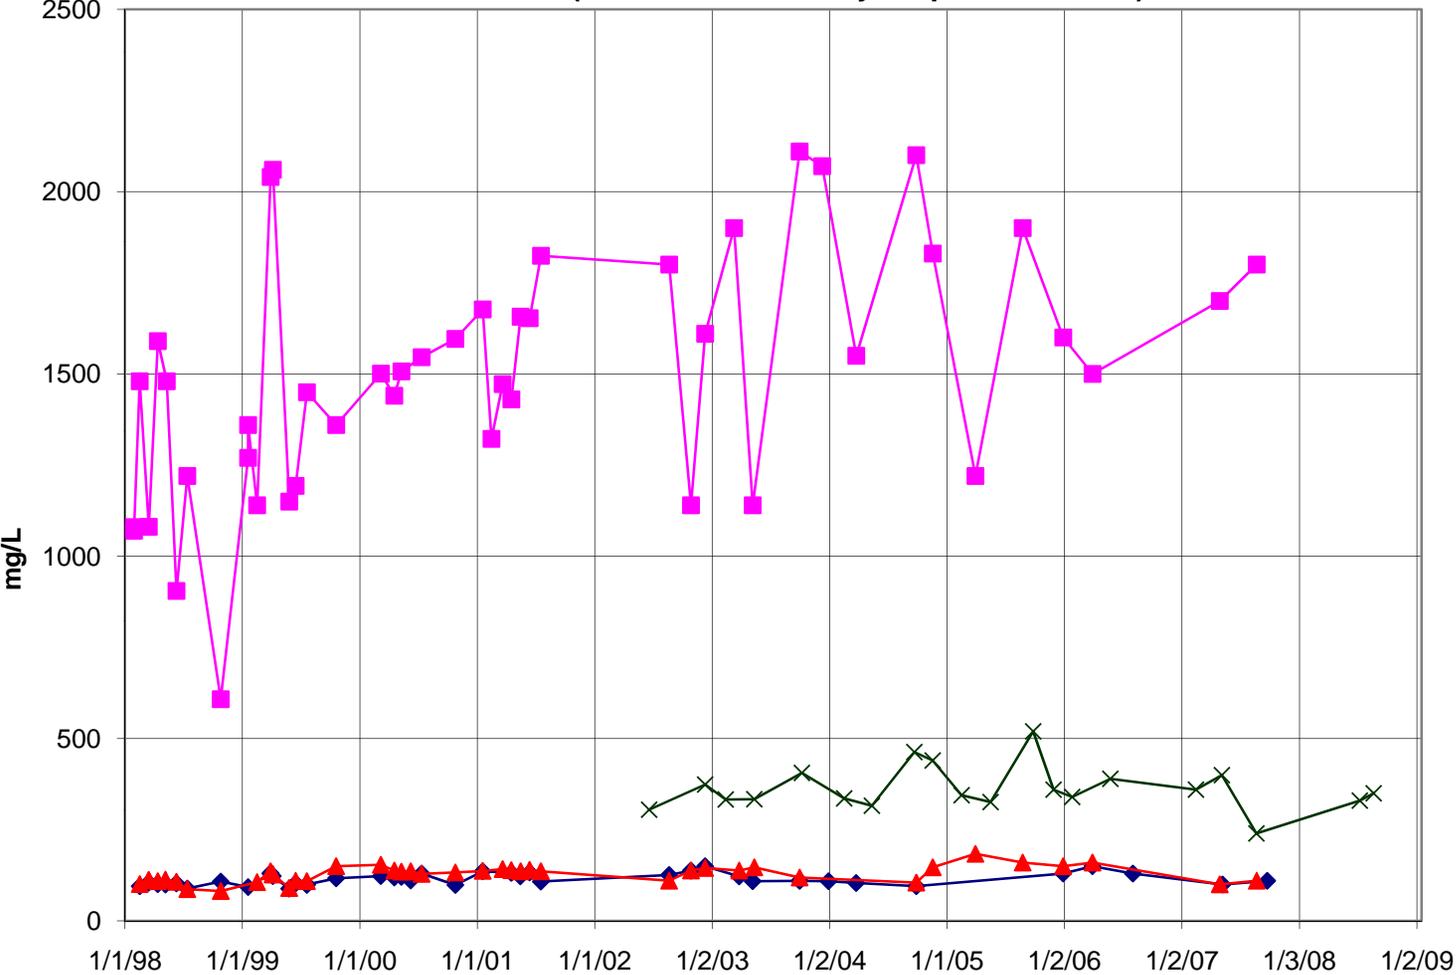
As with pH, high alkalinity values (Figures 3.15a and b) indicate that the waters are well buffered. Fluctuations in alkalinity correlate with those of other parameters, such as hardness (Figures 3.16a and b) and conductivity (Figures 3.17a and b), and also appear to be seasonal. Carbonate minerals in the production rock contribute to the high alkalinity of the drainage from the finger drains. Alkalinity is lowest in samples with the highest groundwater component (e.g. the monitoring wells, Pond D, 23FD-5 and 23FD-7). Calcium and magnesium are the primary contributors to hardness (Figure 3.16a) and reflect dissolution of carbonate minerals, such as calcite and dolomite. Carbonate dissolution neutralizes acidity formed by sulfide oxidation, which is also the source of sulfate shown in Figure 3.18a.

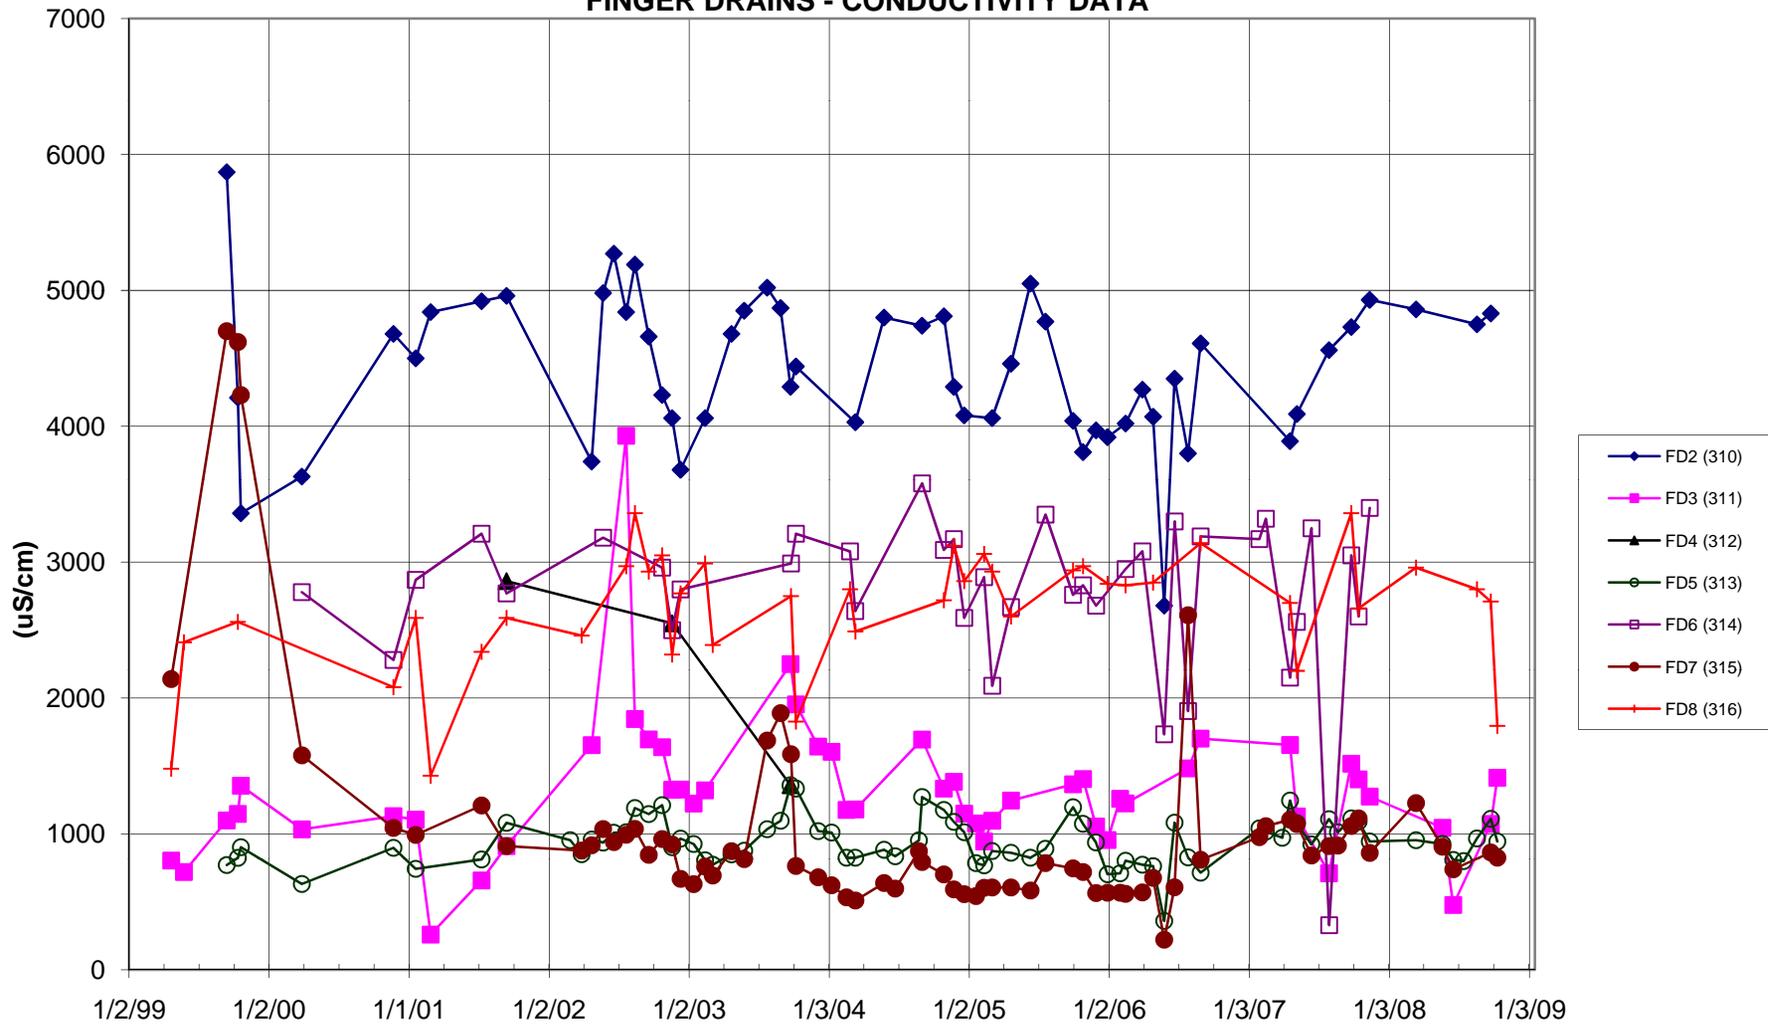
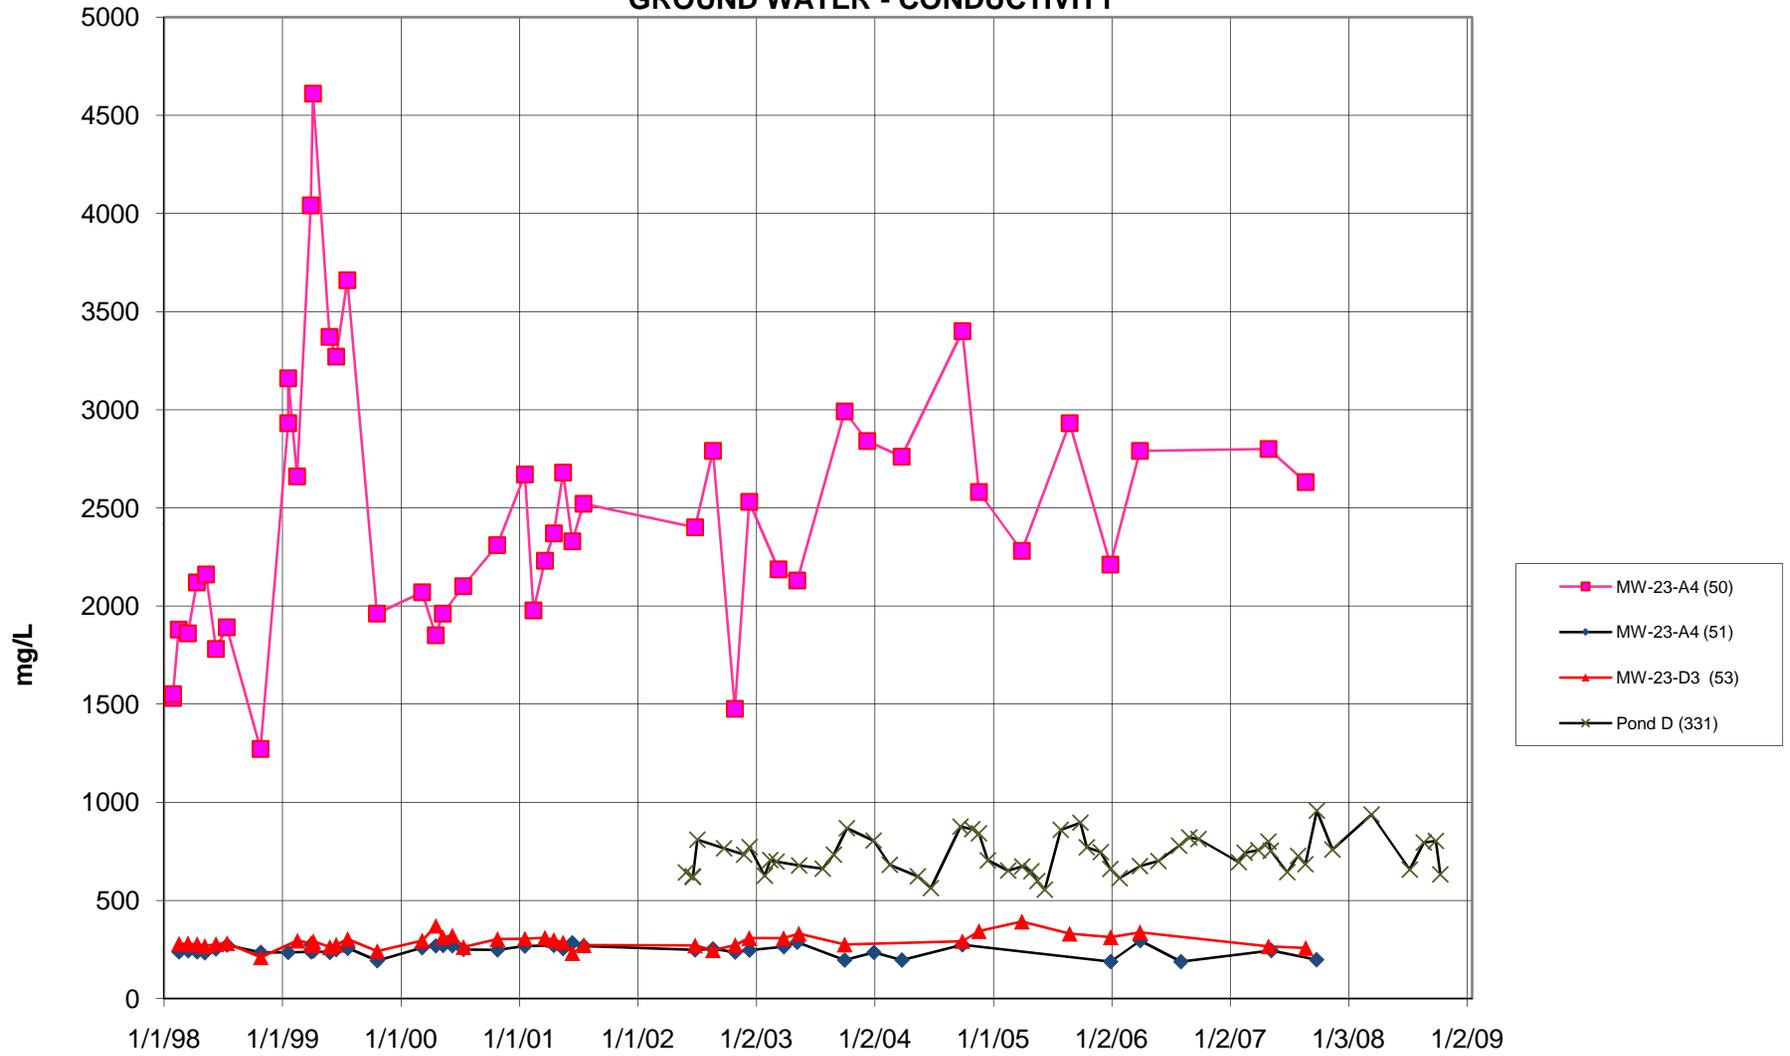
**FIGURE 3.17a GREENS CREEK SITE 23/D INTERNAL MONITORING SITES:
FINGER DRAINS - CONDUCTIVITY DATA**

Finger Drain 23FD-2 has the highest conductivity but consistently low flow, suggesting no significant influence from groundwater. This drain may also be influenced by runoff that infiltrates along the access ramp to the site. The higher conductivity of the site contact waters reflects a larger dissolved load caused by weathering of the production rock. As with tailings, pyrite oxidation and carbonate dissolution contribute dissolved ions such as sulfate, bicarbonate, calcium and magnesium to the contact waters, increasing their conductivity. Sulfate concentrations for the finger drains and groundwater wells are plotted in Figures 3.18a and 3.18b and match closely the relative value patterns of conductivity.

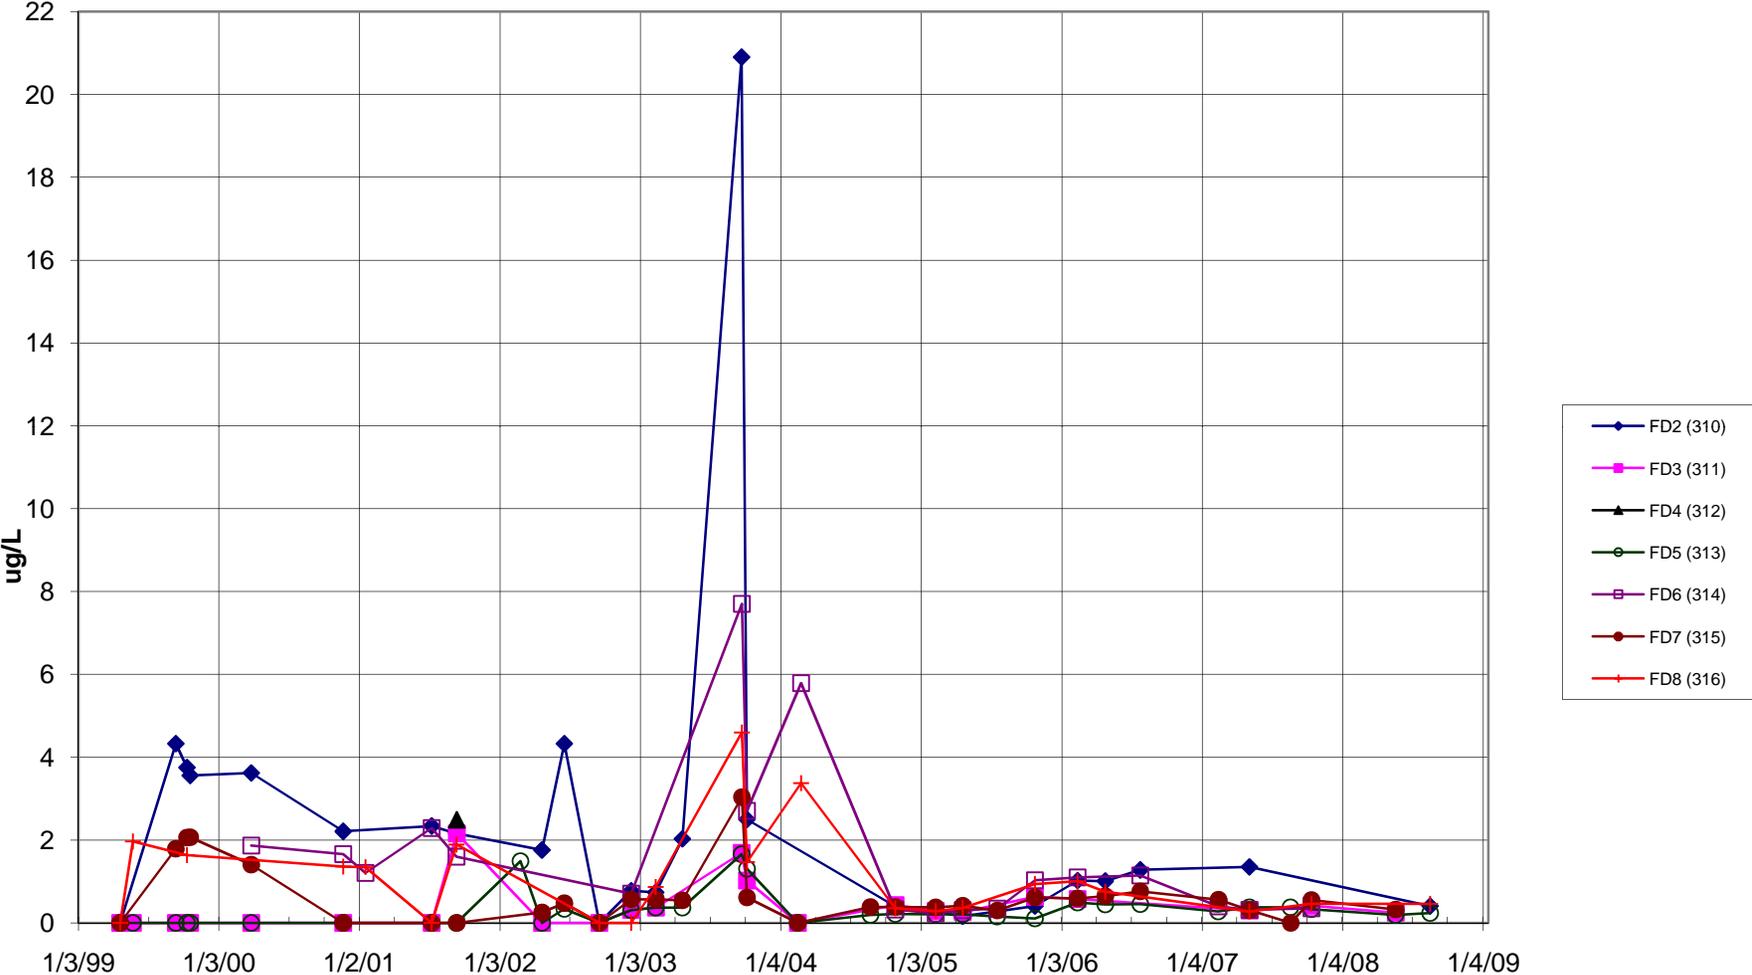
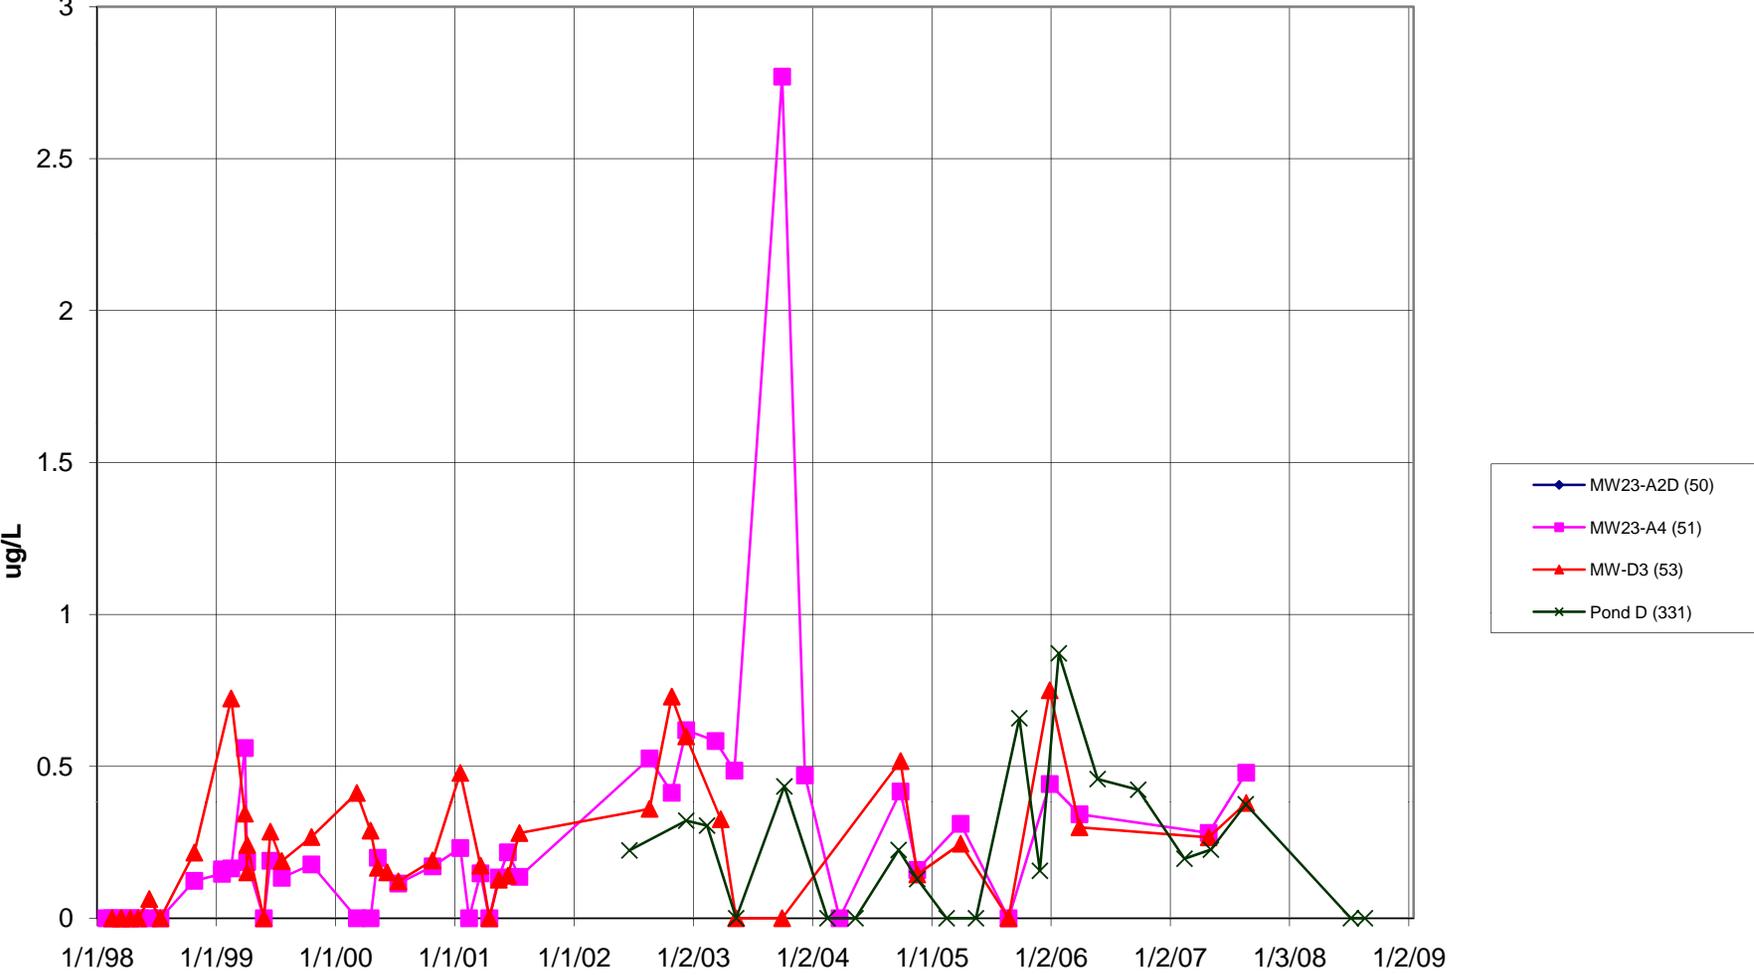
**FIGURE 3.19a GREENS CREEK SITE 23/D INTERNAL MONITORING SITES:
FINGER DRAINS - ARSENIC DATA
(Non-detectable analyses plotted as zero)**

Arsenic data are presented in Figures 3.19a and b and are generally quite low. All finger drains and MW-23-A4 experienced increases in their arsenic concentrations in September 2003, with subsequent decreases back down to historical levels in October. The flows in the finger drains positively correlate with these changes. Fluctuations in arsenic values in 23FD-2 can be attributed to changes in redox conditions. Low arsenic and iron (Figures 3.25 a and b) concentrations indicate that these metals are precipitating as oxyhydroxides on rock surfaces in the pile.

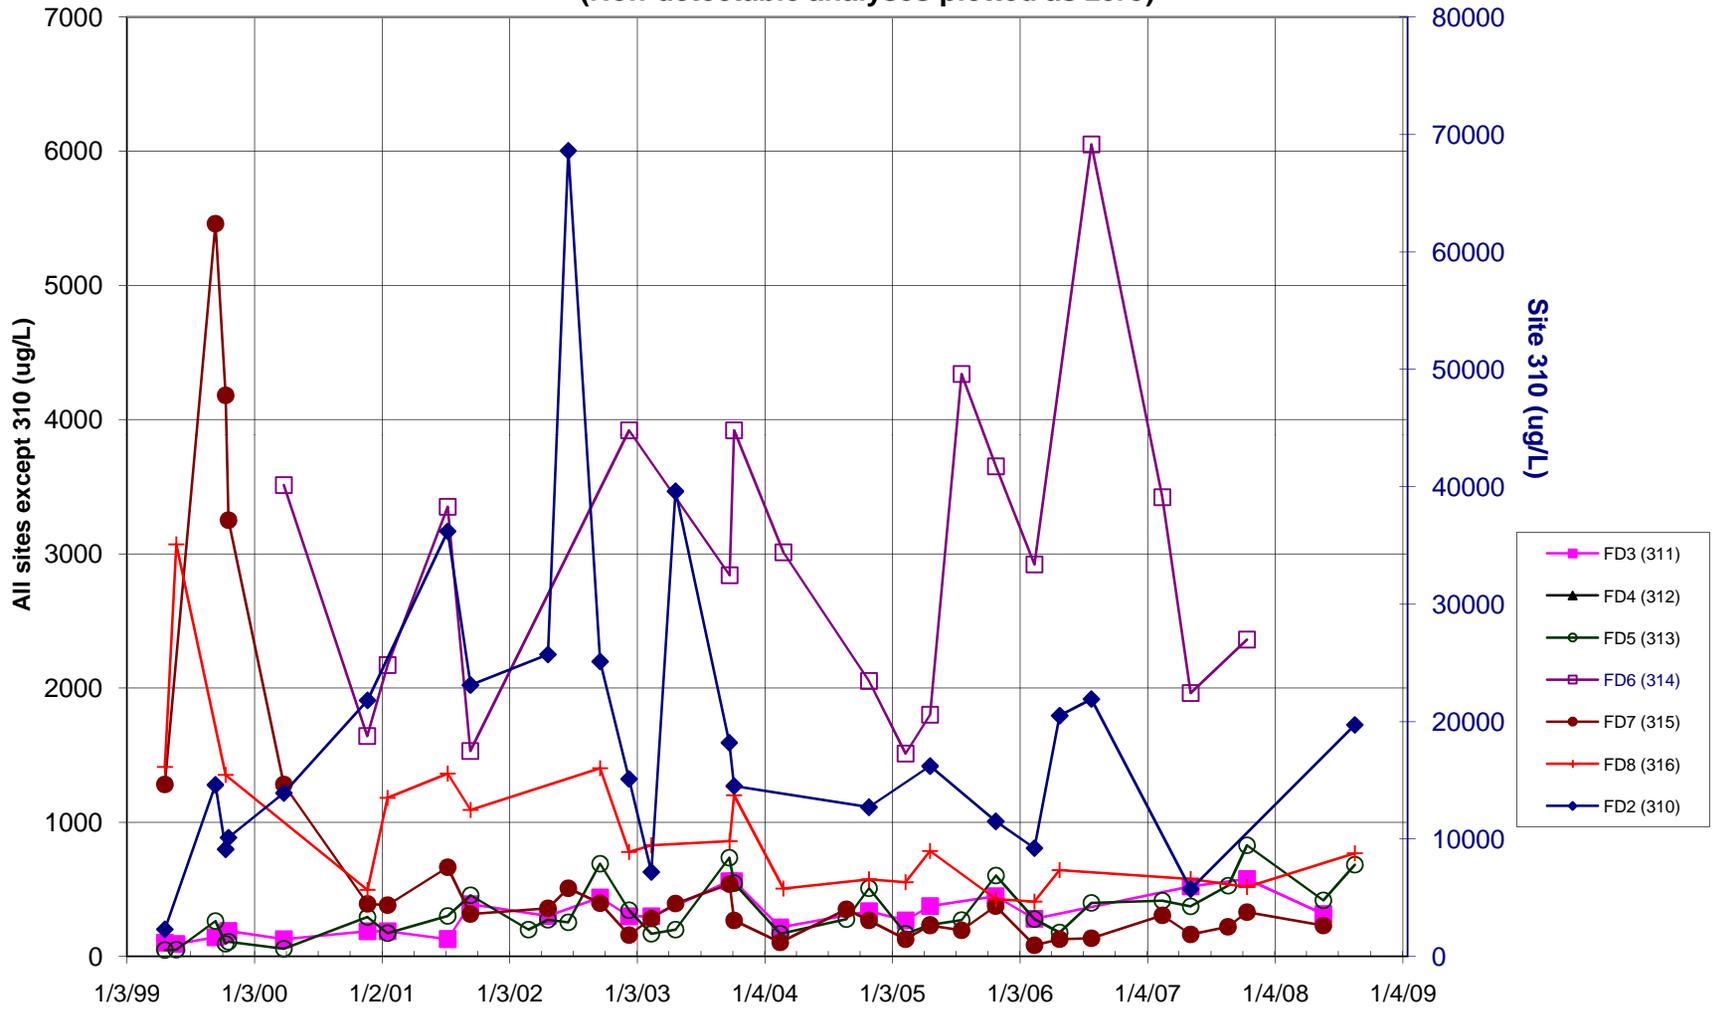
**FIGURE 3.20a GREENS CREEK SITE 23/D INTERNAL MONITORING SITES:
FINGER DRAINS - ZINC DATA
(Non-detectable analyses plotted as zero)**

Figures 3.20a and b show the concentration of zinc in the internal monitoring locations at Site 23/D. Zinc levels appear to be controlled by seasonal conditions. The changes in zinc concentrations mimic those for conductivity and sulfate. 23FD-2 had a zinc concentration of approximately 70 mg/l in June 2002. Although, zinc averages have fluctuated since 2002, there has been an overall decreasing trend. In 2008 zinc levels were near 20 mg/l. Zinc concentrations in the range of 20 to 70 mg/l are consistent with laboratory kinetic weathering tests performed on samples of argillite and serpentinite (Vos, 1993). The zinc concentrations recorded for Pond D are generally below 0.7 mg/l and reflect contributions from several source waters. Pond D receives water from Site D surface runoff, seeps on the slope and at the toe of the site and the effluent from the curtain drain that HGCMC installed between Site D and Site 23. MW-D3 showed elevated zinc concentrations in both 2005 samples: zinc levels rose from an average of 10 µg/l in 1998-2004 to an average of 177 µg/l in 2005. Average sulfate also increased by approximately 30 mg/l in 2005 compared to average values from 2002-2004. The zinc and sulfate returned to within historical limits in 2006. The cause for the increases in 2005 is not immediately apparent; however, if it was the arrival of a contact water front, a significant increase in conductivity, sulfate, calcium and magnesium should have preceded an increase in metals such as lead and zinc.

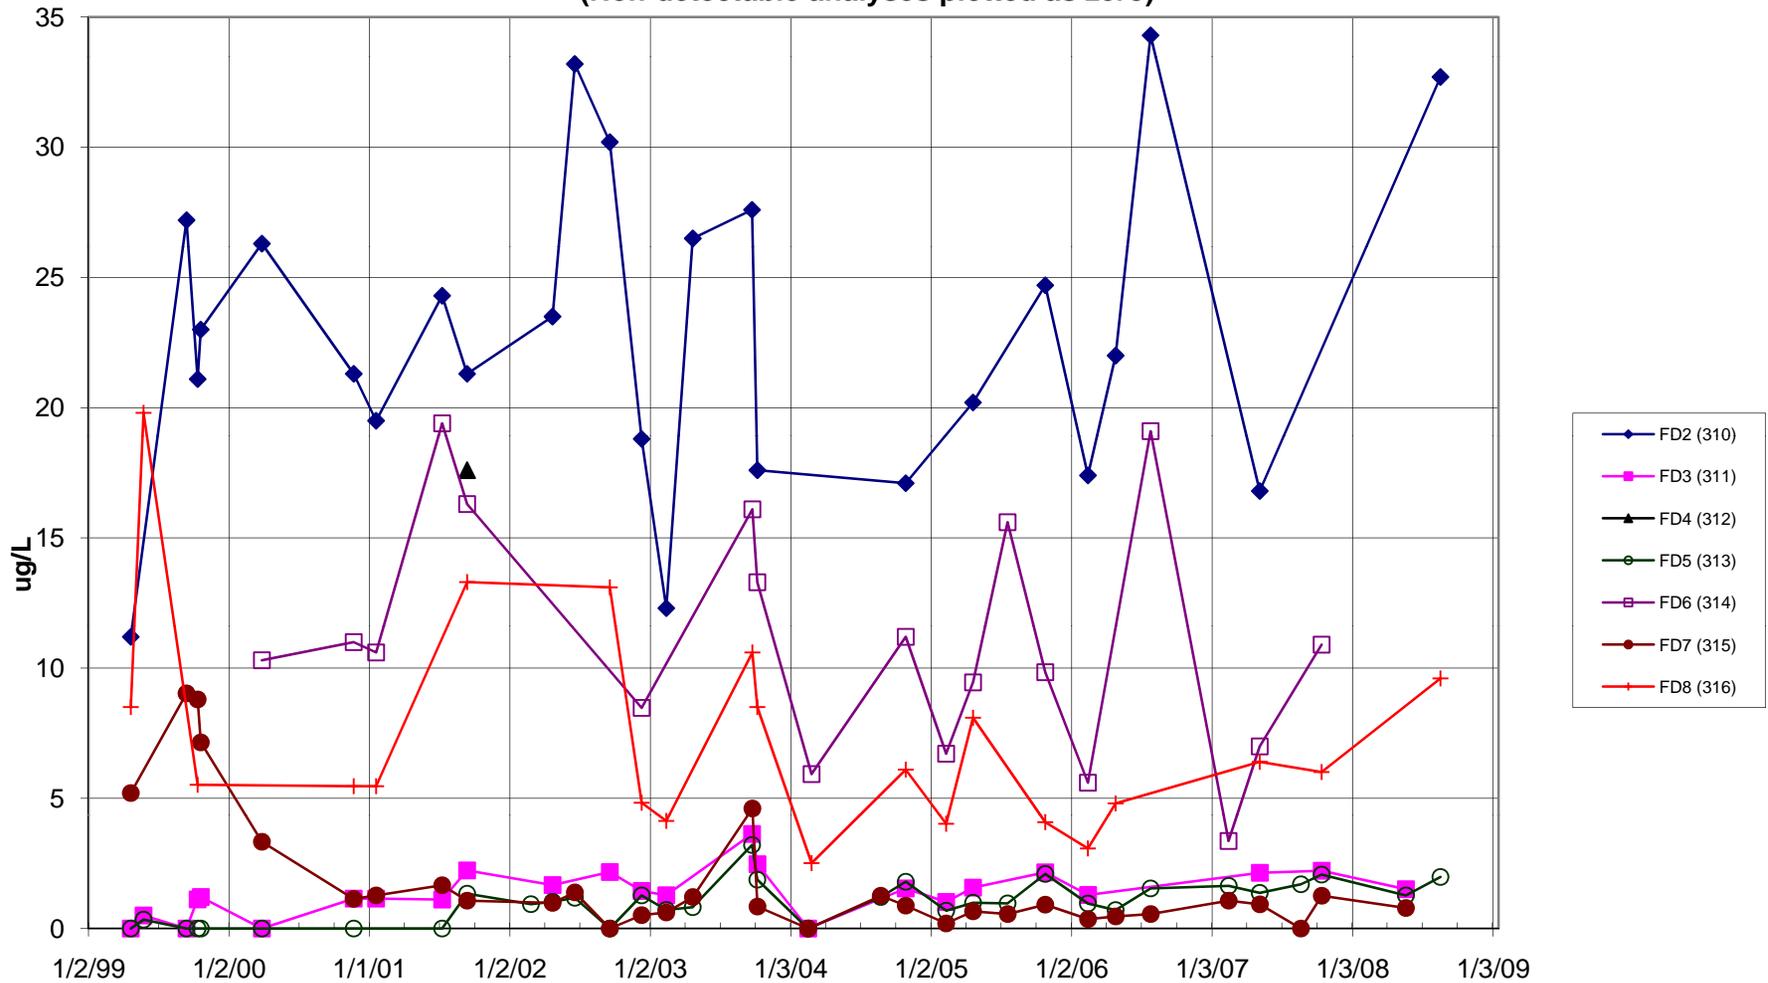
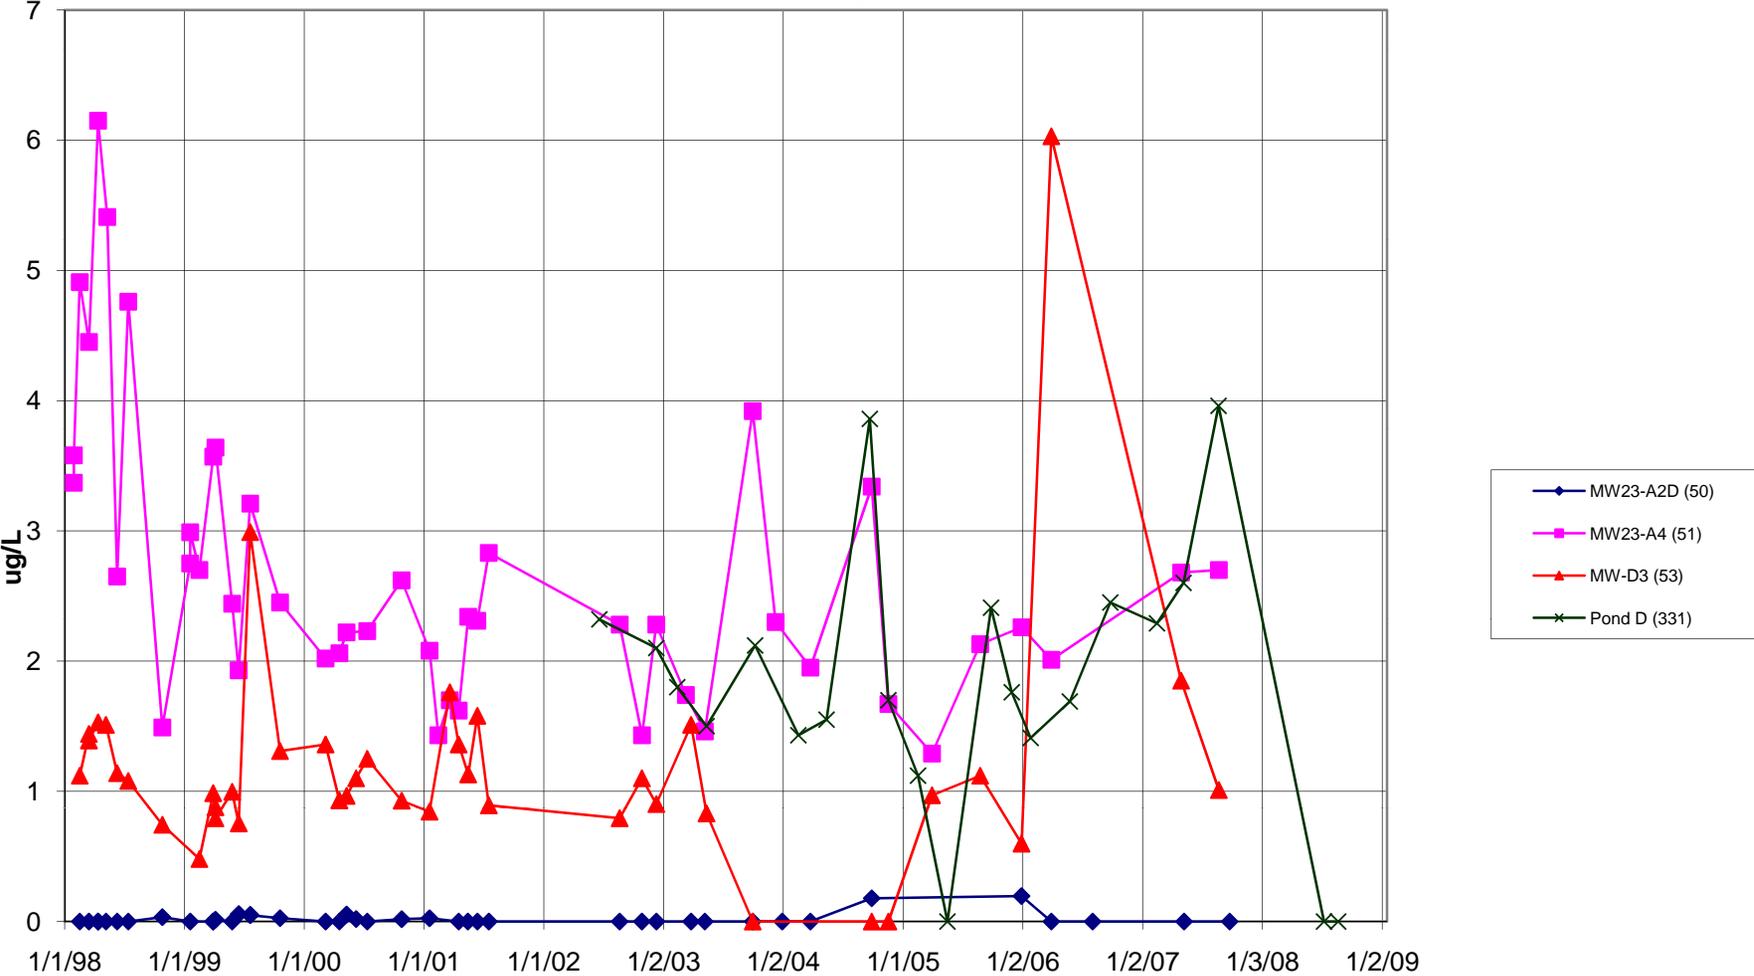
**FIGURE 3.21a GREENS CREEK SITE 23/D INTERNAL MONITORING SITES:
FINGER DRAINS - CADMIUM DATA
(Non-detectable analyses plotted as zero)**

Cadmium concentrations (Figures 3.21a and b) correlate well with those of zinc for the internal monitoring sites although at much lower values (0 to 35 µg/l).
