**TAILINGS AND PRODUCTION ROCK SITE
2008 ANNUAL REPORT**

Hecla Greens Creek Mining Company

April 15, 2009

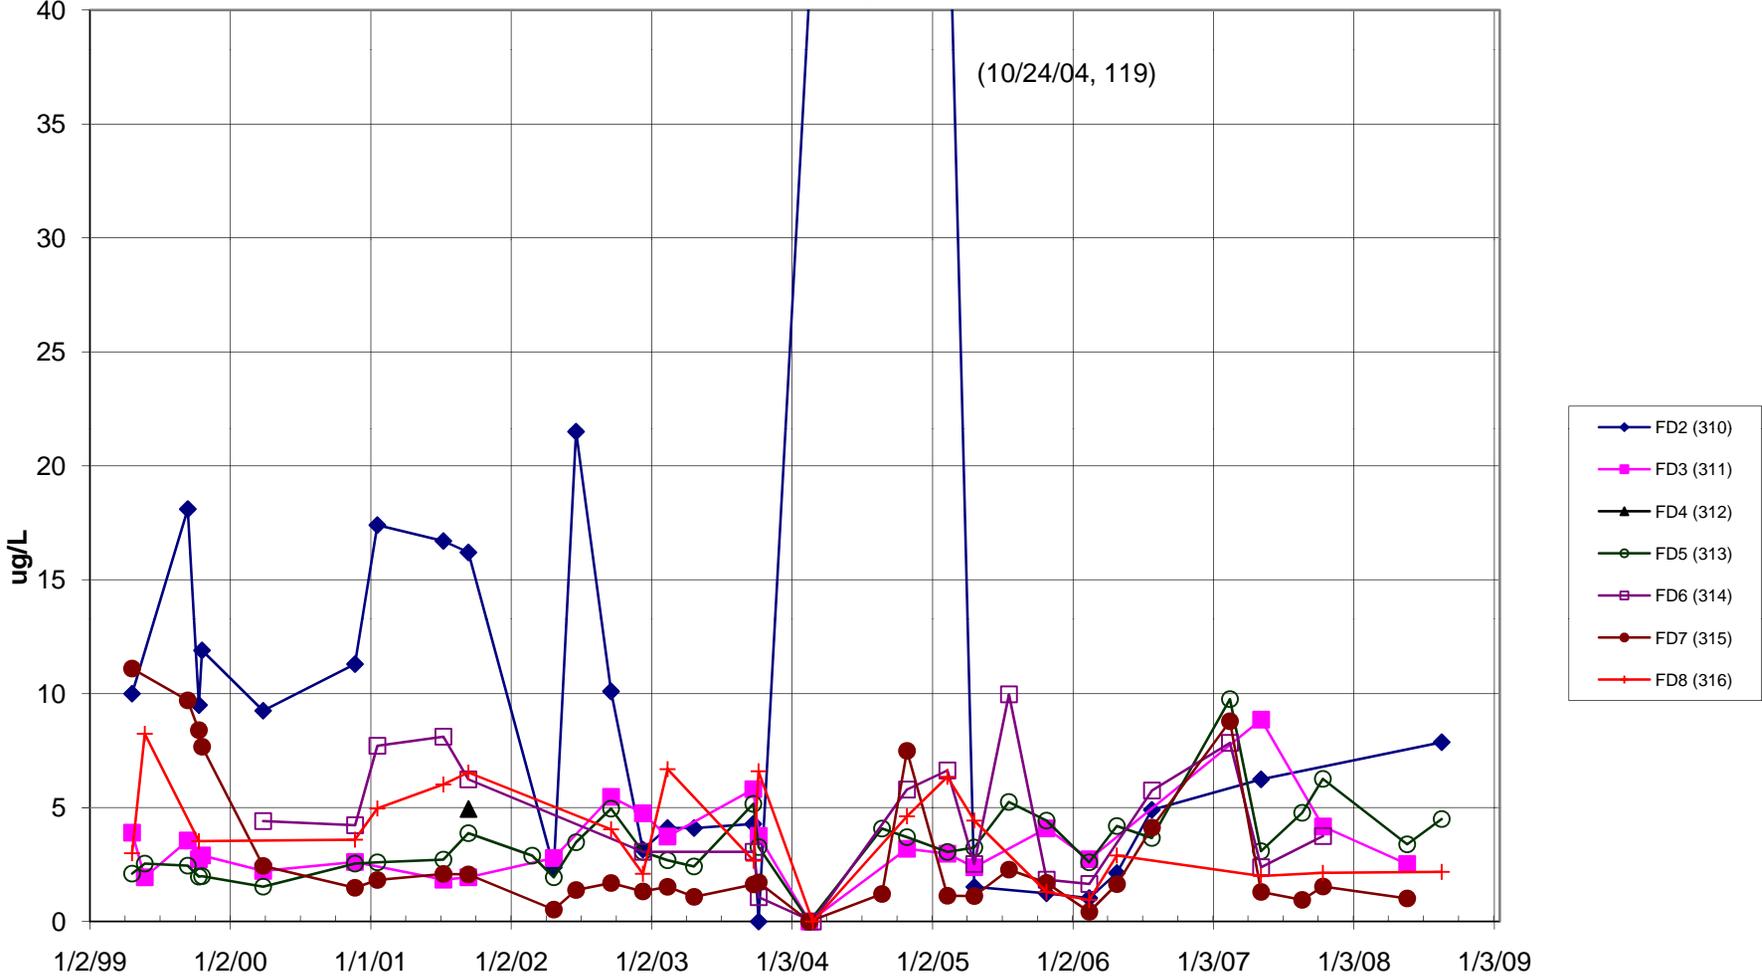
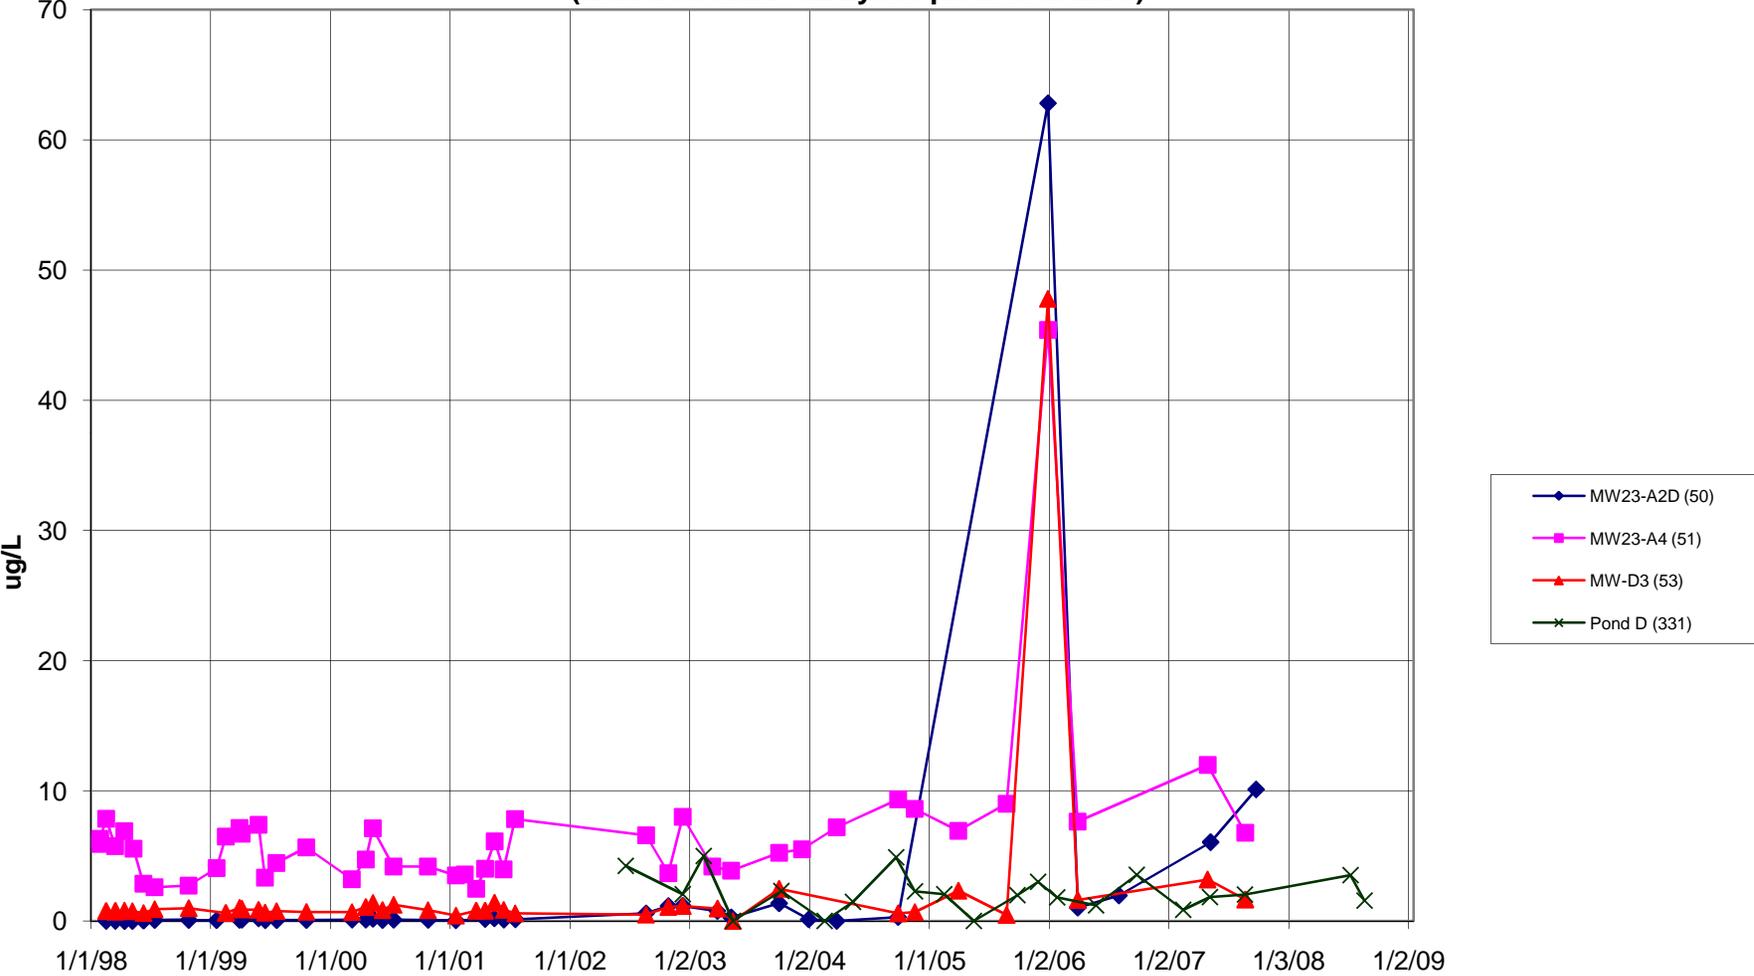
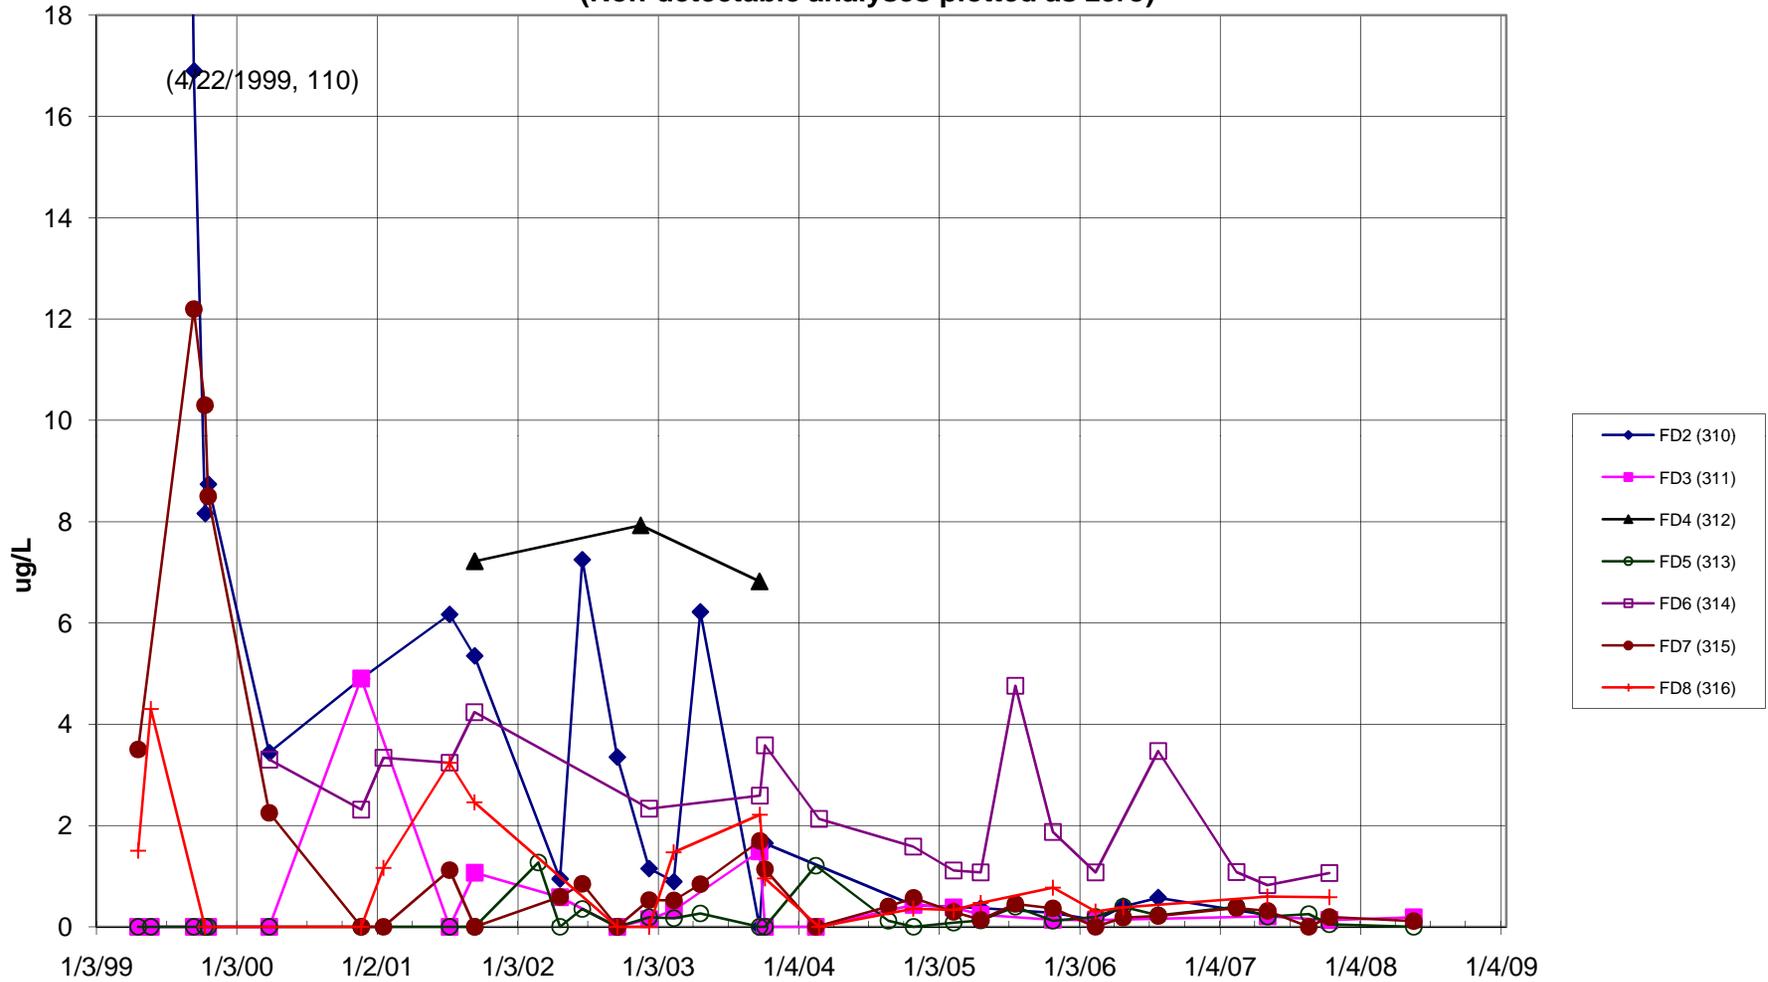
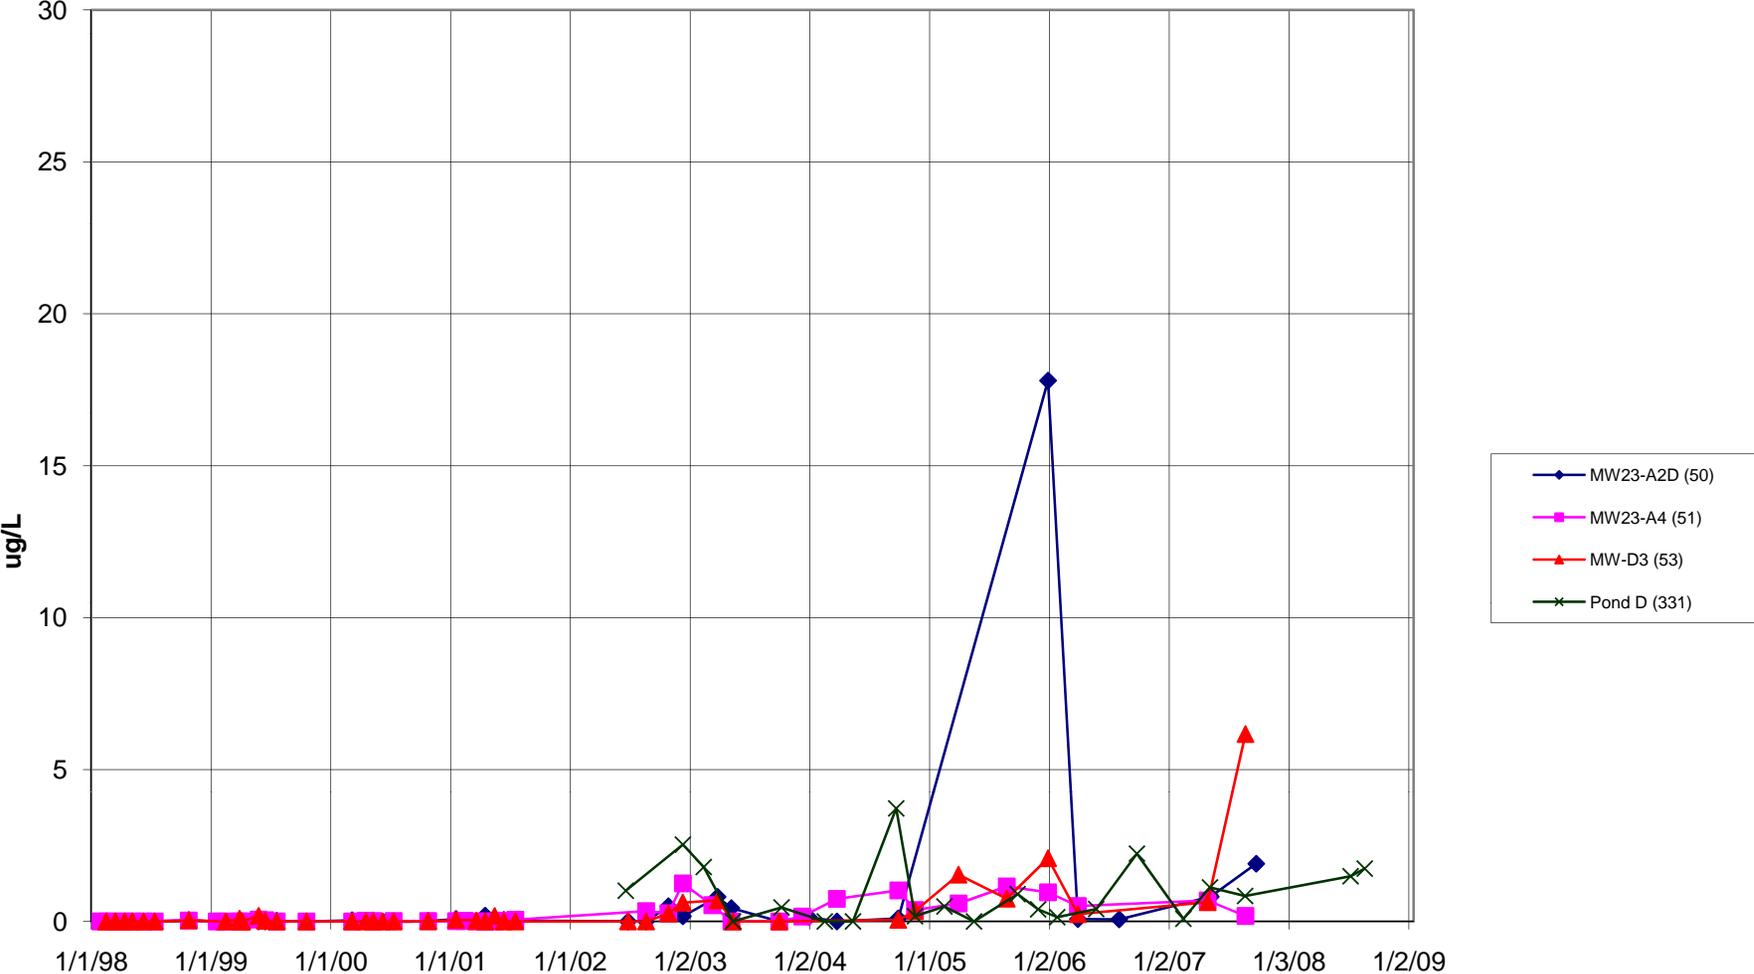
**FIGURE 3.22a GREENS CREEK SITE 23/D INTERNAL MONITORING SITES:
FINGER DRAINS - COPPER DATA
(Non-detectable analyses plotted as zero)**

The concentrations of copper and lead (Figures 3.22a and b and 3.23a and b) are considerably lower than that of zinc in the Site 23/D internal monitoring sites. Both of these metals show the same general trends as zinc with the exception of one anomalous lead result in a sample from 23FD-2 in 1999. The nickel concentrations presented in Figures 3.24a and b support the observation that the drainage from 23FD-2 is different than that of other drainages. It is possible that the material that supplies water to this drain has a greater proportion of serpentinite, which was shown to produce higher zinc and nickel concentrations than other rock types such as argillite and phyllite (Vos, 1993). What appeared to be a linear increase in nickel concentrations in 23FD-2 prior to 2002 now appears to be decreasing or at least cyclical. The December 2005 sample from MW-23-A2D was an order of magnitude higher than historical values and was likely an analytical error as it did not correspond with the conductivity and TDS of that sample. Also, these 2006 and 2008 metal concentrations for this site have returned within historical data values. Monitoring will continue to determine trends.

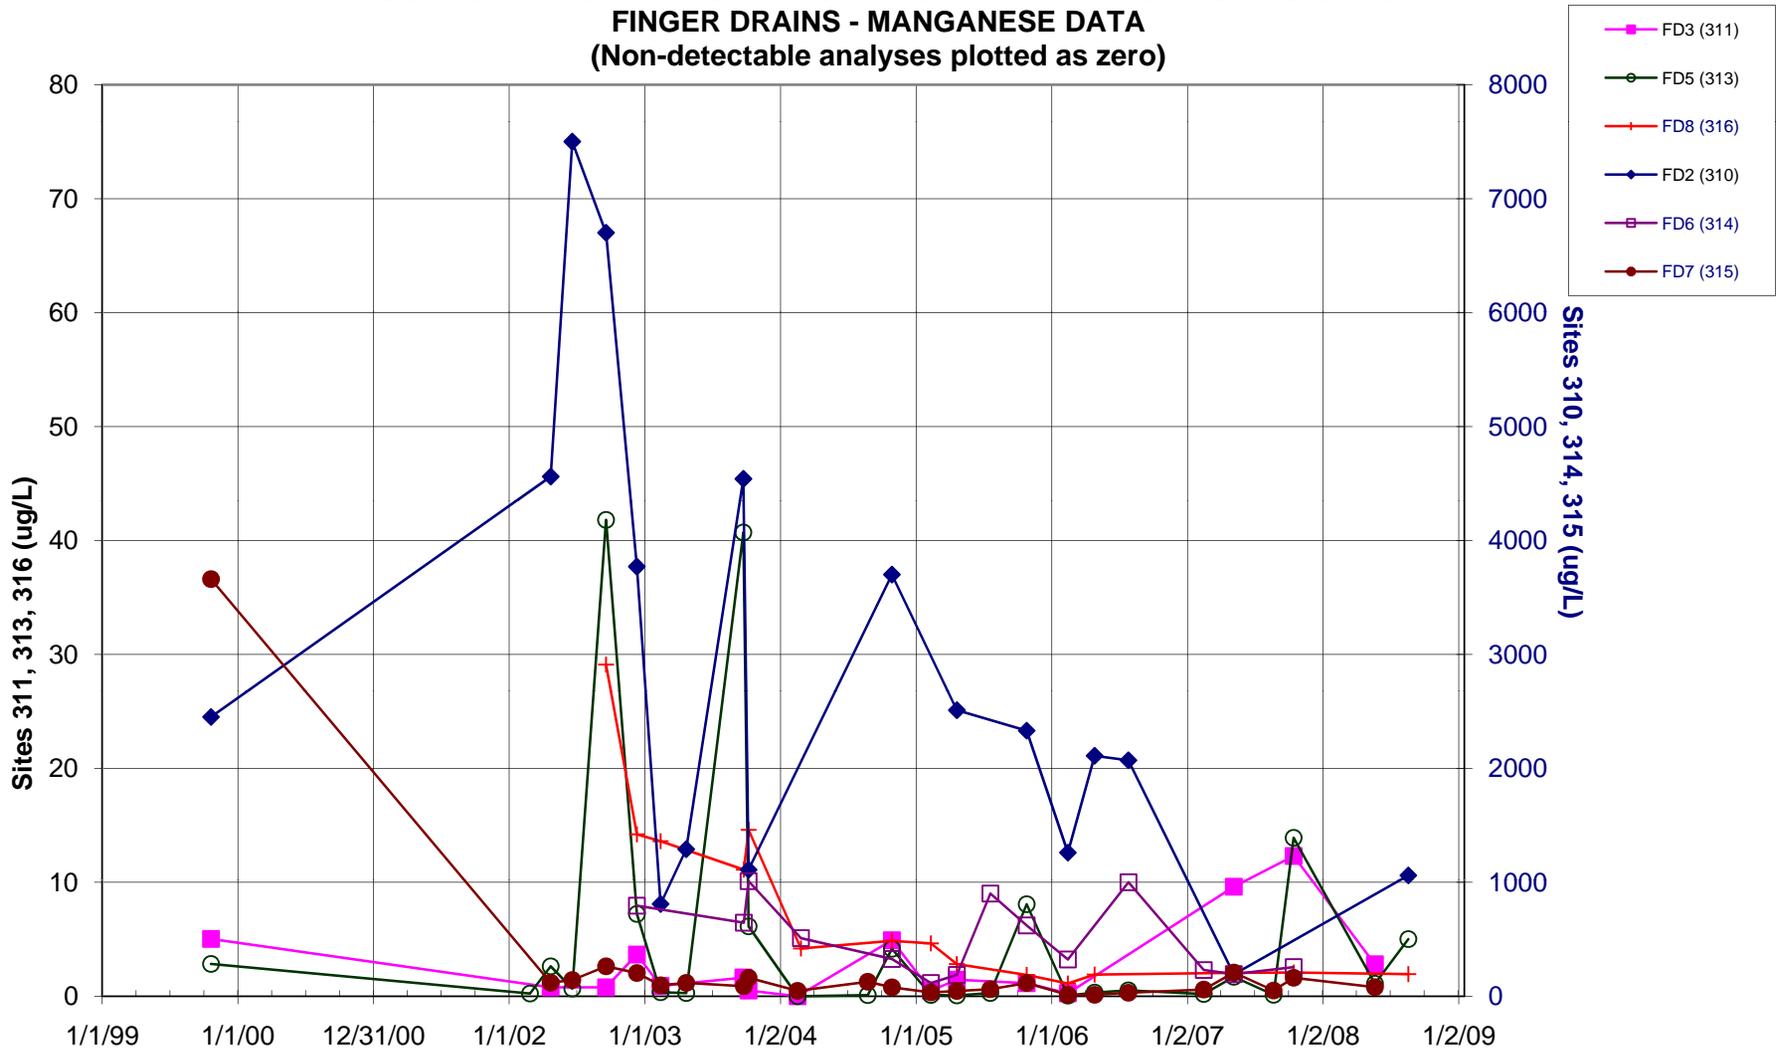
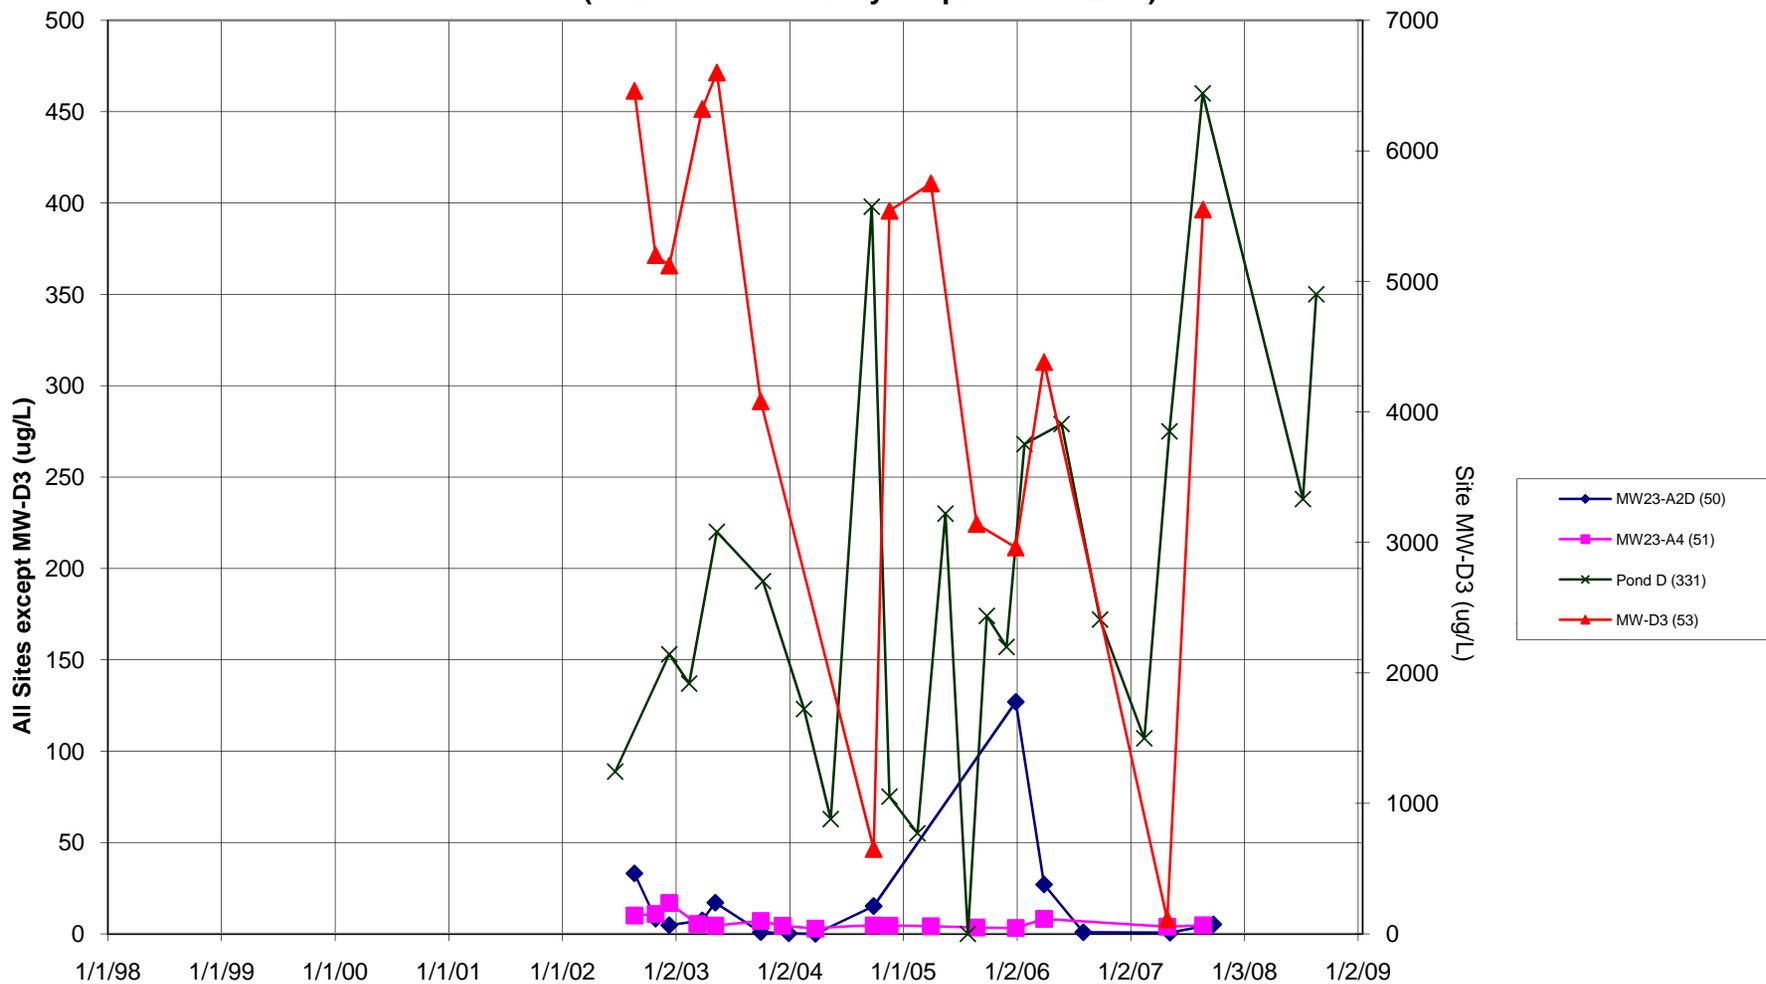
**FIGURE 3.26a GREENS CREEK SITE 23/D INTERNAL MONITORING SITES:
FINGER DRAINS - MANGANESE DATA
(Non-detectable analyses plotted as zero)**

Manganese concentrations (Figures 3.26a and b) are generally less than 50 µg/l for MW23-A2D, MW23-A4, and three of the finger drains (23FD-3, 23FD-5 and 23FD-8). The other three finger drains (23FD-2, 23FD-6 and 23FD-7) and MW-D3 and Pond D have elevated manganese concentrations, indicative of the different redox conditions. Precipitation/dissolution of iron oxyhydroxides and manganese oxides controls the concentrations of iron and manganese in these waters.

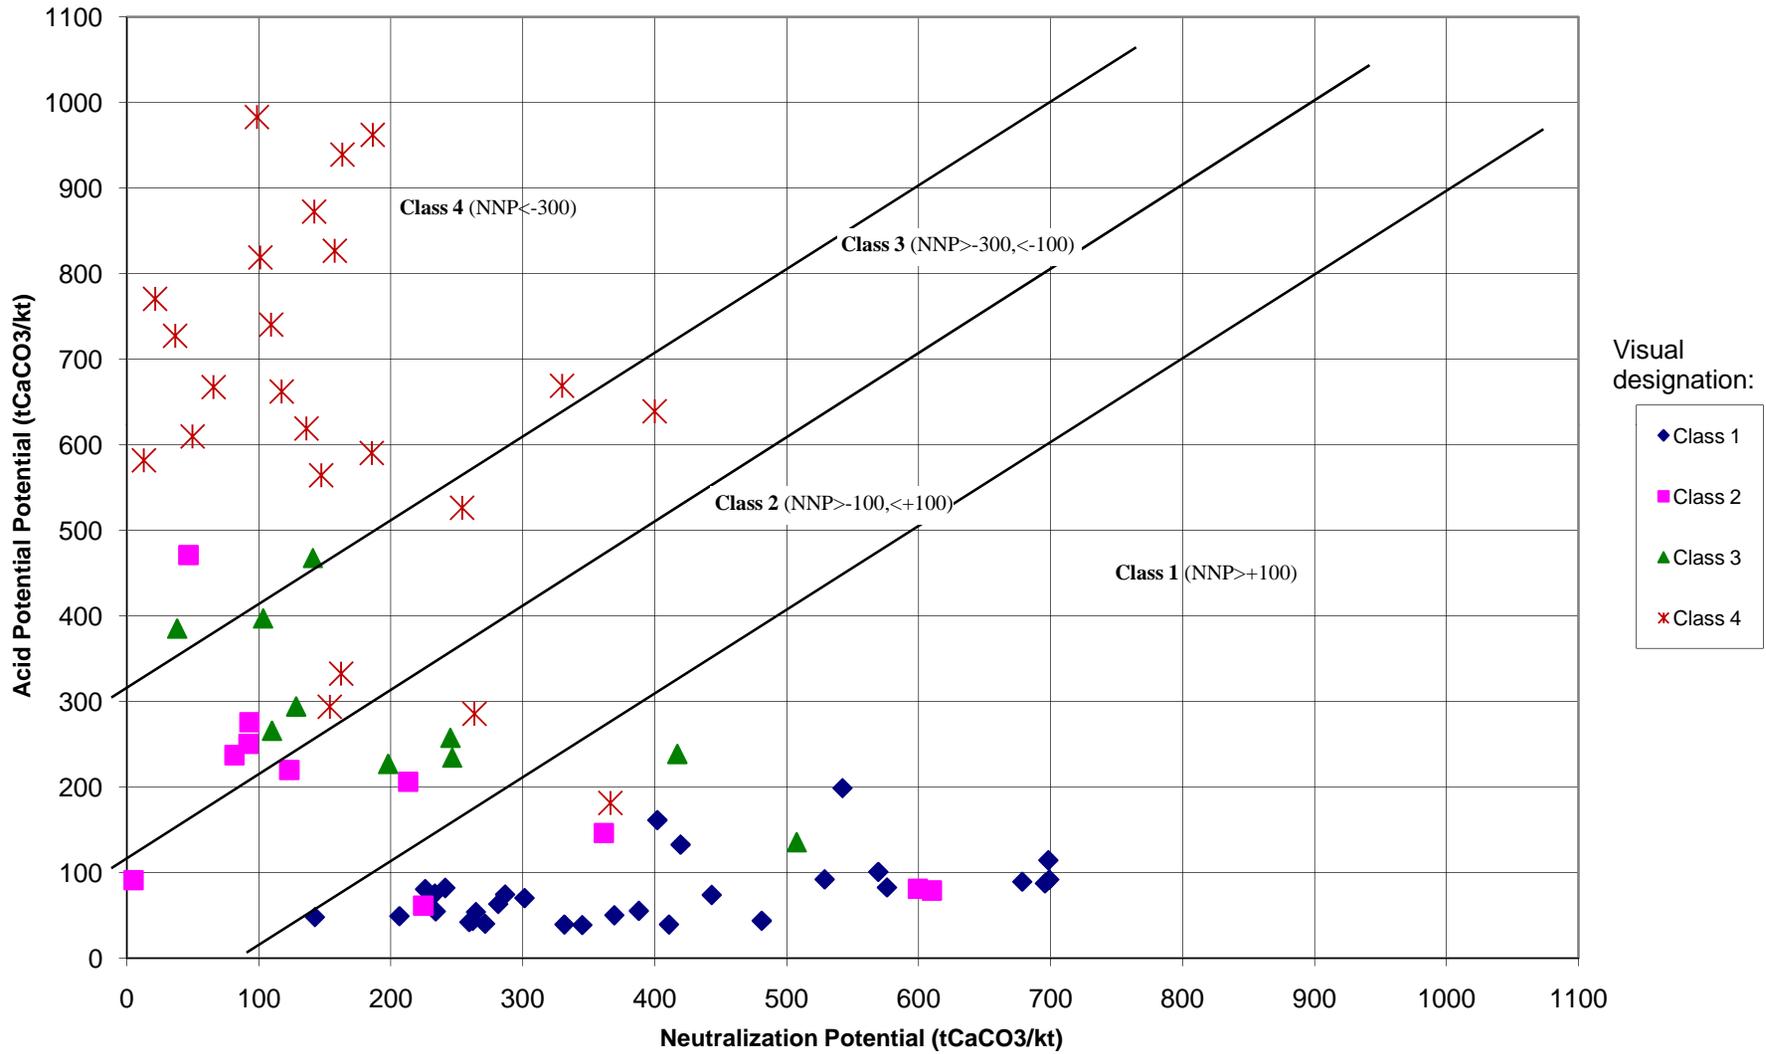
FIGURE 3.28 2008 ABA DATA FROM UNDERGROUND RIB SAMPLES

Acid base accounting (ABA) results from 77 underground rib composites collected in 2008 are presented in Table 3.3 and Figure 3.28. Class 1 rib samples had an average neutralization potential (NP) of 398 tons CaCO₃/1000t, which is equivalent to about 40% carbonate. The Class 1 samples had an average acid potential (AP) of 87 tonsCaCO₃/1000t, which produced an average net neutralization potential (NNP) of 311 tons CaCO₃/1000t. Class 1 production rock does not have the potential to generate acid rock drainage, however HGCMC recognizes the potential for metal mobility (primarily zinc) from this argillite rock. HGCMC has long-recognized this characteristic of Class 1 production rock and handles the material accordingly by placing it in controlled facilities, such as Site 23 and the tailings area.

Figure 3.28 compares actual class designation based on ABA analyses to the results of visual designation use underground to classify the production rock. Of the 77 composites, visual

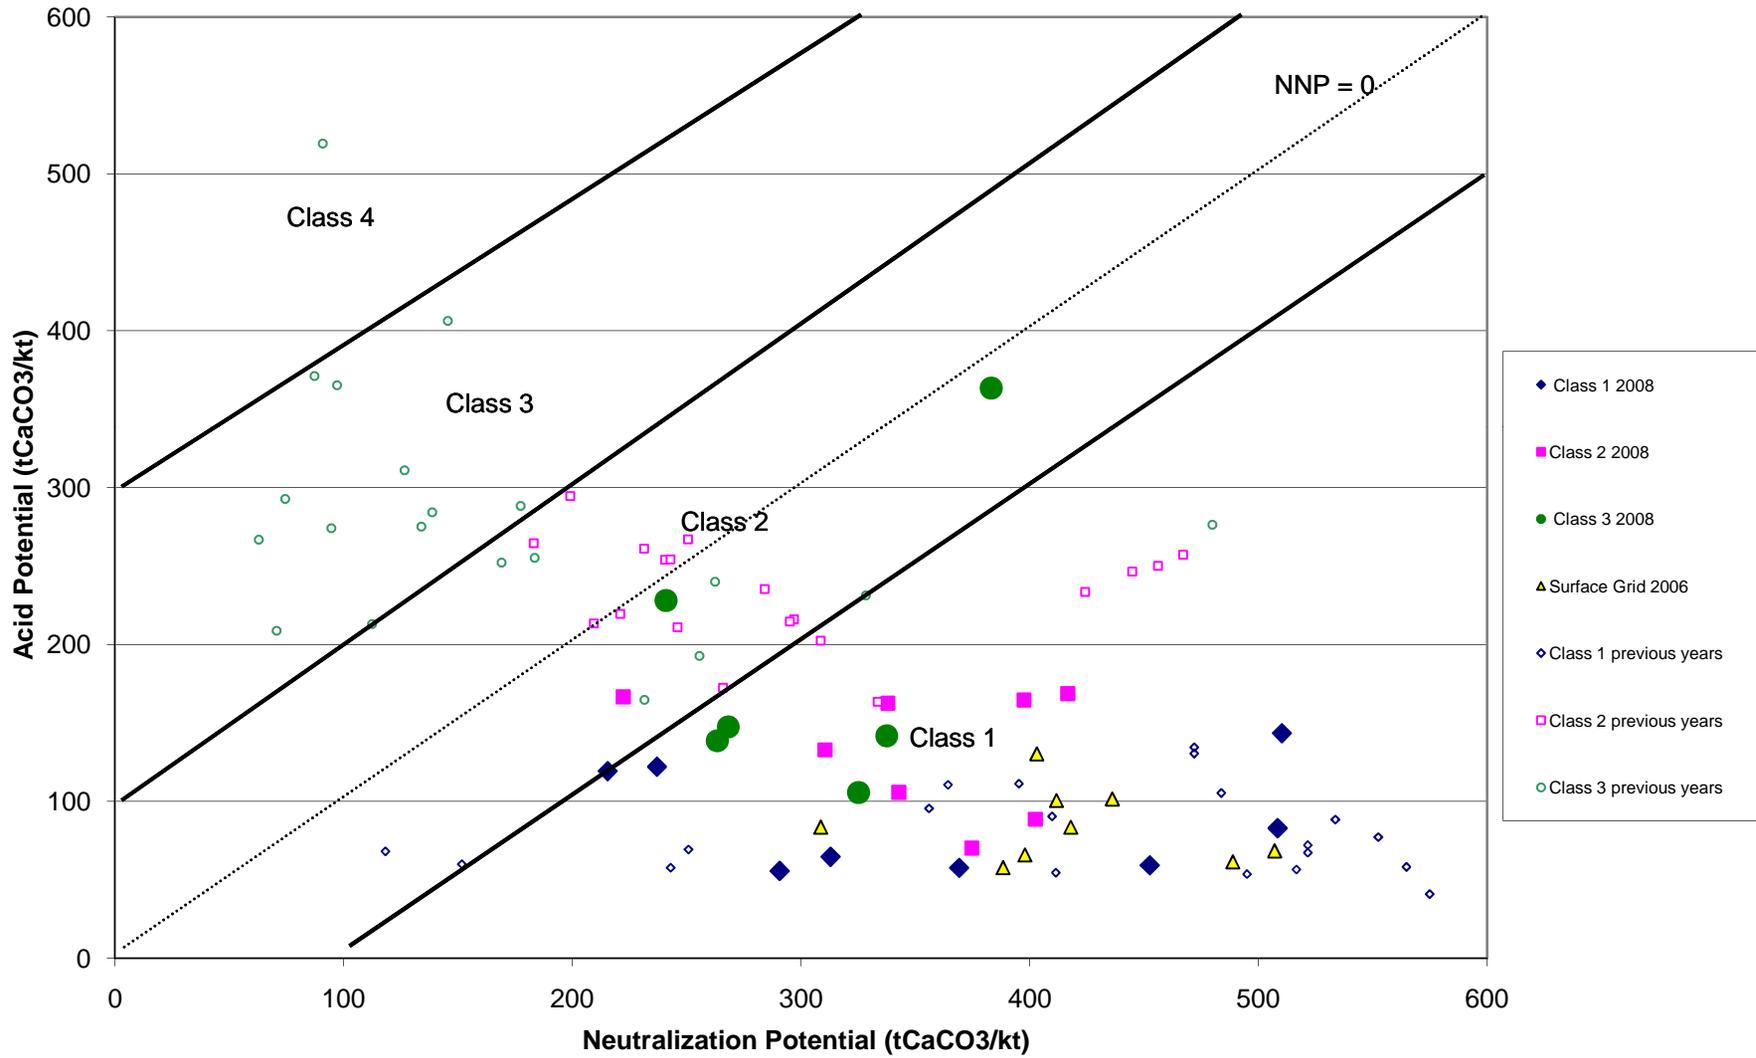
FIGURE 3.29 ACID-BASE ACCOUNTING DATA FOR SURFACE SITE 23

2008 ABA results from the Site 23 active placement areas are shown also in Table 3.3 and Figure 3.29. Active placement area ABA results from previous years as well as the 2006 grid data are also shown on Figure 3.29. The AP to NP distribution in the Site 23 samples is similar to the underground rib samples. Many of the samples at Site 23 were taken near the boundaries of the classification areas, and may be more representative of a mixture of classes. Therefore some of the data points may not fall neatly into the classification areas on the graph. Currently drainage from the Site 23/D area is collected and pumped either to the Mill, or to the Pond 7 water treatment facility for treatment prior to discharge to the ocean floor under the HGCMC NPDES permit AK-004320-6.

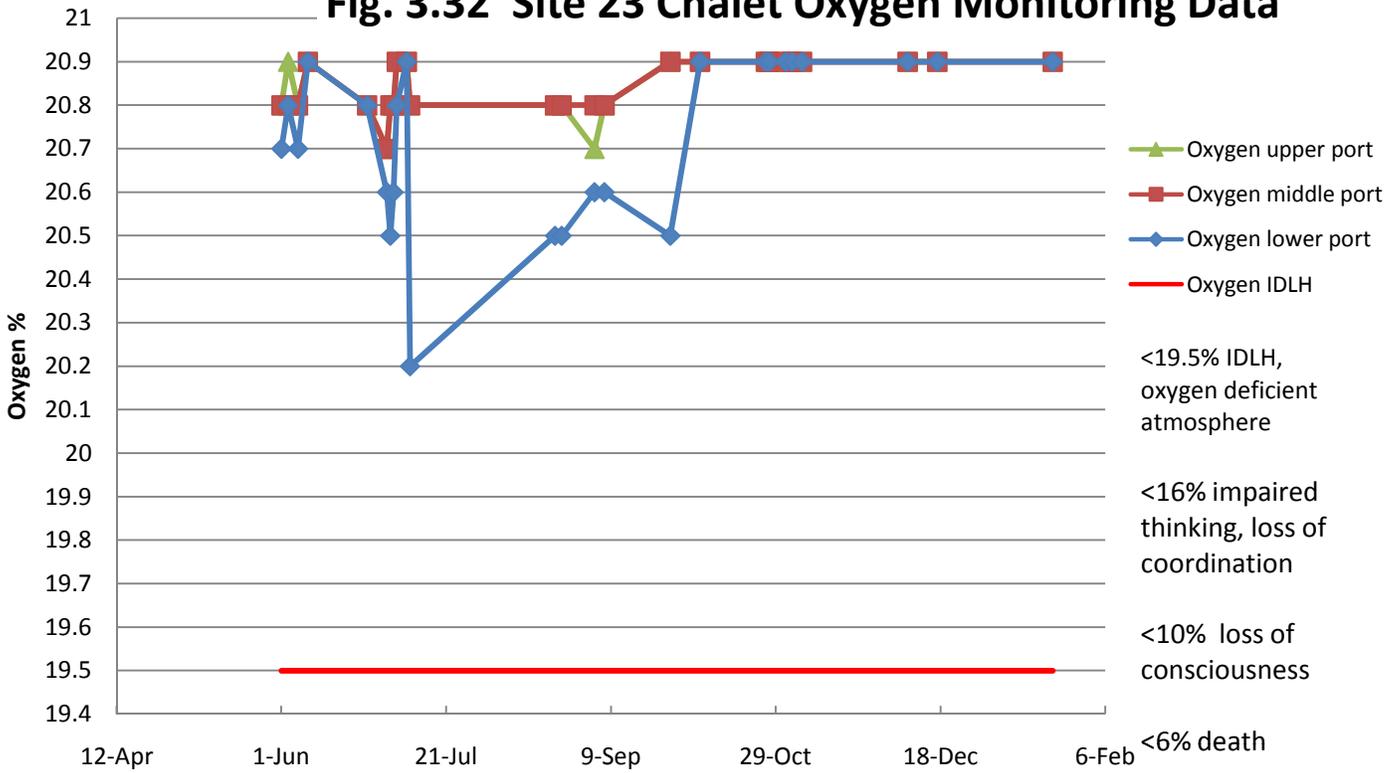
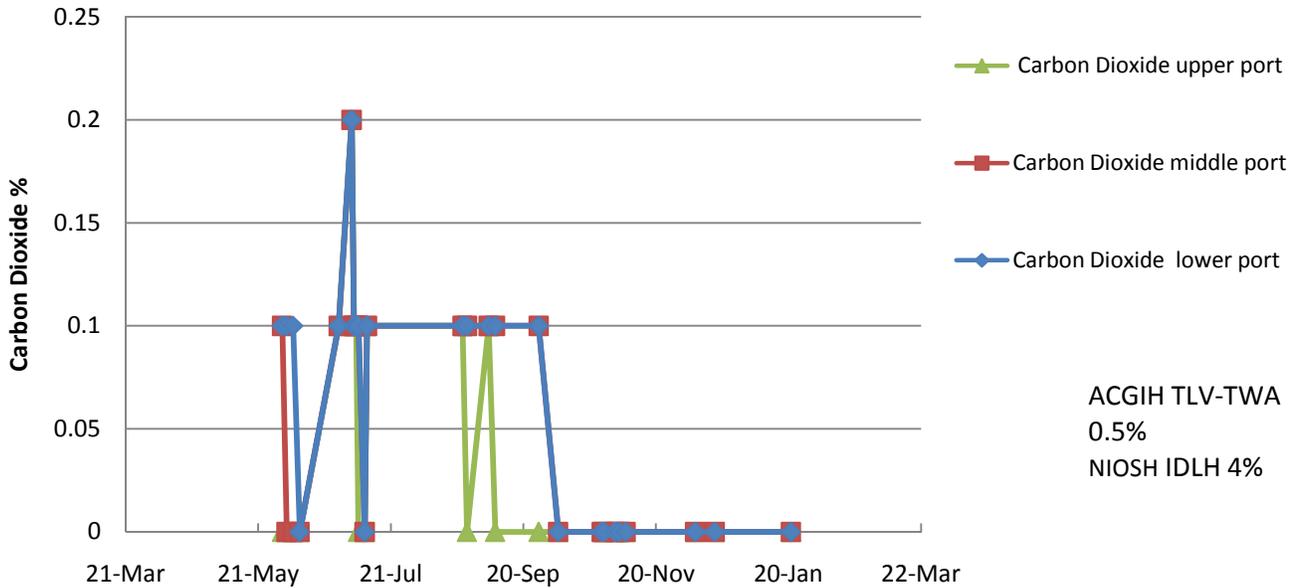
Fig. 3.32 Site 23 Chalet Oxygen Monitoring Data

In 2008 HGCMC began monitoring oxygen and carbon dioxide concentrations in the instrumentation trench building (the “Chalet”) to determine if conditions were unsafe for human entrance. Gas levels showed a slight season fluctuation, but did not approach unsafe levels. Figures 3.32 and 3.33 show oxygen levels decreased slightly and carbon dioxide levels increased slightly in the summer months and were at atmospheric conditions in the winter months (20.9% oxygen and 0% carbon monoxide). These monitoring results are consistent with the conceptual model of pile gas transport. When the internal temperature of the pile is colder than the external air temperature, oxygen-deficient, carbon dioxide-rich air flows out the toe of the pile. When the pile temperature is warmer than external air temperature, oxygen rich air is drawn in at the base of the pile. HGCMC personnel will continue to monitor gas levels in the summer months prior to entering into the building.

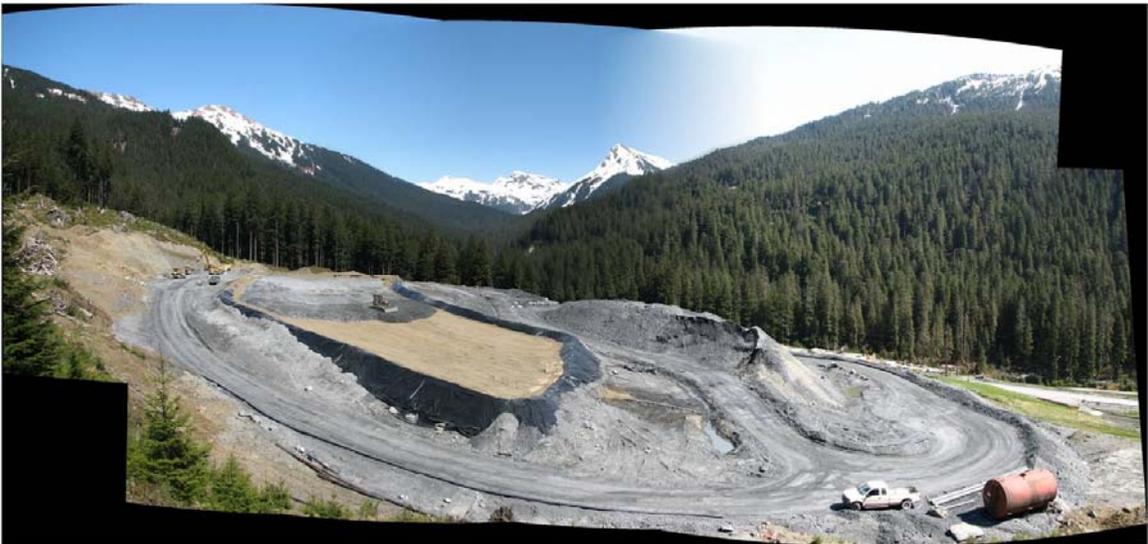
Figure 3.35 Site 23 Temporary Storage Area- June 2008

In 2008, HGCMC received approval from ADEC to construct an interim storage area for waste rock to be backfilled underground (see photo Figure 3.35). This 25,000 cubic yard capacity area was constructed to aid in concurrent reclamation efforts and can potentially be utilized on a continual 12-month schedule. This is a large increase over the previous 920 remuck bay which had a seasonal 700 cubic yard capacity. The area is layered with 6" of sand; a 36 mil reinforced polypropylene liner, another 6" layer of sand, 3' of class 3 production rock, and finally a geofabric layer. An HDPE pipe collects water from the area which is sloped to a central collection point. The water collected in this area drains to Pond 23. Material placed in this area is
