**TAILINGS AND PRODUCTION ROCK SITE
2009 ANNUAL REPORT**

Hecla Greens Creek Mining Company

April 15, 2010

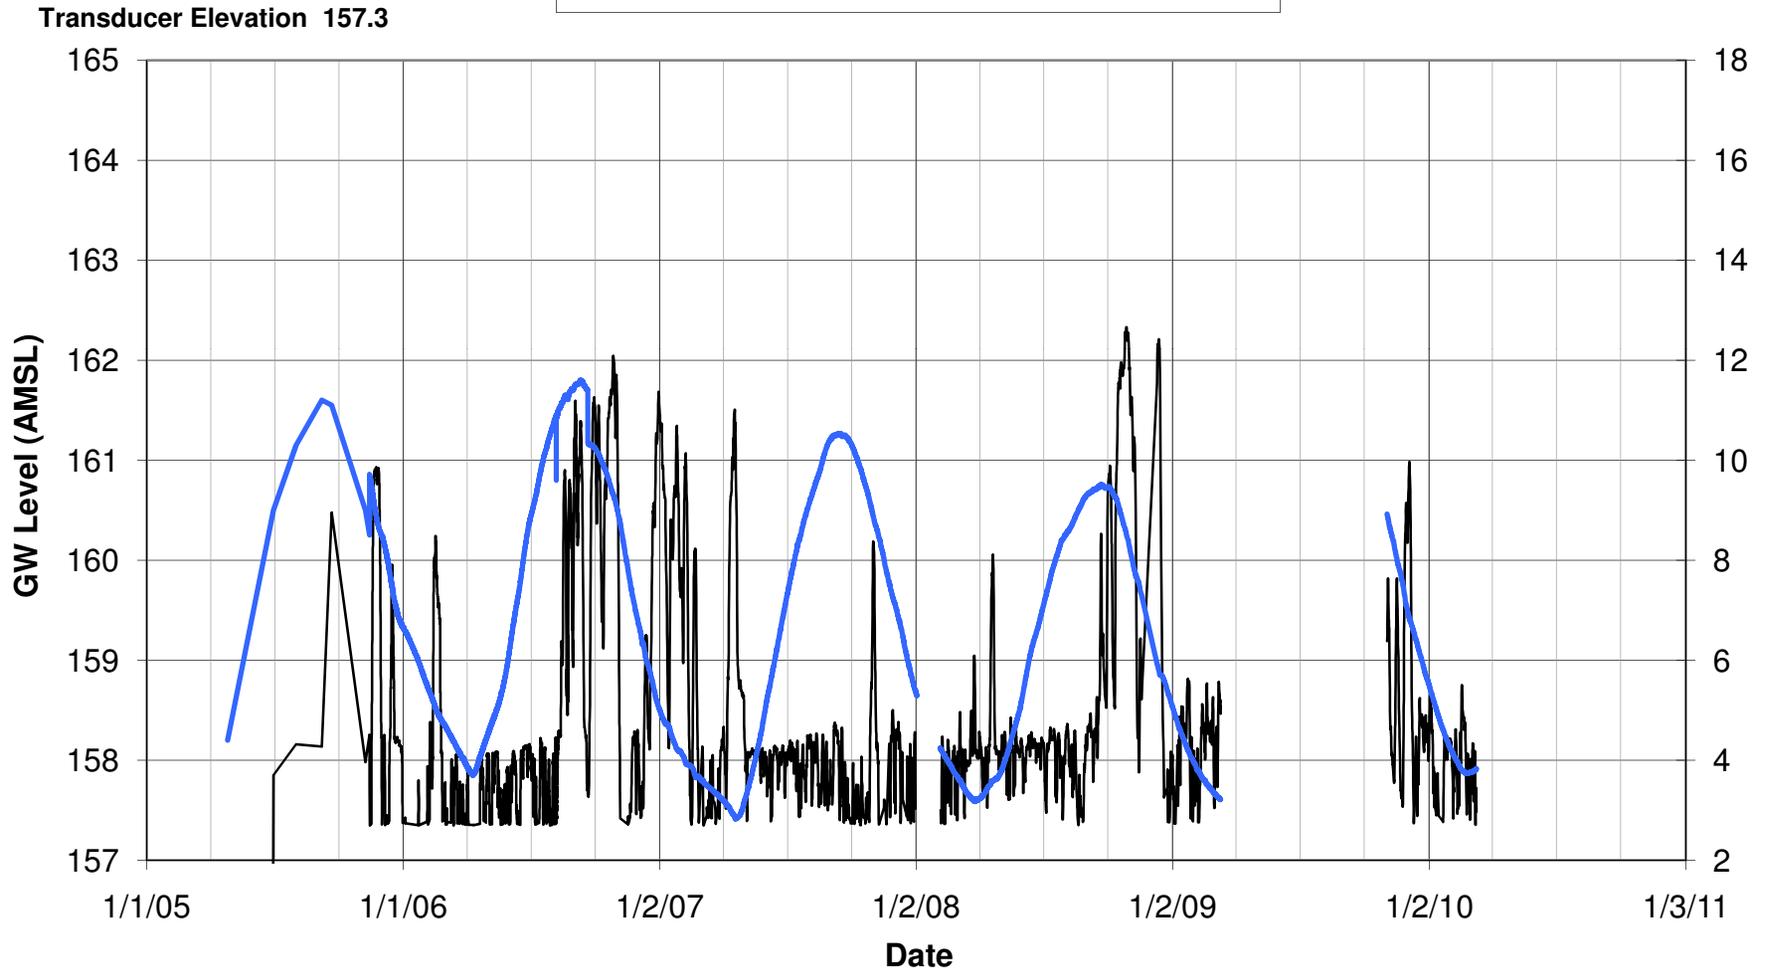
Figure 2.10 Water Level Data for Piezometer 76

The data from standpipe and pneumatic piezometers completed above the blanket drain (Piezometer 76, PZ-T-00-01, PZ-T-00-02, PZ-T-00-03 in Figures 2.10, 2.11, 2.12, 2.13) indicate that saturated conditions can develop above the unsaturated underdrains to a thickness of

approximately 12 feet. This is consistent with the low permeability of the tailings and the uncapped condition of the pile. Covering the pile will help minimize the saturated zone in the pile. This was demonstrated by the over 10 foot decrease in the water table that occurred from 1995 to 1997 when the pile was covered (see Figures 2.1 to 2.7). Water levels have rebounded to, and in some cases above, 1994 elevations in most areas. Areas where water levels exceed their 1994 values are areas where the pile is considerably thicker than it was in 1994. The increase in water levels observed in PZ-T-00-01 (and to a lesser extent in instruments nearby) from 2005 to 2008 is likely a result of new tailings placement in the area and staged decommissioning of Wet Well 2.

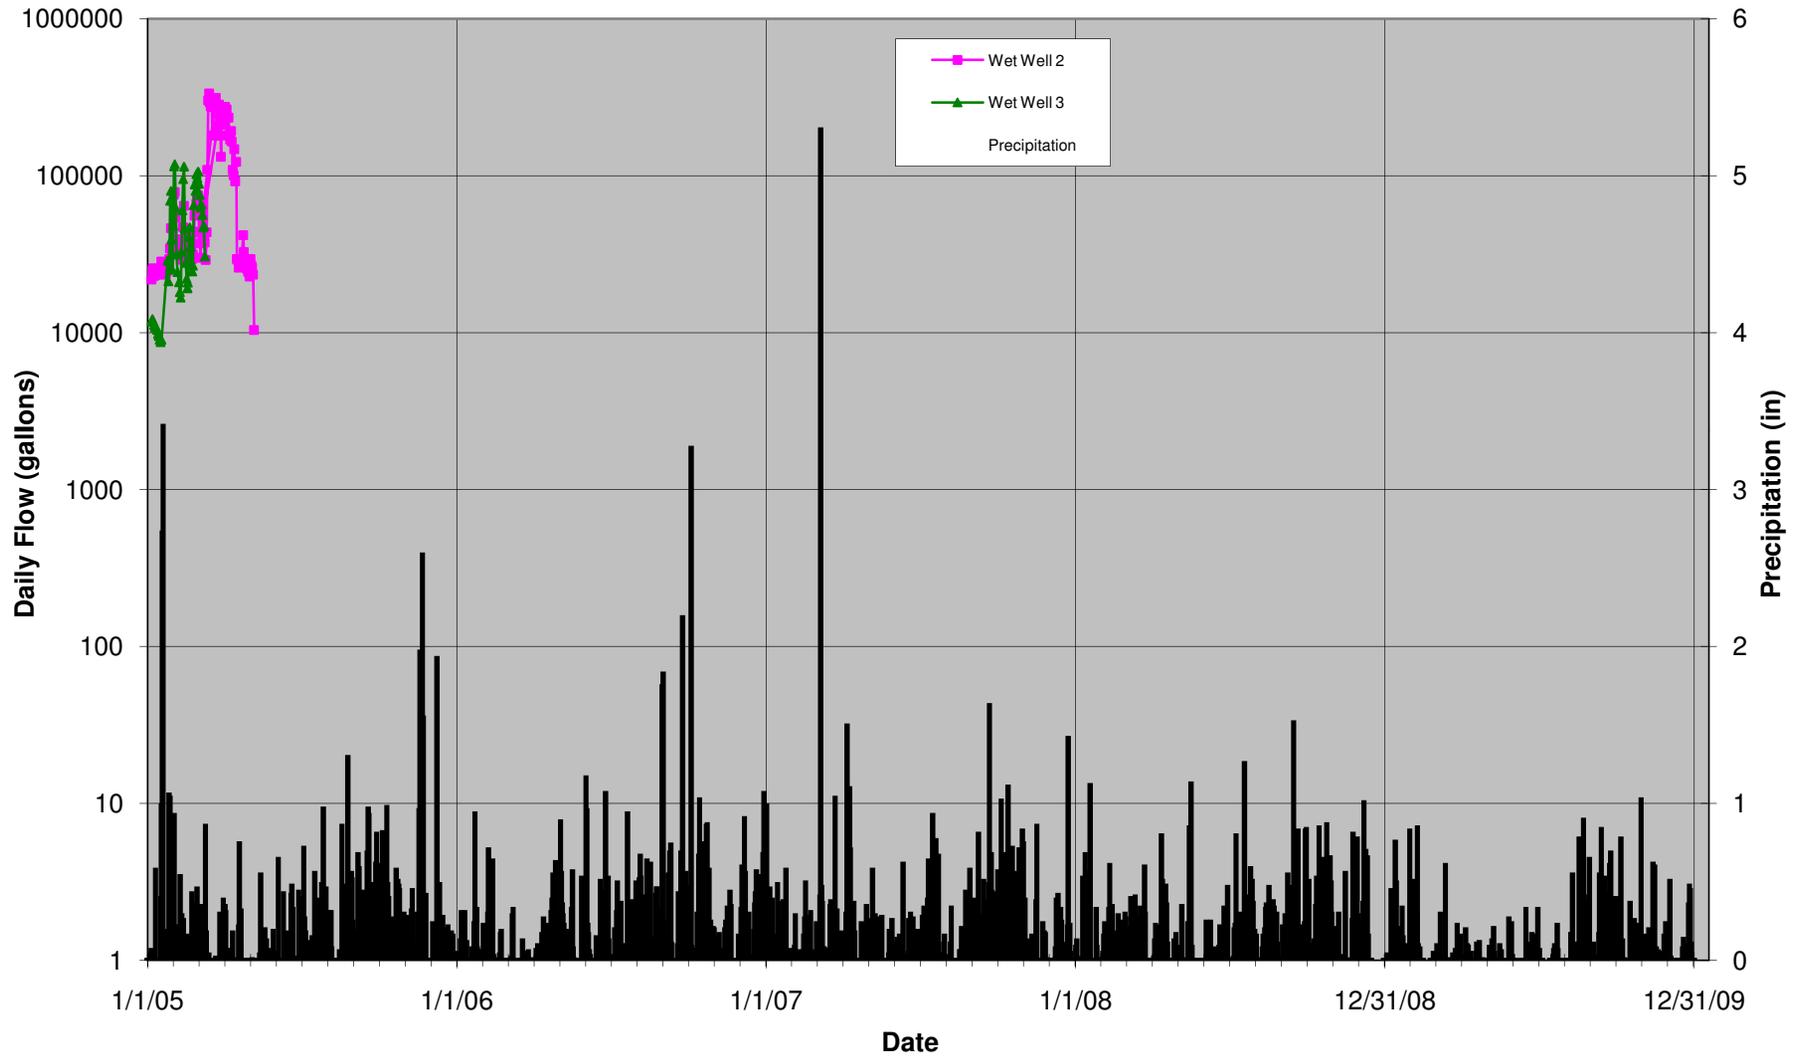
FIGURE 2.19 TAILINGS AREA WET WELL FLOW

Flow data from Wet Wells 2 and 3 are presented with the precipitation data for 2005 – 2009 in Figure 2.19. The wet well flows respond relatively quickly to precipitation events, demonstrating a significant contribution of surface water. The use of the wet well flow meters has been discontinued since 2005 as part of the tailings expansion activities.

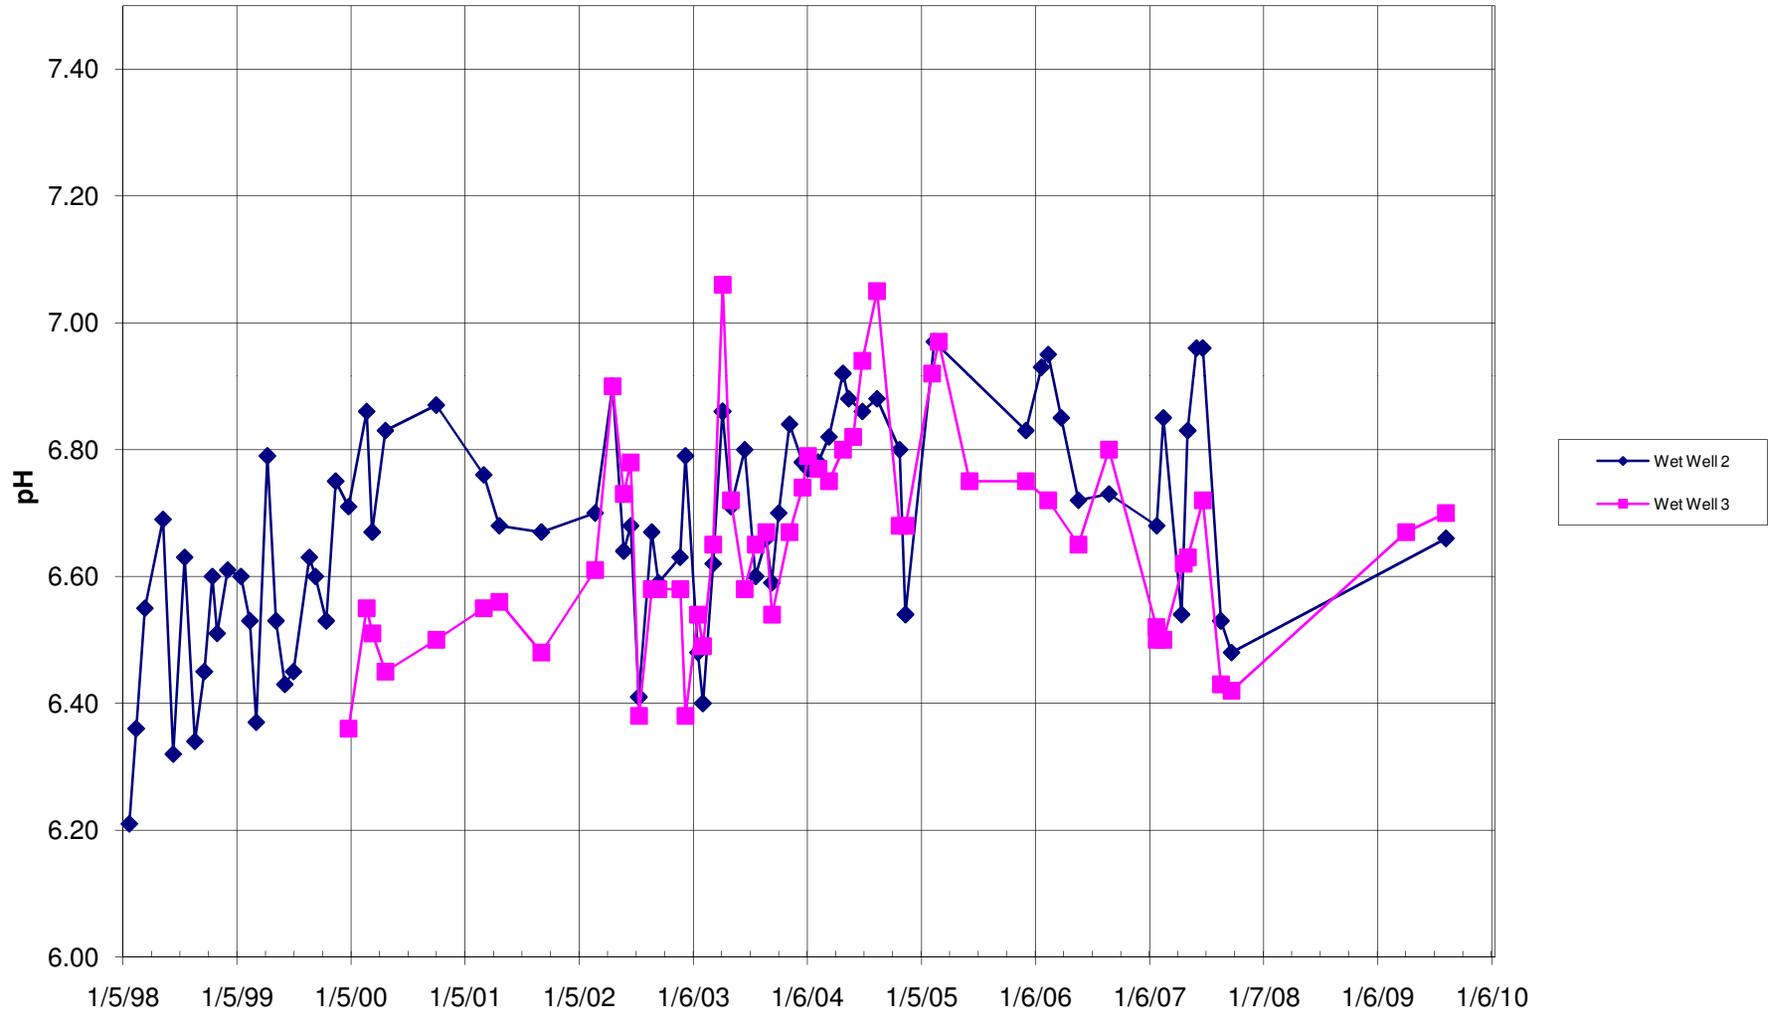
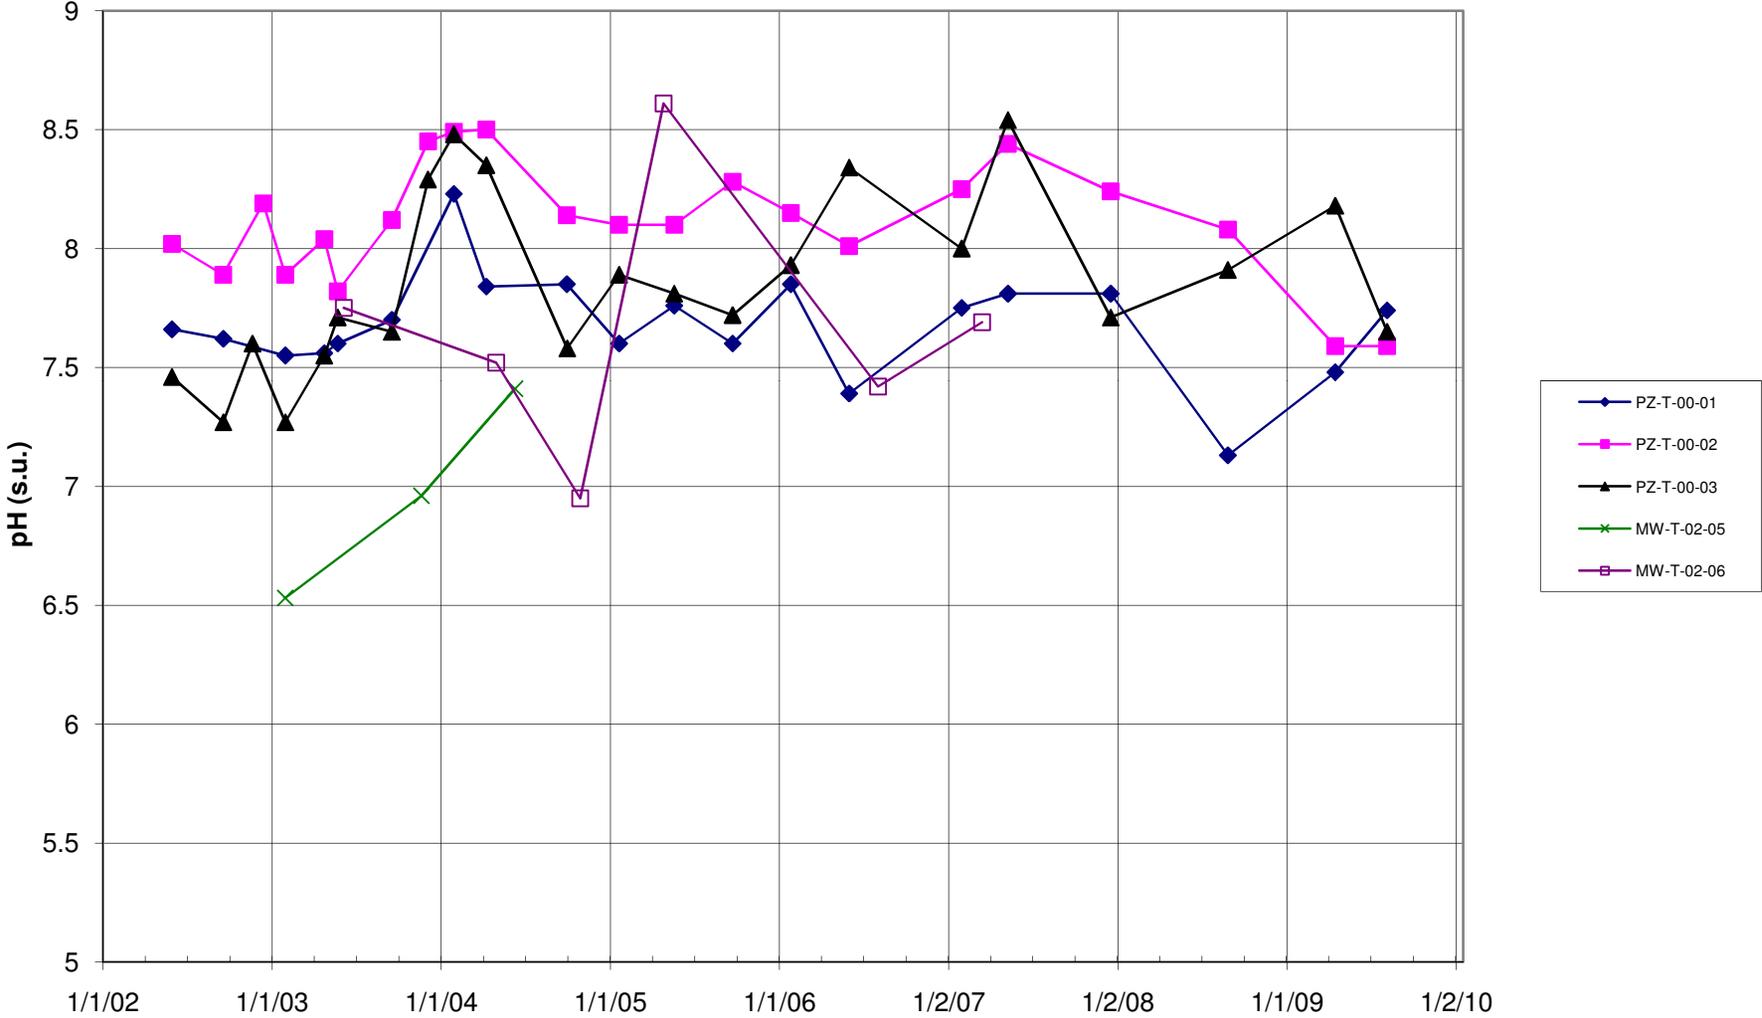
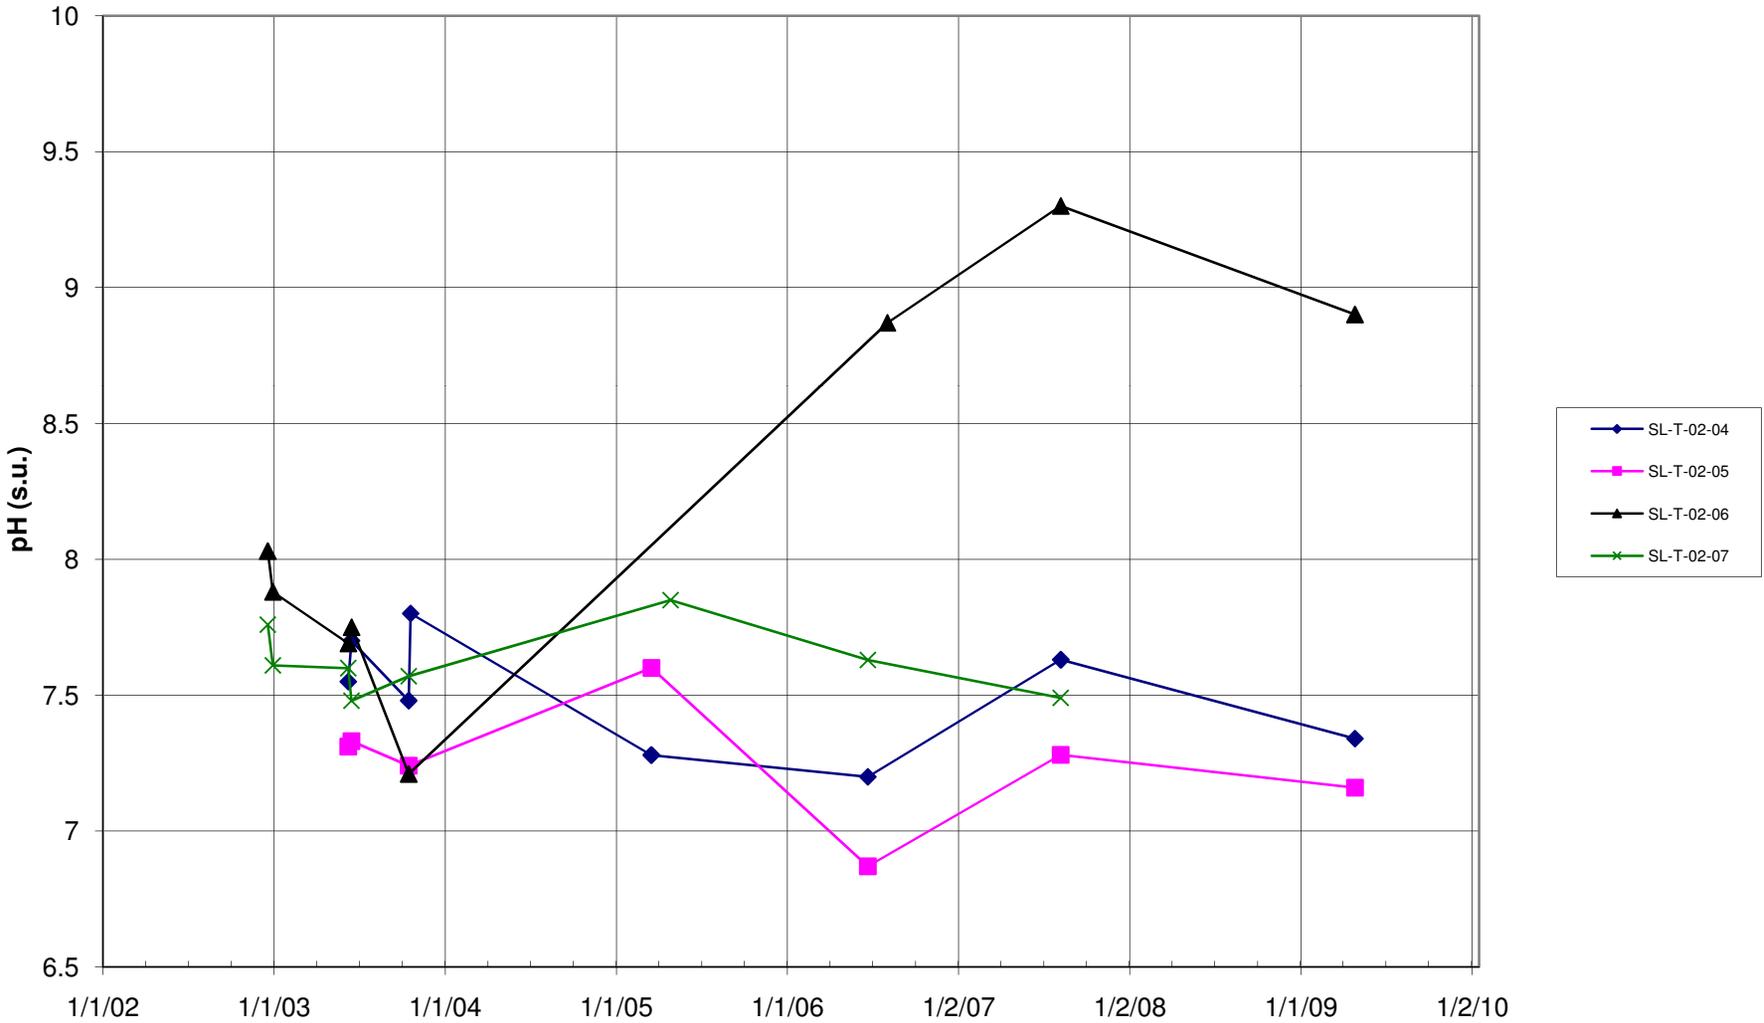
Most values of pH remained between 6 and 8.5 for all internal monitoring site samples in 2009 (Figures 2.20a, b and c). PZ-T-00-01, PZ-T-00-2 and PZ-T-00-3, which screen the lower ten feet of the tailings pile, have the highest pH on average of the internal monitoring sites. This is likely a result of microbial sulfate reduction and equilibration with carbonate in the saturated zone of the pile. The wet wells produce water with slightly lower pH (generally between 6.5 and 7), reflecting minor influences from groundwater (organic acids) and oxidized surface waters (acidity from thiosalt, sulfide and iron oxidation). The suction lysimeters all have pH values between 6.87 and 8.03 with the exception of SL-T-02-06 which has shown pHs above 8.5 since 2006, likely a result of sulfate reduction.

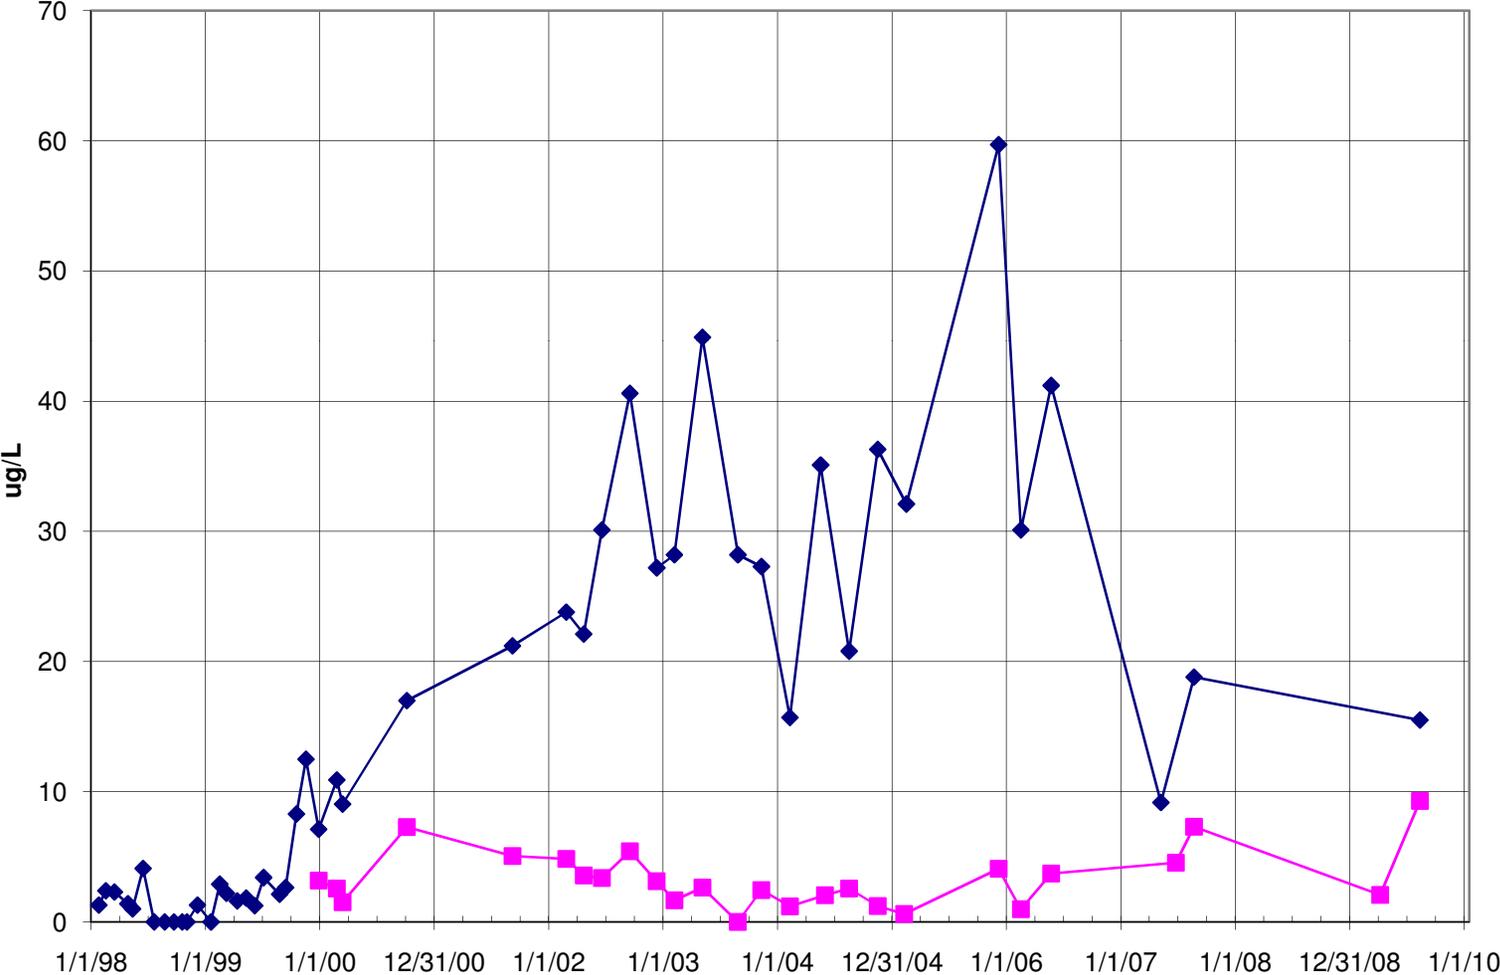
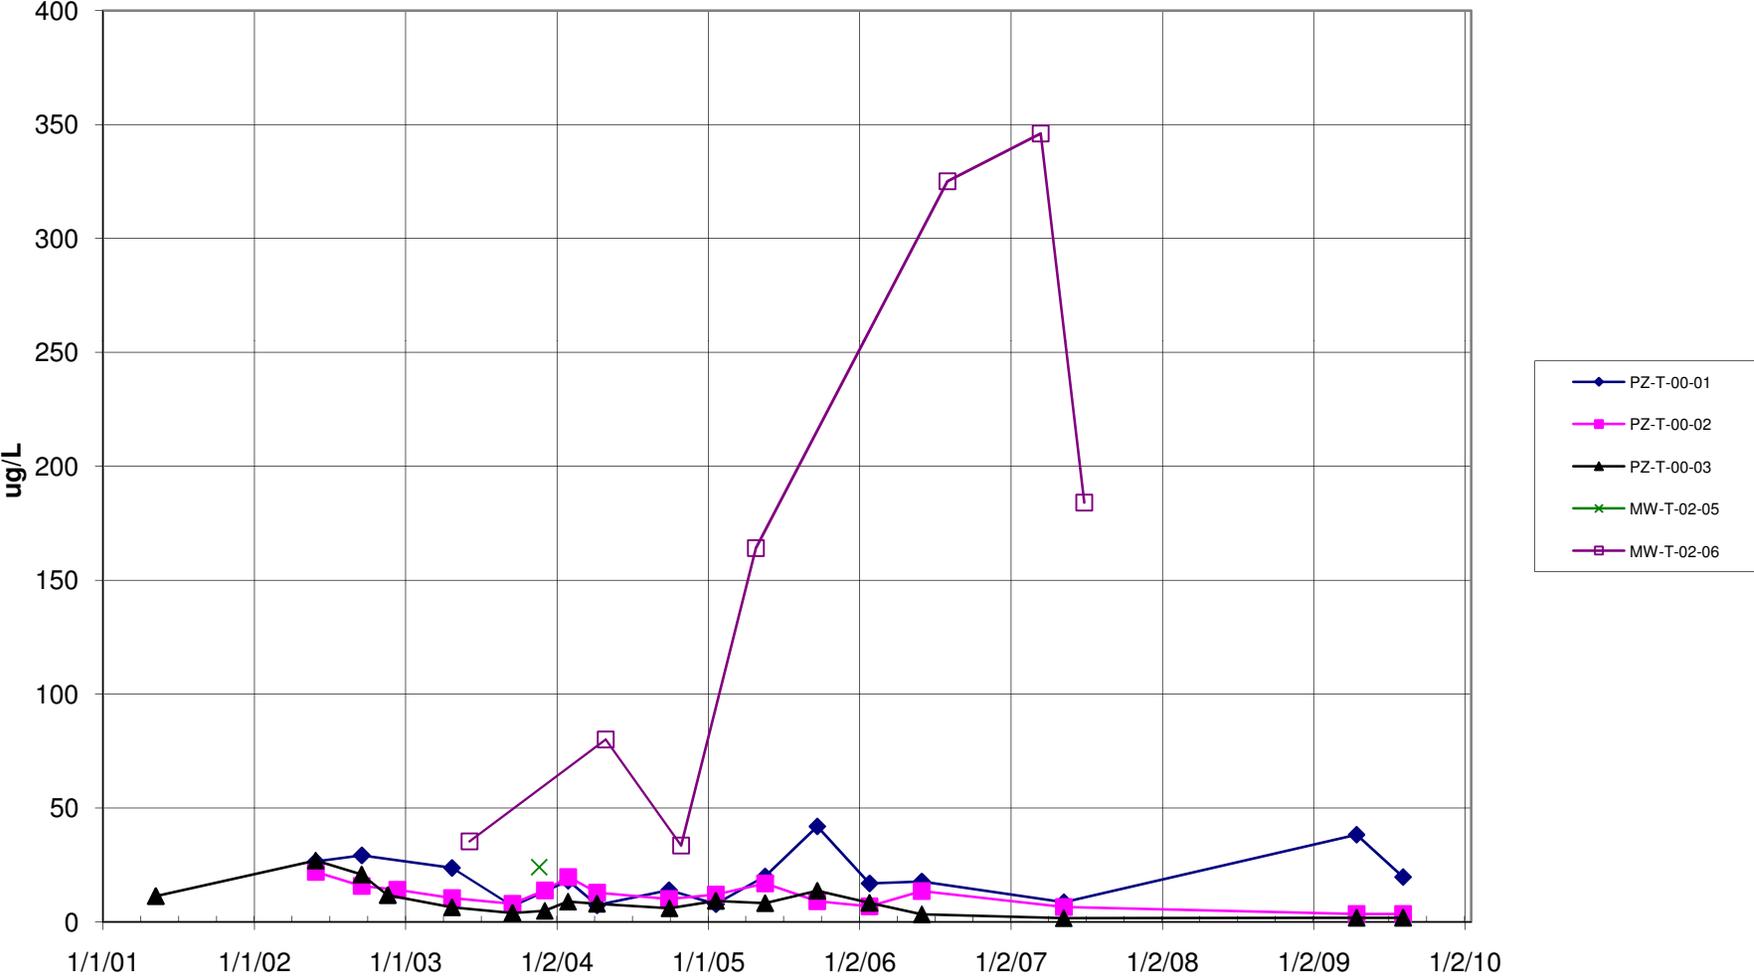
Arsenic data are presented in Figures 2.25a, b and c. The variability in arsenic concentrations observed in Wet Well 2, MW-T-02-06, and some suction lysimeters is related to evolving redox conditions in the pile. As arsenic-bearing minerals such as tetrahedrite/tennantite (and to a lesser

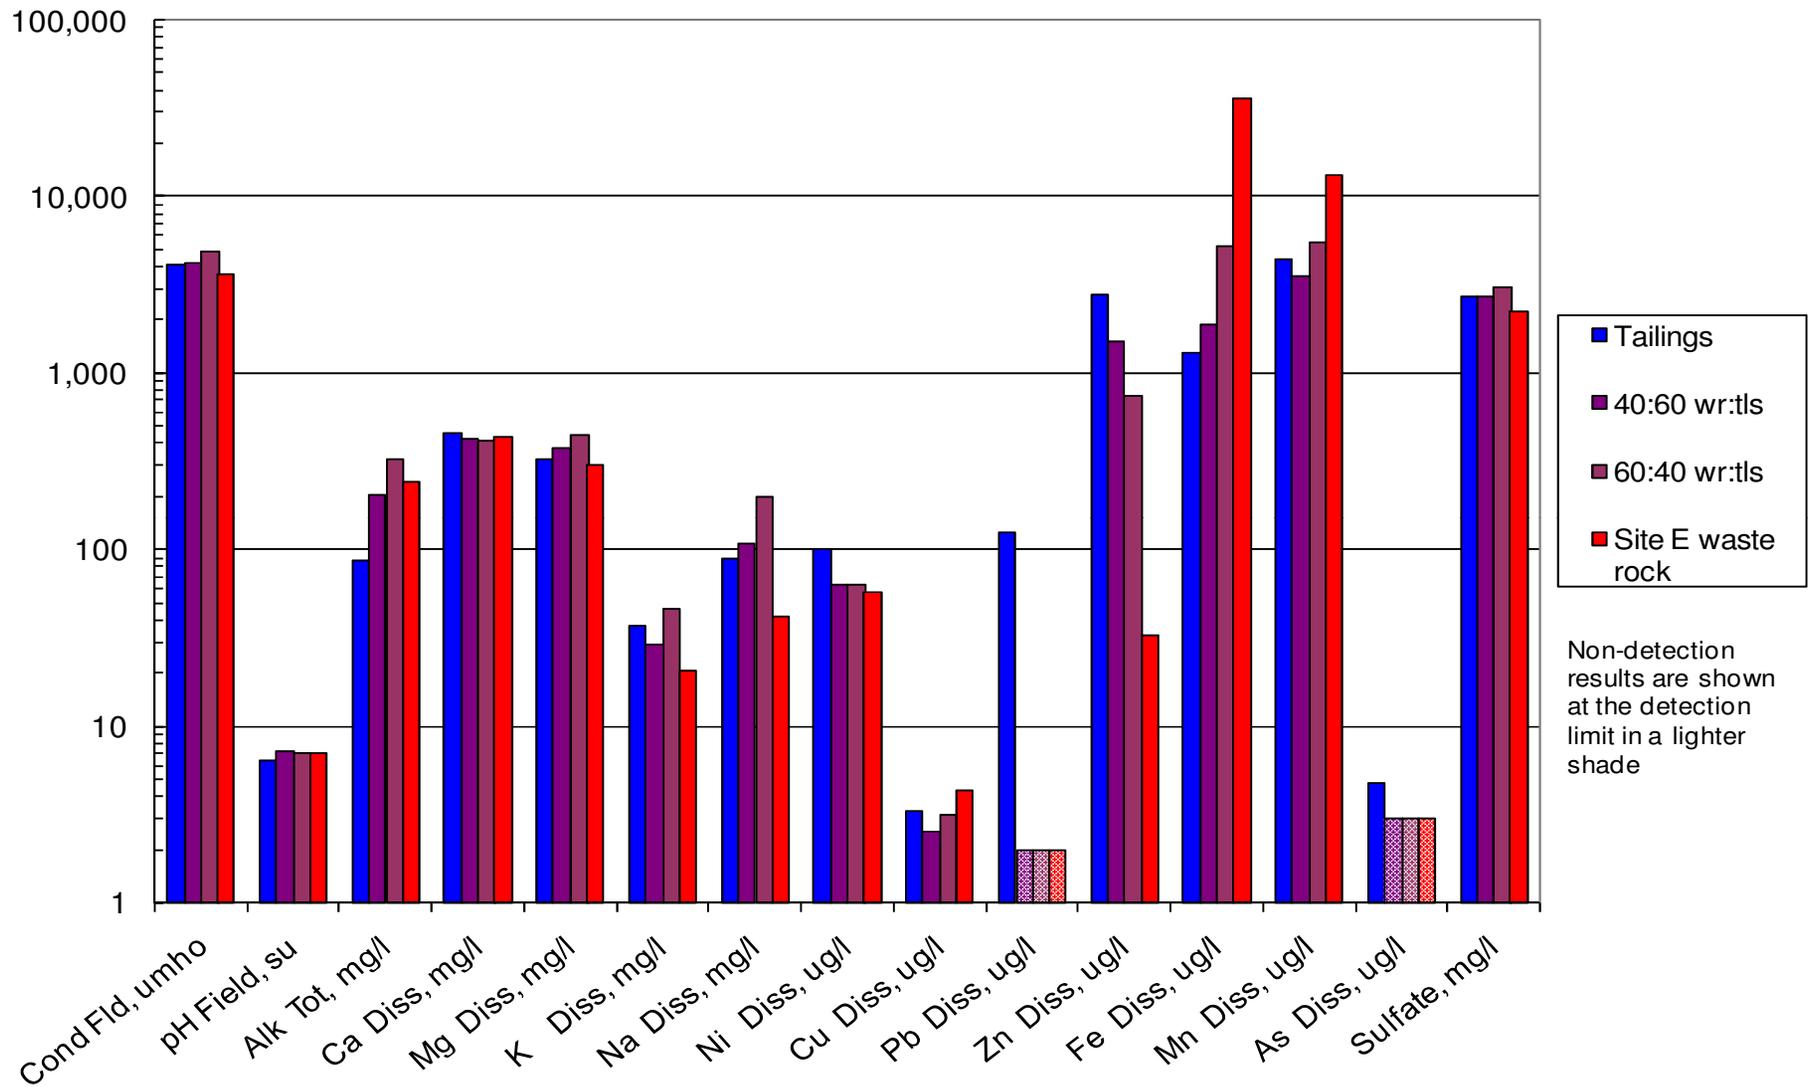
Figure 2.36 Co-disposal Test Drainage Compositions (Site E waste rock)

- Co-disposal of waste rock with tailings exhibited improved pore water chemistry relative to that of tailings and waste rock disposed of separately (Figure 2.36).

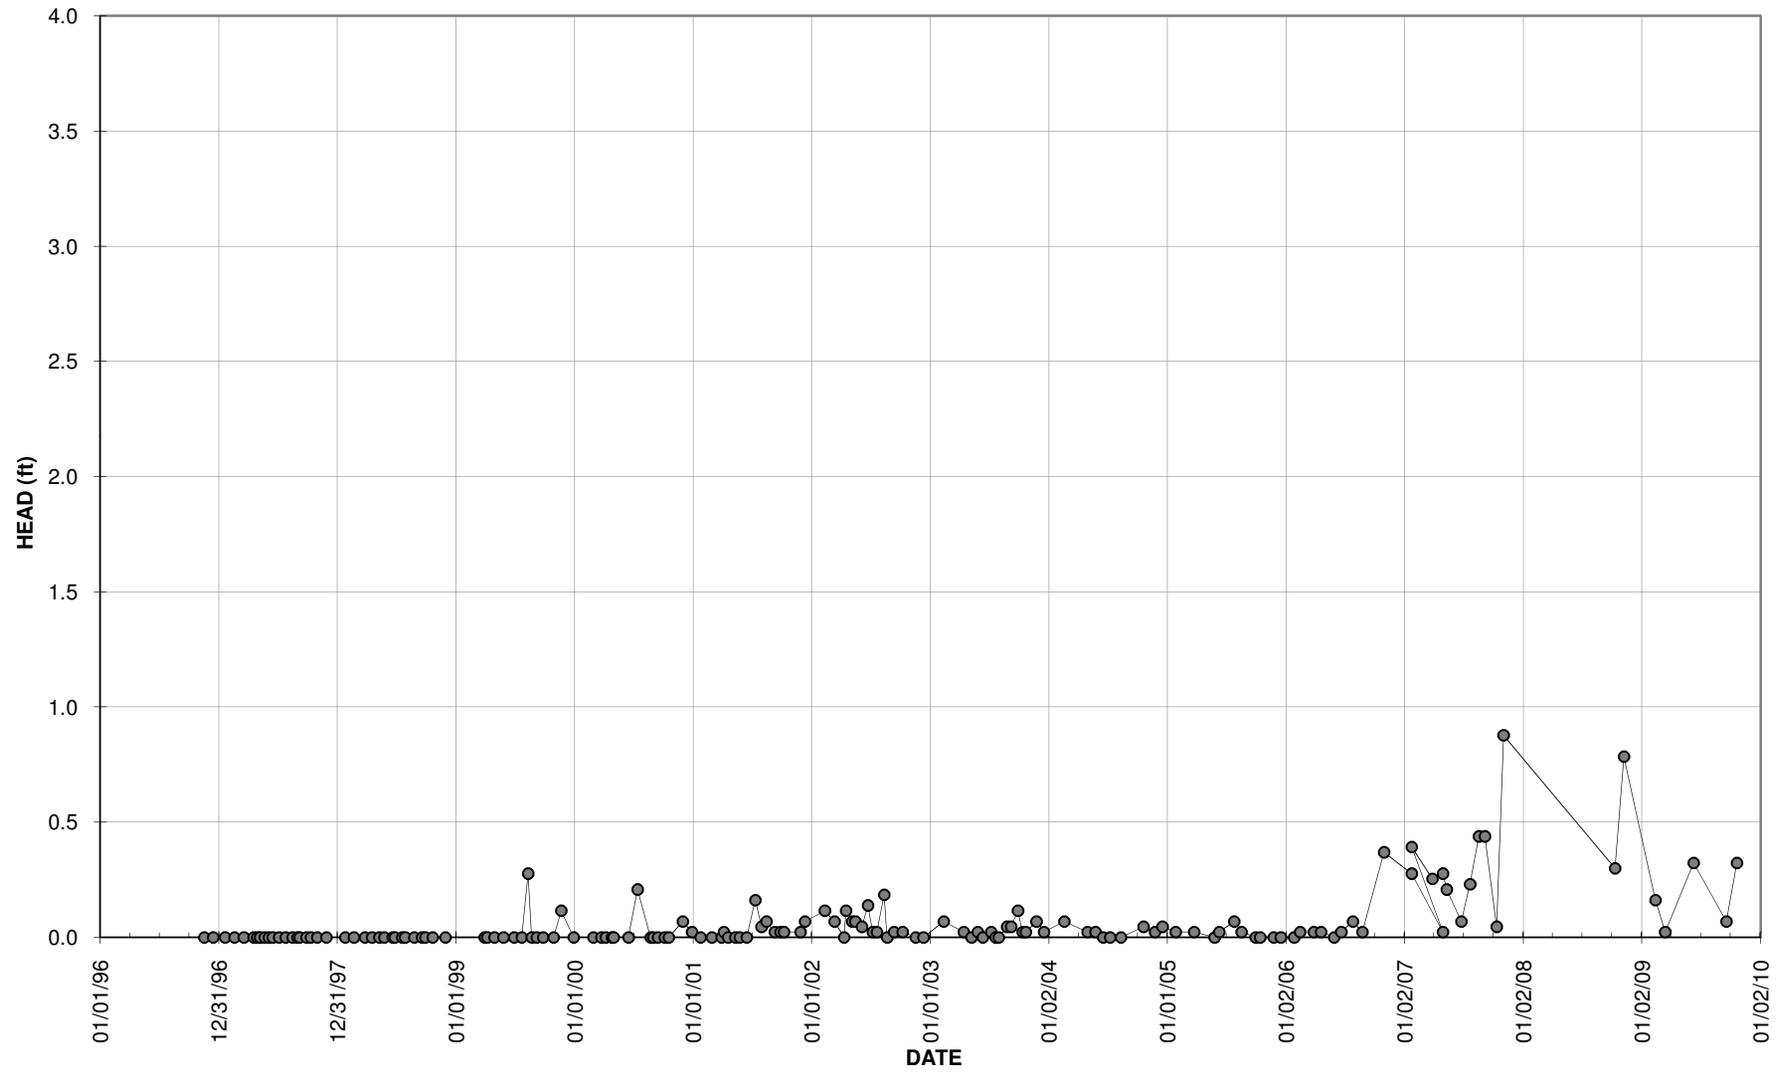
Figure 3.1 Pressure Data for Piezometer 52

Well and piezometer water level data are provided in Figures 3.1 to 3.12. The lack of significant pressure in piezometers installed close to the base of Site 23 (piezometers 52-55, Figures 3.1 to 3.4) demonstrates that the pile remains free draining. This is consistent with the construction of a network of finger drains under the pile and a blanket drain at the pile toe. Comparison of historic versus modeled flow from the finger drains and the curtain drain indicated they are performing as designed and as necessary (EDE 2004). See Appendix 2 for piezometer and finger drain locations. The lack of pore pressure at the toe indicates that pile stability has been maximized. Water levels from several monitoring locations are shown in Appendix 2. The inferred water table is 30 to 60 feet below the base of the production rock pile material up-slope of the Site 23 active placement area and 5 to 20 feet below the base of material placed in Site D and the toe of Site 23, respectively (see also Figures 3.5 to 3.12). MW-23-00-03 data showed an atypical drop in water elevation in August 2007. However, data collected before and after that date are within the historical data range. Observations from wells completed in the colluvium below the sites indicate that perched water tables and braided flow paths exist beneath the site (e.g. compare Figure 3.6 and 3.7). This unit also shows large (up to 10 feet) fluctuations in head levels, which are consistent with perched, confined conditions and channel-like flow. There is a distinct seasonal pattern to the water level fluctuations beneath Site 23/D, particularly in the alluvial sands (Figures 3.9 and 3.11).

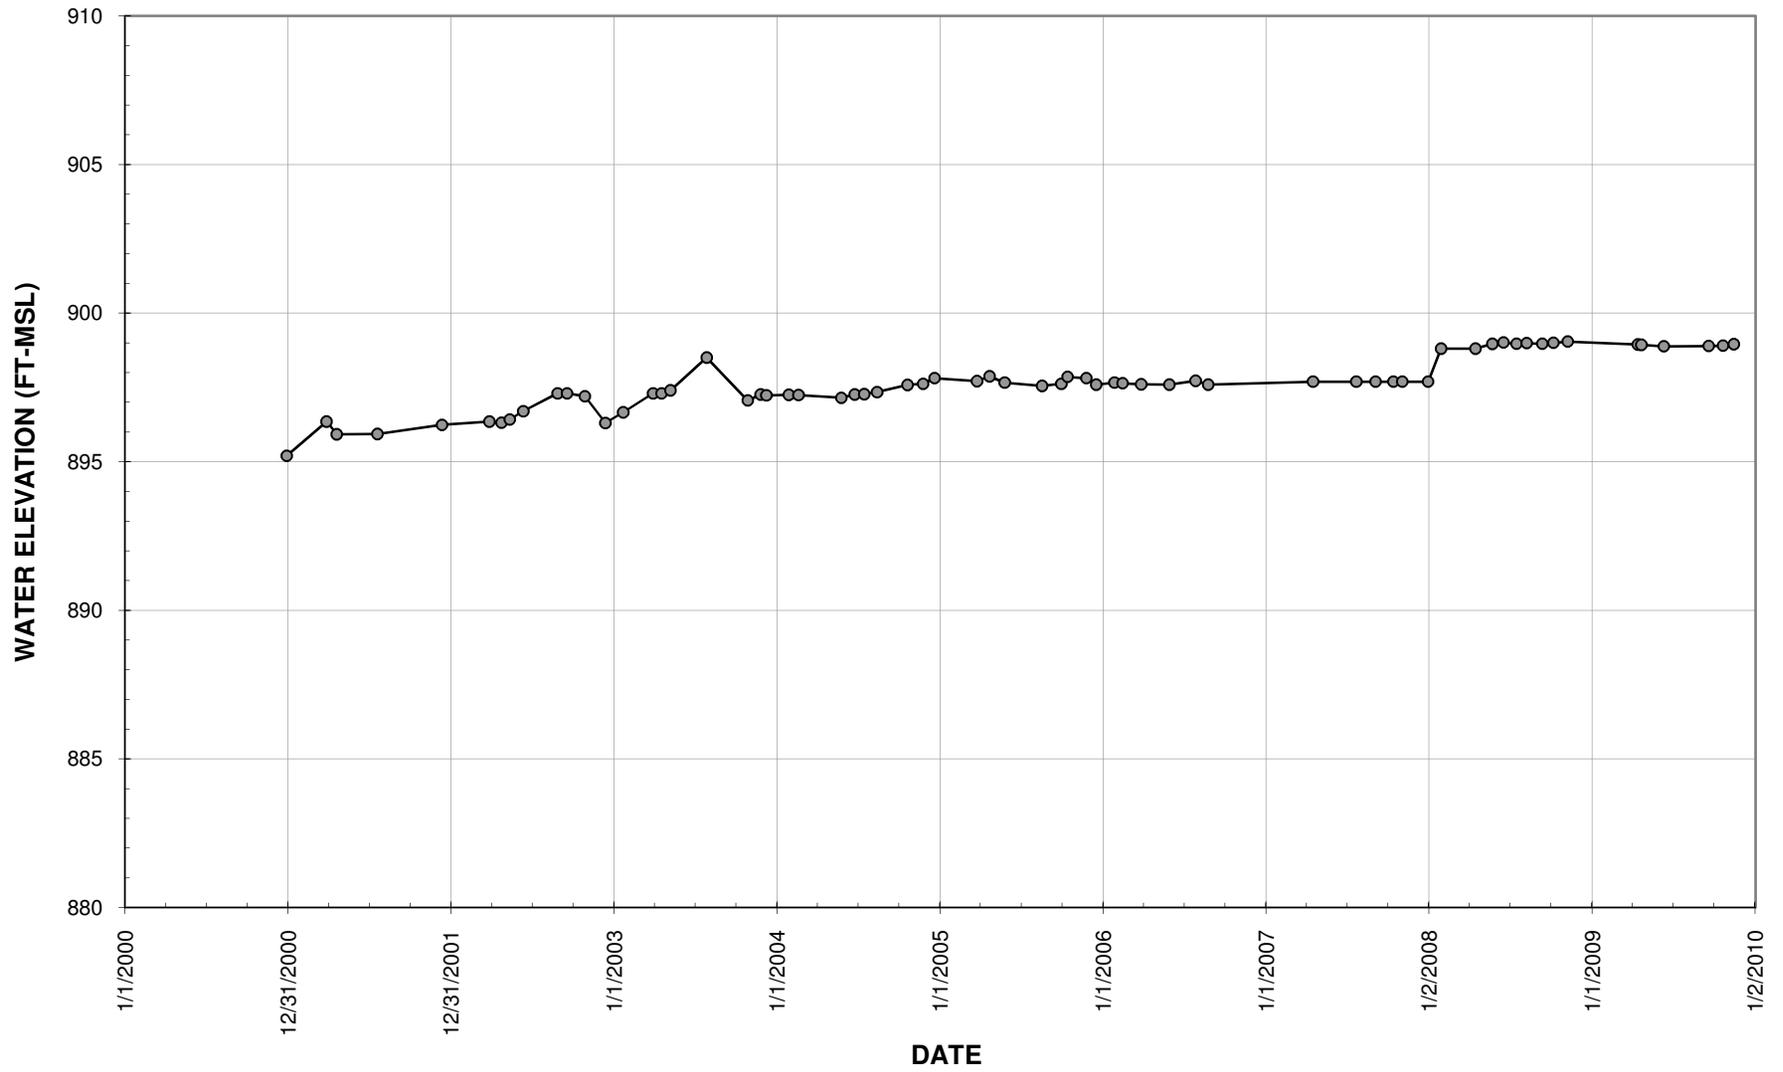
Figure 3.8 Water Level Data for Well MW-23-98-01

The silty/clay till that underlies the colluvial unit impedes downward flow and has an upward hydrologic gradient caused by its confining the more permeable bedrock below it. MW-23-98-01 (Figure 3.8) is completed in the till unit and indicates a water table near the top of the till, which is approximately 100 feet below the existing topographic surface. Alluvial sands occur between the colluvial unit and the silt/clay till near the toe of Site 23 and under Site D. Data from MW-23-A4 and MW-D-94-D3 (Figures 3.9 and 3.11) indicate that the sands are saturated. A curtain drain installed in between Site D and Site 23 in 1994 collects water that flows at the base of the colluvial unit and the top of the alluvial sands (see as-built and sections). This drain helps reduce pore pressures in the foundation of Site D, as well as capturing infiltration waters from Site 23.

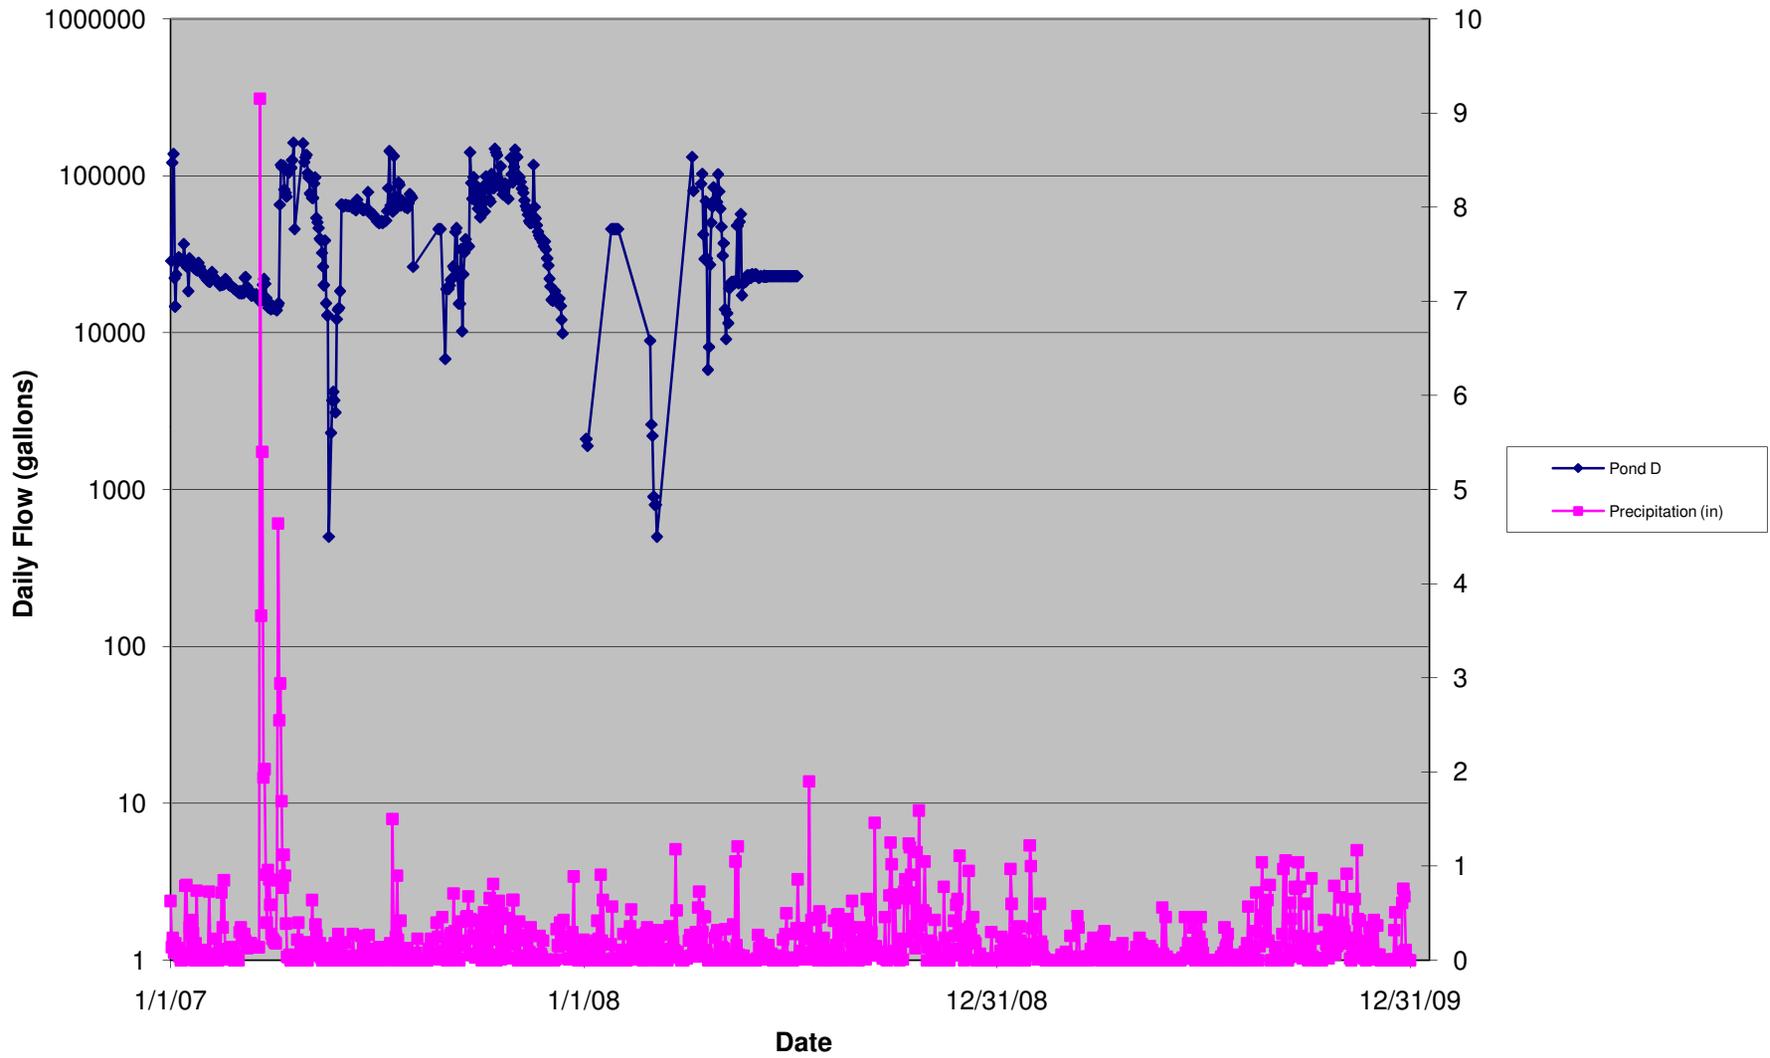
Figure 3.13 Pond D Flow Data

Flow data for Pond D are shown with precipitation in Figure 3.13. The Pond D flow meter was not operating from July 2008 through 2009 due to changes in pumping/piping as noted above. Once all equipment is in place and operating, flow measurements will resume.
