**TAILINGS AND PRODUCTION ROCK SITE
2009 ANNUAL REPORT**

Hecla Greens Creek Mining Company

April 15, 2010

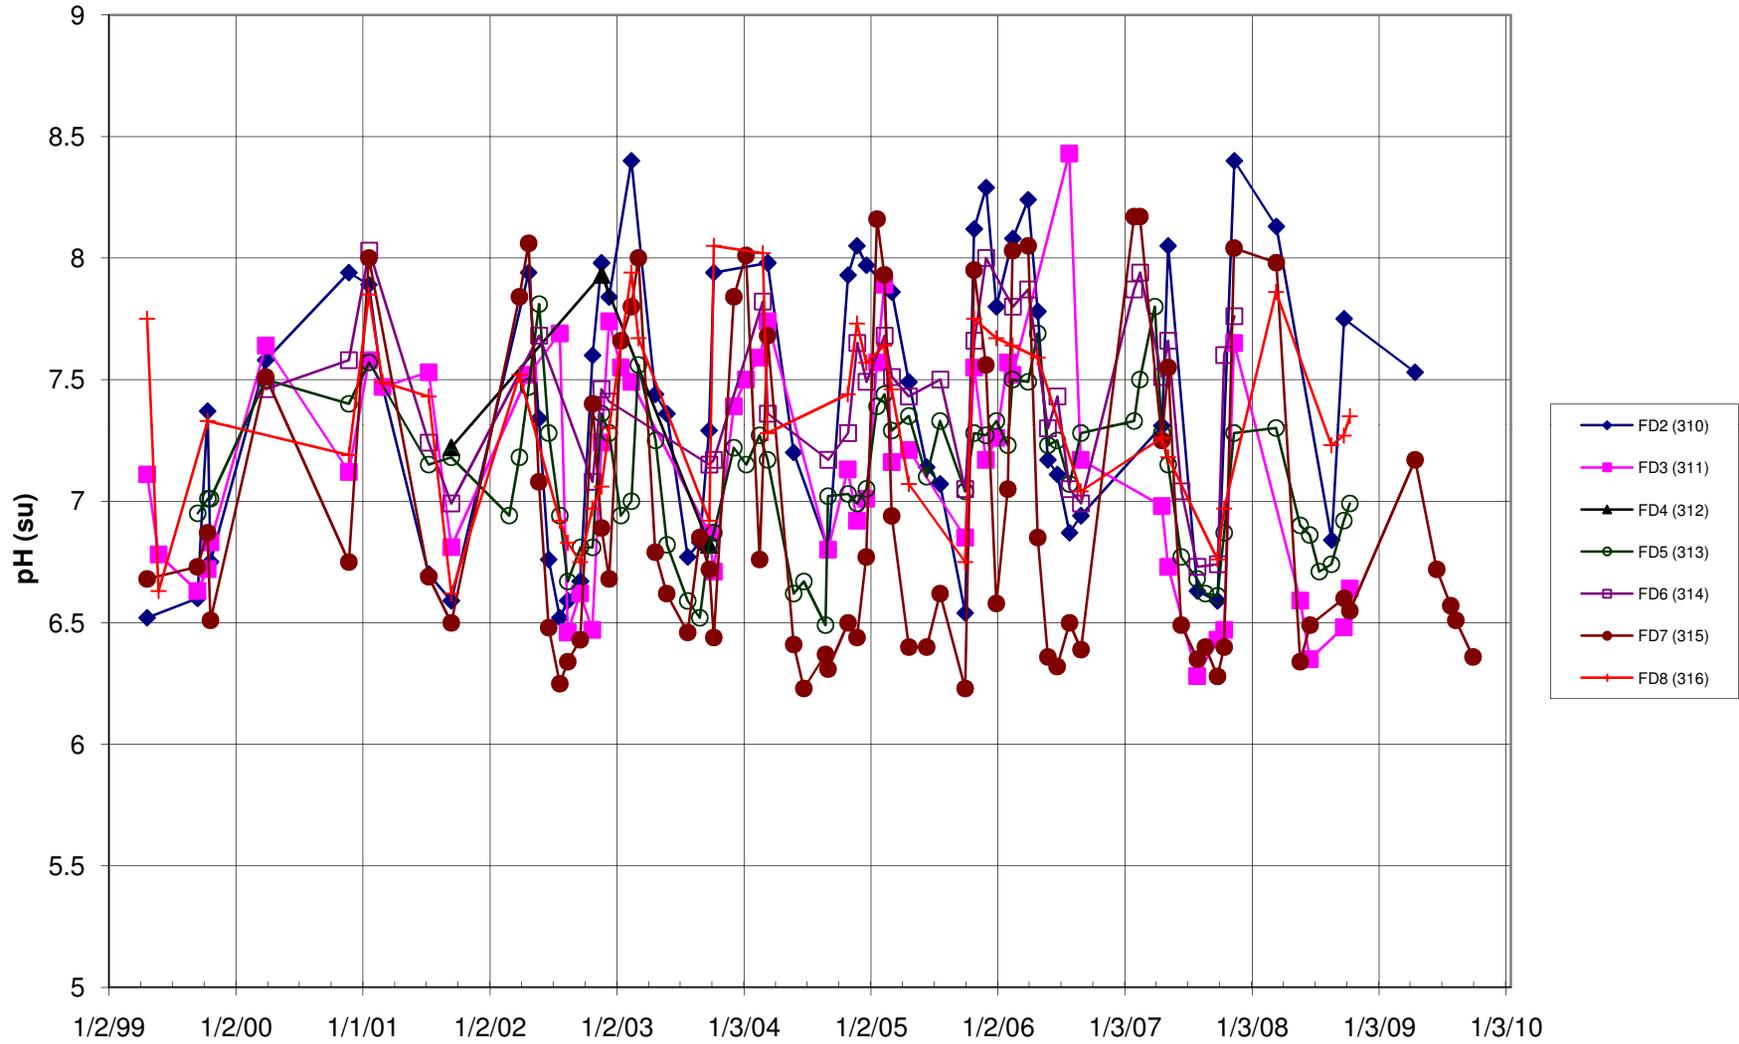
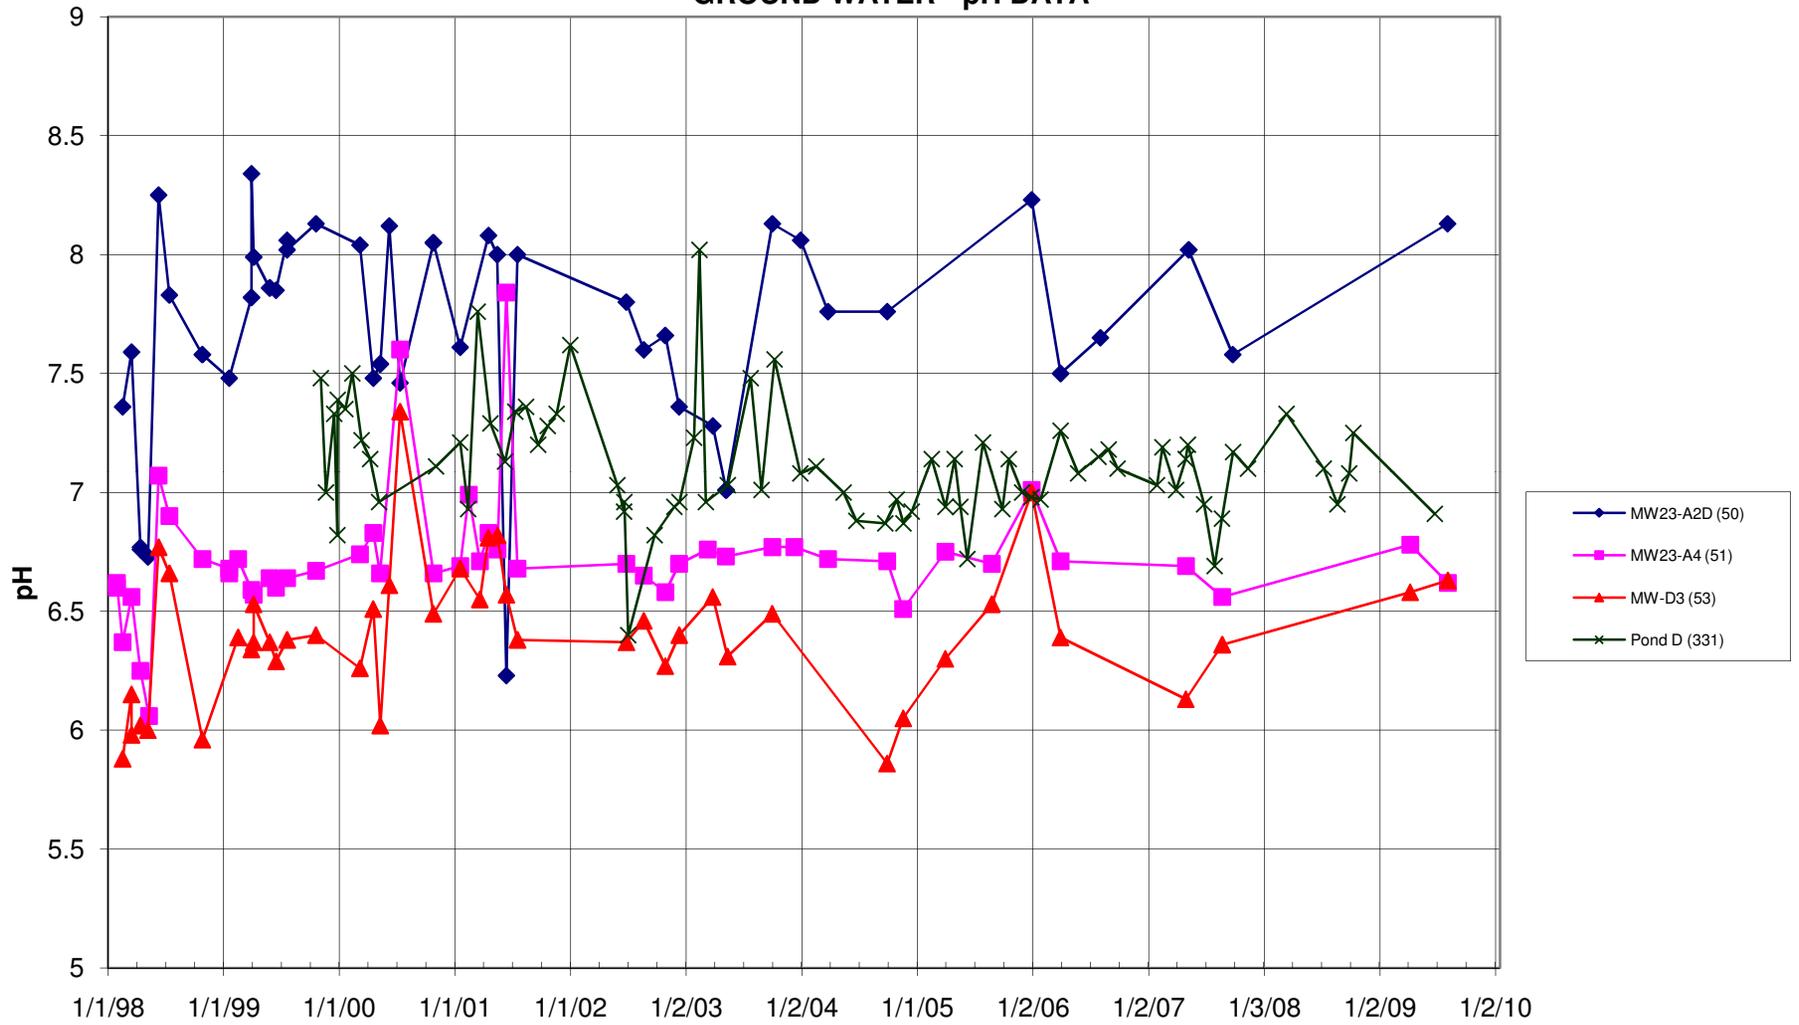
Figure 3.14a shows the pH of waters collected from Site 23 Finger Drains 2 through 8, and Figure 3.14b shows the pH of monitoring wells MW-23-A2D, MW-23-A4, MW-D3 and Pond D (see as-built in Appendix 2 for locations). Values of pH were between 6 and 8.5 for all internal monitoring site samples in 2009. The lower pH values (generally pH 6.0 to 7.0) were recorded in MW-23-A4 and MW-D3, both of which are completed in alluvial sands beneath Site 23 and Site D, respectively. MW-23-A2D, which screens colluvium up-gradient of Site 23 typically has the highest pH (generally pH 7.0 to 8.5). The Site 23 finger drains fluctuate at values between those of the monitoring wells. Figures 3.14a and b suggest that waters from different foundation units have different pH values and that Site 23 and Site D contact waters and the materials with which they are in contact exhibit sufficient buffering capacity to prevent acidification of site drainage in the near term. Seasonal fluctuations are apparent in the finger drains with highest pH values occurring in winter months and lower pH in mid to late summer.

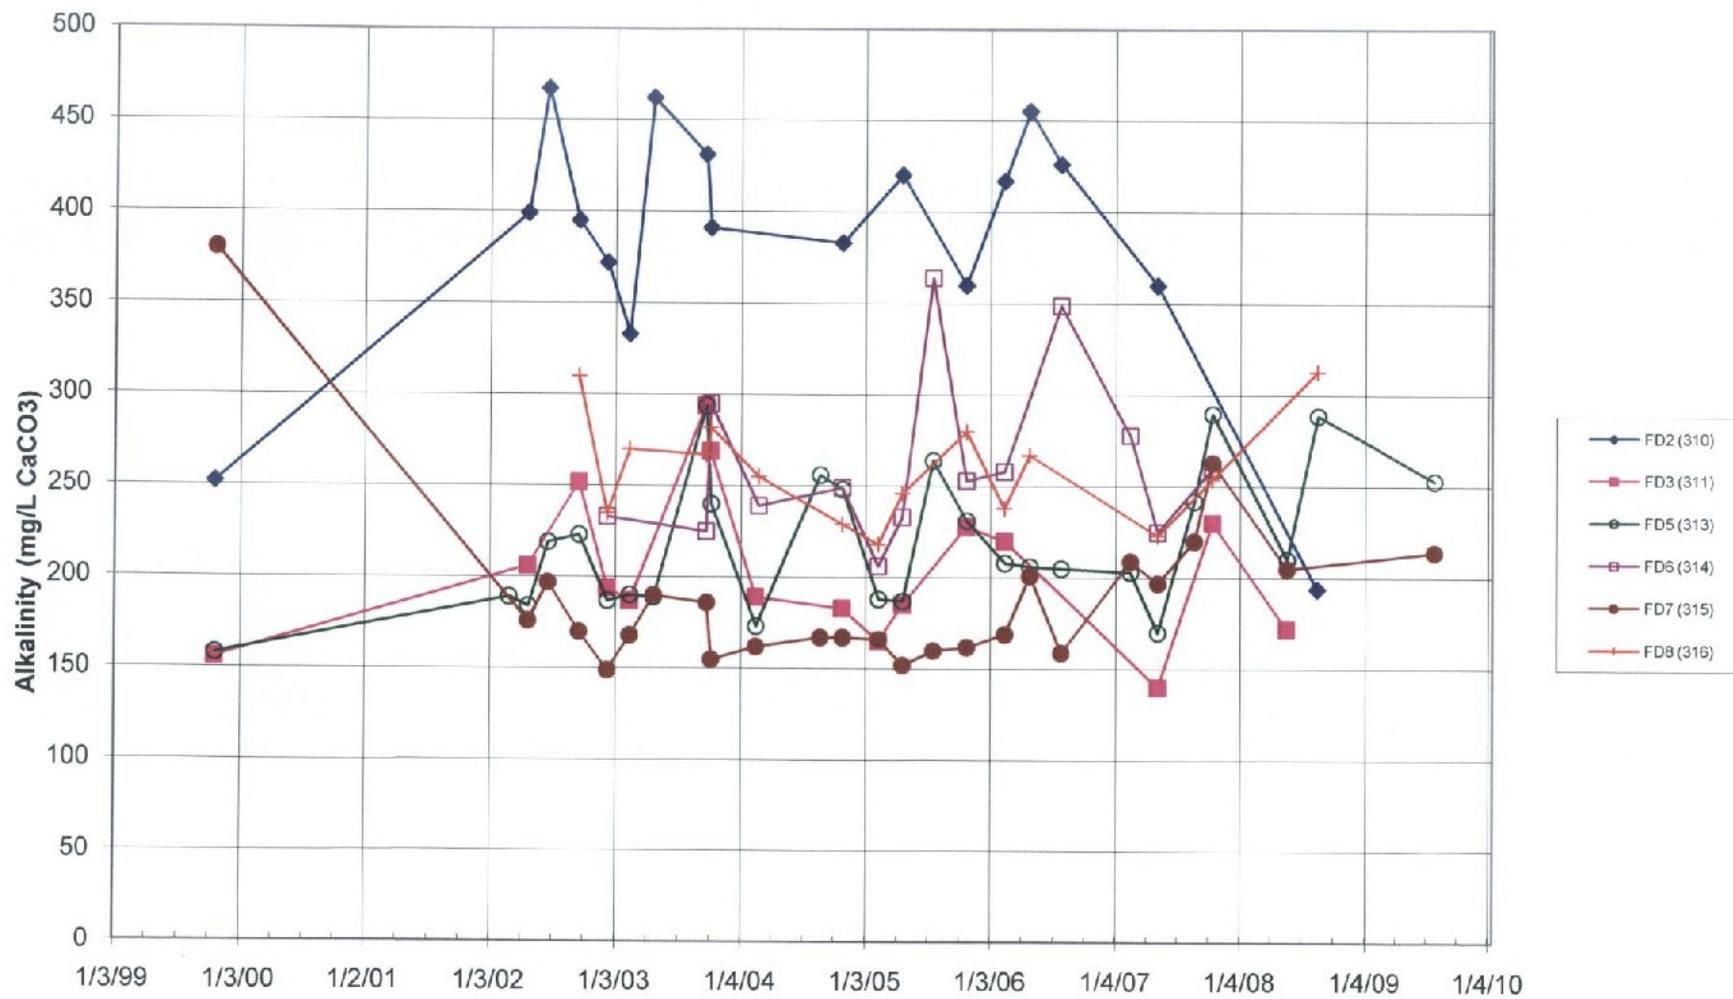
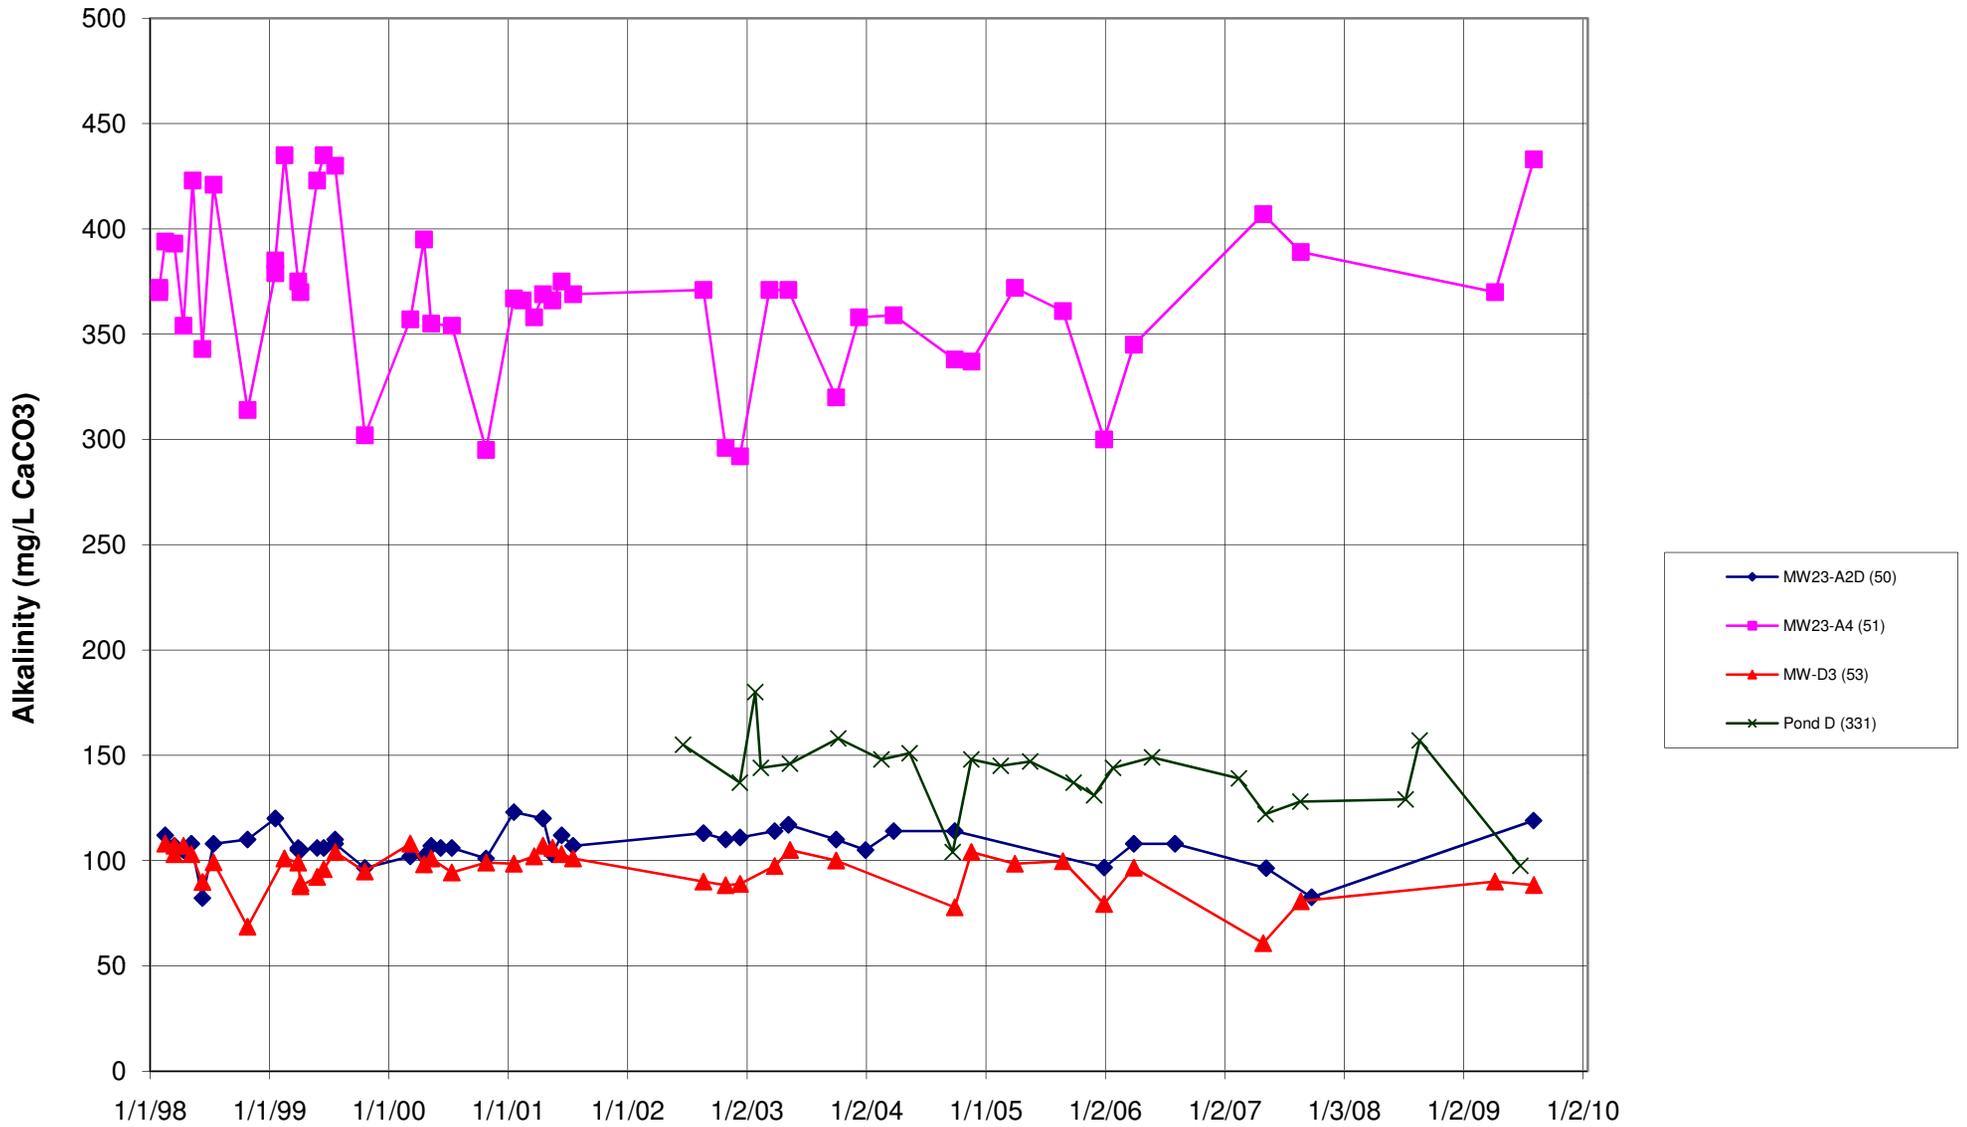
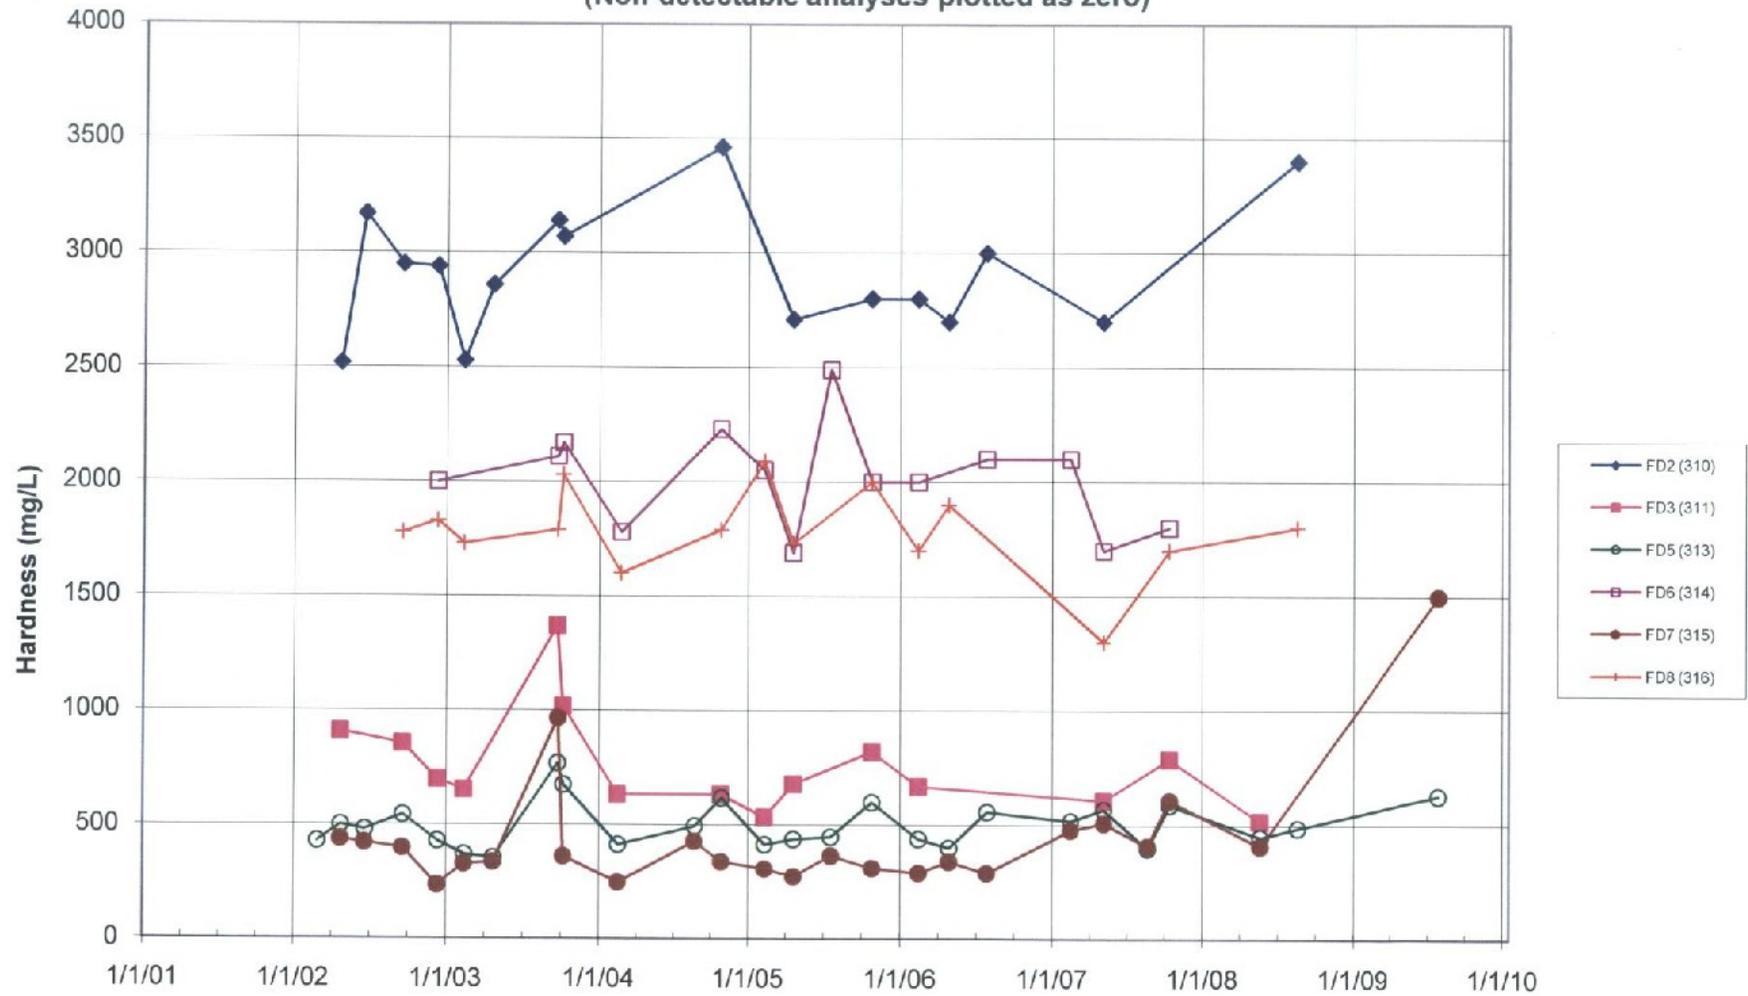
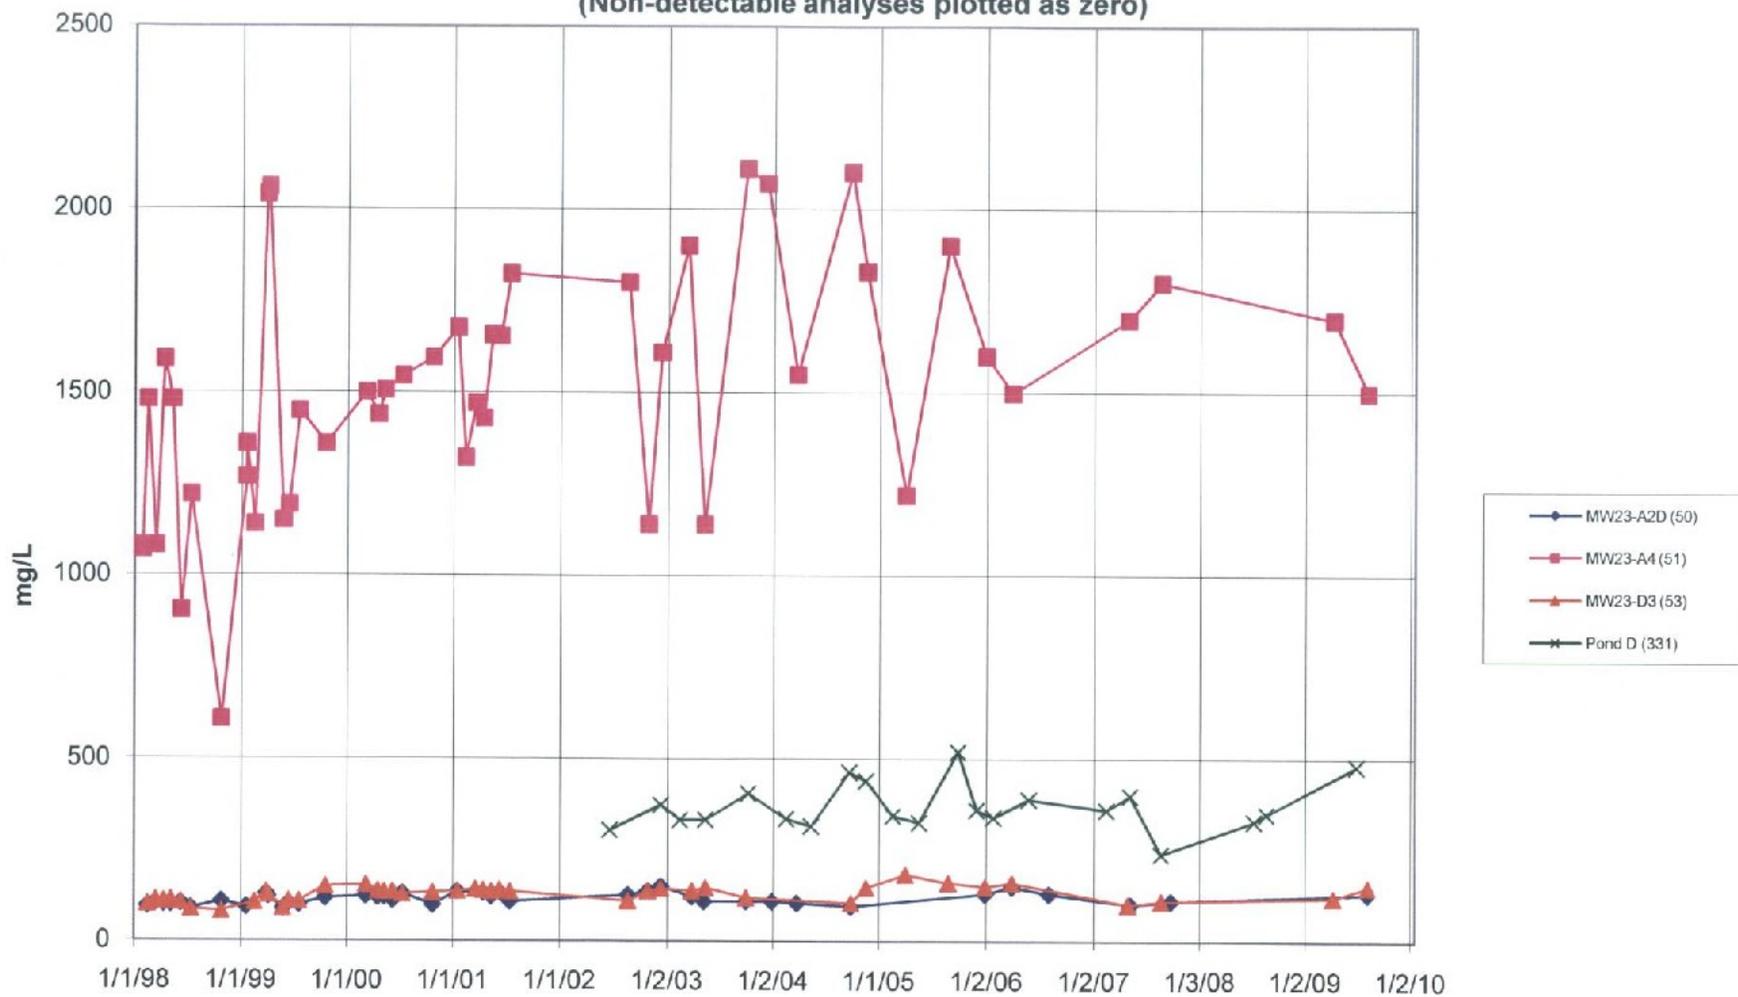
As with pH, high alkalinity values (Figures 3.15a and b) indicate that the waters are well buffered. Fluctuations in alkalinity correlate with those of other parameters, such as hardness (Figures 3.16a and b) and conductivity (Figures 3.17a and b), and also appear to be seasonal. Carbonate minerals in the production rock contribute to the high alkalinity of the drainage from the finger drains. Alkalinity is lowest in samples with the highest groundwater component (e.g. the monitoring wells, Pond D, 23FD-5 and 23FD-7). Calcium and magnesium are the primary contributors to hardness (Figure 3.16a) and reflect dissolution of carbonate minerals, such as calcite and dolomite. Carbonate dissolution neutralizes acidity formed by sulfide oxidation, which is also the source of sulfate shown in Figure 3.18a.

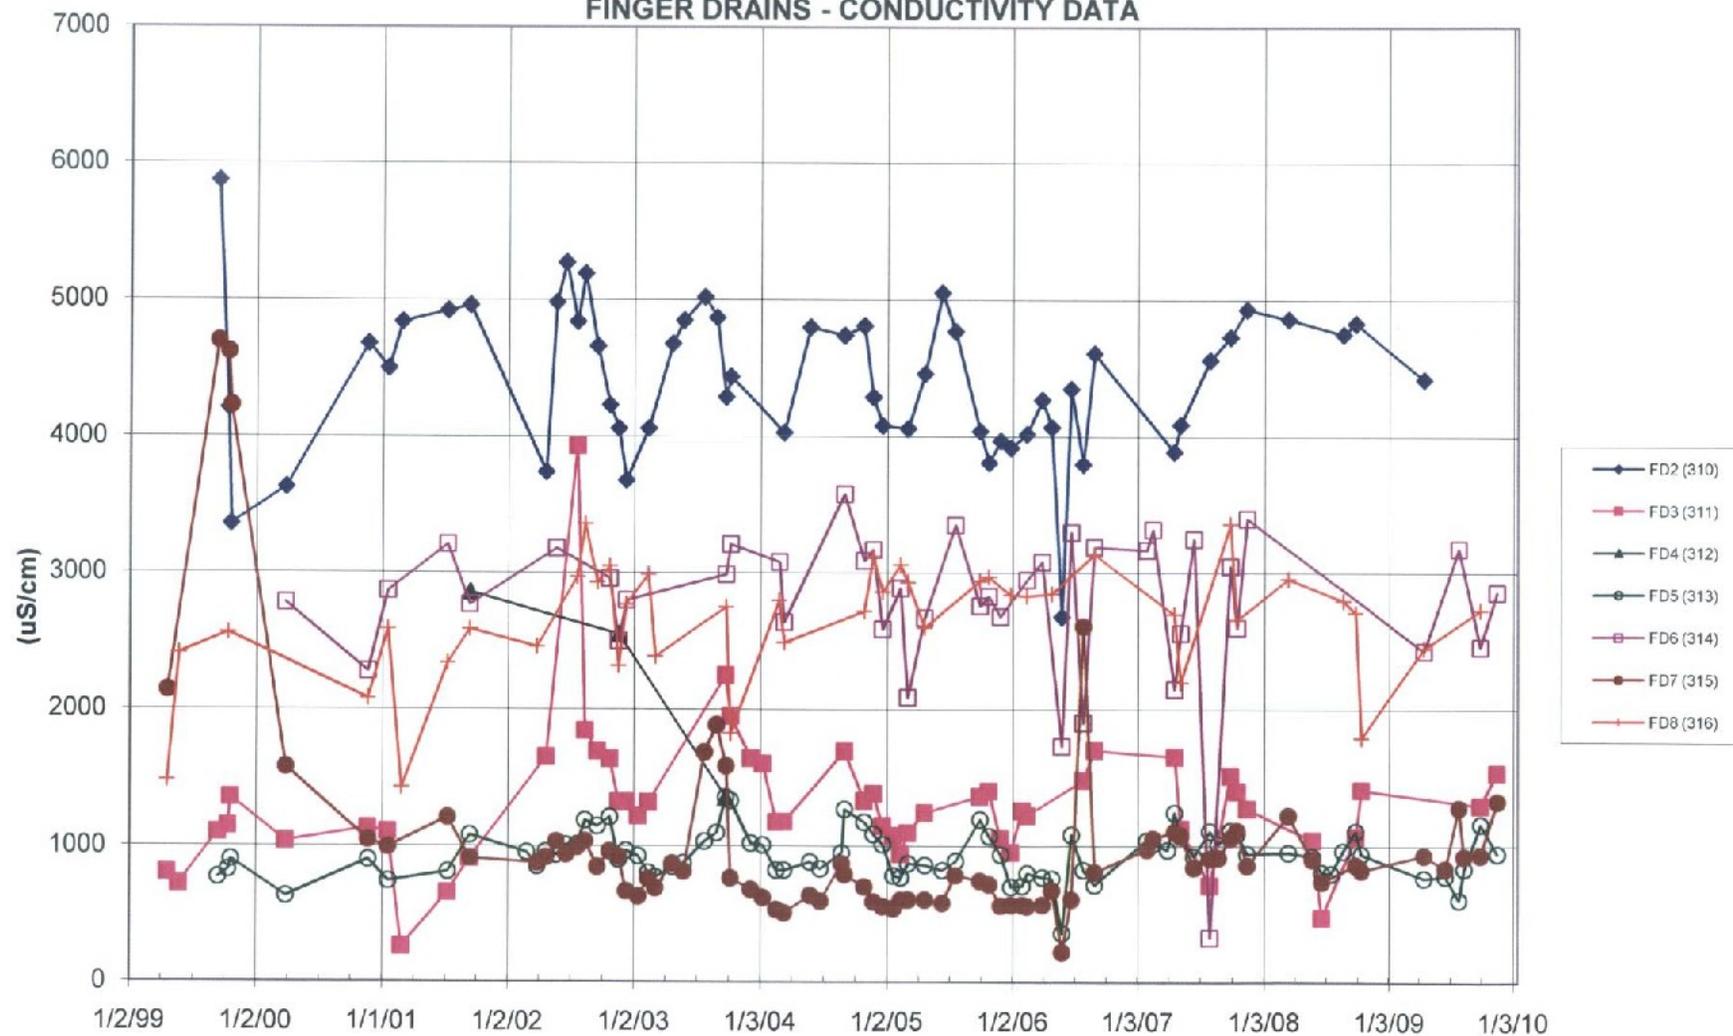
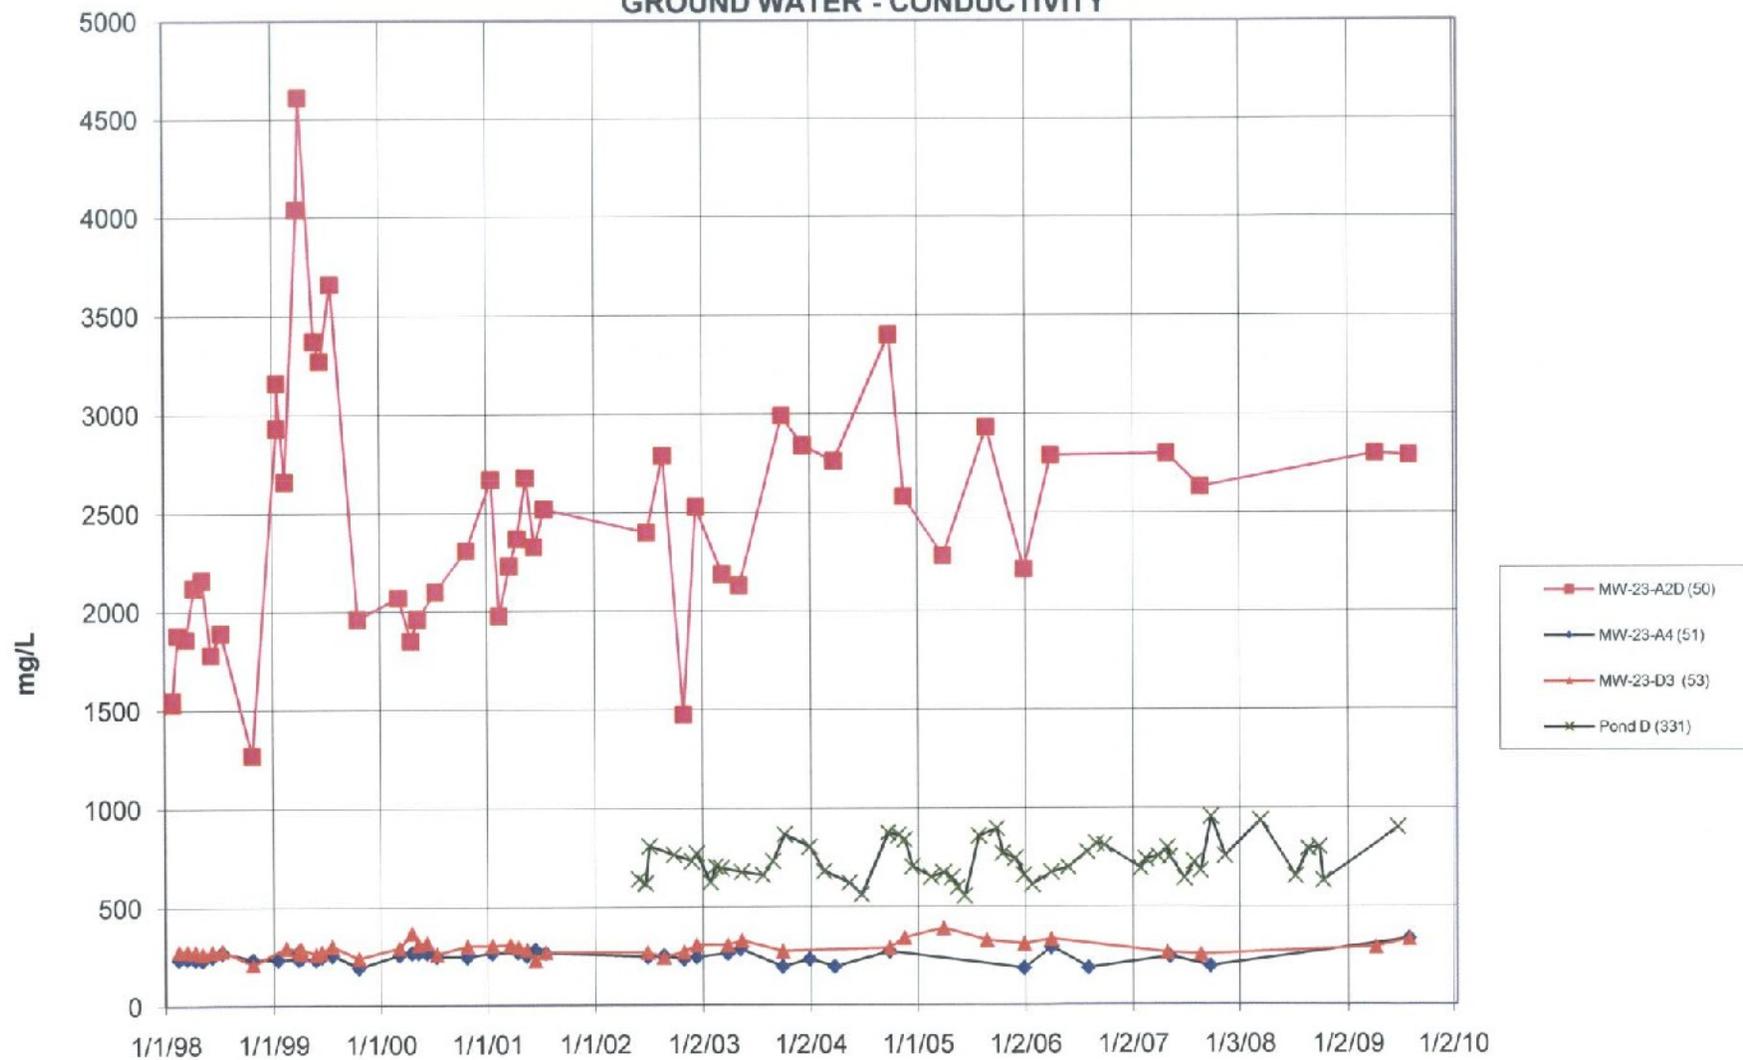
Conductivity results from internal monitoring site waters are presented in Figures 3.17a and b. The 2009 conductivity measurements continue to range up to 4,420 $\mu\text{S}/\text{cm}$. MW-23-A2D and MW-D3 have the lowest conductivity. MW-D3 is completed in alluvial sands below the fill placed at Site D. The finger drains with the highest flow (e.g. 23FD-5, which directly drains an excavated spring) generally have lower conductivities than the drains with lower flow. This reflects a larger contribution from groundwater to the high-flow drains relative to a higher proportion of site contact water in the other finger drains. The significant decrease in conductivity in 23FD-7 that occurred in 2000 is probably the result of incorporation of

Finger Drain 23FD-2 has the highest conductivity but consistently low flow, suggesting no significant influence from groundwater. This drain may also be influenced by runoff that infiltrates along the access ramp to the site. The higher conductivity of the site contact waters reflects a larger dissolved load caused by weathering of the production rock. As with tailings, pyrite oxidation and carbonate dissolution contribute dissolved ions such as sulfate, bicarbonate, calcium and magnesium to the contact waters, increasing their conductivity. Sulfate concentrations for the finger drains and groundwater wells are plotted in Figures 3.18a and 3.18b and match closely the relative value patterns of conductivity. The drier than average spring and summer in 2009 likely contributed to a greater buildup of oxidation products and reduced groundwater contribution to the water balance. This may result in higher conductivity and sulfate values for some sample sites.

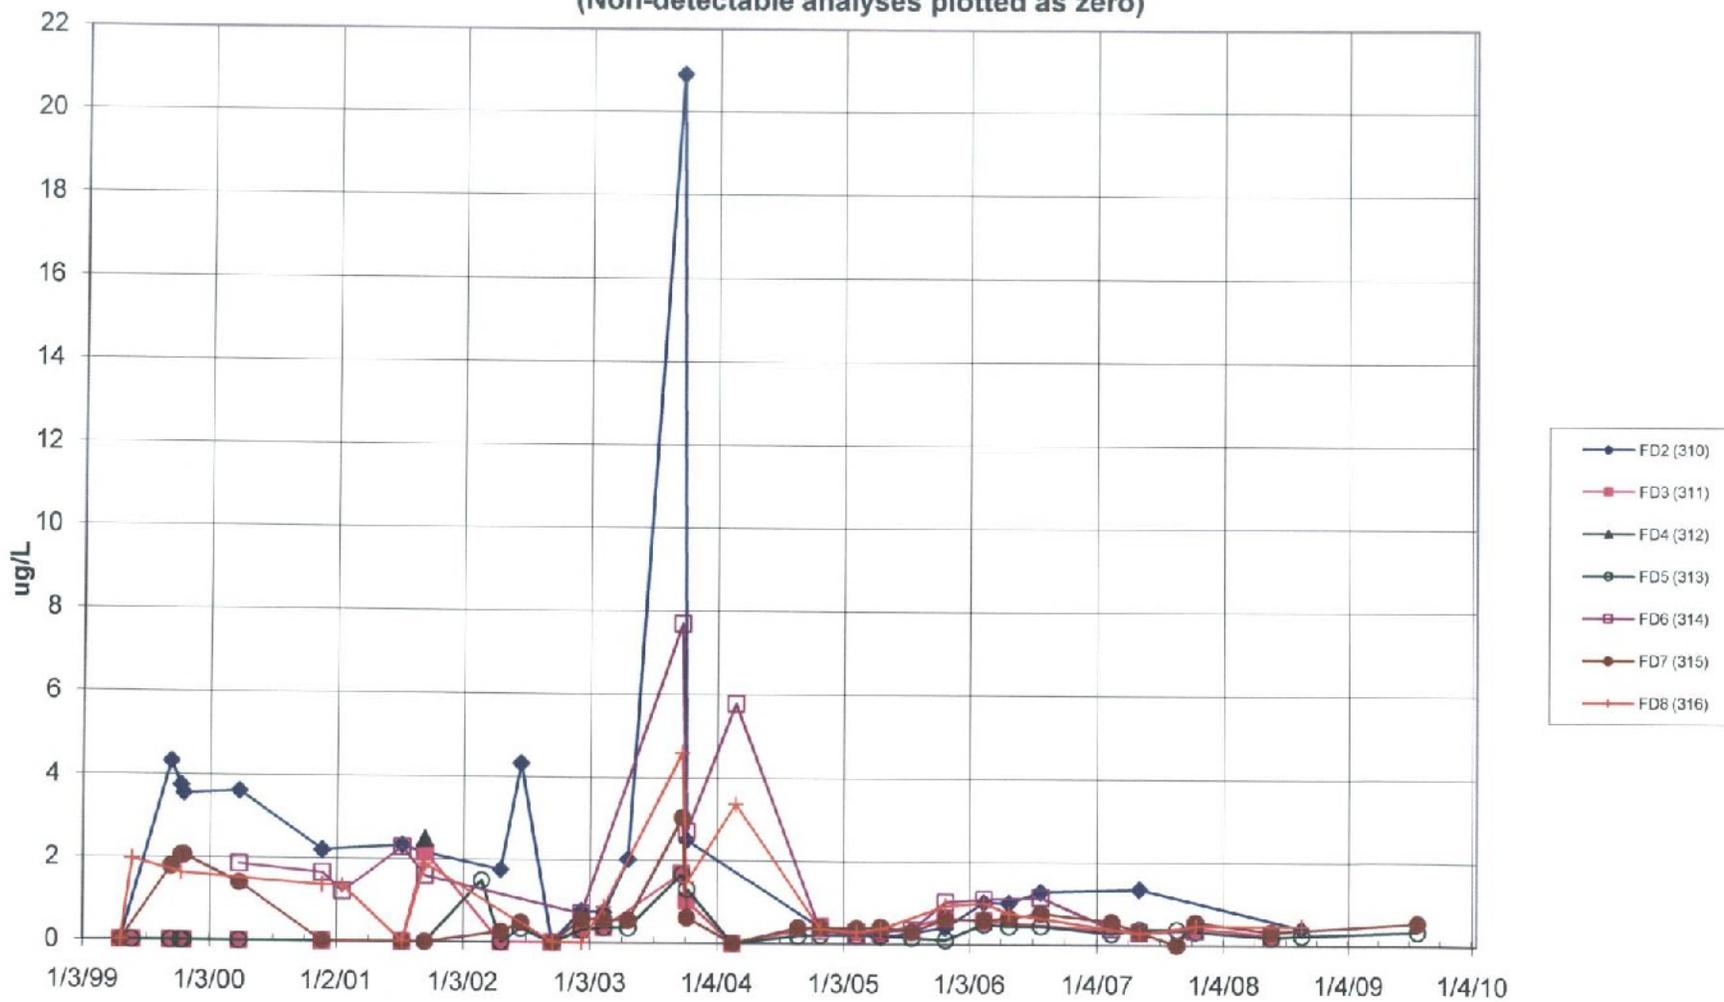
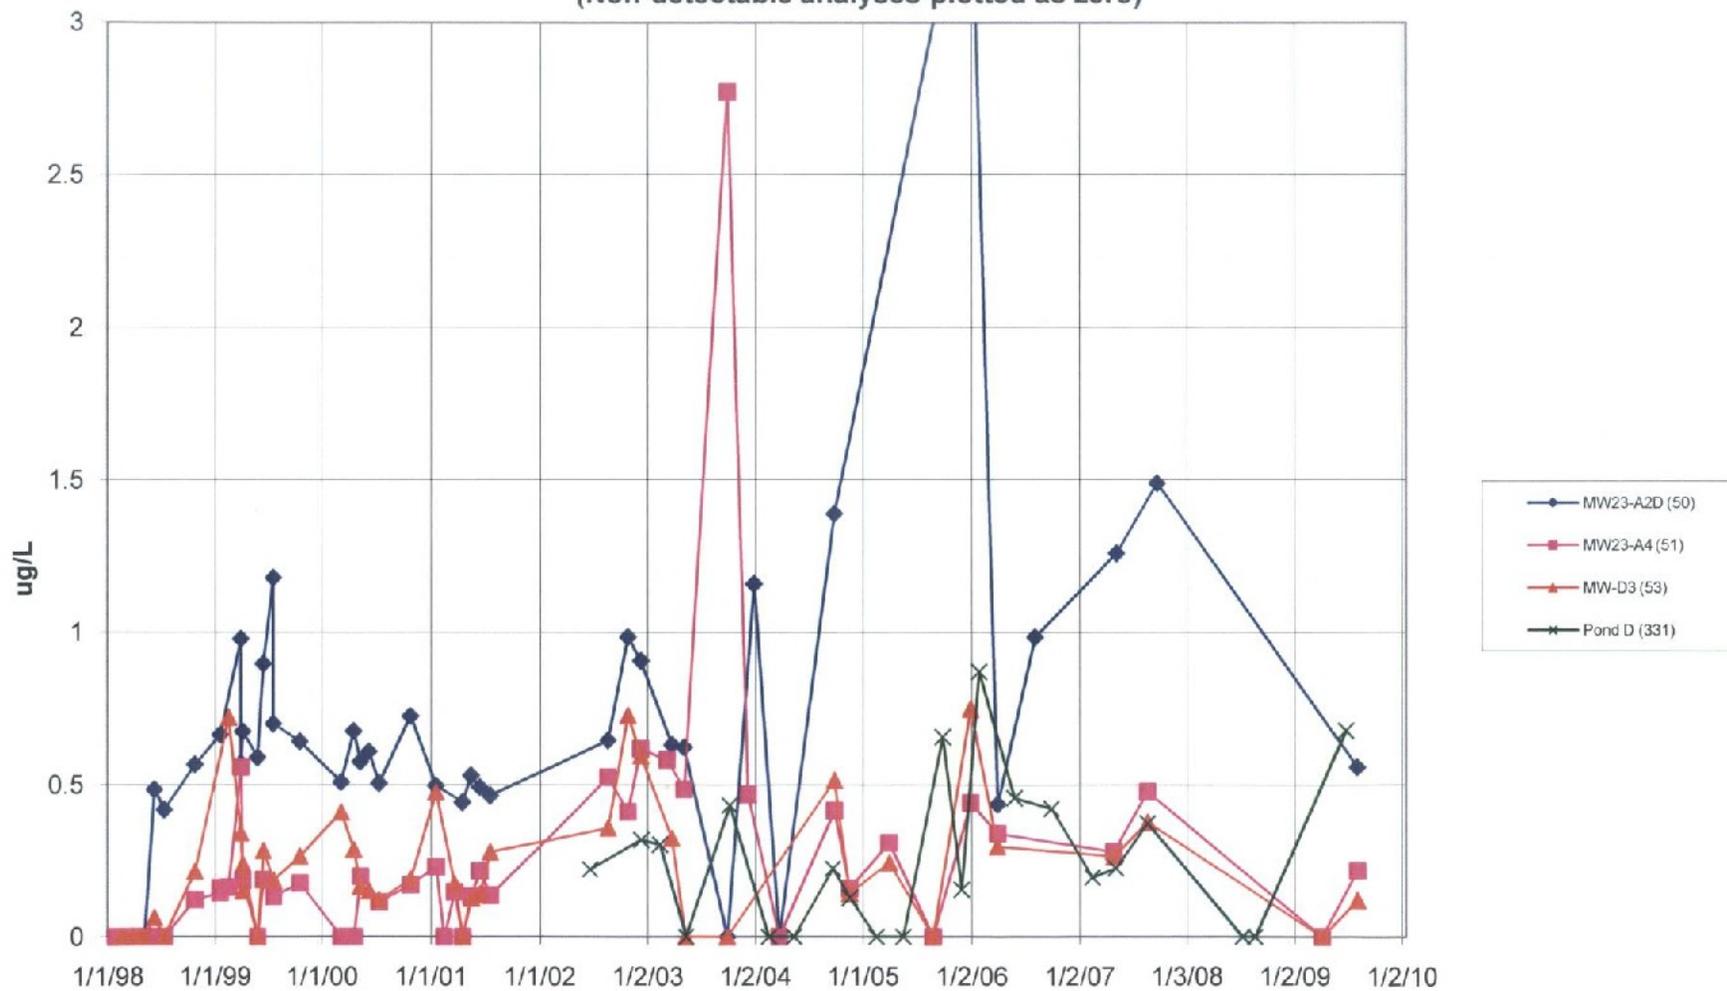
Arsenic data are presented in Figures 3.19a and b and are generally quite low. All finger drains and MW-23-A4 experienced increases in their arsenic concentrations in September 2003, with subsequent decreases back down to historical levels in October. The flows in the finger drains positively correlate with these changes. Fluctuations in arsenic values in 23FD-2 can be attributed to changes in redox conditions. Low arsenic and iron (Figures 3.25 a and b) concentrations indicate that these metals are precipitating as oxyhydroxides on rock surfaces in the pile.

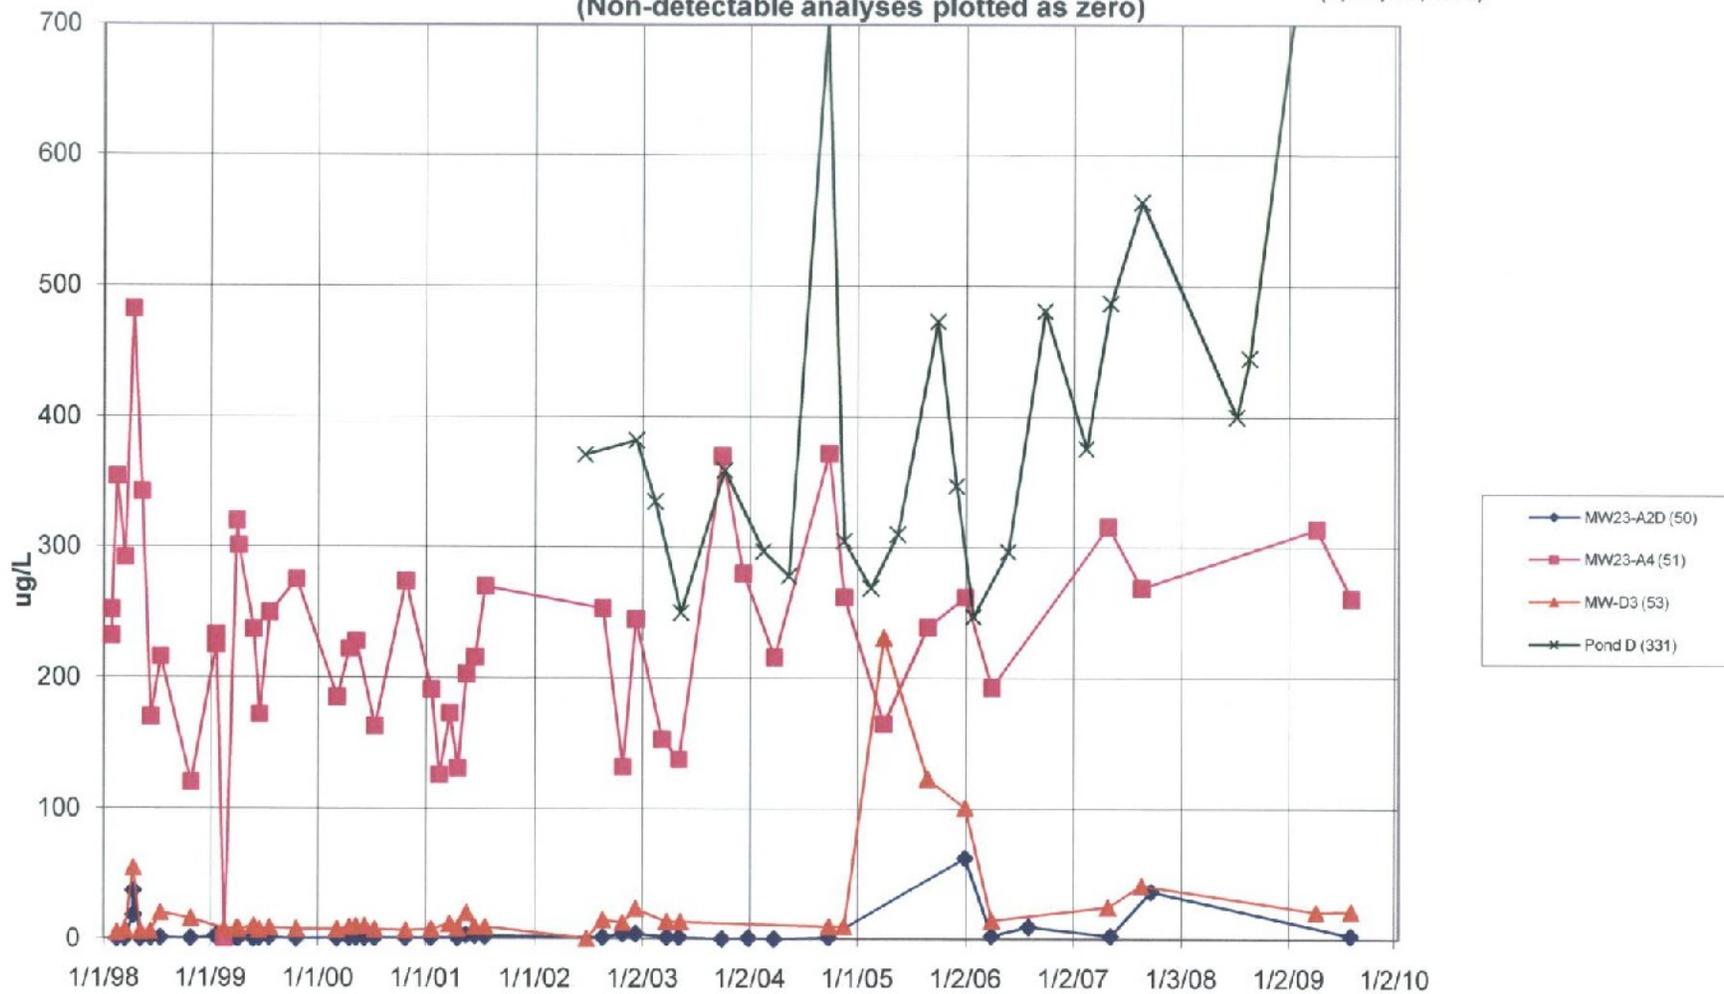
FIGURE 3.20b GREENS CREEK SITE 23/D INTERNAL MONITORING SITES:
GROUND WATER - ZINC DATA

Figures 3.20a and b show the concentration of zinc in the internal monitoring locations at Site 23/D. Zinc levels appear to be controlled by seasonal conditions. The changes in zinc concentrations mimic those for conductivity and sulfate. 23FD-2 had a zinc concentration of approximately 70 mg/l in June 2002. Although, zinc averages have fluctuated since 2002, there has been an overall decreasing trend. In 2009 zinc levels were near 20 mg/l. Zinc concentrations in the range of 20 to 70 mg/l are consistent with laboratory kinetic weathering tests performed on samples of argillite and serpentinite (Vos, 1993). The zinc concentrations recorded for Pond D are generally below 0.9 mg/l and reflect contributions from several source waters. Pond D receives water from Site D surface runoff, seeps on the slope and at the toe of the site and the effluent from the curtain drain that HGCMC installed between Site D and Site 23. MW-D3 showed elevated zinc concentrations in both 2005 samples: zinc levels rose from an average of 10 µg/l in 1998-2004 to an average of 177 µg/l in 2005. Average sulfate also increased by approximately 30 mg/l in 2005 compared to average values from 2002-2004. The zinc and sulfate returned to within historical limits in 2006. The cause for the increases in 2005 is not immediately apparent; however, if it was the arrival of a contact water front, a significant increase in conductivity, sulfate, calcium and magnesium should have preceded an increase in metals such as lead and zinc.

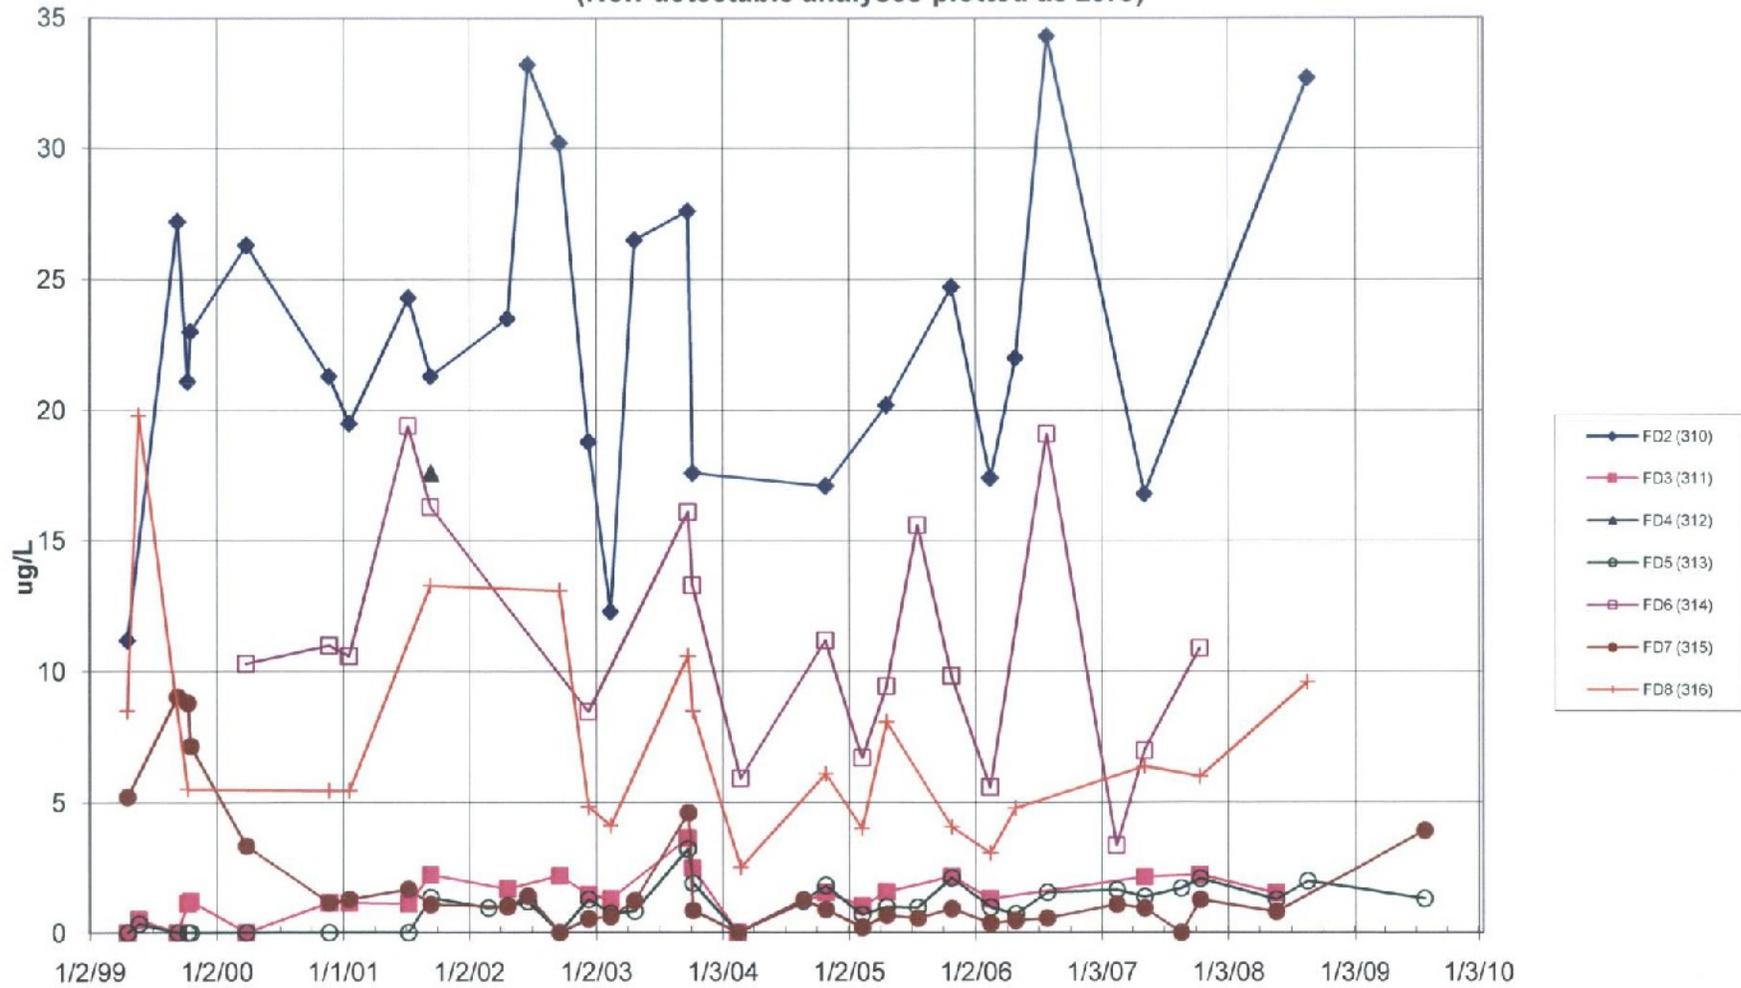
**FIGURE 3.21a GREENS CREEK SITE 23/D INTERNAL MONITORING SITES:
FINGER DRAINS - CADMIUM DATA
(Non-detectable analyses plotted as zero)**

Cadmium concentrations (Figures 3.21a and b) correlate well with those of zinc for the internal monitoring sites although at much lower values (0 to 35 µg/l).
