**TAILINGS AND PRODUCTION ROCK SITE
2009 ANNUAL REPORT**

Hecla Greens Creek Mining Company

April 15, 2010

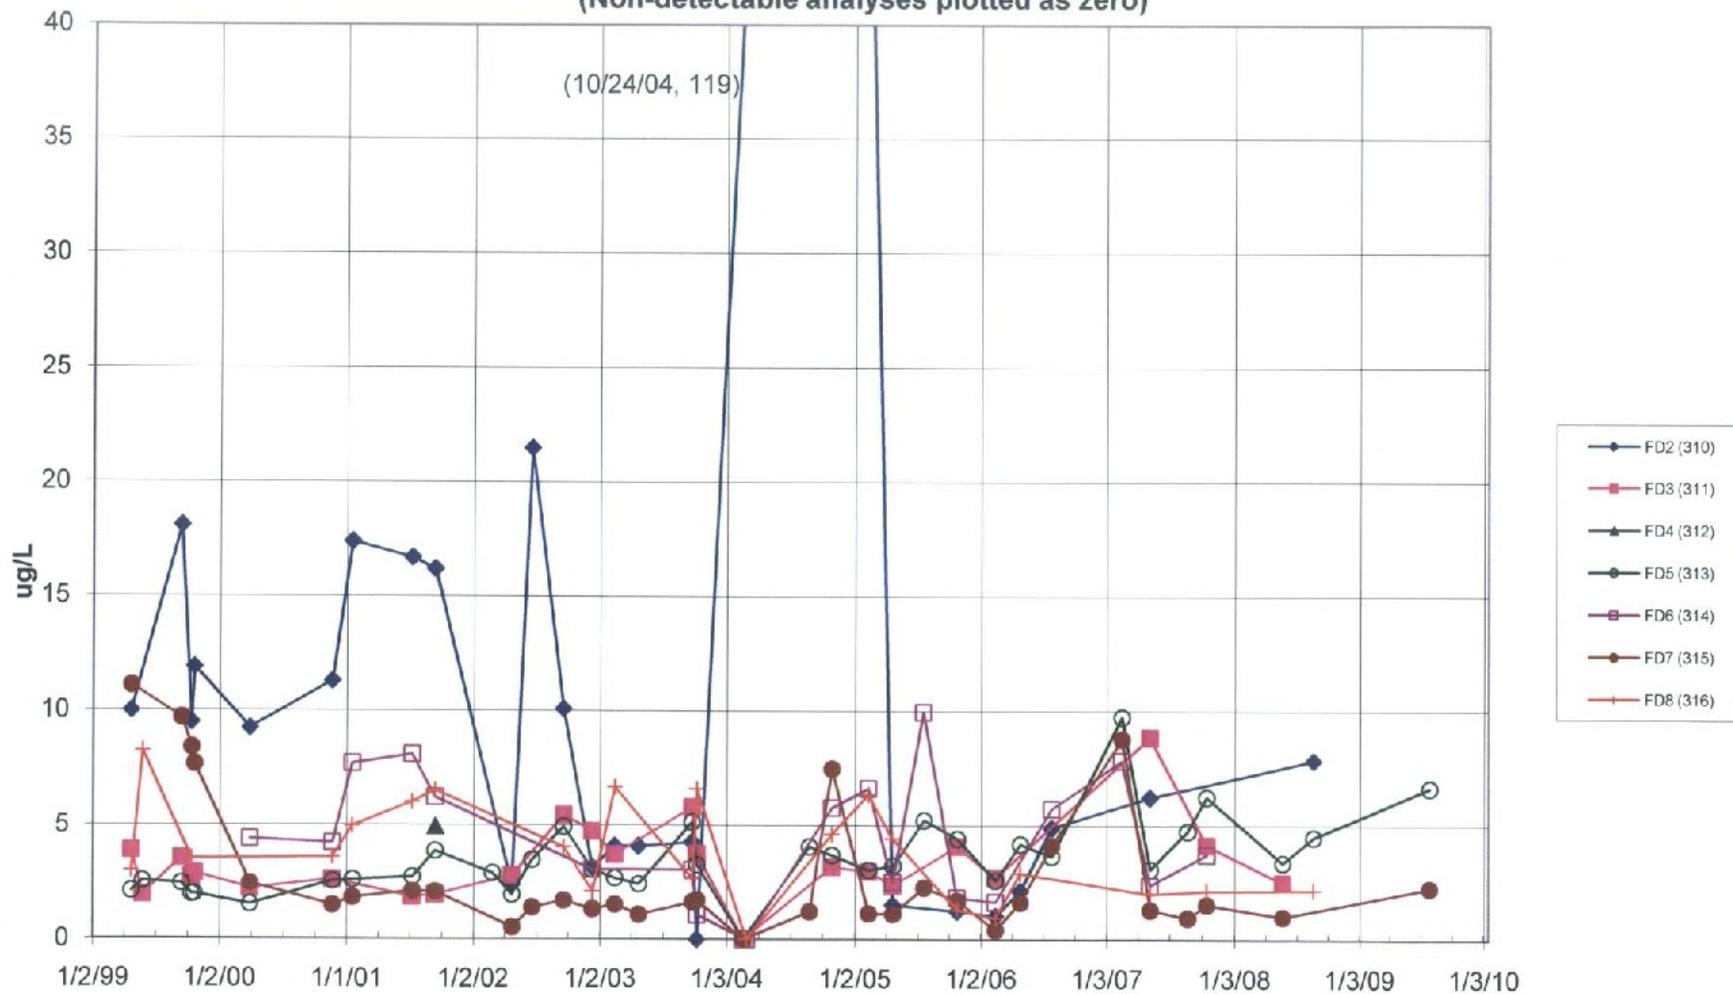
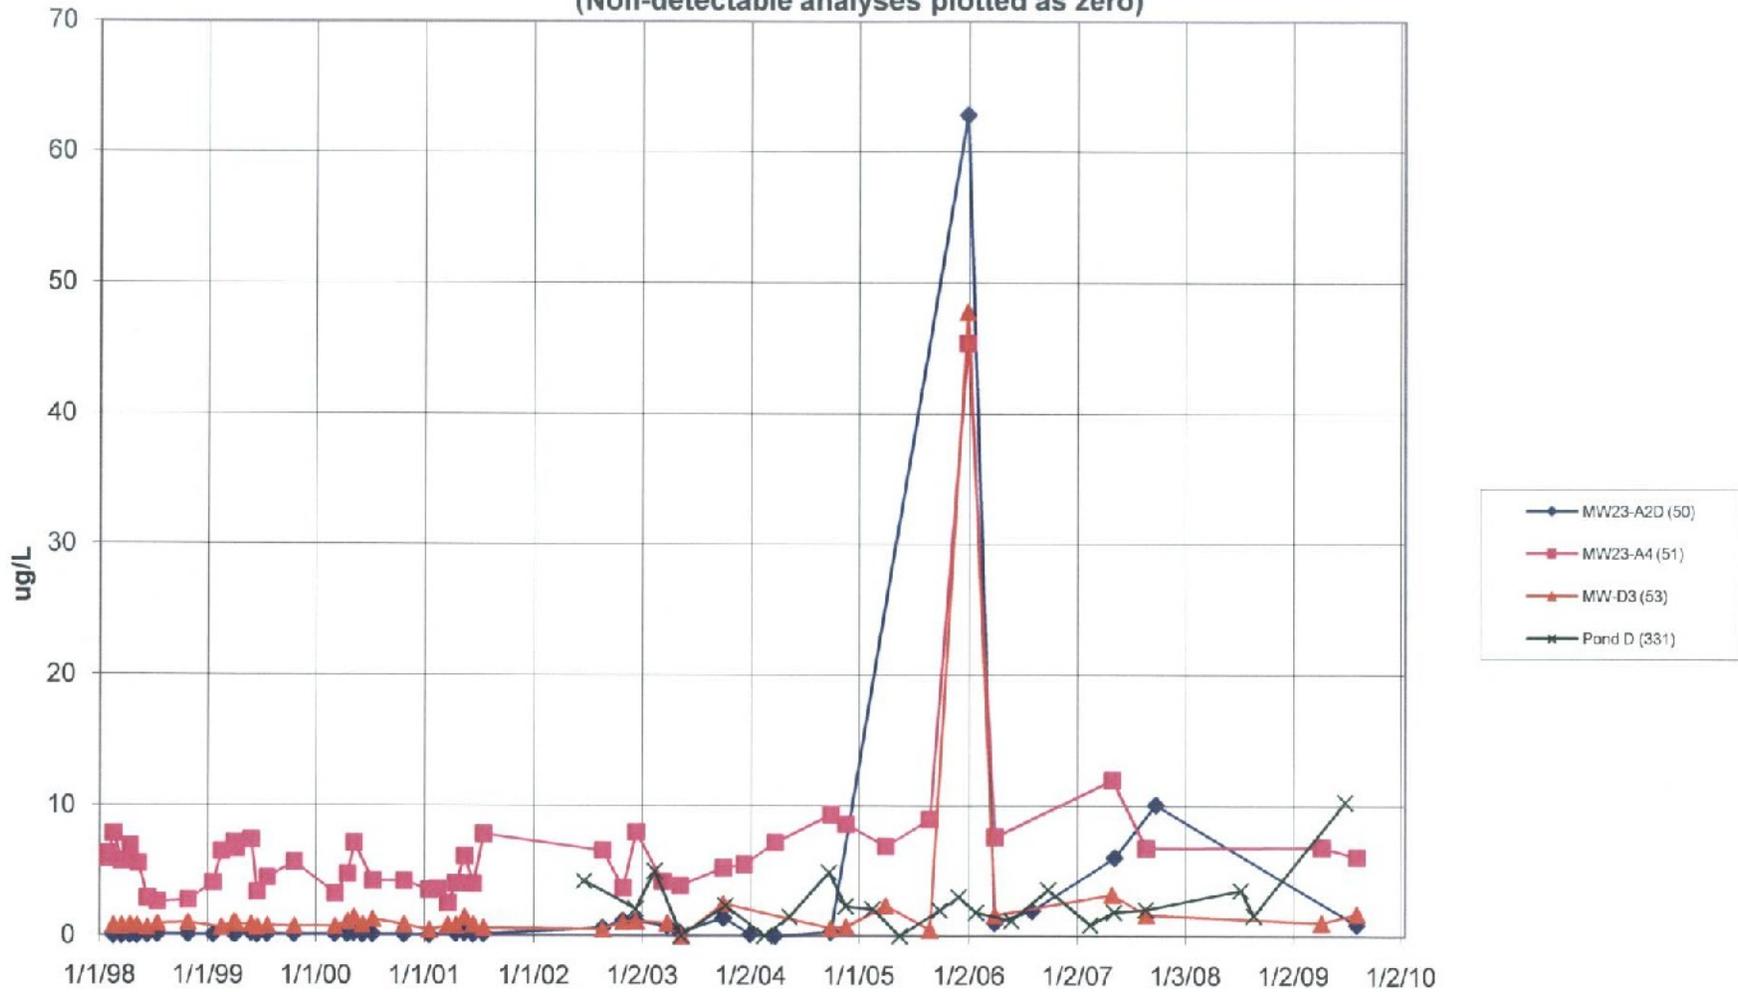
**FIGURE 3.22a GREENS CREEK SITE 23/D INTERNAL MONITORING SITES:
FINGER DRAINS - COPPER DATA
(Non-detectable analyses plotted as zero)**

The concentrations of copper and lead (Figures 3.22a and b and 3.23a and b) are considerably lower than that of zinc in the Site 23/D internal monitoring sites. Both of these metals show the same general trends as zinc with the exception of one anomalous lead result in a sample from

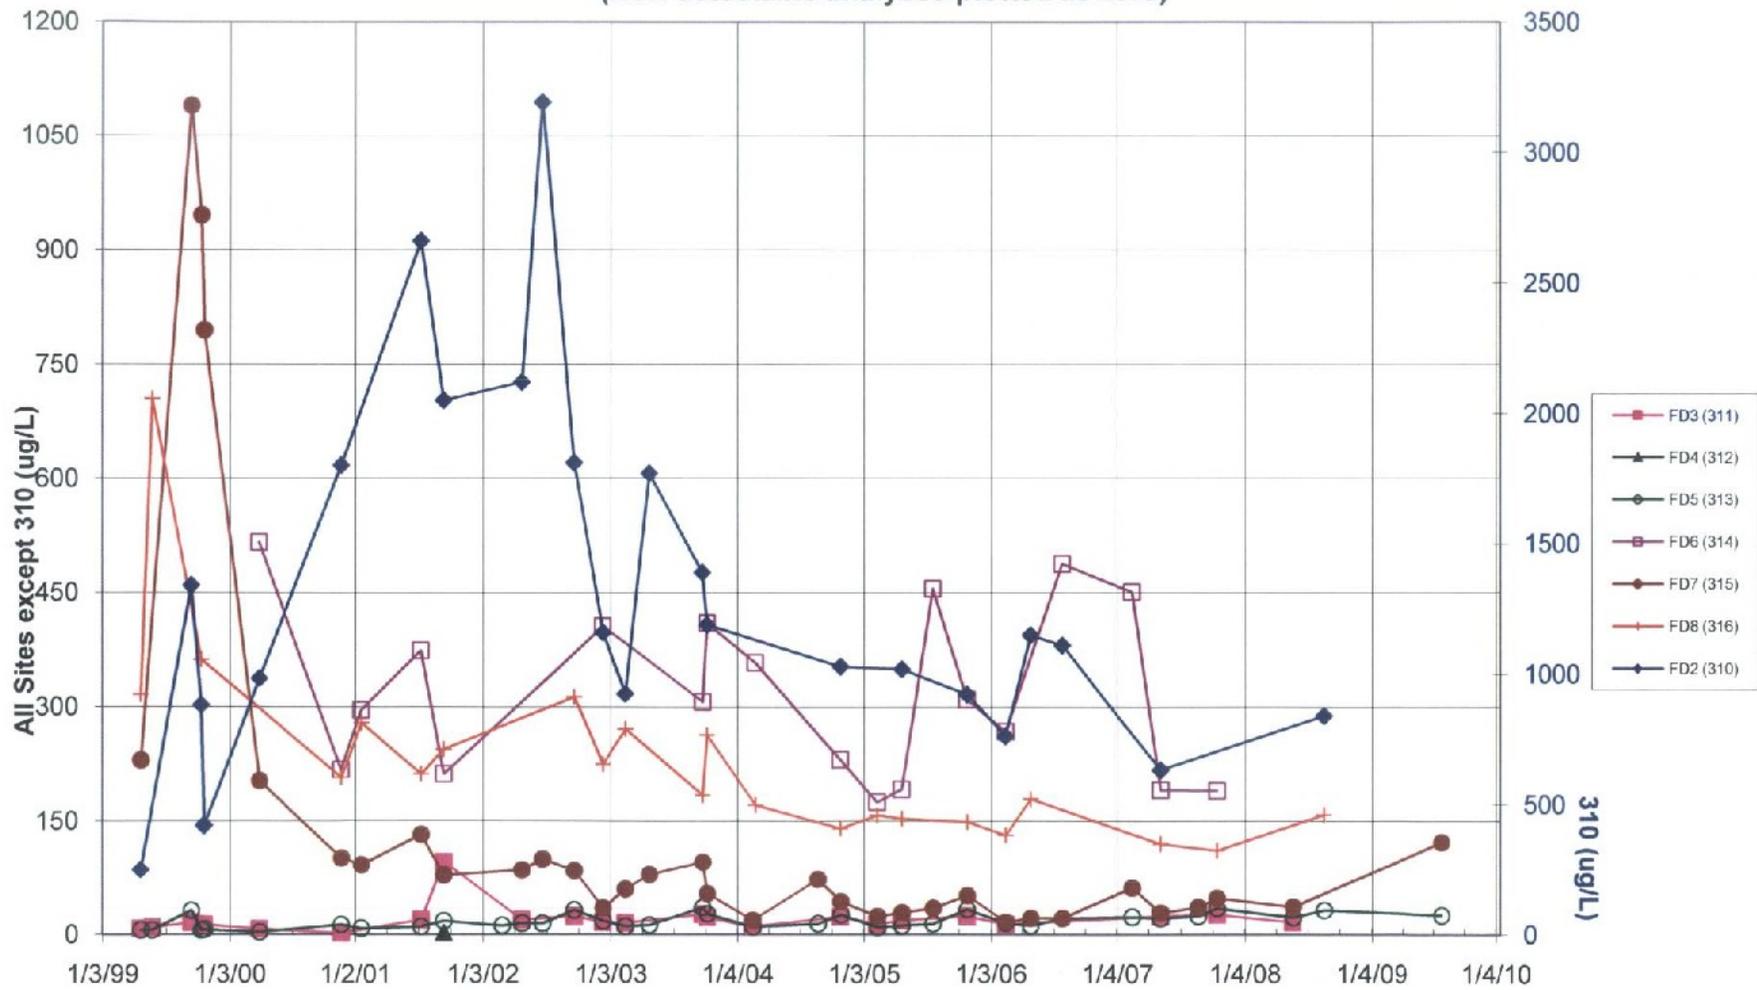
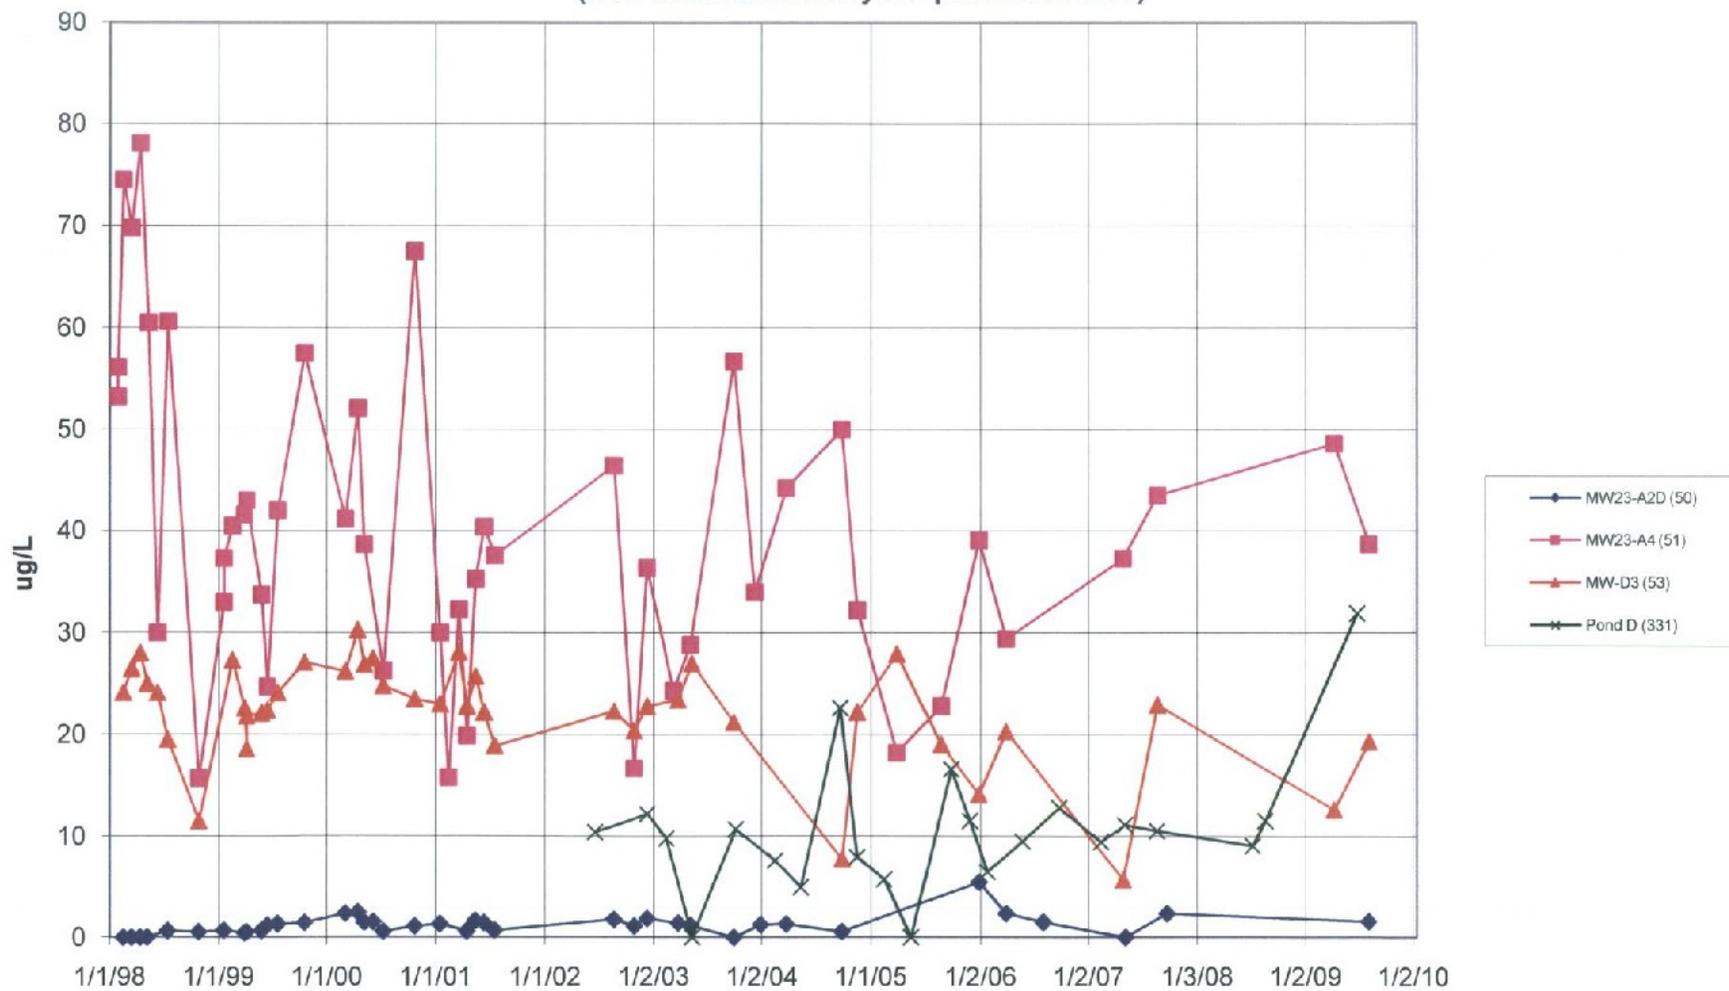
**FIGURE 3.24a GREENS CREEK SITE 23/D INTERNAL MONITORING SITES:
FINGER DRAINS - NICKEL DATA
(Non-detectable analyses plotted as zero)**

23FD-2 in 1999. The nickel concentrations presented in Figures 3.24a and b support the observation that the drainage from 23FD-2 is different than that of other drainages. It is possible that the material that supplies water to this drain has a greater proportion of serpentinite, which was shown to produce higher zinc and nickel concentrations than other rock types such as argillite and phyllite (Vos, 1993). What appeared to be a linear increase in nickel concentrations in 23FD-2 prior to 2002 now appears to be decreasing or at least cyclical. The December 2005 sample from MW-23-A2D was an order of magnitude higher than historical values and was likely an analytical error as it did not correspond with the conductivity and TDS of that sample. Also, the more recent metal concentrations for this site have returned within historical data values. Monitoring will continue to determine trends.

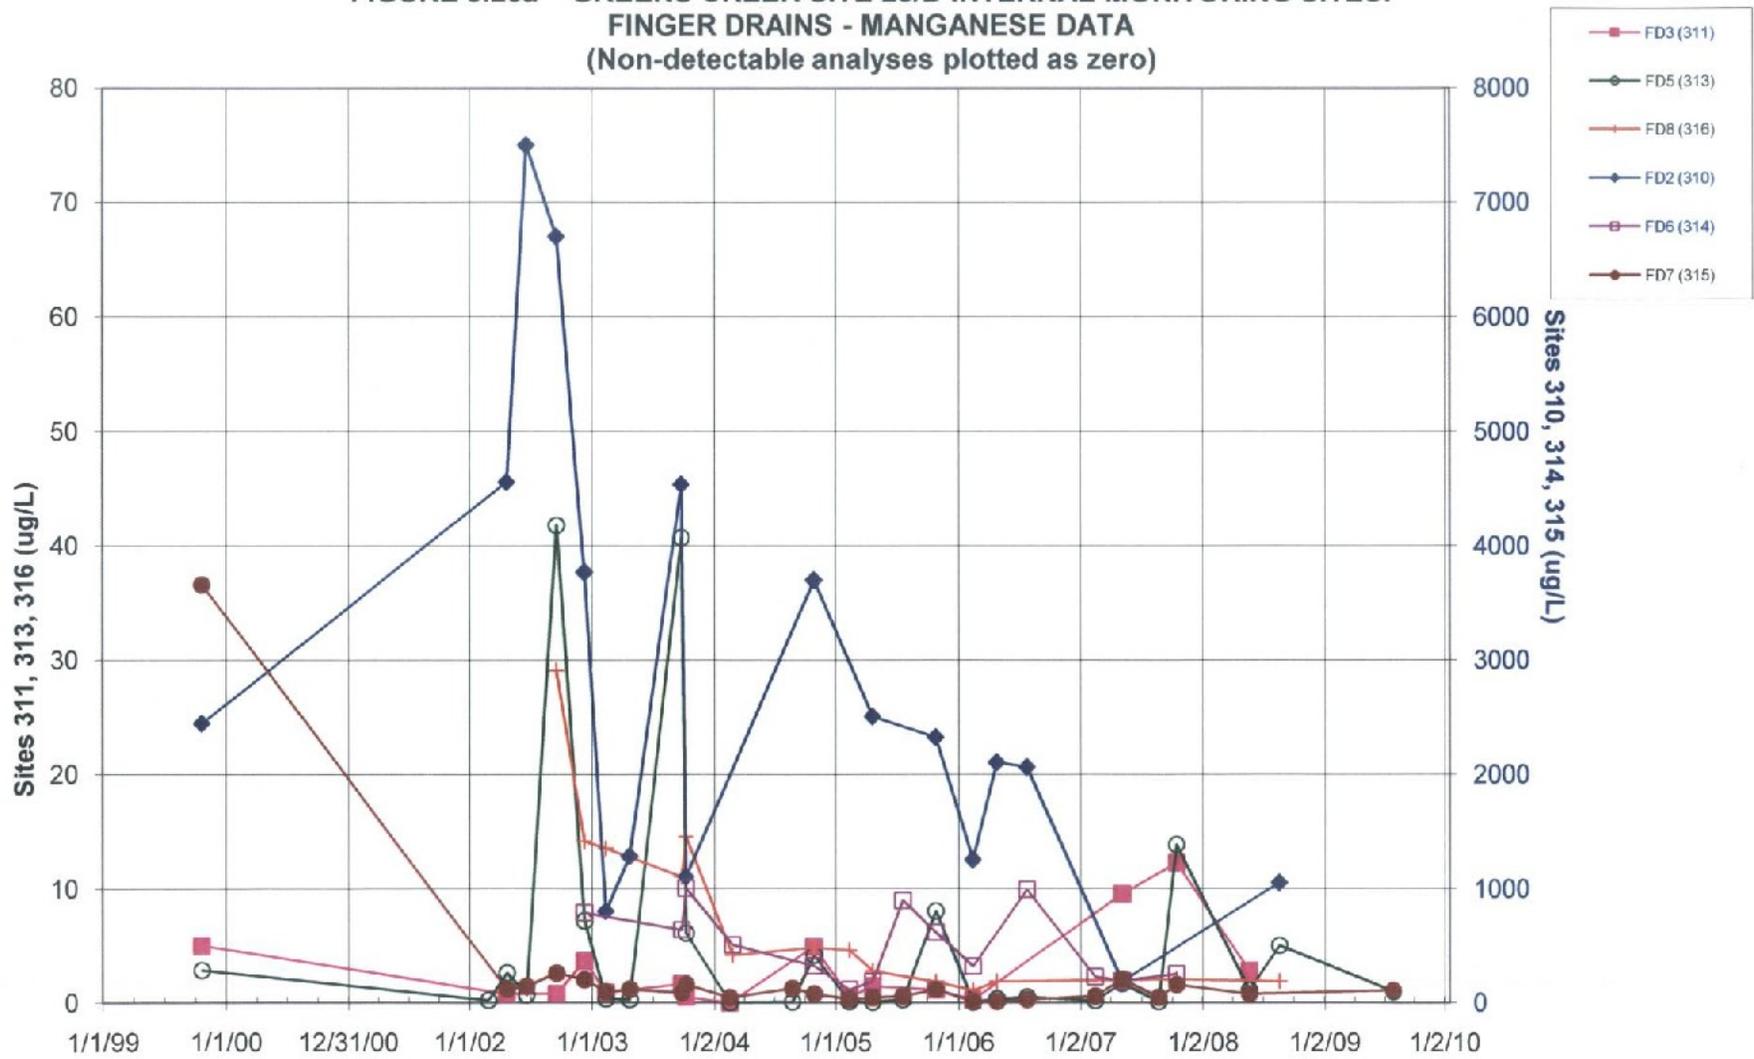
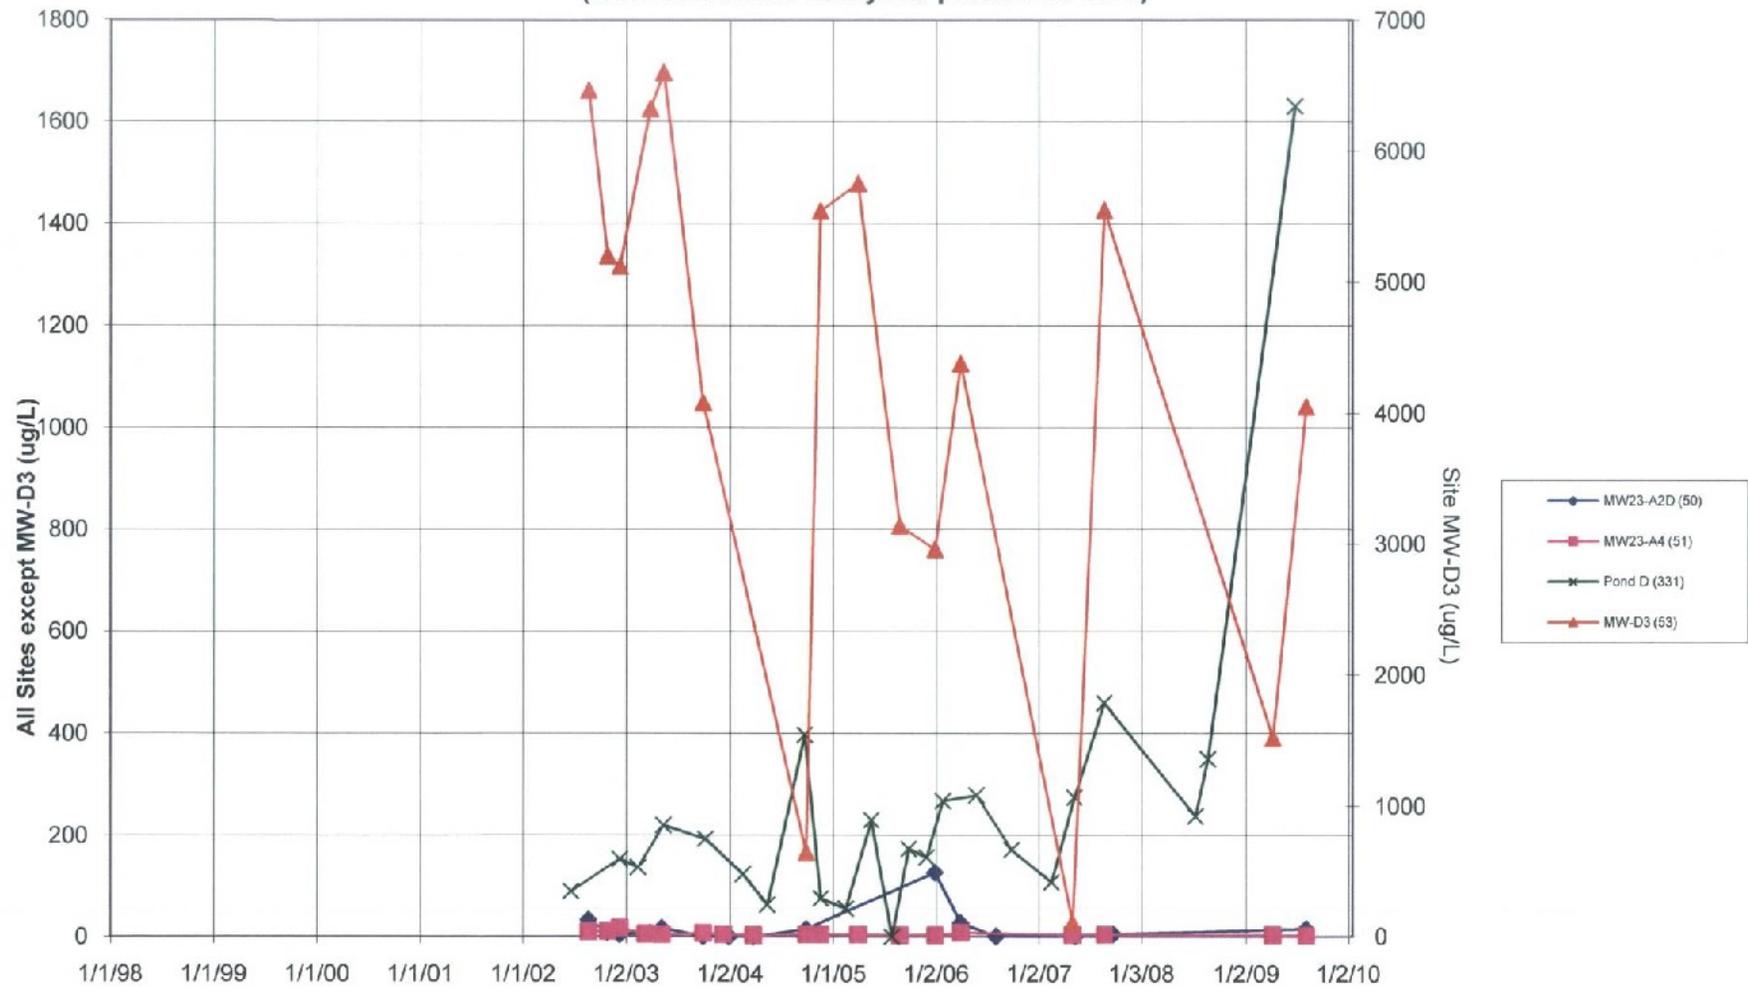
**FIGURE 3.26a GREENS CREEK SITE 23/D INTERNAL MONITORING SITES:
FINGER DRAINS - MANGANESE DATA
(Non-detectable analyses plotted as zero)**

Manganese concentrations (Figures 3.26a and b) are generally less than 50 µg/l for MW23-A2D, MW23-A4, and three of the finger drains (23FD-3, 23FD-5 and 23FD-8). The other three finger drains (23FD-2, 23FD-6 and 23FD-7) and MW-D3 and Pond D have elevated manganese concentrations, indicative of the different redox conditions. Precipitation/dissolution of iron oxyhydroxides and manganese oxides controls the concentrations of iron and manganese in these waters.

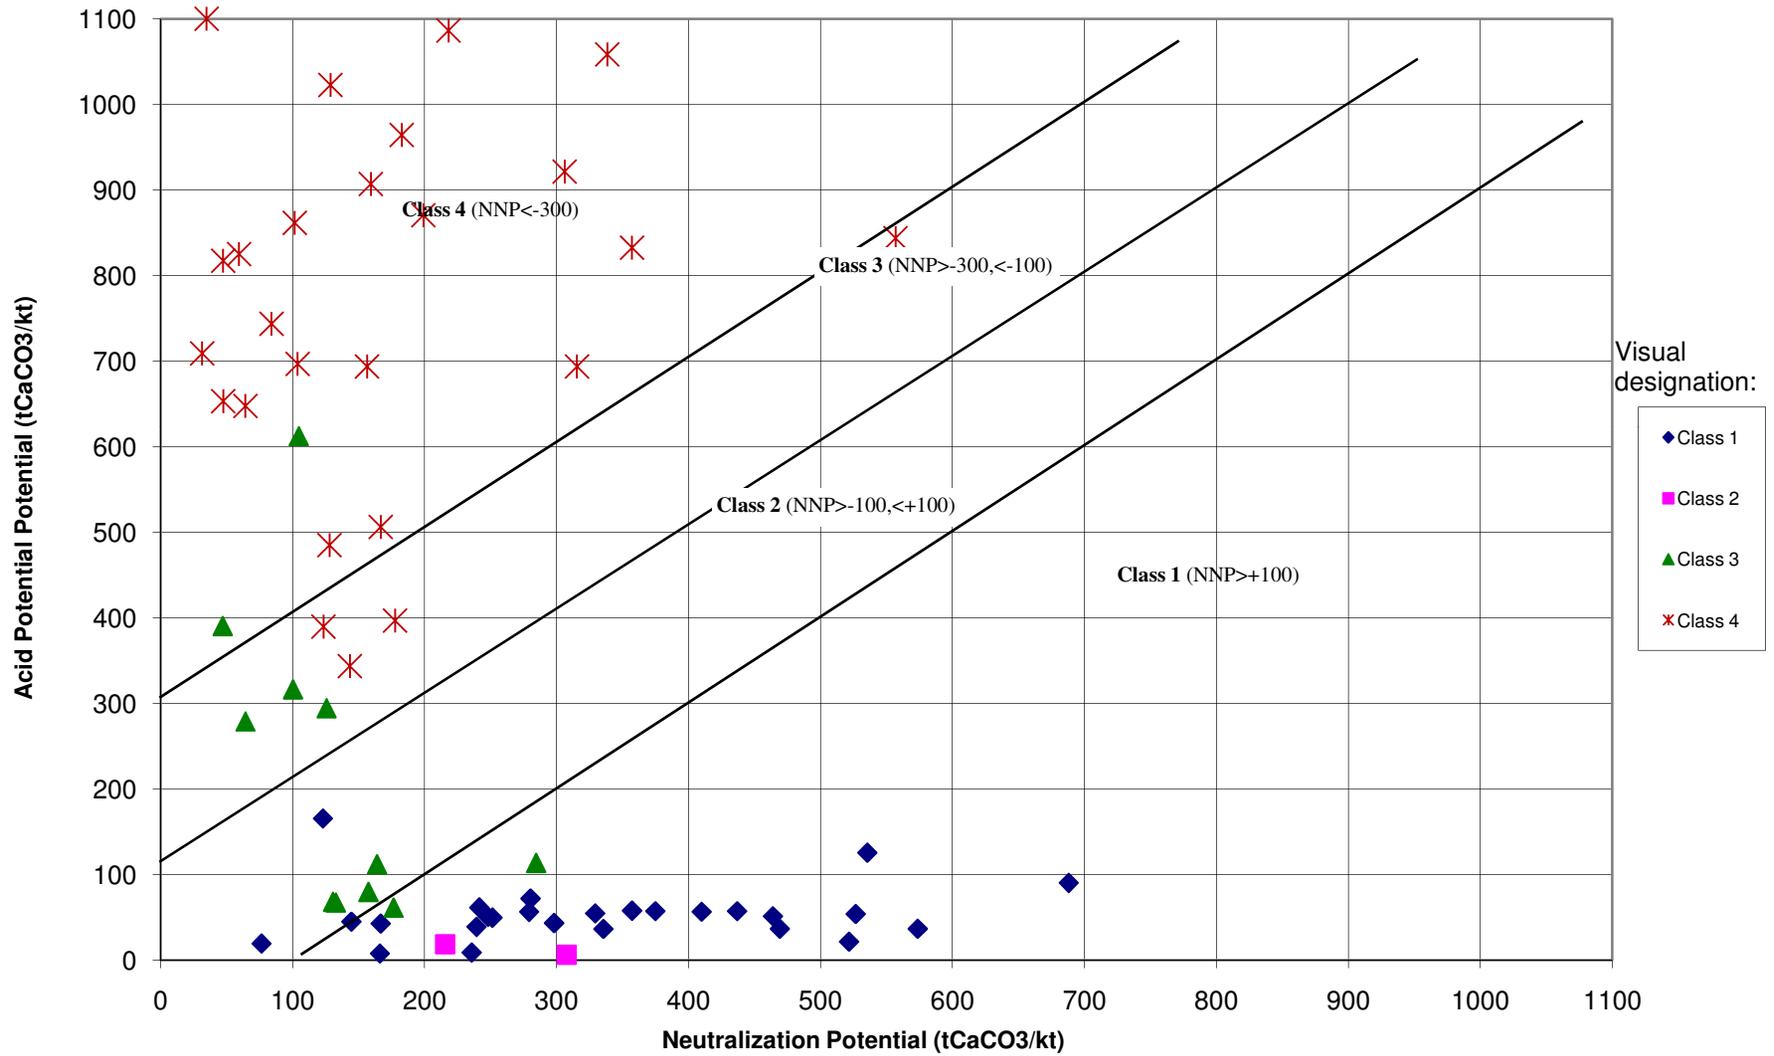
FIGURE 3.28 2009 ABA DATA FROM UNDERGROUND RIB SAMPLES

Acid base accounting (ABA) results from 71 underground rib composites collected in 2009 are presented in Table 3.3 and Figure 3.28. Class 1 rib samples had an average neutralization potential (NP) of 349 tons CaCO₃/1000t, which is equivalent to about 35% carbonate. The Class 1 samples had an average acid potential (AP) of 51 tons CaCO₃/1000t, which produced an average net neutralization potential (NNP) of 298 tons CaCO₃/1000t. Class 1 production rock does not have the potential to generate acid rock drainage; however, HGCMC recognizes the potential for metal mobility (primarily zinc) from this argillite rock. HGCMC has long-recognized this characteristic of Class 1 production rock and handles the material accordingly by placing it in controlled facilities, such as Site 23 and the tailings area.

Figure 3.28 compares actual class designation based on ABA analyses to the results of visual designation use underground to classify the production rock. Of the 71 composites, visual classification assigned 5 sample (7%) to a lower, less conservative class. Fifty-four (76%) of the composites were assigned to the appropriate class and 12 (17%) to a higher, more conservative class. These data represent a 93% success rate for the visual classification program.

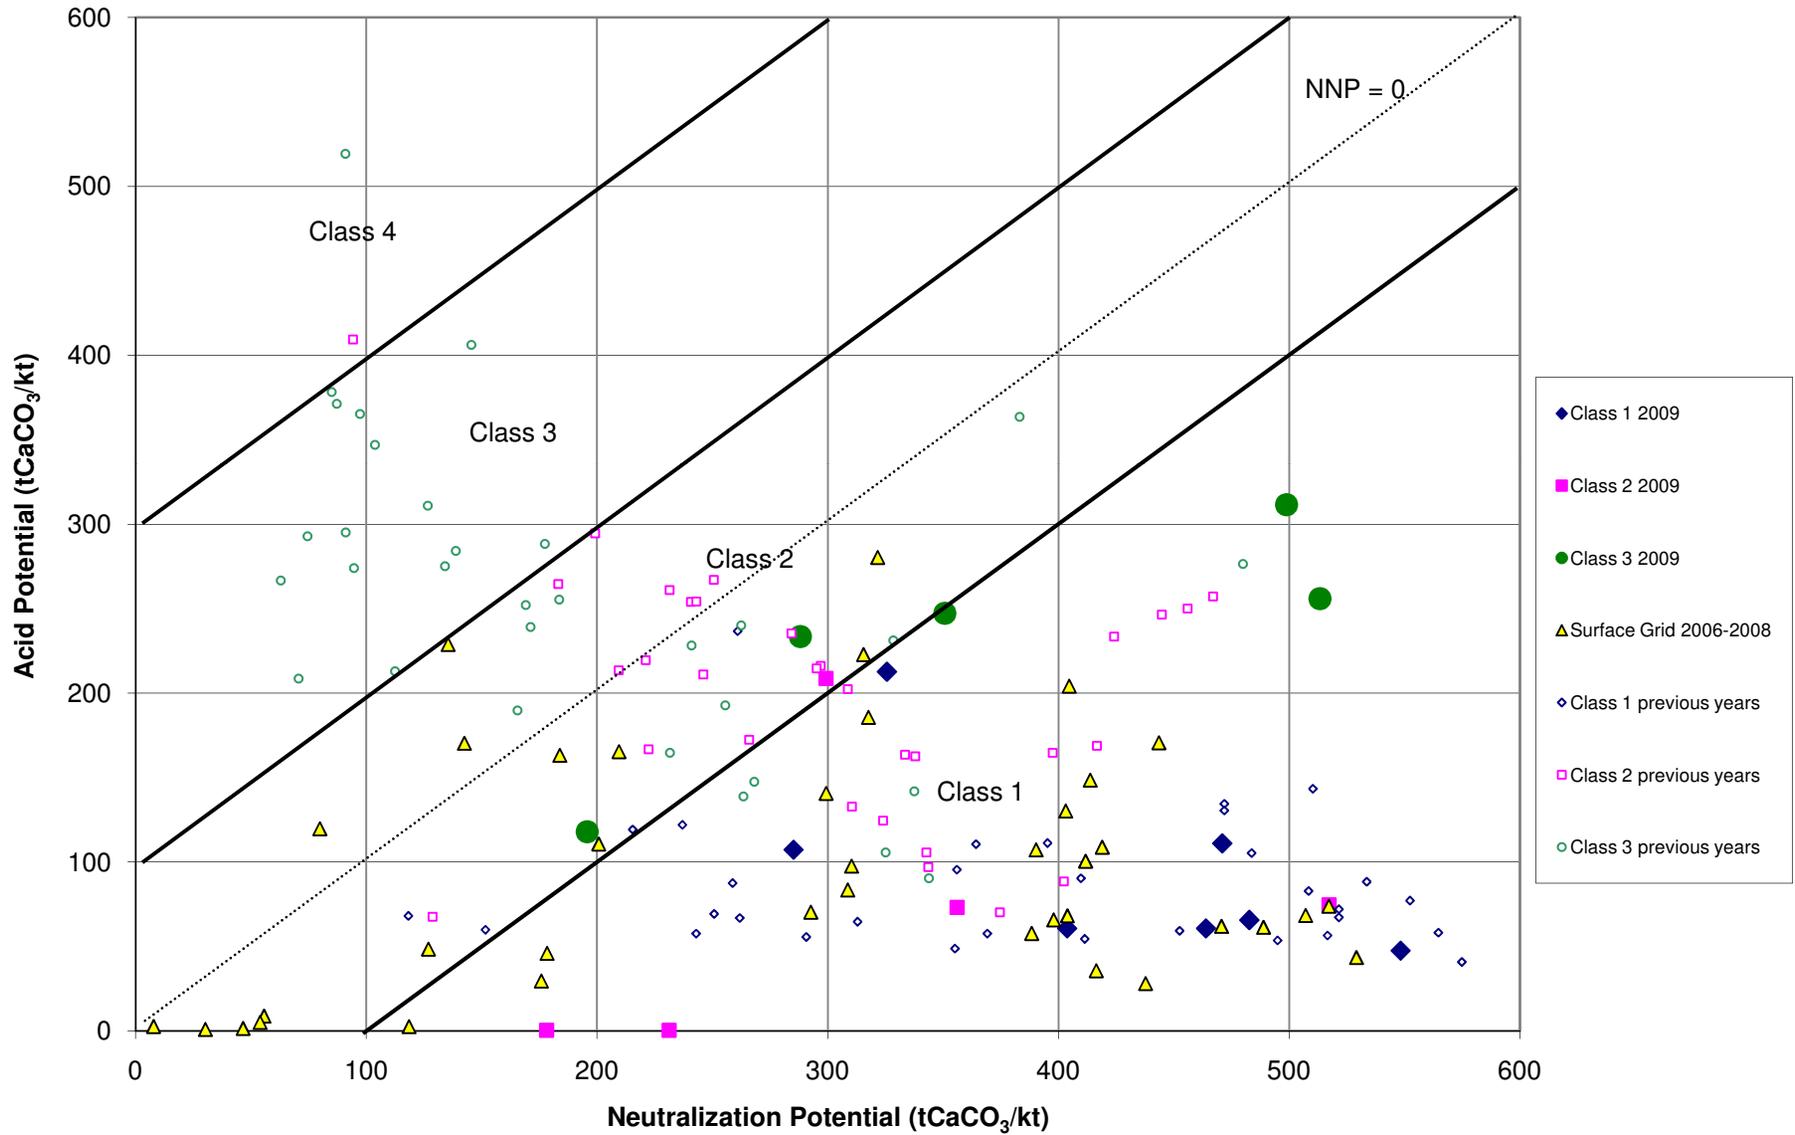
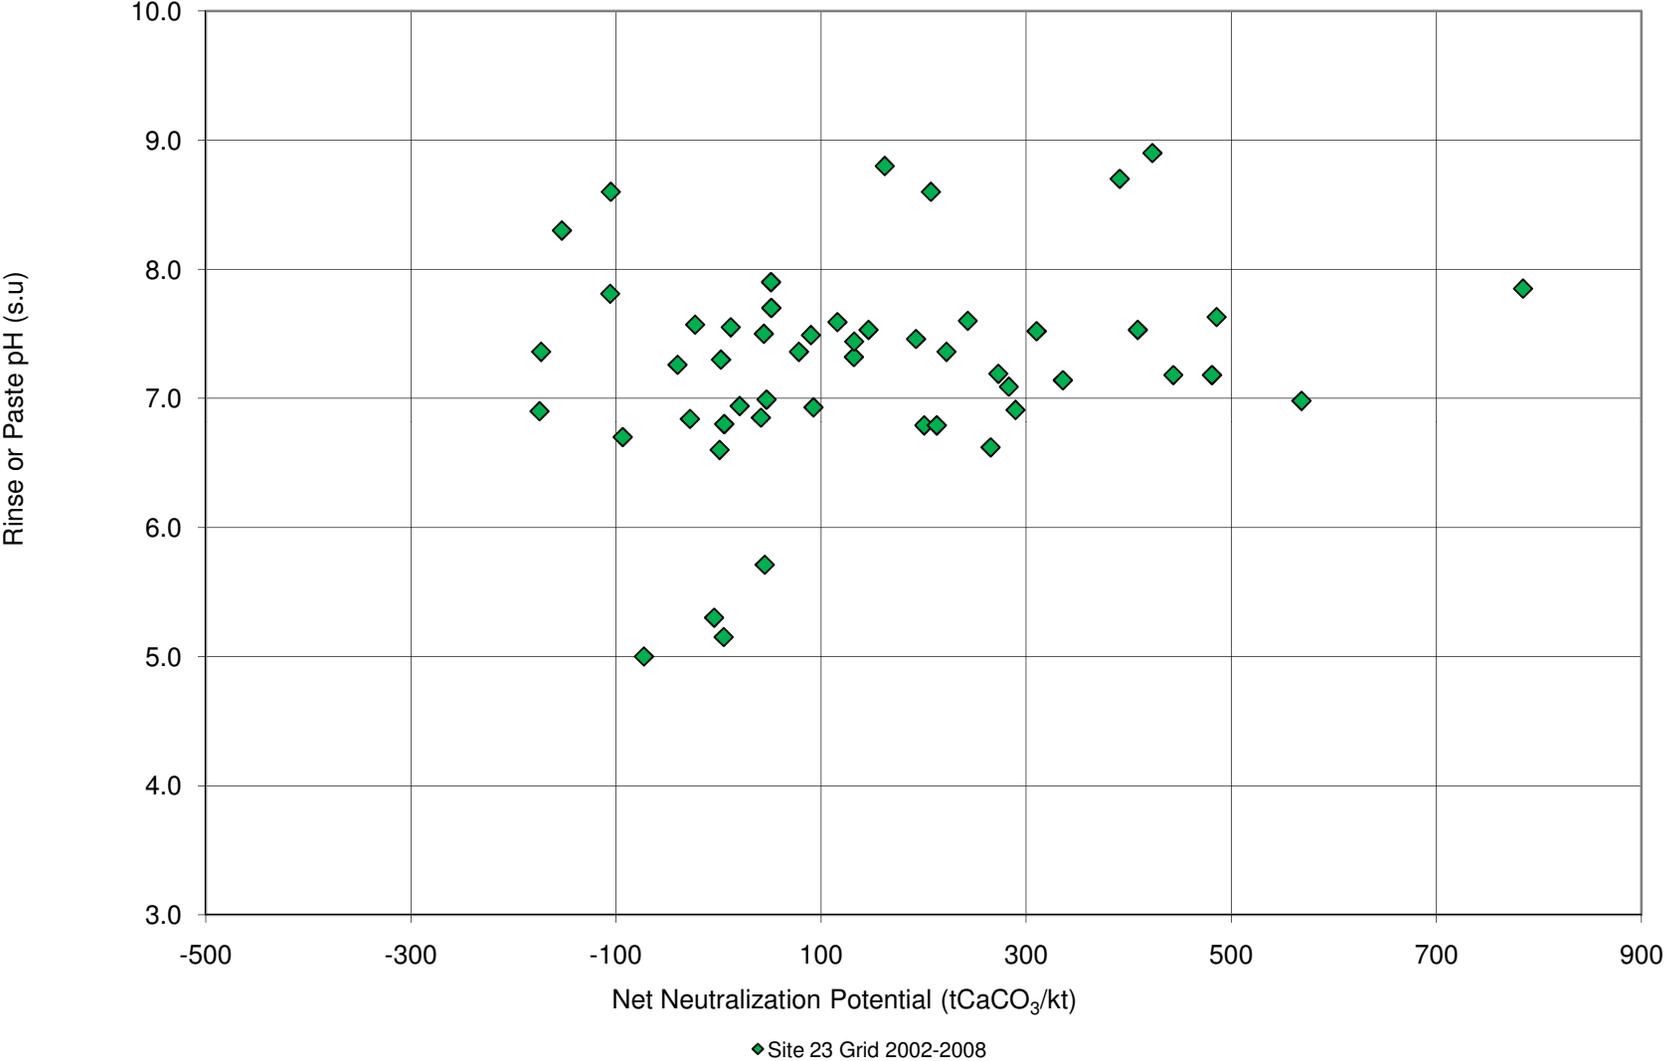
FIGURE 3.29a SITE 23 ABA DATA

2009 ABA results from the Site 23 active placement areas are shown also in Table 3.3 and Figure 3.29. Active placement area ABA results from previous years as well as the 2006-2008 grid data are also shown on Figure 3.29. The AP to NP distribution in the Site 23 samples differs from that of the underground rib samples. The Class 2 and Class 3 stockpiles areas are frequently empty except for a safety berm, which is constructed of Class 1 rock in the absence of other material. It is probable that several of the samples included this material. The grid sampling is also skewed toward higher NNP values because most of the outer surface of the pile is covered with Class 1 rock.

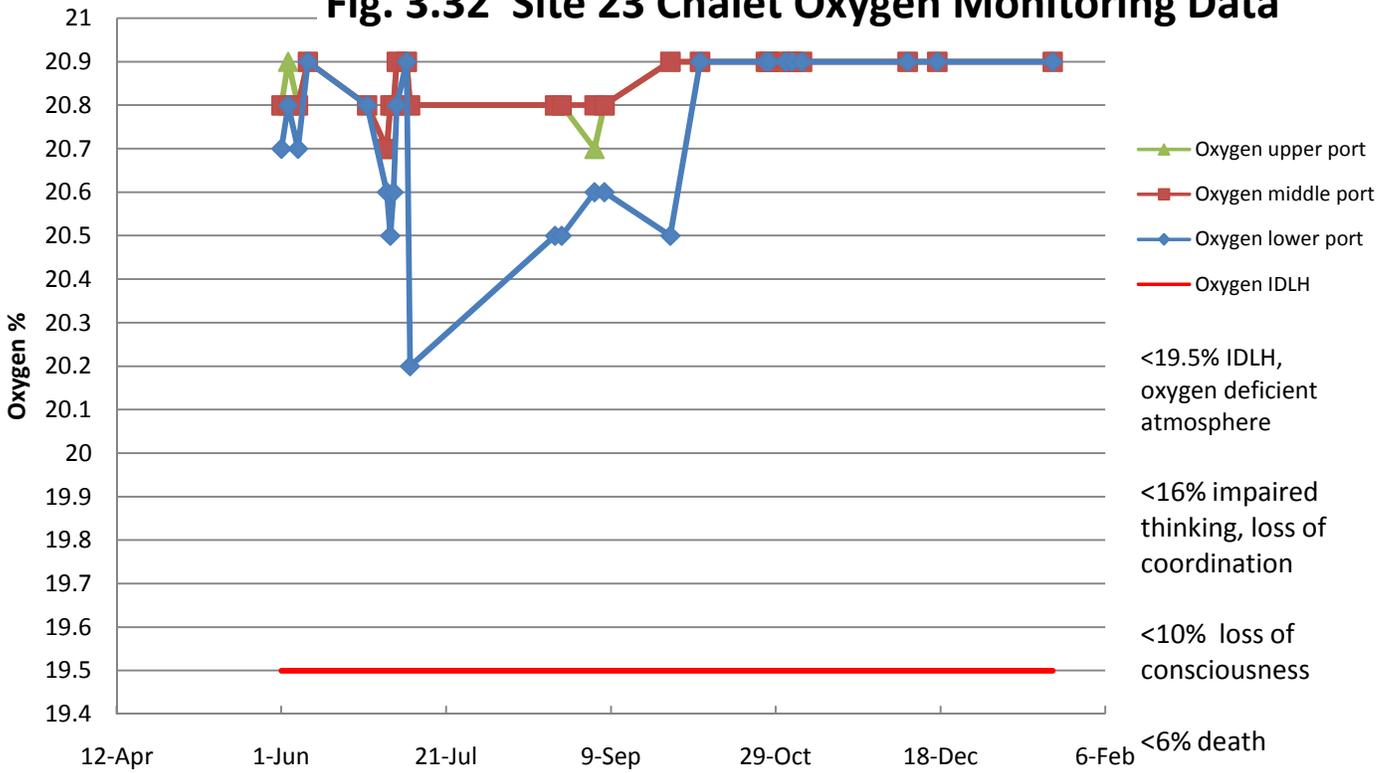
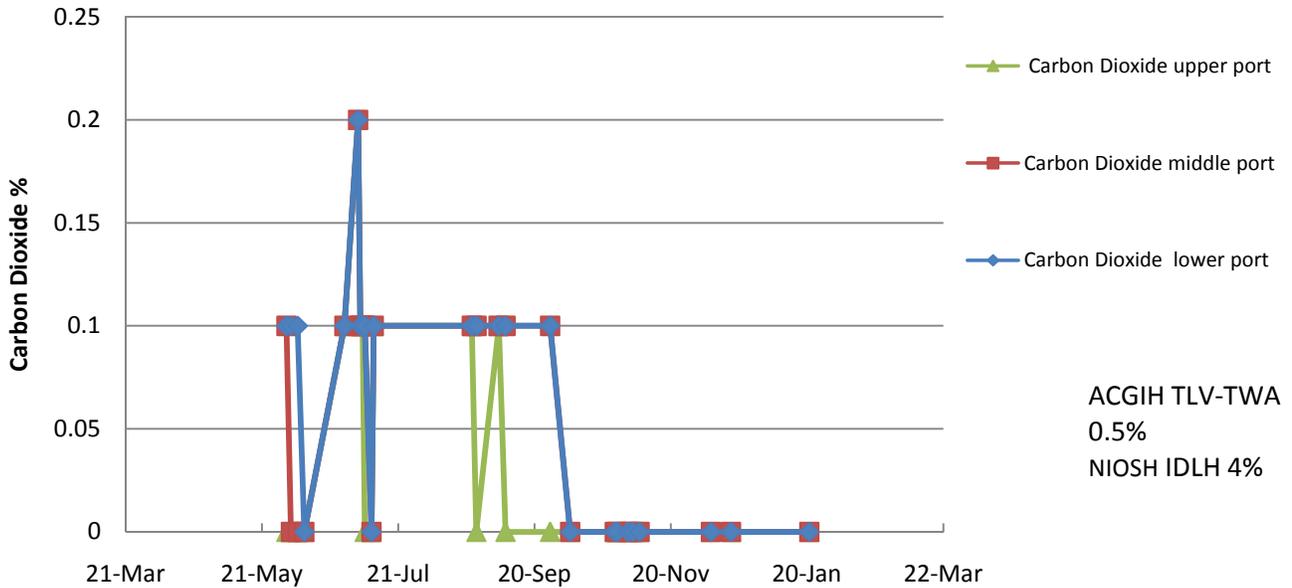
Fig. 3.32 Site 23 Chalet Oxygen Monitoring Data

In 2008 HGCMC began monitoring oxygen and carbon dioxide concentrations in the instrumentation trench building (the “Chalet”) to determine if conditions were unsafe for human entrance. Gas levels showed a slight season fluctuation, but did not approach unsafe levels. Figures 3.32 and 3.33 show oxygen levels decreased slightly and carbon dioxide levels increased

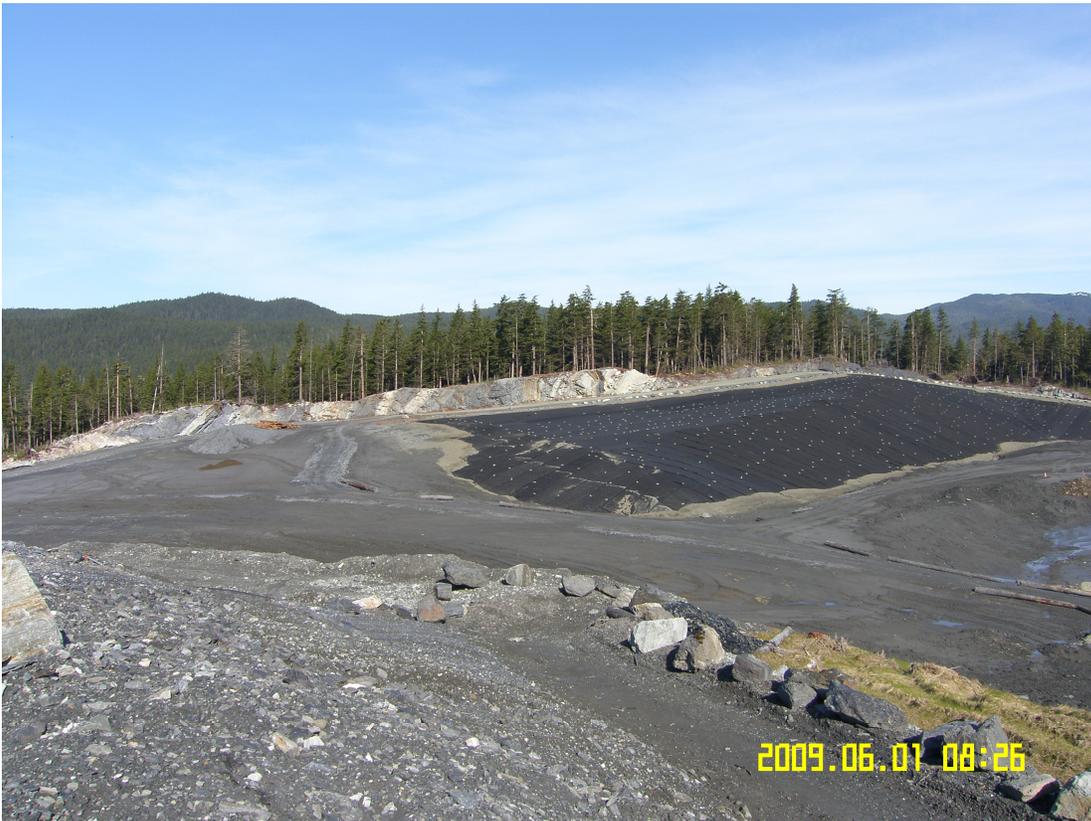
Figure 2.39 Northwest Expansion Area June 2009

Photographs from 2009 are presented in Figures 2.39 to 2.40 (Appendix 4). Figure 2.39 shows the Northwest area of the Tailings Facility on June 1, 2009.

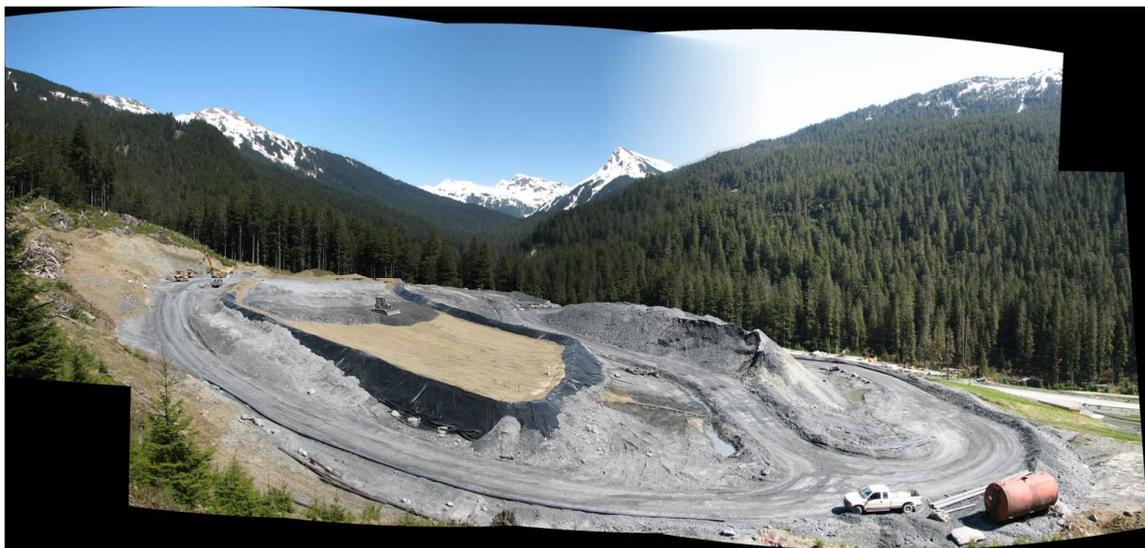
Figure 3.35 Site 23 Temporary Storage Area- June 2008

In 2008, HGCMC received approval from ADEC to construct an interim storage area for waste rock to be backfilled underground (see photo Figure 3.35). This 25,000 cubic yard capacity area was constructed to aid in concurrent reclamation efforts and can potentially be utilized on a continual 12-month schedule. This is a large increase over the previous 920 remuck bay which had a seasonal 700 cubic yard capacity. The area is layered with 6" of sand; a 36 mil reinforced polypropylene liner, another 6" layer of sand, 3' of class 3 production rock, and finally a geofabric layer. An HDPE pipe collects water from the area which is sloped to a central collection point. The water collected in this area drains to Pond 23. Material placed in this area is treated with up to 1 wt% lime. Waste rock from the B and D Pond berms, the 1350 and segments of the pipeline excavation were placed at the Site 23 temporary storage area. These materials are backfilled underground as space and resources become available.

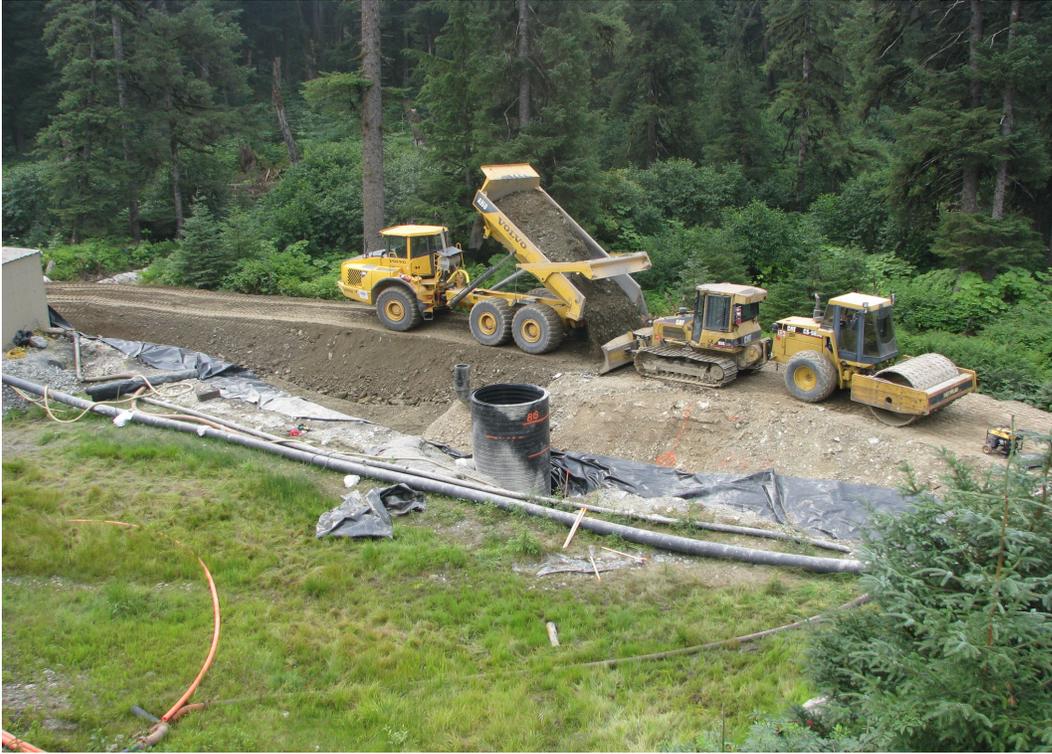
Figure 3.34 shows an aerial photo of Site 23 in June 2008. The interim storage area at Site 23 is shown in Figure 3.35. Figure 3.36 shows the D Pond berm removal work in progress.

Figure 3.36 Pond D Activities August 2009, showing replacement of berm material, and new caisson
