## Field Monitoring Report -- Pebble Copper/Gold Exploration Project --

Drill Hole/Site No.: 12547	Date: 7/17/2012
Rig No.: 3	Time: 1:05 pm
Activity: Cementing and casing for water	
<ul style="list-style-type: none"> <li>■ Condition of Drilling Site:</li> </ul>	<ul style="list-style-type: none"> <li>■ Sump Pit (continued):</li> </ul>
<ul style="list-style-type: none"> <li>○ Distance from water body: .2 mi</li> </ul>	<ul style="list-style-type: none"> <li>○ Location and extent of discharged material: About 30' from drill.</li> </ul>
<ul style="list-style-type: none"> <li>○ Location of fuel storage: Just east of mat</li> </ul>	<ul style="list-style-type: none"> <li>○ Topsoil, muck, tundra stockpiled: on liners</li> </ul>
<ul style="list-style-type: none"> <li>○ Sorbent pads present: yes</li> </ul>	<ul style="list-style-type: none"> <li>○ Hose color:</li> </ul>
<ul style="list-style-type: none"> <li>○ Tundra mat: good</li> </ul>	
<ul style="list-style-type: none"> <li>○ Pipe off tundra: yes</li> </ul>	<ul style="list-style-type: none"> <li>■ Drill Water Supply:</li> </ul>

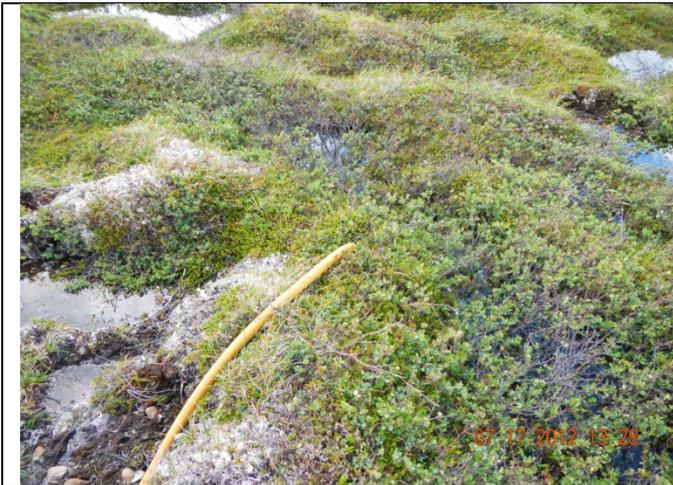
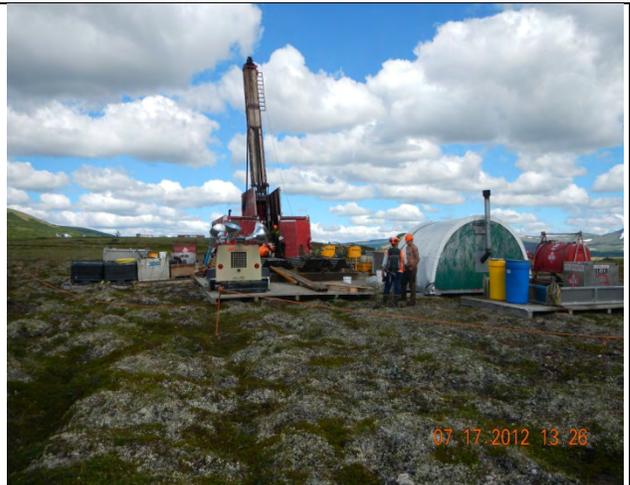
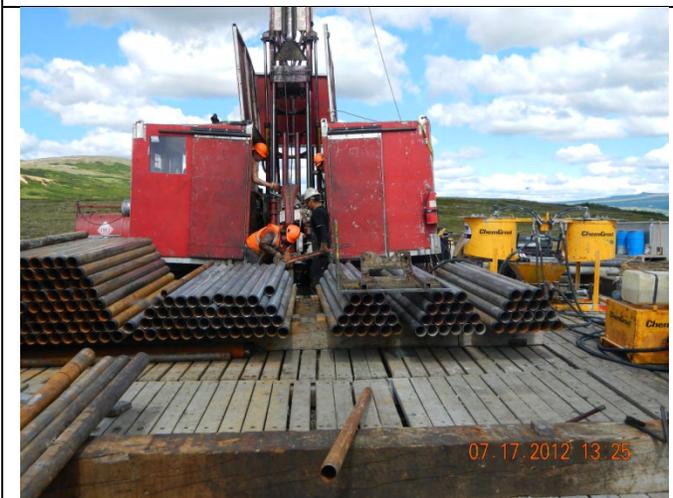
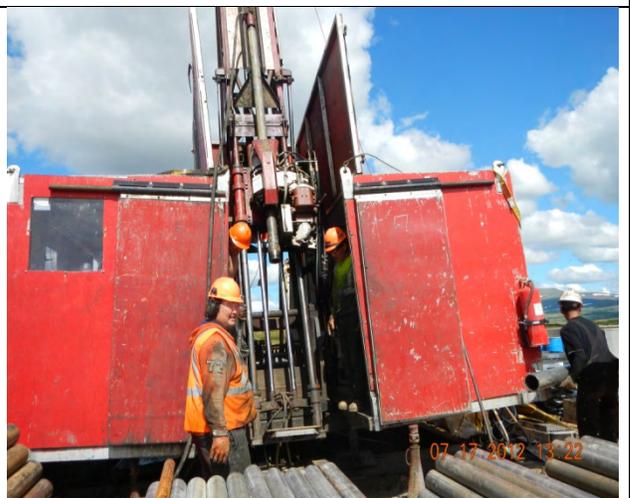
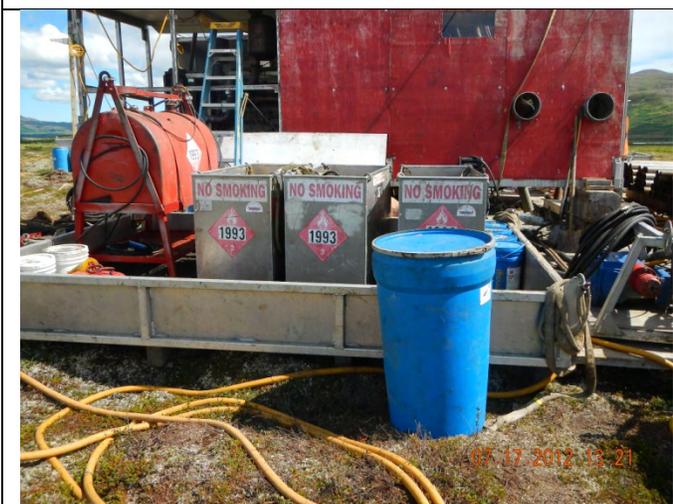
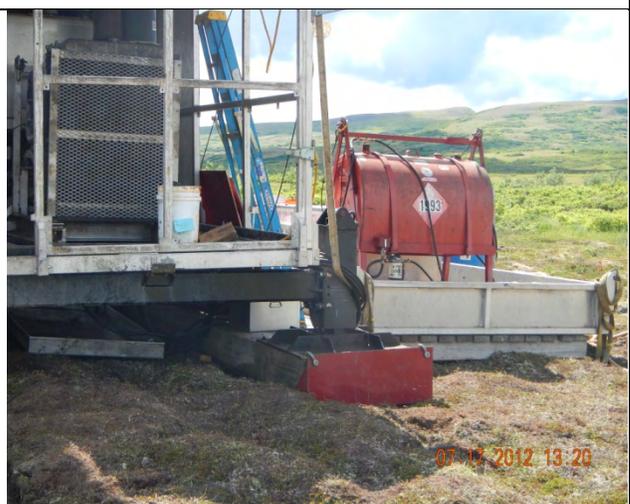
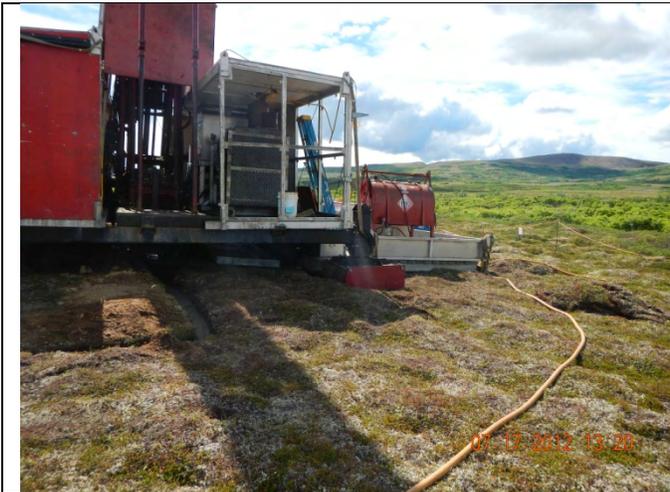
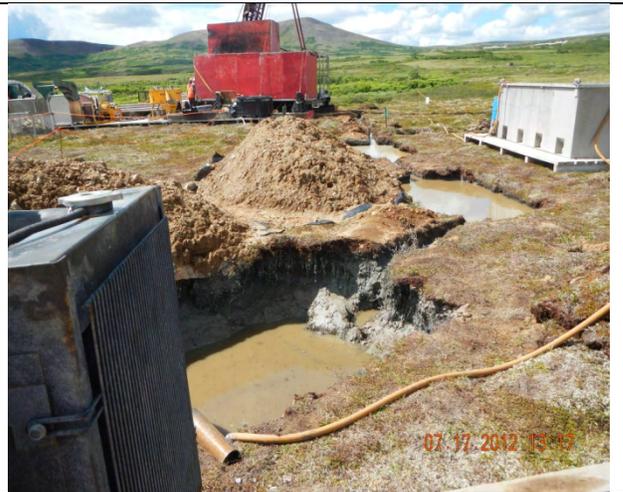
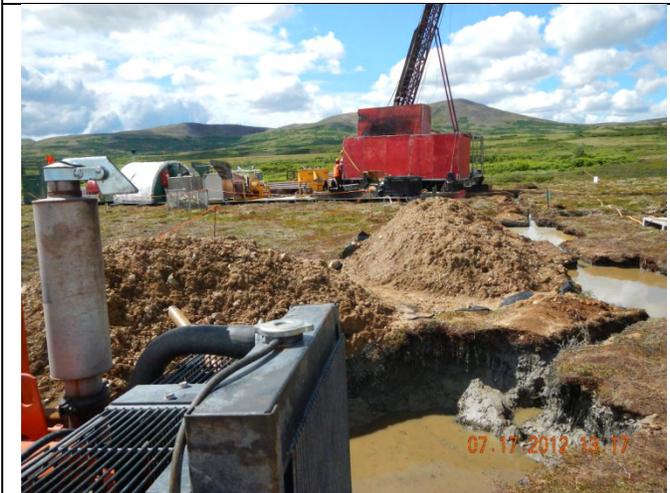
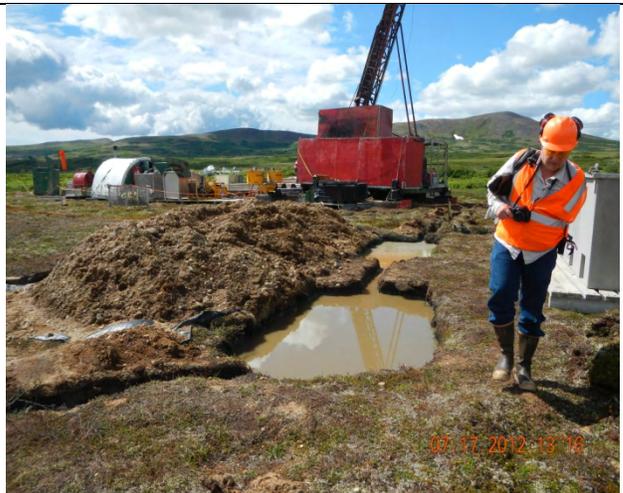
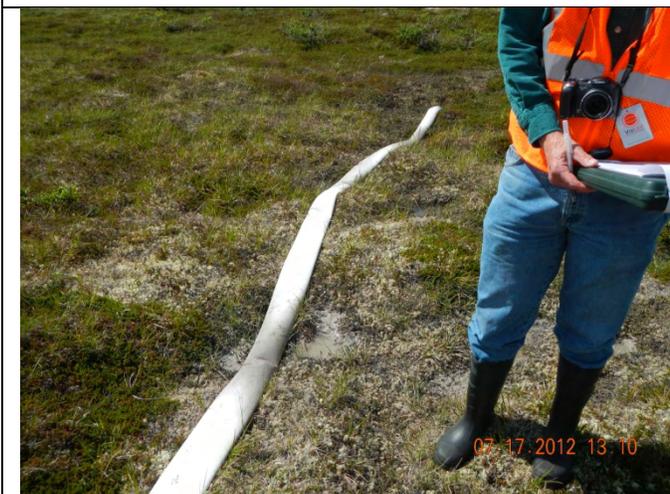
<ul style="list-style-type: none"> <li>○ Intake description: Mesh screen</li> </ul>
<ul style="list-style-type: none"> <li>■ Drilling Activity:</li> </ul>	<ul style="list-style-type: none"> <li>○ Structure clear of debris: yes</li> </ul>
<ul style="list-style-type: none"> <li>○ Drill additives in use: Extreme # one and quik-trol-gold.</li> </ul>	<ul style="list-style-type: none"> <li>○ Mesh size: standard</li> </ul>
<ul style="list-style-type: none"> <li>○ Recirculation tank: Yes, recirculating</li> </ul>	<ul style="list-style-type: none"> <li>○ Submerged: Yes</li> </ul>
<ul style="list-style-type: none"> <li>○ Water discharged: yes, about 200 feet to uplands.</li> </ul>	<ul style="list-style-type: none"> <li>○ Fuel/generator location to source: over 100 ft from source</li> </ul>
<ul style="list-style-type: none"> <li>○ Artesian zone encountered: no</li> </ul>	<ul style="list-style-type: none"> <li>○ Catch basin for fuel supply: yes</li> </ul>

<ul style="list-style-type: none"> <li>○ Sorbent pads: yes</li> </ul>
<ul style="list-style-type: none"> <li>■ Sump Pit:</li> </ul>	<ul style="list-style-type: none"> <li>○ Hose color: yellow</li> </ul>
<ul style="list-style-type: none"> <li>○ Location: Just south of pad</li> </ul>	
<ul style="list-style-type: none"> <li>○ Discharge trench: yes</li> </ul>	<ul style="list-style-type: none"> <li>■ Other Comments: broken glass tube (about 1-inch diameter by 1-foot long) found on tundra, unknown origin.</li> </ul>
<ul style="list-style-type: none"> <li>○ Dimensions of pit: standard, 3 in use.</li> </ul>	
<ul style="list-style-type: none"> <li>○ In use: Yes</li> </ul>

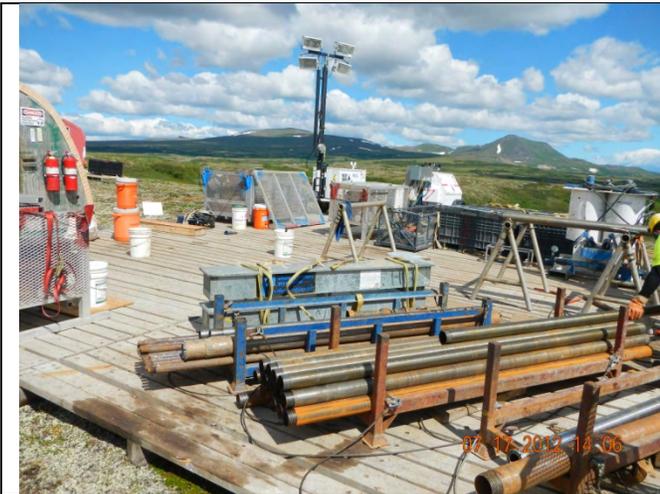
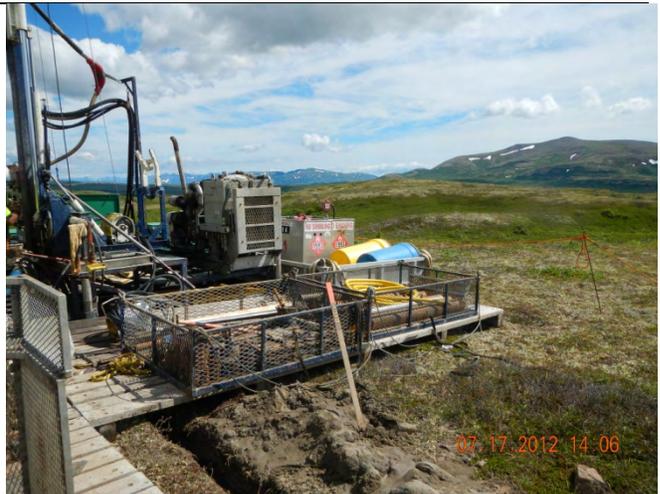
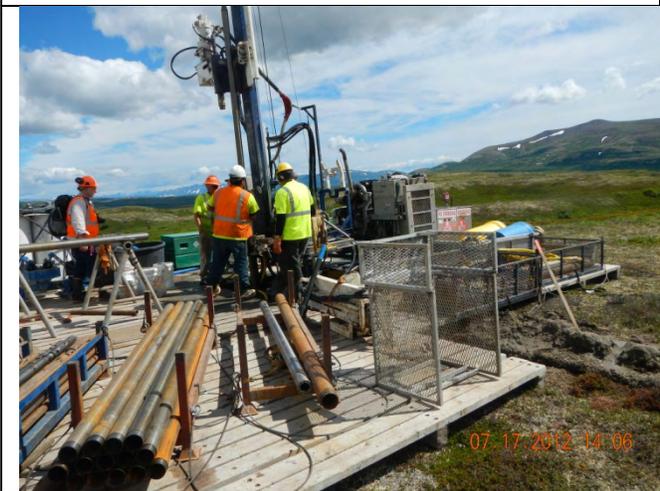
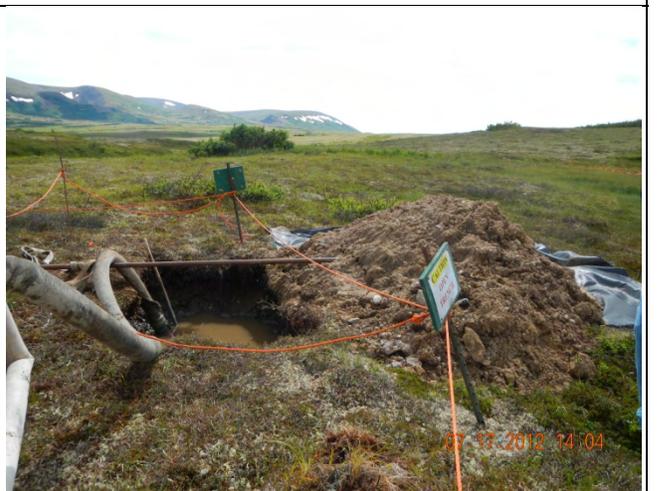
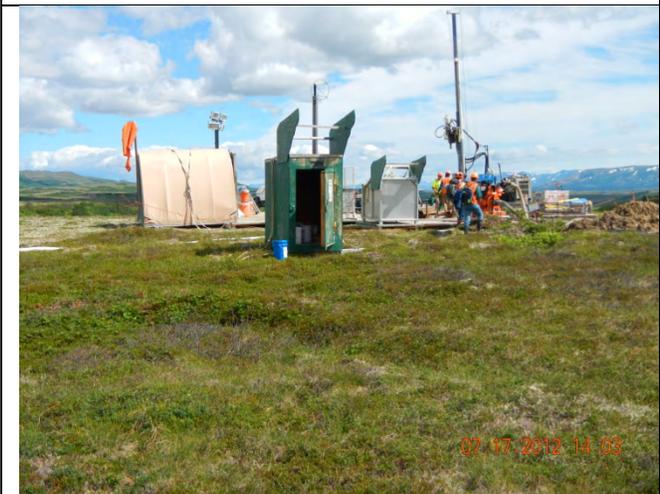
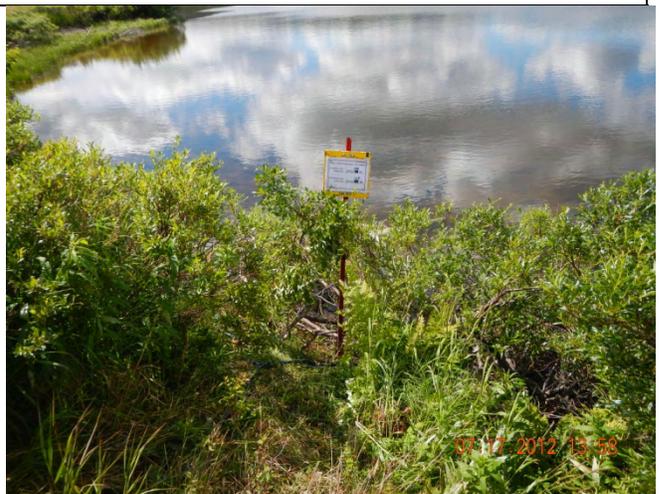
○ Drill additives in use:	○ Mesh size: standard
○ Recirculation tank:	○ Submerged: No – drill rig down for repairs.
○ Water discharged:	○ Fuel/generator location to source: 100 ft from source
○ Artesian zone encountered: no	○ Catch basin for fuel supply: yes
	○ Sorbent pads: yes
■ Sump Pit:	○ Hose color: yellow
○ Location:	
○ Discharge trench: yes	■ Other Comments:
○ Dimensions of pit: standard	
○ In use:
