Field Monitoring Report -- Pebble Copper/Gold Exploration Project --

Personnel: Kerwin Krause & Jim Renkert (DNR/DMLW) & Jeff Norberg (Manager, Site Compliance & Reclamation, PLP)	Inspection Date: August 21, 2012
	Site Contact: Jeff Norberg & Tom Jordan
	APMA #s: A126118 (GH 12-3333 and DDH 12551), A122788 (DDH 12550) & A113111 (DDH 12552)
<ul style="list-style-type: none"> ■ Inspection Type: 	<ul style="list-style-type: none"> ■ Wildlife Observed:
<ul style="list-style-type: none"> ○ Complete: X (GH 12-3333 & DDH 12551) 	<ul style="list-style-type: none"> ○ Bear: X (Several Brown)
<ul style="list-style-type: none"> ○ Partial: X (DDH 12550 and DDH 12552) 	<ul style="list-style-type: none"> ○ Caribou:
<ul style="list-style-type: none"> ○ Follow-up: 	<ul style="list-style-type: none"> ○ Moose: X (Several)
<ul style="list-style-type: none"> ○ Response to Public Complaint: 	<ul style="list-style-type: none"> ○ Waterfowl: X (Swans)
	<ul style="list-style-type: none"> ○ Fish: X

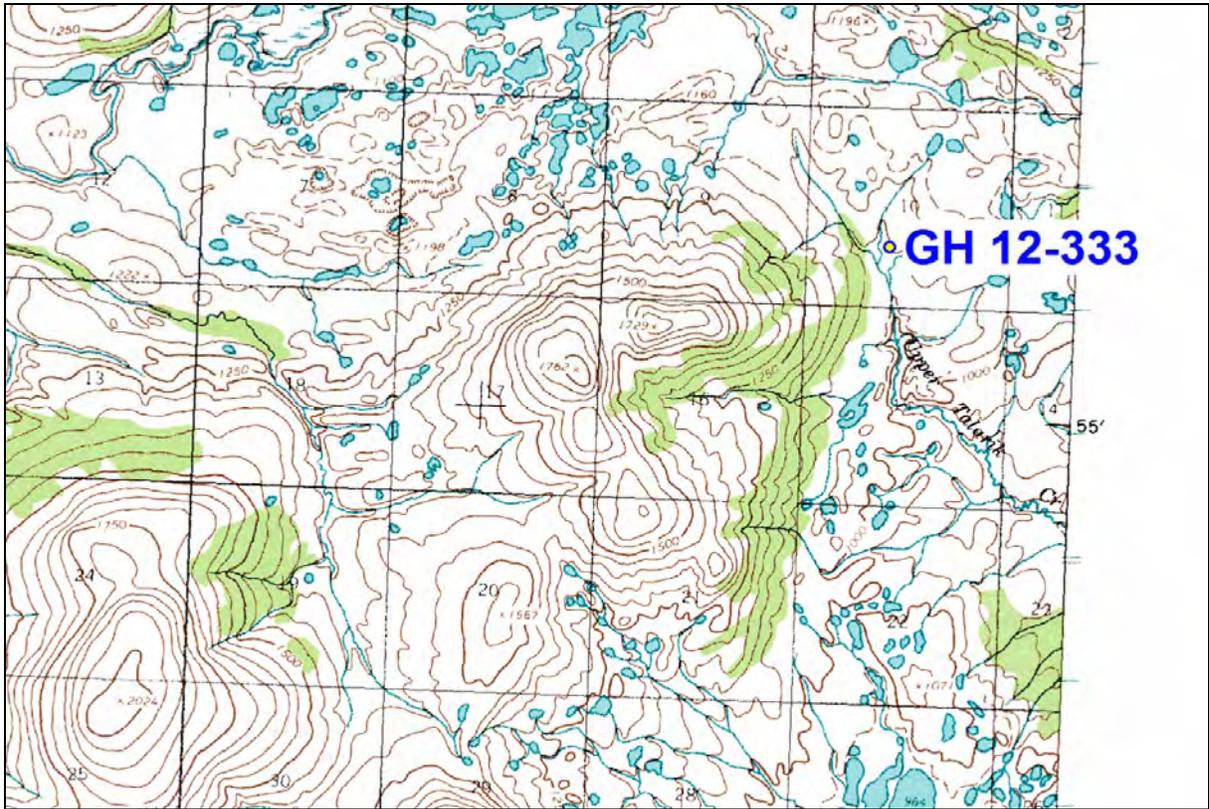
Drill Hole/Site No.: GH 12-333	Date: August 21, 2012
Rig No.: 4	Time: 11:50 AM
Activity: Drilling Geo-Tech Mud Rotary Hole	
<ul style="list-style-type: none"> ■ Condition of Drilling Site: Orderly (Pictures 1&2) 	<ul style="list-style-type: none"> ■ Sump Pit (continued): Water from sump pit pumped up slope and away from any surface water and discharged on tundra.
<ul style="list-style-type: none"> ○ Distance from waterbody: ~ 500 feet 	<ul style="list-style-type: none"> ○ Location and extent of discharged material: See above
<ul style="list-style-type: none"> ○ Location of fuel storage: Adjacent to pads 	<ul style="list-style-type: none"> ○ Topsoil, muck, tundra stockpiled: Yes
<ul style="list-style-type: none"> ○ Sorbent pads present: Yes, 1 barrel 	<ul style="list-style-type: none"> ○ Hose color: White
<ul style="list-style-type: none"> ○ Tundra mat: Yes, and all drill related equipment situated on pads.

<ul style="list-style-type: none"> ○ Discharge trench: Yes 	<ul style="list-style-type: none"> ■ Other Comments: Orderly and clean
<ul style="list-style-type: none"> ○ Dimensions of pit: 3 foot x 4 foot 	
<ul style="list-style-type: none"> ○ In use: Yes

GH 12-333 Looking South
