PIONEERS' HOME & TOTEM SQUARE

HISTORIC STRUCTURES REPORT

Alaska Department of Natural Resources
Office of History and Archaeology
2017

Summer Louthan, Architectural Historian

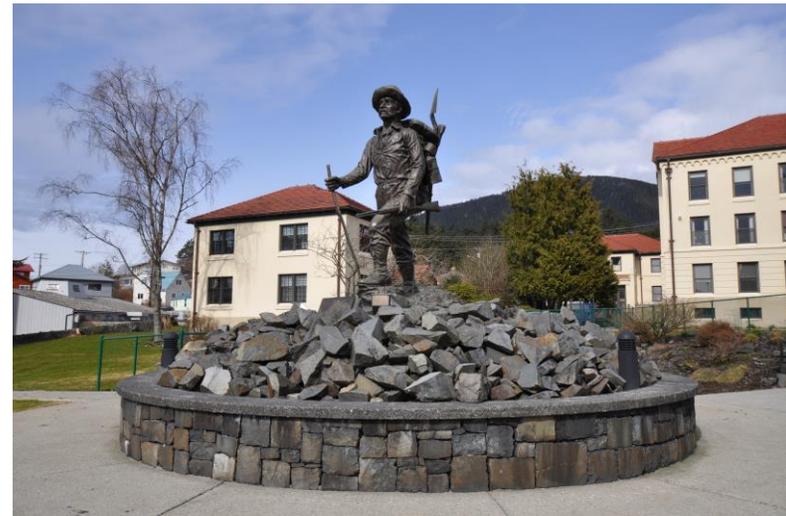
Figure 114. The Prospector statue.

The Prospector statue is in good to fair condition (*figure 114*). The statue is beginning to show signs of oxidization. Trash was found accumulating in the rock base of the statue, consisting of cigarette butts and empty plastic bottles. Biological growth was found on the loose stones around the base of the statue.

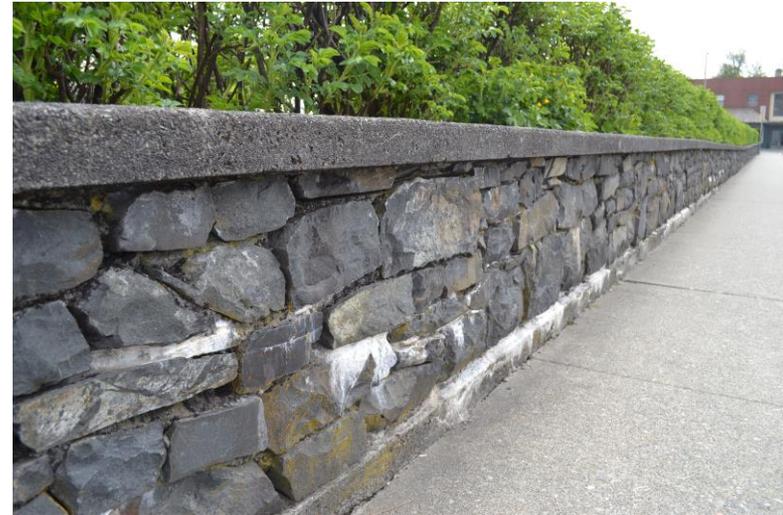
Figure 116. Stone perimeter wall along Katlian Street sidewalk.

The stone perimeter wall is in fair to poor condition. It shows signs of mortar degradation, significant in some locations. Heavy deposits of calcite from deteriorating concrete can be found on the stone face in many locations along the wall (*figure 117*).

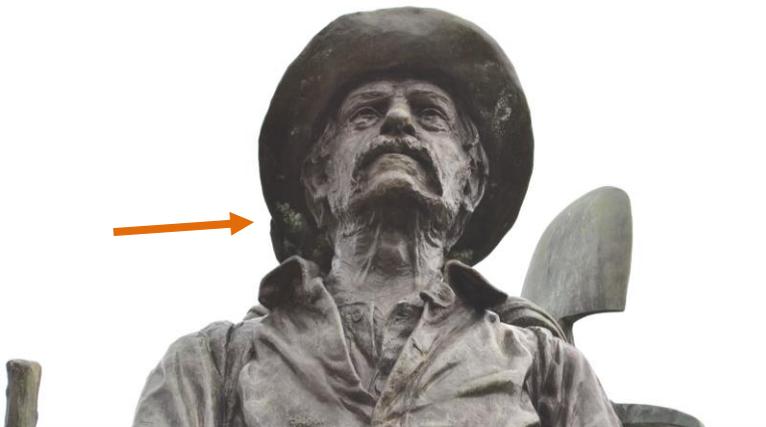
Figure 121. Detail of *The Prospector* statue showing early signs of oxidation under the hat brim.

It is recommended that a cleaning and waxing schedule be developed for *The Prospector*. Ideally, cleaning and waxing

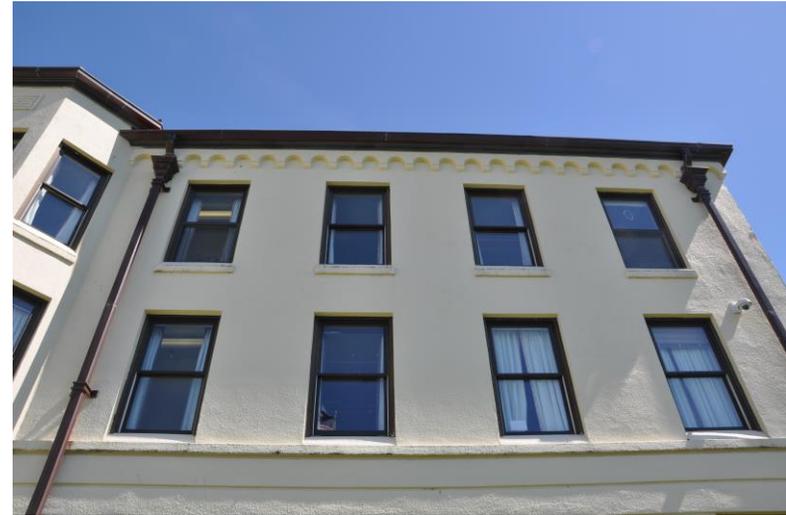
The majority of the windows at the Pioneers' Home are double hung one-over-one dark grey aluminum clad wood windows recessed back into the concrete walls with a simple concrete sill (*figure 133*). The originals were six-over-one double hung wood windows painted a light color similar to the color of the walls. Architect George Gove recommended having the windows "exactly like the wall color or perhaps just a trifle lighter," stating that

Figure 133. One-over-one double hung aluminum clad wood windows (primary windows at the Pioneers' Home).

The next time the windows are replaced at the Pioneers' Home, it is highly recommended that an effort be made to return to the original six-over-one double hung window configuration. It is also

recommended that any new windows be returned to the lighter paint color specified by the original architect. Windows are an important aspect of the architectural character of the Pioneers' Home, and the current windows have significantly altered the architect's design of the building.

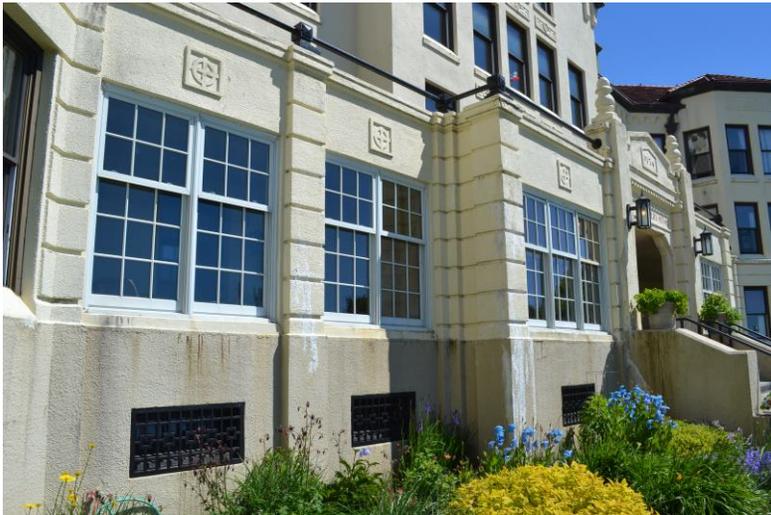
The windows on the sun porch are Pella "Architect Series" windows with integral light technology with interior and exterior muntin bars permanently adhered to single sheets of insulated glass (*Figure 134*). A non-glare insulating spacer is adhered between the sheets to give an appearance of true divided lights. The exterior of the windows is white in color, differentiating them from the darker gray color of the majority of the windows in the building. The porch windows were replaced in 2001. The original porch windows were

Figure 134. View of paired six-over-nine windows of sun porch.

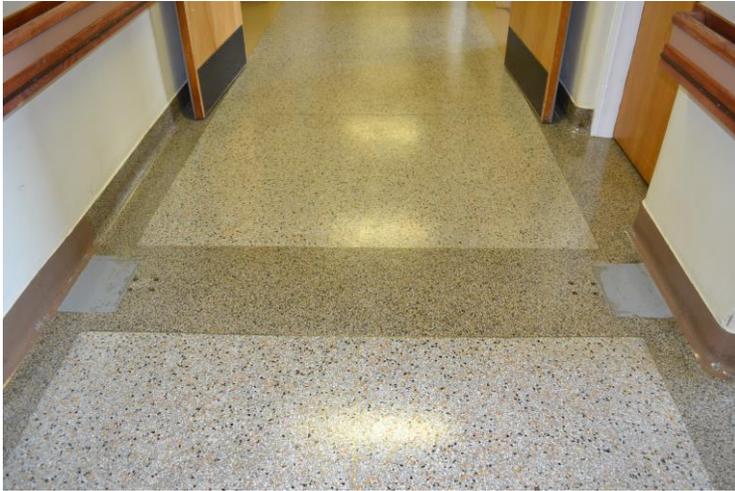
The terrazzo flooring is in fair condition. Insensitive patching has occurred throughout the Home which has significantly affected the quality and appearance of the flooring. The majority of the patching has occurred during several renovation projects which removed walls, corridor doors, and changed locations of doorways. In most locations where this work has occurred, the terrazzo was either patched with concrete or painted over with no attempt to match the historic flooring (*figure 143*).

Figure 142. View of two tone terrazzo flooring in hallways.

Whenever possible, attempts should be made to remove inappropriate patchwork and patch with new terrazzo flooring. Where the terrazzo has been painted, attempts should be made to remove the paint to assess the condition of the terrazzo. Care should be taken in the removal of this paint so as not to damage the flooring. Acids, caustic soda, or any ingredient independently or in combination, in any compound fluid or solution will damage the terrazzo and should be avoided.

Seal the terrazzo surface with high strength colorless slip and stain-resistant penetrating sealer with Ph factor between 7 and 10 that does not affect color or physical properties of terrazzo surface.

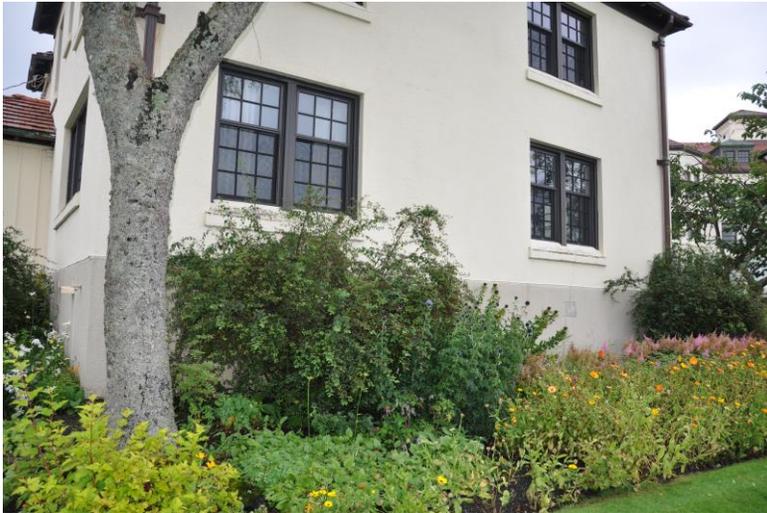
Figure 150. View of plantings on southwest façade.

The grounds of the Superintendent's Home are in good condition. The landscaping and lawns are meticulously maintained. Walkways are in good repair with no significant changes in height that might impede smooth travel. Plantings along the one story laundry room off the rear of the building are overgrown (figure 151). Plantings on the northwest elevation are right against the building.

Ensure that good drainage continues around the perimeter of the building. Landscaping (namely trees and large shrubs) should be kept 5'-10' from the building foundation. Trees should be kept trimmed to ensure branches remain away from the Home's roof and upper story and to limit the accumulation of leaves in gutters. Plantings along the northeast and northwest elevations should be thinned or removed and any new plantings should be kept 3' from the building foundation. The large shrubs at the rear of the building should be trimmed back from the building as well.

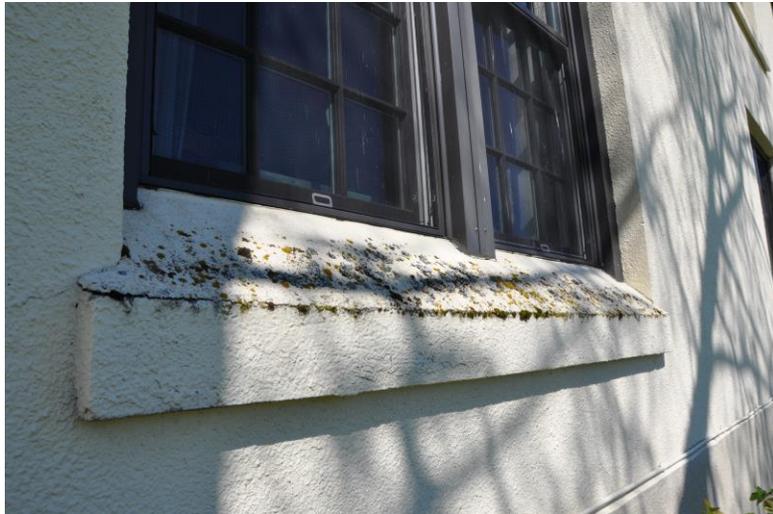
The walls of the Superintendent's Home are in good condition showing little signs of wear or damage. The walls were last painted in 2001. Biological growth was found on a number of the concrete window sills along the southwest elevation most likely because of the proximity of a large tree located near the windows (figure 153).

Figure 153. Biological growth on concrete window sill on southwest façade.

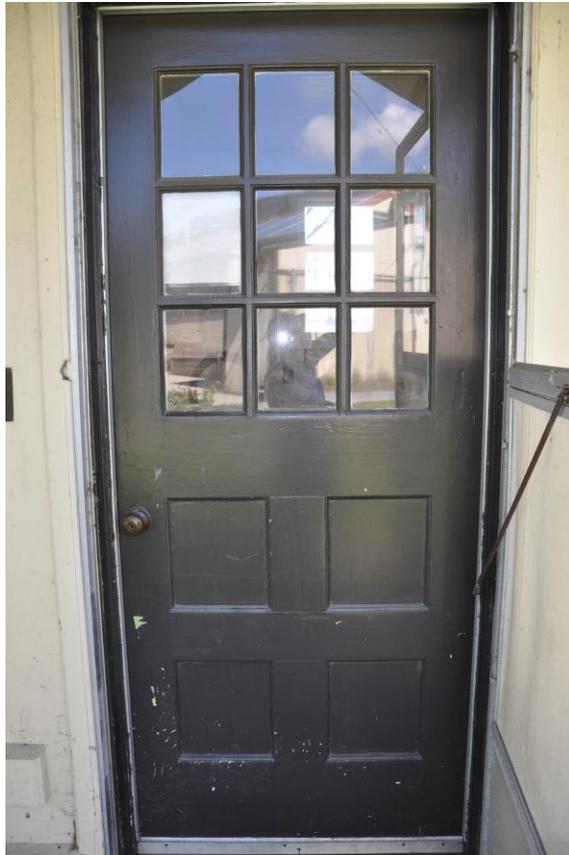
The windows of Superintendent's Home were replaced in the early 2000s and are in good condition. The original doors are in good condition. The screen door at the rear entry is in fair condition, with a broken screen and dents in the metal.

Figure 155. Original door, rear entryway for Superintendent's Home.

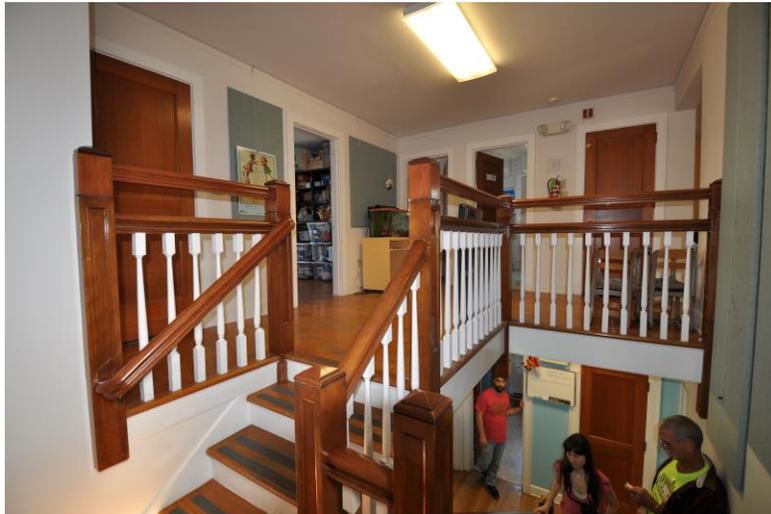
At the top of the stairs on the second floor is a large open hall (*figure 168*). The second floor originally had five bedrooms. The two bedrooms on the southeast side of the building have had their closets and wash basins removed; turning what was once two bedrooms into one large space (*figure 170*). The three rooms on the northwest side of the building retain their original configuration with their wash basins and closets intact. The second floor also has a full bath with the original oval shower/tub, toilet stall, and sink. An original slop sink closet is located off the hall.

Figure 168. View of second floor stair landing. Note extra railing added to top of the banister.

The original stairway railings, balusters, and box newel posts remain. The box newel posts have inset panels on each side with simple low pyramid caps. The railing at the second floor landing has had a second wooden hand railing placed above the original to raise the height of the railing. An additional wood railing has been installed along the wall side of the stairway to meet code.

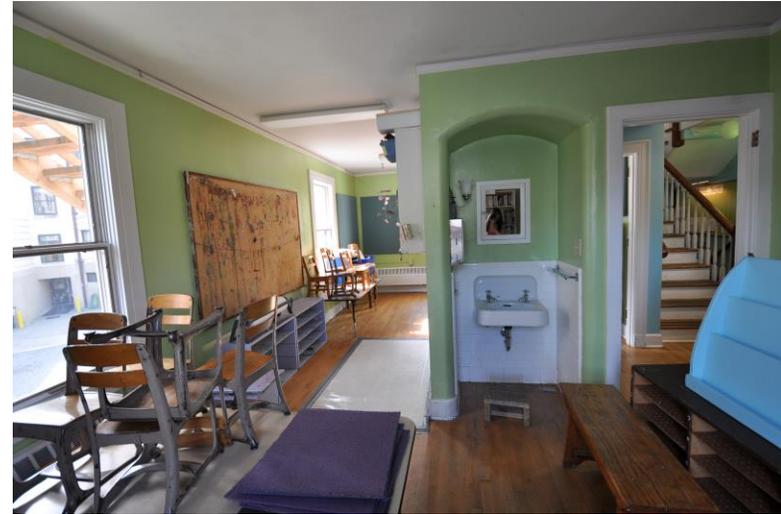
Figure 169. Original first floor bedrooms of Nurses' Quarters with closets removed, recessed wash basins remain.

The floors in the Nurses' Quarters are in fair condition with general wear expected of flooring of its age. The wood floor in the first floor bedrooms where the closets were removed has been covered with a linoleum sheet that has been duct taped down (*figure 169*).

Retention of the wood floors and the 1" hexagon ceramic tiles is highly recommended. Whenever possible, it is recommended that the floors, especially on the second floor, be refinished. Rugs should be used in high traffic areas wherever possible to help protect the wood floors from wear. Chairs and furniture should have felt added to their feet to limit scratching the floors when furniture is moved.

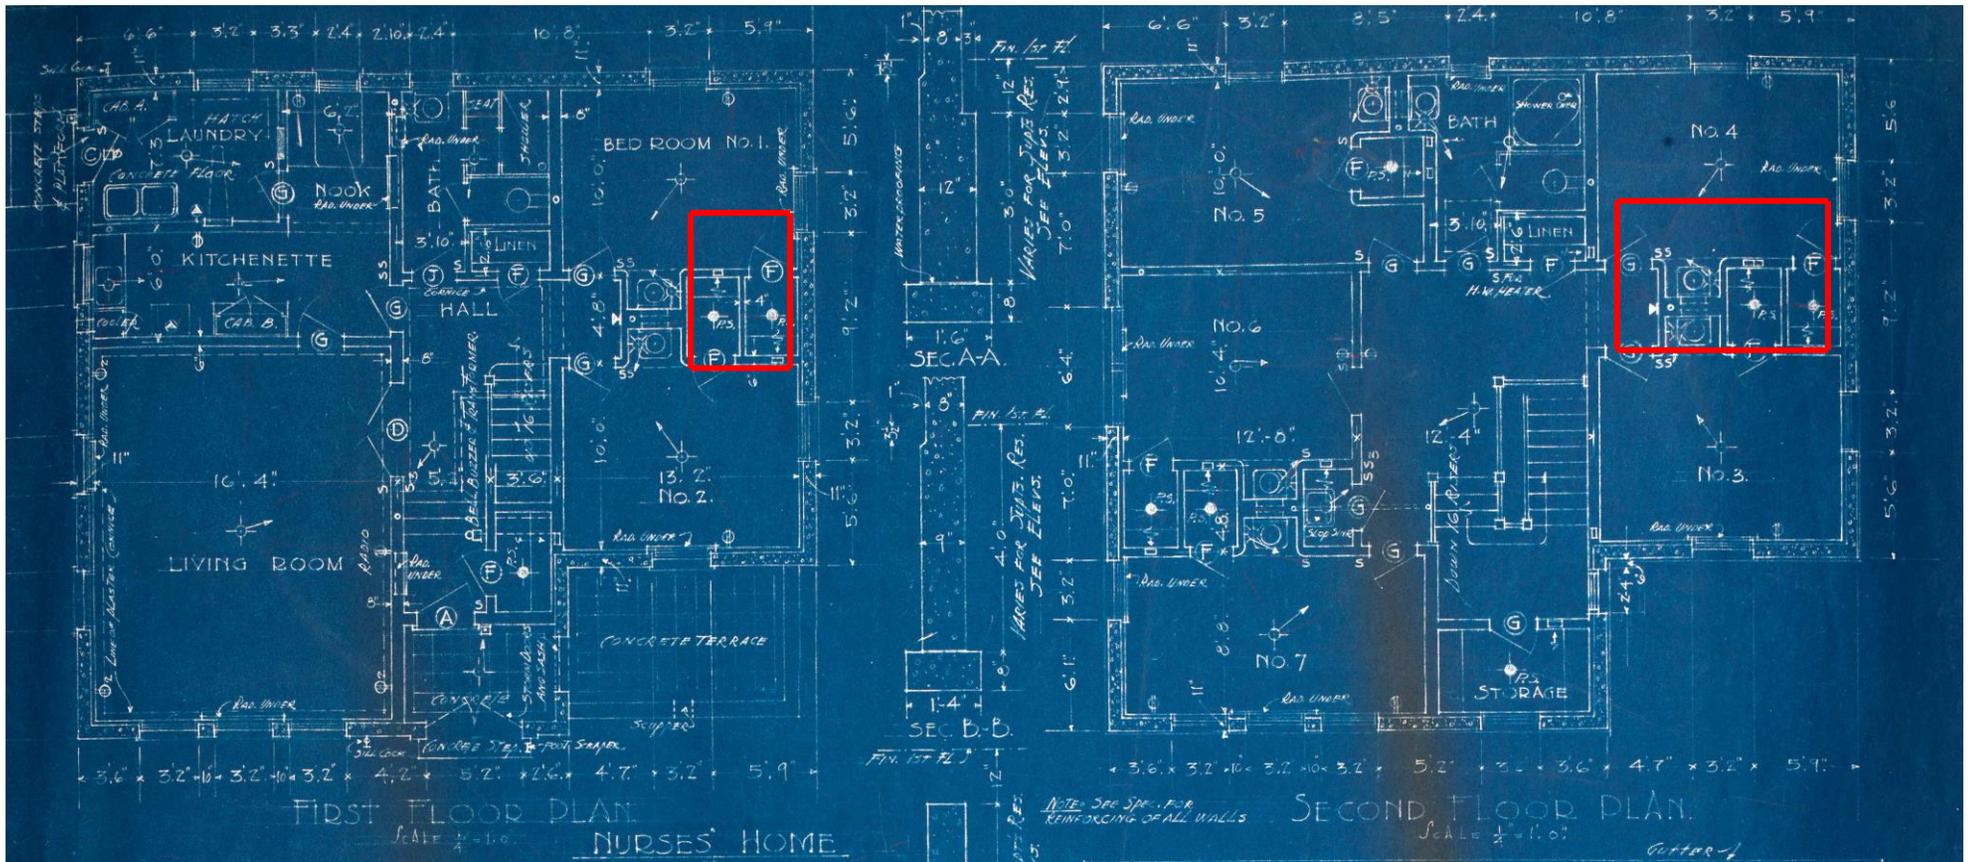
Figure 170. Original blueprints for the Nurses' Quarters. Areas highlighted in red show where walls have been removed changing the original floorplan.

The layout of the Nurses' Quarters is important in defining the historic character of the building and the purpose for which it was constructed. Caution should be exercised in future planning that would radically change the remaining character-defining spaces. Primary spaces such as the entryway, stair hall and stairway, and living room are important to the character of the building and should be retained. As the building was built for the specific use as shared housing the bedroom spaces are an important feature. The addition of new walls dividing rooms, or the removal of any additional walls to make larger rooms should be avoided.

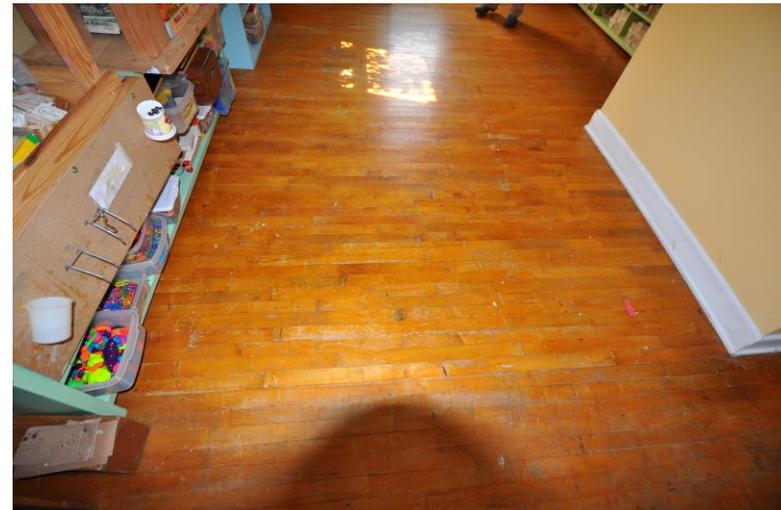
Figure 172. View of wood flooring in the second floor bedrooms of the Nurses' Quarters

The wood floors on the second floor have experienced more wear than the first floor (*figure 172*).

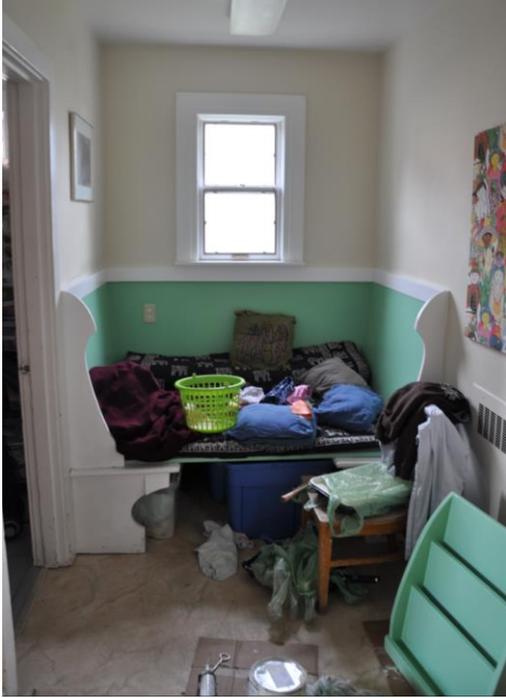
The original kitchen cabinets have been moved from the first floor and are now located in the front bedroom of the second floor (figure 176). The built in benches for the eating nook in the kitchenette remain but the table has been removed (figure 175).

Figure 175. View of built-in bench (table missing) in nook of Nurses' Quarters kitchenette.

Original doors and trim should remain in place. Doors should remain stained and not be painted white. If the cabinets in the kitchenette are replaced, an effort should be made to return it to a configuration similar to the original design. The original cabinets currently in the front upstairs bedroom should be returned to their original location. Plaster cornices, picture molding, and stairway boxed newel posts, handrails and balusters should be retained. Original bathroom features should remain in place. Cabinet doors and drawers should be kept in working order.

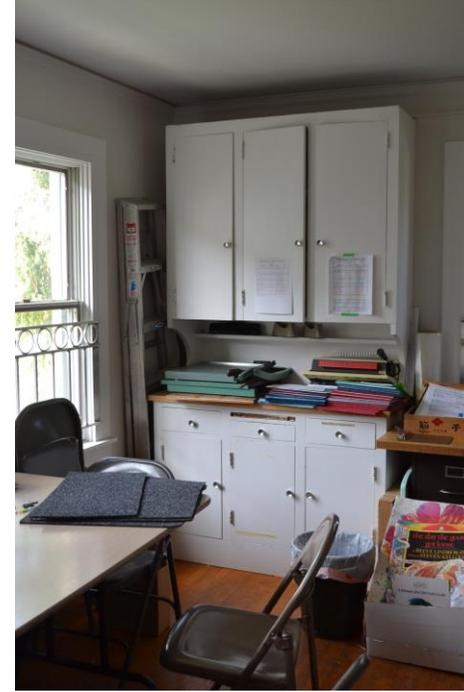
Figure 176. View of original kitchen cabinets now located in front bedroom on second floor of Nurses' Quarters.

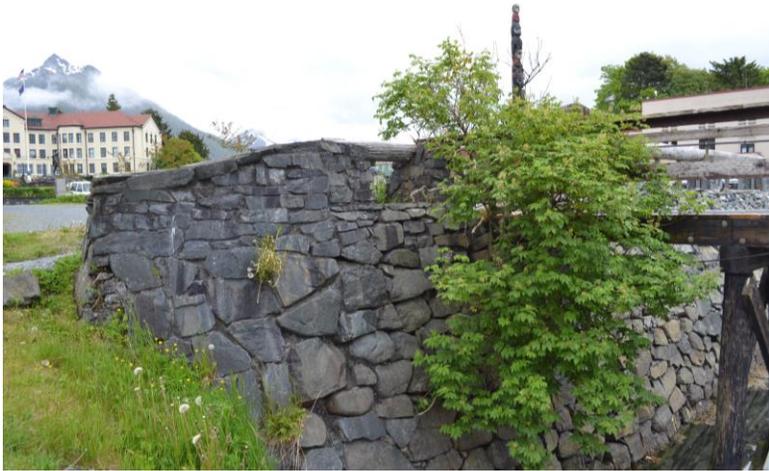
Totem Square is in good condition. The grass lawn is in good condition indicating that the new drainage systems are functioning as intended. A few of the cable rails along the retaining wall fence have become loose or have pulled completely out of the stone columns (*figure 181*). Some of the stones along the top of the seawall have become dislodged or are entirely missing. A tree is growing out of the remaining portion of the original stonewall (*figure 180*).

Figure 180. View of stone seawall along west side of Totem Square.

For the continued maintenance of the totem pole maintenance/inspection schedule be developed and carried out. Inspections should check for loose parts, damage, and signs of decay or insect infestation. Borates and water repellent should be periodically applied. The application of borates and water repellent should occur every 3 – 5 years, depending on when the water repellents have worn off (or when water no longer beads up on the surface of the wood).³ The tree growing out of what remains of the original wall should be removed to prevent it from causing any additional damage.

Broken cable rails should be fixed or replaced. Missing stones along the seawall should be replaced. The seawall should be monitored yearly to insure any missing stones are replaced in a timely manner. Insure grass is kept neat and re-seed as needed in areas of high traffic near totem pole and interpretive sign.
