# **Environmental Audit Of the Greens Creek Mine**

## **FINAL REPORT**

**SRK Project 1UK005.001**

**March 2009**

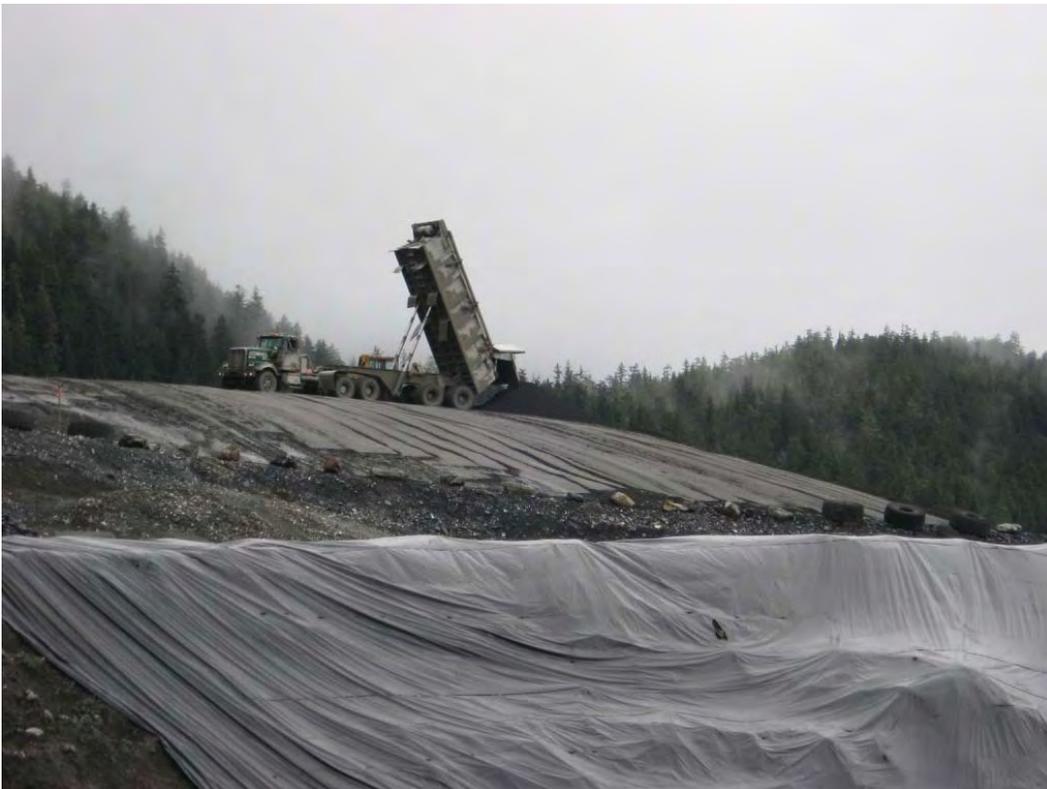
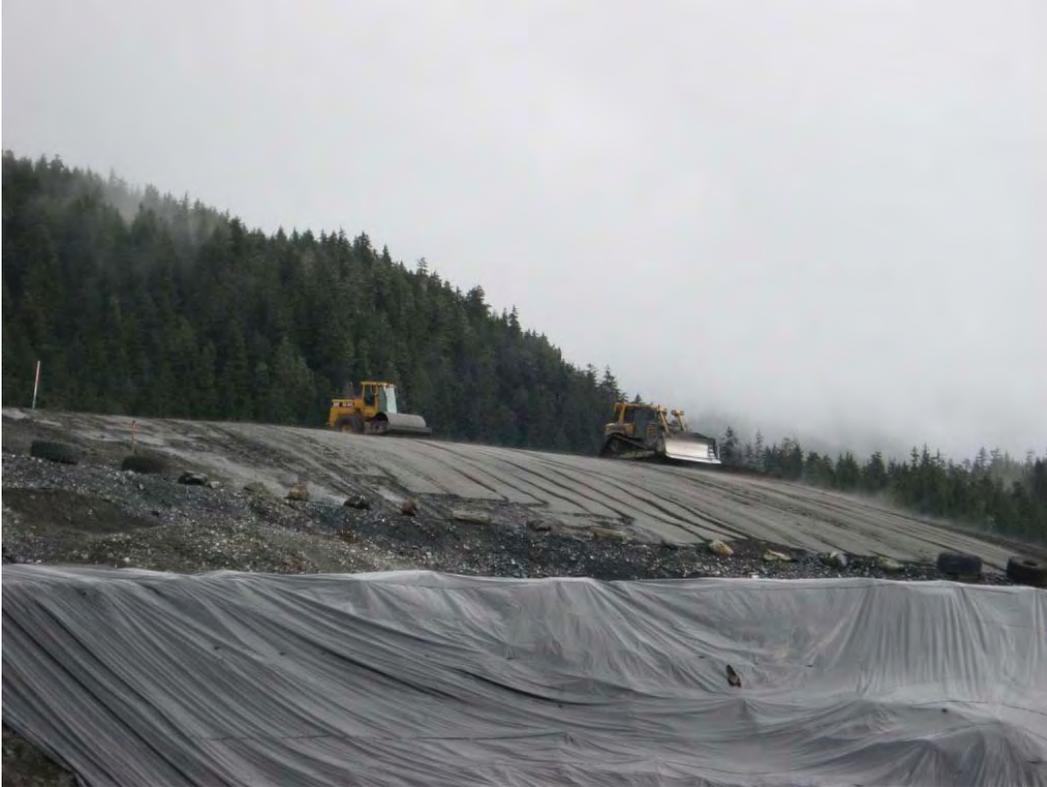
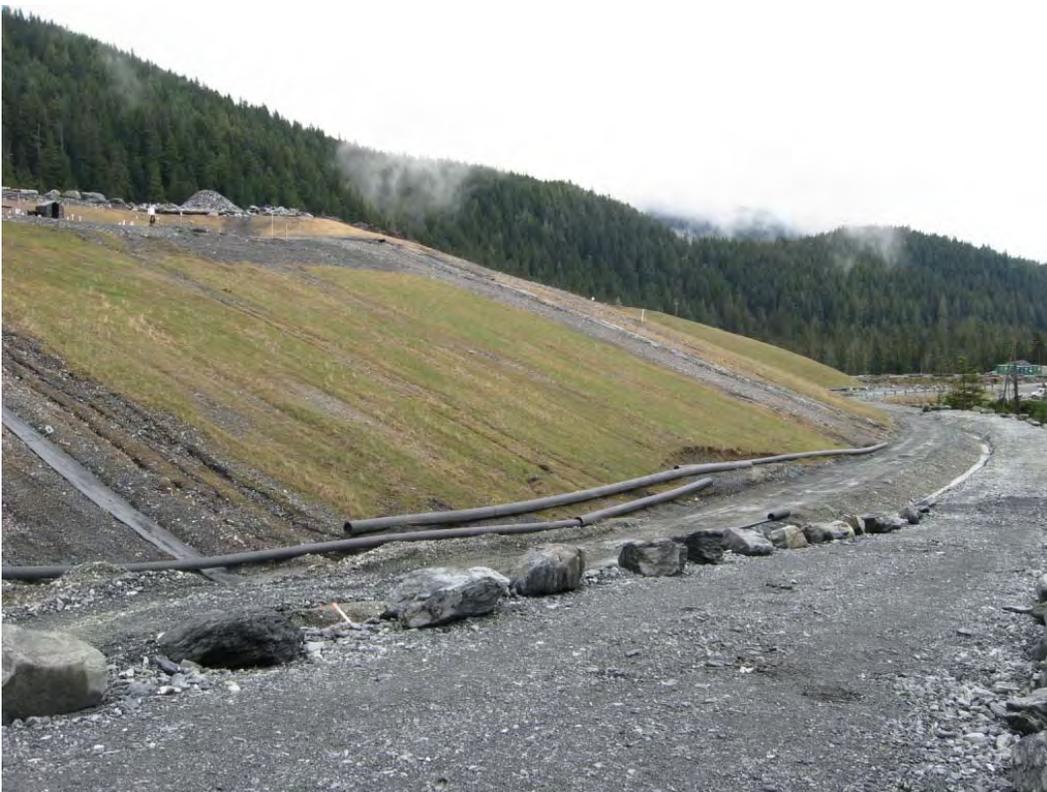
Dewatered tailings are preferentially placed into the underground mine as structural backfill. Those which are not placed underground as backfill are placed on the surface in a "dry-stack" tailings pile at the Tailings Disposal Facility (TDF, Photo 4 through Photo 6). Development of the TDF

**Photo 4: Haul Truck dumping tailings at the Tailings Disposal Facility**

**Photo 5: After spreading, the tailings are compacted with a self propelled, vibrating drum compactor**

**Photo 6: A revegetated slope, with a granular toe buttress, on the west side of the Tailings Disposal Facility**

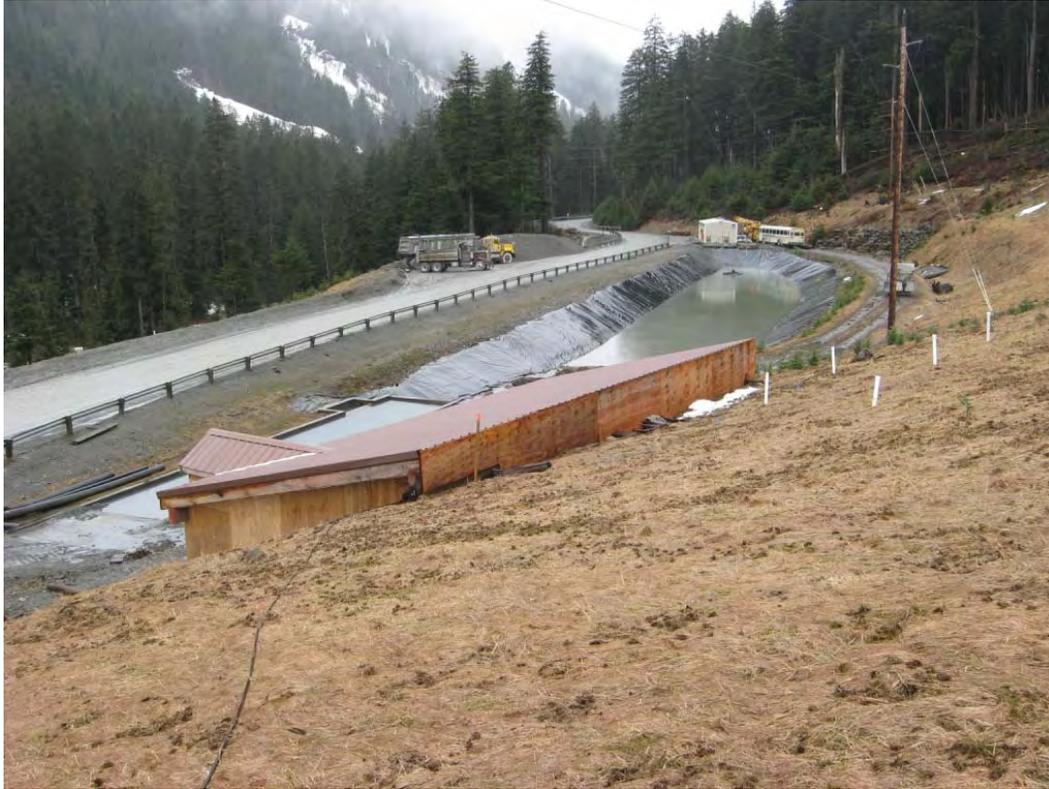
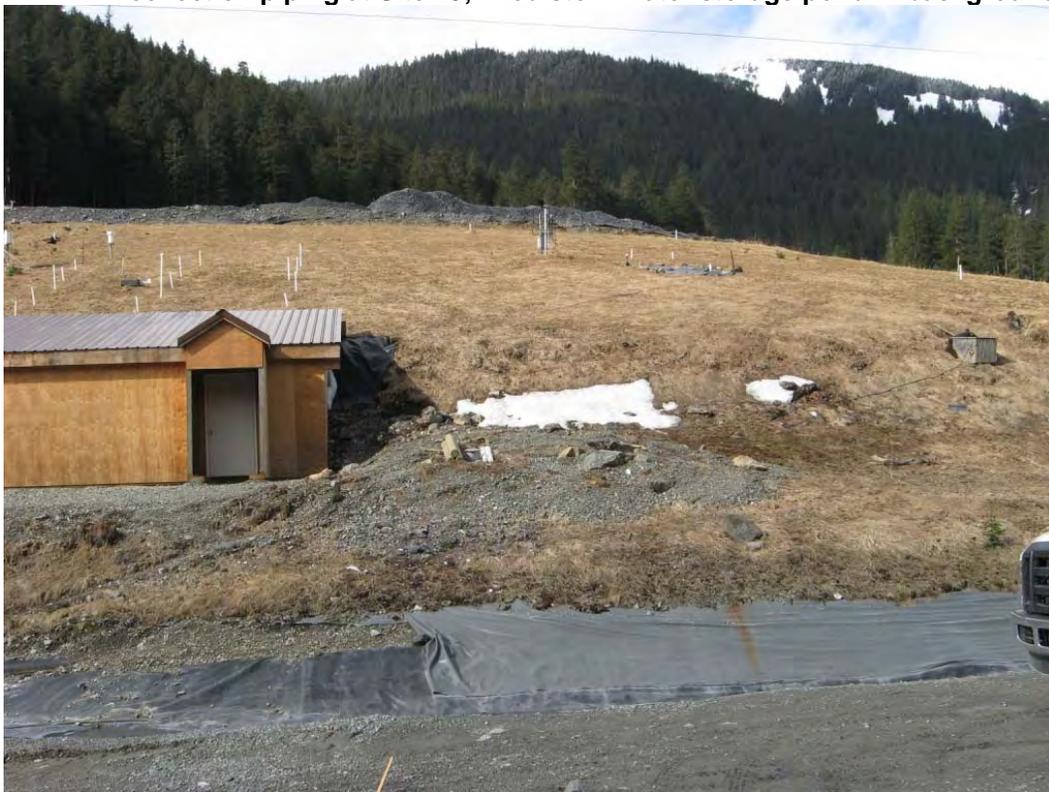
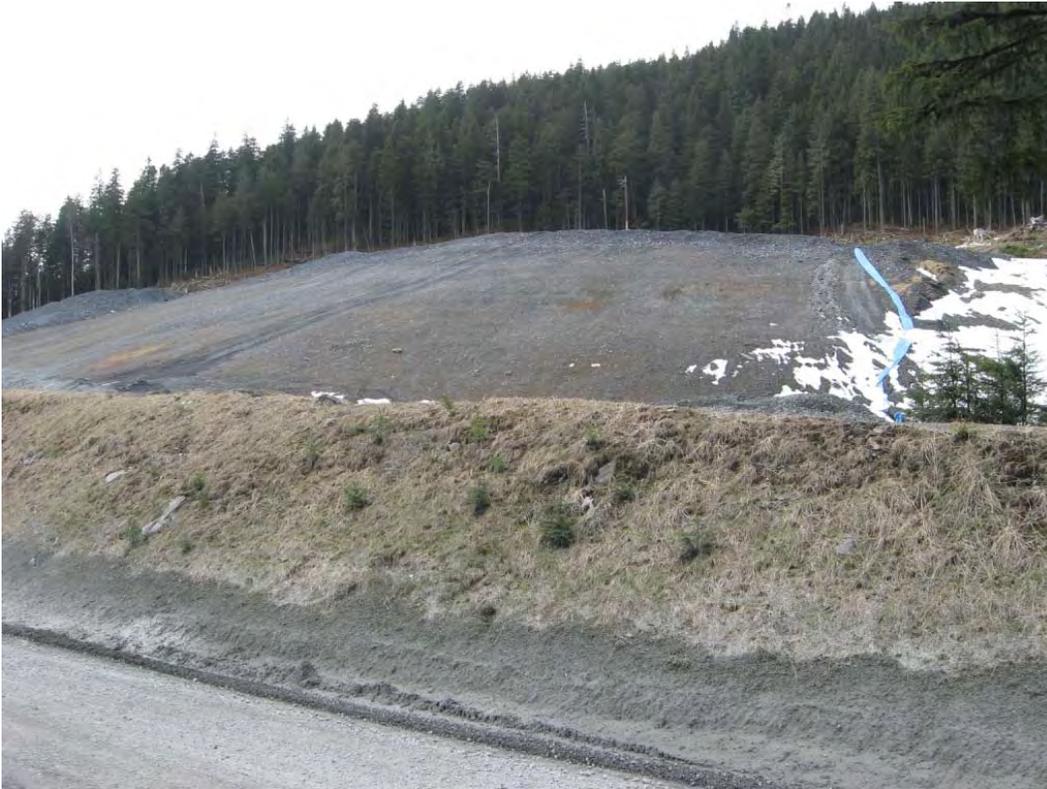
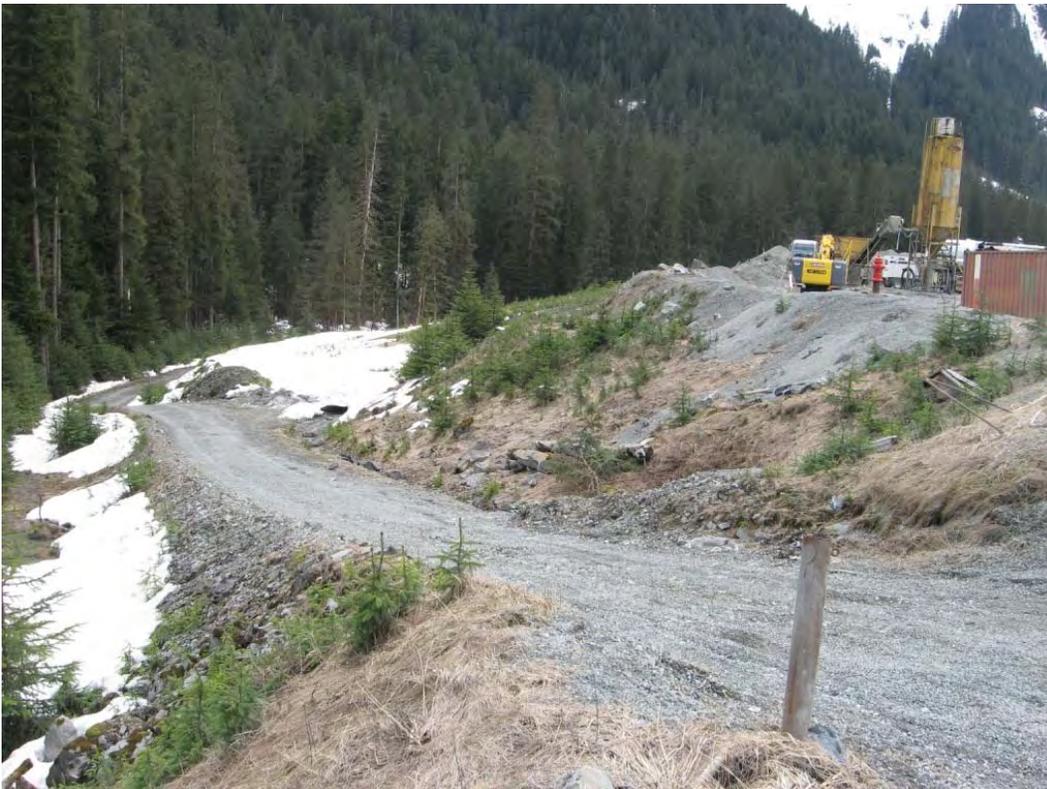
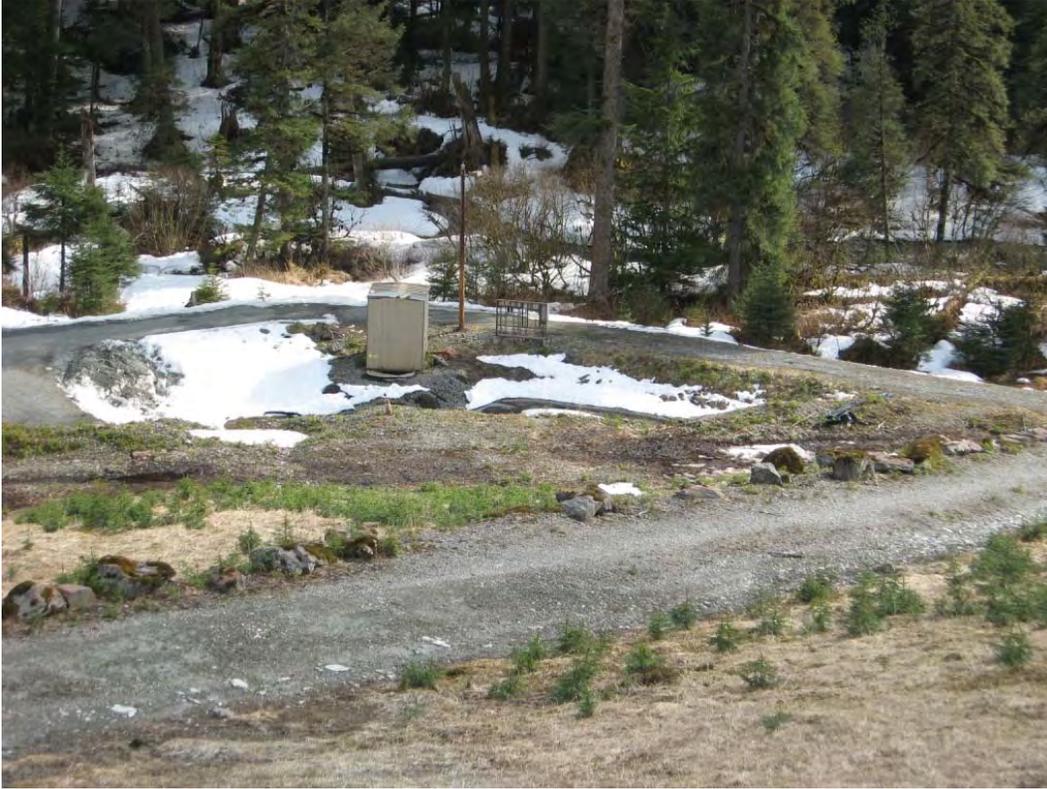
Site 23 production rock site is situated on the valley sideslope, above Site D and Greens Creek (Photo 7 through Photo 11). It has received production rock from the underground mine since 1995. As of the spring of 2008, the site had received approximately 1 million tons of production rock.

**Photo 7: Side view of the cover (foreground) and wooden housing for seepage collection piping at Site 23; lined stormwater storage pond in background**

**Photo 8: Frontal view of the test cover and wooden housing for seepage collection at Site 23; Active disposal of production rock in background**

**Photo 9: Groomed final slope on the lower portion of Site 23**

**Photo 10: Side view, looking west, across Site D**

**Photo 11: Stormwater pond facilities at the toe of Site D; Greens Creek is visible at right, in background**

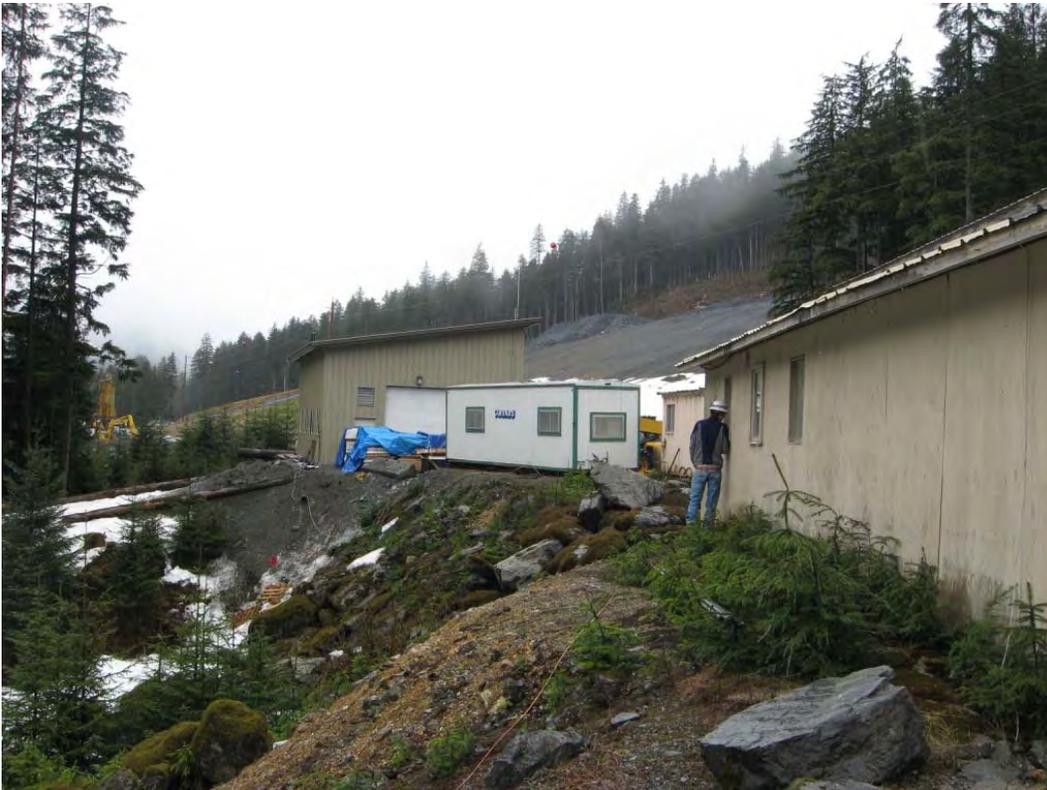
**Photo 12: Side view, looking west at mine buildings which have been constructed on fill within Site C, part of Site C has no production rock**

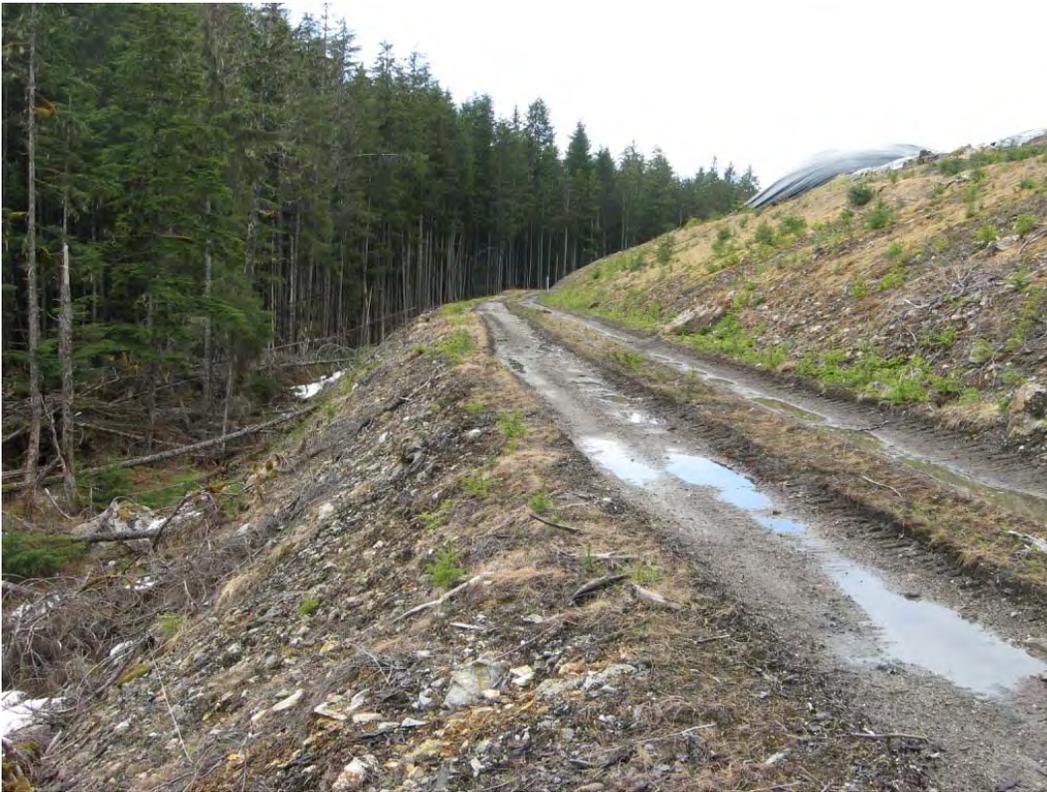
**Photo 13: Perimeter berm constructed of production rock at Site E**

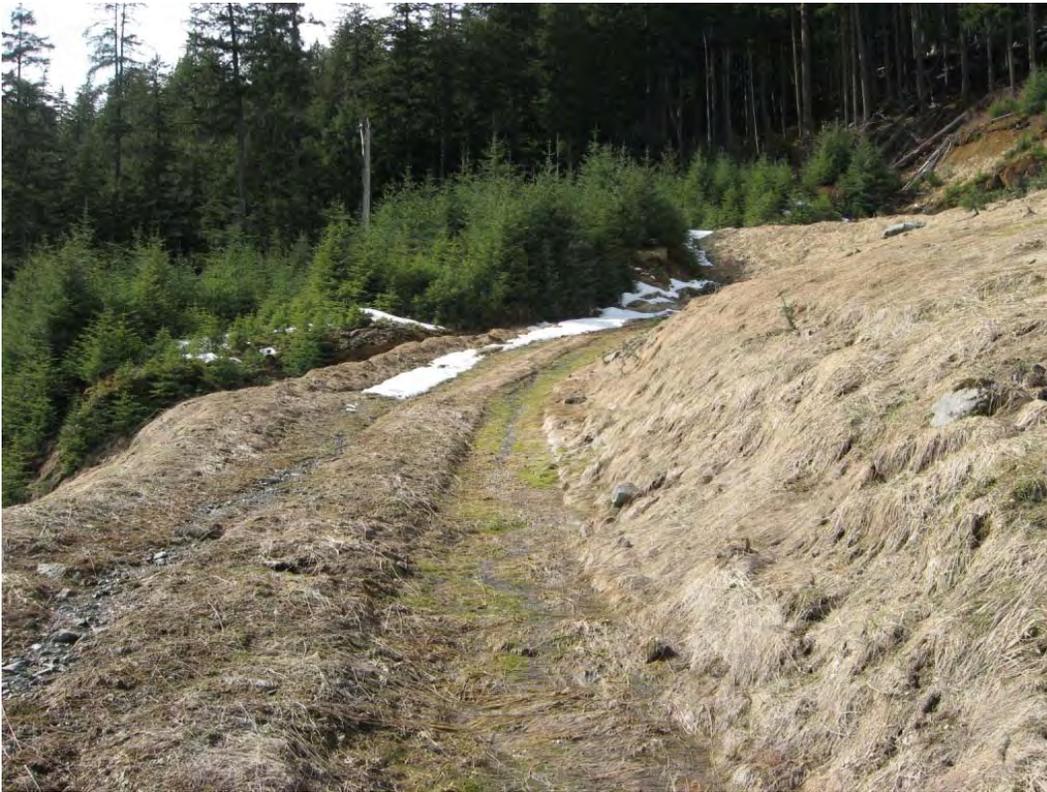
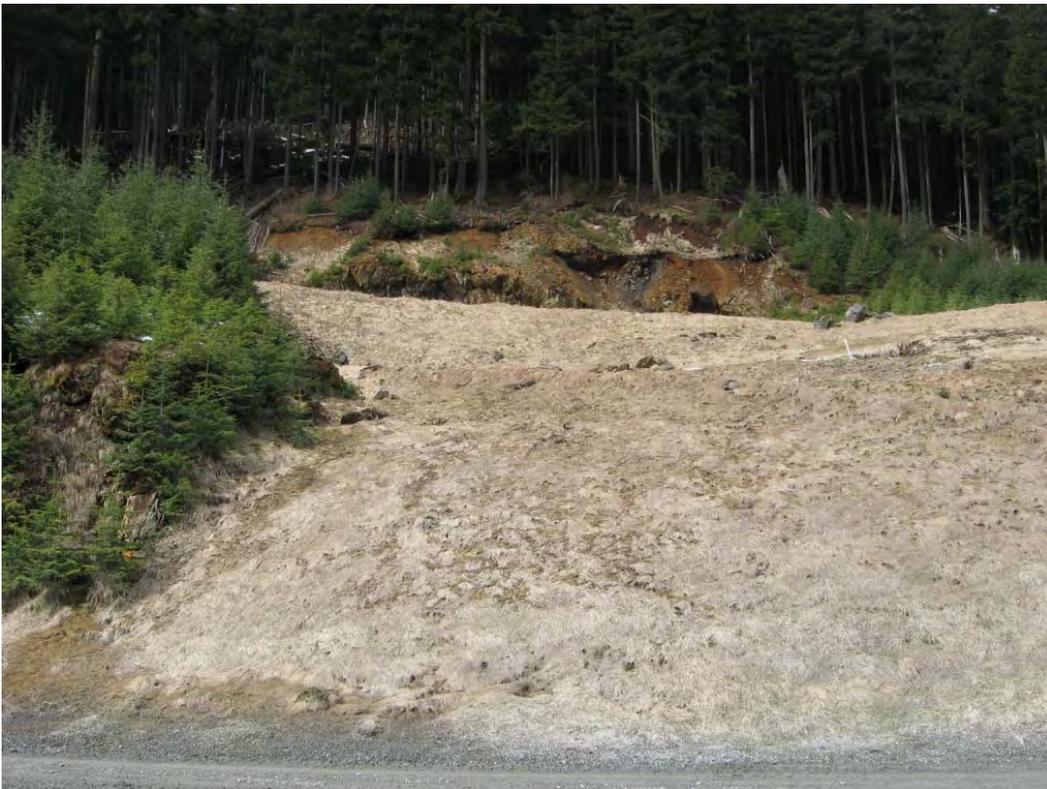
**Photo 15: Access ramp across the front of the reclaimed and revegetated production rock at Pit 405**

**Photo 16: Frontal view of the reclaimed and revegetated production rock at Pit 405**

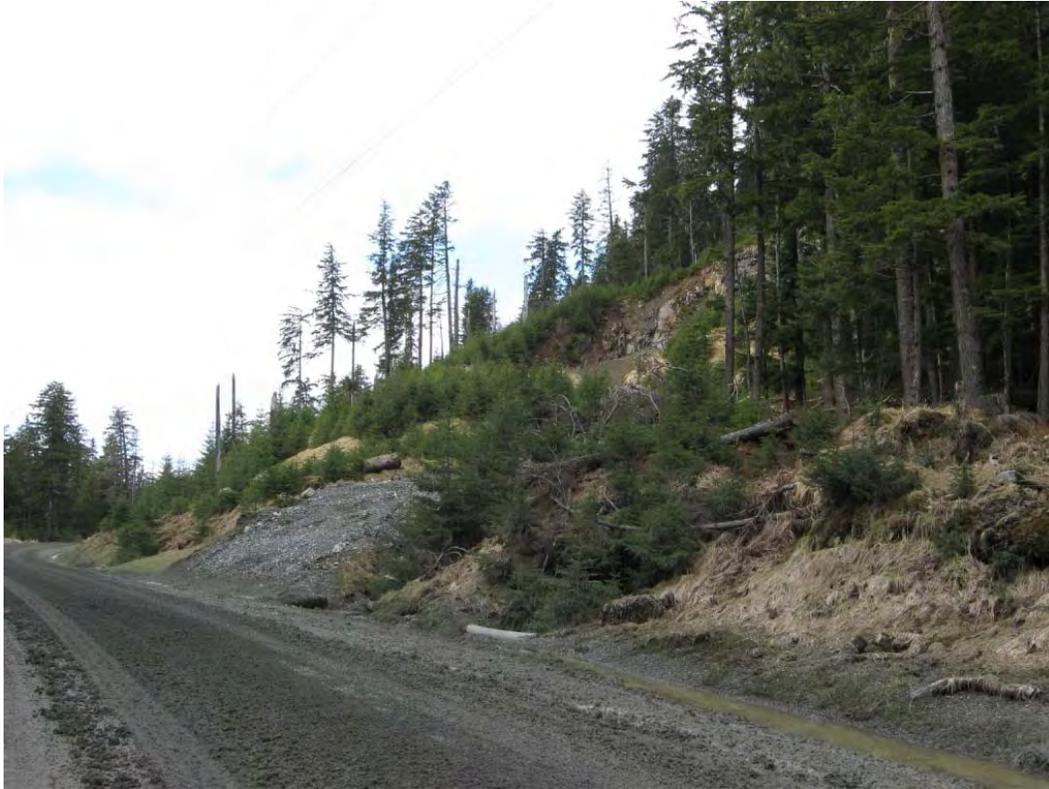
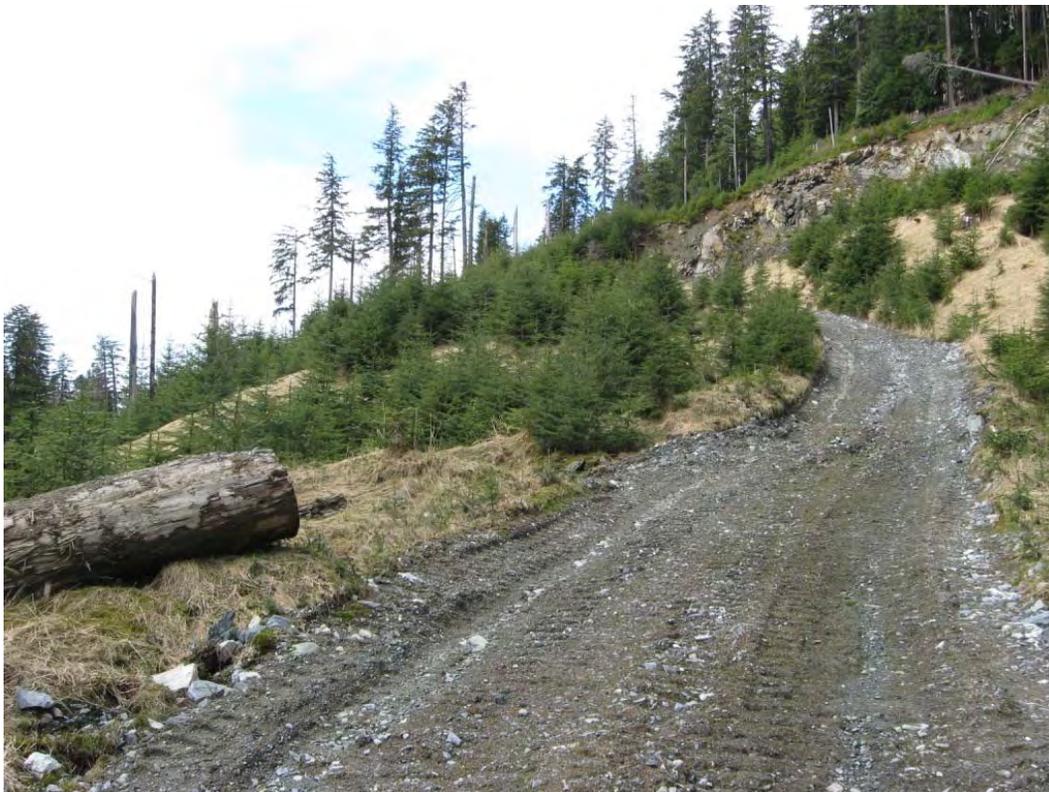
**Photo 17: Side view of the access ramp and reclaimed and revegetated production rock in Pit 6**

**Photo 18: Looking up the access ramp that overlies reclaimed and revegetated production rock in Pit 6**

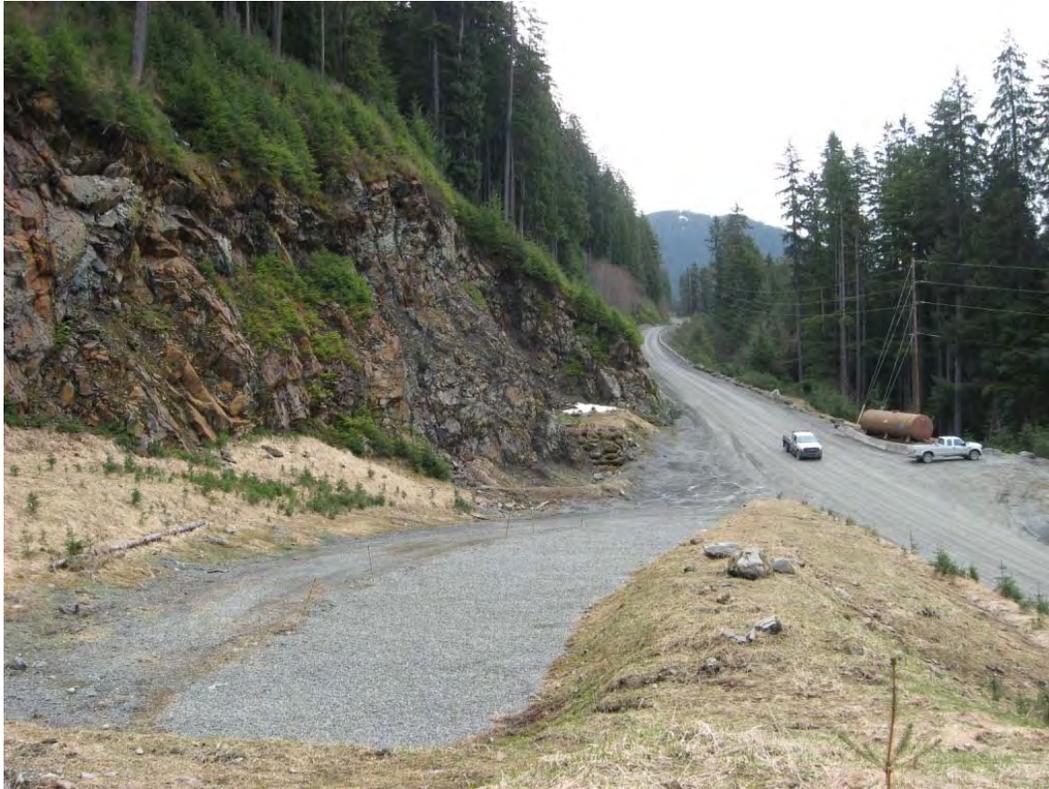
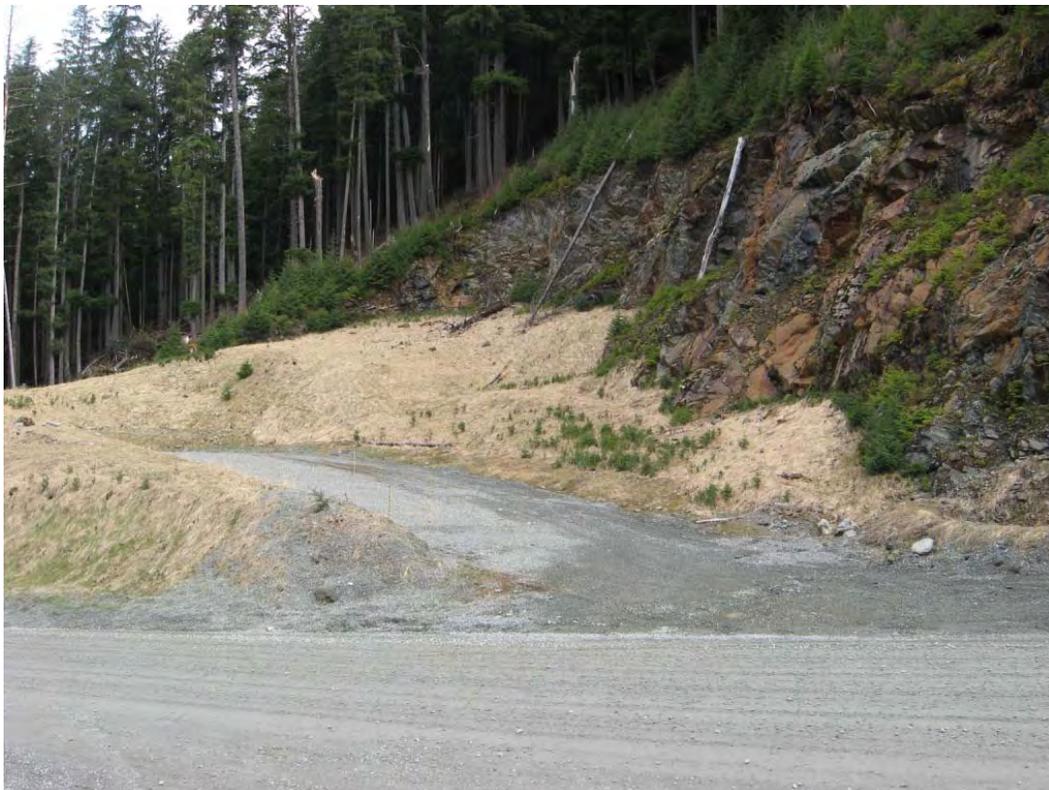
**Photo 19: Looking down the access ramp that overlies reclaimed and revegetated production rock in Pit 174**

**Photo 20: Side view of the access ramp and reclaimed and revegetated production rock in Pit 174**

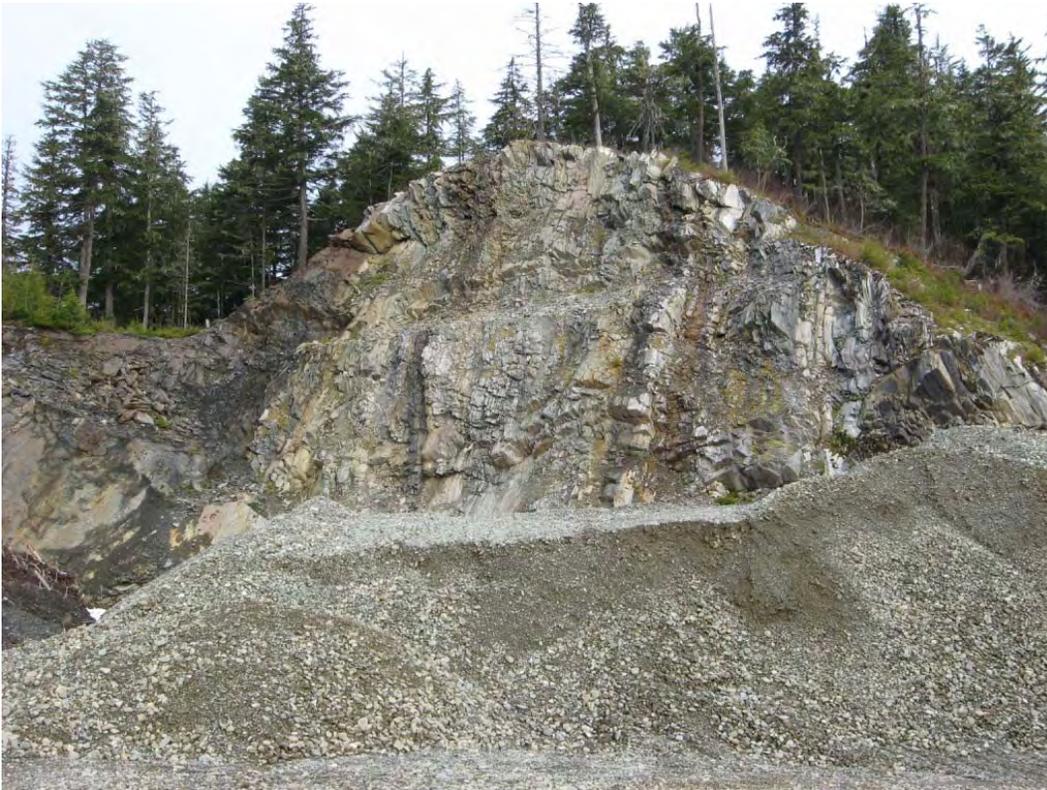
**Photo 21: Frontal view of the exposed bedrock backslope at Pit 7**

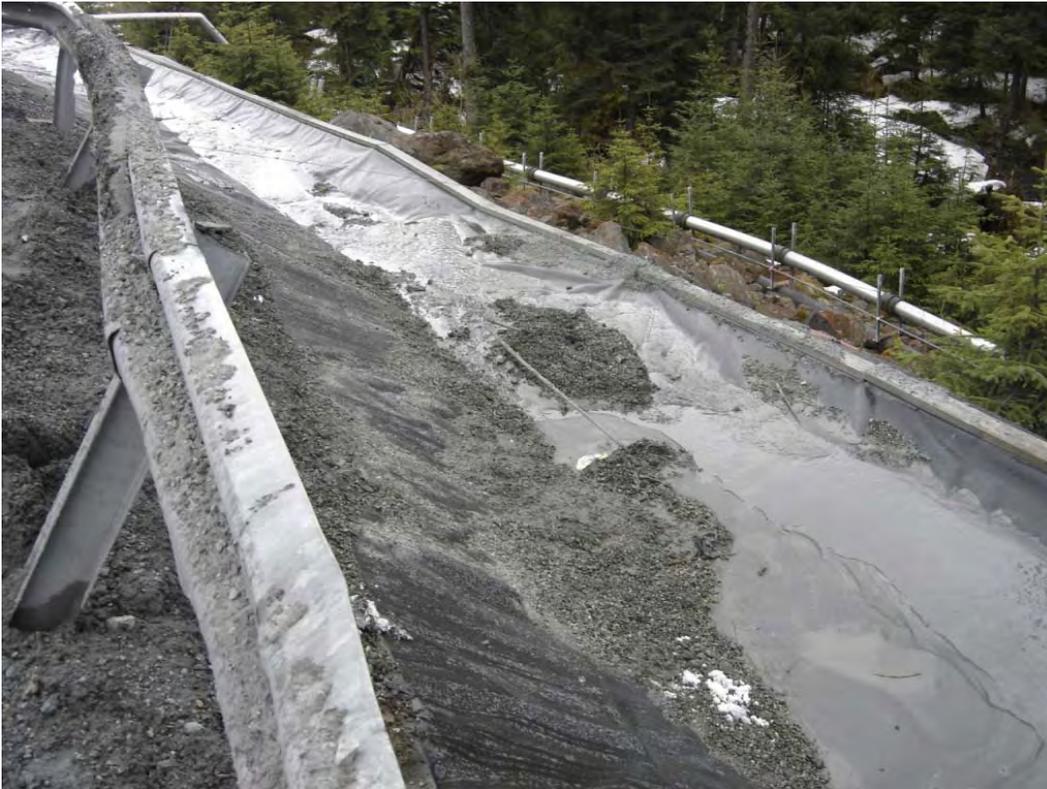
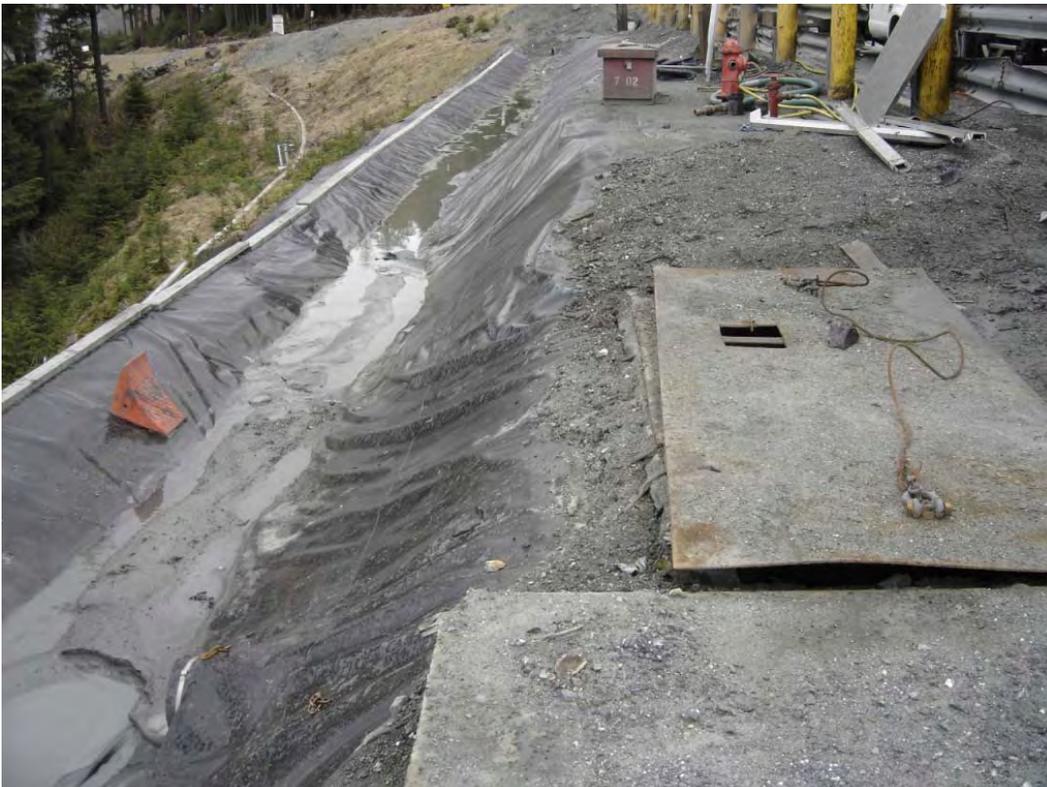
1. The lined ditch immediately below the equipment wash area at the mill – approximate 40 to 50% of the ditch was blocked by gravel/sediments, significantly reducing the capacity of the ditch. SRK recommends immediate removal of the blockage (Photo 23 and Photo 24).

**Photo 23: Ditch at 920 Area Looking East**

**Photo 24: Ditch at 920 Area Looking West**

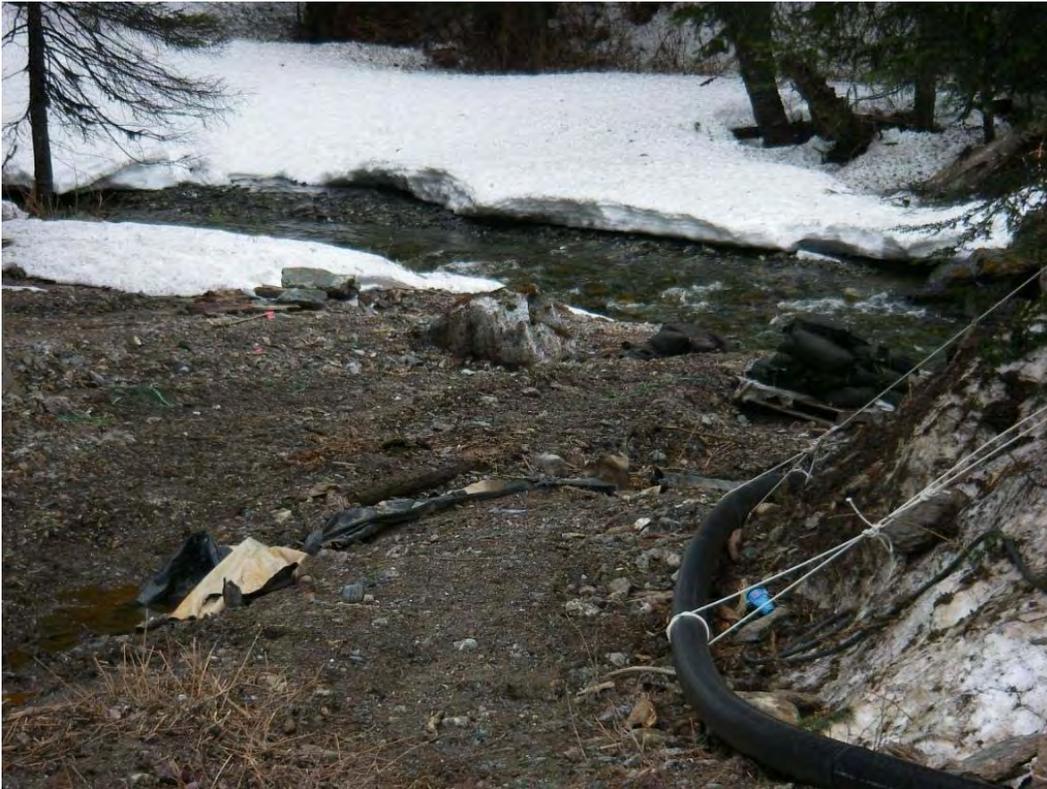
2. The area of construction for the temporary fresh water intake line (near the potable water treatment plant) – the area poses a high potential to impact the quality of Greens Creek due to the flushing of fines directly into the Creek upstream of the weir. SRK recommends stabilization of the area as soon as possible to prevent the unnecessary deposition of silt into Greens Creek upstream of the intake weir (Photo 25).

**Photo 25: Construction Area near Freshwater Intake**

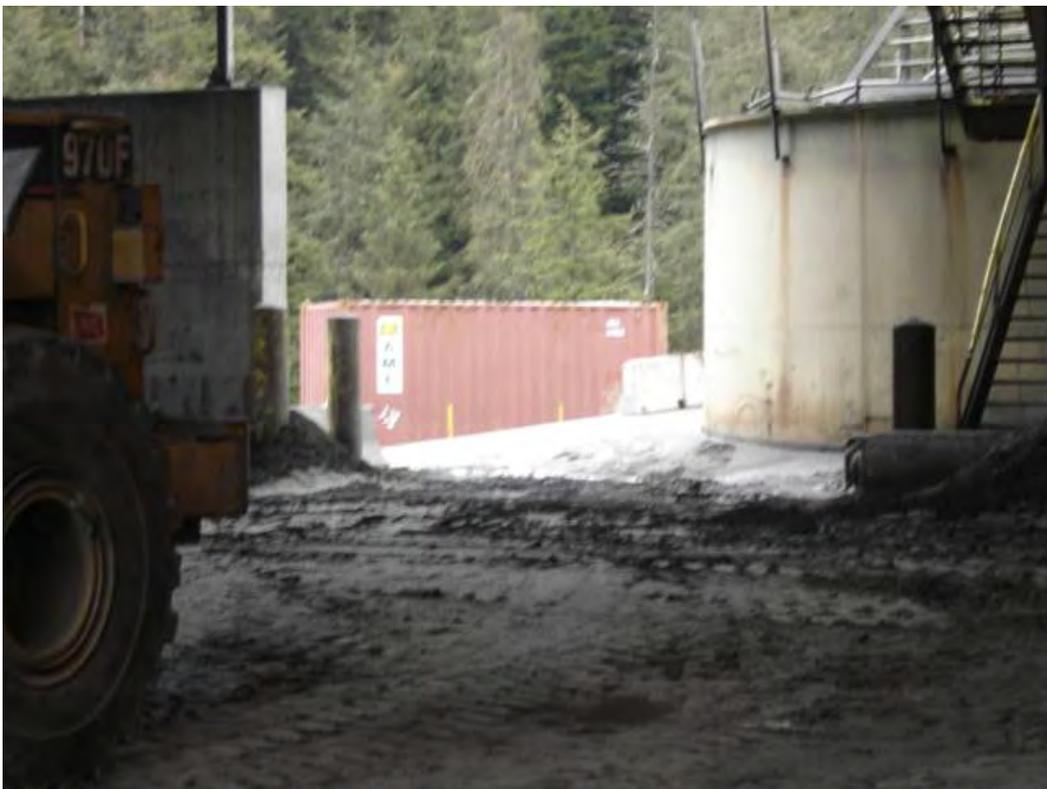
4. Secondary containment for the tailings thickener (largest thickener closet to the tailings load-out area). As it is currently constructed, the newly installed concrete containment would direct any unanticipated discharge from this thickener into the road area west of the thickener. This is a risk area for a puncture of the thickener based on indications on the side of the wall of the tank (small dents and scratches primarily) that it has been struck by equipment (presumably). SRK recommends improvement of the secondary containment of the tailings thickener in the vicinity of the tailings load-out area as soon as possible to reduce the potential of discharge to the road area in the event of an unanticipated discharge from the tailings thickener (Photo 26 and Photo 27).

**Photo 26: Tailings Thickener**

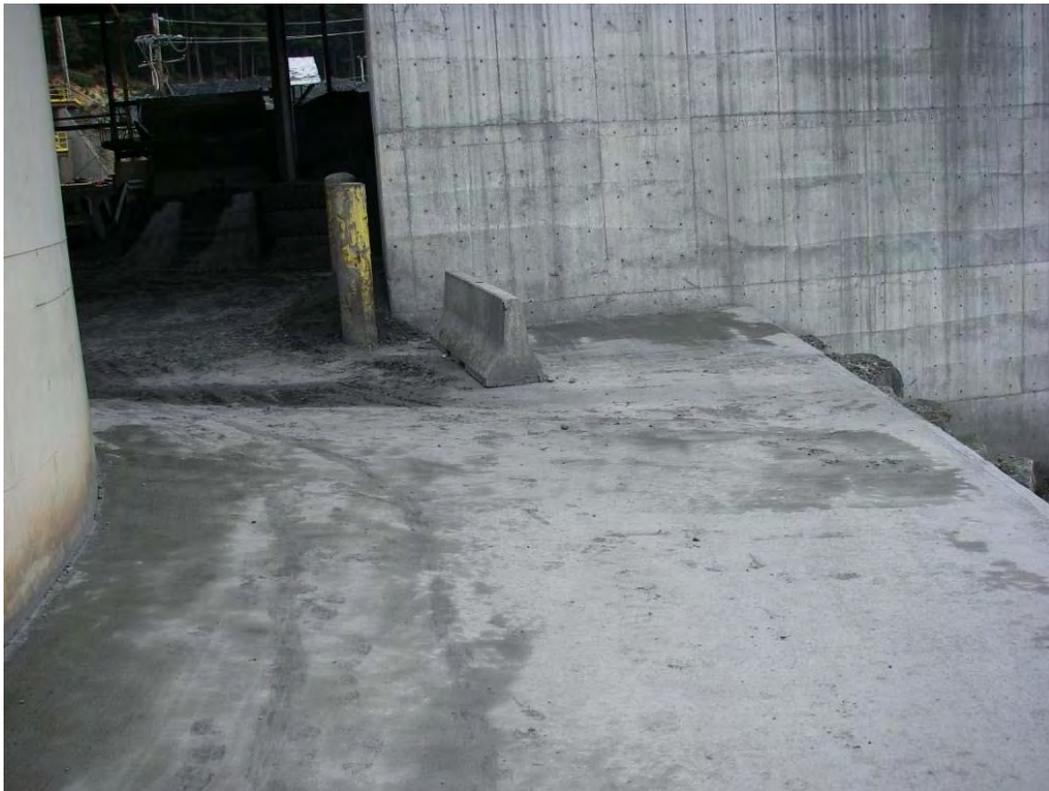
**Photo 27: Tailings Thickener Concrete Containment**

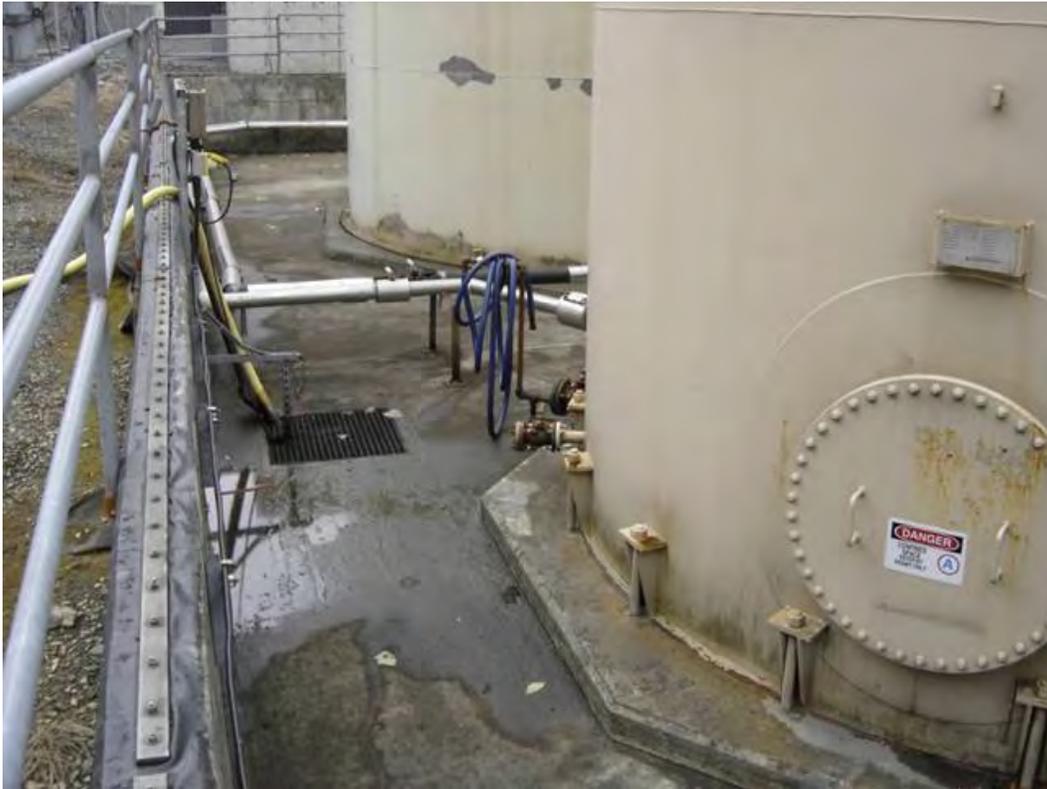
| HGCMC Site Aspect | Inspection Observations | Comments/Recommendation |
|--|---|---|
| Bulk fuel storage area | <p>The bulk fuel storage area was inspected as was the secondary containment (Photo 29). The secondary containment was adequate in size and was found in good condition with no significant cracks or holes in either the concrete floor or walls. The area was dry with only very small amounts of ponded precipitation water.</p> <p>The secondary containment in the transformer substation immediately beside the mill bulk fuel reports to the bulk fuel containment area and the pipe between the two appeared to be unrestricted.</p> <p>A concrete wall has been constructed between the transformer station and the bulk fuel storage area as a safety precaution.</p> | |

Photo 29: Secondary Containment for Fuel Storage at 920 Area

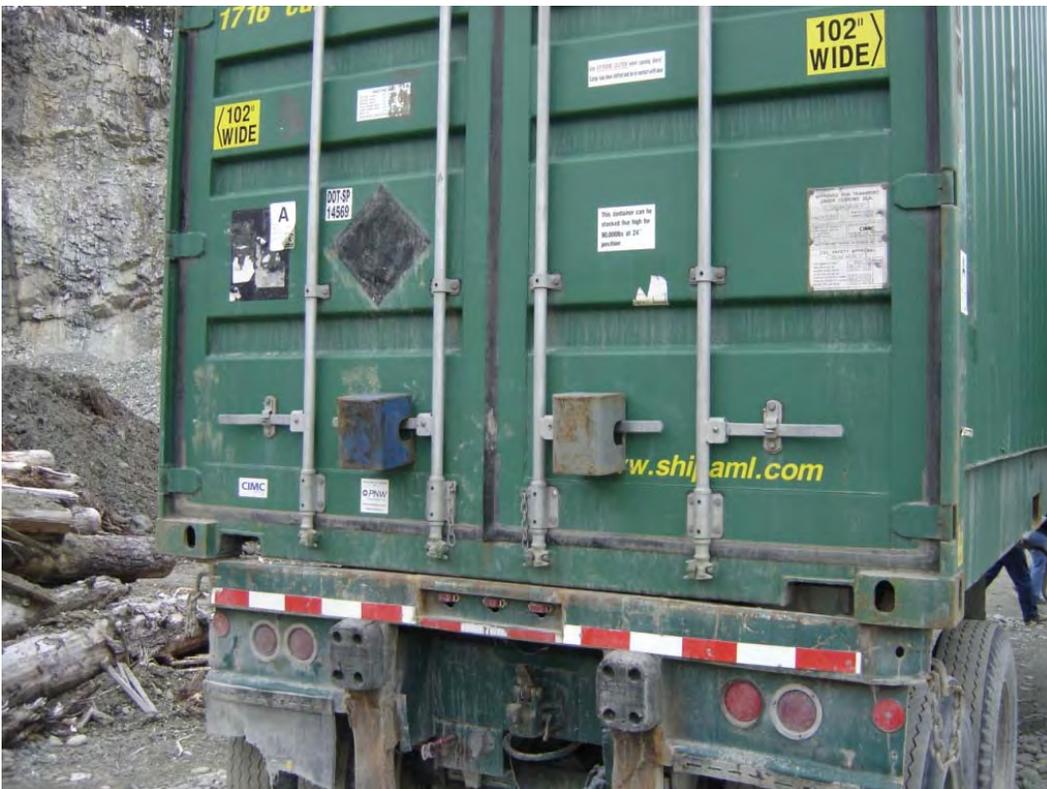
| HGCMC Site Aspect | Inspection Observations | Comments/Recommendation |
|--|---|---|
| <p>Powder Magazine (Area 7)</p> | <p>The explosive magazine were inspected and found to be in good order with appropriate separation of materials. All magazines were found dry and securely locked to prevent unauthorized access (Photo 30).</p> | |

Photo 30: Explosives Storage
