Greens Creek Mine Inspection Report

Agency Personnel: Operator Contacts: Inspection Objectives: September 12, 2024 7:00AM to 4:00PM Overcast, frequent scattered showers occasionally heavy. Wind gusts to 35mph. 50°F. Jesse Garnett White, William Groom, and Carolyn Curley Paula Lillesve Site Inspection

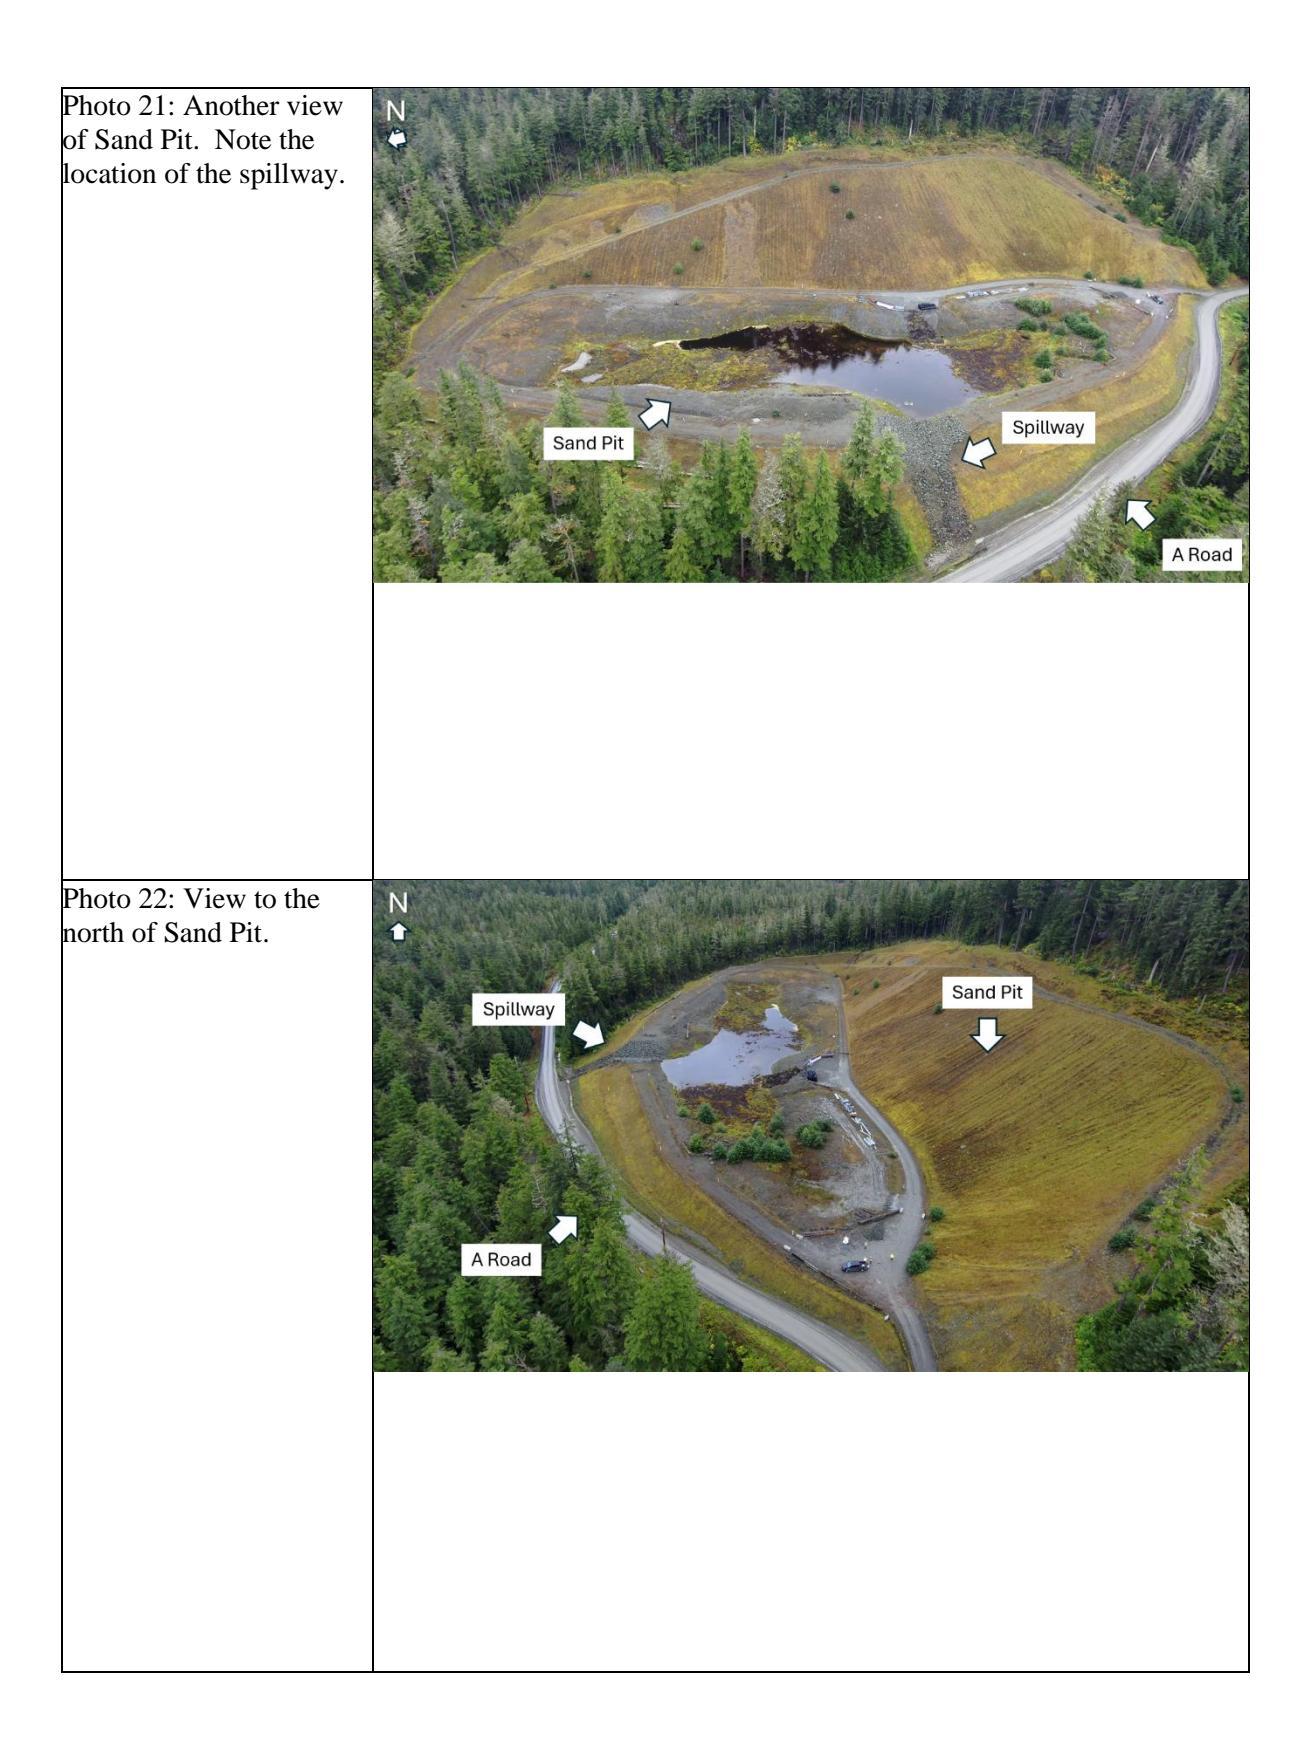
Reclamation surrounding Sand Pit was stable with various grasses, ferns, and small tree growth. This area was reclaimed about 5 years ago, which gives an indicator at the rate re-vegetation occurs. The graded eastern slopes were also stable and in good condition. The pit contained water and growth media including peat,

various grasses, and woody debris. The spillway was well above the current pit water level and in good condition. The flat area surrounding the pit is now a temporary laydown and storage area (Map 5, Photos 20-22).

Photo 19: Another view N T Pit 6 of Material Site E and Pond E. B Road Pond E Material Site E Photo 20: Sand Pit. Sand N A Road Pit was a quarry for sand Ţ Hawk Inlet material that was exhausted in 2016. It is now an excellent example of reclamation and how vegetation quickly takes hold on reclaimed areas at Spillway Greens Creek. Sand Pit contains overburden material for mine reclamation and is used as Sand Pit a temporary storage and laydown area.
