**TAILINGS AND PRODUCTION ROCK SITE
2003 ANNUAL REPORT**

Kennecott Greens Creek Mining Company

December 2004

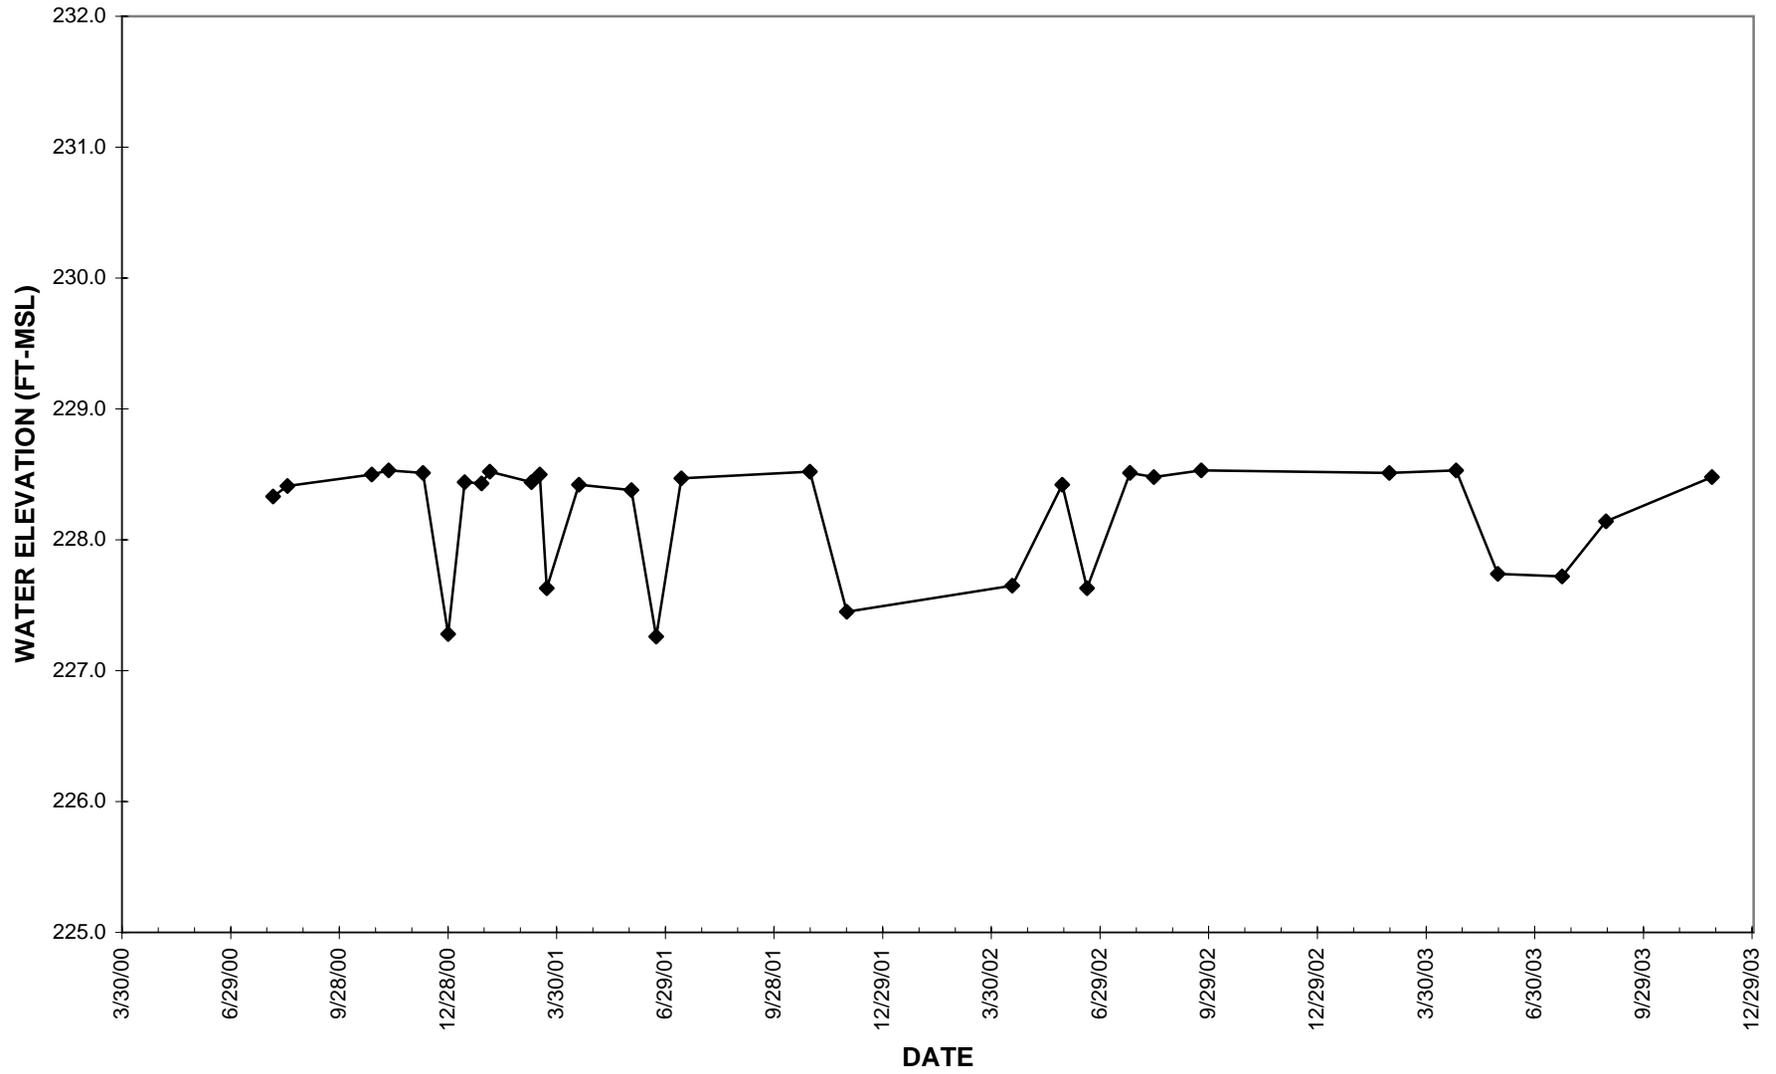
FIGURE 2.15 WATER LEVEL DATA FOR WELL MW-T-00-03A

Water levels for four wells completed east and west of the pile are shown for comparison in Figures 2.15 to 2.18. The eastern wells, MW-T-00-3A (Figure 2.15) and MW-T-00-3B (Figure 2.16), are completed in the shallow sands 12 and 17 feet, respectively, below ground surface. The shallower well shows a water table at the surface and the deeper well indicates a water elevation about three feet below ground surface throughout 2003. The water table remained close to an elevation of 228 feet in 2003. Wells MW-T-01-03A and MW-T-01-03B are installed west of the

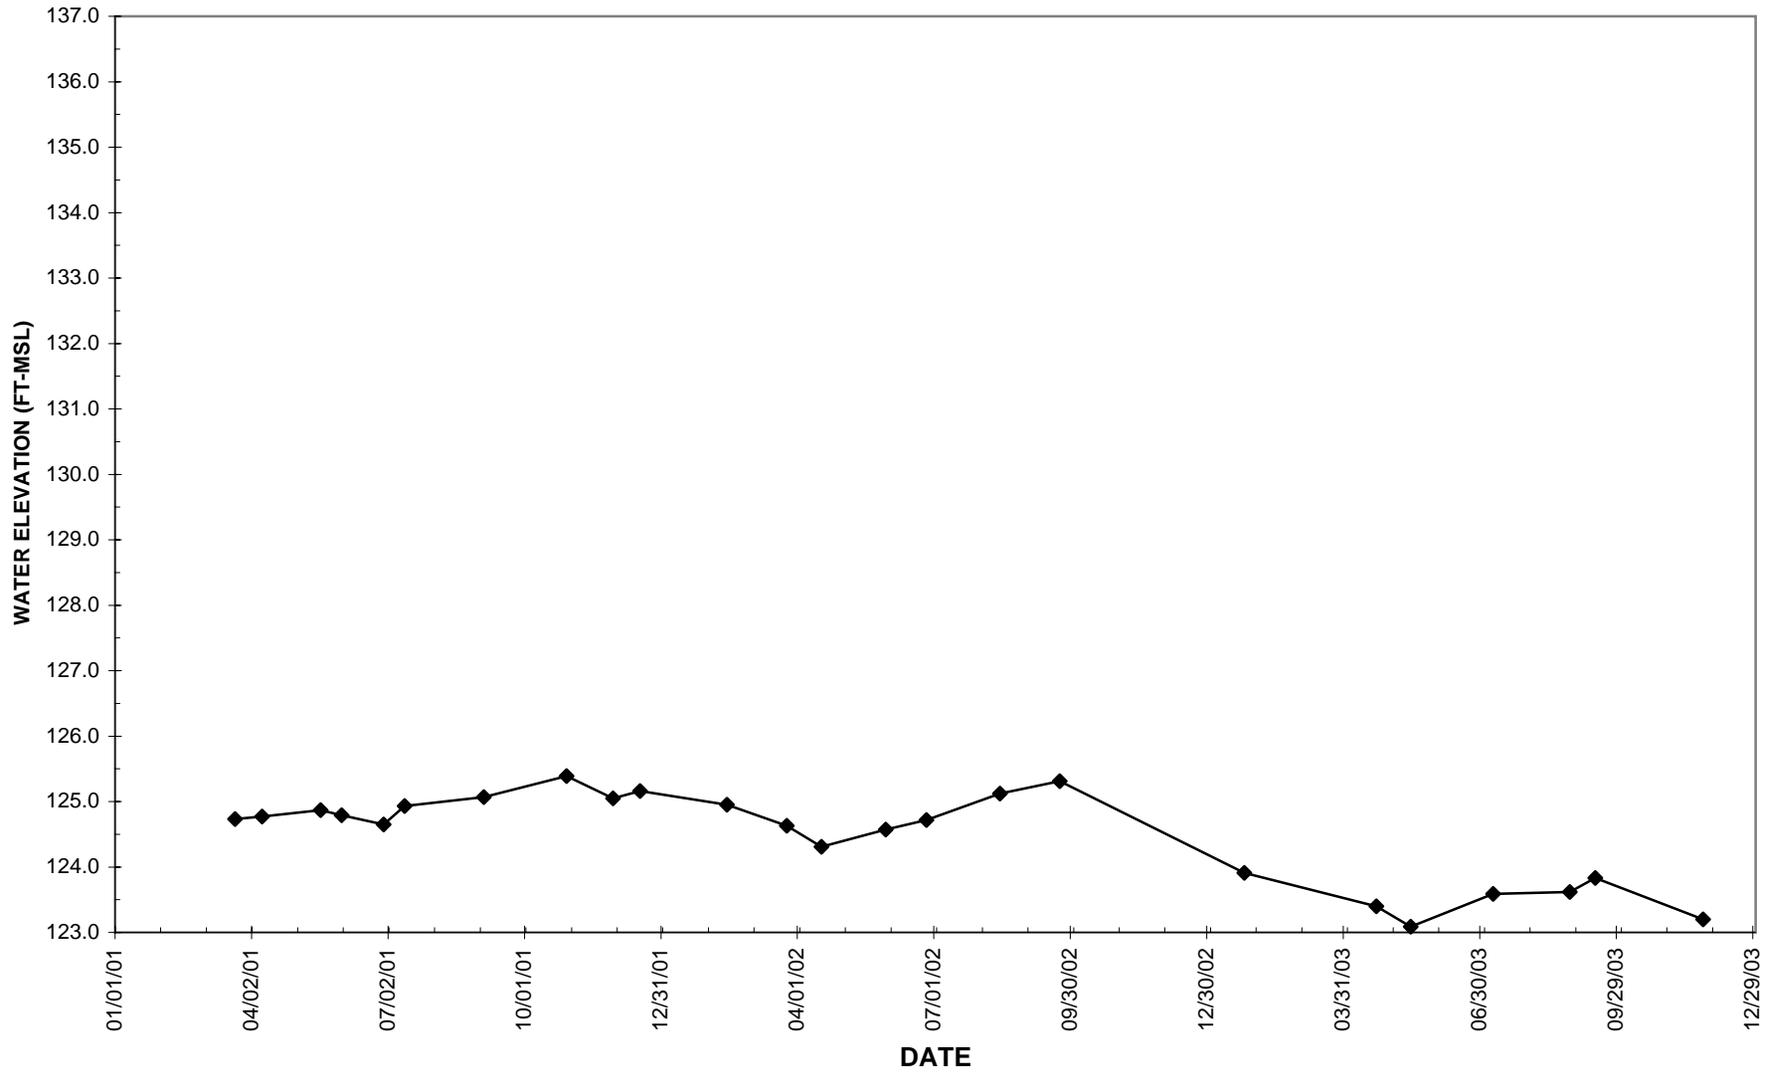
FIGURE 2.17 WATER LEVEL DATA FOR WELL MW-T-01-03A

pile. Their water levels are shown in Figures 2. 17 and 2.18, respectively. MW-T-01-03A is completed in bedrock to a depth of 20 feet and MW-T-01-03B is completed in clayey silt to a depth of 12 feet. The bedrock well indicates a water elevation drop of approximately 1 foot from 2002 to 2003, with an average of 123.5 feet in 2003. The clayey silt well shows a water elevation of 130 feet. Figure 2.18 suggests that it may have taken approximately six months for the water level to equilibrate after it was baled dry following a slug injection test in February 2001. If this is the case it reflects the very low permeability of the clayey silt. The ground surface elevation is 134 feet in the proximity of these two wells.

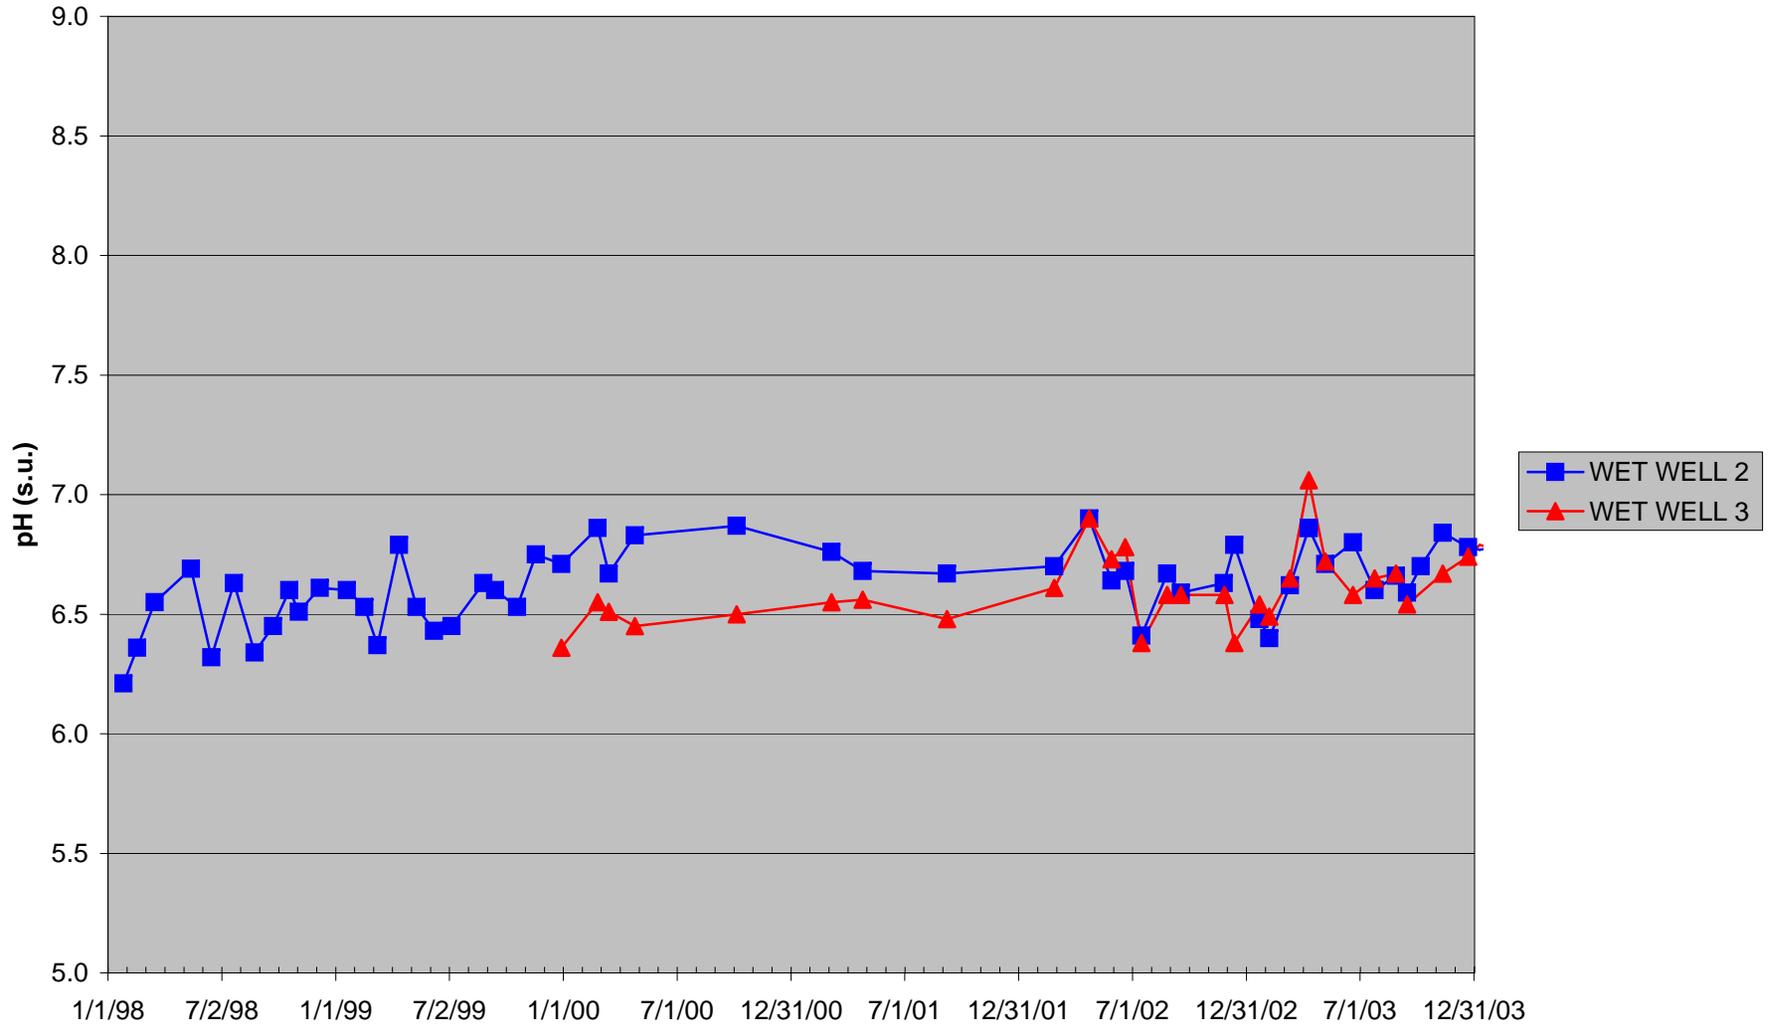
FIGURE 2.20a GREENS CREEK TAILINGS AREA INTERNAL MONITORING SITES:
WET WELLS - pH DATA

Values of pH were between 6 and 8.5 for all internal monitoring site samples in 2003 (Figure 2.20a, b and c). PZ-T-00-01, PZ-T-00-2 and PZ-T-00-3, which screen the lower ten feet of tailings pile, have the highest pH of the internal monitoring sites. This is likely a result of

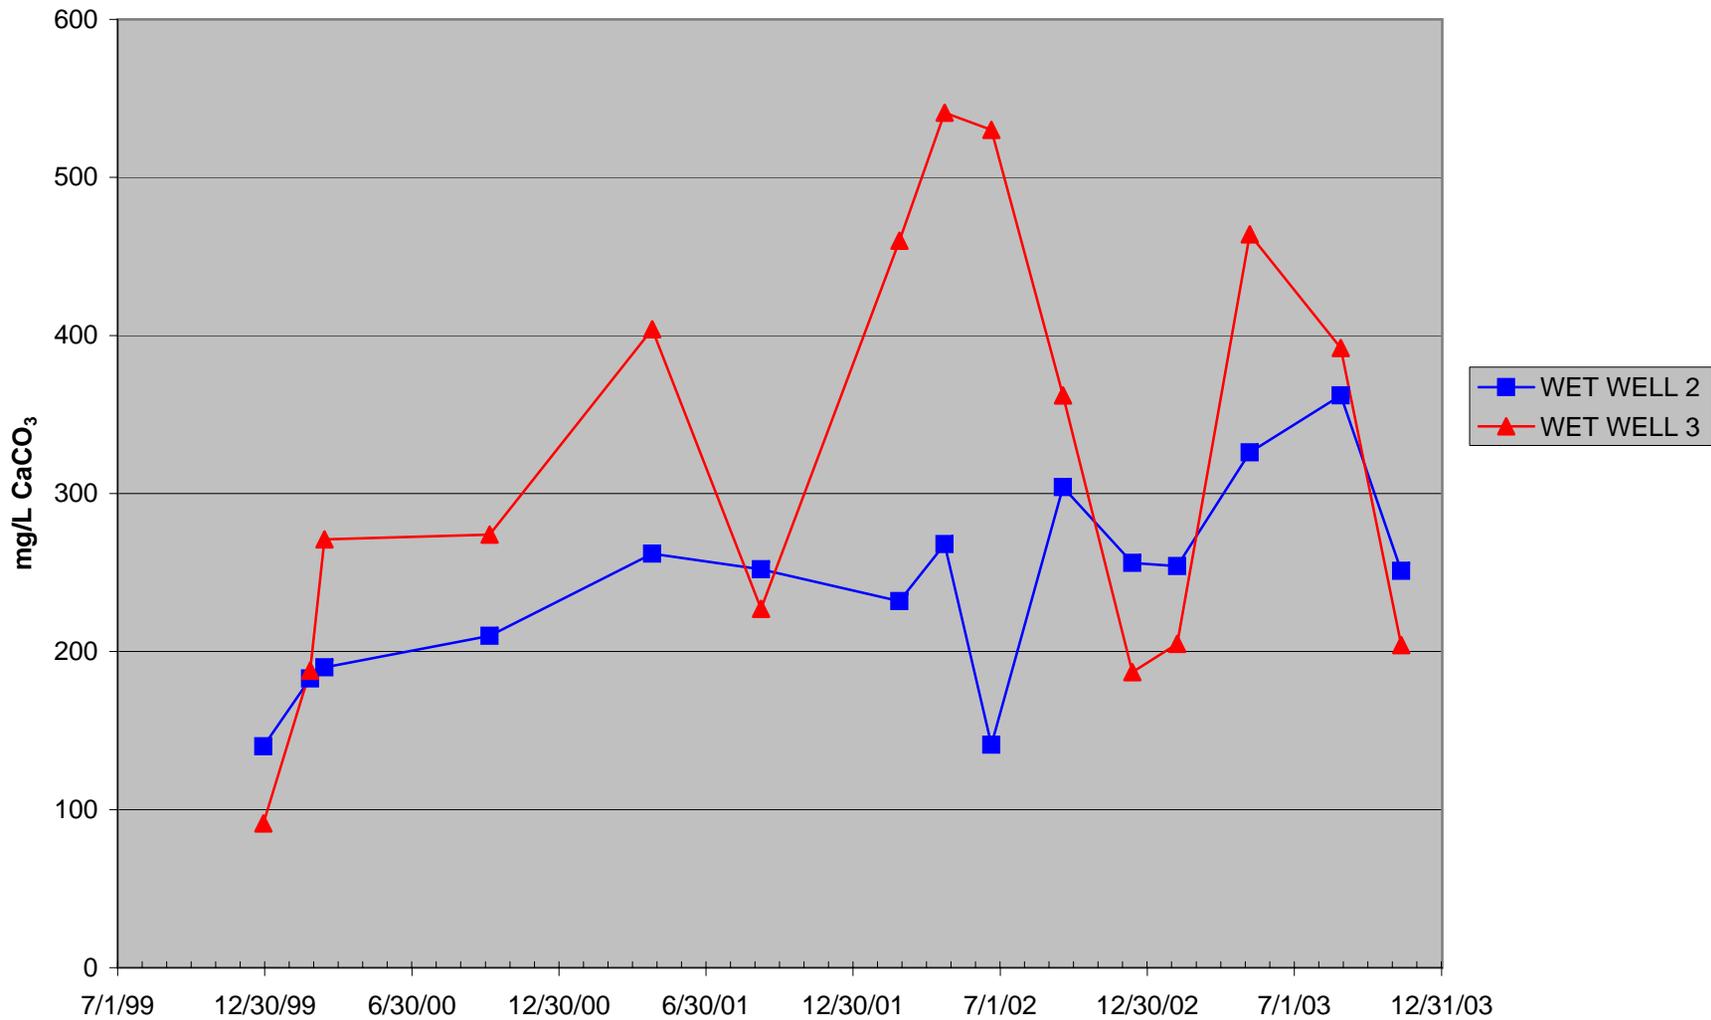
**FIGURE 2.21a GREENS CREEK TAILINGS INTERNAL MONITORING SITES:
WET WELLS - ALKALINITY
(Non-detectable analyses plotted as zero)**

Alkalinity data are presented in Figure 2.21a and b. Alkalinity generally ranges between 200 and 600 mg/l CaCO₃ within the tailings pile, consistent with buffering from carbonate minerals and the products of microbial sulfate reduction. The fact that these internal waters are near-neutral to alkaline and have substantial alkalinity indicates that the buffering capacity of the tailings is sufficient to prevent acidification of site drainage in the near-term (at least tens of years).

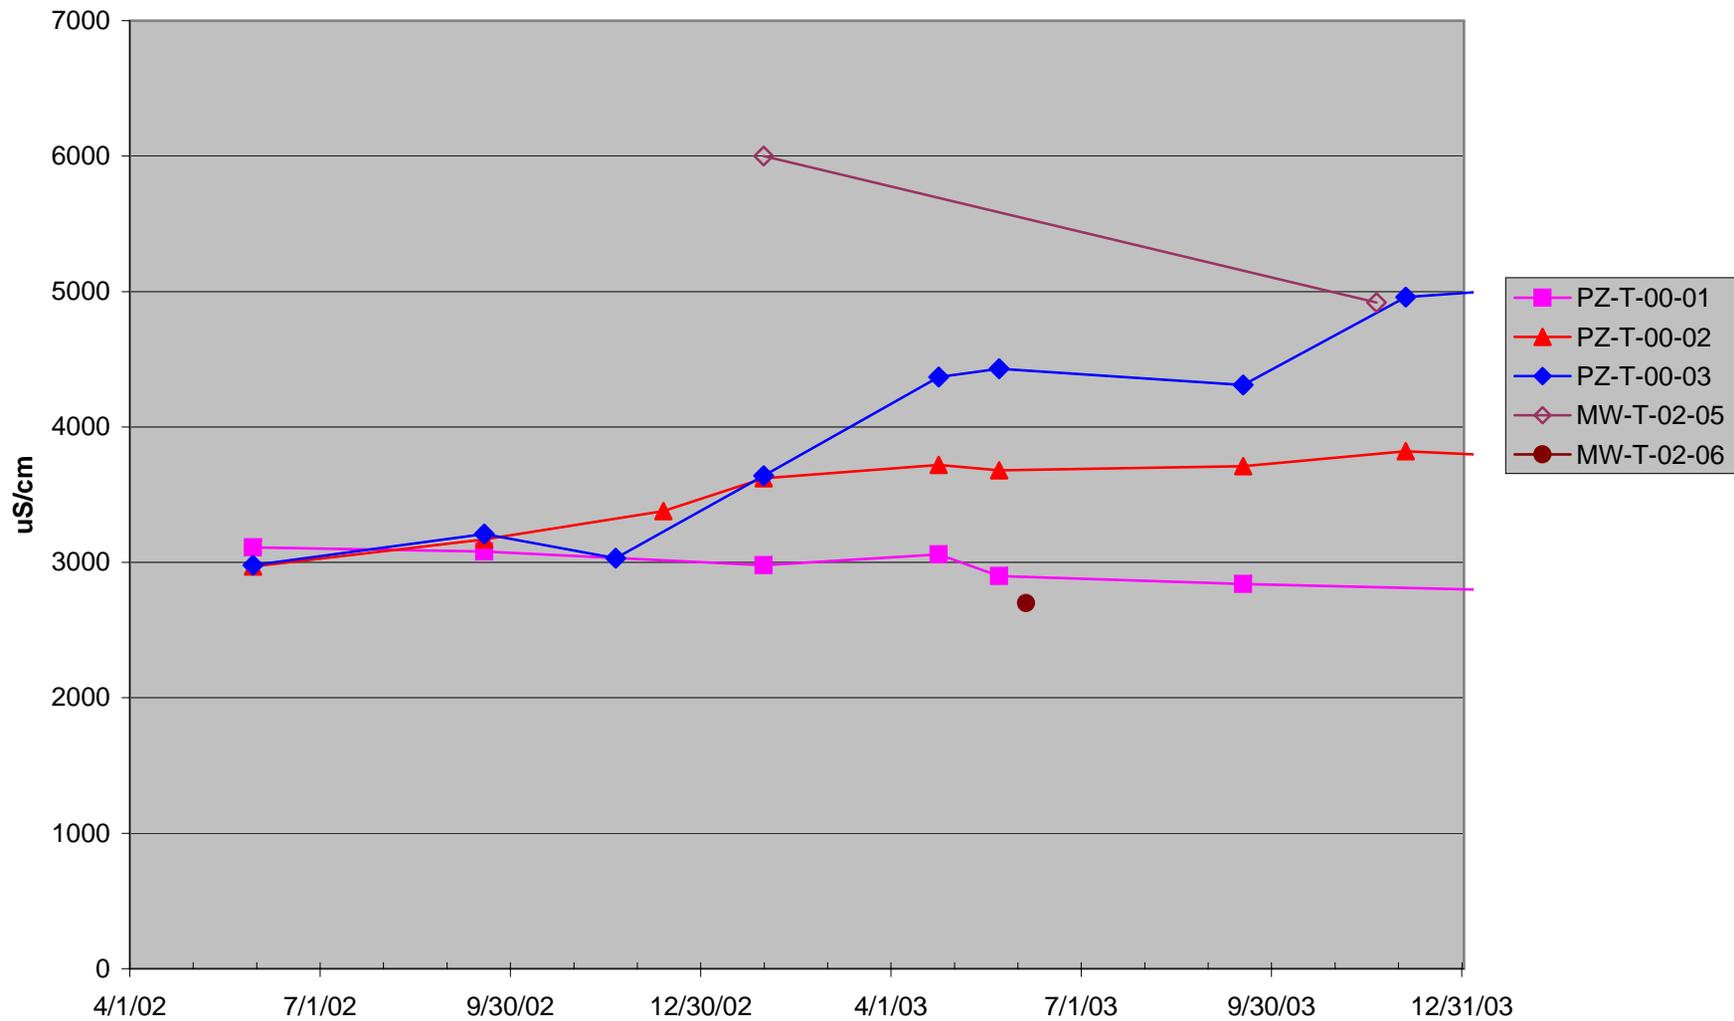
**FIGURE 2.22b GREENS CREEK TAILINGS INTERNAL MONITORING SITES:
TAILINGS COMPLETIONS - CONDUCTIVITY DATA**

The conductivity results from internal monitoring site waters are presented in Figure 2.22a, b, and c. 2003 conductivity measurements are between 1898 (wet wells) and 7350 (suction lysimeters) uS/cm. The higher conductivity of the site contact waters reflects a larger dissolved load caused by weathering of the tailings. Pyrite oxidation and carbonate dissolution contribute dissolved ions such as sulfate, bicarbonate, calcium and magnesium to the contact waters, increasing their conductivity. Wet Well 3 has a different capture area than Wet Well 2 and shows a different pattern with respect to conductivity. The changes in conductivity observed in Wet Well 3 probably reflect changes in the relative contributions from runoff, addition of the Northwest Diversion Ditch flow, infiltration and groundwater as the West Buttress was constructed. The suction lysimeters have conductivity values ranging from 3320 to 7350 uS/cm. Suction lysimeter samples are drawn from the smallest pore spaces of the unsaturated zone. Water held in these pores is often isolated from flow paths and thus has higher dissolved constituent concentrations than water from the saturated zone and foundation drains.

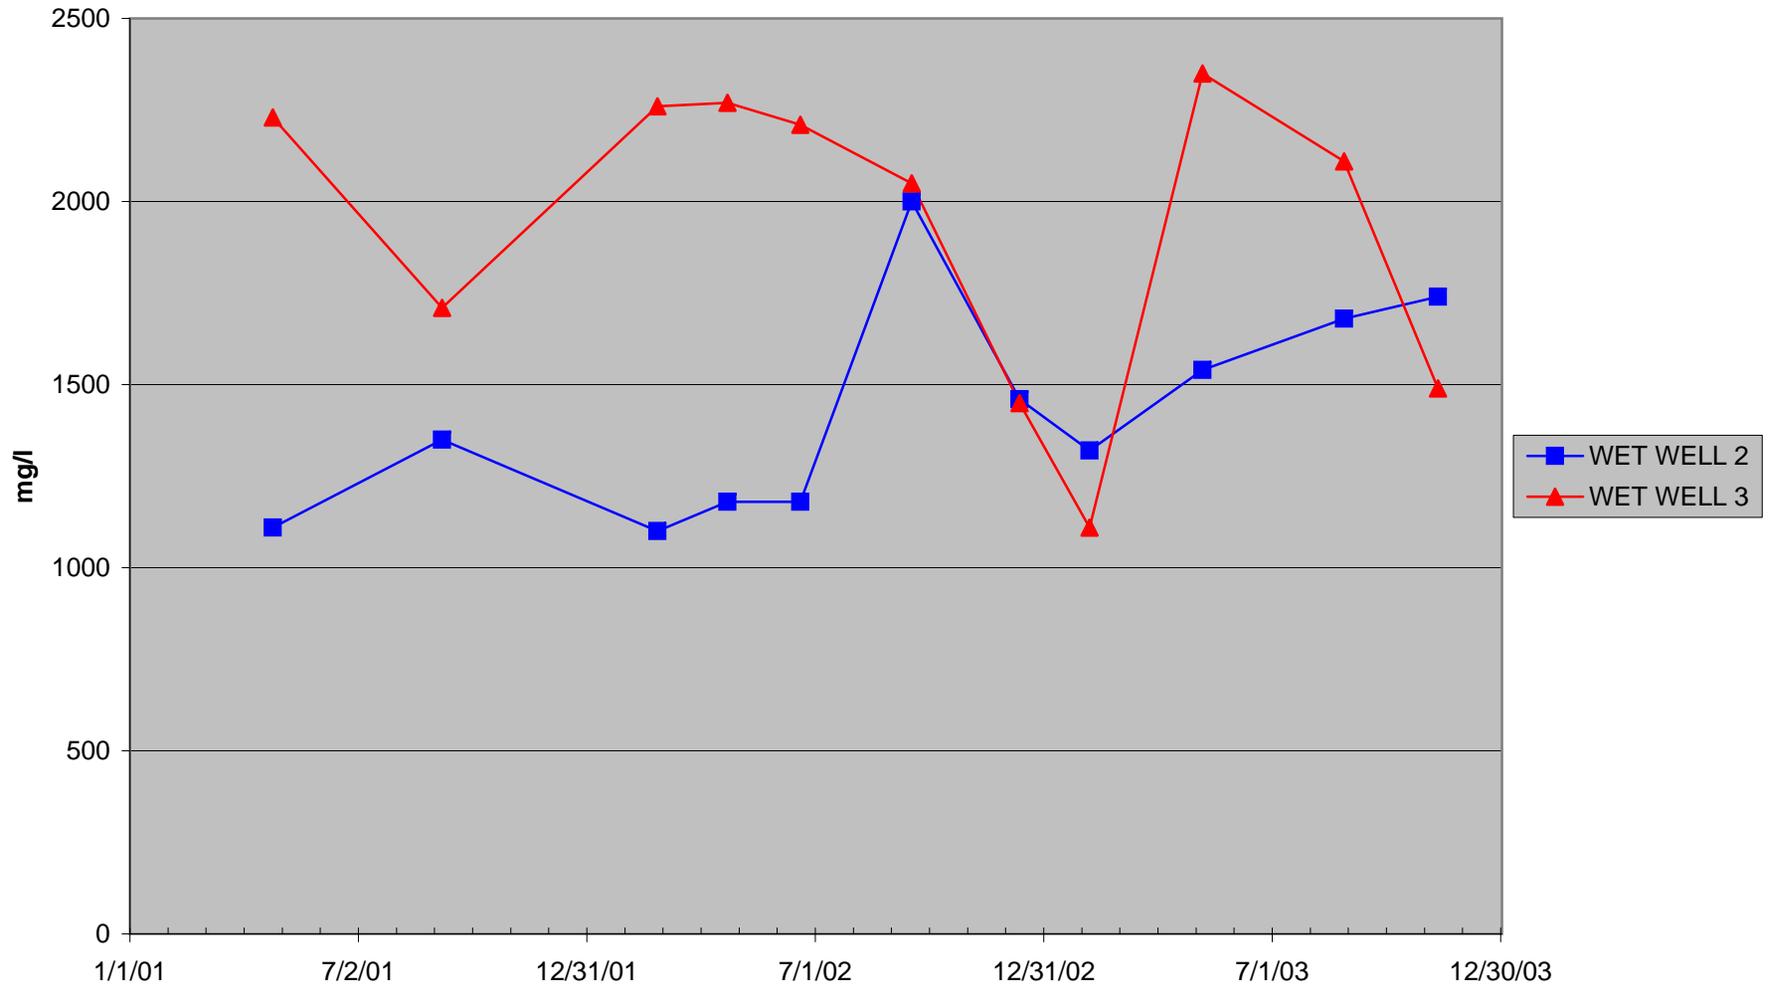
**FIGURE 2.23a GREENS CREEK TAILINGS INTERNAL MONITORING SITES:
WET WELLS - HARDNESS DATA
(Non-detectable analyses plotted as zero)**

Hardness and sulfate concentrations are consistent with the conductivity results. Calcium and magnesium are the primary contributors to hardness (Figure 2.23a and b) and reflect dissolution of carbonate minerals, such as calcite and dolomite. Carbonate dissolution neutralizes acidity formed by sulfide oxidation, which is also the source of sulfate shown in Figure 2.24a, b, and c. Sulfate concentrations range between 500 and 3000 mg/l in the tailings pile waters. The increase in sulfate and other constituents seen in PZ-T-00-03 likely reflects the replacement of interstitial process water with infiltrating surface water, which carries a higher dissolved load.

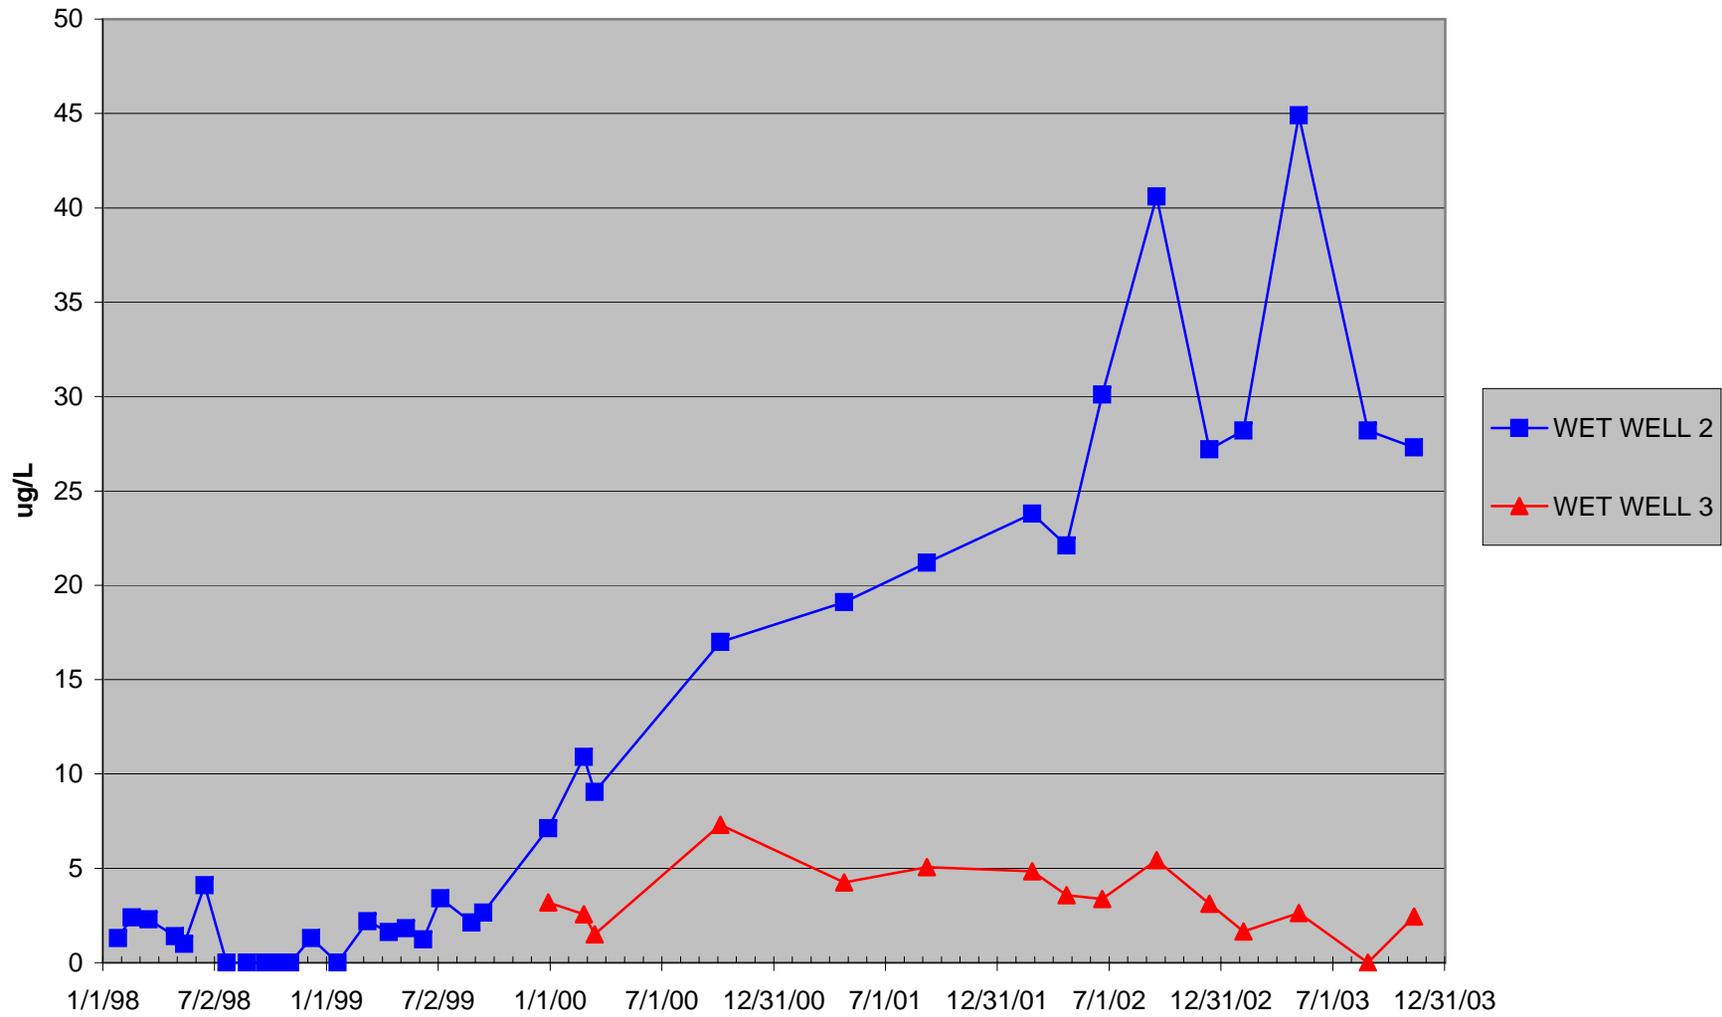
**FIGURE 2.25a GREENS CREEK TAILINGS INTERNAL MONITORING SITES:
WET WELLS- ARSENIC DATA
(Non-detectable analyses plotted as zero)**

Arsenic data are presented in Figures 2.25a, b and c. The data, especially for Wet Well 2 (and other sites to a lesser extent) show a distinct increasing trend. As arsenic-bearing minerals such as tetrahedrite/tennantite (and to a lesser extent pyrite) weather, the arsenic that is released is typically co-precipitated with iron oxy-hydroxides. As the pile grows, reducing conditions overtake areas that were once oxidizing. This was particularly true as the water table rose following removal of the temporary PVC cover that was placed on the pile in 1995 (removal began in 1997). Dissolution of oxyhydroxides (and possibly sulfates) should occur as the waters respond to the changing redox conditions. This will contribute arsenic (and iron) to the drainage water. Arsenic concentrations in the drainage will decrease when redox conditions in the pile stabilize.

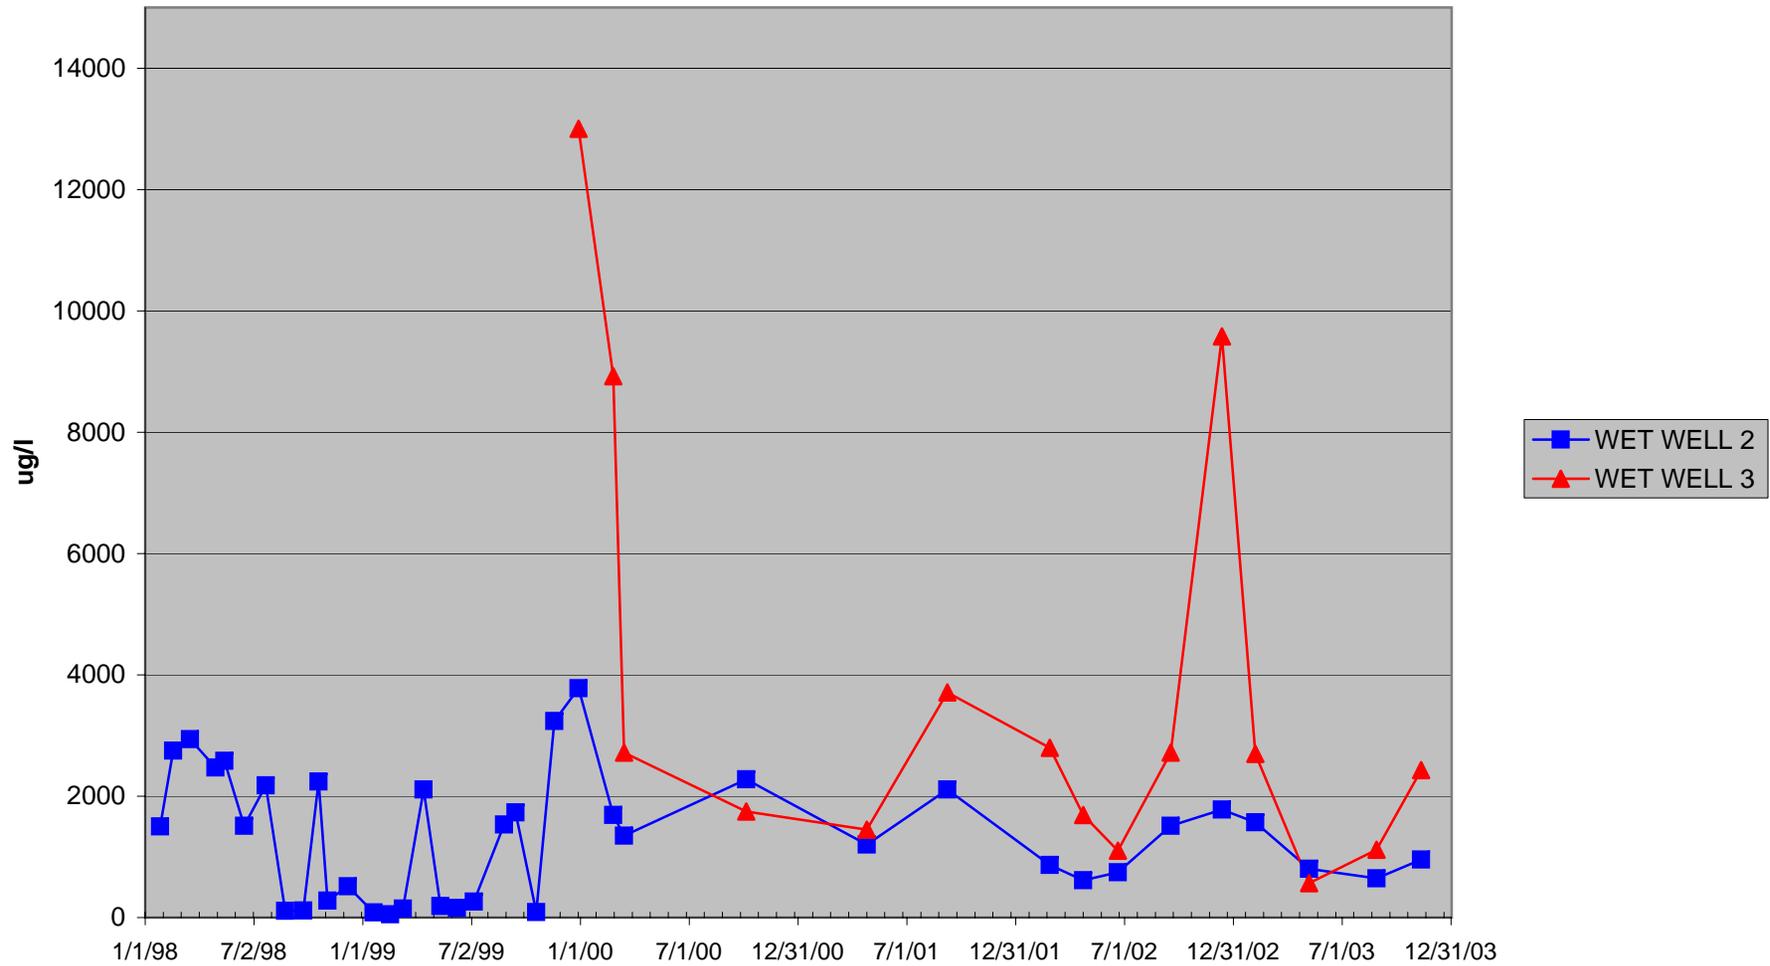
**FIGURE 2.26a GREENS CREEK TAILINGS INTERNAL MONITORING SITES:
WET WELLS - ZINC DATA
(Non-detectable analyses plotted as zero)**

Figure 2.26a, b and c shows the concentration of zinc from the monitoring sites. Zinc levels from the saturated zone of the pile continue to remain low (Figure 2.26b), a result of sulfate reduction, which promotes zinc sulfide precipitation. The zinc concentration in MW-T-02-06 suggests that sulfate reduction may not be occurring in this portion of the west buttress. Placement of argillite on the outer slopes of the West Buttress has also led to higher zinc concentrations in Wet Well 3 from flushing of this newly placed material. In 2003, the zinc concentration in this wet well returned to within historical limits. The two 20 foot suction lysimeters showed zinc

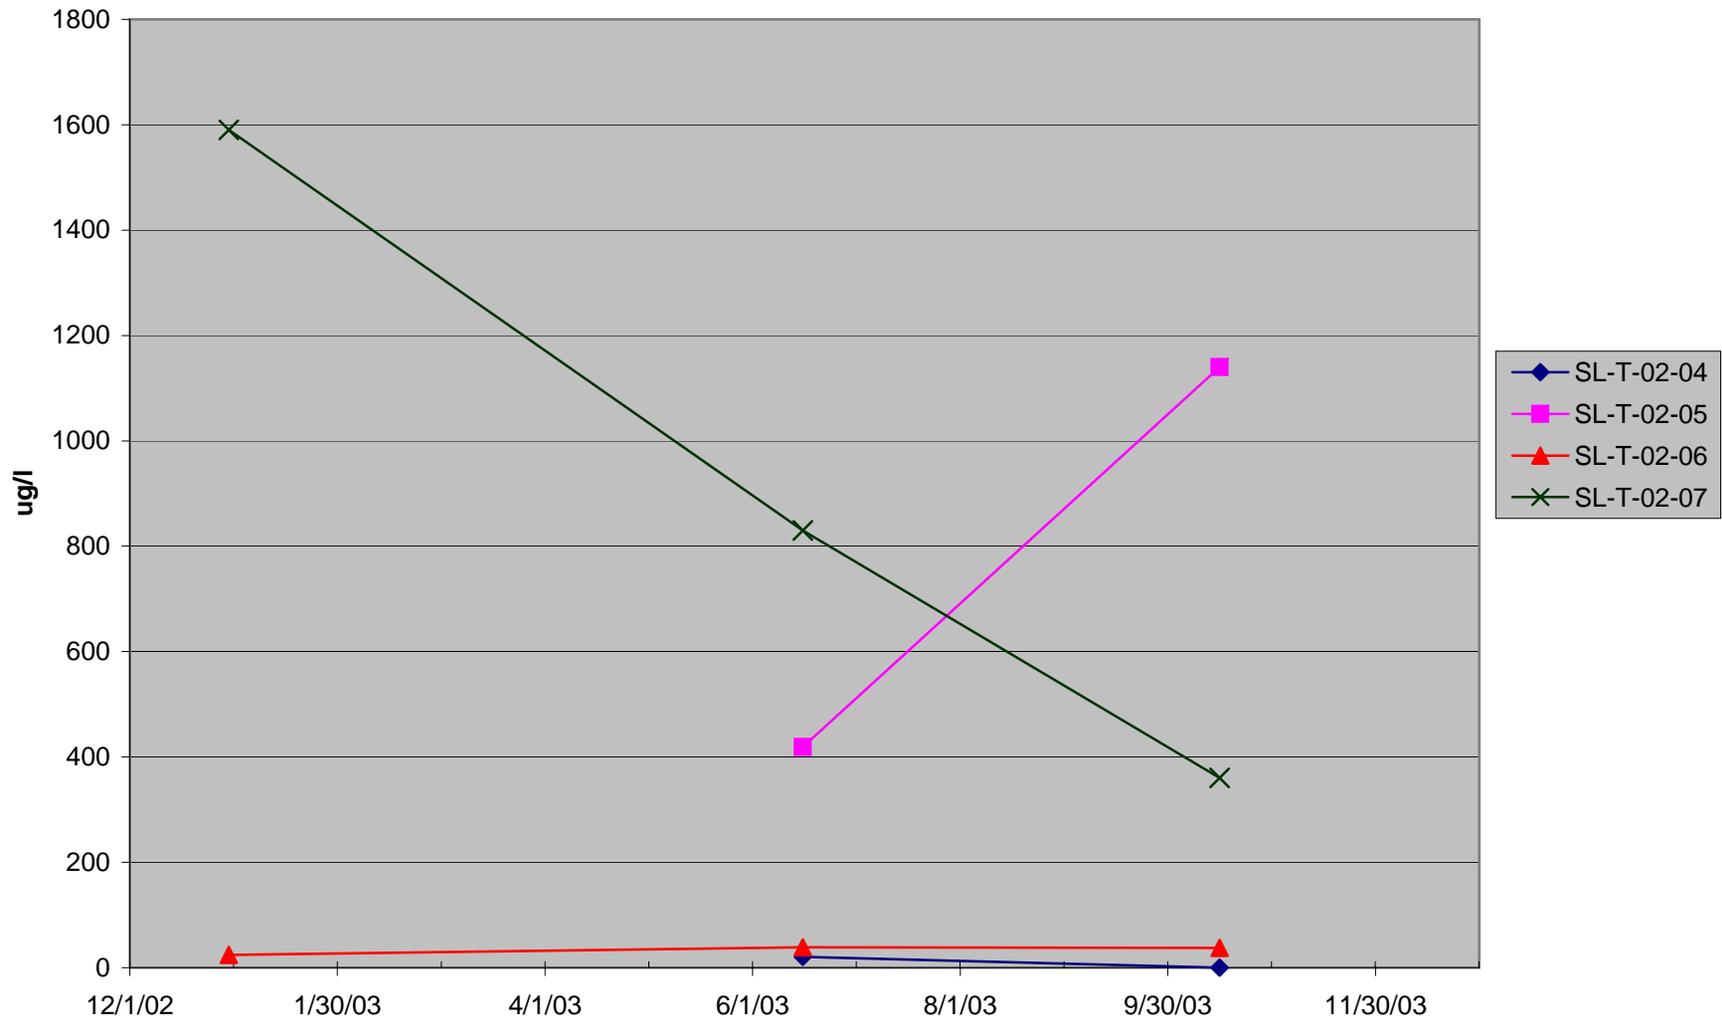
**FIGURE 2.26c GREENS CREEK TAILINGS INTERNAL MONITORING SITES:
SUCTION LYSIMETERS - ZINC DATA
(Non-detectable analyses plotted as zero)**

concentrations between 400 – 1600 ppb (SL-02-05, SL-02-07), and the two 40 foot lysimeters (SL-02-04, SL-02-06) had zinc concentrations less than 50 ppb (Figure 2.26c).

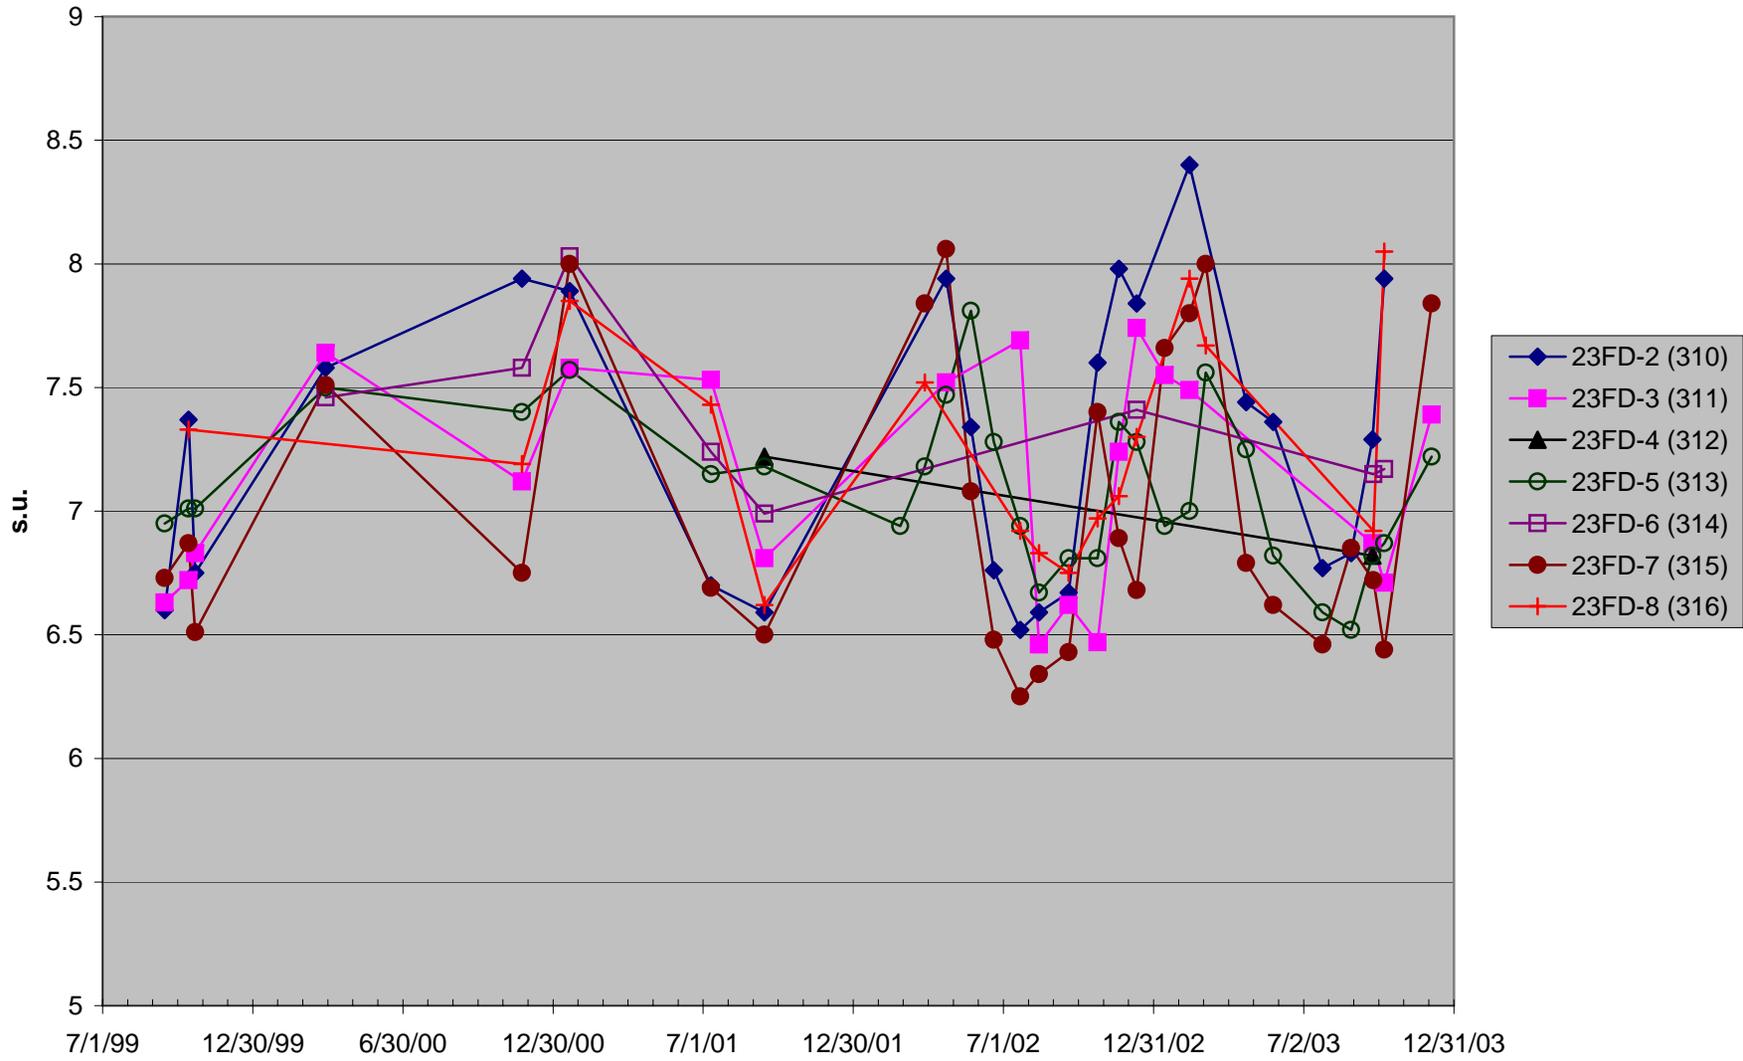
FIGURE 3.14a GREENS CREEK SITE 23/D INTERNAL MONITORING SITES: FINGER DRAINS - pH DATA

Figure 3.14a shows the pH of waters collected from Site 23 Finger Drains 2 through 8, and Figure 3.14b shows the pH of monitoring wells MW-23-A2D, MW-23-A4, MW-D3 and Pond D (see as-built in Appendix 2 for locations). Values of pH were between 6 and 8.5 for all internal monitoring site samples in 2003. The lower pH values (generally pH 6 to 7) were recorded in MW-23-A4 and MW-D3, both of which are completed in alluvial sands beneath Site 23 and Site D, respectively. MW-23-A2D, which screens colluvium up-gradient of Site 23 typically has the highest pH (generally pH 7.0 to 8.0). The Site 23 finger drains fluctuate at values between those of the monitoring wells. Figure 3.14a and b suggest that waters from different foundation units have different pH values and that Site 23 and Site D contact waters and the materials with which they are in contact exhibit sufficient buffering capacity to prevent acidification of site drainage in the near term. Seasonal fluctuations are apparent in the finger drains with highest pH values occurring in winter months and lower pH in mid to late summer.

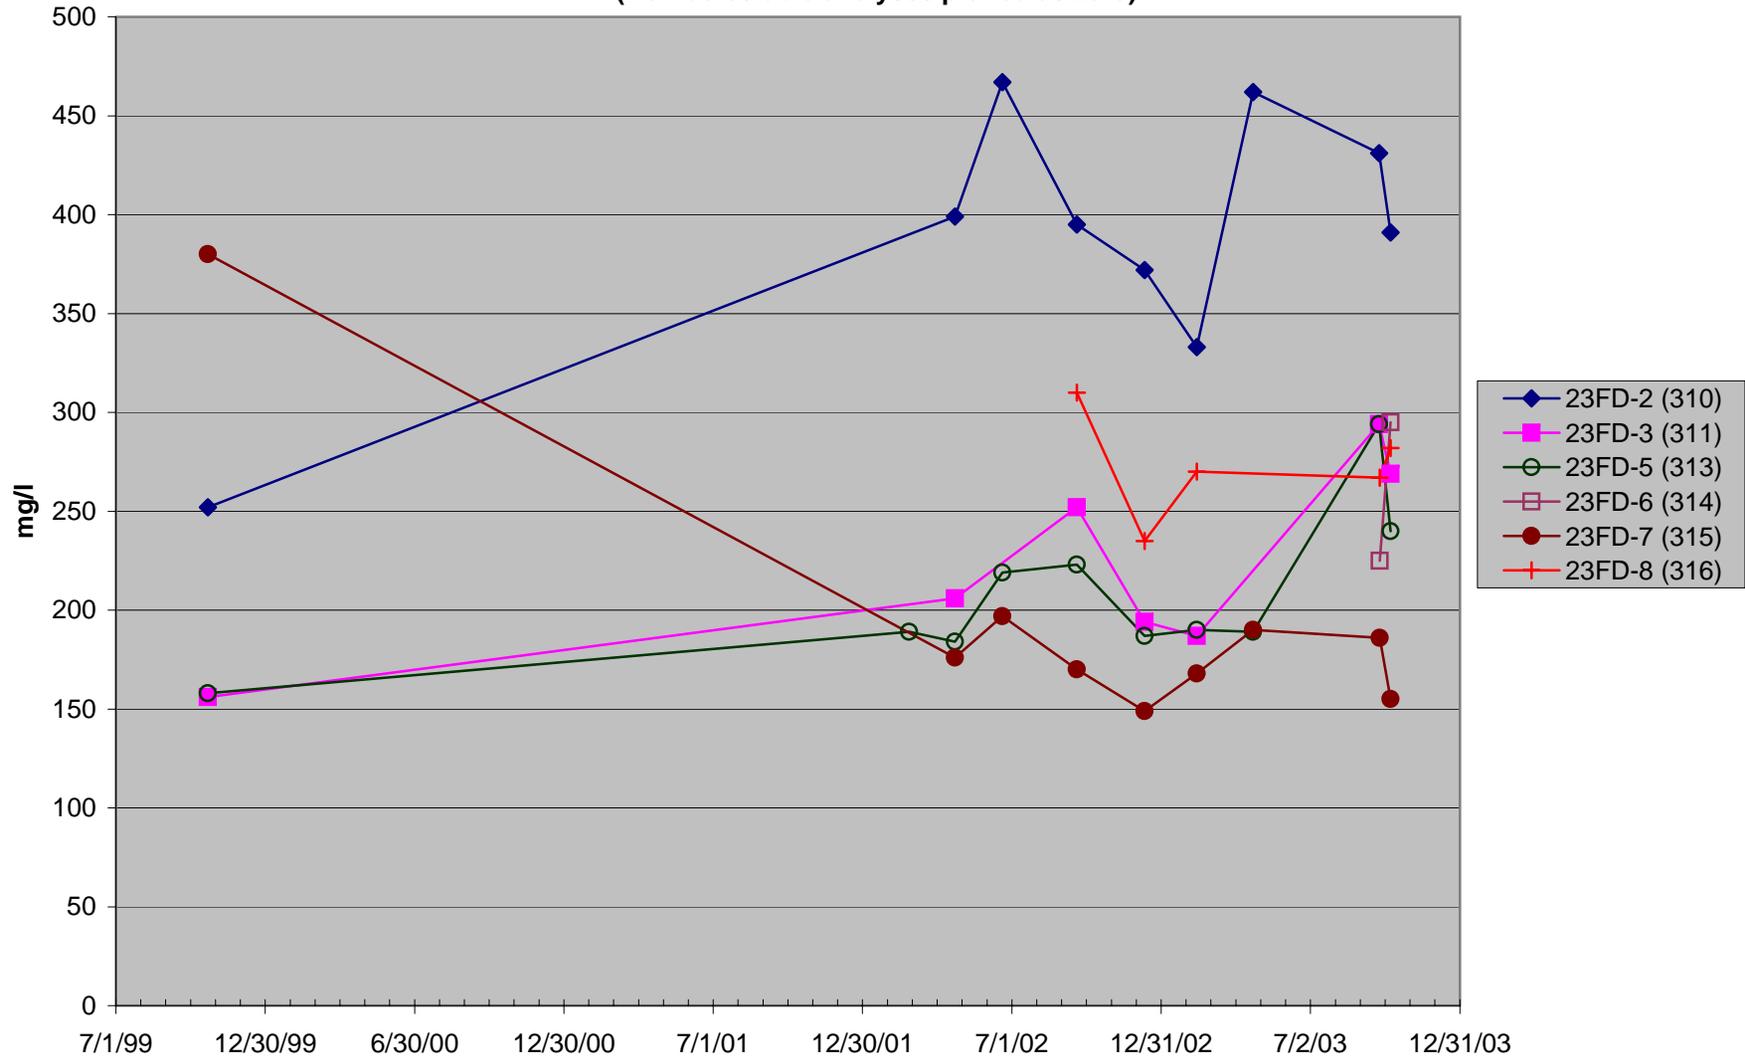
**FIGURE 3.15a GREENS CREEK SITE 23/D INTERNAL MONITORING SITES:
FINGER DRAINS - ALKALINITY DATA
(Non-detectable analyses plotted as zero)**

As with pH, high alkalinity values (Figure 3.15a and b) indicate that the waters are well buffered. Fluctuations in alkalinity correlate with those of other parameters, such as hardness (Figure 3.16a and b) and conductivity (Figure 3.17a and b), and appear to be seasonal. Carbonate minerals in the production rock contribute to the high alkalinity of the drainage from the finger drains. Alkalinity is lowest in samples with the highest groundwater component (e.g. the monitoring wells, D Pond, 23FD-5 and 23FD-7). Calcium and magnesium are the primary contributors to hardness (Figure 3.16a) and reflect dissolution of carbonate minerals, such as calcite and dolomite. Carbonate dissolution neutralizes acidity formed by sulfide oxidation, which is also the source of sulfate shown in Figure 3.18a.
