**TAILINGS AND PRODUCTION ROCK SITE
2003 ANNUAL REPORT**

Kennecott Greens Creek Mining Company

December 2004

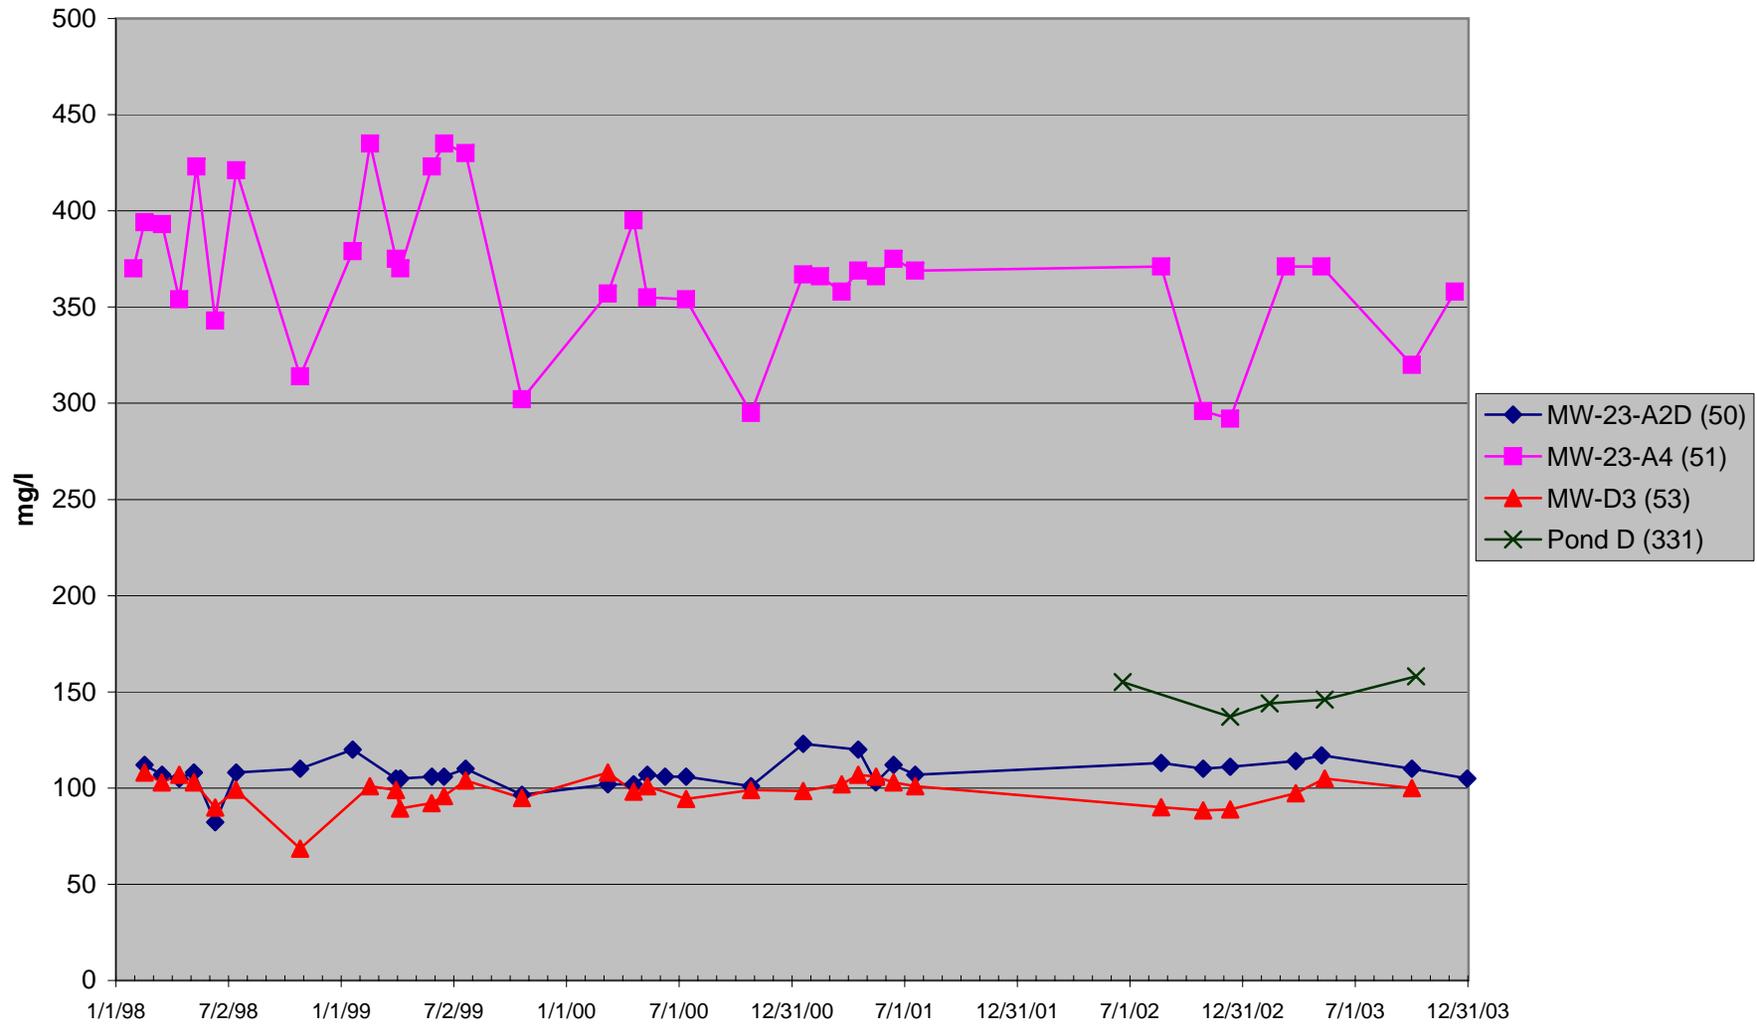
**FIGURE 3.15b GREENS CREEK SITE 23/D INTERNAL MONITORING SITES:
GROUND WATER - ALKALINITY DATA
(Non-detectable analyses plotted as zero)**

As with pH, high alkalinity values (Figure 3.15a and b) indicate that the waters are well buffered. Fluctuations in alkalinity correlate with those of other parameters, such as hardness (Figure 3.16a and b) and conductivity (Figure 3.17a and b), and appear to be seasonal. Carbonate minerals in the production rock contribute to the high alkalinity of the drainage from the finger drains. Alkalinity is lowest in samples with the highest groundwater component (e.g. the monitoring wells, D Pond, 23FD-5 and 23FD-7). Calcium and magnesium are the primary contributors to hardness (Figure 3.16a) and reflect dissolution of carbonate minerals, such as calcite and dolomite. Carbonate dissolution neutralizes acidity formed by sulfide oxidation, which is also the source of sulfate shown in Figure 3.18a.

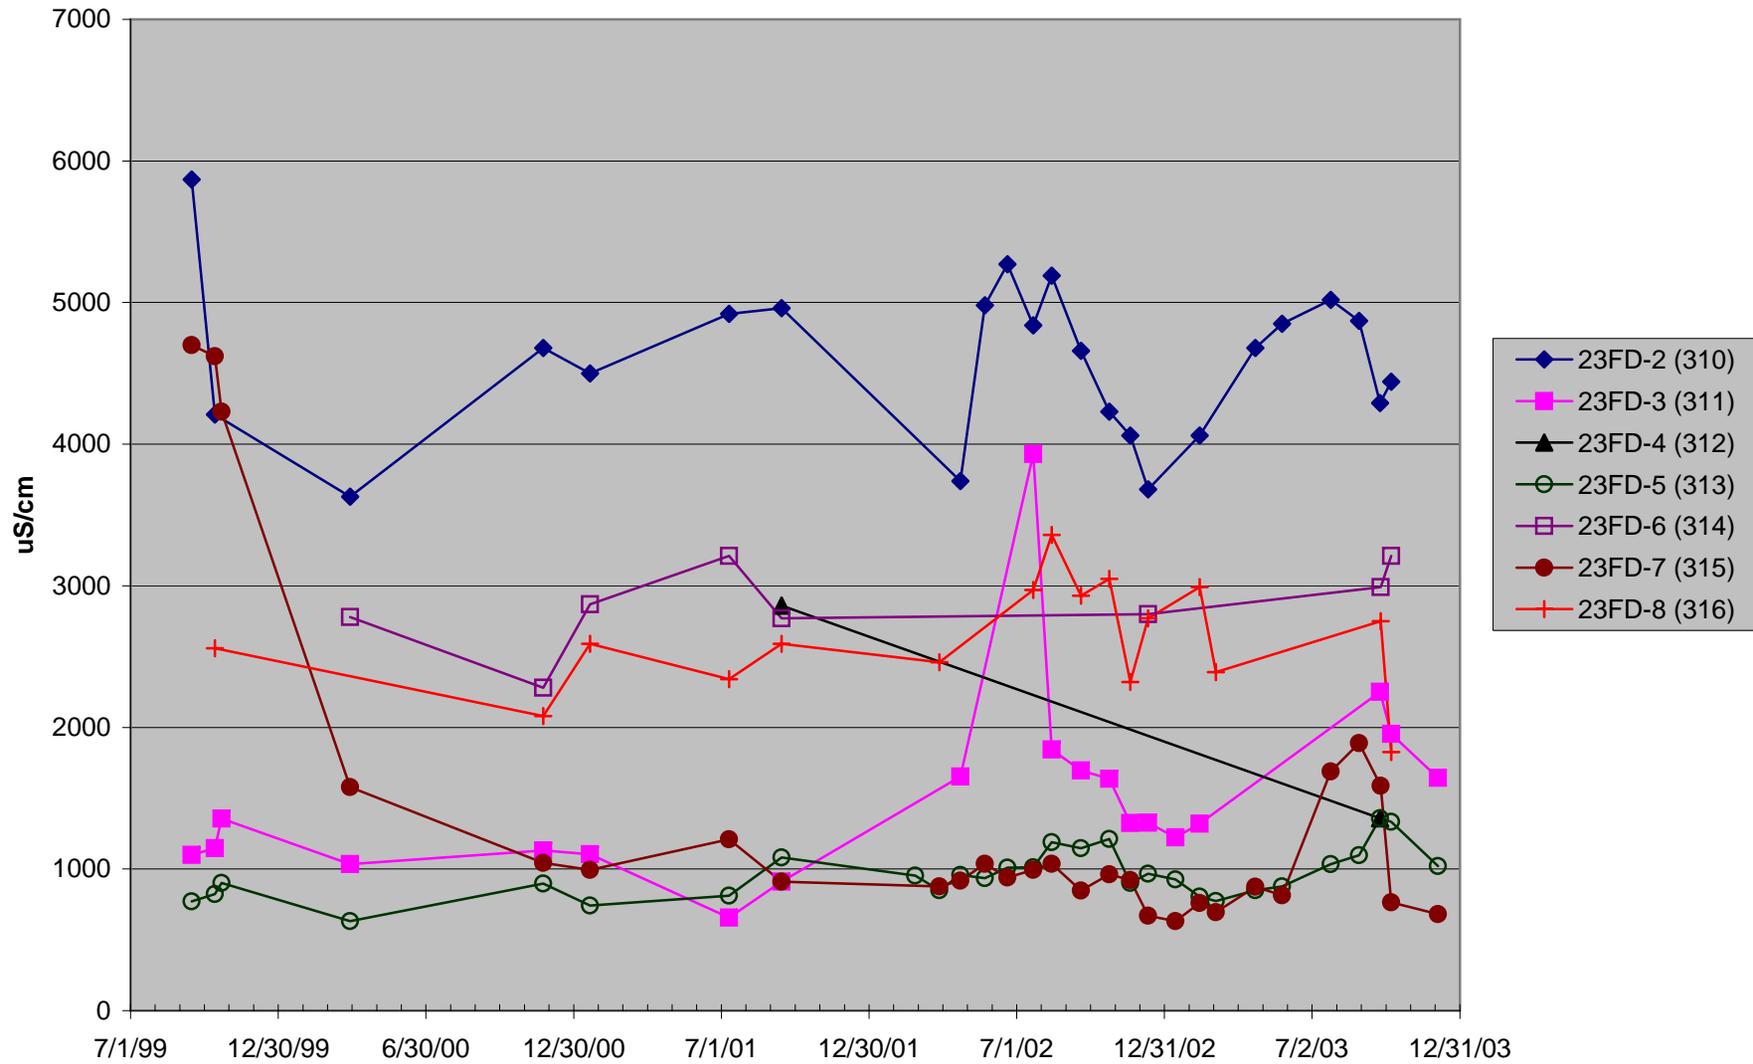
**FIGURE 3.17a GREENS CREEK SITE 23/D INTERNAL MONITORING SITES:
FINGER DRAINS - CONDUCTIVITY DATA**

Conductivity results from internal monitoring site waters are presented in Figure 3.17a and b. 2003 conductivity measurements range up to 5020 uS/cm. MW-23-A2D and MW-D3 have the lowest conductivity. MW-D3 is completed in alluvial sands below the fill placed at Site D. The finger drains with the highest flow (e.g. 23FD-5, which directly drains an excavated spring) have the lower conductivities than the drains with lower flow. This reflects a larger contribution from groundwater to the high-flow drains relative to a higher proportion of site contact water in the other finger drains. The significant decrease in conductivity in 23FD-7 that occurred in 2000 is probably the result of incorporation of groundwater collected in the upper portion of the drain above the active placement area. The presence of contact water in the alluvial sand below Site 23 (as seen in MW-23-A4) is not surprising given the permeable nature of the colluvium that lies immediately beneath the site. A clay till layer underlies the colluvium and alluvial sands beneath

The fact that MW-D3 does not show signs of a contribution from contact water suggests that an upward hydrologic gradient may exist beneath Site D. Finger Drain 23FD-2 has the highest conductivity but consistently low flow, suggesting no significant influence from groundwater. This drain may also be influenced by runoff that infiltrates along the access ramp to the site. The higher conductivity of the site contact waters reflects a larger dissolved load caused by weathering of the production rock. As with tailings, pyrite oxidation and carbonate dissolution contribute dissolved ions such as sulfate, bicarbonate, calcium and magnesium to the contact waters, increasing their conductivity. Sulfate concentrations for the finger drains are plotted in Figure 3.18a and match closely the relative value patterns of conductivity.

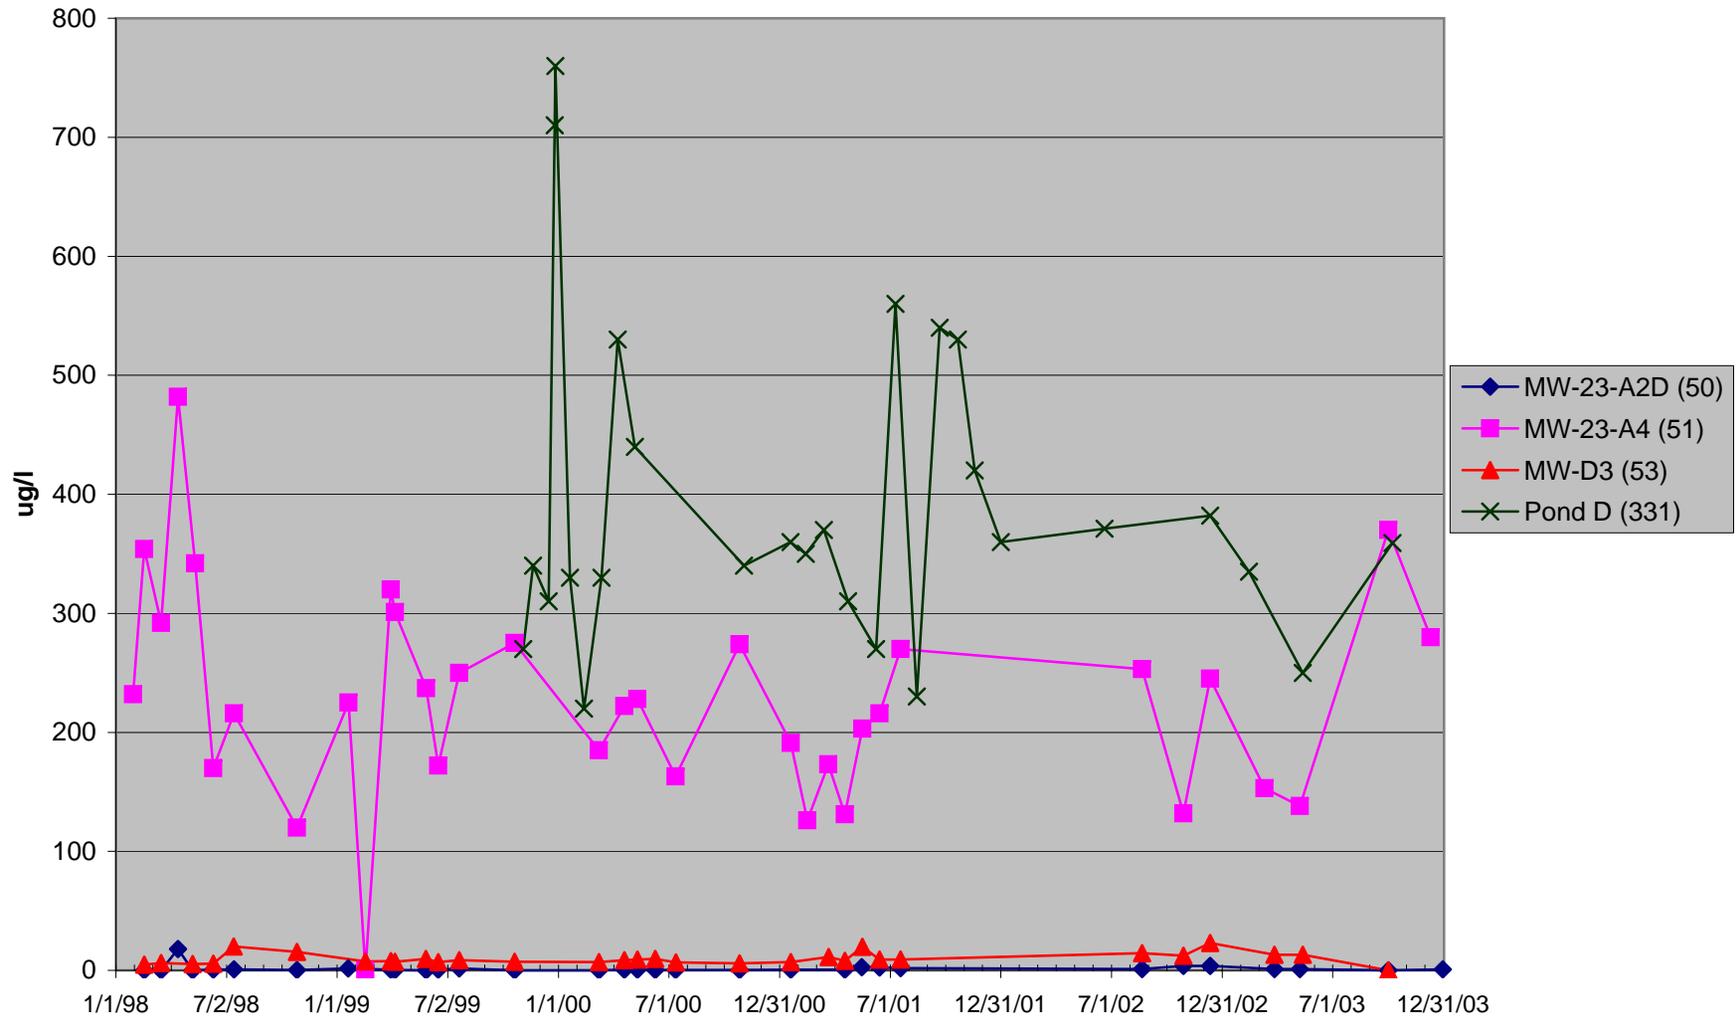
**FIGURE 3.20b GREENS CREEK SITE 23/D INTERNAL MONITORING SITES:
GROUND WATER - ZINC DATA
(Non-detectable analyses plotted as zero)**

Figure 3.20a and b shows the concentration of zinc in the internal monitoring locations at Site 23/D. Zinc levels appear to be controlled by seasonal conditions. The changes in zinc concentrations mimic those for conductivity and sulfate. 23FD-2 had a zinc concentration of approximately 70 mg/l in June 2002. In 2003, the zinc concentration averaged 20 mg/l. Zinc concentrations in the range of 20 to 70 mg/l are consistent with kinetic weathering tests performed on samples of argillite and serpentinite (Vos 1993). The zinc concentrations recorded for Pond D are generally below 0.7 mg/l and reflect contributions from several source waters. Pond D receives water from Site D surface runoff, seeps on the slope and at the toe of the site and the effluent from the curtain drain that KGCMC installed between Site D and Site 23.

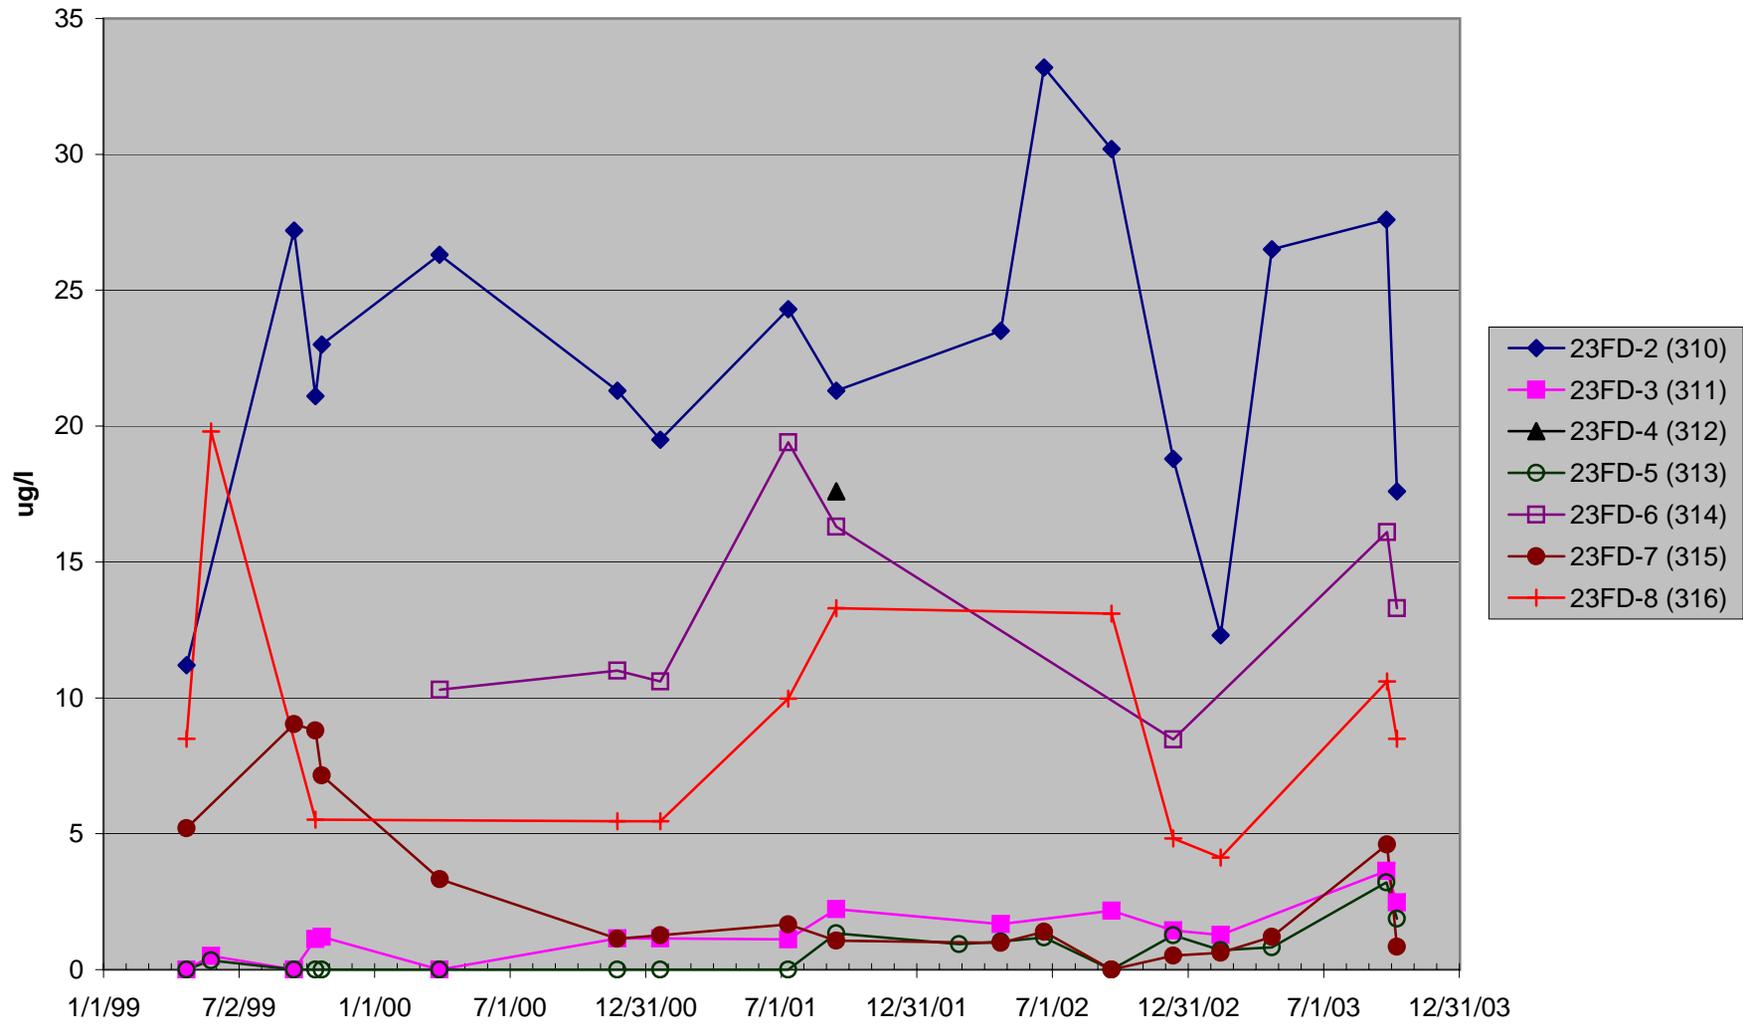
**FIGURE 3.21a GREENS CREEK SITE 23/D INTERNAL MONITORING SITES:
FINGER DRAINS - CADMIUM DATA
(Non-detectable analyses plotted as zero)**

Cadmium concentrations (Figure 3.21a and b) correlate well with those of zinc for the internal monitoring sites although at much lower values (0 to 35 ppb).

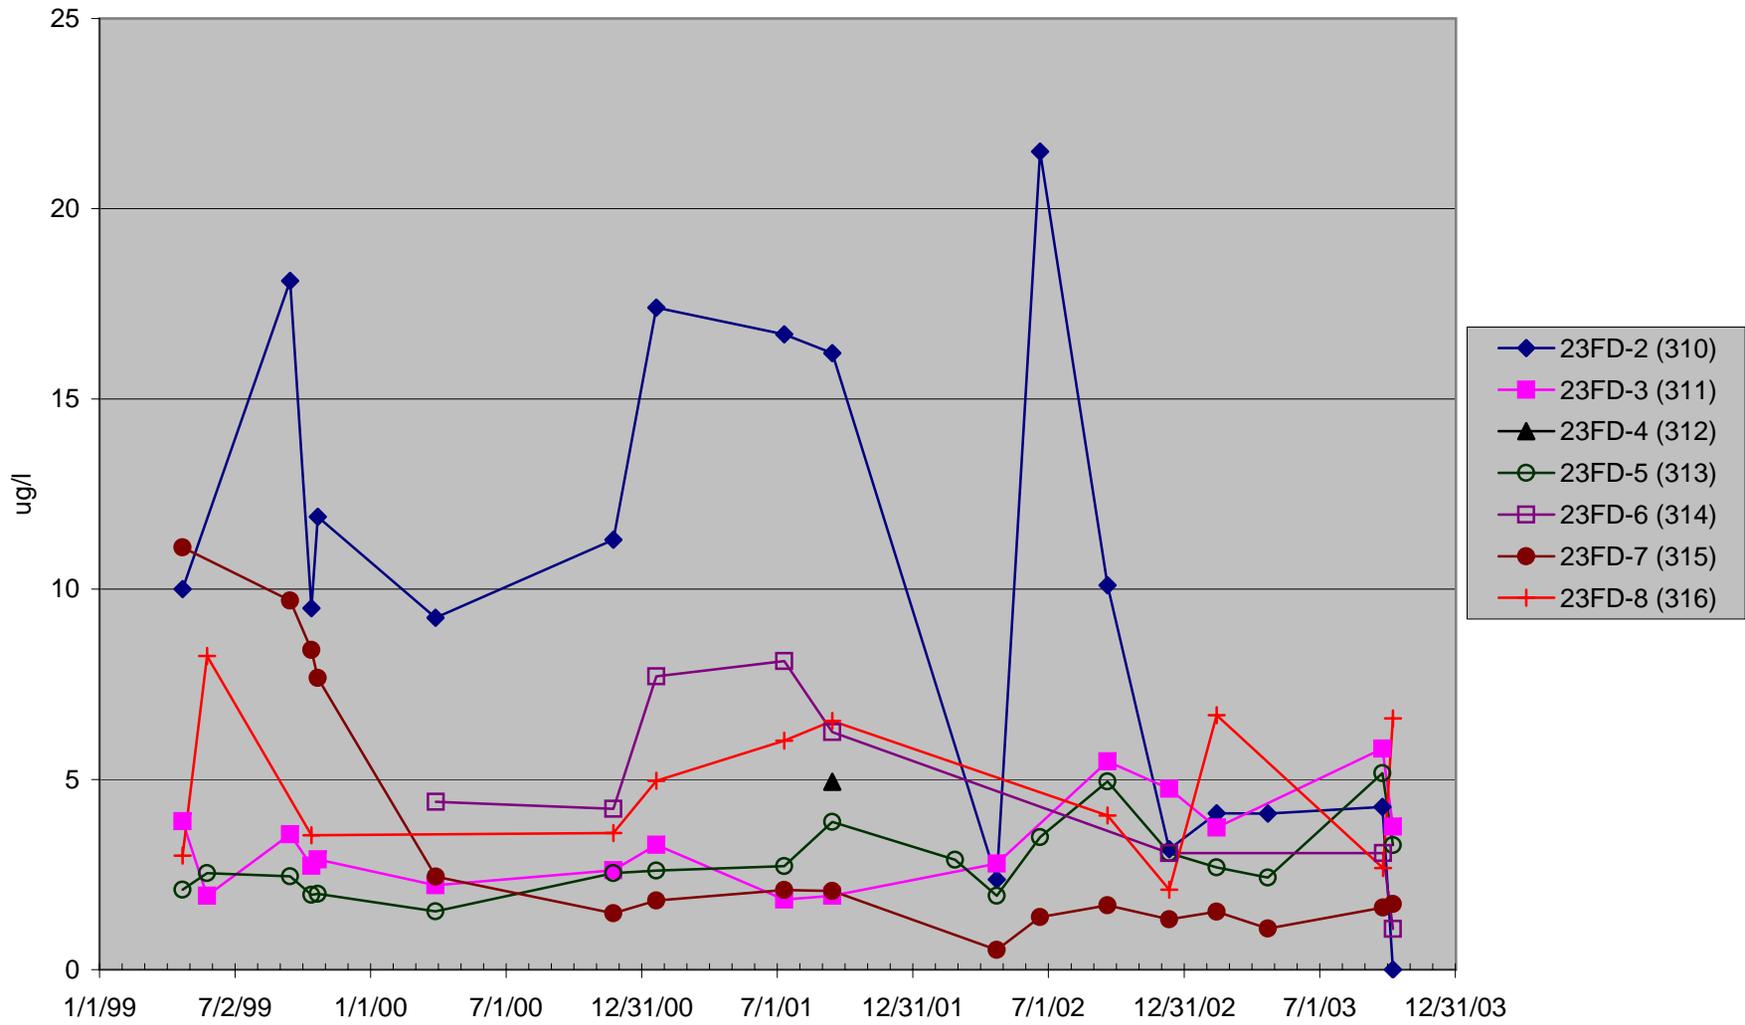
**FIGURE 3.22a GREENS CREEK SITE 23/D INTERNAL MONITORING SITES:
FINGER DRAINS - COPPER DATA
(Non-detectable analyses plotted as zero)**

The concentrations of copper and lead (Figures 3.22a and b and 3.23a and b) are considerably lower than that of zinc in the Site 23/D internal monitoring sites. Both of these metals show the same general trends as zinc with the exception of one anomalous lead result in a sample from 23FD-2 in 1999. The nickel concentrations presented in Figure 3.24a and b support the observation that the drainage from 23FD-2 is different than that of other drainages. It is possible that the material that supplies water to this drain has a greater proportion of serpentinite, which was shown to produce higher zinc and nickel concentrations than other rock types such as argillite and phyllite (Vos 1993). What appeared to be a linear increase in nickel concentrations in 23FD-2 prior to 2002 now appears to be decreasing or at least cyclical.

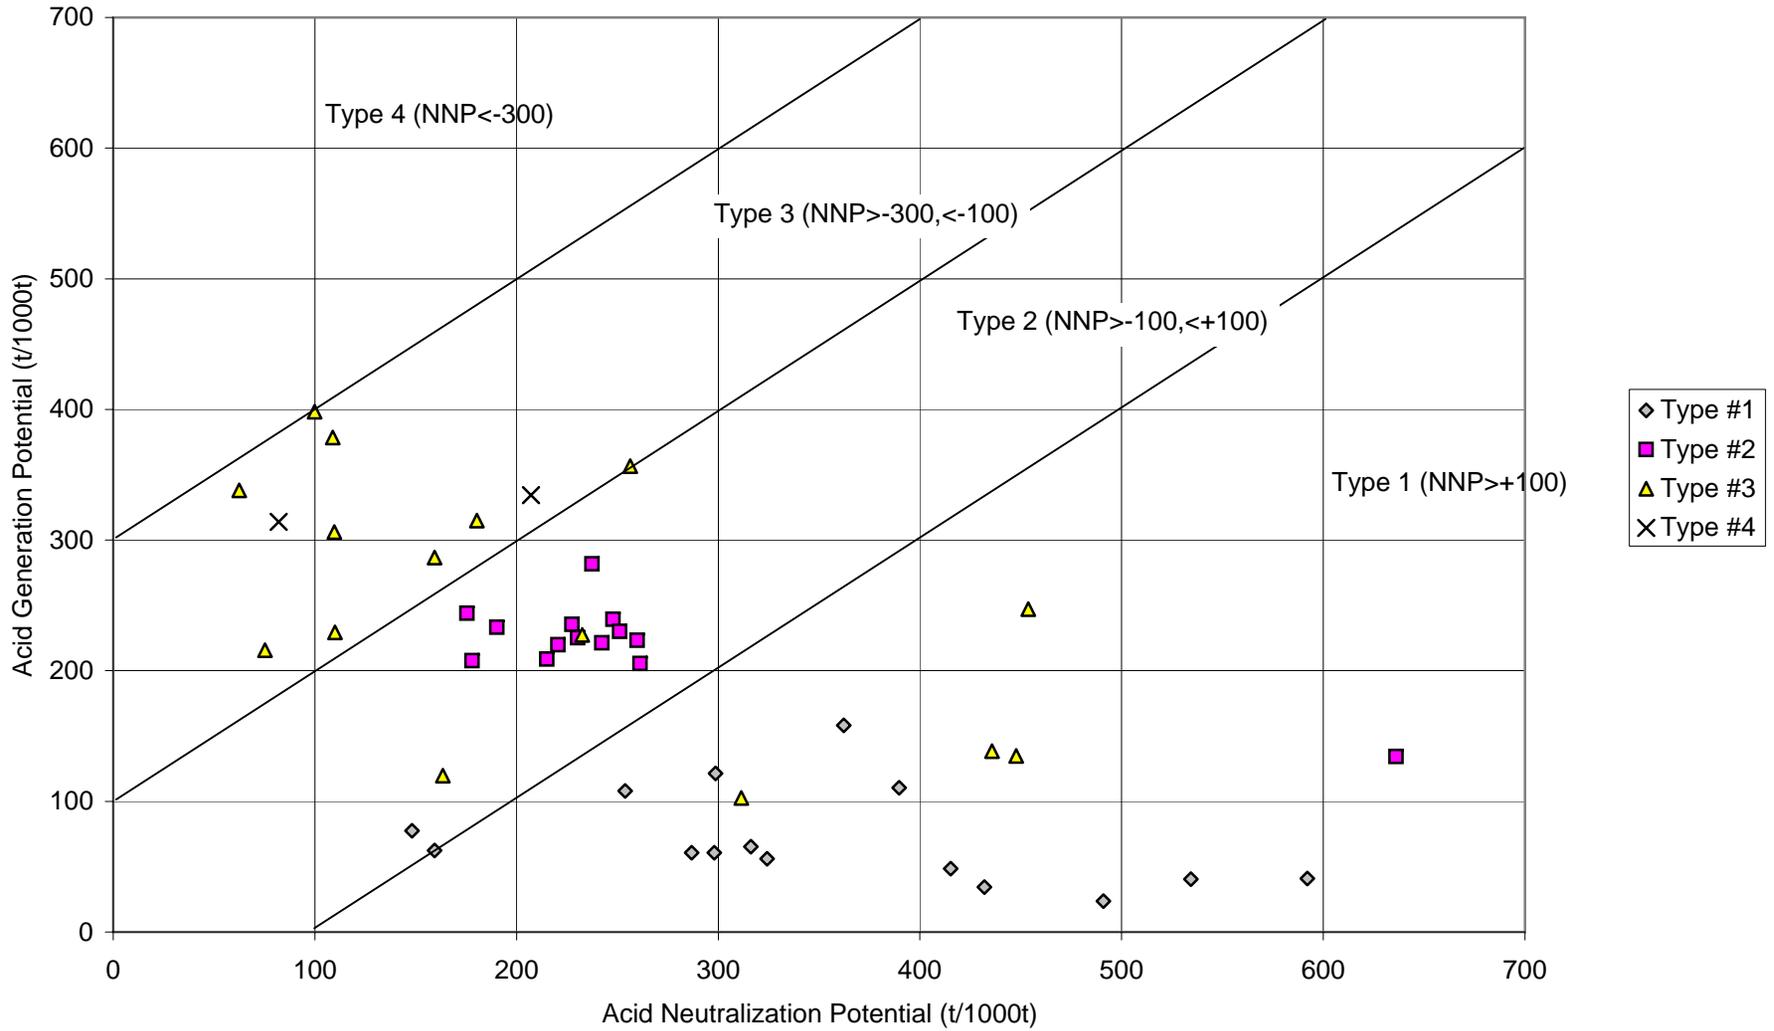
FIGURE 3.26 2003 UNDERGROUND RIB SAMPLES

Figure 3.26 compares actual class designation based on ABA analyses to the results of visual designation use underground to classify the production rock. Of the 46 composites, visual classification assigned only 2 samples (4%) to a lower, less conservative class. 35 (76%) of the composites were assigned to the appropriate class and 9 (20%) to a higher, more conservative class. These data represent a 96% success rate for the visual classification program.

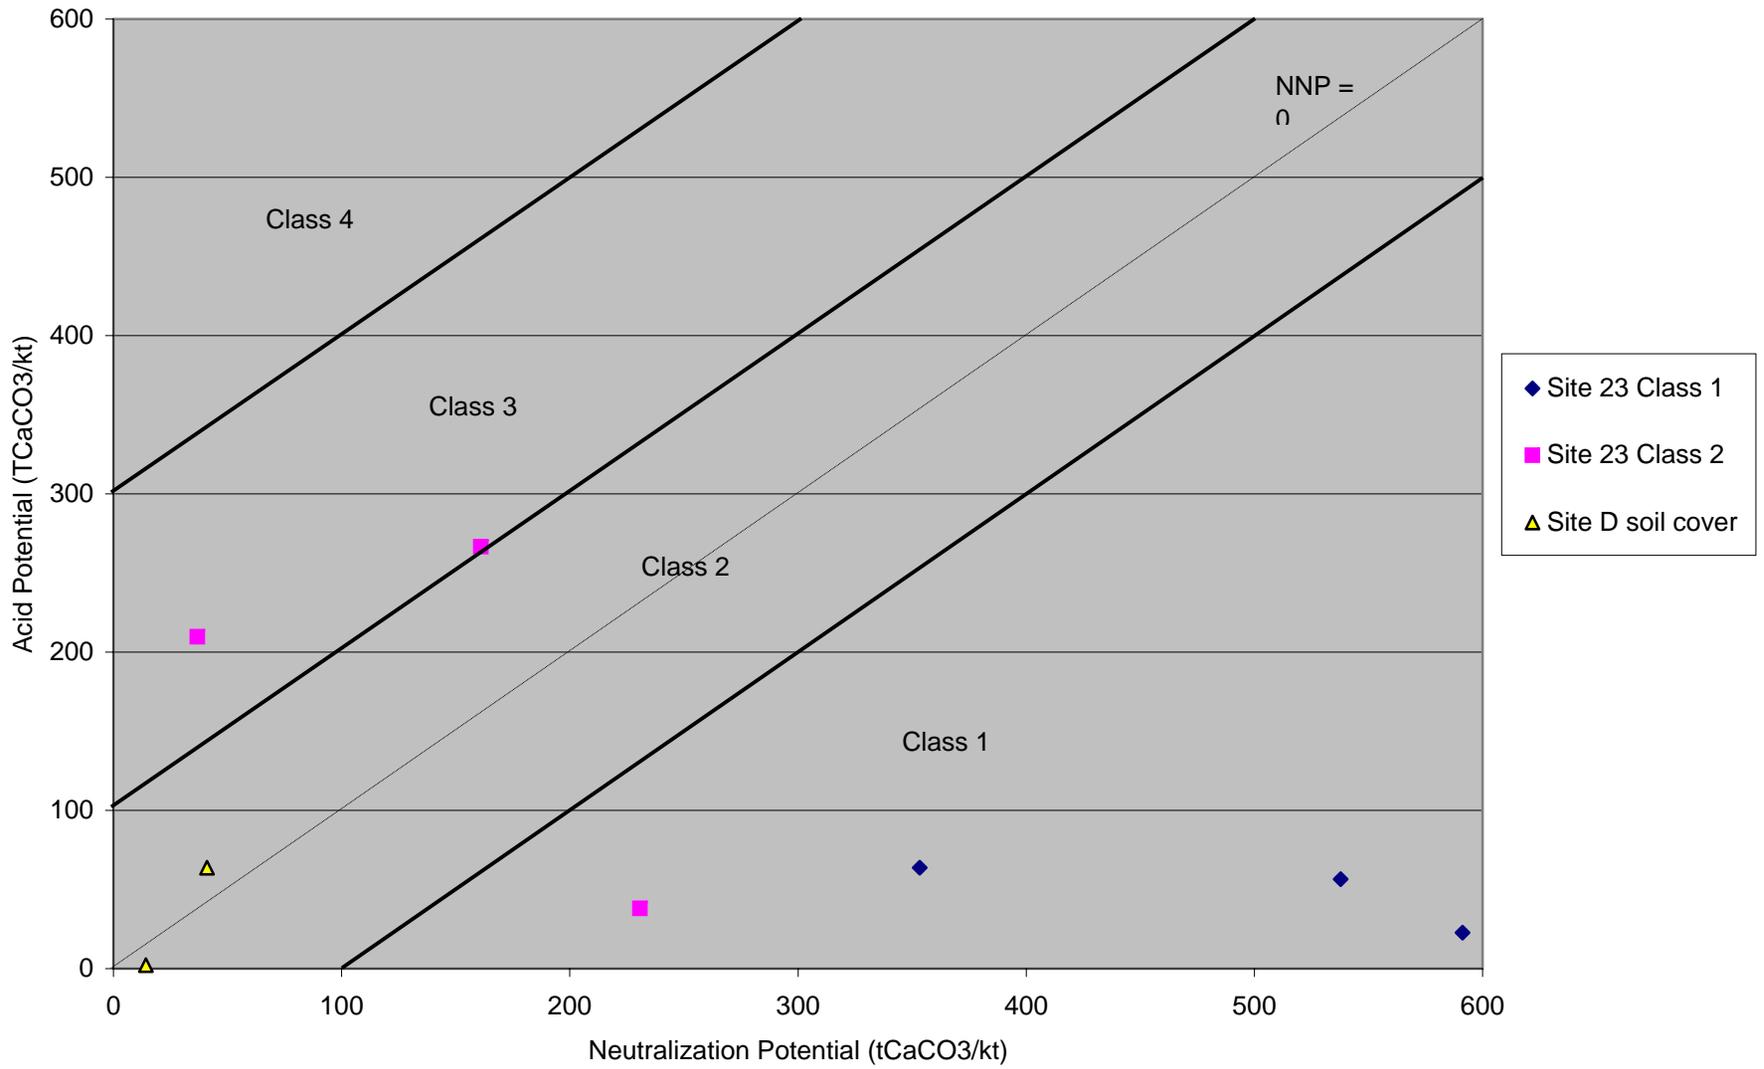
FIGURE 3.27 2003 ACID-BASE ACCOUNTING ANALYSES

Table 3.3 and Figure 3.27 shows the ABA data from surface sampling at Site 23 and the Site D interim soil cover. The AP to NP distribution in the Site 23/D samples is similar to the underground rib samples. Many of the samples at Site 23 were taken near the boundaries of the classification areas, and may be more representative of a mixture of classes. Therefore some of the data points do not fall neatly into the classification areas on the graph.

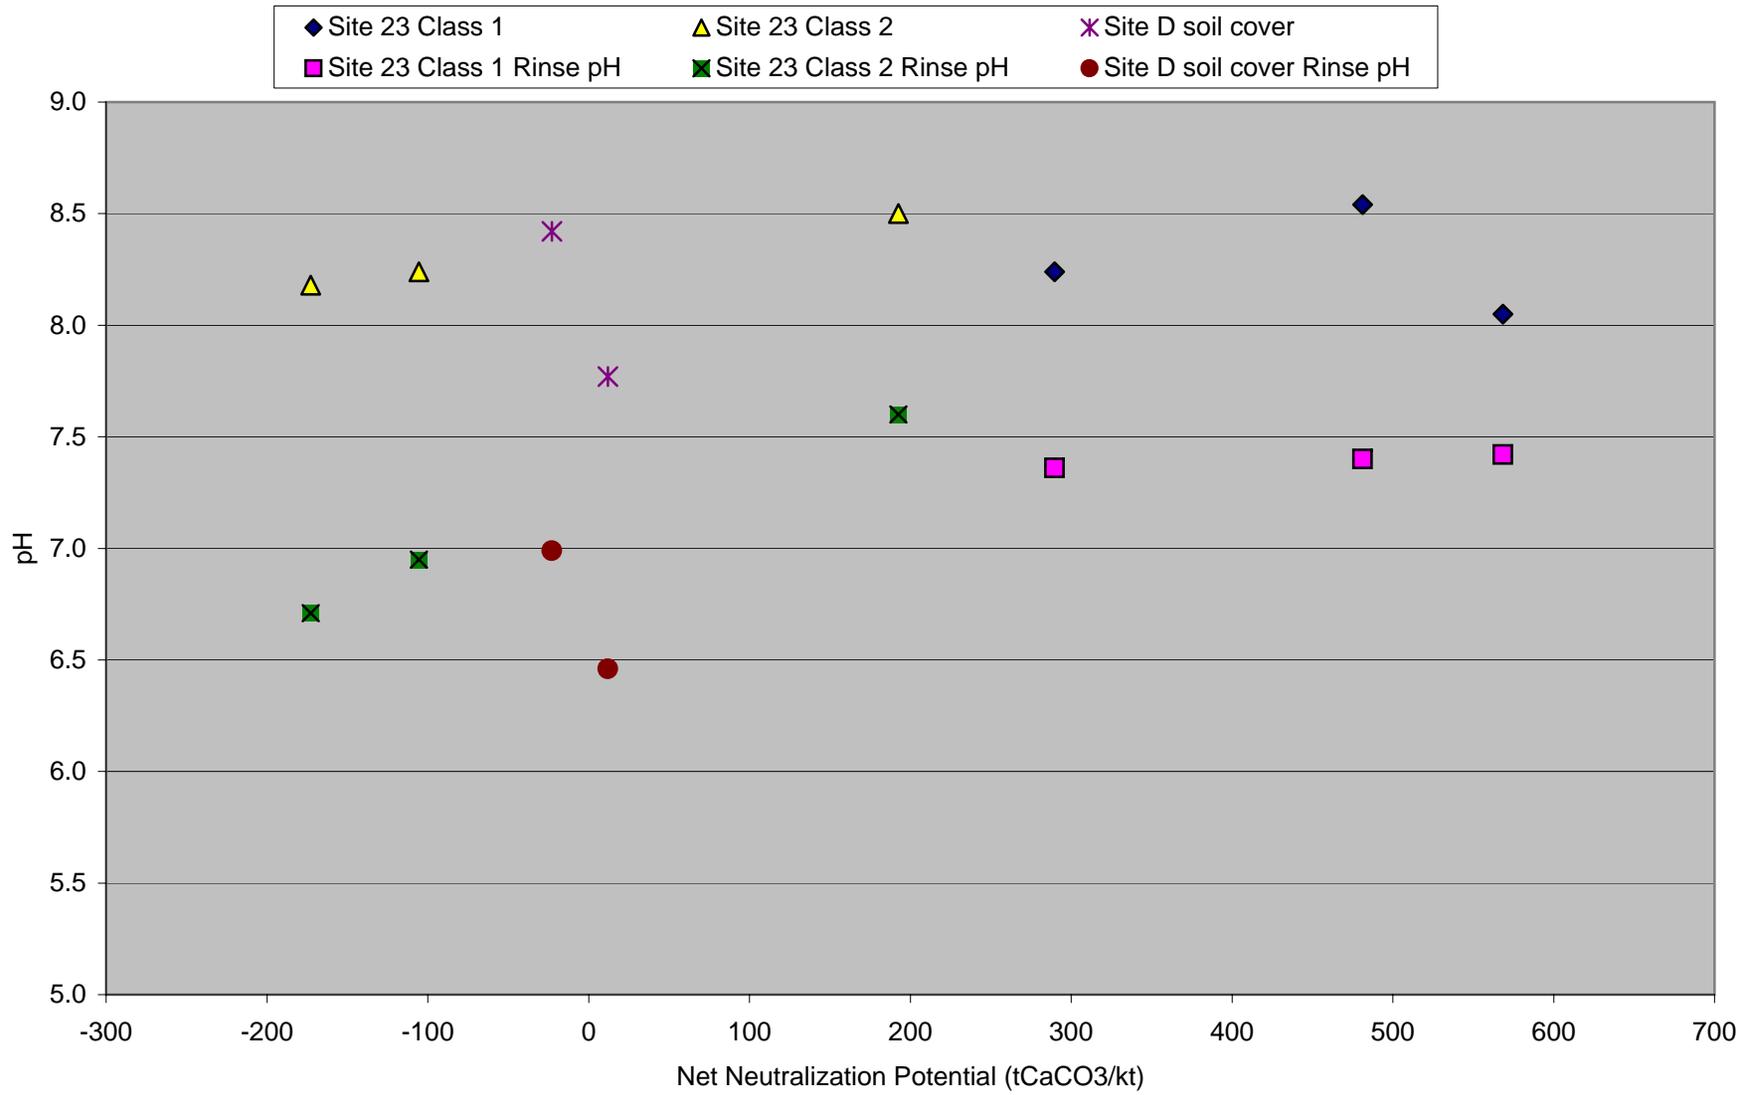
FIGURE 3.28 2003 pH versus NNP

During the grid sampling of Site 23 and Site D, 32 rinse pH measurements were taken. None of the samples had a rinse pH value less than 6.0. Currently drainage from this area is collected and pumped to the Pit 5 water treatment facility. The distribution of pH and NNP (Figure 3.28) illustrates that alkaline conditions persist at both sites. The difference between paste pH and rinse pH is due to different preparation methods. The paste pH is typically higher than rinse pH because the sample is pulverized, which tends to expose fresh mineral surfaces. The rinse pH method uses more water, which can dissolve oxidation products and lower the test solution pH.

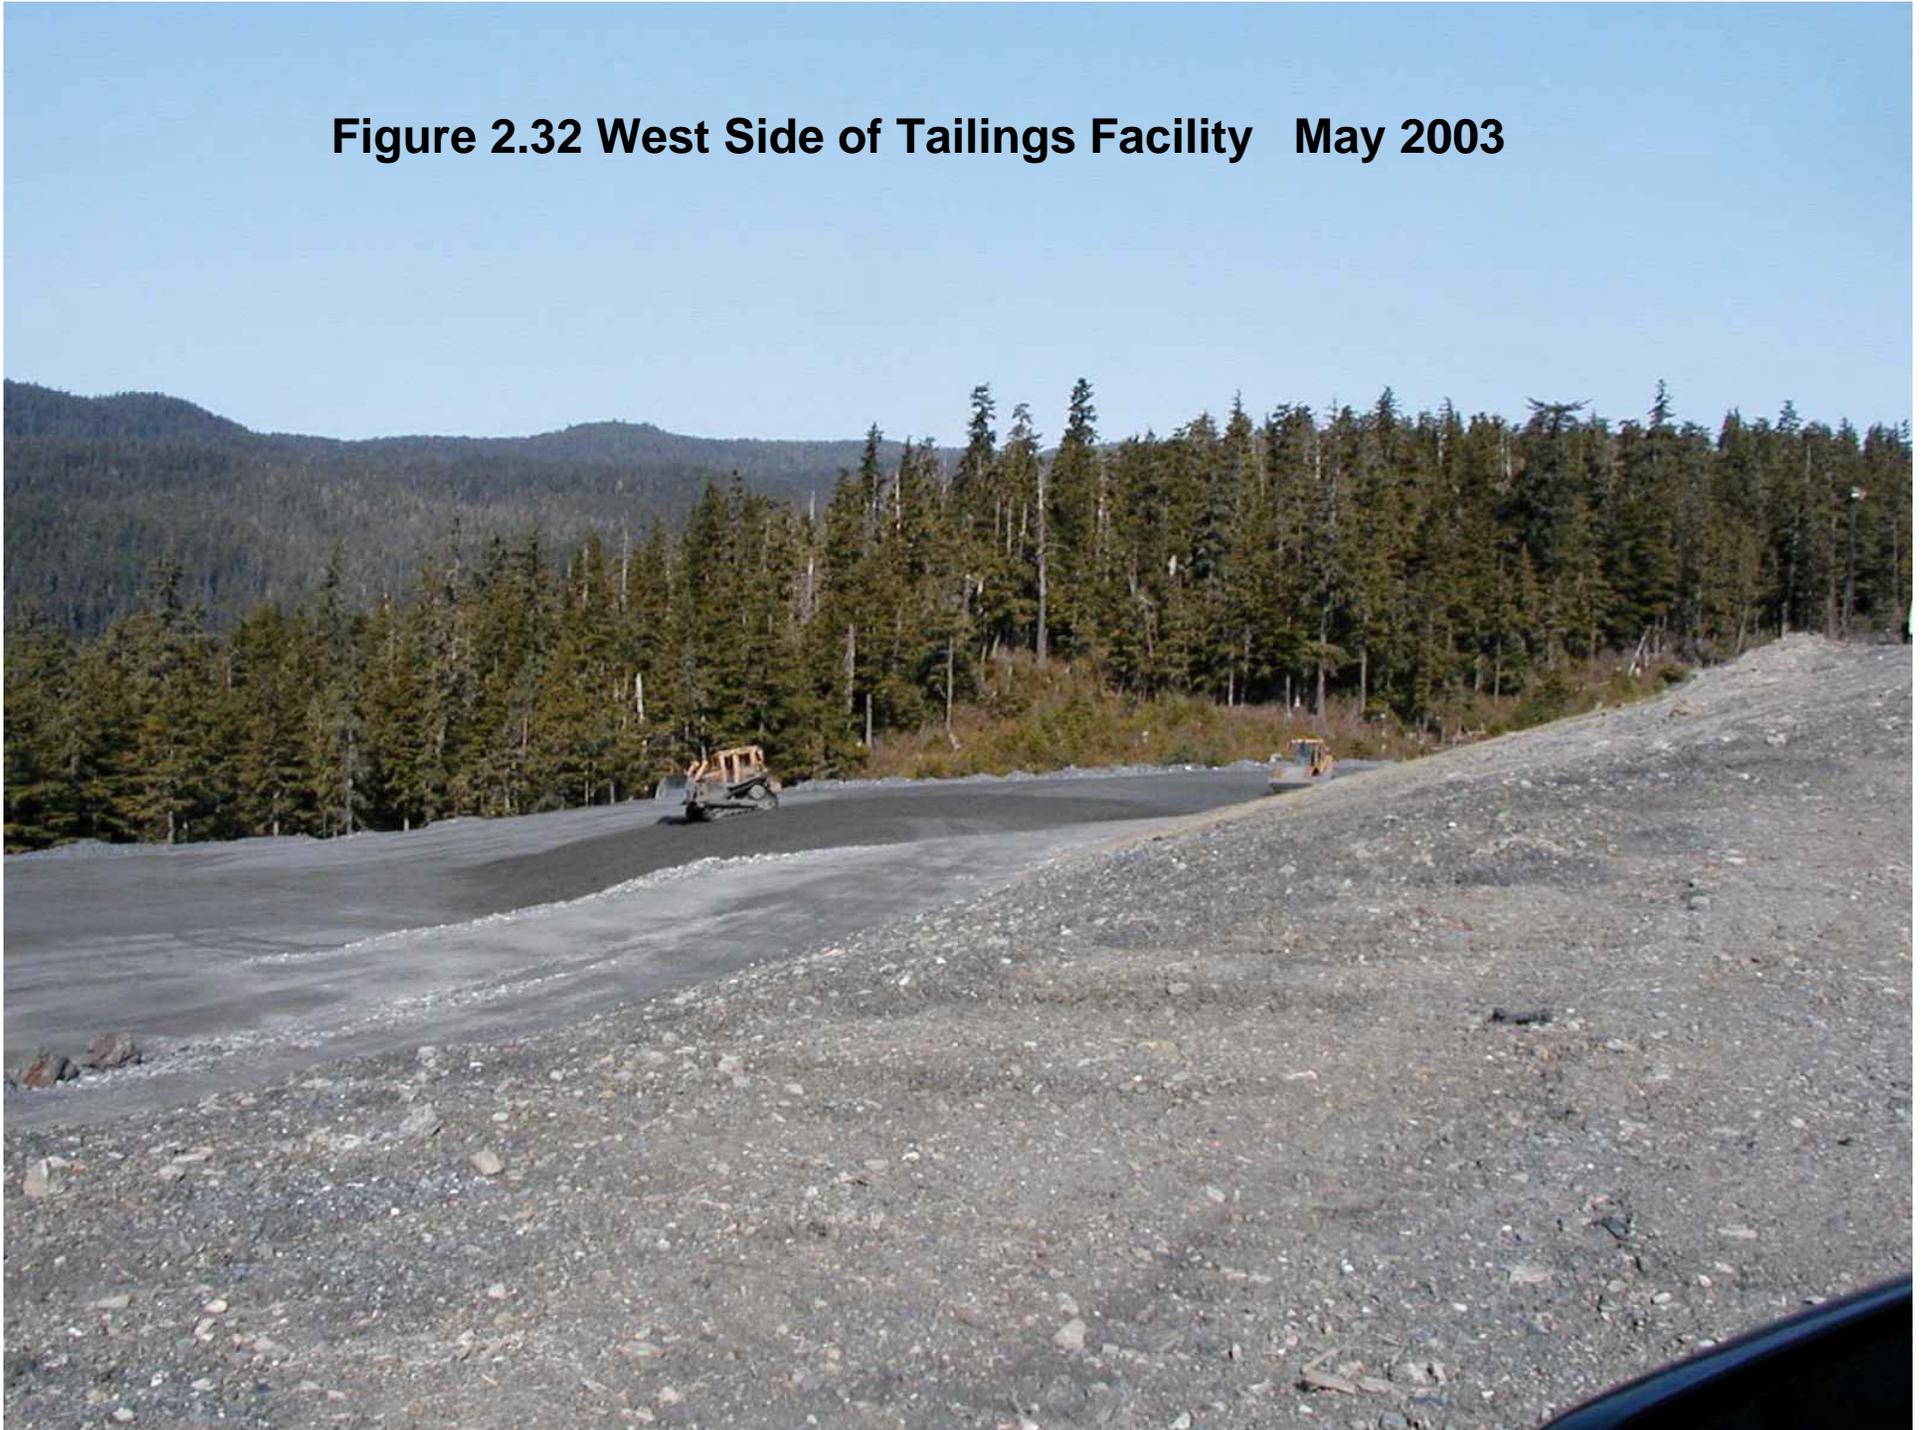
Figure 2.32 West Side of Tailings Facility May 2003

Figure 2.32 shows the west side of tailings, in a typical placement area. Tailings are spread in thin lifts with a bulldozer (left) and compacted with a vibratory roller (right). The tailings are spread and compacted in thin, inclined lifts in a cell that has an overall thickness of approximately five feet. This promotes drainage and dissipation of pore pressures that rise as the material is compacted. 17% of the overall placed tails for 2003 were put into West Buttress. Tailings are placed in cells and the 3H:1V outer slope is covered with Class 1 production rock or native materials to minimize erosion.

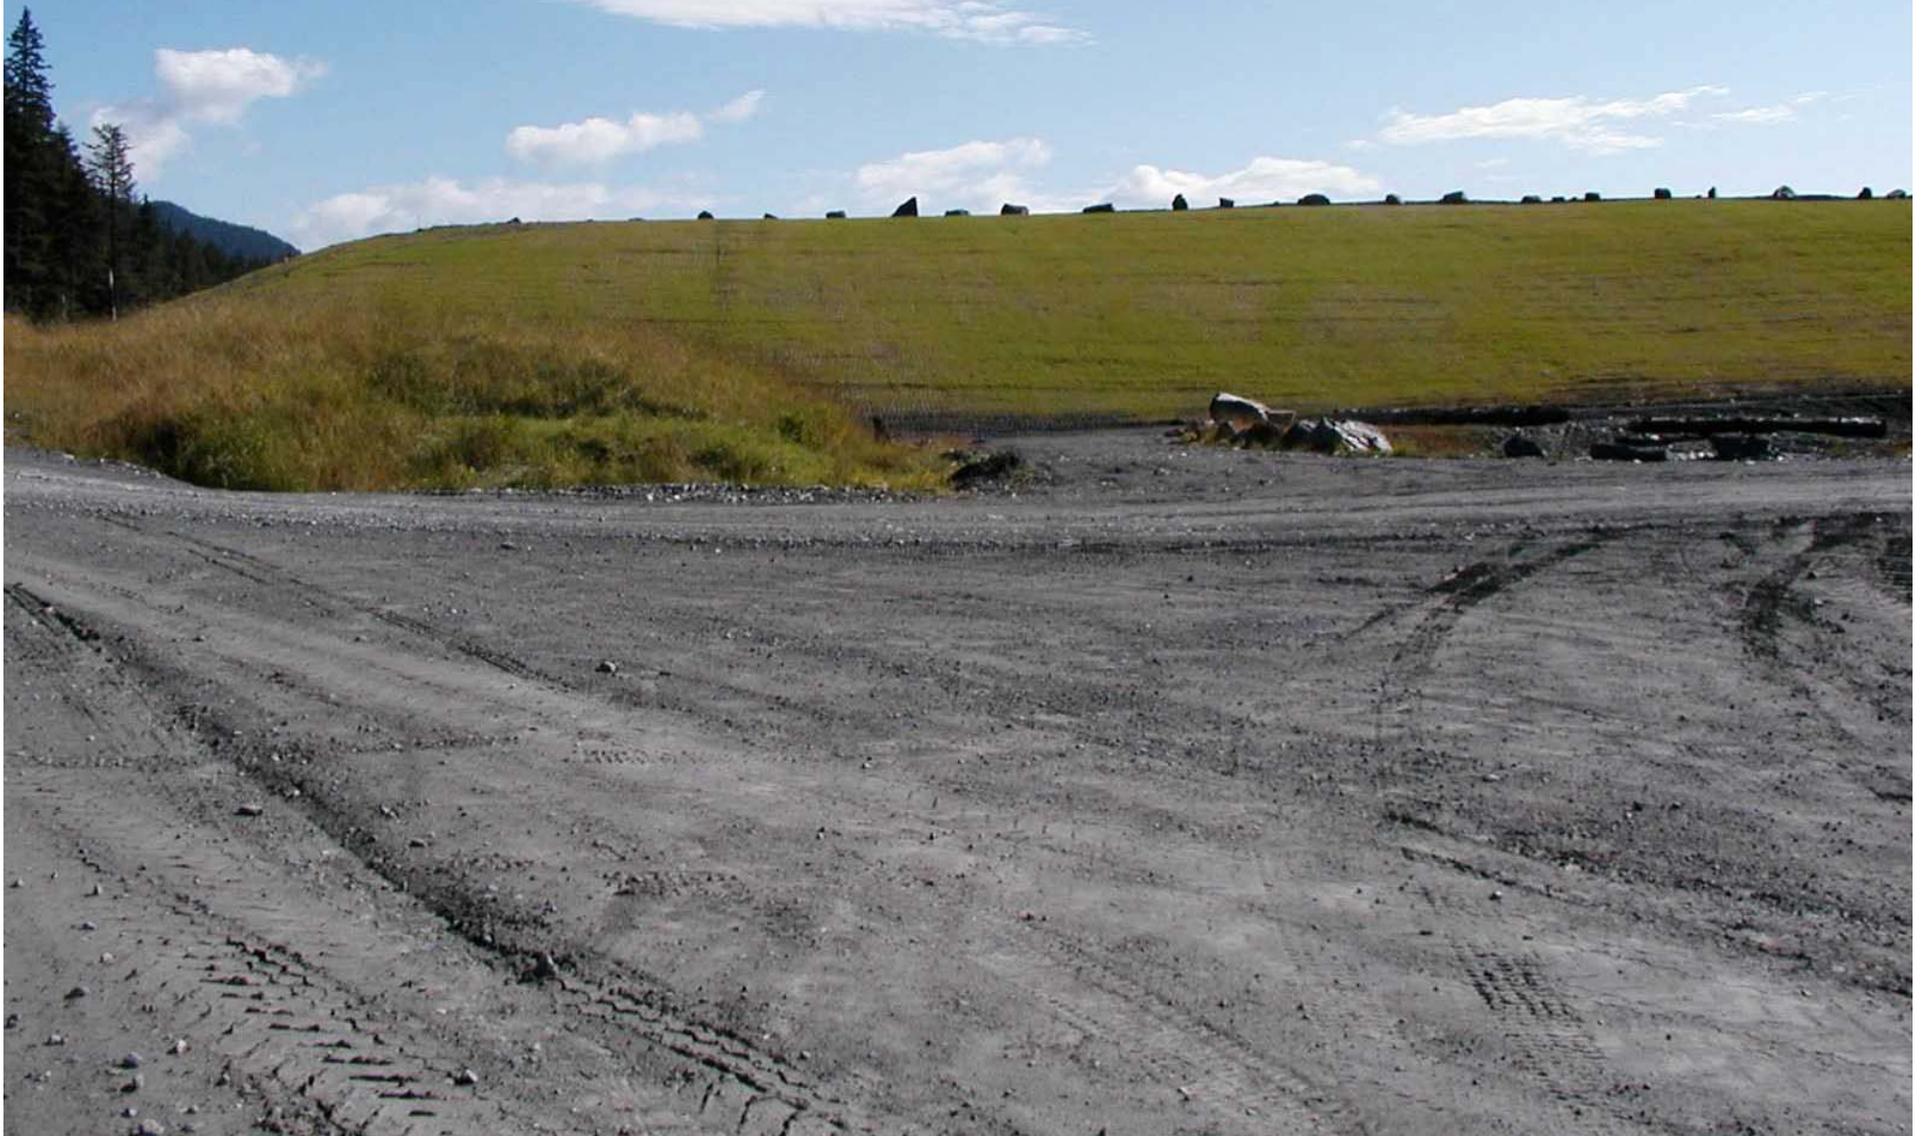
**Figure 2.33 North Side of Tailings Facility (Post Hydroseeding)
August 2003**

Figure 2.33 shows the north side of tailings. The photo was taken in August, a few months after the area had been hydroseeded.
