**TAILINGS AND PRODUCTION ROCK SITE
2007 ANNUAL REPORT**

Kennecott Greens Creek Mining Company

April 15, 2008

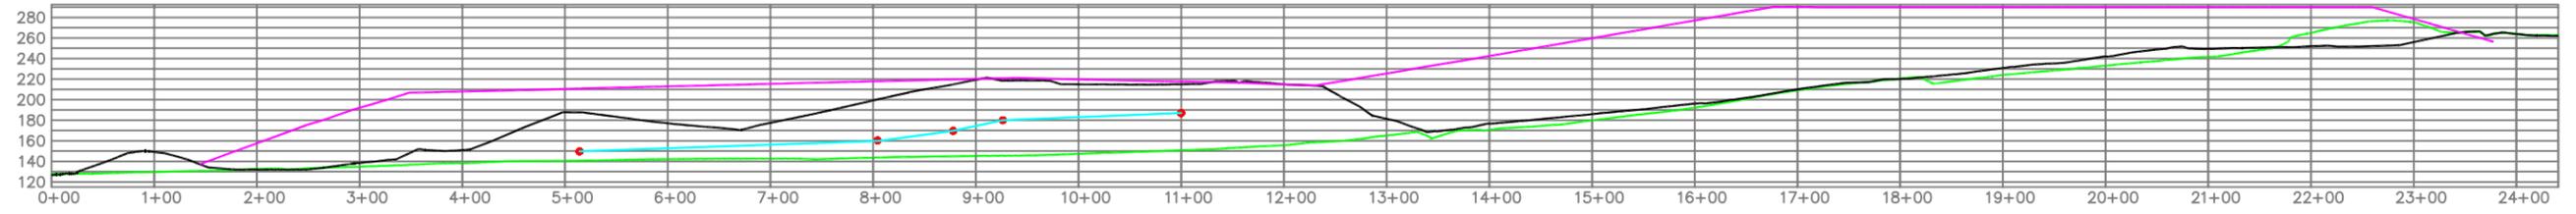
DATUM ELEV
SECTION AA

Section AA of the tailings facility as-built shows the inferred water table in the tailings pile. The maximum saturated thickness (approximately 35 feet) occurs near the center of the main portion of the pile. However, that water table level does not extend close to the down-slope toes of the pile. The foundations of the West Buttress and southern portion of the pile are well drained, as indicated by typically consistent unsaturated conditions in the blanket drains (MW-T-00-05A, Figure 2.14) and at the base of the West Buttress (piezometers 74 and PZ-T-05-08 in Figures 2.8 and 2.9). Low head elevations near the pile toe maximize the pile's geotechnical stability. Intermittent head increases are localized and of short duration and should not have an adverse effect on pile stability.

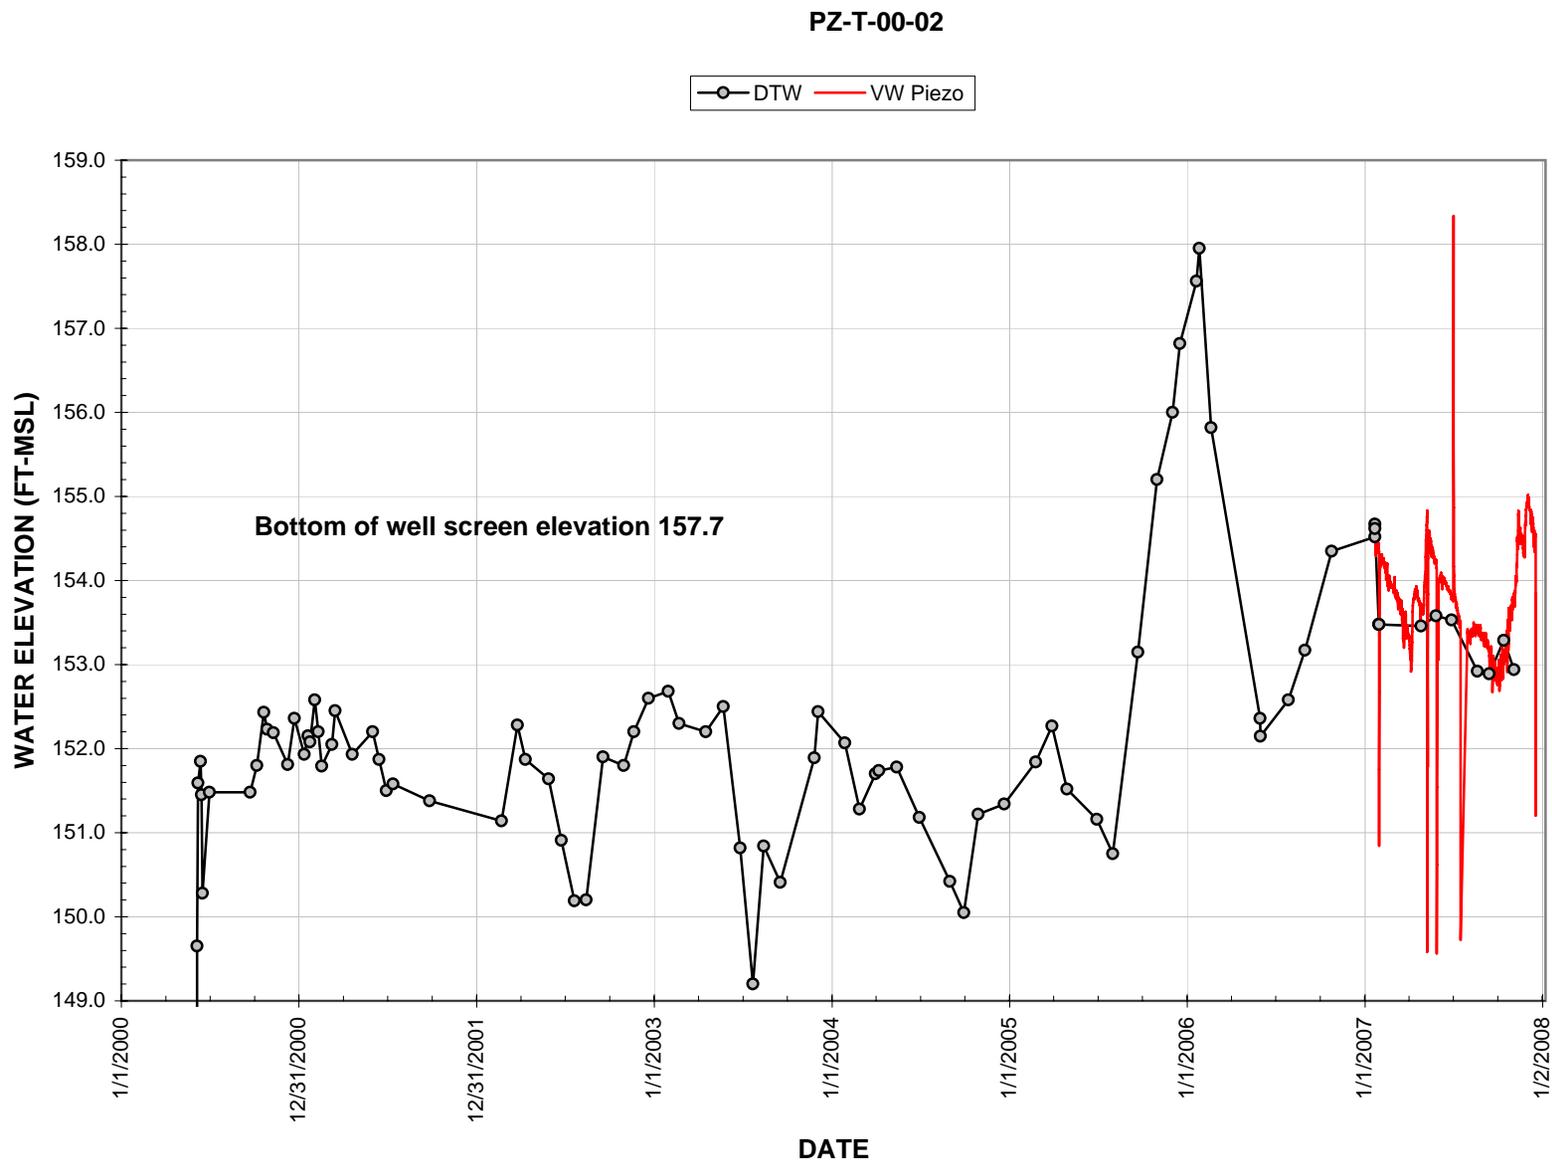
Figure 2.12 Water Level Data for Standpipe Piezometer PZ-T-00-02

The data from standpipe piezometers completed above the blanket drain (PZ-T-00-01, PZ-T-00-02, PZ-T-00-03 in Figures 2.11, 2.12, 2.13) indicate that the water perches above the unsaturated underdrains to a thickness of approximately 12 feet. This is consistent with the low permeability of the tailings and the un-capped condition of the pile. Covering the pile will help minimize the saturated zone in the pile. This was demonstrated by the over 10 foot decrease in the water table that occurred from 1995 to 1997 when the pile was covered (see Figures 2.1 to 2.7). Water levels have rebounded to, and in some cases above, 1994 elevations in most areas. Areas where water levels exceed their 1994 values are areas where the pile is considerably thicker than it was in 1994.

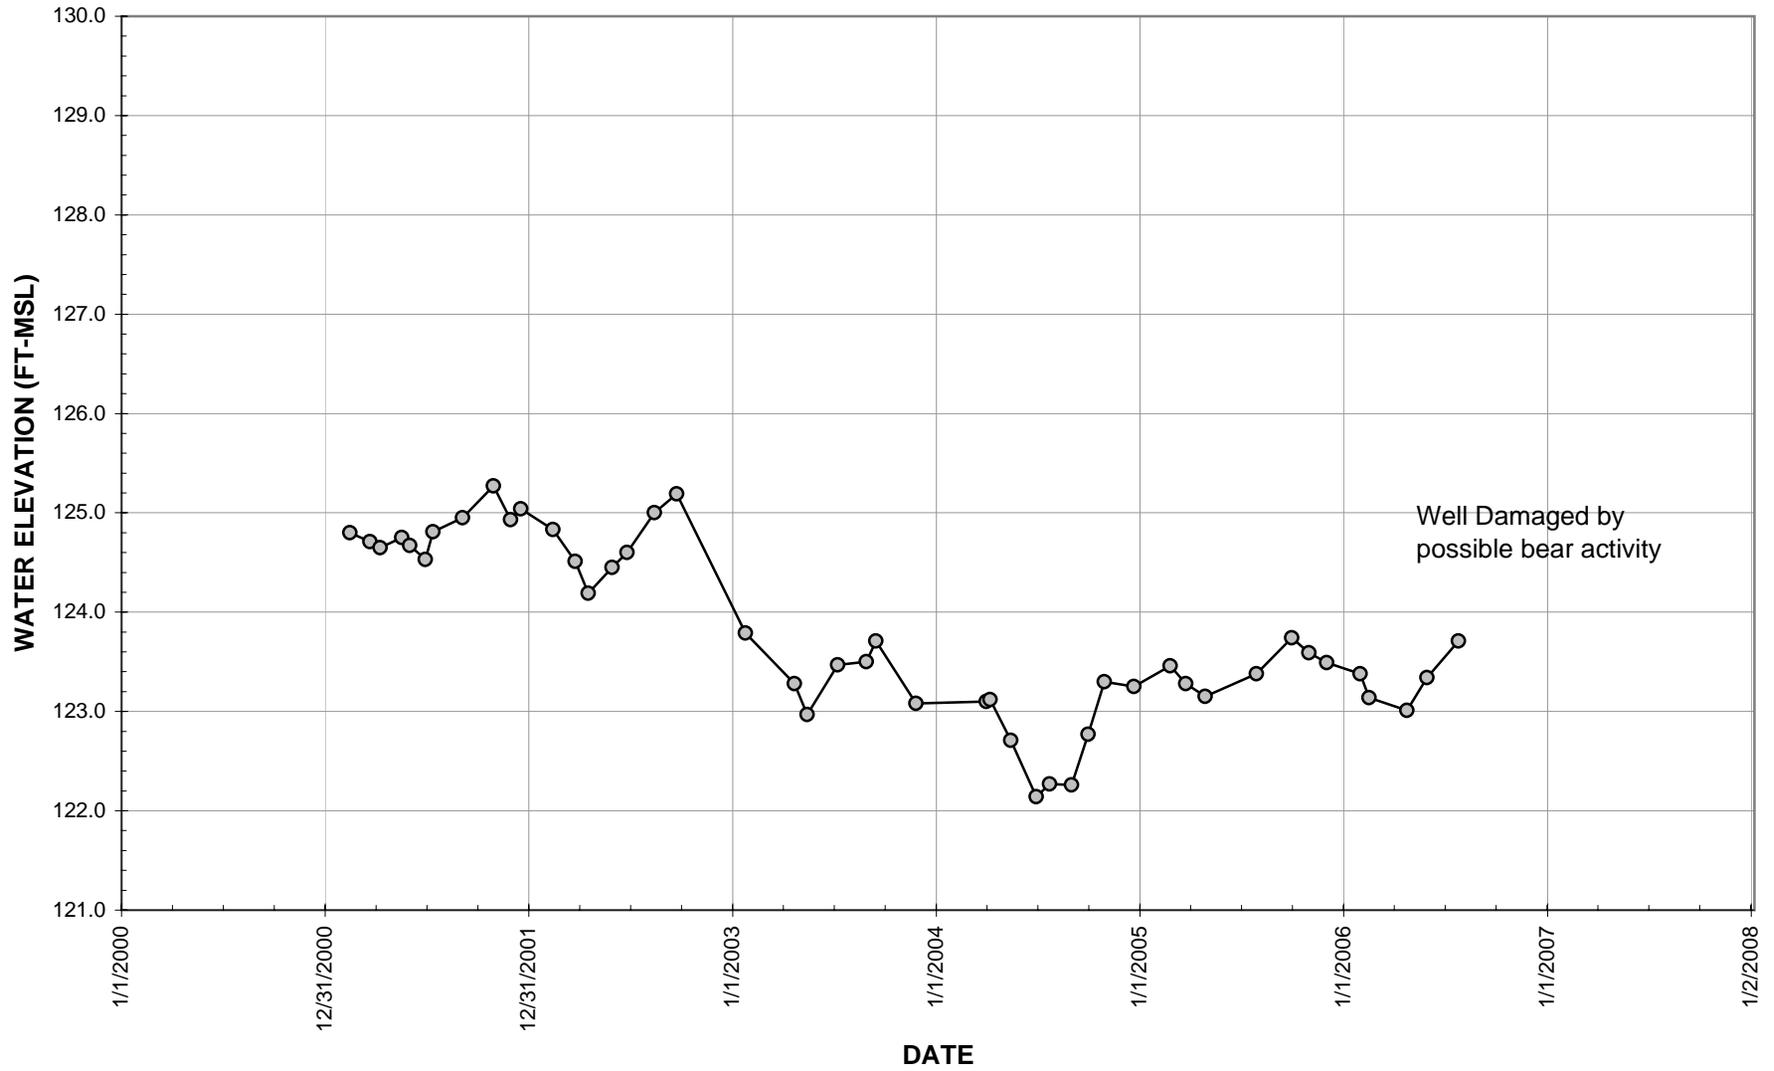
Figure 2.17 Water Level Data for Well MW-T-01-03A

Water levels for four wells completed east and west of the pile are shown for comparison in Figures 2.15 to 2.18. The eastern wells, MW-T-00-03A (Figure 2.15) and MW-T-00-03B (Figure 2.16), are completed in the shallow sands 12 and 17 feet, respectively, below ground surface. The figures for these wells show that the water elevation in shallow completions in native materials can be readily influenced by abnormal weather conditions. Wells MW-T-01-03A and MW-T-01-03B are installed west of the pile. Their water levels are shown in Figures 2.17 and 2.18, respectively. MW-T-01-03A is completed in bedrock to a depth of 20 feet and MW-T-01-03B is completed in clayey silt to a depth of 12 feet. These wells show similar water level fluctuations with weather conditions as the two eastern wells. However, the water level in MW-T-01-03B shows a larger differential than MW-T-01-03A because silts and clays hold more water in tension, so a small increase in water content causes a large change in head. The ground surface elevation is 134 feet in the proximity of these two wells. Both MW-T-01-03A and MW-T-01-03B were damaged, likely by wildlife, in the summer of 2006. Several attempts were made to repair the wells in 2007, but they could not be recovered. Therefore, no data were obtained from those wells in 2007. KGCMC will make another attempt to repair the wells in 2008 and if unsuccessful, will consider replacing them during a future drilling program.

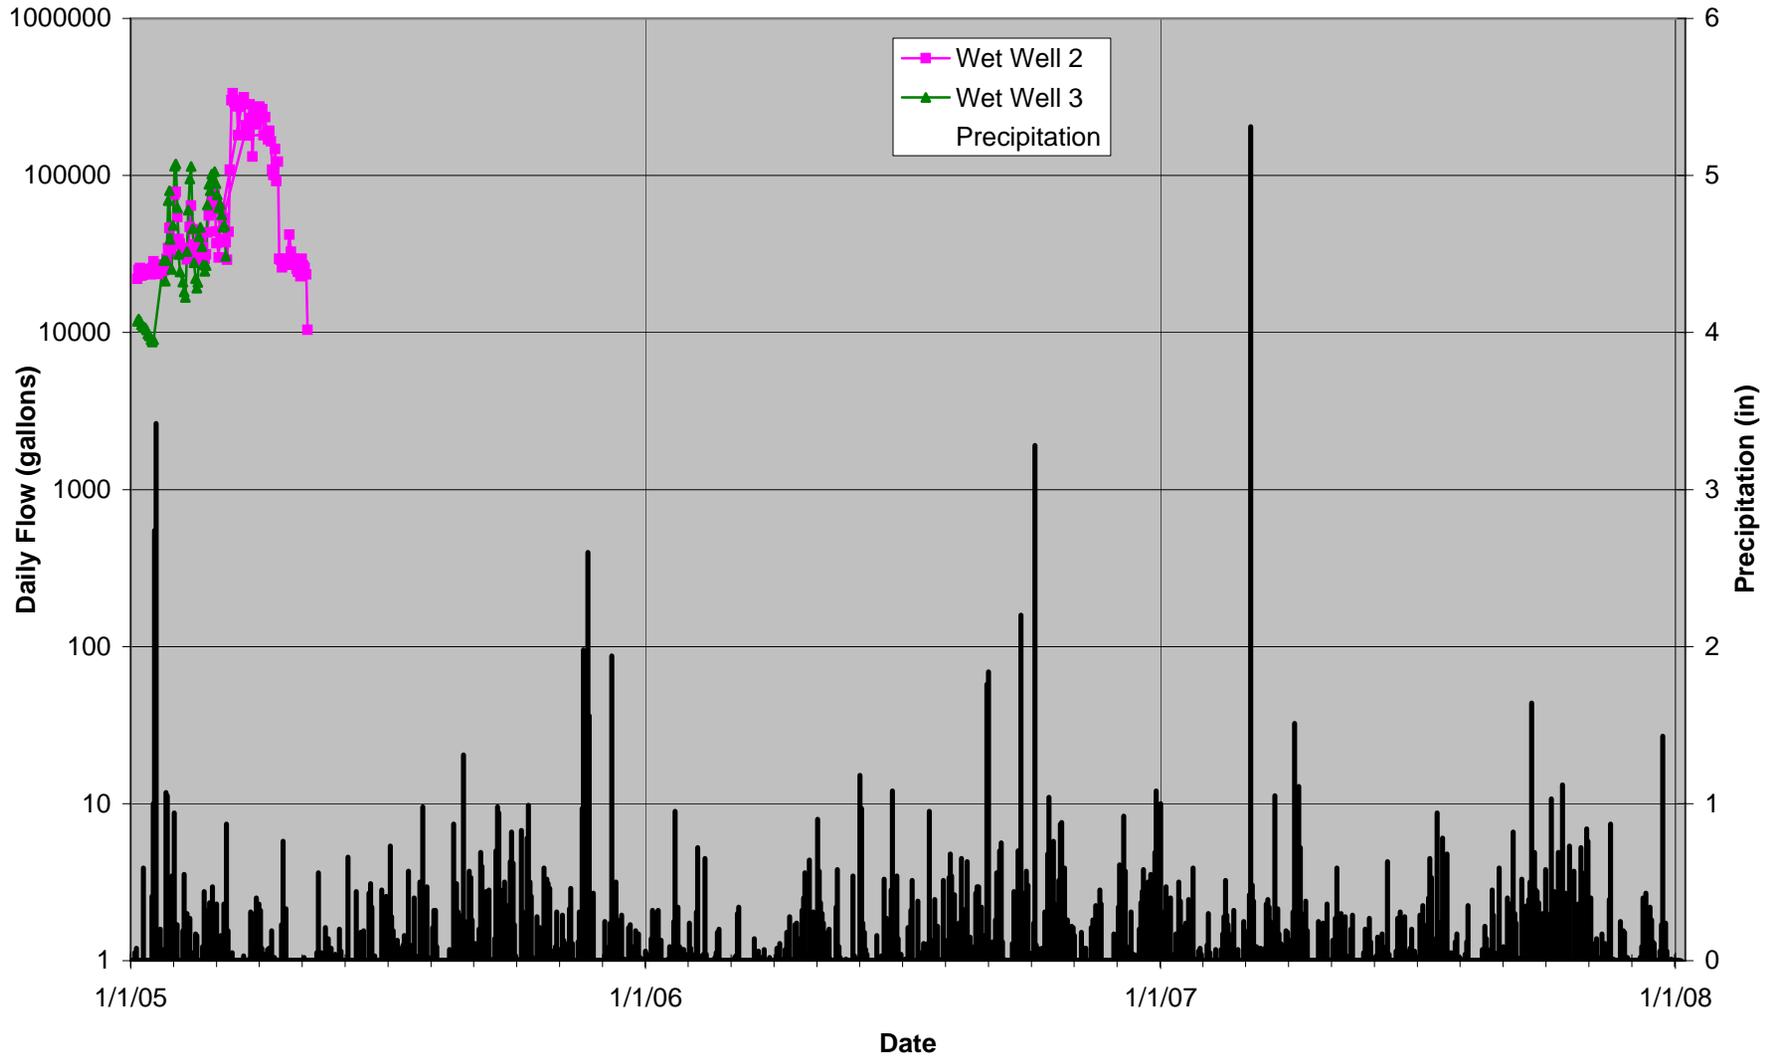
Figure 2.19 Tailings Area Wet Well Flow Data

Precipitation and temperature data are presented in Table 2.4. The precipitation data collected in 2007 is far greater than would be expected and does not likely represent actual precipitation. The area experienced record snow levels in 2007. The rain gage at the Tailings area was buried in snow which resulted in an excess of snow melt entering the rain gage (via a funneling effect) during periods of melting and produced higher than actual precipitation readings. However, precipitation measurements for months that the gage was not covered in snow (summer and fall) gave accurate precipitation data. June was the driest month with 2.64 inches. July and August were the warmest months while February exhibited the coolest temperatures. Flow data from Wet Wells 2 and 3 for 2005 are presented with the precipitation data in Figure 2.19. The wet well flows respond relatively quickly to precipitation events, demonstrating a significant contribution of surface water. The use of the wet well flow meters has been discontinued since 2005 as part of

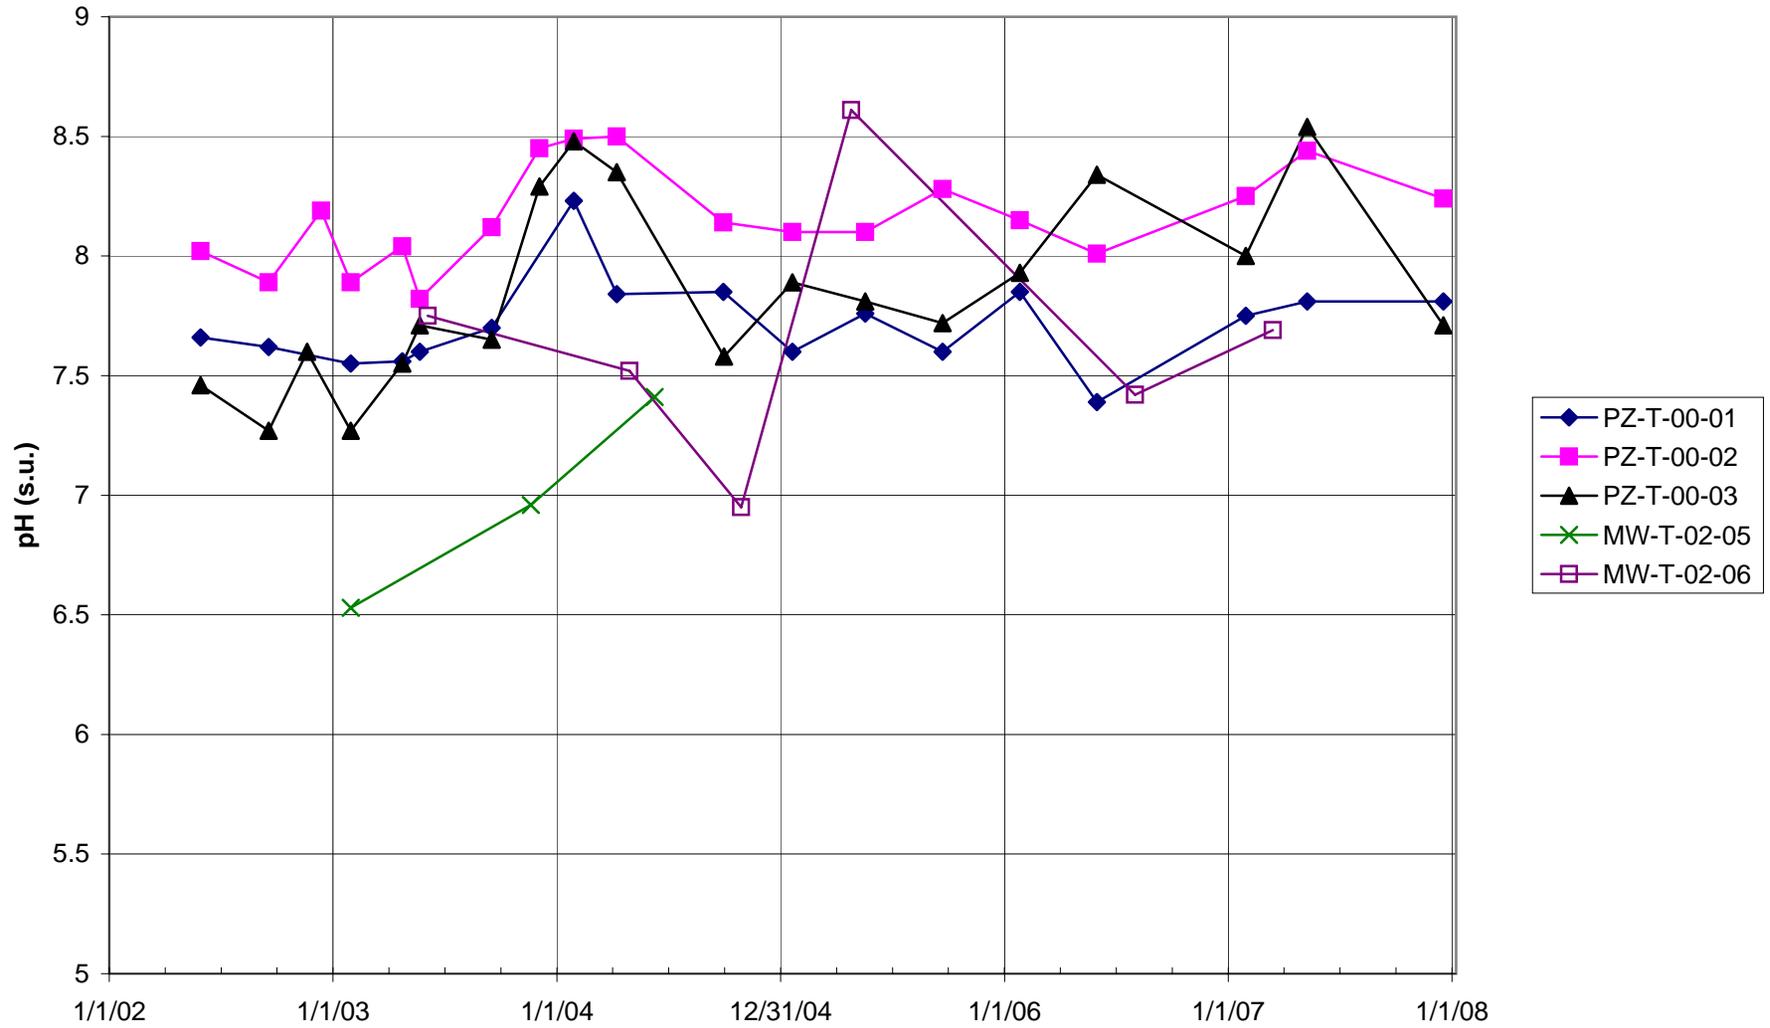
**FIGURE 2.20b GREENS CREEK TAILINGS INTERNAL MONITORING SITES:
TAILINGS COMPLETIONS - pH DATA**

Most values of pH remained between 6 and 8.5 for all internal monitoring site samples in 2007 (Figures 2.20a, b and c). PZ-T-00-01, PZ-T-00-2 and PZ-T-00-3, which screen the lower ten feet of tailings pile, have the highest pH of the internal monitoring sites. This is likely a result of microbial sulfate reduction and equilibration with carbonate in the saturated zone of the pile. The wet wells produce water with slightly lower pH (generally between 6.5 and 7), reflecting minor influences from groundwater (organic acids) and oxidized surface waters (acidity from thiosalt, sulfide and iron oxidation). The suction lysimeters all have pH values between 6.87 and 8.03 with the exception of SL-T-02-06 in 2006 and 2007 which showed pHs of 8.87 and 9.3, likely a result of sulfate reduction.

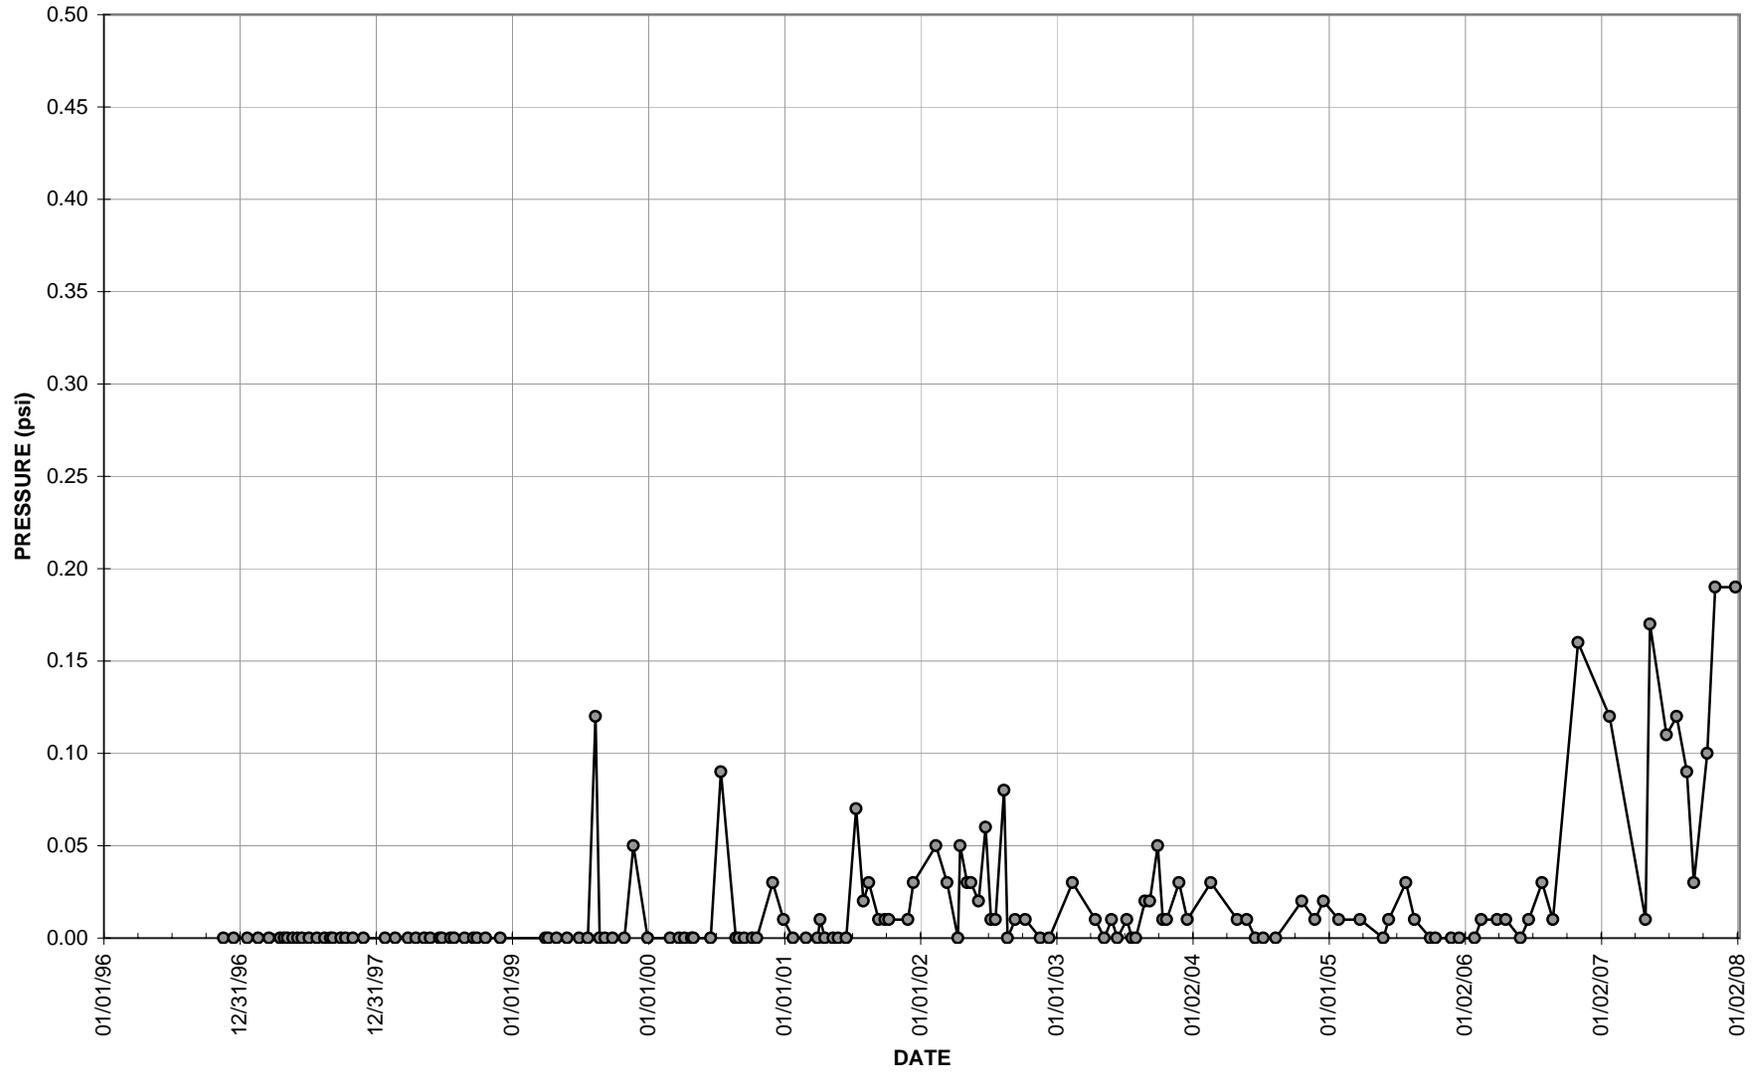
Figure 3.1 Pressure Data for Piezometer 52

Well and piezometer water level data are provided in Figures 3.1 to 3.12. The lack of significant pressure in piezometers installed close to the base of Site 23 (piezometers 52-55, Figures 3.1 to 3.4) demonstrates that the pile remains free draining. This is consistent with the construction of a network of finger drains under the pile and a blanket drain at the pile toe. Comparison of historic versus modeled flow from the finger drains and the curtain drain indicated they are performing as designed and as necessary (EDE, 2004). See Appendix 2 for piezometer and finger drain locations. The lack of pore pressure at the toe indicates that pile stability has been maximized. Water levels from several monitoring locations are shown in Appendix 2. The inferred water table is 30 to 60 feet below the base of the production rock pile material up-slope of the Site 23 active placement area and 5 to 20 feet below the base of material placed in Site D and the toe of Site 23, respectively (see also Figures 3.5 to 3.12). MW-00-03 data showed an atypical drop in water elevation in August 2007. However, data collected before and after that date are within the historical data range. Observations from wells completed in the colluvium below the sites indicate that perched water tables and braided flow paths exist beneath the site (e.g. compare Figure 3.6 and 3.7). This unit also shows large (up to 10 feet) fluctuations in head levels, which are consistent with perched, confined conditions and channel-like flow. There is a distinct seasonal pattern to the water level fluctuations beneath Site 23/D, particularly in the alluvial sands (Figures 3.9 and 3.11).

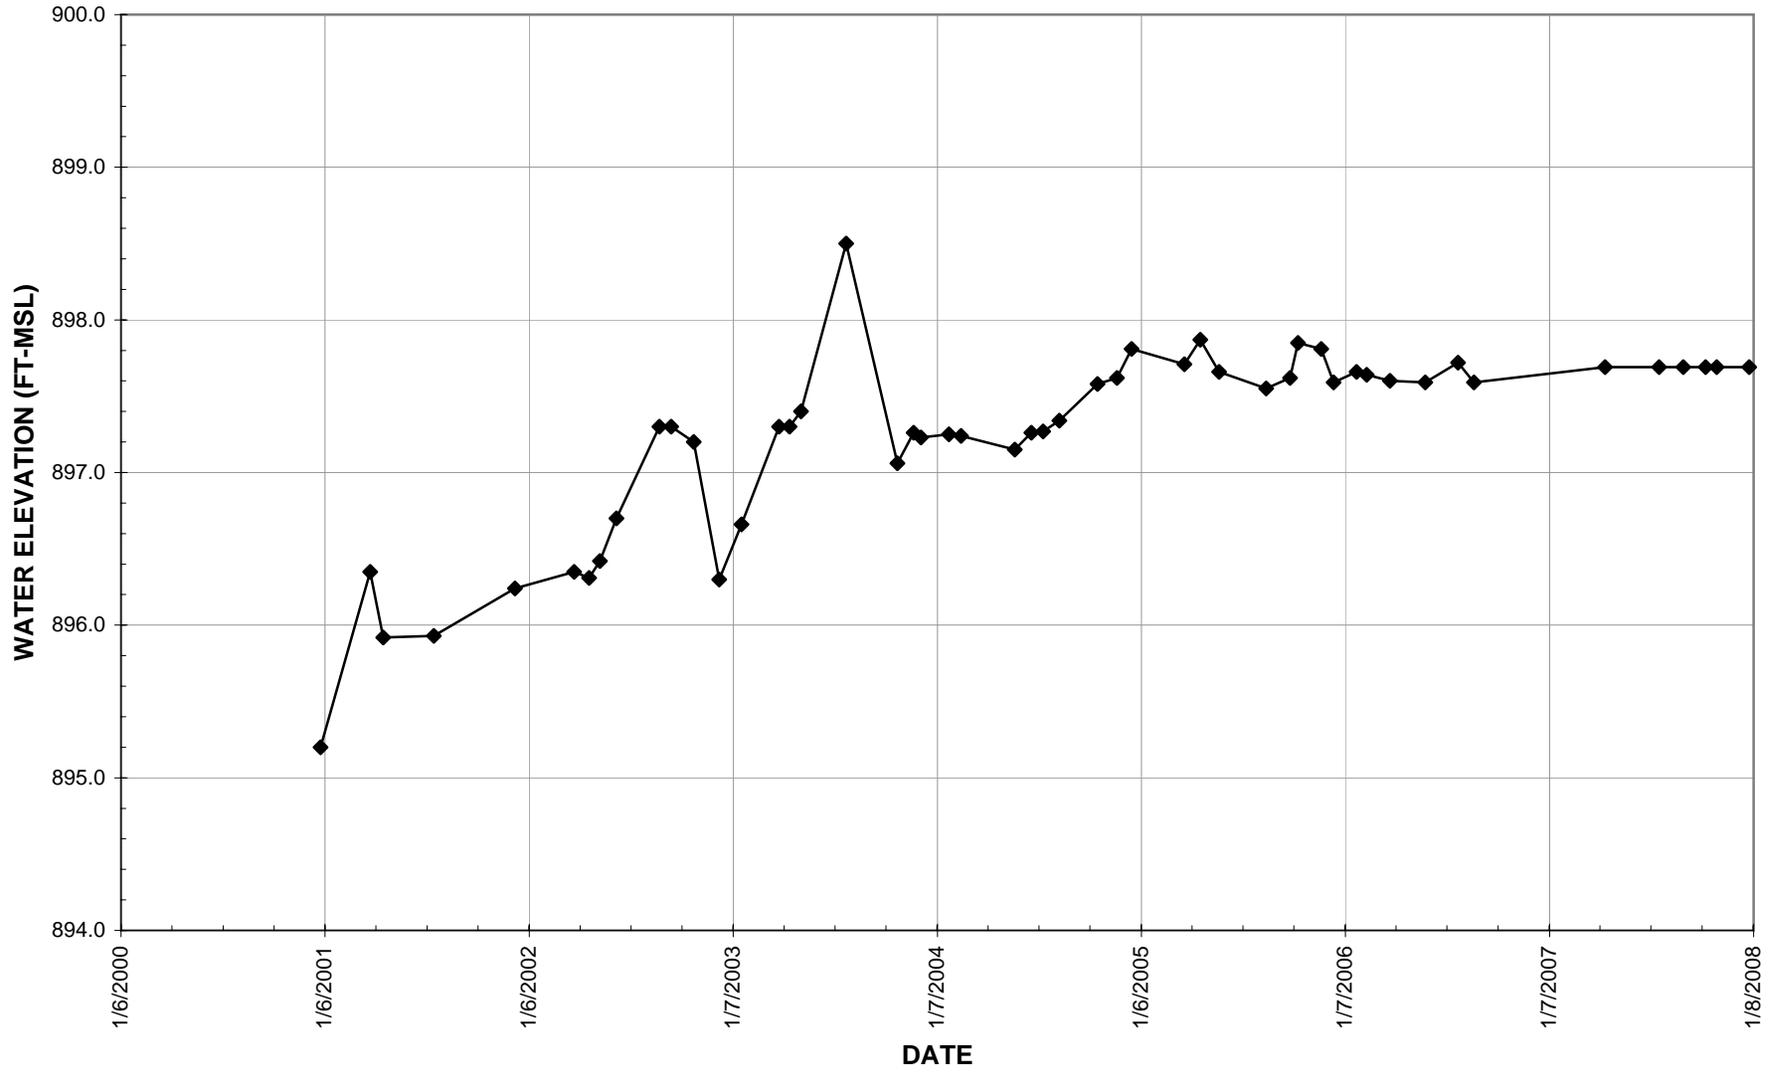
Figure 3.8 Water Level Data for Well MW-23-98-01

The silty/clay till that underlies the colluvial unit impedes downward flow and has an upward hydrologic gradient caused by its confining the more permeable bedrock below it. MW-23-98-01 (Figure 3.8) is completed in the till unit and indicates a water table near the top of the till, which is approximately 100 feet below the existing topographic surface. Alluvial sands occur between the colluvial unit and the silt/clay till near the toe of Site 23 and under Site D. Data from MW-23-A4 and MW-D-94-D3 (Figures 3.9 and 3.11) indicate that the sands are saturated. A curtain drain installed in between Site D and Site 23 in 1994 collects water that flows at the base of the colluvial unit and the top of the alluvial sands (see as-built and Section CC for locations). This drain helps reduce pore pressures in the foundation of Site D, as well as capturing infiltration waters from Site 23.

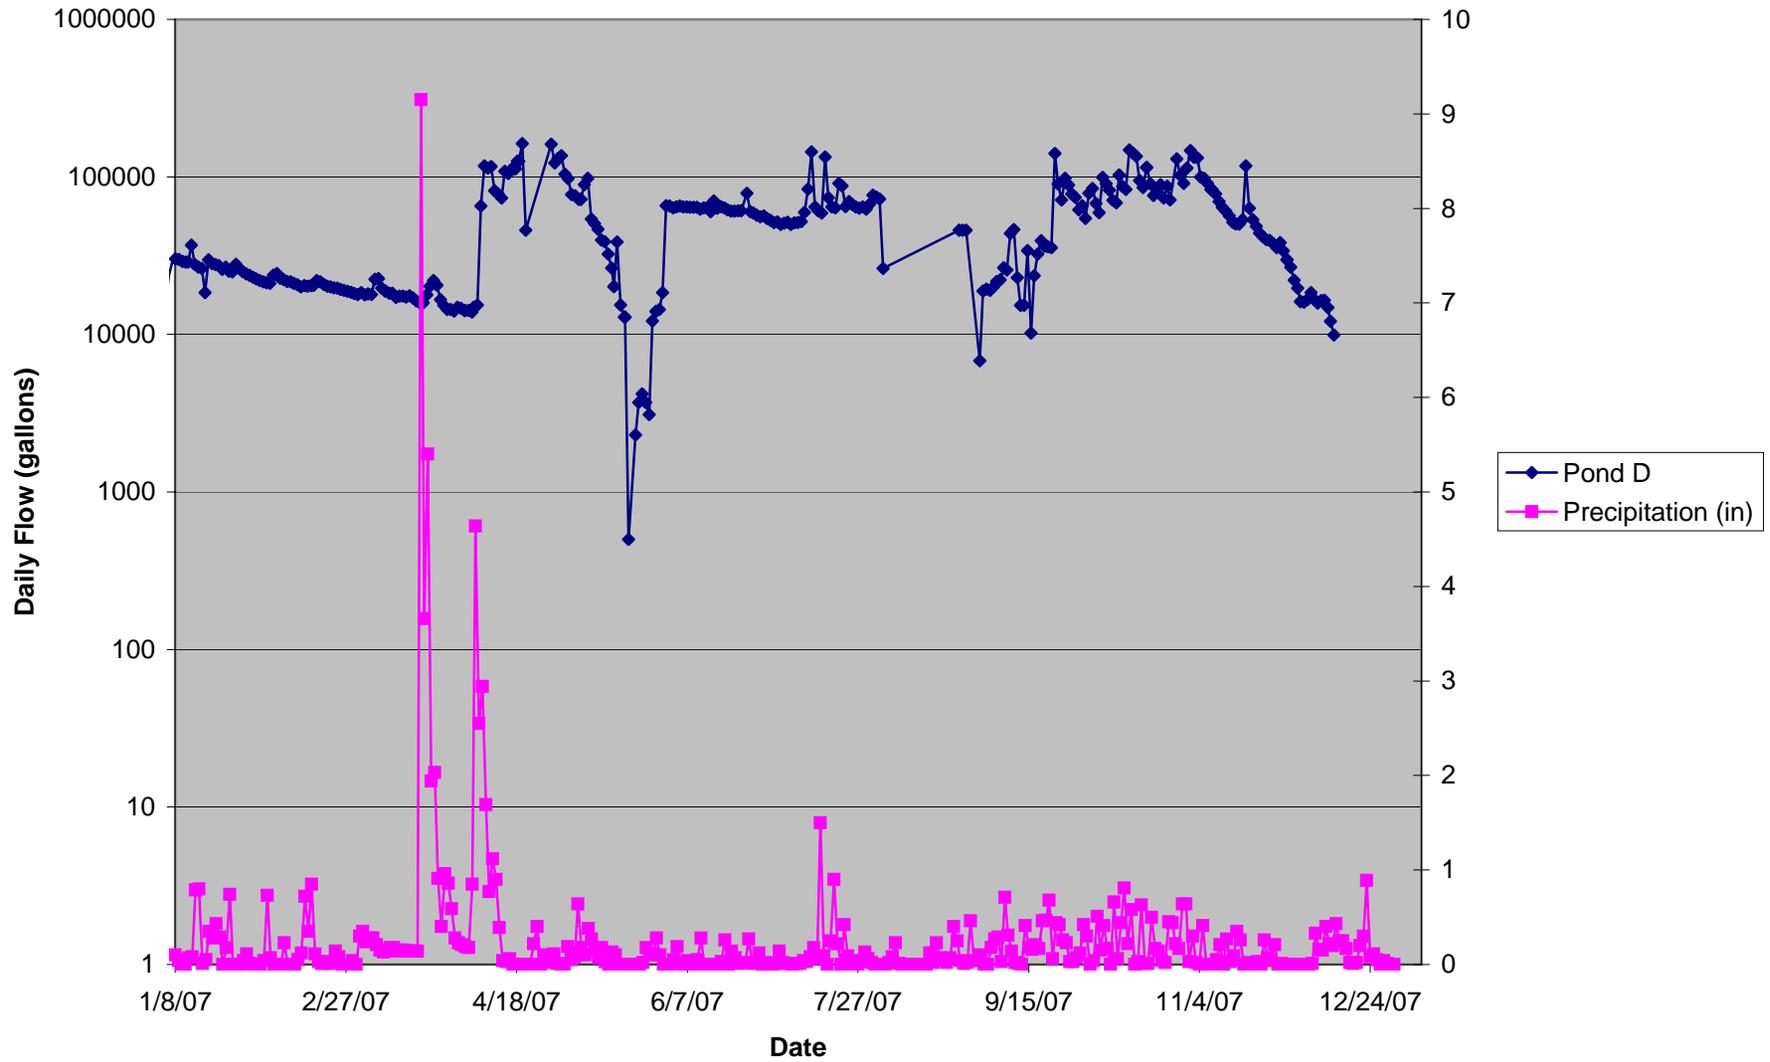
Figure 3.13 Pond D Flow Data

Flow data for Pond D are shown with precipitation in Figure 3.13. Pond D flow showed an overall lower and less consistent flowrate than in prior years. This is likely due to the diversion of a spring from the backslope of Site 23 in 2006. The spring was previously reporting to Pond D, but is now routed into a Site 23 ditch. A review of curtain drain and Pond D flow measurements suggest that the current Pond D flow meter readings are approximately 40% low (EDE, 2004). Piping and flow meter modifications may be required to obtain more accurate readings.

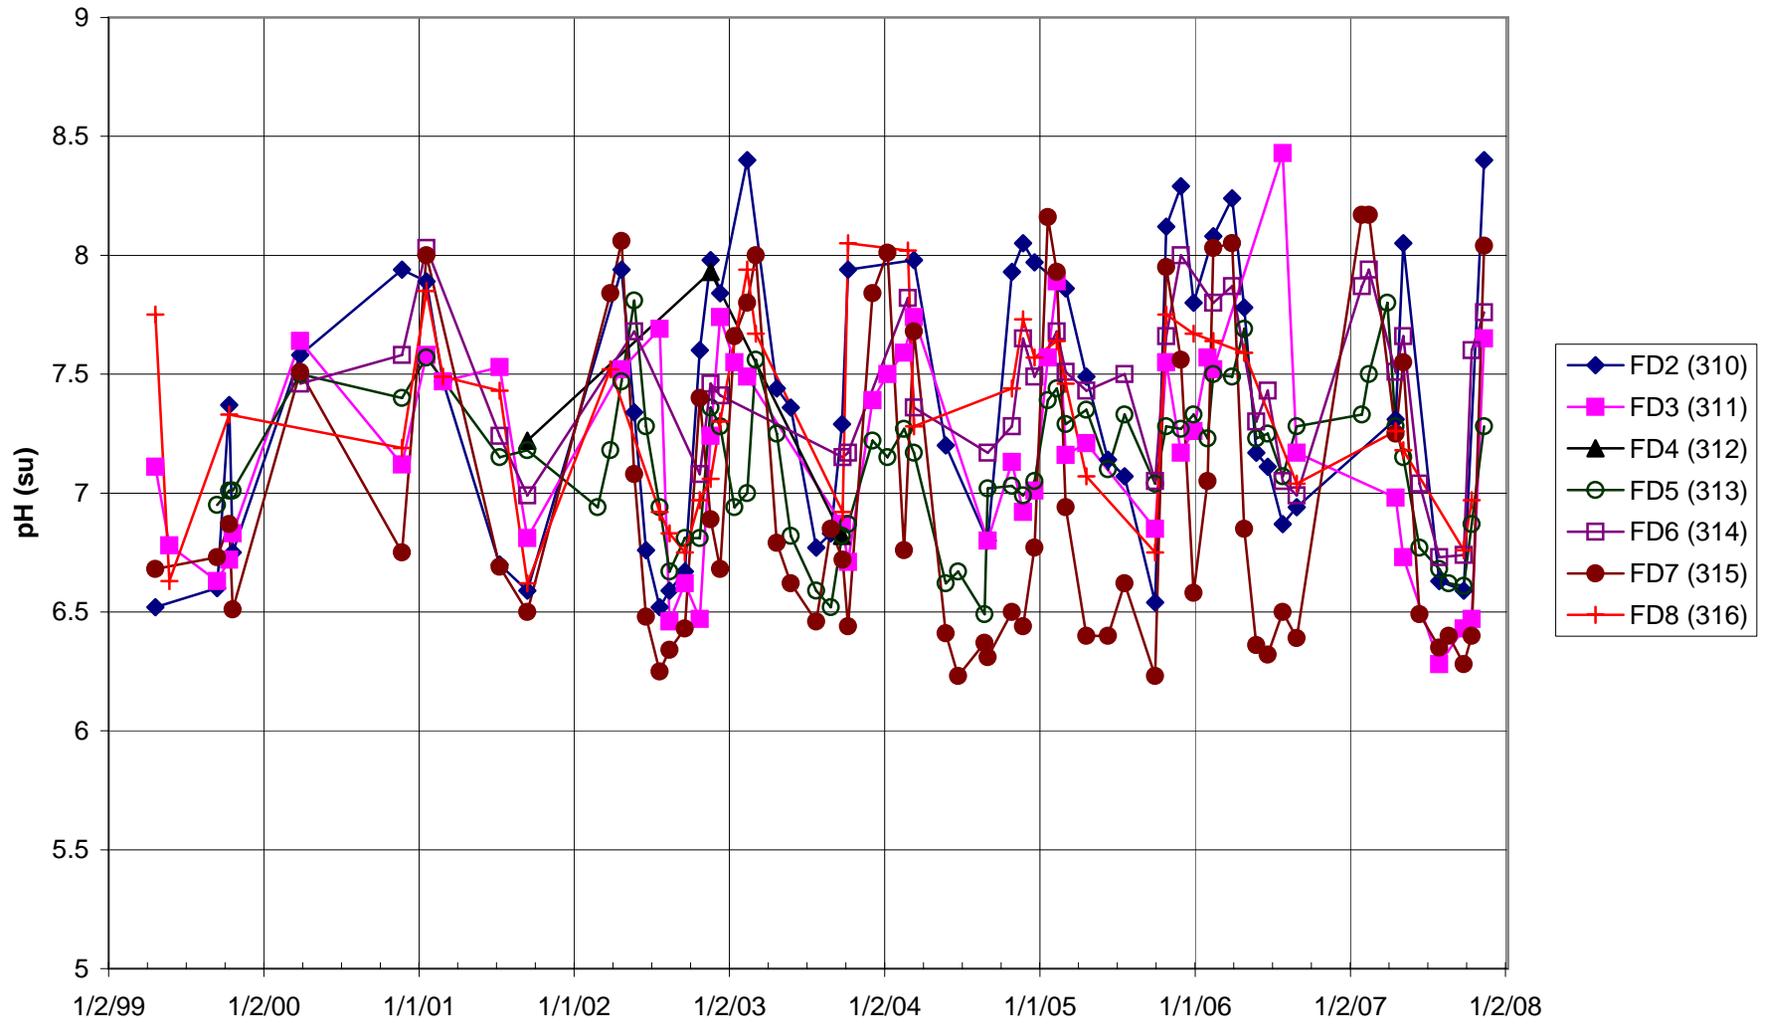
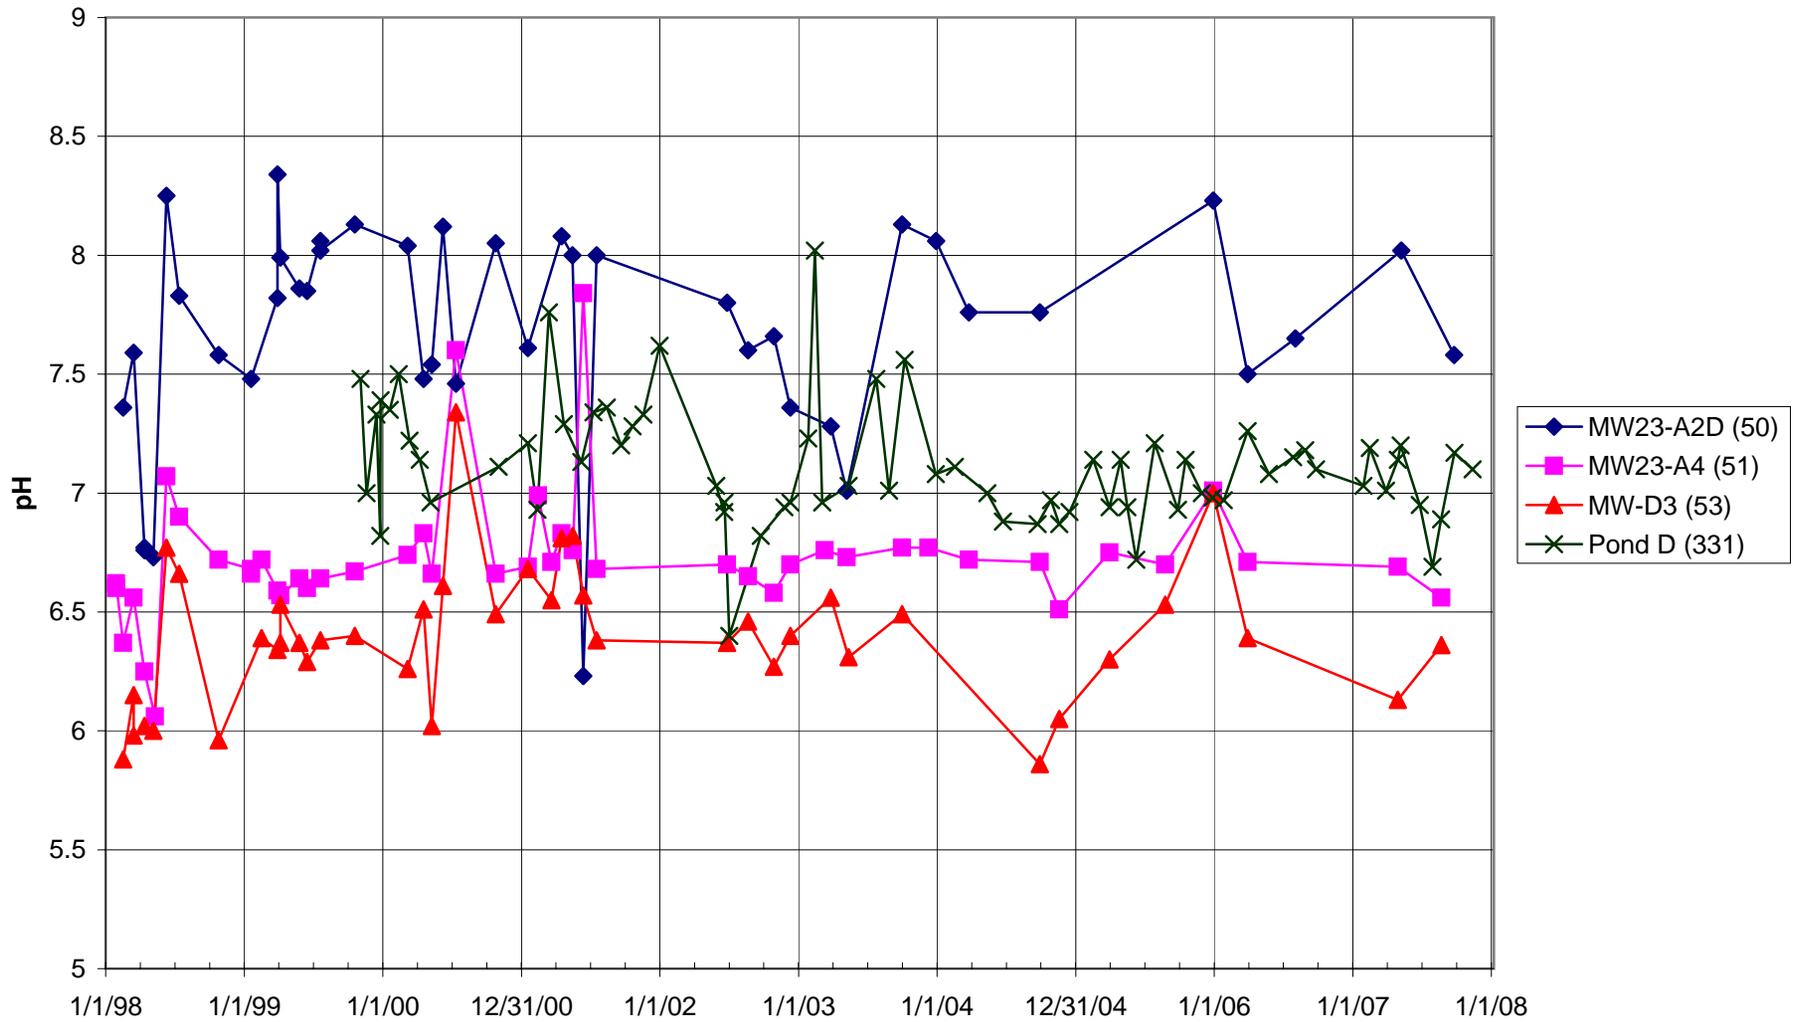
Figure 3.14a shows the pH of waters collected from Site 23 Finger Drains 2 through 8, and Figure 3.14b shows the pH of monitoring wells MW-23-A2D, MW-23-A4, MW-D3 and Pond D (see as-built in Appendix 2 for locations). Values of pH were between 6 and 8.5 for all internal monitoring site samples in 2007. The lower pH values (generally pH 6.0 to 7.0) were recorded in MW-23-A4 and MW-D3, both of which are completed in alluvial sands beneath Site 23 and Site D, respectively. MW-23-A2D, which screens colluvium up-gradient of Site 23 typically has the highest pH (generally pH 7.0 to 8.5). The Site 23 finger drains fluctuate at values between those of the monitoring wells. Figures 3.14a and b suggest that waters from different foundation units have different pH values and that Site 23 and Site D contact waters and the materials with which they are in contact exhibit sufficient buffering capacity to prevent acidification of site drainage in the near term. Seasonal fluctuations are apparent in the finger drains with highest pH values occurring in winter months and lower pH in mid to late summer.
