**TAILINGS AND PRODUCTION ROCK SITE
2007 ANNUAL REPORT**

Kennecott Greens Creek Mining Company

April 15, 2008

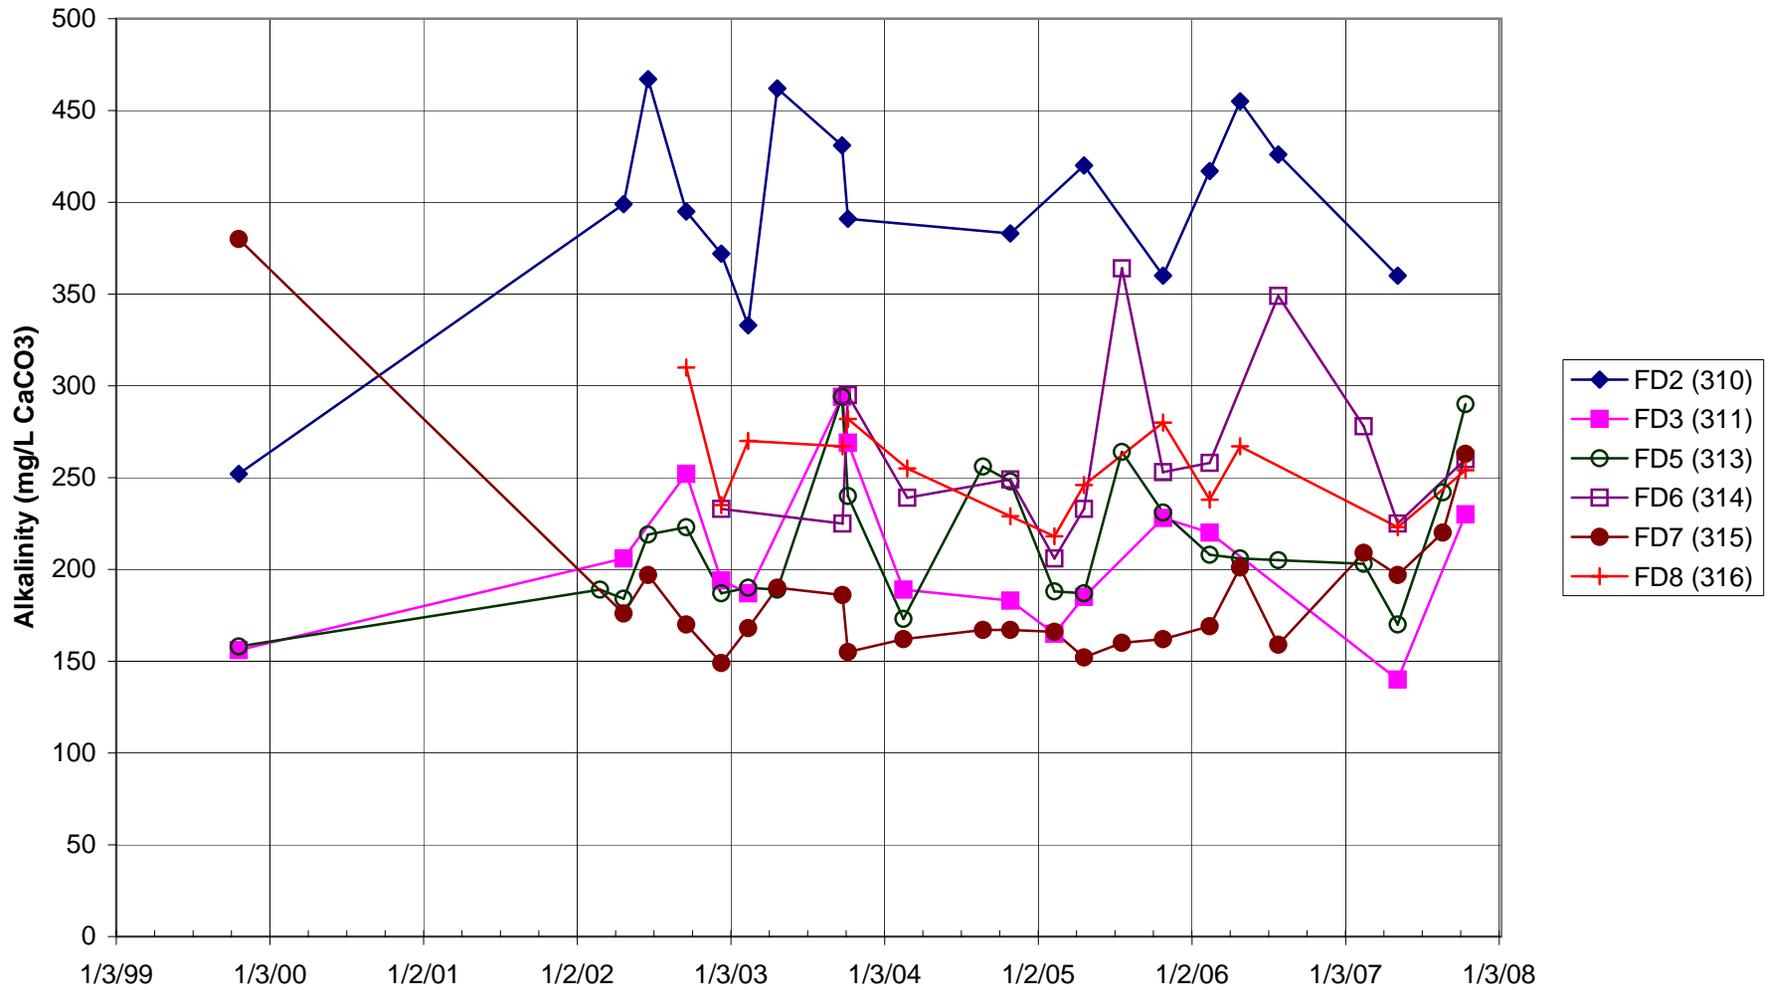
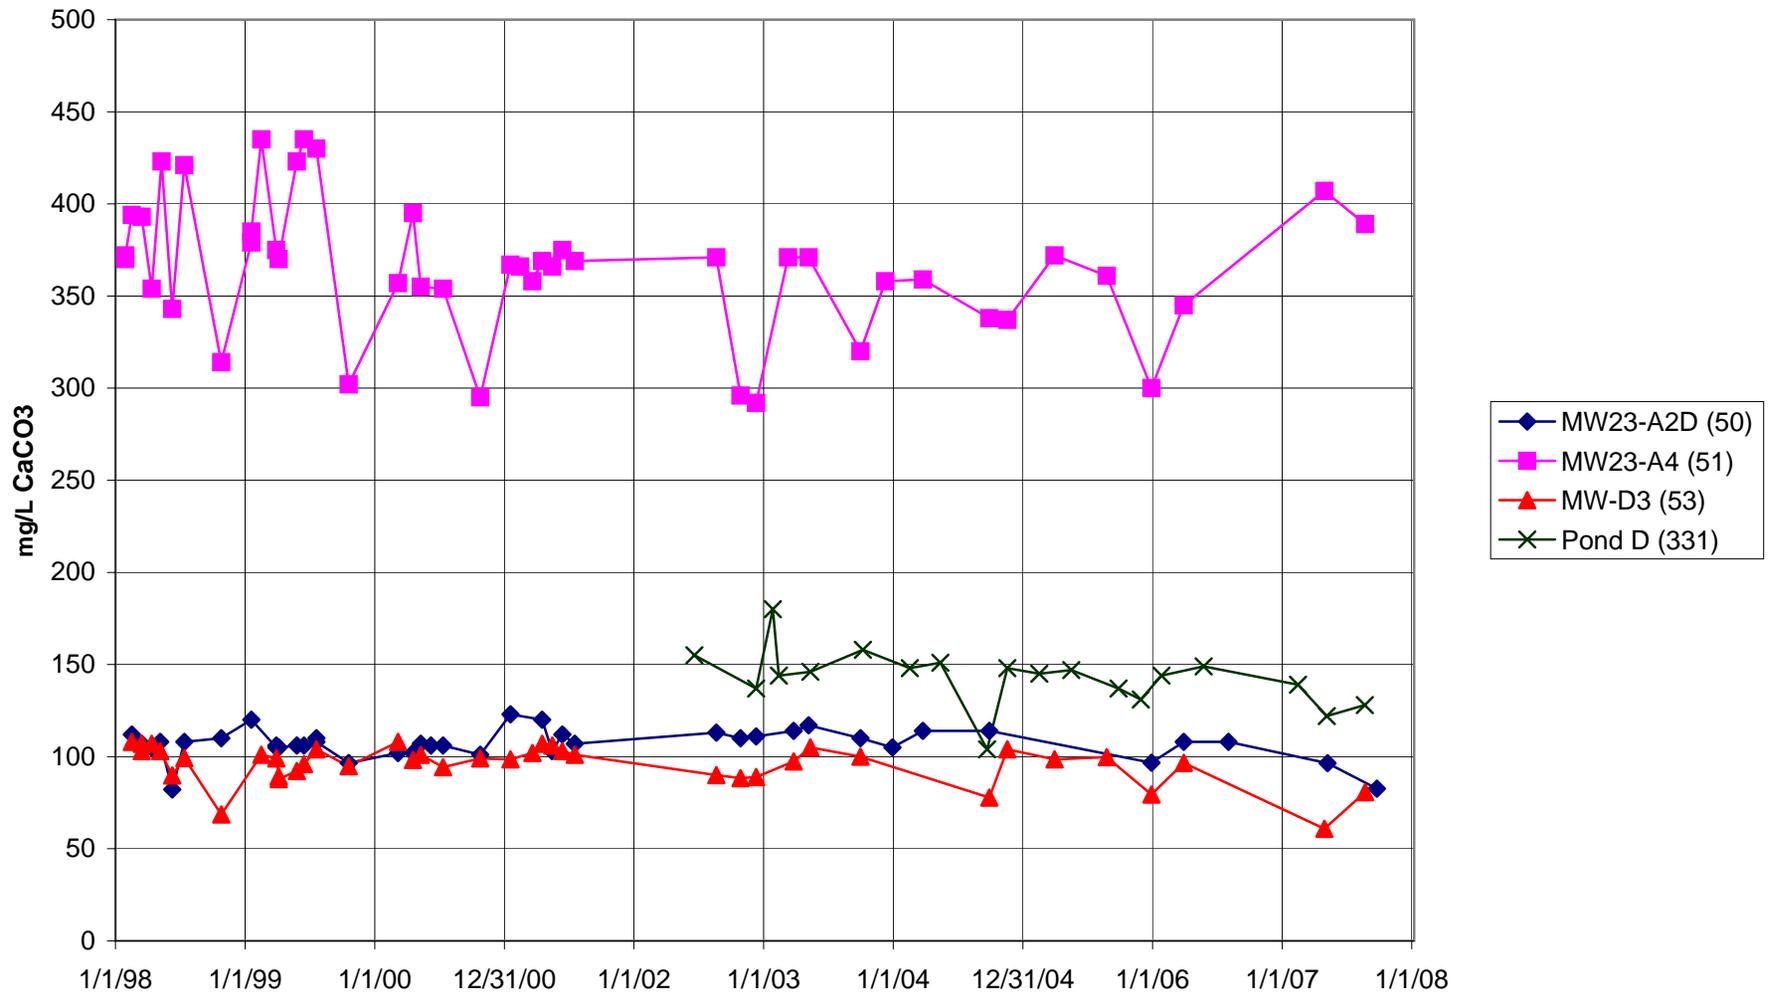
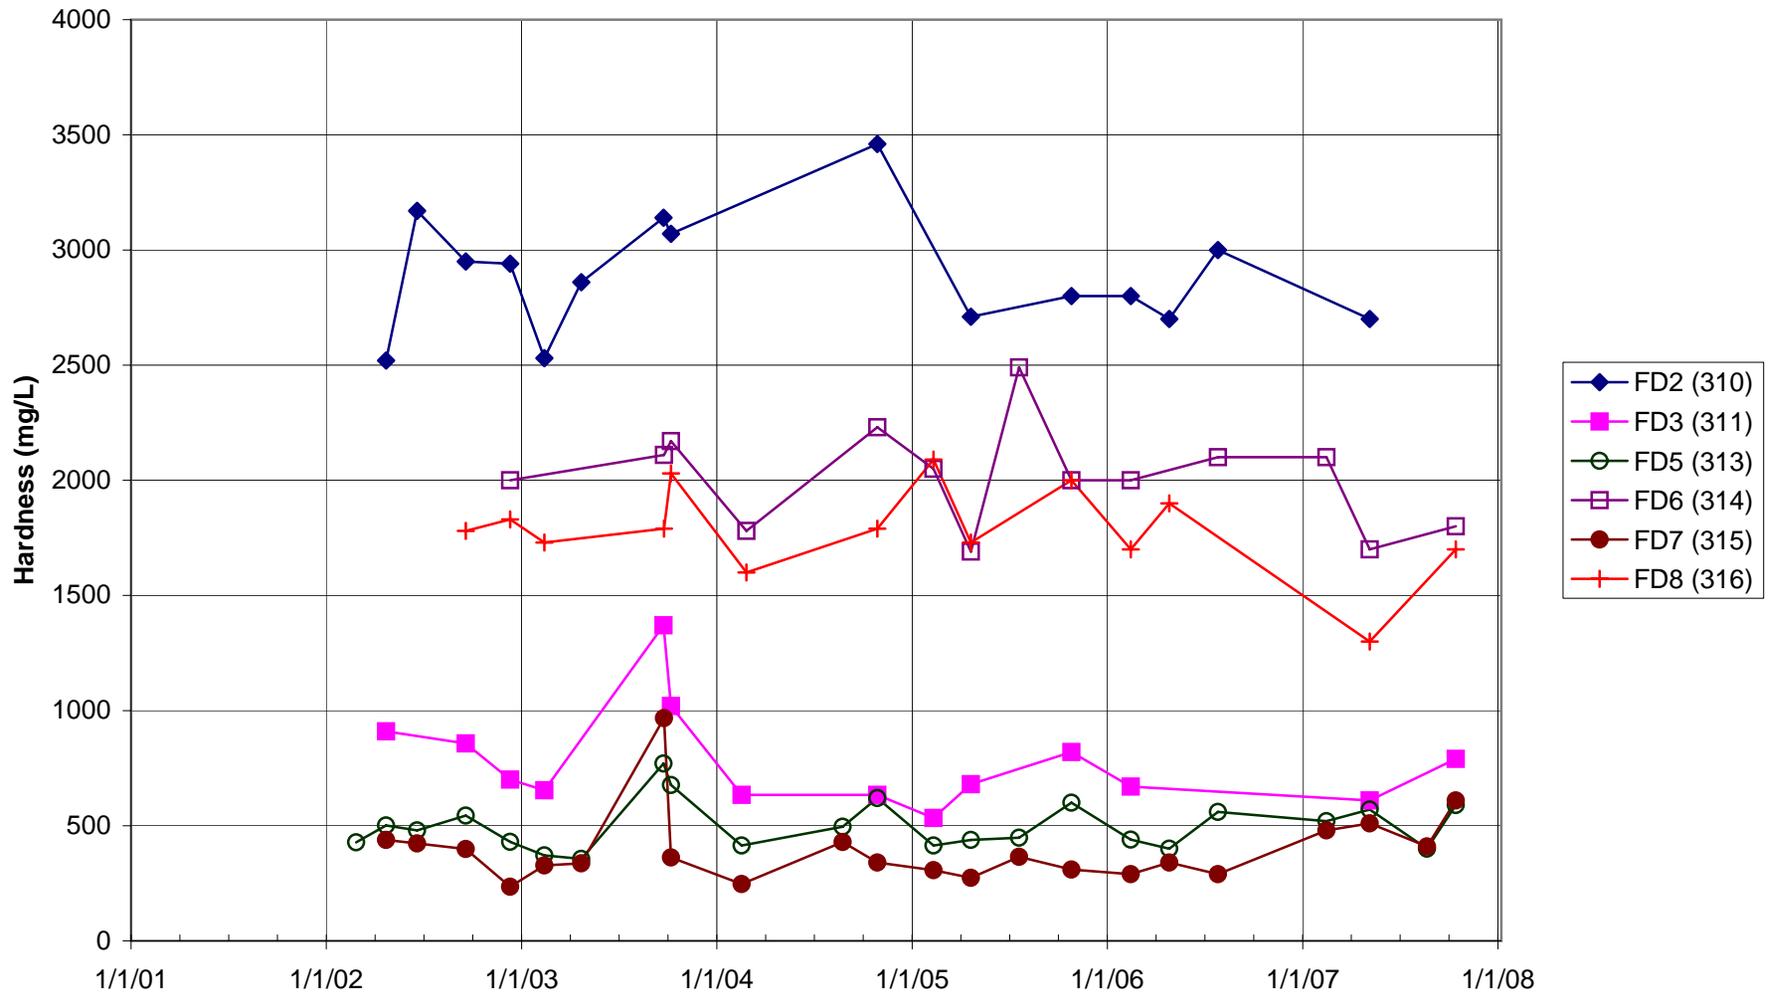
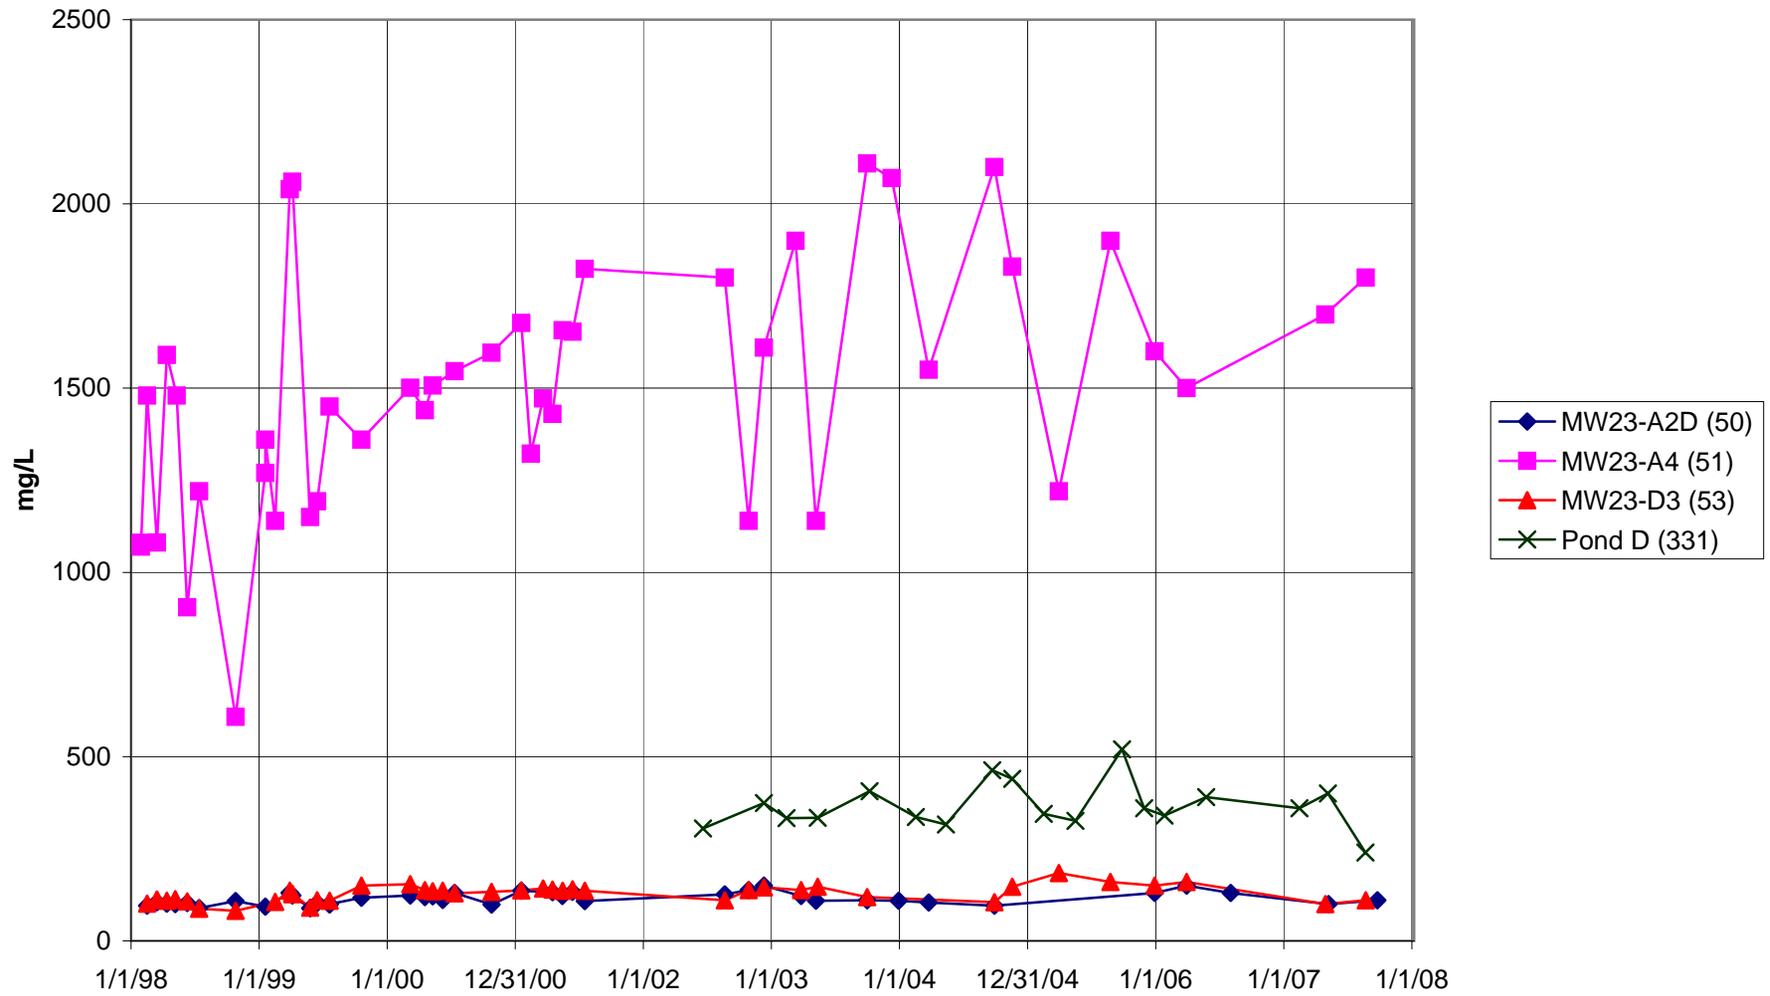
As with pH, high alkalinity values (Figures 3.15a and b) indicate that the waters are well buffered. Fluctuations in alkalinity correlate with those of other parameters, such as hardness (Figures 3.16a and b) and conductivity (Figures 3.17a and b), and also appear to be seasonal. Carbonate minerals in the production rock contribute to the high alkalinity of the drainage from the finger drains. Alkalinity is lowest in samples with the highest groundwater component (e.g. the monitoring wells, D Pond, 23FD-5 and 23FD-7). Calcium and magnesium are the primary contributors to hardness (Figure 3.16a) and reflect dissolution of carbonate minerals, such as calcite and dolomite. Carbonate dissolution neutralizes acidity formed by sulfide oxidation, which is also the source of sulfate shown in Figure 3.18a.

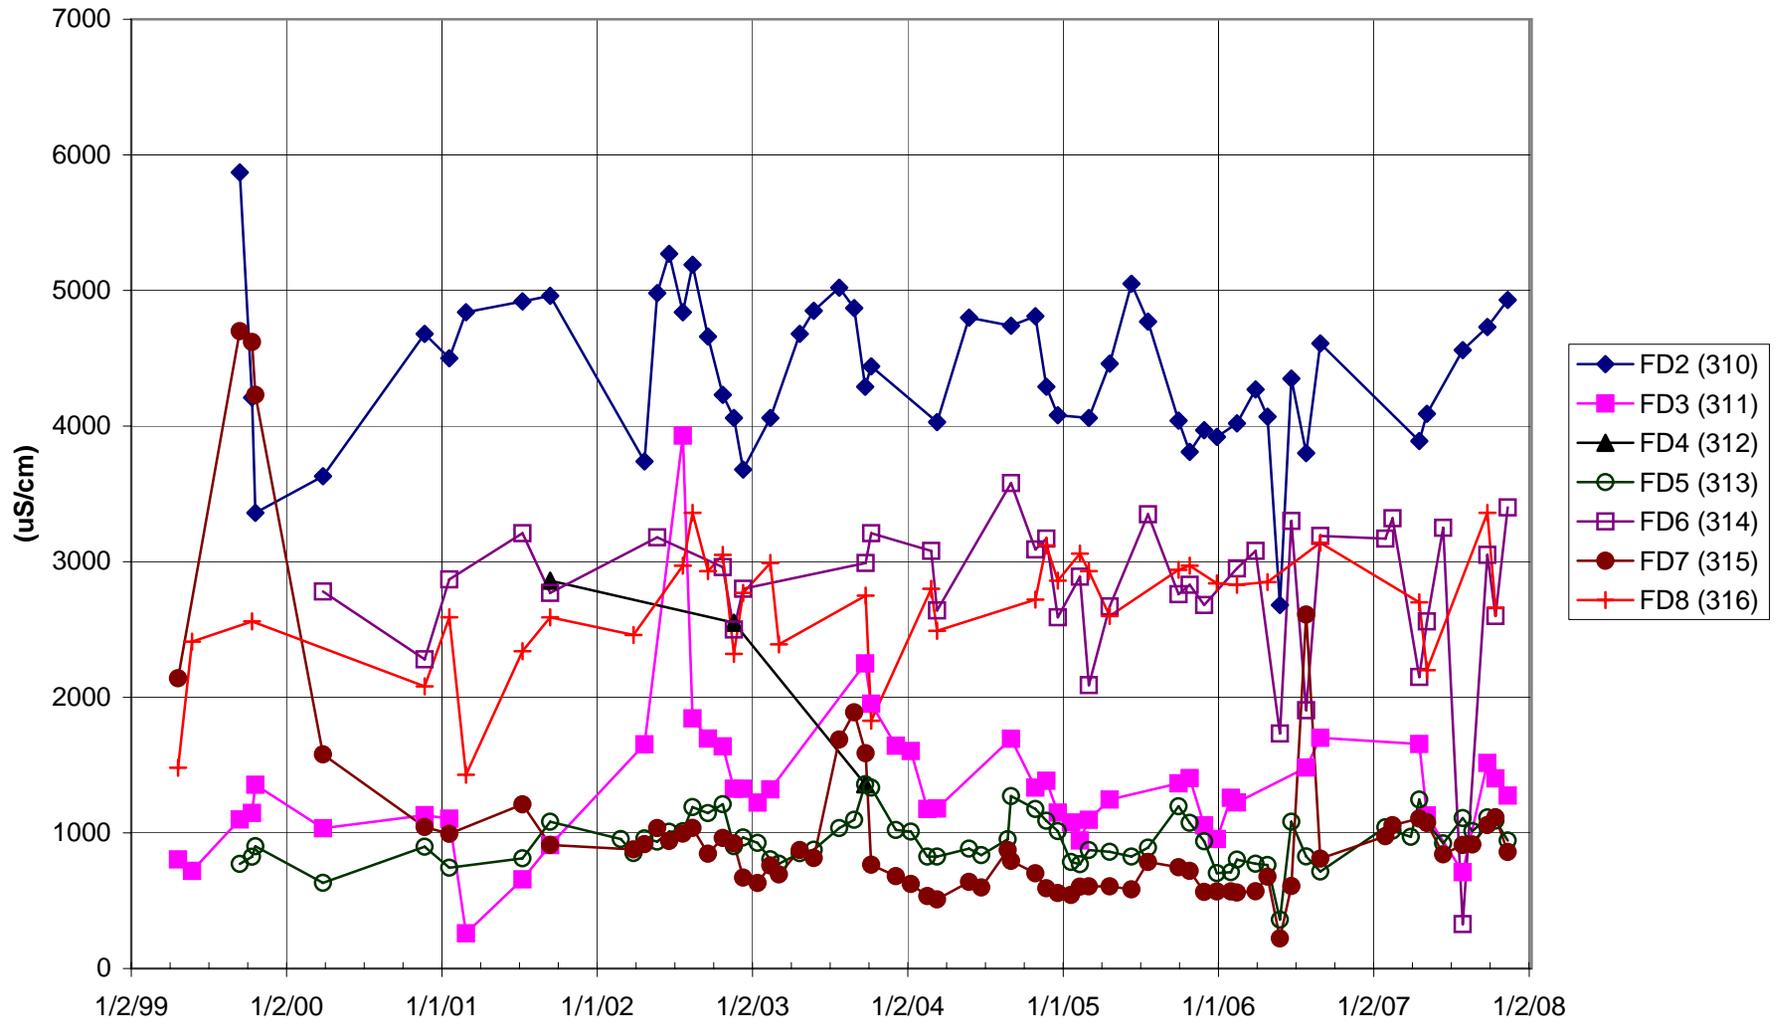
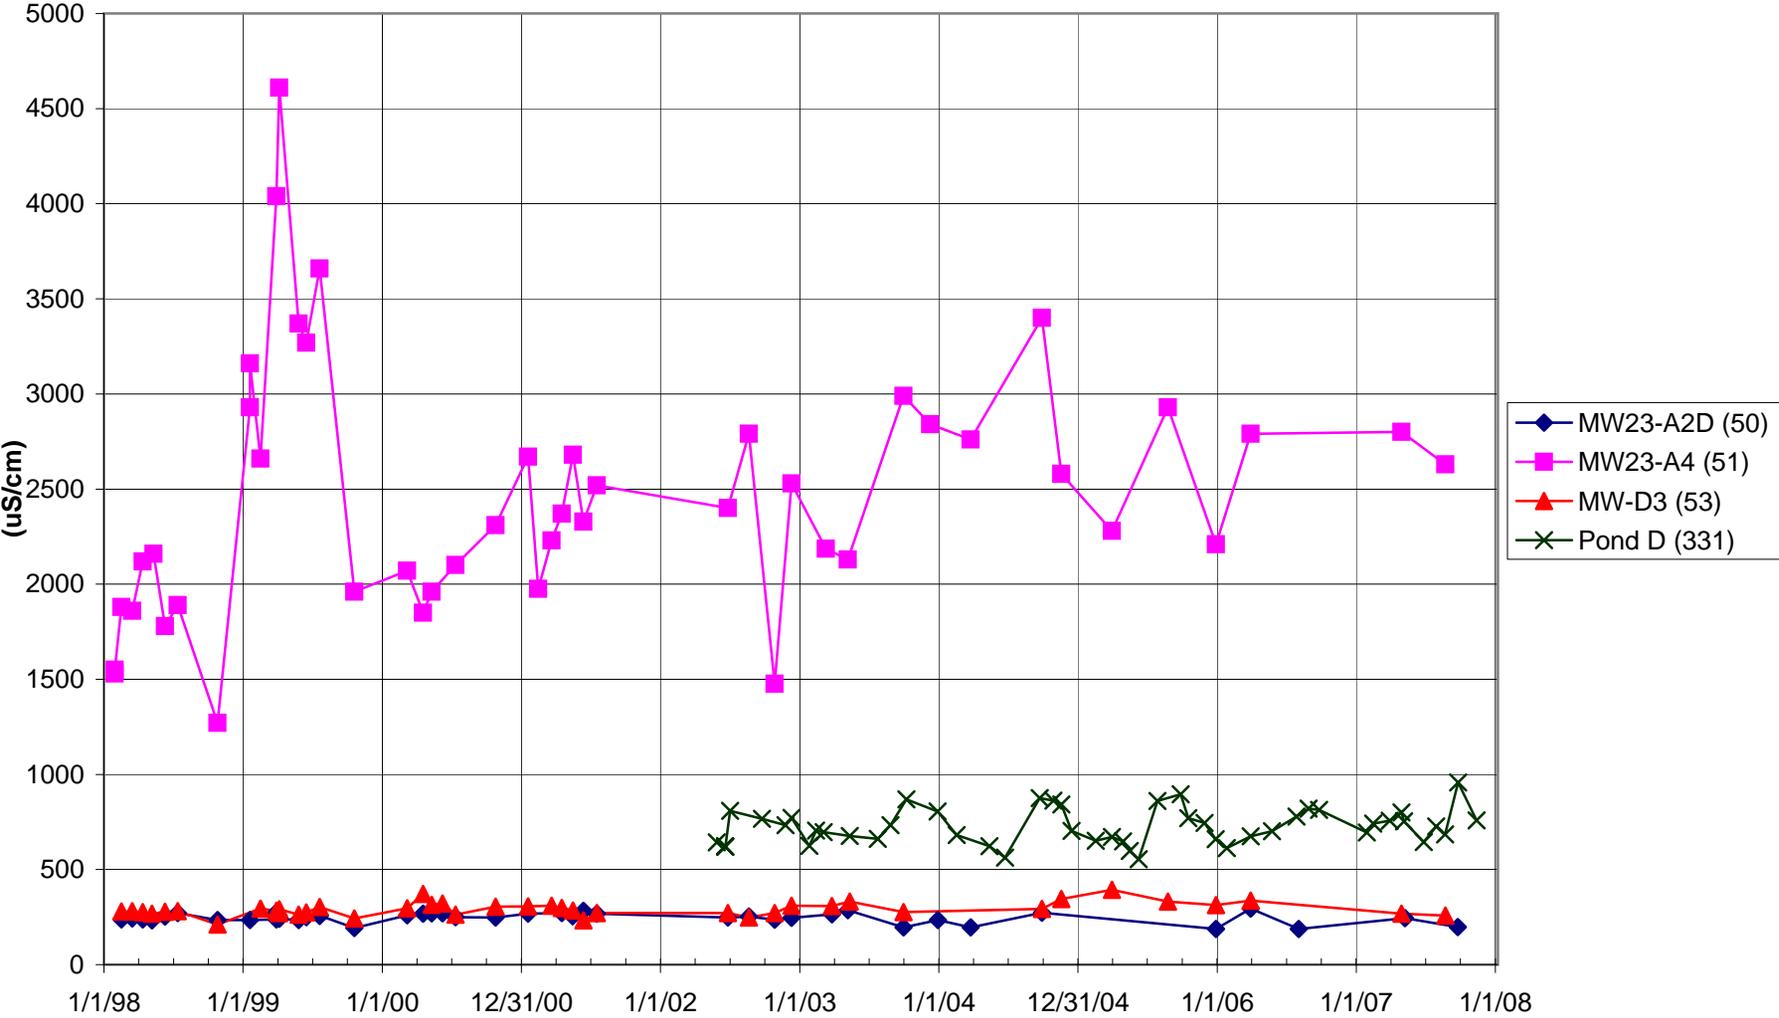
Conductivity results from internal monitoring site waters are presented in Figures 3.17a and b. These 2007 conductivity measurements continue to range up to 4,930 $\mu\text{S}/\text{cm}$. MW-23-A2D and MW-D3 have the lowest conductivity. MW-D3 is completed in alluvial sands below the fill

Finger Drain 23FD-2 has the highest conductivity but consistently low flow, suggesting no significant influence from groundwater. This drain may also be influenced by runoff that infiltrates along the access ramp to the site. The higher conductivity of the site contact waters reflects a larger dissolved load caused by weathering of the production rock. As with tailings, pyrite oxidation and carbonate dissolution contribute dissolved ions such as sulfate, bicarbonate, calcium and magnesium to the contact waters, increasing their conductivity. Sulfate concentrations for the finger drains and groundwater wells are plotted in Figures 3.18a and 3.18b and match closely the relative value patterns of conductivity.

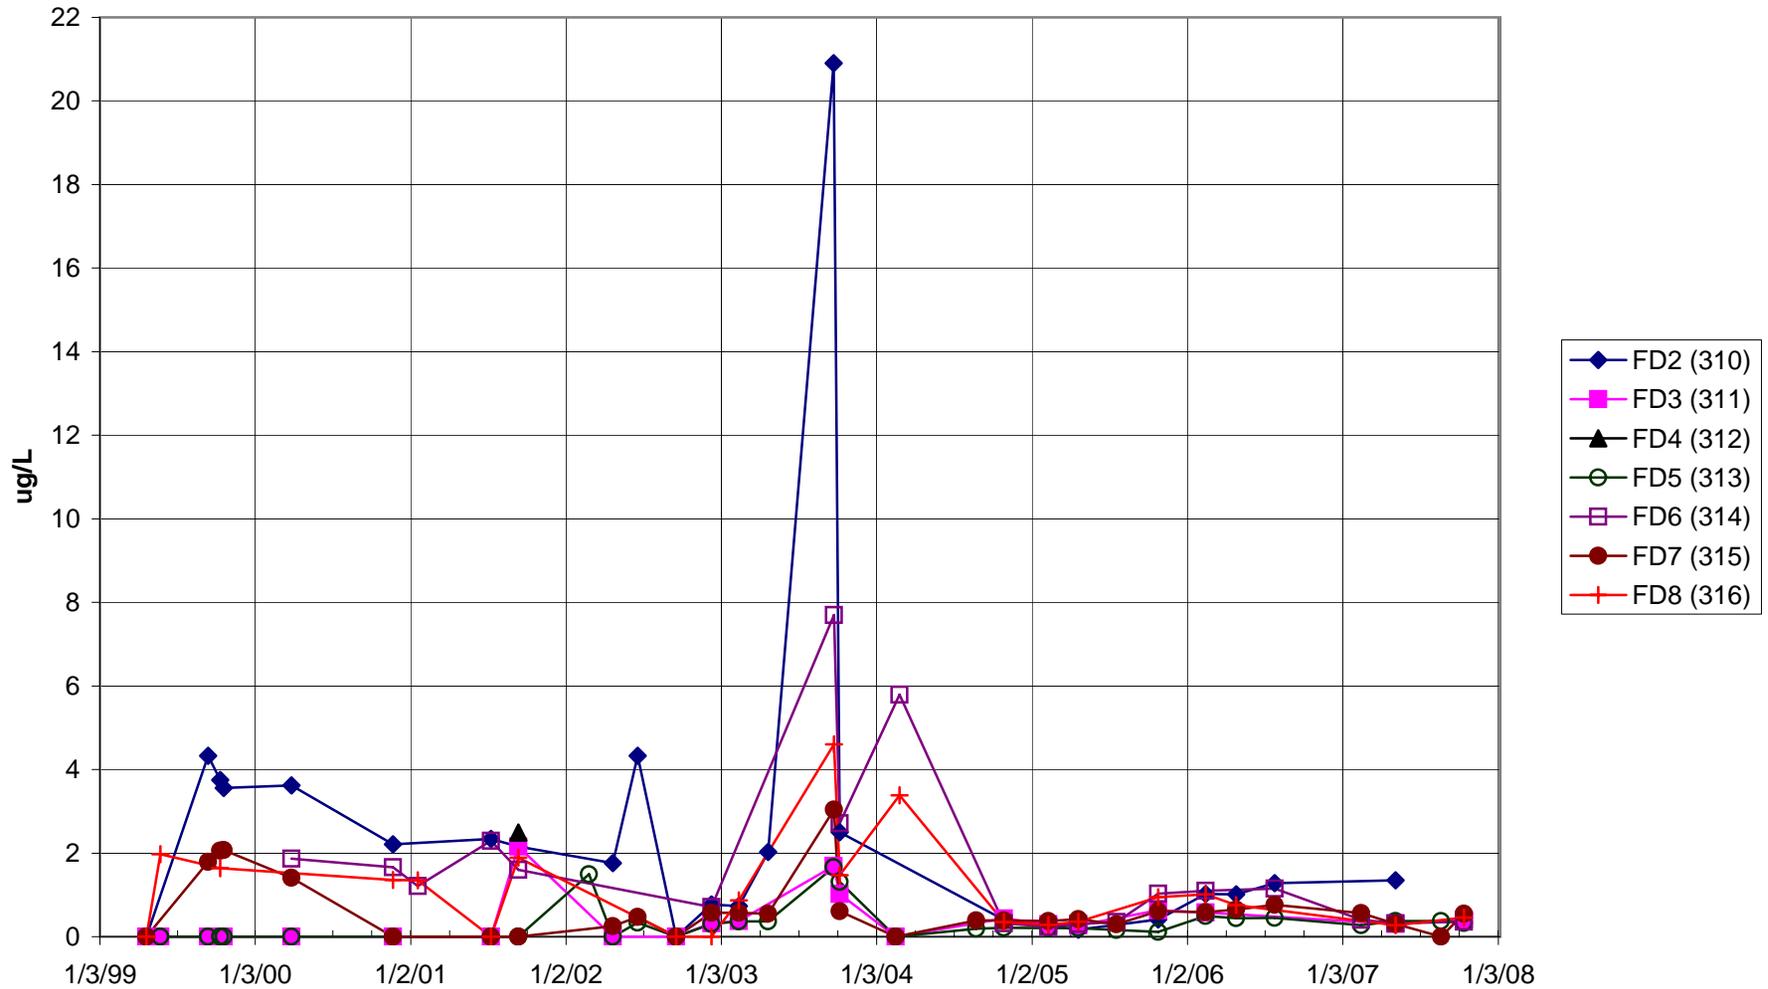
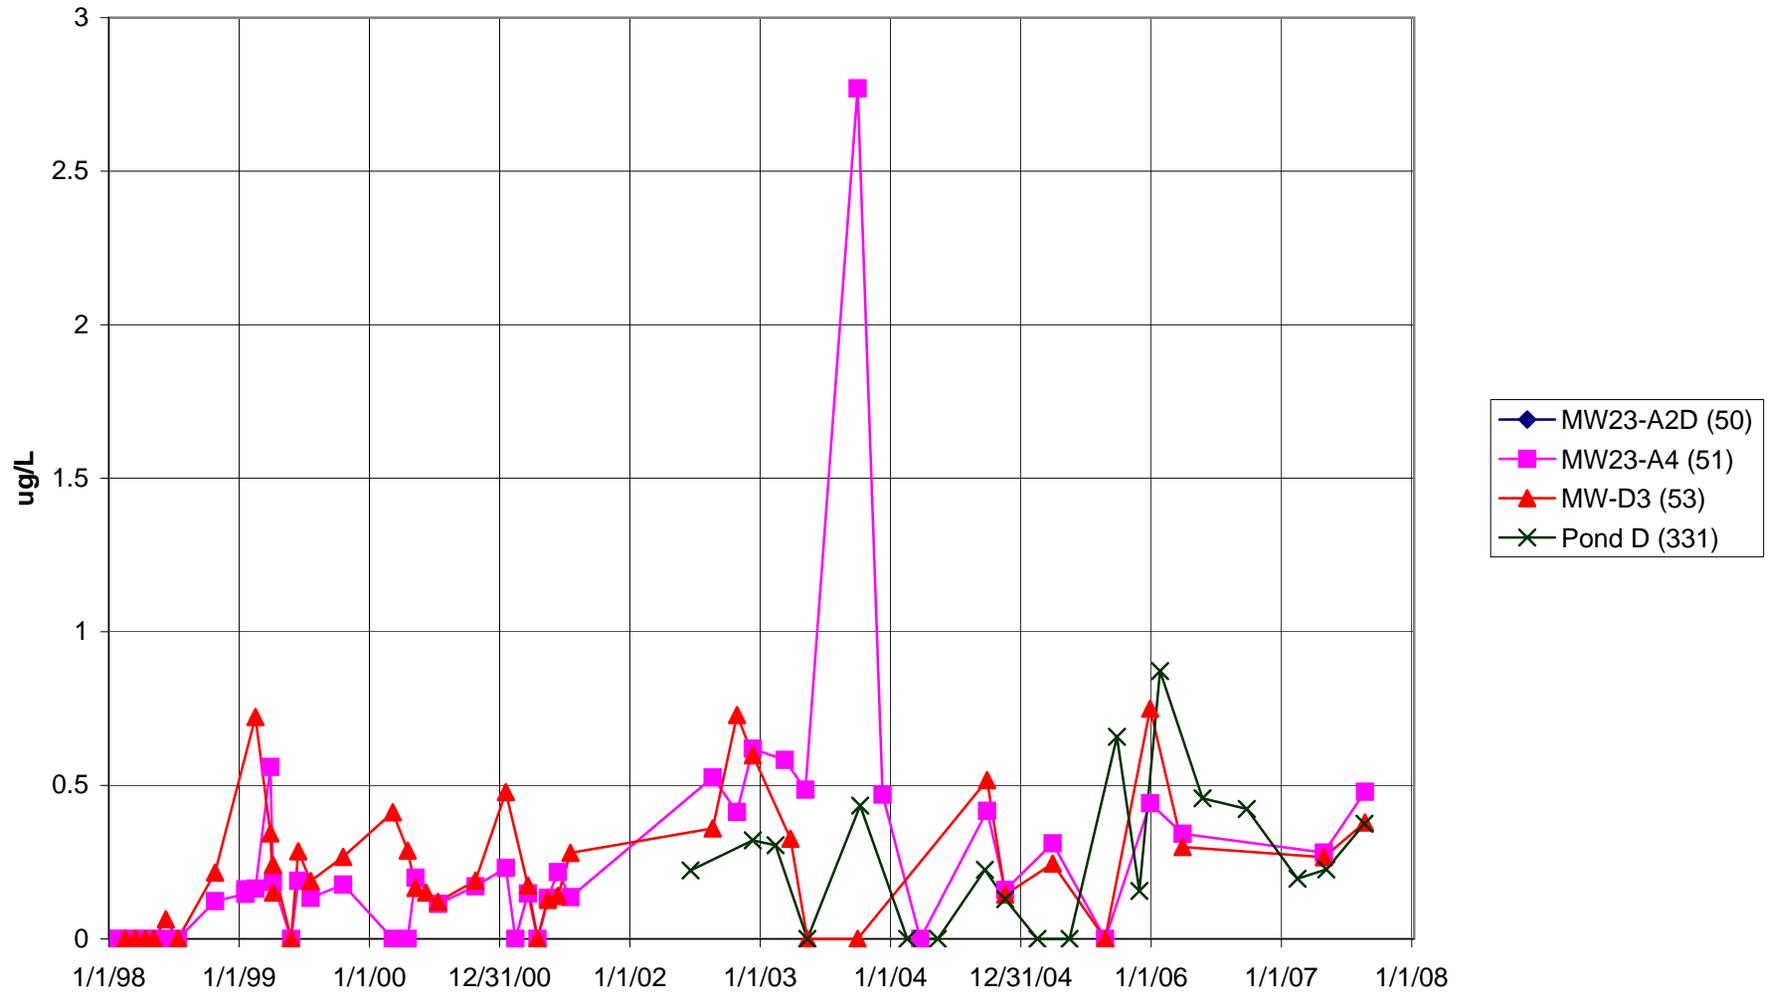
Arsenic data are presented in Figures 3.19a and b and are generally quite low. All finger drains and MW-23-A4 experienced increases in their arsenic concentrations in September 2003, with subsequent decreases back down to historical levels in October. The flows in the finger drains positively correlate with these changes. Fluctuations in arsenic values in 23FD-2 can be attributed to changes in redox conditions. Low arsenic and iron (Figures 3.25 a and b) concentrations indicate that these metals are precipitating as oxyhydroxides on rock surfaces inside the pile.

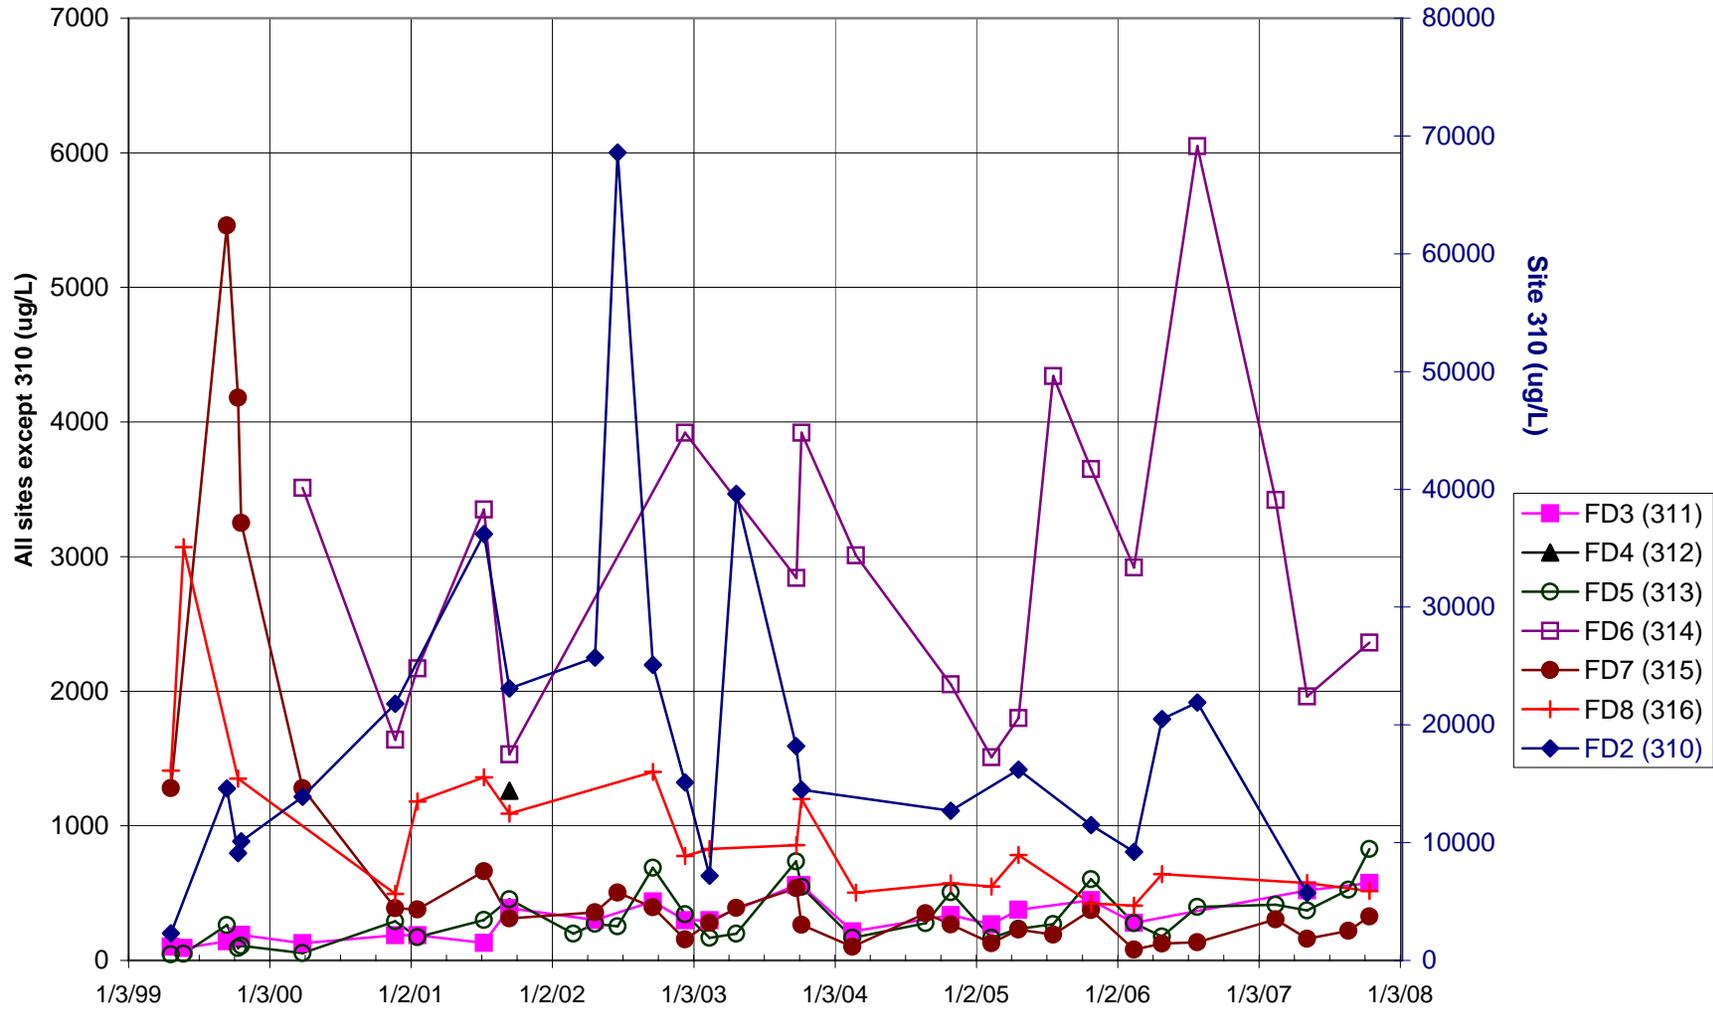
**FIGURE 3.20a GREENS CREEK SITE 23/D INTERNAL MONITORING SITES:
FINGER DRAINS - ZINC DATA
(Non-detectable analyses plotted as zero)**

Figures 3.20a and b shows the concentration of zinc in the internal monitoring locations at Site 23/D. Zinc levels appear to be controlled by seasonal conditions. The changes in zinc concentrations mimic those for conductivity and sulfate. 23FD-2 had a zinc concentration of approximately 70 mg/l in June 2002. Although, zinc averages have fluctuated since 2002, there has been an overall decreasing trend. In 2007 zinc levels were near 6 mg/l. Zinc concentrations in the range of 20 to 70 mg/l are consistent with laboratory kinetic weathering tests performed on samples of argillite and serpentinite (Vos, 1993). The zinc concentrations recorded for Pond D are generally below 0.7 mg/l and reflect contributions from several source waters. Pond D receives water from Site D surface runoff, seeps on the slope and at the toe of the site and the effluent from the curtain drain that KGCMC installed between Site D and Site 23. MW-D3 showed elevated zinc concentrations in both 2005 samples: zinc levels rose from an average of 10 µg/l in 1998-2004 to an average of 177 µg/l in 2005. Average sulfate also increased by approximately 30 mg/l in 2005 compared to average values from 2002-2004. The zinc and sulfate returned to within historical limits in 2006. The cause for the increases in 2005 is not immediately apparent; however, if it was the arrival of a contact water front, a significant increase in conductivity, sulfate, calcium and magnesium should have preceded an increase in metals such as lead and zinc.

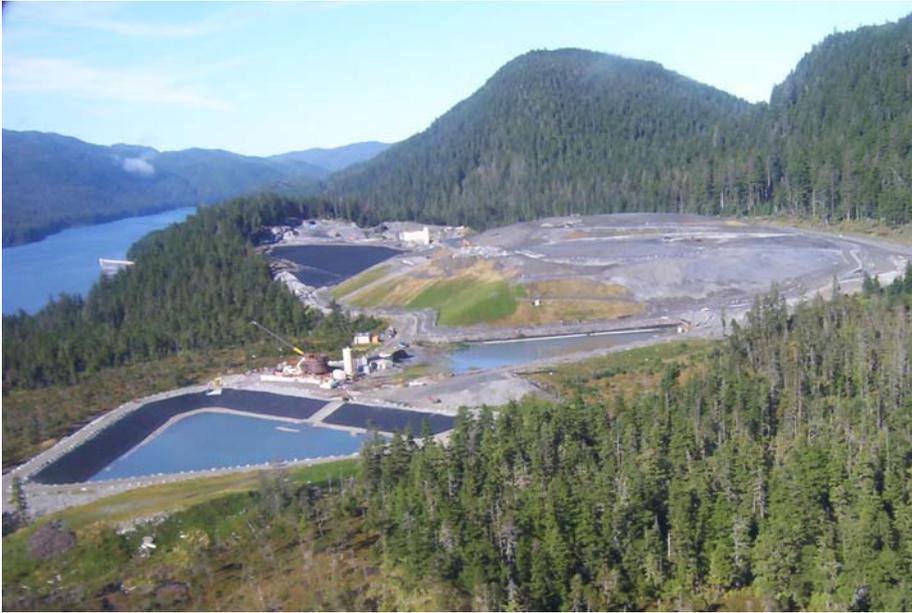
Fig 2.36 Aerial Photo of Tailings Area September 2007

Photographs taken during routine site inspections in 2007 are presented in Figures 2.36 to 2.38 (Appendix 4). Figure 2.36 shows an aerial photo of the tailings area taken in September 2007. Figure 2.36 shows work on the Northwest excavation area in July. Completion of the liner at tailings is shown in Figure 2.38. The water treatment plant under construction is shown in Figures 2.39a and 2.39b.

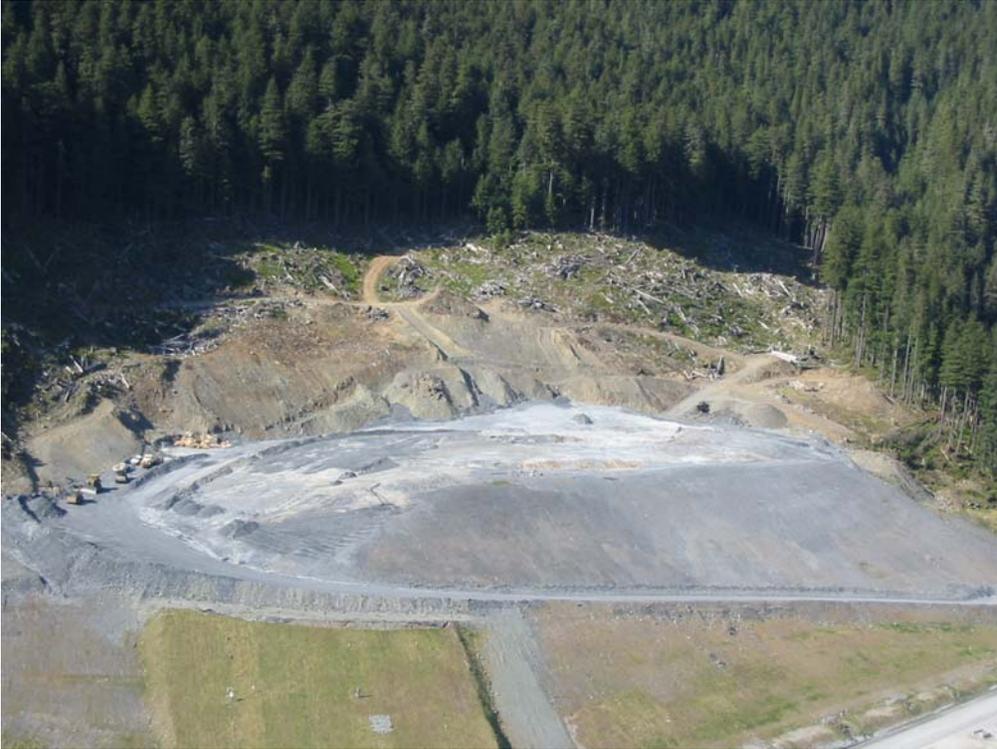
Fig. 3.33 Site 23 May 2007

Figures 3.33 and 3.34 show photographs of Site 23. Figure 3.33 shows an aerial photo of Site 23 in May 2007. The excavation of backslope material in September 2007 is shown in Figure 3.34.
