July 23, 2015

## **The June 17, 2015 Inspection of the Kensington Gold Mine**

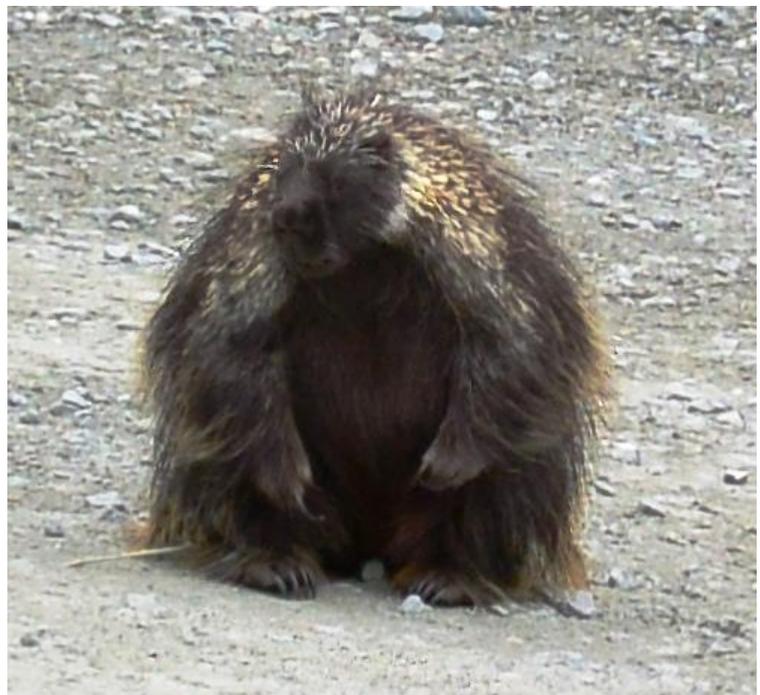
Unbeknownst to the team, we were being watched... While we were milling about and taking pictures, a curious porcupine set up camp in front of the pickup (Figure 3). The little critter watched us intently as we moved about. Even when we were within 10 feet of it, the porcupine showed no fear. Kensington has a strict policy about dealing with wildlife at the mine. Employees caught feeding the bears and other predators are terminated, and the workers are taught hazing techniques to keep them out of the camp. Bears in particular have been an issue at the mine, particularly around the camp area where the smell of food emanates around-the-clock. Revised policies

Figure 3 A curious Porcupine ensuring quality control

pertaining to the handling of garbage and food, along with employee training has dramatically reduced the occurrences of bears interacting with humans on the mine site. The presence of the porcupine is not a concern to the workers at the mine, but the slow moving creature may pose a hazard to itself due to porcupine – tire interactions.
