August 8, 2013

June 25 and July 16, 2013 Inspectors: David Schmerge – USFS
David Wilfong – ADNR

July 29, 2013 Inspectors: David Schmerge – USFS
Jill Weitz – ADEC
David Wilfong – ADNR

Inspections of the Kensington Gold Mine

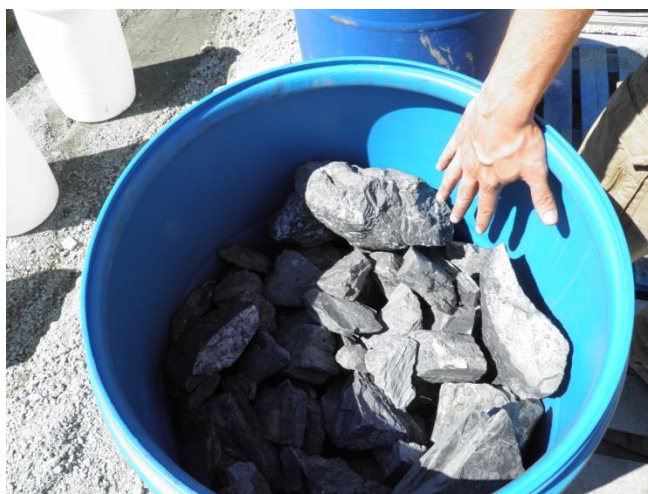
Figure 8 Filled barrel.

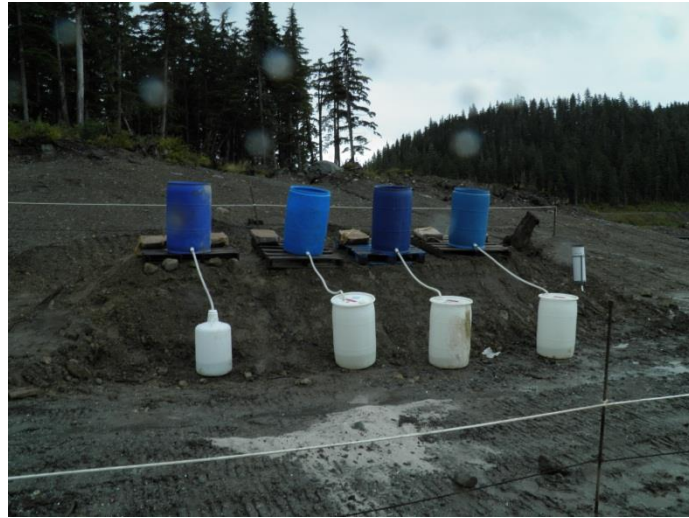
Figure 9 Completed barrel test area.

The barrel tests are designed to be a real time estimation of how the potentially acid generating graphitic phyllite will react when it has been disturbed and exposed to the elements, as it has been near the TTF dam. The leachate collection containers will be emptied once per month at regular intervals (unless frozen). The volume of liquid will be recorded, and if the volume of leachate is sufficient, a full suite chemical analysis will be performed. If the volume of liquid is not sufficient at a minimum, a measurement of pH and conductivity will be performed. The gathered data will be used to estimate the time needed for newly exposed GP to naturally attenuate to neutral conditions. The information will be used to help design a final closure configuration for the facility. The post-mining land use of the area is to consist of a remote hunting and fishing lodge. The overall post-mining TTF surface area will be approximately triple the pre-mining surface area.

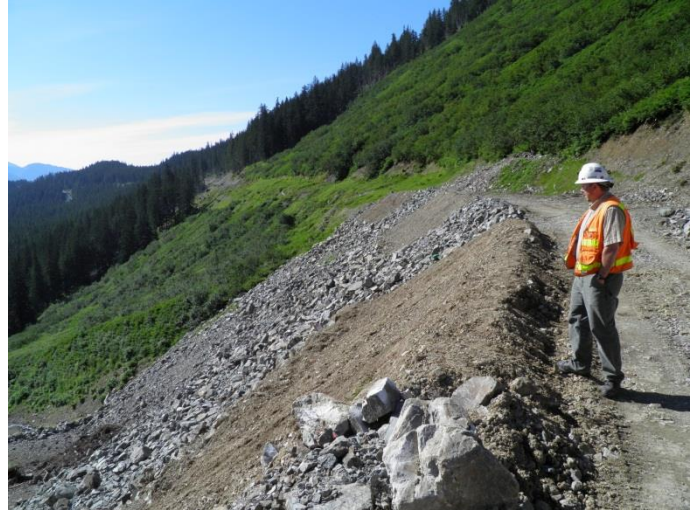
Figure 12 Completed Revegetation Test Plots

Although the construction deadline was surpassed, corrective action was not needed, and while on site on July 29, the plots were visited, and the soil had been spread and seeded according to the approved plan. As stated in the approved Revegetation Test Plot Plan, the same seed mix was used to plant each plot, but different additives were used. One plot used soil with no additive. One plot used a biopolymer designed to deter soil erosion and promote growth. The third plot used fertilizer and mulch spread on the soil with the seed. On July 29, none of the plots showed any growth, so it was too early to make any comparison. Each week, data from each plot is recorded. The results will be used to choose a method for revegetating the site.
