Manh Choh Mine Field Inspection Report

Inspection Date:	June 25, 2025
Time:	9:00 AM to 1:00 PM
Weather:	Partly cloudy in the morning becoming overcast with broken clouds in the afternoon clearing later in the day. Slight breeze at lower elevations with winds reaching around 20mph higher up with an average temperature of 60°F.
DNR Personnel:	Aaron Kruse, William Groom, Ashley Adoko
DEC Personnel:	Trisha Bower, Laona DeWilde
Manh Choh Personnel:	Paige Lambert, Luke Walker
Inspection Objectives:	Site Inspection

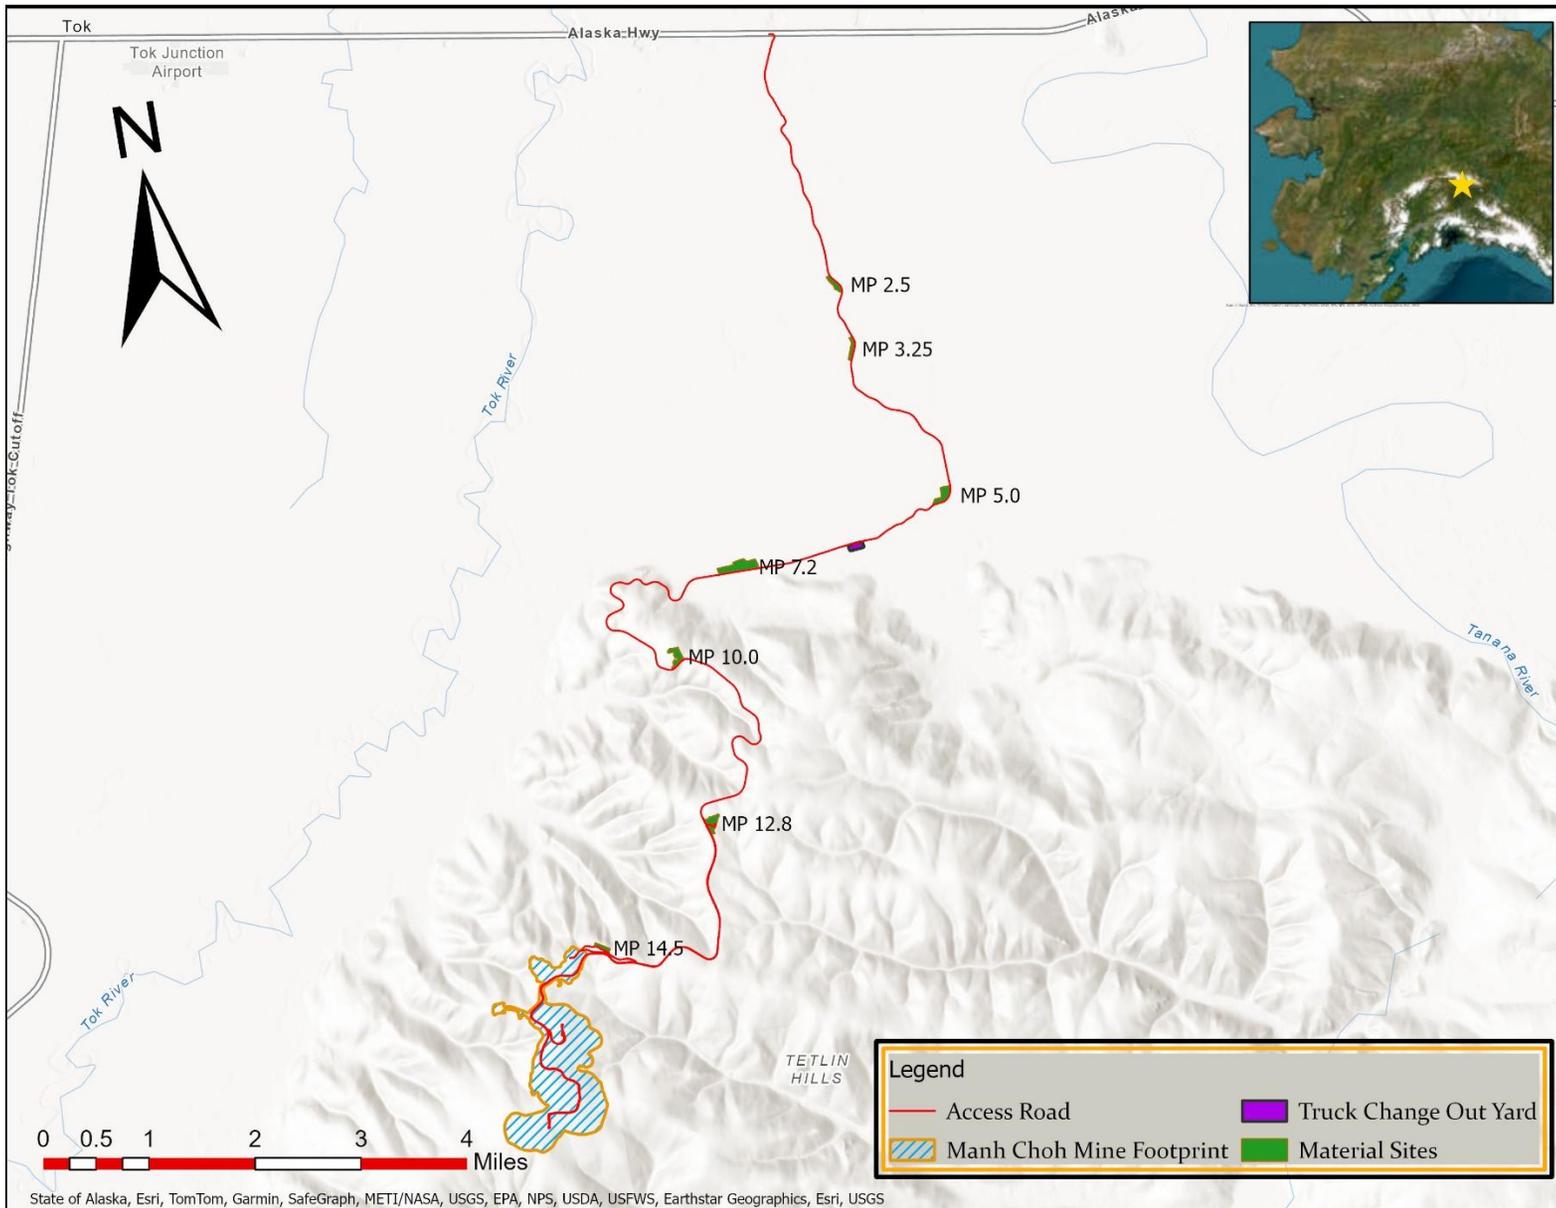
Map 1: Footprint of the Manh Choh Mine and supporting facilities including mine road access and borrow sites on Tetlin Land.

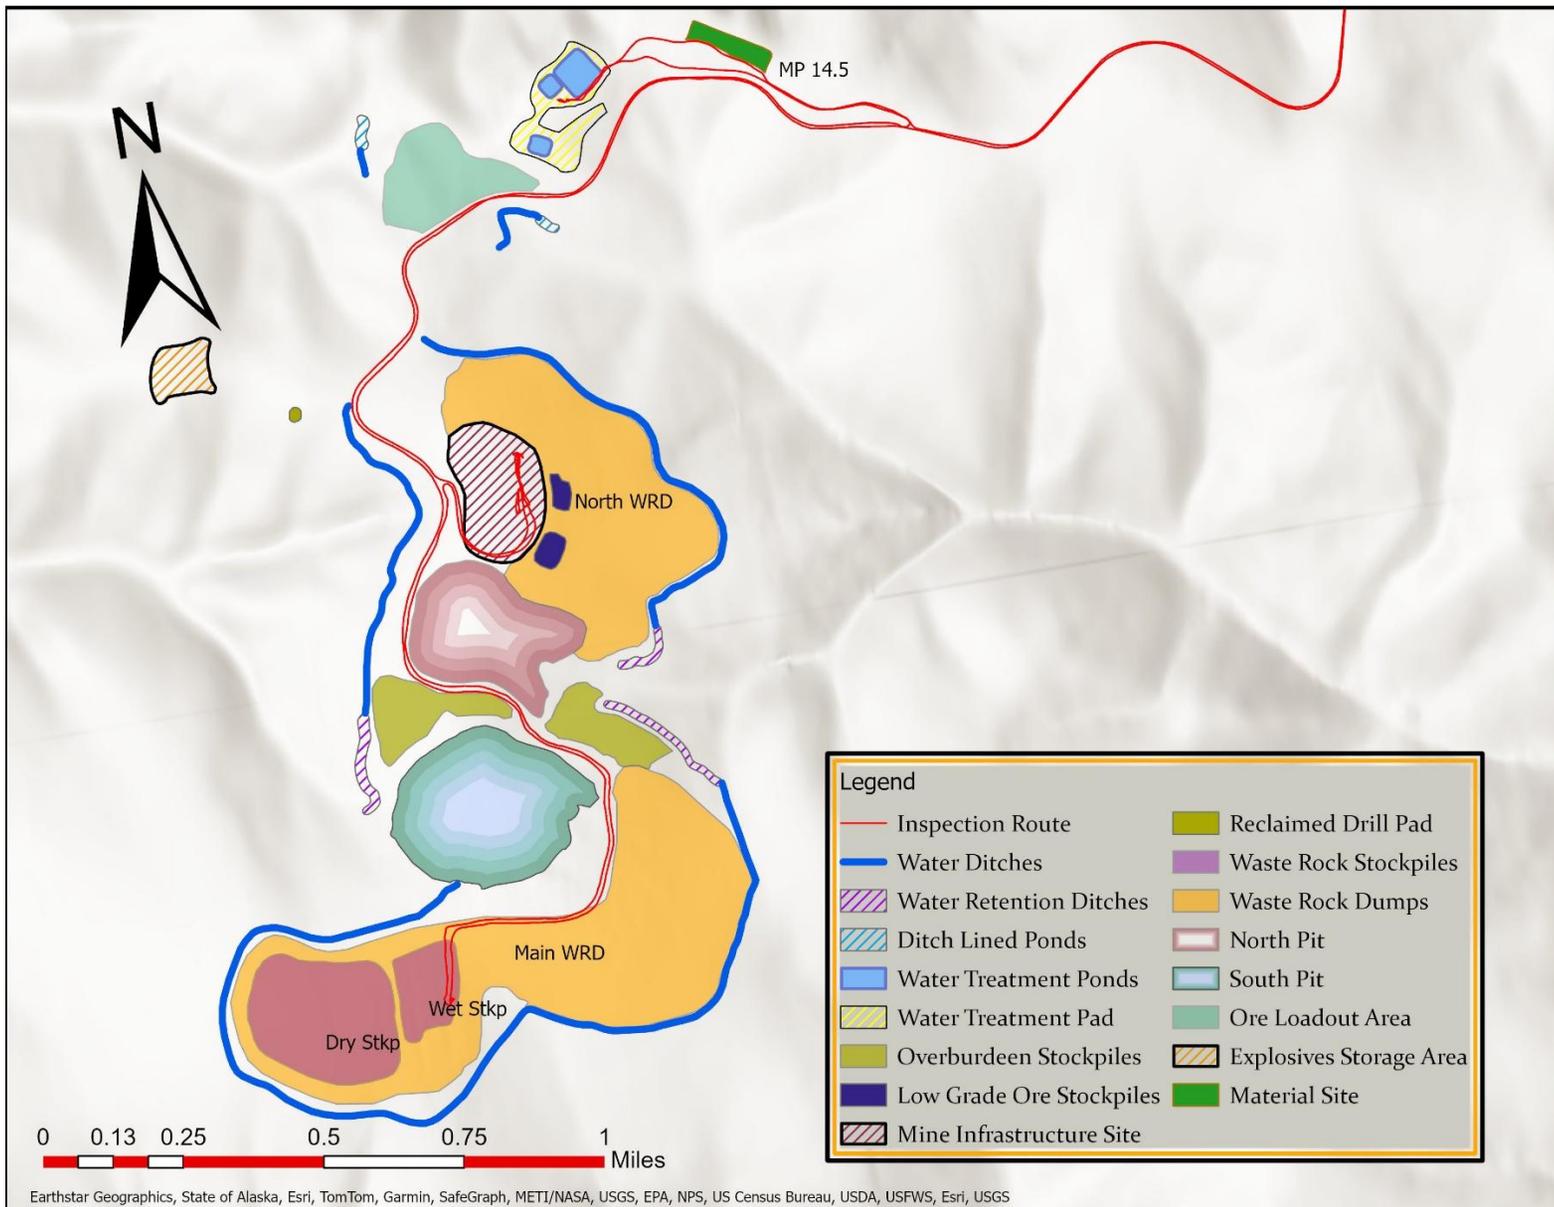
Map 2: Layout of the Manh Choh Mine's facilities, active areas of disturbance, and water management documented during inspection.
