## Manh Choh Mine Field Inspection Report

<b>Inspection Date:</b>	September 19, 2025
<b>Time:</b>	1:00 PM to 4:00 PM
<b>Weather:</b>	Overcast in the afternoon with a cloud ceiling of $\approx$ 2000 feet with broken cloud cover later in the day. Slight breeze at lower elevations with gusts around 10mph higher up with an average temperature of 50°F.
<b>DNR Personnel:</b>	Aaron Kruse, William Groom, Erika Alexander, Jonathan Kummer
<b>Manh Choh Personnel:</b>	Brent Culleton, Doreen Mark
<b>Inspection Objectives:</b>	Site Inspection

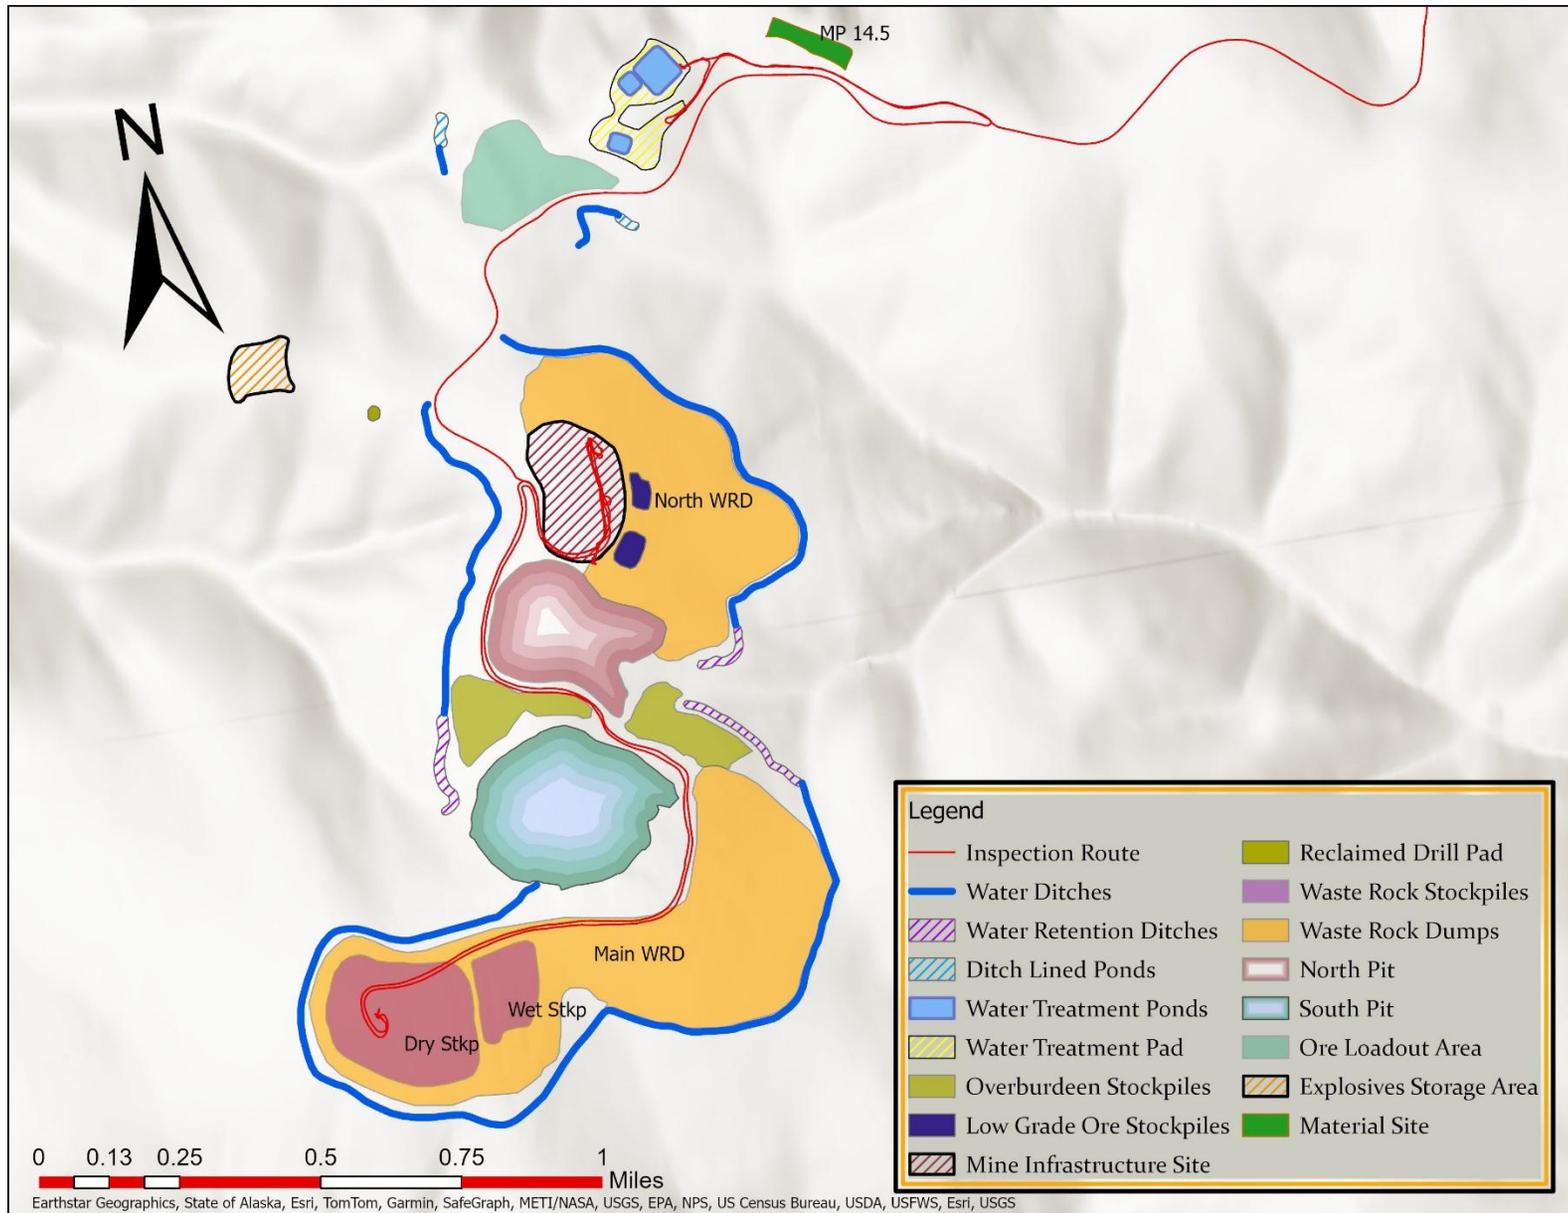
Map 2: Manh Choh Mine layout of major facilities, active areas of disturbance, and water management documented during inspection.
