DIVISION OF MINING, LAND AND WATER

## Field Inspection of the Pebble Copper/Gold Project

July 26-27, 2007

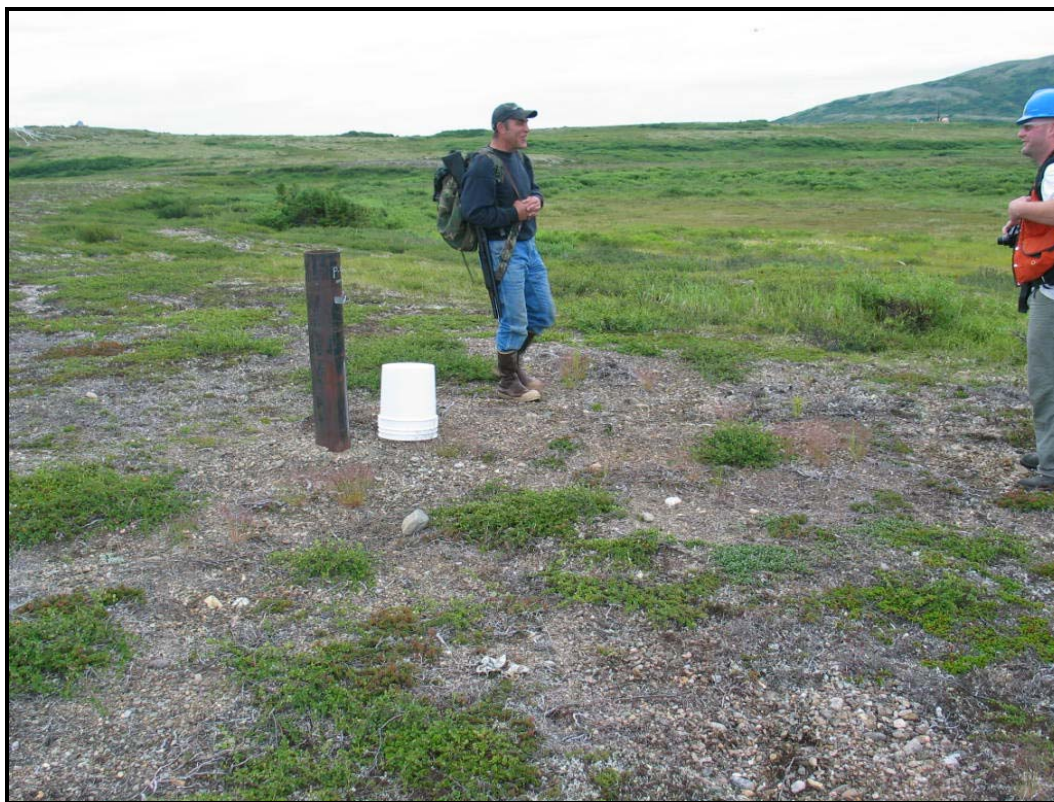
Photo #8. Piezometer well #P4.

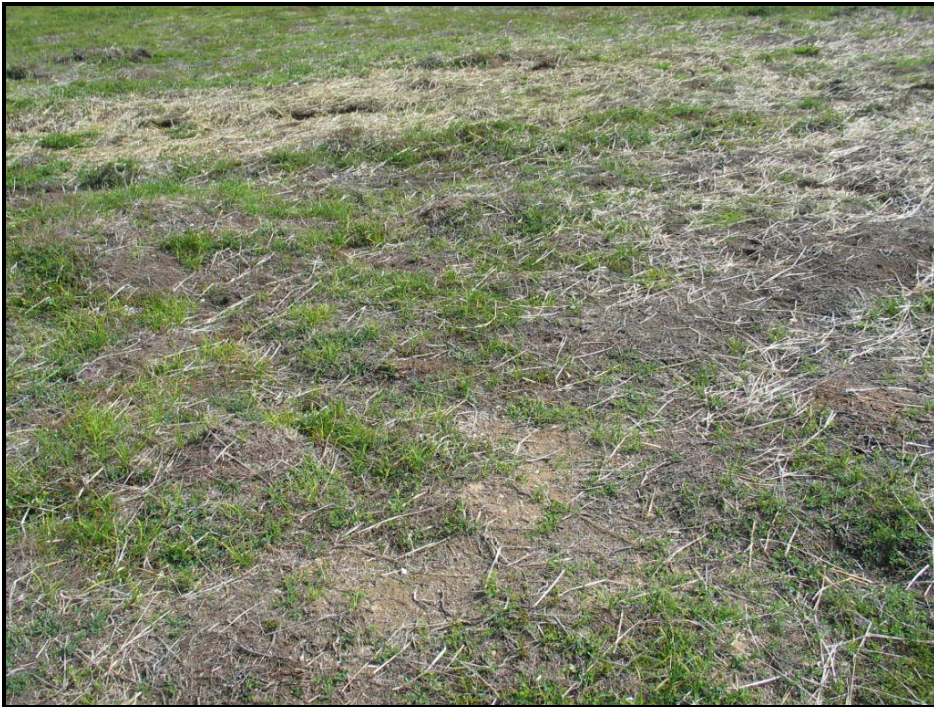
Photo #37. DDH 6350 reclamation
