DEPARTMENT OF NATURAL RESOURCES

DIVISION OF MINING, LAND and WATER

POGO INSPECTION REPORT

Inspection Date: May 11, 2010
Weather: Windy, Cloudy, 50 degrees F.
Time of Inspection: 8:30 am to 3:00 pm
Operator Contact: Stacy Staley, Larry Davey, Todd Roth, Sally McLeod, Mike Carney, Makoto Umedera, Ben Farnham – Sumitomo Pogo
Agency Personnel: Brent Martellaro, Stephanie Lovell – ADNRR; Tim Pilon, Pete McGee – ADEC; Jack Winters – ADF&G; Lisa Harbo - OED
Inspection Objectives: General Inspection of Mine Site

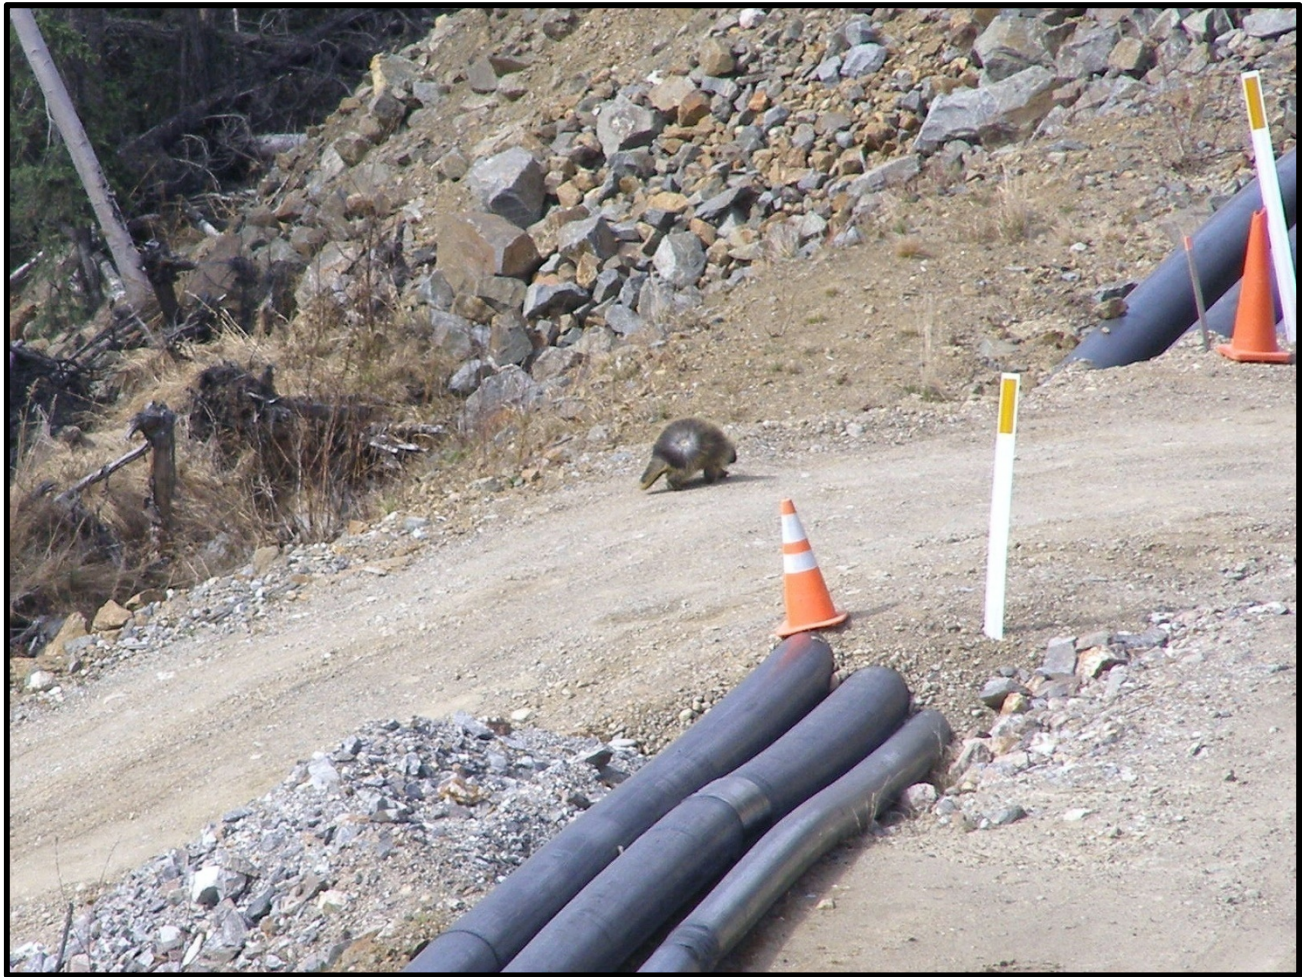
Photo 12 – RTP

The water level in the RTP is quite low considering the post runoff time of year (Photo 12). While the low snowfall this past winter may be much of the reason, the successful diversion of water around the Drystack and RTP is contributing to the control of water balance.
