## **POGO MINE INSPECTION REPORT**

**Inspection Date:** September 12, 2013

**Inspection Objectives:** General Inspection

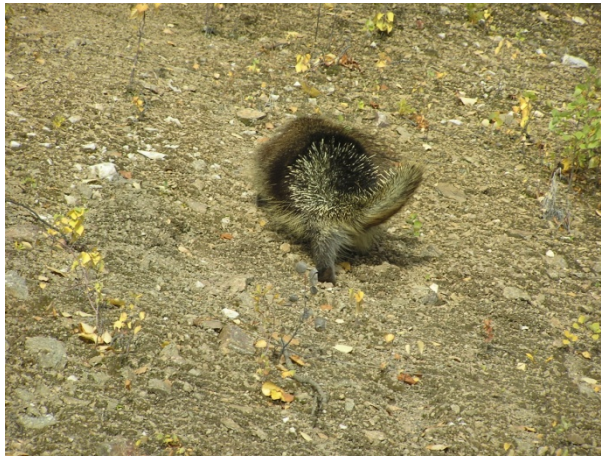
The work for the 2150 portal continues as shown in Photo 27 and Photo 28. General site photos indicate that berms along the access road are in good condition (Photo 29), the seasonal changes are visible (Photo 30), and animal habitat is sustained (Photo 31).

Photo 31: That's all folks...
