**FORT KNOX GOLD MINE**

**PLAN OF OPERATIONS&WASTE MANAGEMENT PERMIT  
RENEWALS**

Updated April 2026

This document is the Operations & Maintenance Manual (O&M Manual) for the Fairbanks Gold Mining, Inc. (FGMI) Walter Creek Valley Fill Heap Leach Pad (WCHL) located near Fairbanks, Alaska in the North Star Borough. This O&M Manual has been prepared to facilitate both effective and efficient practices for the operation, maintenance, surveillance, and documentation of the facility. This document contains information and instructions that will assist FGMI operations and maintenance personnel in the performance of their duties; as well as contribute to their training in recommended procedures. Also included in this manual is an organizational chart showing key personnel, and a remedial action contingency plan that covers general emergency response and communication procedures.

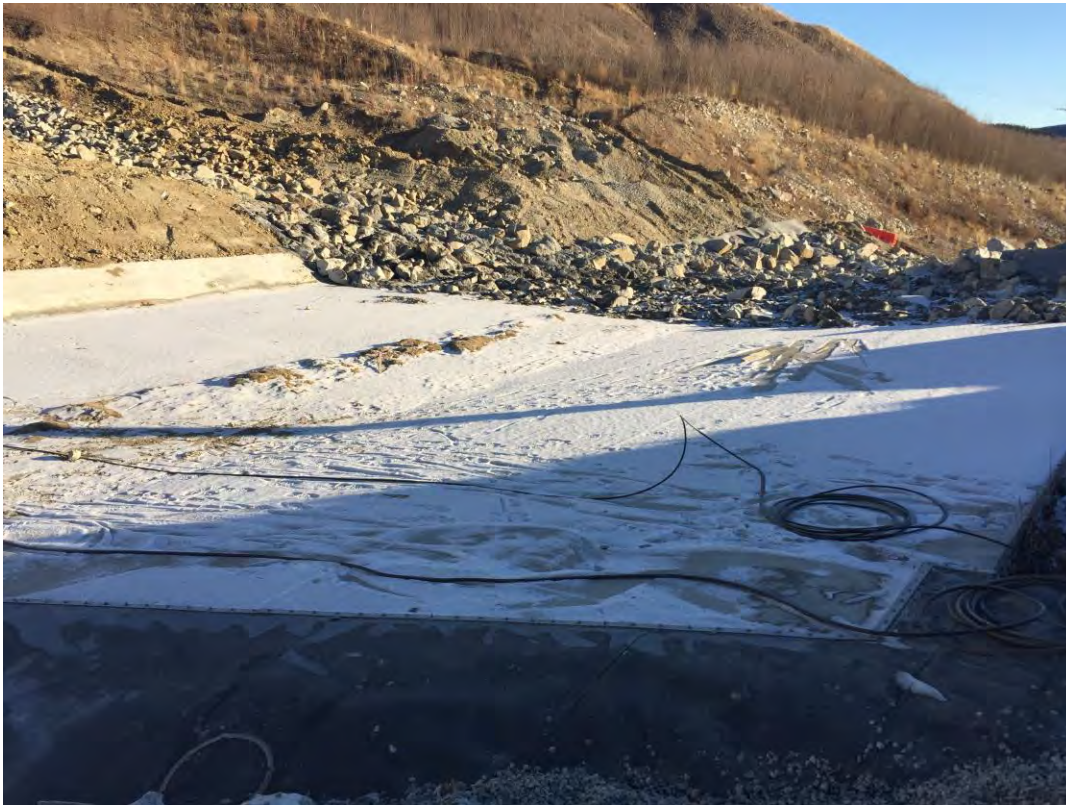
**Figure 2-3 – Concrete Spillway**

A spillway has been constructed through the Northern side of the embankment and is photographed in Figure 2-3. In the event of an emergency, the spillway protects the main embankment from being overtopped by a rising solution pond. The spillway invert sits at the 1650.5 elevation, which is 2.5 feet below the embankment's design crest. Where it crosses through the embankment, the South side slopes down at a 10:1 gradient to a flat channel bottom that is 35' wide and constructed of concrete. From the channel bottom, the North side slopes back up at a ratio of 2:1. The spillway has been designed to maintain 0.5 foot of freeboard on the dam while passing the peak flow from a 100-year/24-hour storm event. This freeboard is deemed acceptable within the weir section because:

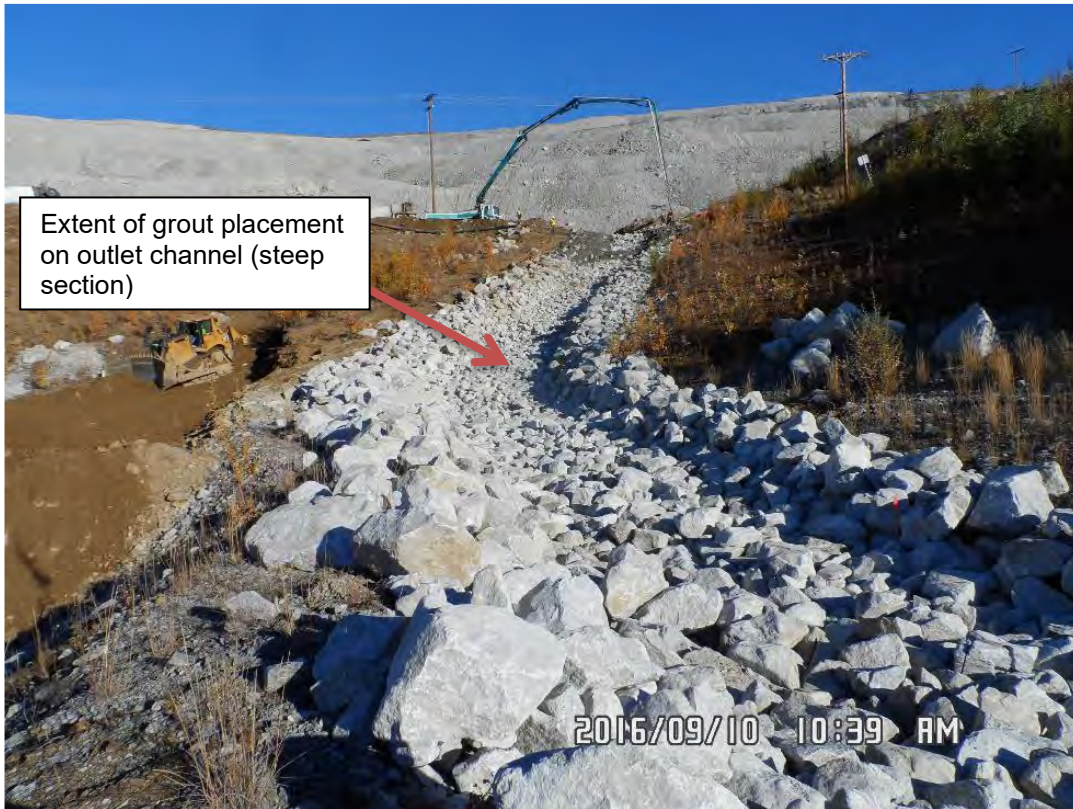
Figure 2-4 – Riprap Lined Spillway Channel

The spillway will direct any overflow to the downstream TSF via the riprap-lined and grout supported spillway channel, seen in Figure 2-4. The outlet channel matches the channel width of 35-ft initially and then transitions down to 15' in some areas. Channel width varies and is determined by the depth, cross-sectional area, and steepness of the channel section. The end results in to provide a continuous channelized flow from the concrete spillway to the outlet channel discharge point, immediately upstream of the TSF.

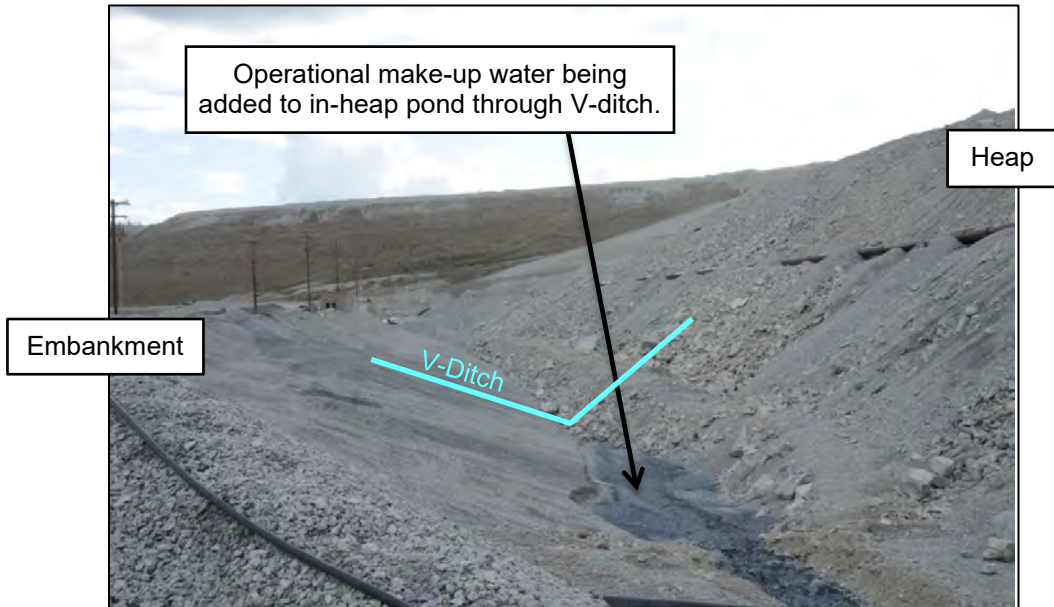
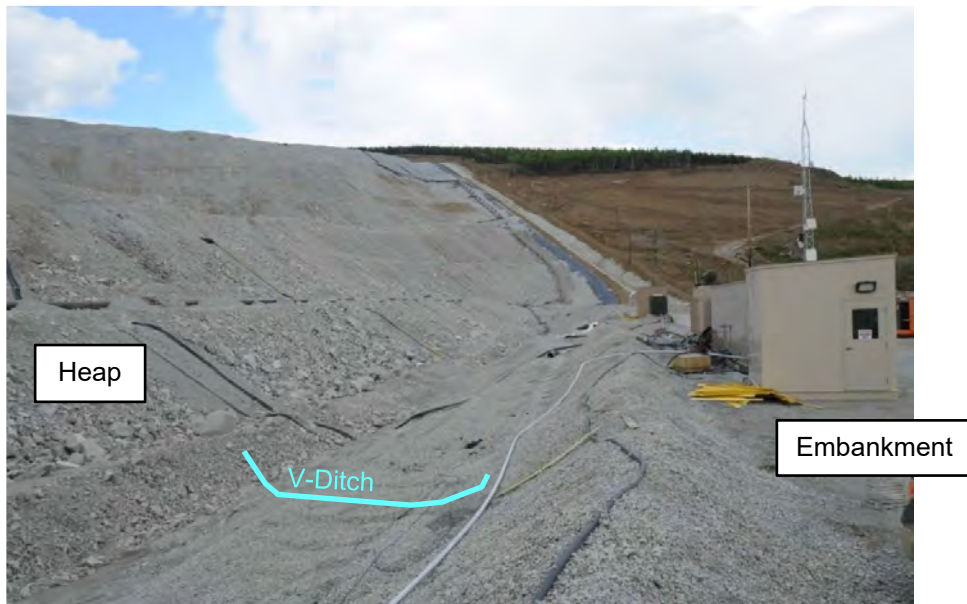
In the time prior to the spillway becoming active, solution levels will rise in the pond and begin to pool in the area between the upstream face of the embankment and run of mine ore. Seen in Figure 2-6 and Figure 2-7, this area is known as the “V” swale or “V” Ditch. During normal operations, this area is available to temporarily store storm water runoff that flows to it from around the heap toe. Flow or accumulation in this area will enter the pervious ore at the base of the heap and drain into the pond below. The estimated as-built storage volume of the swale is approximately 6.2 million gallons. In the unlikely event that the surface of the swale is completely frozen, the calculated runoff volume of 38 million gallons from the 100-year/24-hour design storm event could be conveyed through the emergency spillway.

**Figure 2-6 – V Ditch Looking South**

**Figure 2-7 – V Ditch Looking North**

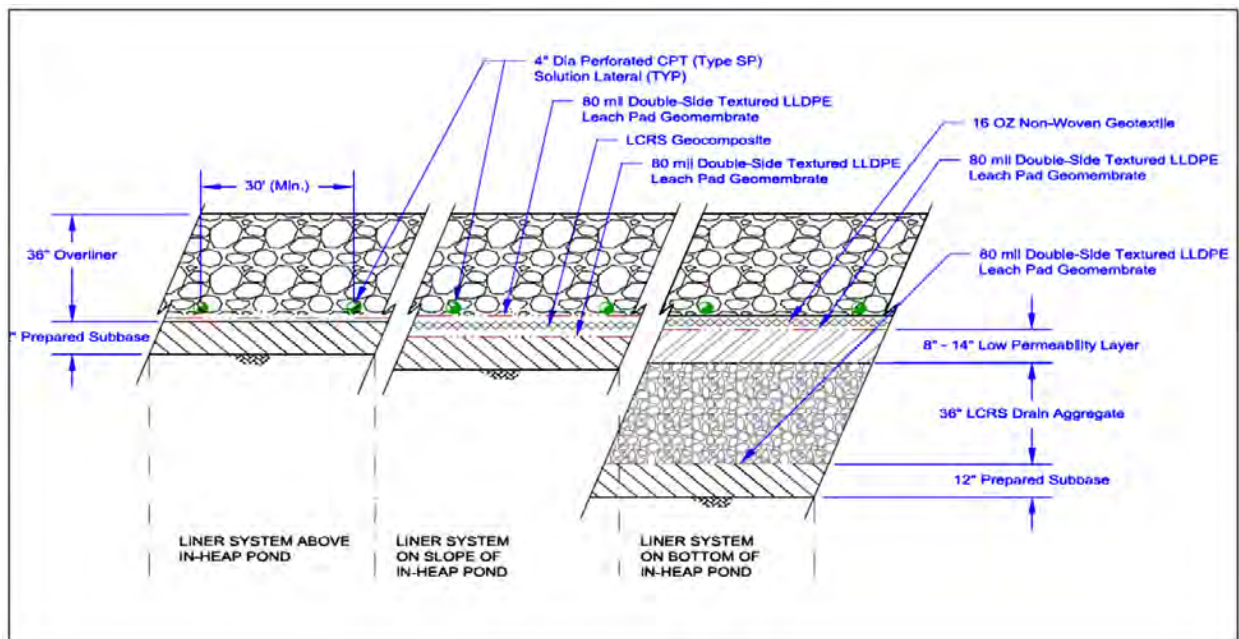
**Figure 2-9 – Composite Liner Cross Section**

- 1) 12-inch-thick low permeability prepared sub base
- 2) 80-mil double-side textured LLDPE geomembrane liner
- 3) 3-foot-thick overliner cover with solution collection pipes buried within. These pipes are a direct extension of the pipes placed in zone 1. Along with promoting drainage, the overliner and solution collection pipework will significantly reduce head pressure on the zone 2 liner. Feet of head on liner in zone 2 is designed to be less than 1 foot on average.

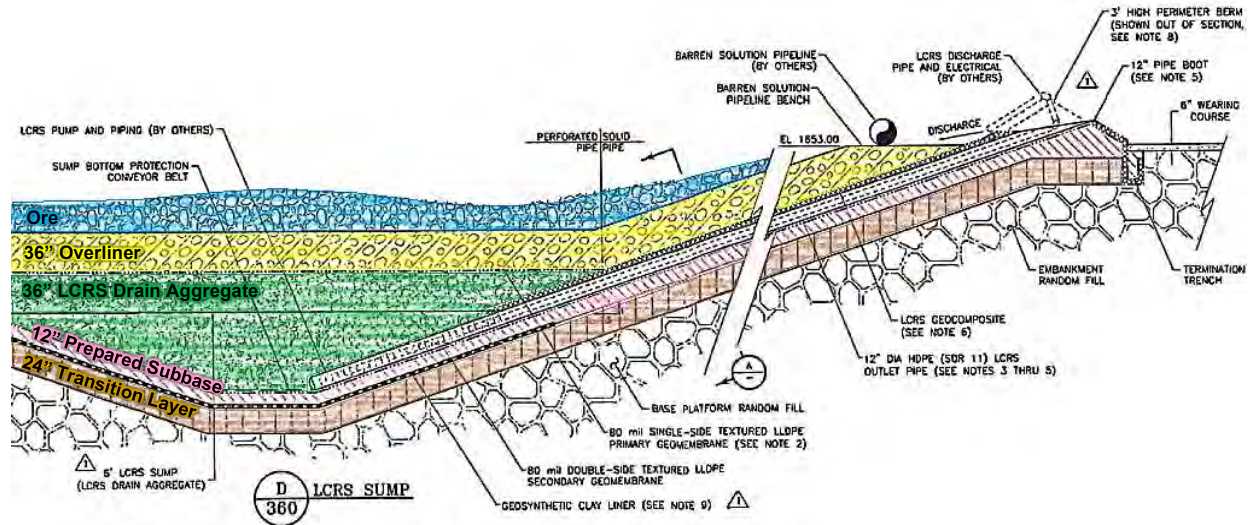
**Figure 2-10 – LCRS Details**

from the bottom of the LCRS sump to the embankment crest. The portions of the pipes within the sump are slotted with openings sized appropriately with to avoid migration of the LCRS drain aggregate into the pipes. The bottom of the LCRS sump has been protected from damage by the outlet pipes with the placement of conveyor belting. A layer of geosynthetic clay liner was installed below the LCRS sump, between the 12-inch-thick prepared sub base and the secondary liner, to further limit the potential for leakage. Reference Figure 2-10 for LCRS details

The LCRS is part of the double lined pond zone. The LCRS serves as a monitoring and collection system for any process solution passing through the primary liner; it also provides a hydraulic break between the primary and secondary containment liners. This break means that although the head acting on the primary liner is the full depth of process solution during operations, the head acting on the secondary liner is designed to be less than one foot.

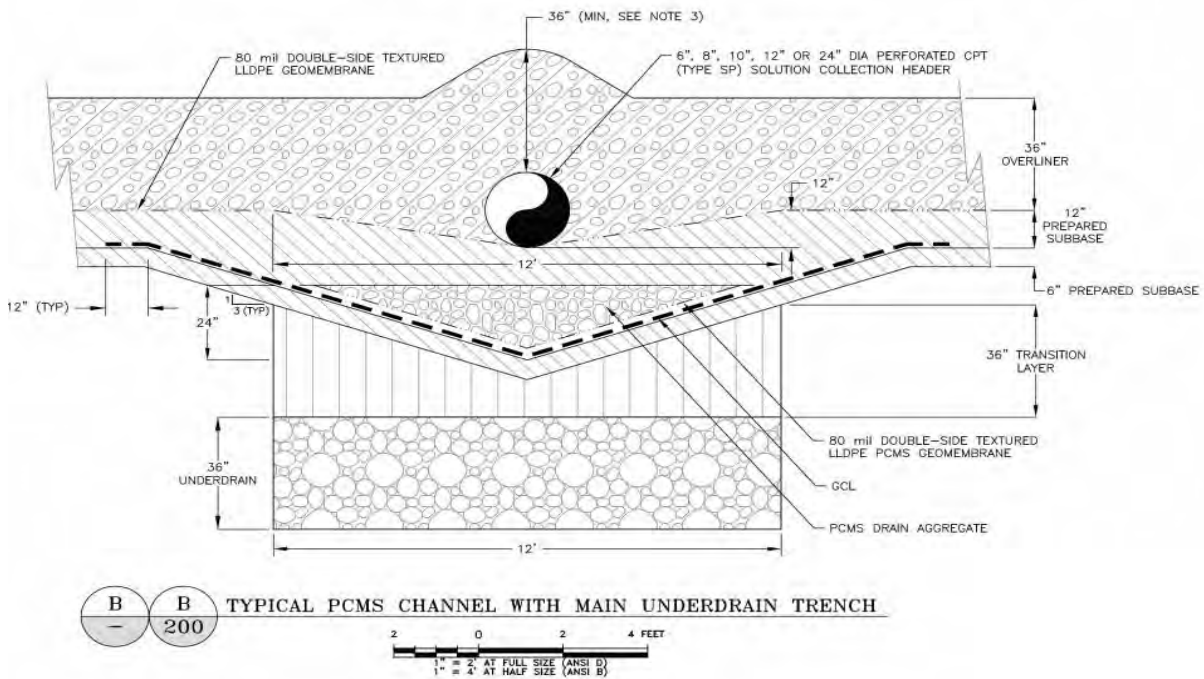
Figure 2-12 – PCMS Channel Detail

In the three drainages, the PCMS consists of a lined “V” channel filled with pervious PCMS drain aggregate. The design width of the top of the PCMS channel is 12 feet, and the depth is 2 feet. The composite liner for the channel includes a geosynthetic clay liner (GCL) overlain by an 80-mil double-side textured LLDPE geomembrane. The GCL was used in lieu of the prepared sub base to simplify construction and extends about a foot outside the edges of the PCMS trench. Figure 2-12 illustrates the design.

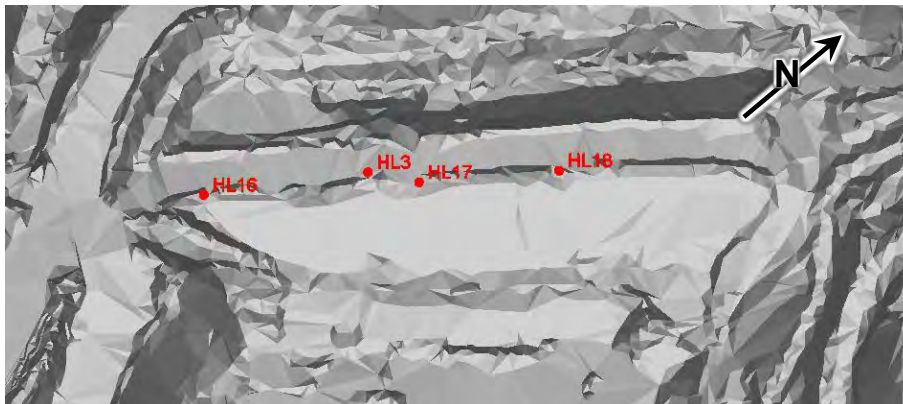
**Figure 3-4 – WCHL Embankment Prisms**

Seven survey monuments are installed to enable monitoring of embankment movements. Three are located on the 50-foot-wide bench at the top of the base platform. Surveying the four embankment monuments will be on a quarterly basis. These are also to be surveyed following any significant seismic event. Data will be reviewed by the Engineer of Record (EOR) at a minimum of once per year. Review by the EOR will occur more frequently if movements in any direction exceed 0.05 foot from the movements reported in the previous annual inspection. FGMI’s survey department records survey data in a spreadsheet which is entered into the Fulcrum database.

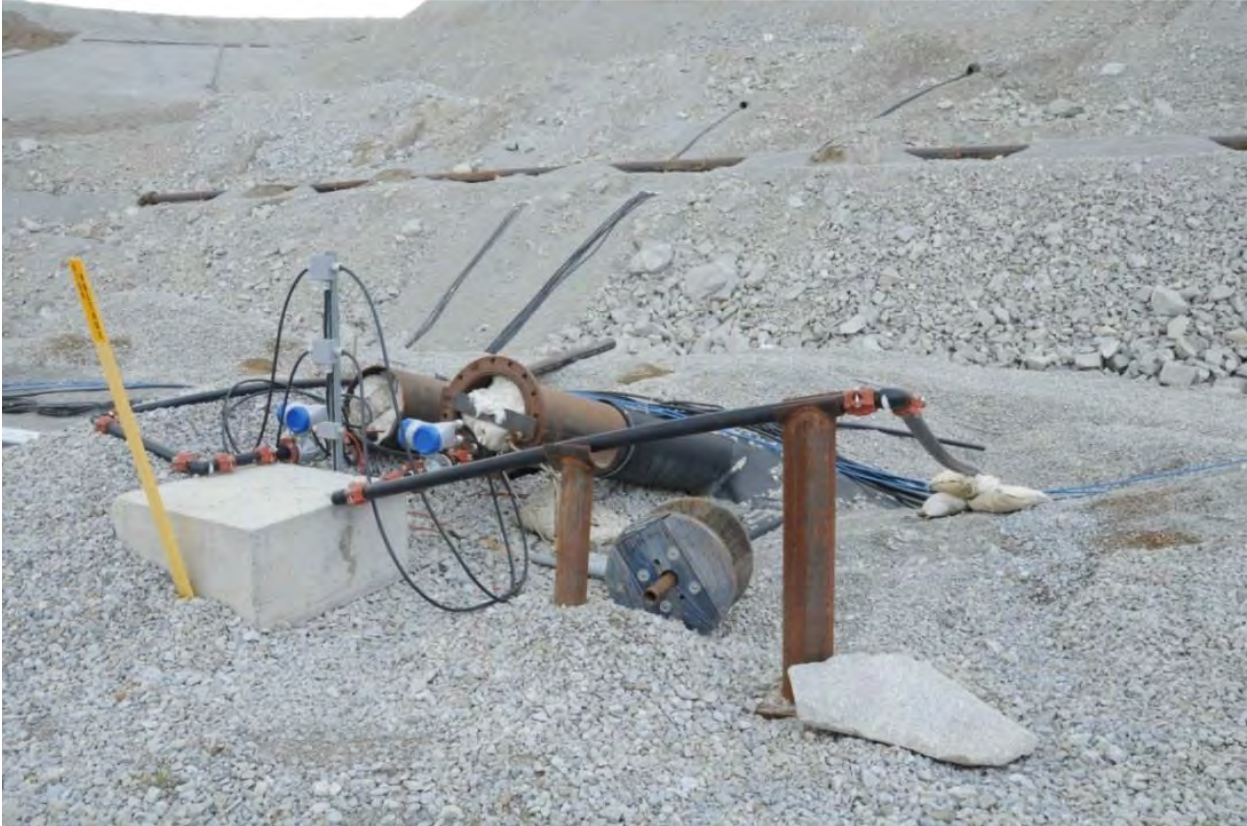
**Figure 3-9 – LCRS Solution Collection Pipes**

The LCRS monitors and collects process solution passing through the primary liner of the in-heap pond. It is buried beneath the pond so there is no practical way to perform maintenance. The estimated leakage rate to the LCRS at the long term normal operating pond level was expected to be 330 gpm during design of the WCHL. A pond level at elevation 1648 feet was expected to result in an estimated 520 gpm. Actual leakage rates have been much smaller and are on the order of 0.05 gpm.”

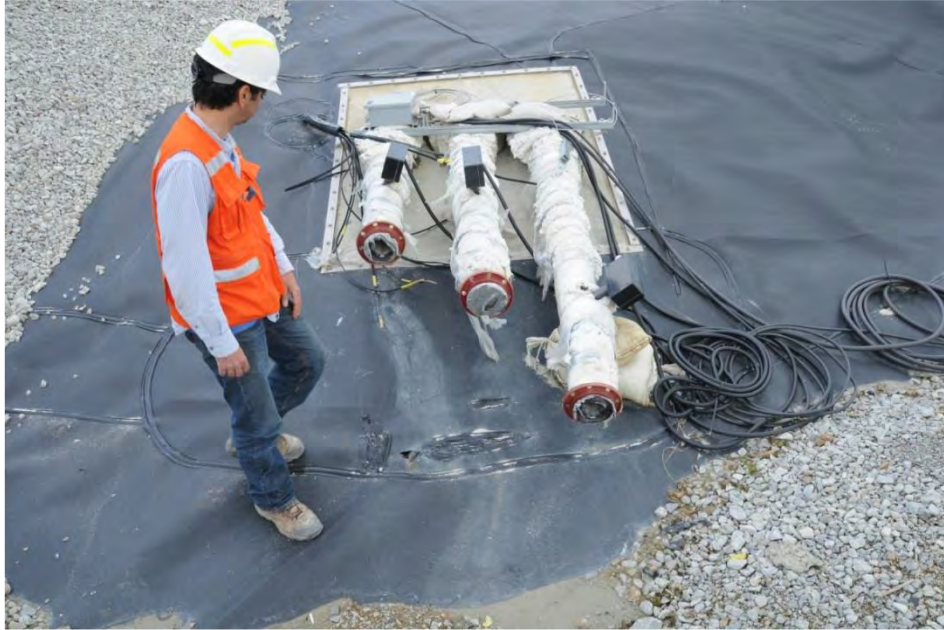
**Figure 3-10 – Close-up View of the PCMS Outlets**

The only accessible portion of the PCMS are the outlet monitoring points located in the northeast corner of the in-heap storage pond along the slope just behind the spillway. The outlet monitoring points are exposed and will discharge any flows directly onto the double lined pond area. The PCMS outlets have heat traces at the ends of the pipes that will be maintained as part of the routine FGMI maintenance program.

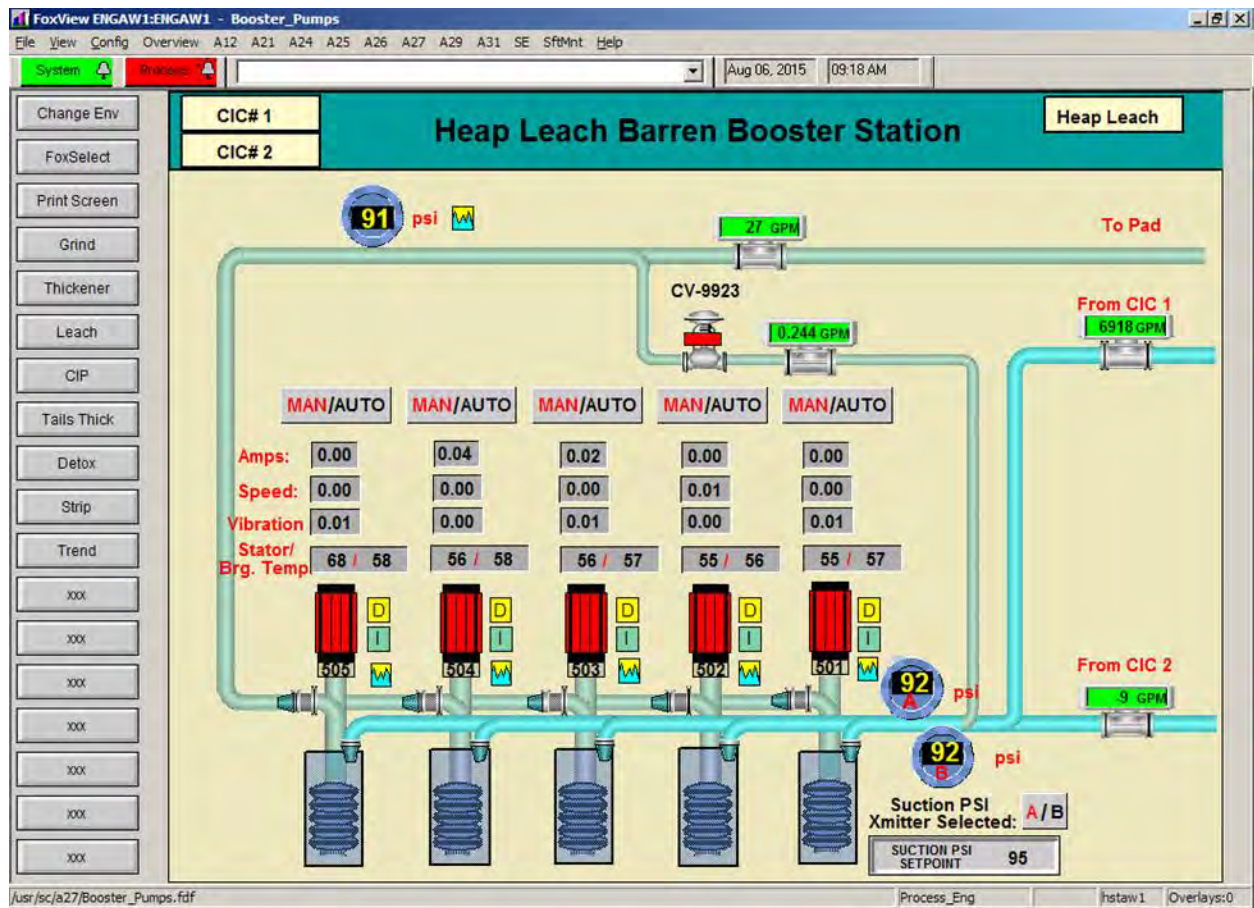
Figure 3-12 – CIC Booster Station DCS Interface

operation/oversight of the booster station is done remotely through the Data Collection System (DCS) interface in the mill control room. A picture of the DCS interface is seen in the following Figure 3-12.

A recirculation valve has been installed to protect the equipment associated with the booster station, named CV-9923 in the DCS system. This valve is controlled by mechanical pressure and the indicator seen in the DCS is for the pilot solenoid that enables it. If the inlet pressure drops below 30 psi or any pump is placed into manual mode, whether it be at the local hand station or on the DCS, the pilot valve will open and allow operation of the recirculation valve. The indicator on the DCS screen does not indicate whether the valve is open or closed, just if it is enabled.

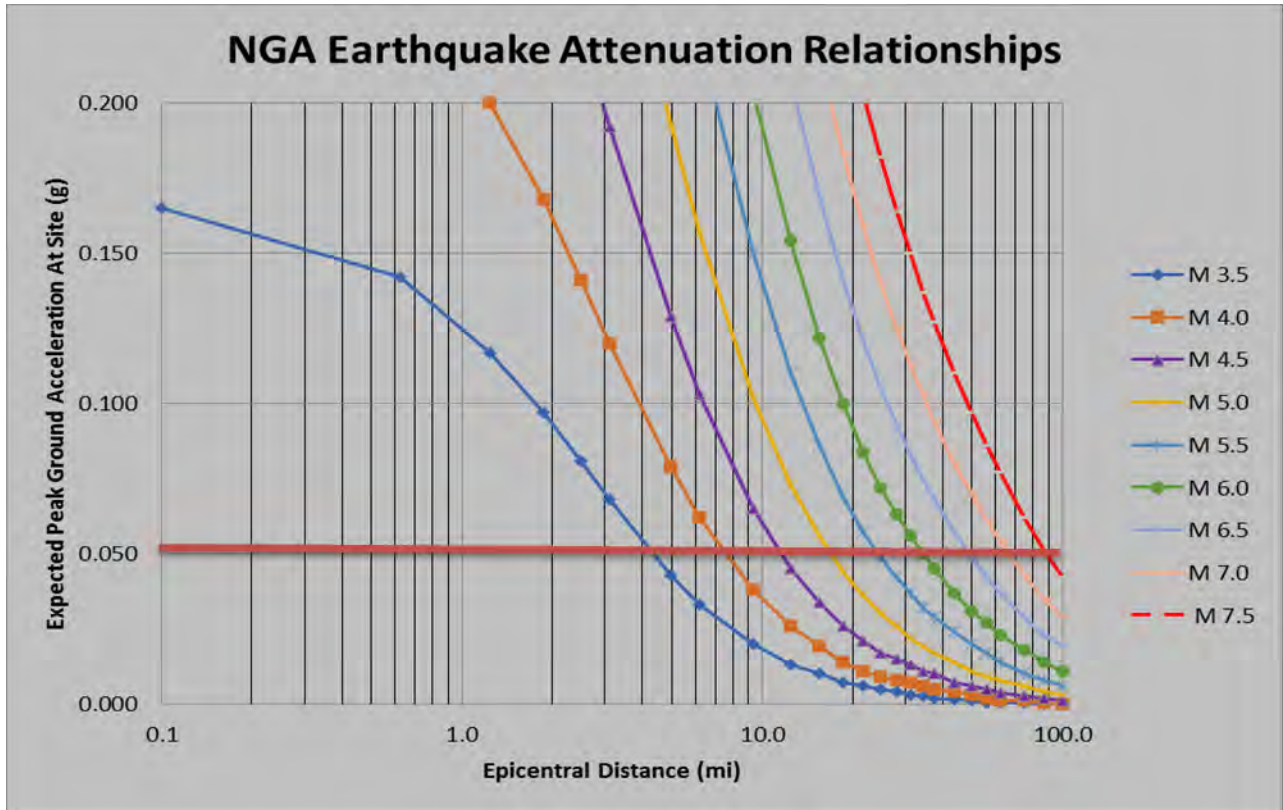
Figure 4-1 NGA Earthquake Attenuation Relationships

Magnitude	Miles Away		
5.0	15		
5.2	17		
5.4	19		
5.6	21	Magnitude	Miles Away
5.8	22	7.8	50
6.0	24	8.0	53
6.2	27	8.2	57
6.4	29	8.4	62
6.6	32	≥8.5	63
6.8	34		
7.0	37		
7.2	40		
7.4	43		
7.6	47

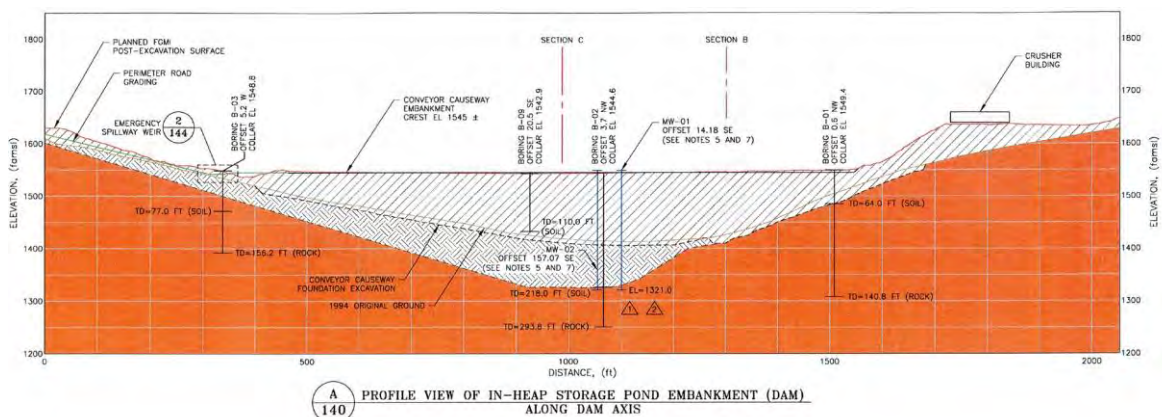
**Figure 2-1 In-Heap Storage Embankment**

The BCHL in-heap storage pond embankment uses the existing 200 to 250 foot wide conveyor causeway as its core element resulting in an approximate 95-foot embankment with a crest elevation of 1545 fmsl. Reference Figure 2-1. Due to prior loading against the conveyor causeway by both the Barnes Creek and Fish Creek stockpiles, no significant future deformations of the causeway are expected as a result of the planned BCHL development.

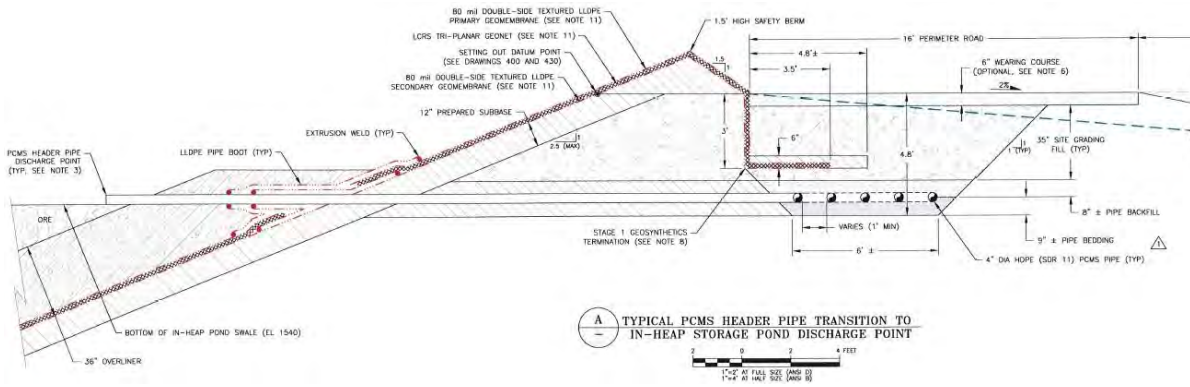
Figure 2-10 – PCMS Discharge

Just above the limit of the in-heap storage pond, the flows within each PCMS channel transition through a small lined sump into a 4-inch-diameter solid-wall header pipe that directs the flow to the discharge and monitoring point in the northeast corner of the in-heap storage pond. See Figure 2-10

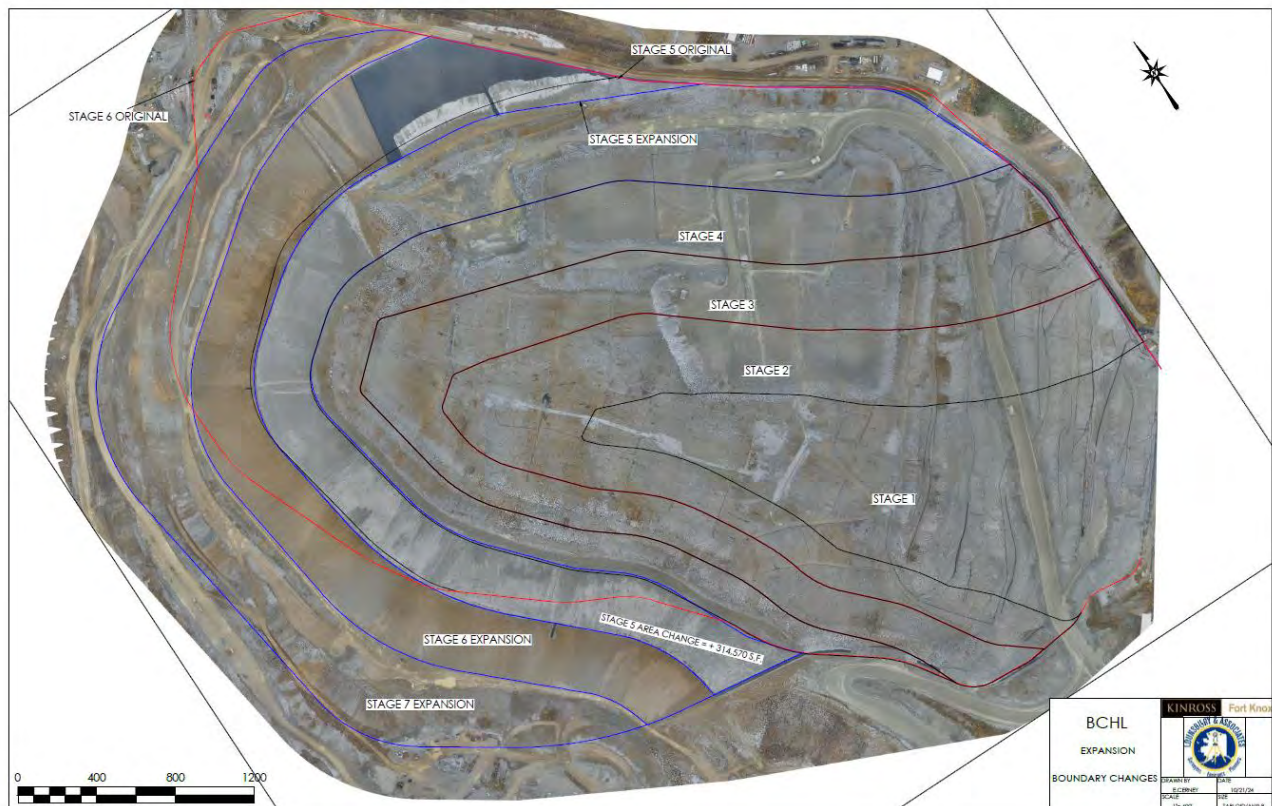
**Figure 2-12 Stage 1 and Stage 2 Ore Configuration**

Run-of-mine ore from the Fort Knox pit is placed on the pad year-round and is stacked in lifts that are a nominal fifty feet. Material dumped out generally settles to an angle of repose slope of about 37.5° (1.3' Horizontal to 1' Vertical). Catch benches are included between each successive lift of ore such that the overall exterior slope is at a ratio of 3H:1V (18.4°). Stage 1 through Stage 5 ore configuration is shown in Figure 2-12

As the active dump face advances, ripping of the area behind the face with a dozer loosens the surface compaction created by heavy equipment traffic. Ripping enables the barren solution flowing through feedline pipes and drip tube emitters to infiltrate the ore that minimizes surface ponding, and provides an interlocking surface for the subsequent lift. Reference Figure 2-12

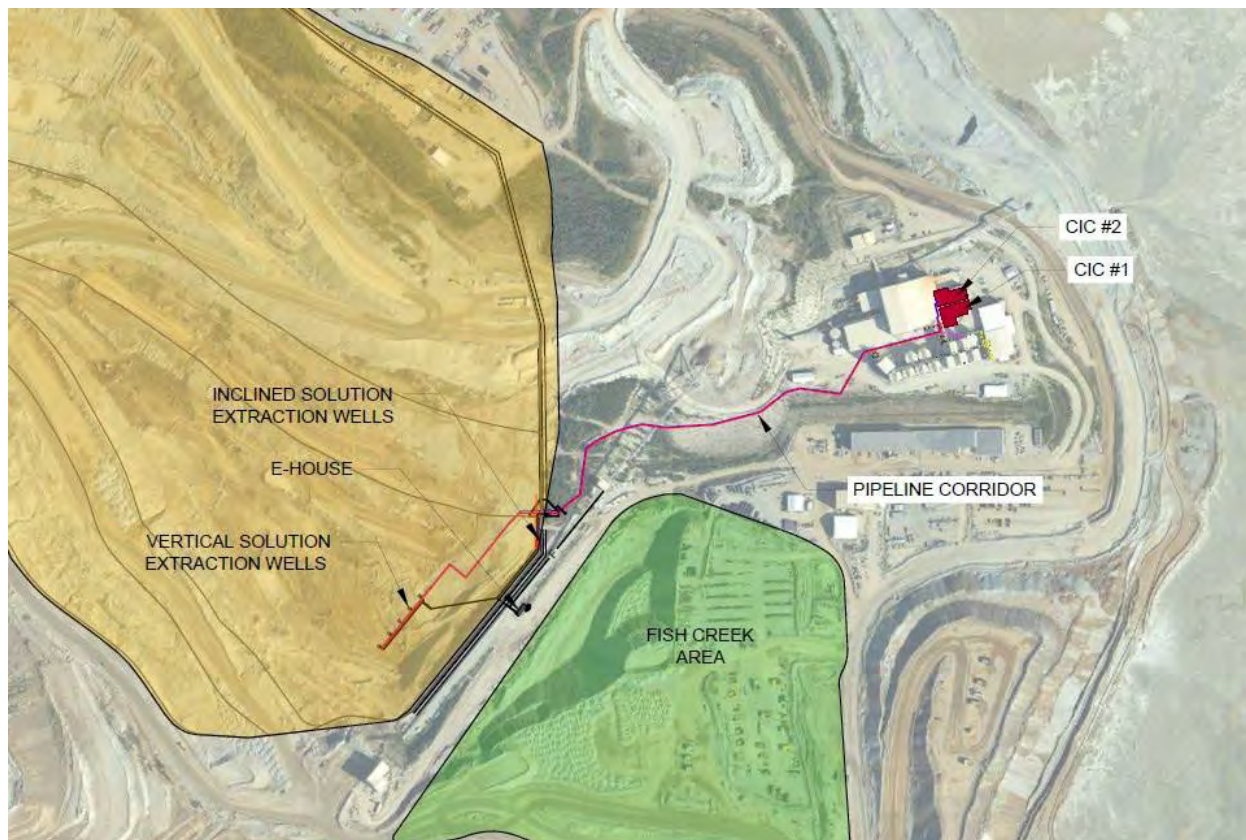
**Figure 2-13 Pipeline Corridor**

Solution transport between BCHL and the CIC plants is through a 30-inch lean line and a 36-inch pregnant line located within a pipeline corridor that is approximately 3,700 lineal feet. The corridor is constructed either on the surface or subsurface (trench and buried). There are two small sections of pipeline, one leads off the inclined wells (used for startup and future emergency operations) and the other from the vertical solution collection wells (used for normal long term operations). The junction of these two sections is located on the north end of the embankment crest and is constructed on the surface. From there the corridor turns northerly following native ground passing under the conveyor belt heading northeasterly following the coarse ore stockpile bench until it arrests a short distance on the mill bench. This portion is a constructed trapezoidal trench. The pipeline is encircled with LLDPE liner filled with mill reject ore. The trench is backfilled with mill reject ore. From this point the corridor continues towards the CIC plants. This section is a field fit excavated trench. The pipeline is encircled in a LLDPE liner filled with mill reject ore. The trench is backfilled with cover material and asphalt. The pipeline ties into the CIC plant pipe network. See Figure 2-13 below

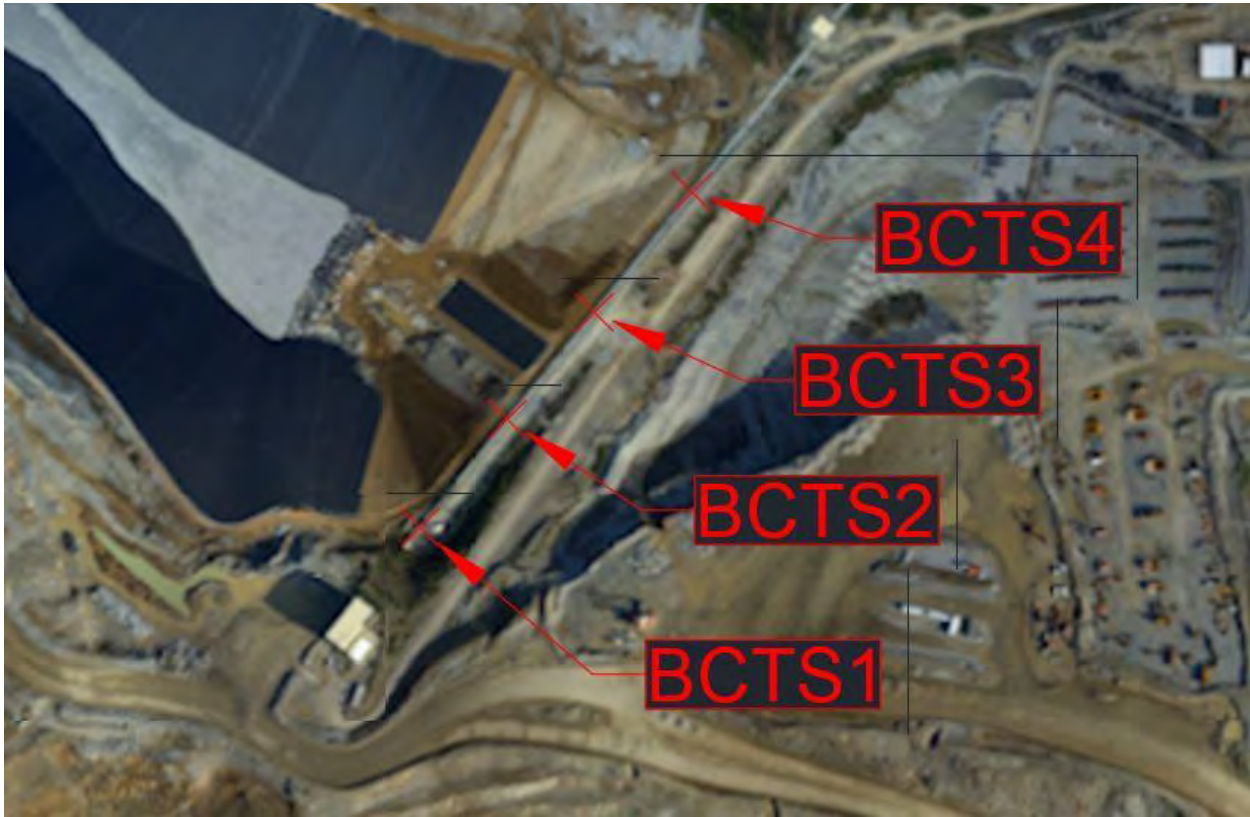
**Figure 3-1 Survey Monuments**

A series of four survey monuments are installed along the crest of the embankment to allow monitoring of potential movements. Reference Figure 3-1. The monuments will be read on a quarterly basis. These are also to be surveyed following any significant seismic event. Data will be reviewed by the Engineer of Record (EOR) at a minimum of once per year. Review by the EOR will occur more frequently if movements in any direction exceed 0.05 foot from the movements reported in the previous annual inspection. FGMI’s survey department records survey data in a spreadsheet that is maintained by the environmental department.

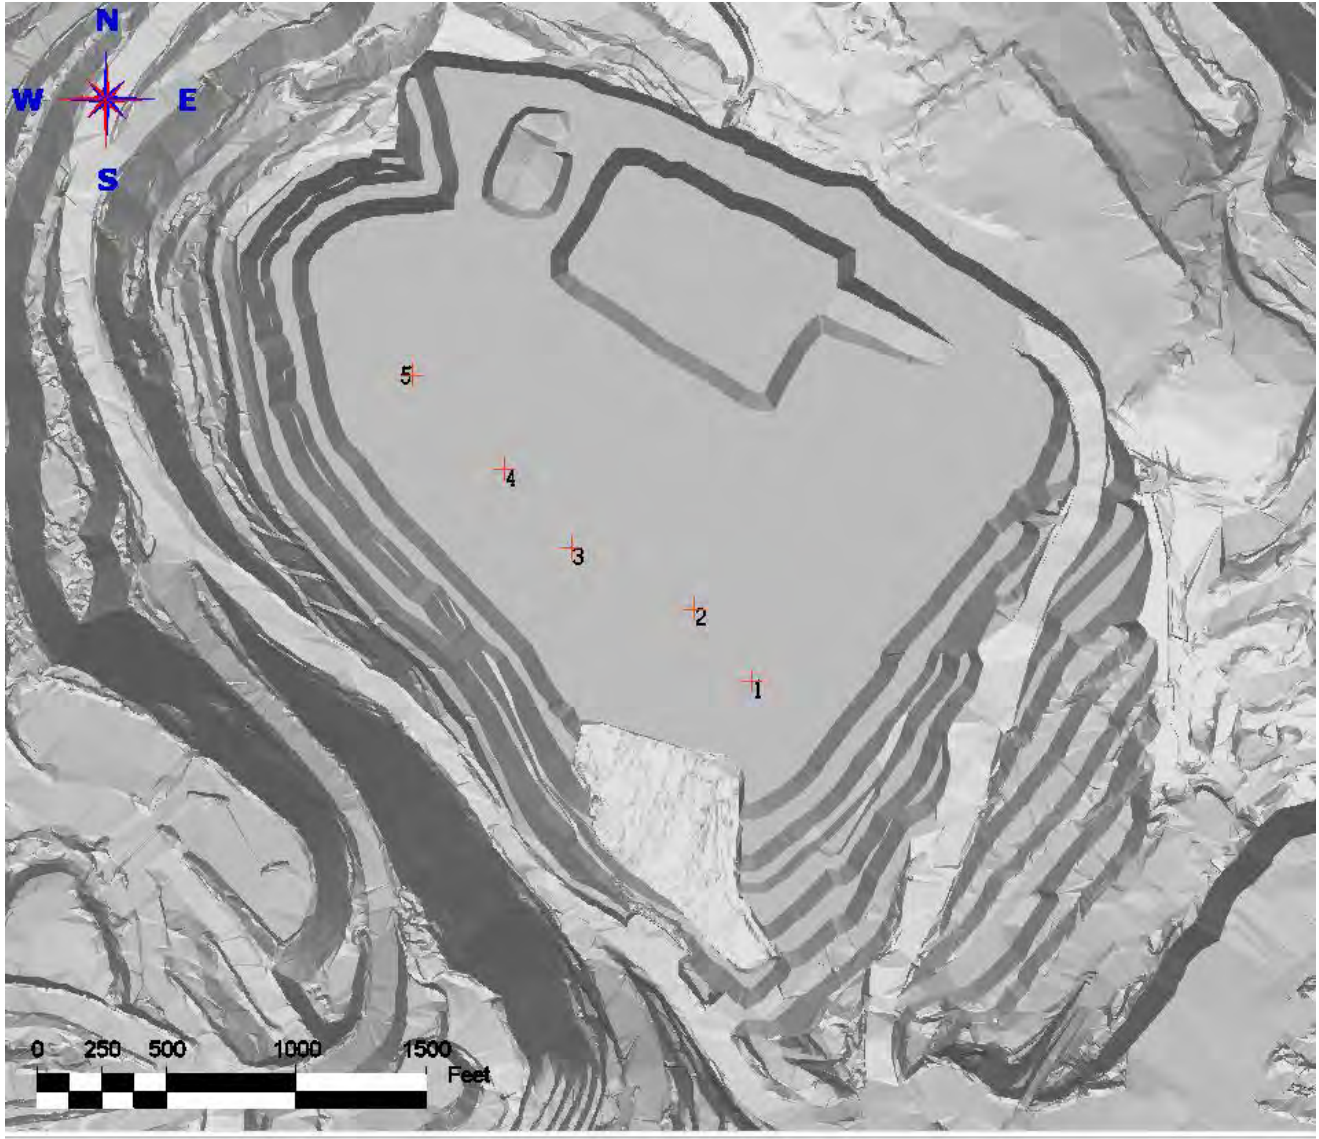
The wells are shown in the figure below.

4	65.00589775	-147.3714288	1970
5	65.00688446	-147.3737406	1970

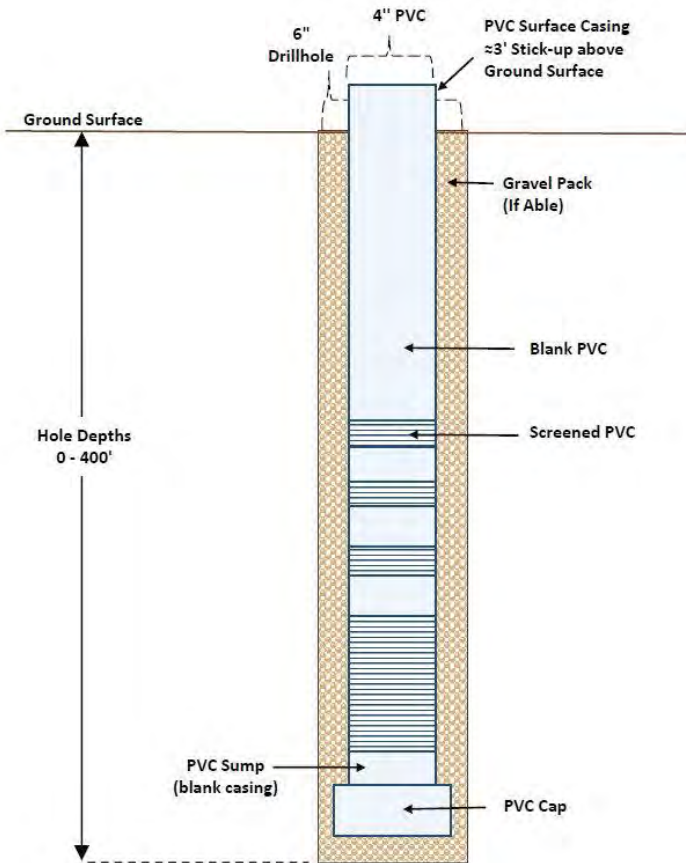
# Solution Well Diagram

The solution wells were installed using a six-inch bit. A 3-inch pvc drop pipe was installed along the full length of the six-inch hole. The annular space between the drop pipe and the undisturbed heap leach material was backfilled with pea gravel. The top 80 feet of pvc is solid with the remaining length screened. The drop pipe is capped at the bottom the screened section. A generalized schematic of the wells is provide below.

Not to scale

Well ID	Well Depth (feet bgs)
1	323.2
2	301.2
3	260.1
4	240.9
5	183.6

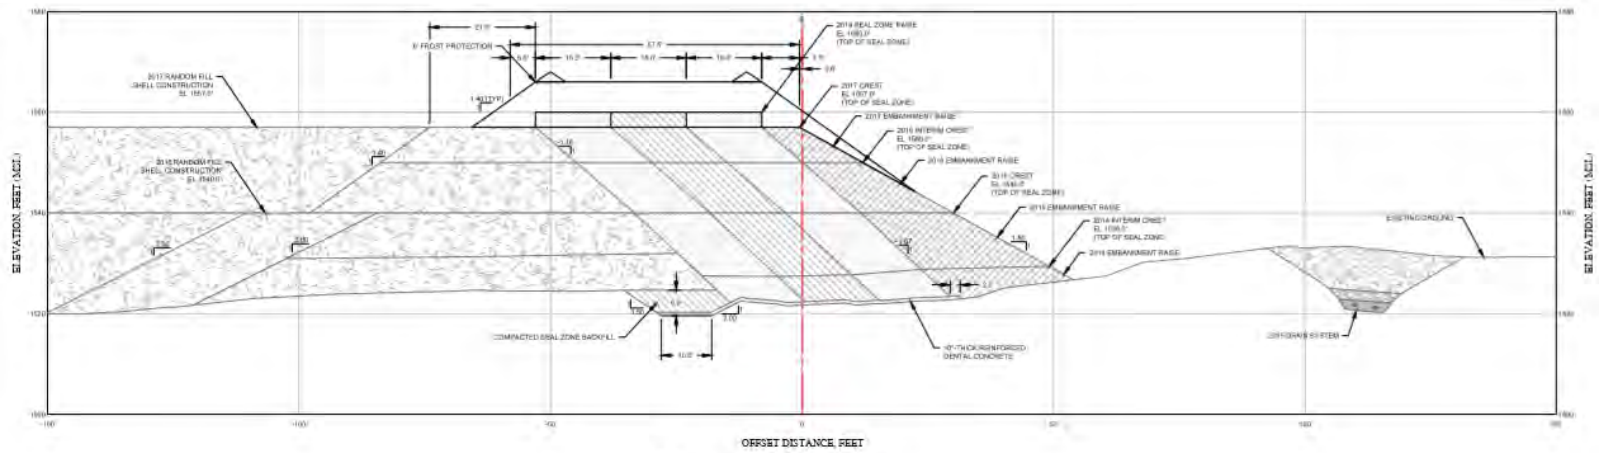
Figure 2-3 - South Abutment

D  
1000 CROSS SECTION STATION 2+00.00  
TYPICAL SLOPING CUTOFF TRENCH

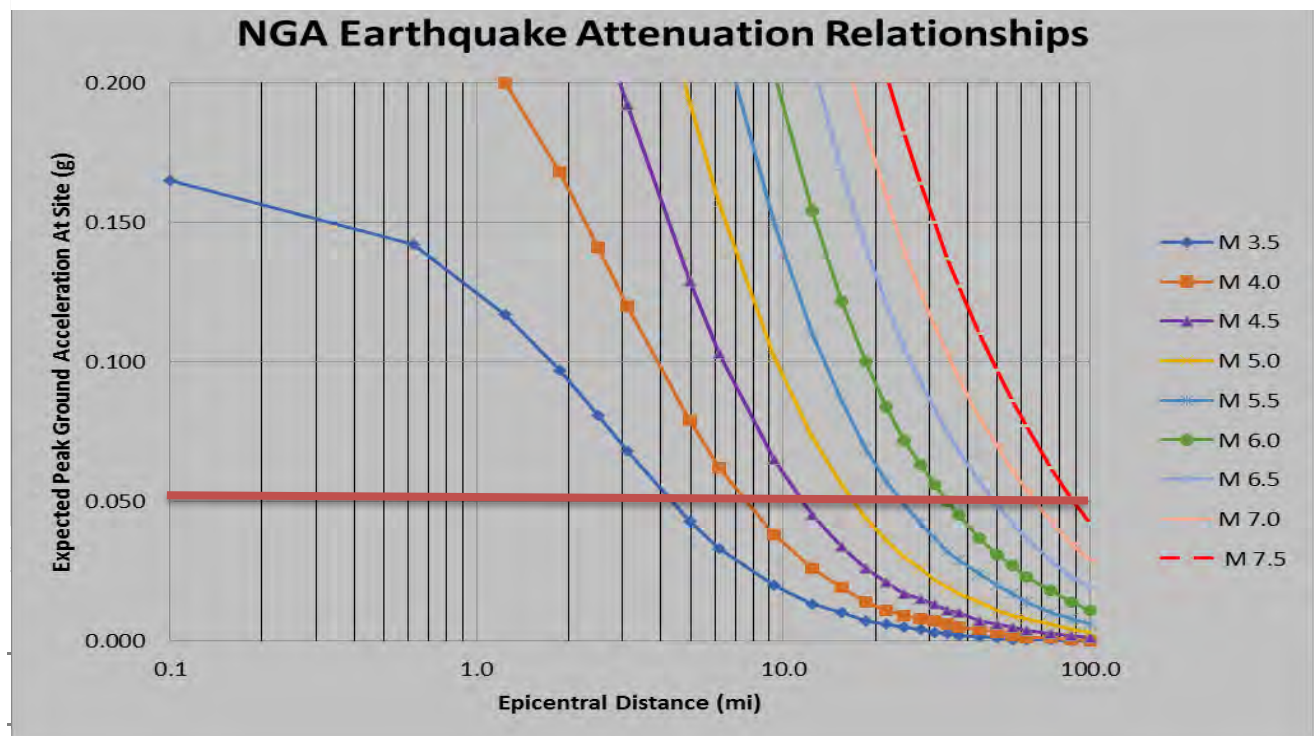
Figure 4-1 - Earthquake Attenuation Plot and Table

Epicentral Distance	Miles	0.1	0.6	1.2	1.9	2.5	3.1	4.1	5.0	6.2	7.8	9.3	10.2	12.4	15.5	10.8
<b>Peak Horizontal Ground Acceleration (PHGA) Expected at Mine Site (g)</b>																
<b>Earthquake Magnitude</b>	<b>M 3.5</b>	0.165	0.142	0.117	0.097	0.081	0.068	0.050	0.043	0.033		0.020		0.013	0.010	
	<b>M 4.0</b>	0.275	0.239	0.200	0.168	0.141	0.120		0.079	0.062	0.050	0.038		0.026	0.019	
	<b>M 4.5</b>	0.411	0.361	0.307	0.260	0.223	0.192		0.129	0.103		0.065	0.050	0.045	0.034	
	<b>M 5.0</b>	0.555	0.494	0.426	0.368	0.318	0.278		0.193	0.157		0.102		0.073	0.056	0.050
	<b>M 5.5</b>	0.698	0.630	0.552	0.483	0.424	0.375		0.269	0.222		0.150		0.110	0.086	
	<b>M 6.0</b>	0.811	0.740	0.658	0.584	0.520	0.465		0.345	0.291		0.204		0.154	0.122	
	<b>M 6.5</b>	0.922	0.851	0.768	0.691	0.623	0.565		0.432	0.370		0.269		0.208	0.169	
	<b>M 7.0</b>	0.969	0.905	0.827	0.754	0.689	0.631		0.498	0.434		0.327		0.260	0.215	
<b>M 7.5</b>	0.993	0.935	0.866	0.799	0.739	0.685		0.557	0.494		0.384		0.314	0.266

Earthquakes affecting the Fort Knox dams are categorized as insignificant, minor, or major. Inspections must be conducted by FGMI environmental personnel and designated operators after any seismic event with a Peak Ground Horizontal Acceleration (PGHA) exceeding 0.05g in accordance with Figure 4.1 and Table 4.2.

Earthquakes are classified as insignificant, minor, or major, with regard to the Fort Knox dams. An inspection of the dams should be conducted by FGMI environmental and designated operators following any seismic event that produces a Peak Ground Horizontal Acceleration (PGHA) greater than 0.05g. Reference Figure 4.1 and Table 4.2 All geotechnical instruments will be read or surveyed. The Engineer of Record will be contacted and made aware of the occurrence and brought out to site if the situation is warranted. Instrumentation data will be entered into FULCRUM (web based instrumentation data collection program). Heightened attention should be given the normal daily inspection. Any necessary repairs will be completed as soon as practical.

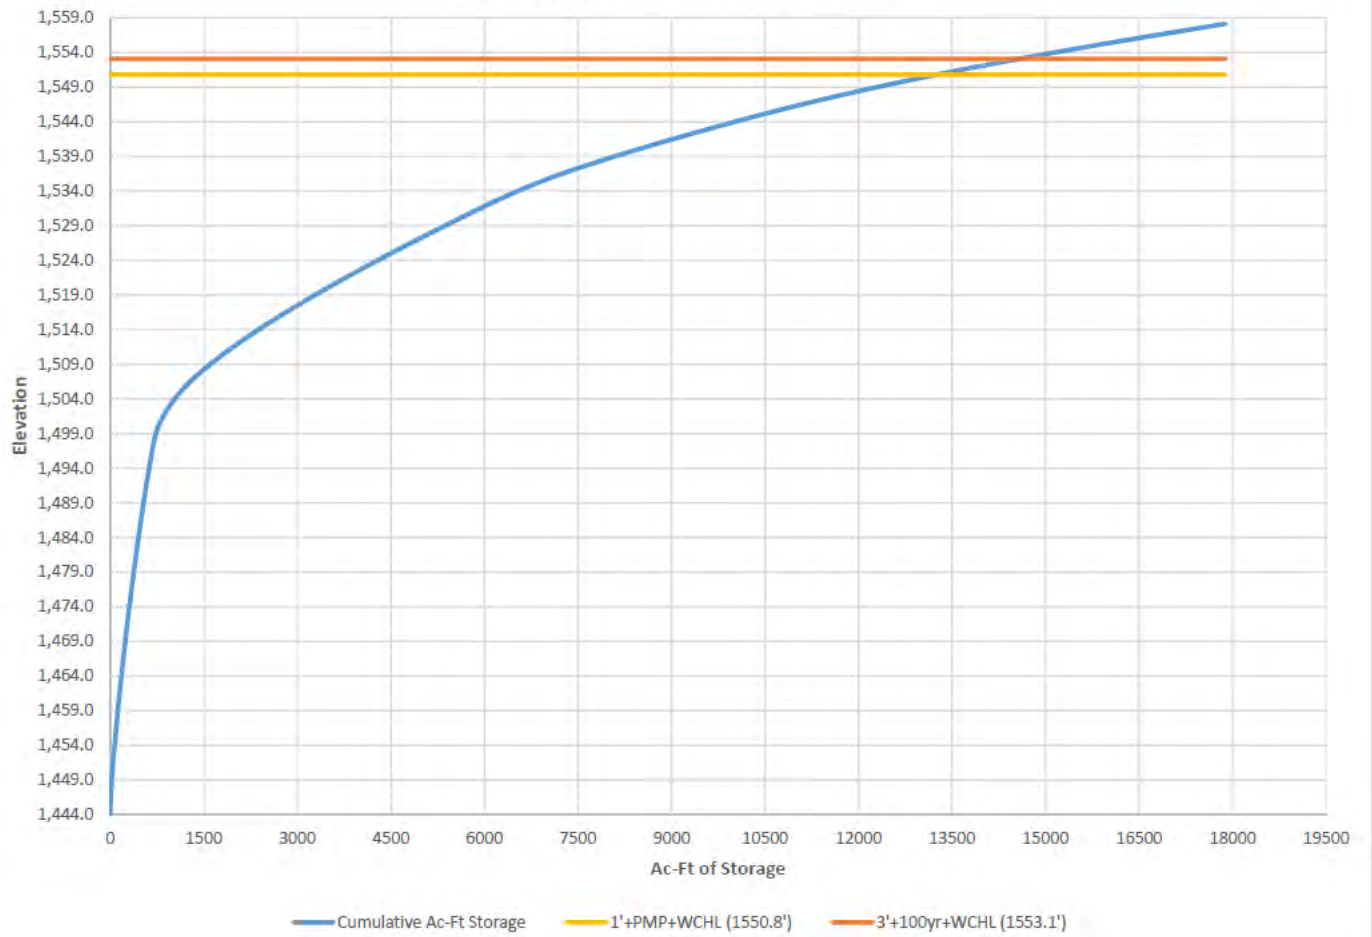
### **Tailing Facility Stage Storage Curve**

TSF Stage Storage - 1558.16 Seal Zone
