**General Plan of Operations
Appendix 05
Best Management Practice Plan**

STATEMENT OF MANAGEMENT COMMITMENT
HELCA HECLA GREENS CREEK MINING COMPANY
BEST MANAGEMENT PRACTICE PLAN

This Best Management Practice Plan has been prepared to control and contain potential pollutants at the Hecla Greens Creek Mining Company (HGCMC) site.

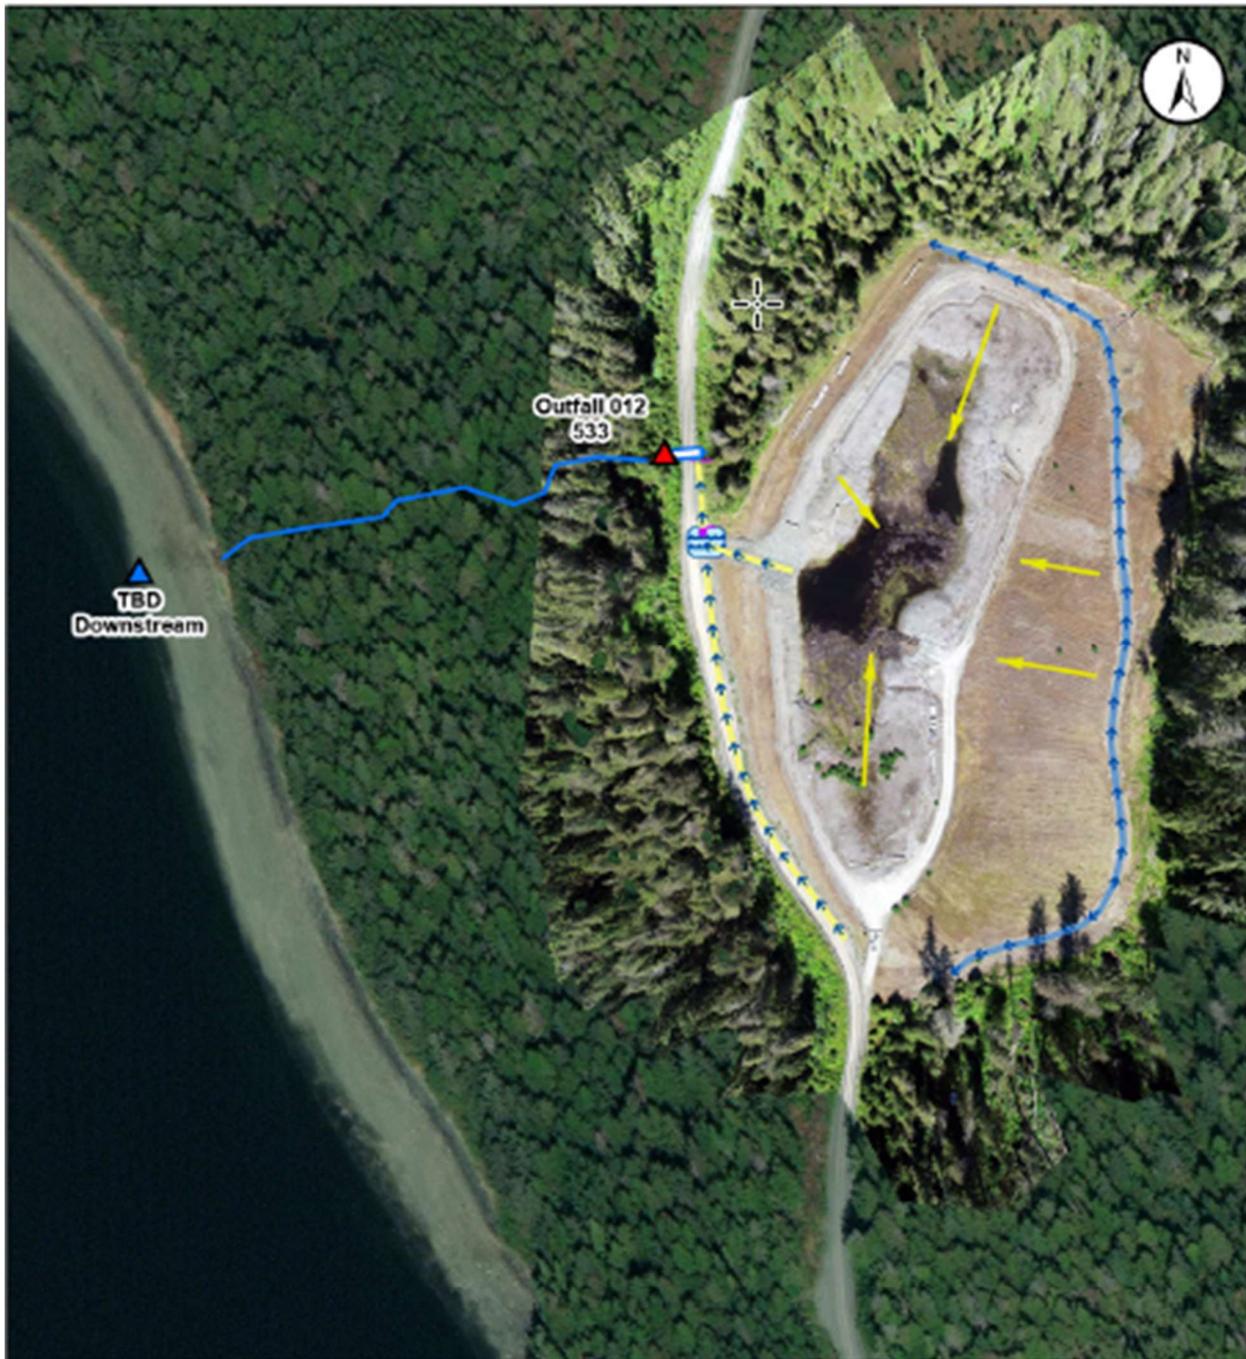
Figure 15. APDES Outfall 012

**Site Specific BMPs
APDES Outfall 012 - Sand Pit Area**

BMPs are continually maintained, therefore BMP position and quantity are representative and may not be exact to figure location.

Figure 15 details this area and shows the flow patterns on the site.
