Pogo RTP Operating and Maintenance Manual

Pogo RTP Dam NID ID#AK00304

Sumitomo Metal Mining Pogo LLC P.O. Box 145 Delta Junction, Alaska 99737

Revision 1: November 2011

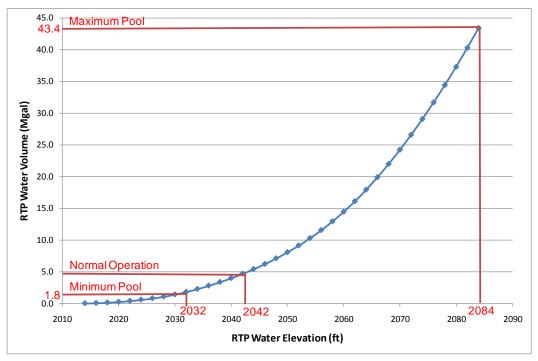
Figure 1: RTP volume-elevation curve

The RTP was originally designed as a water source for process makeup water at the Mill and drilling water at the underground mine. However, the source of the process makeup water has been changed to the treated mine water and the gravel pit pond water. The drilling water in underground is now supplied by the underground water recycling system. The storage objective of RTP has been changed to keep the minimum volume of water in case enough water cannot be supplied from the treated mine water and gravel pit pond. The water storage goal at the RTP is set at 5 Mgal. This is enough to supply makeup water to the mill for about 20 days, assuming a water consumption rate of 100 gpm at the Mill. **Figure 1** shows the RTP reservoir volume-elevation curve.

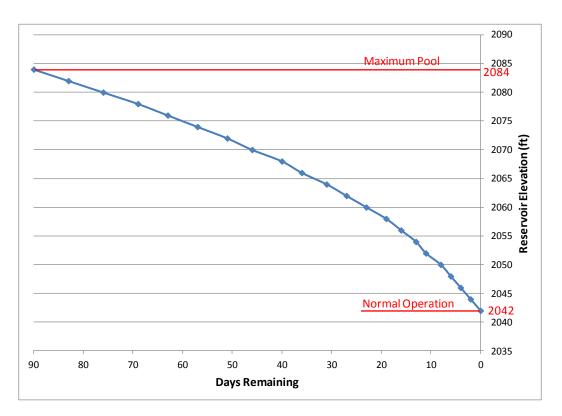
Figure 2: Drawdown curve for 300 gpm discharge from RTP

If the RTP water volume exceeds 5 Mgal (RTP reservoir elevation: 2,042 feet amsl), the RTP water is discharged into WTP#2, treated and then discharged into ORTW. The discharge rate from RTP is limited to 300 gpm due to the treatment capacity of WTP#2. **Figure 2** shows the drawdown curve for 300 gpm discharge from the RTP.

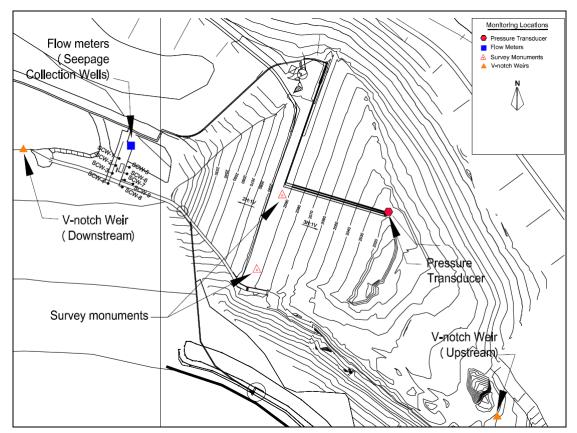
Figure 3: Pogo RTP Dam monitoring locations

The monitoring and frequencies are summarized in **Table 2**. **Figure 3** shows the location of monitoring points.

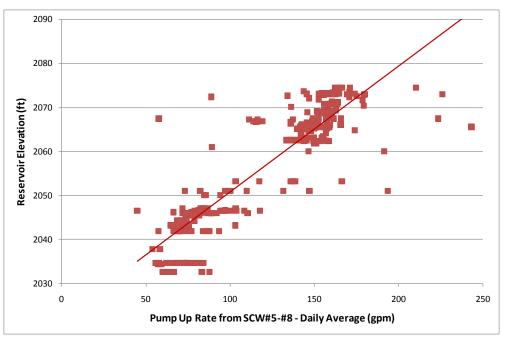
The pump-up rates of the SCWs are dependent on the reservoir elevation. Historically, the pump up rate from SCW#5 - 8 increases from 70 gpm up to 170 gpm in proportion to the reservoir elevation (see **Figure 4**). The SCW#9 dries up when the reservoir elevation is 2,060 feet amsl (RTP volume: 14.4 Mgal) or lower. Once the reservoir level exceeds 2,060 feet amsl, the pump up rate from SCW#9 increases up to 170 gpm in proportion to the reservoir elevation (see **Figure 5**). The combined pump up rate from SCW#5 - 8 and SCW#9 is between 70 gpm and 340 gpm under normal operating conditions.
