Document Details			
Document Title	DSTF Construction and Maintenance Plan	Document Type (e.g. PRO, FOR, SWP, GUI)	Plan
Document Number (if known)	PGO-ENV-005-PLA	Review Frequency	2 yrs. <input checked="" type="checkbox"/> 1 yr. <input type="checkbox"/> Other _____
Issuing Department	Pogo > Environmental	Date of Next Review	06/06/2021

Document No:	PGO-ENV-005-PLA
Revision No:	7
Issue Date:	06/20/2020
Page No:	4 of 30

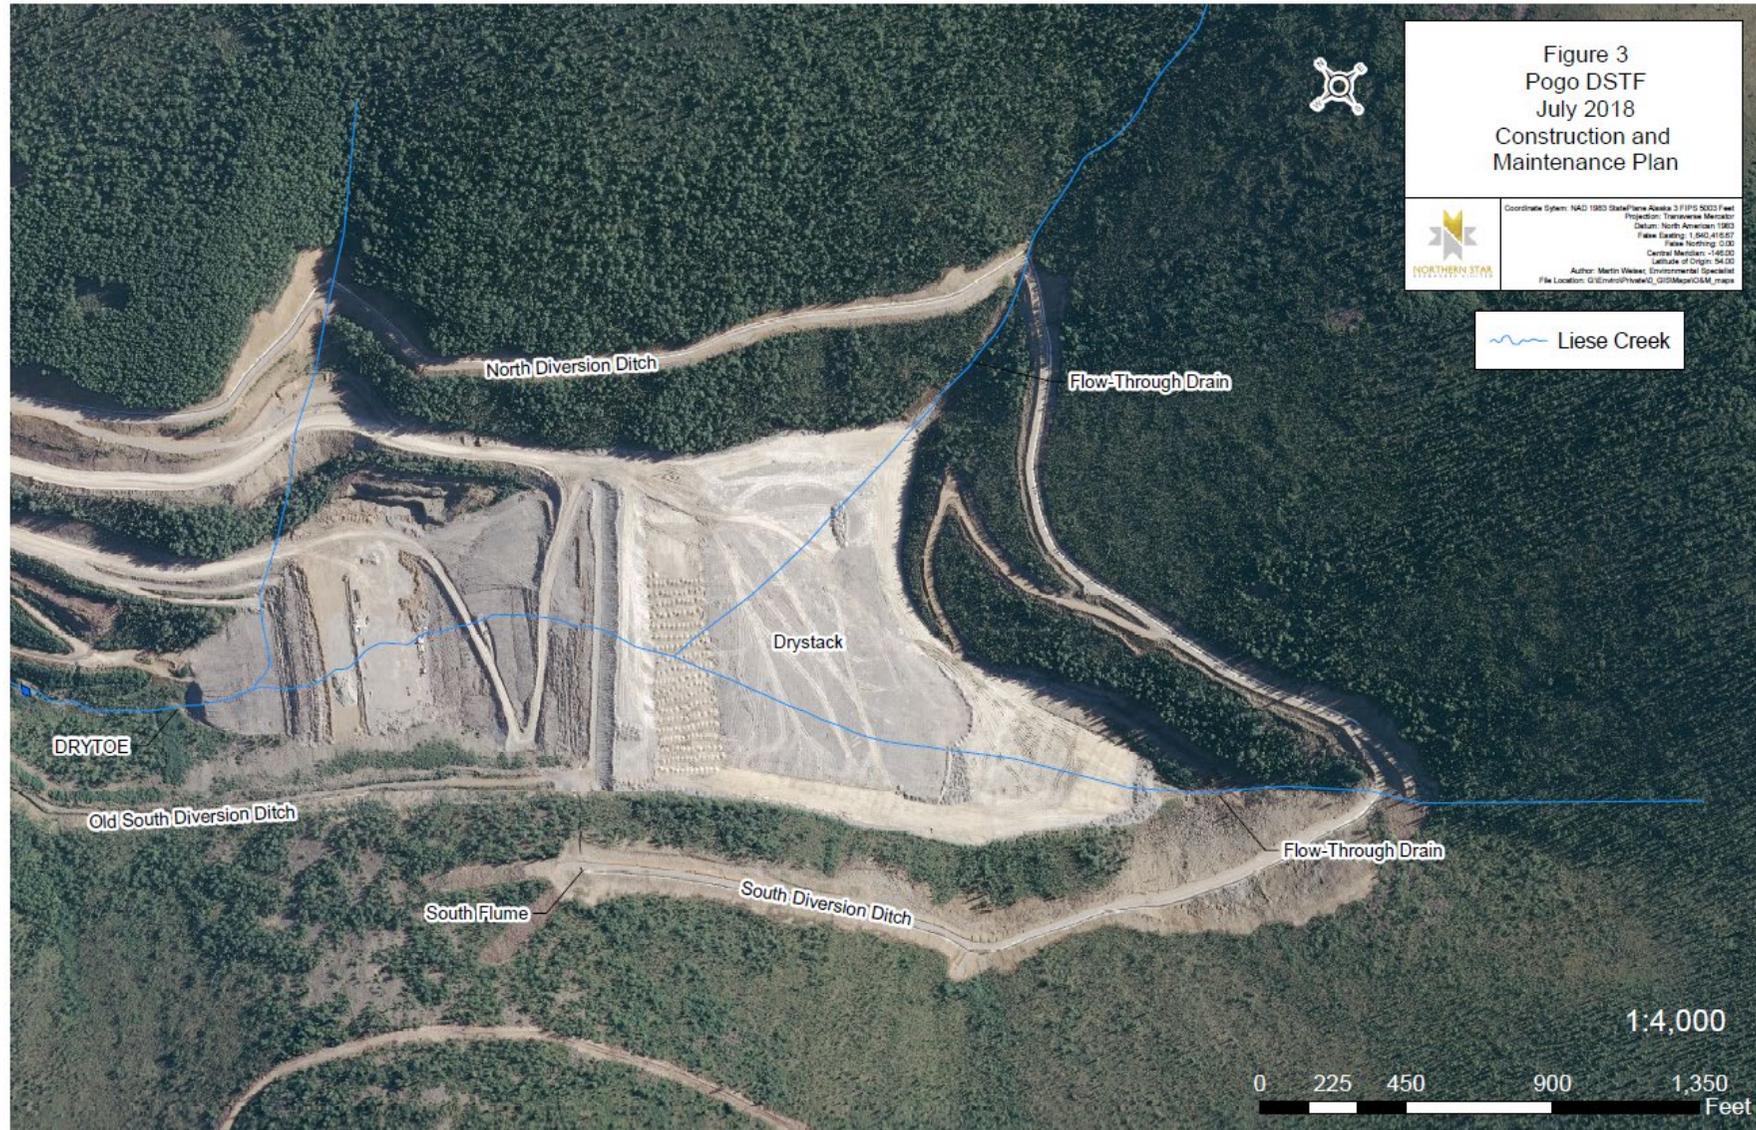
Figure 2: Flow-Through Drain Locations

All runoff in and around the DSTF is directed to the Recycle Tailings Pond (RTP) by means of a network of drains. Flow-through drains are constructed in the existing stream valleys within the DSTF area to augment the existing drainage courses and allow them to pass runoff under the stack. The drains are extended upstream of the existing stream as the elevation of GPA rises. **Figure 1** shows the general configuration of the DSTF, **Figure 2** shows aerial view of Flow-Through Drains, and **Figure 3** depicts the cross-section of the flow-through drains. The rock fill used in the flow-through drains is between 12 inch and 36 inch in size and covered with filter material to prevent fines from migrating into the dewatered flotation tailings. The flow-through drain filter consists of two layers: Filter 1 and Filter 2. The sand (0.04 inch to 0.2 inch in size) is used for Filter 1, and gravel (0.2 inch to 4 inch in size) is used for Filter 2. The corresponding flow capacity of the flow-through drains are calculated to be approximately 120 times the daily average flow of 0.47 cfs (200 gpm) measured at the Flume 1 on Liese Creek. The flow through drains are designed to the equivalent to a 1:10,000-year/24-hour storm event with no allowance for freeboard and without the diversion ditch (AMEC,2004a).

The starter berm was constructed as the initial containment for the GPA with the material from nearby colluvium excavations. The toe berm, downstream of the starter berm was constructed of non-mineralized rock and acts as a foundation of the shell area. The toe berm was extended to downstream before the construction of the second and third shell. The starter berm and toe berm are located directly upstream of the DRYTOE, shown in **Figure 2**.

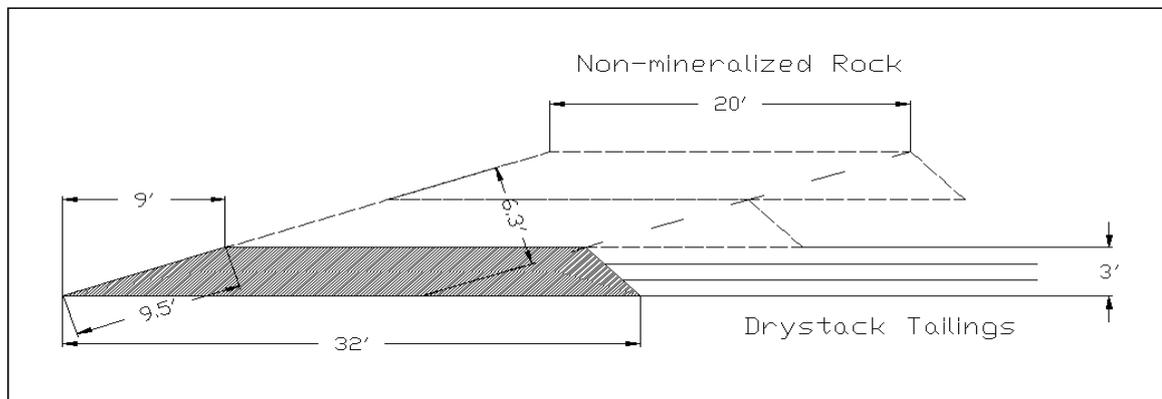
Figure 4: Typical Cross Section of Shell 2 and Shell 3

There are three shells on the DSTF. The first shell (Shell 1) was constructed using non-mineralized rock to a width of 100 ft on the 3:1 slope. The haul road has been constructed on the Shell 1. The second shell (Shell 2) and third shell (Shell 3), which was constructed in 2010, and is a composite shell consisting of non-mineralized rock and dewatered flotation tailings. Non-mineralized rock is placed at the face slope to a width of 20 feet, and then the dewatered flotation tailings are placed inside of the non-mineralized rock and compacted (see **Figure 4**). The width of the Shell 2 and Shell 3 is about 180 ft and 150 ft, respectively. Both Shells 2 and 3 have not been completed. They are each approximately 100 feet below the design elevation. These shells will be completed prior to DSTF closure.

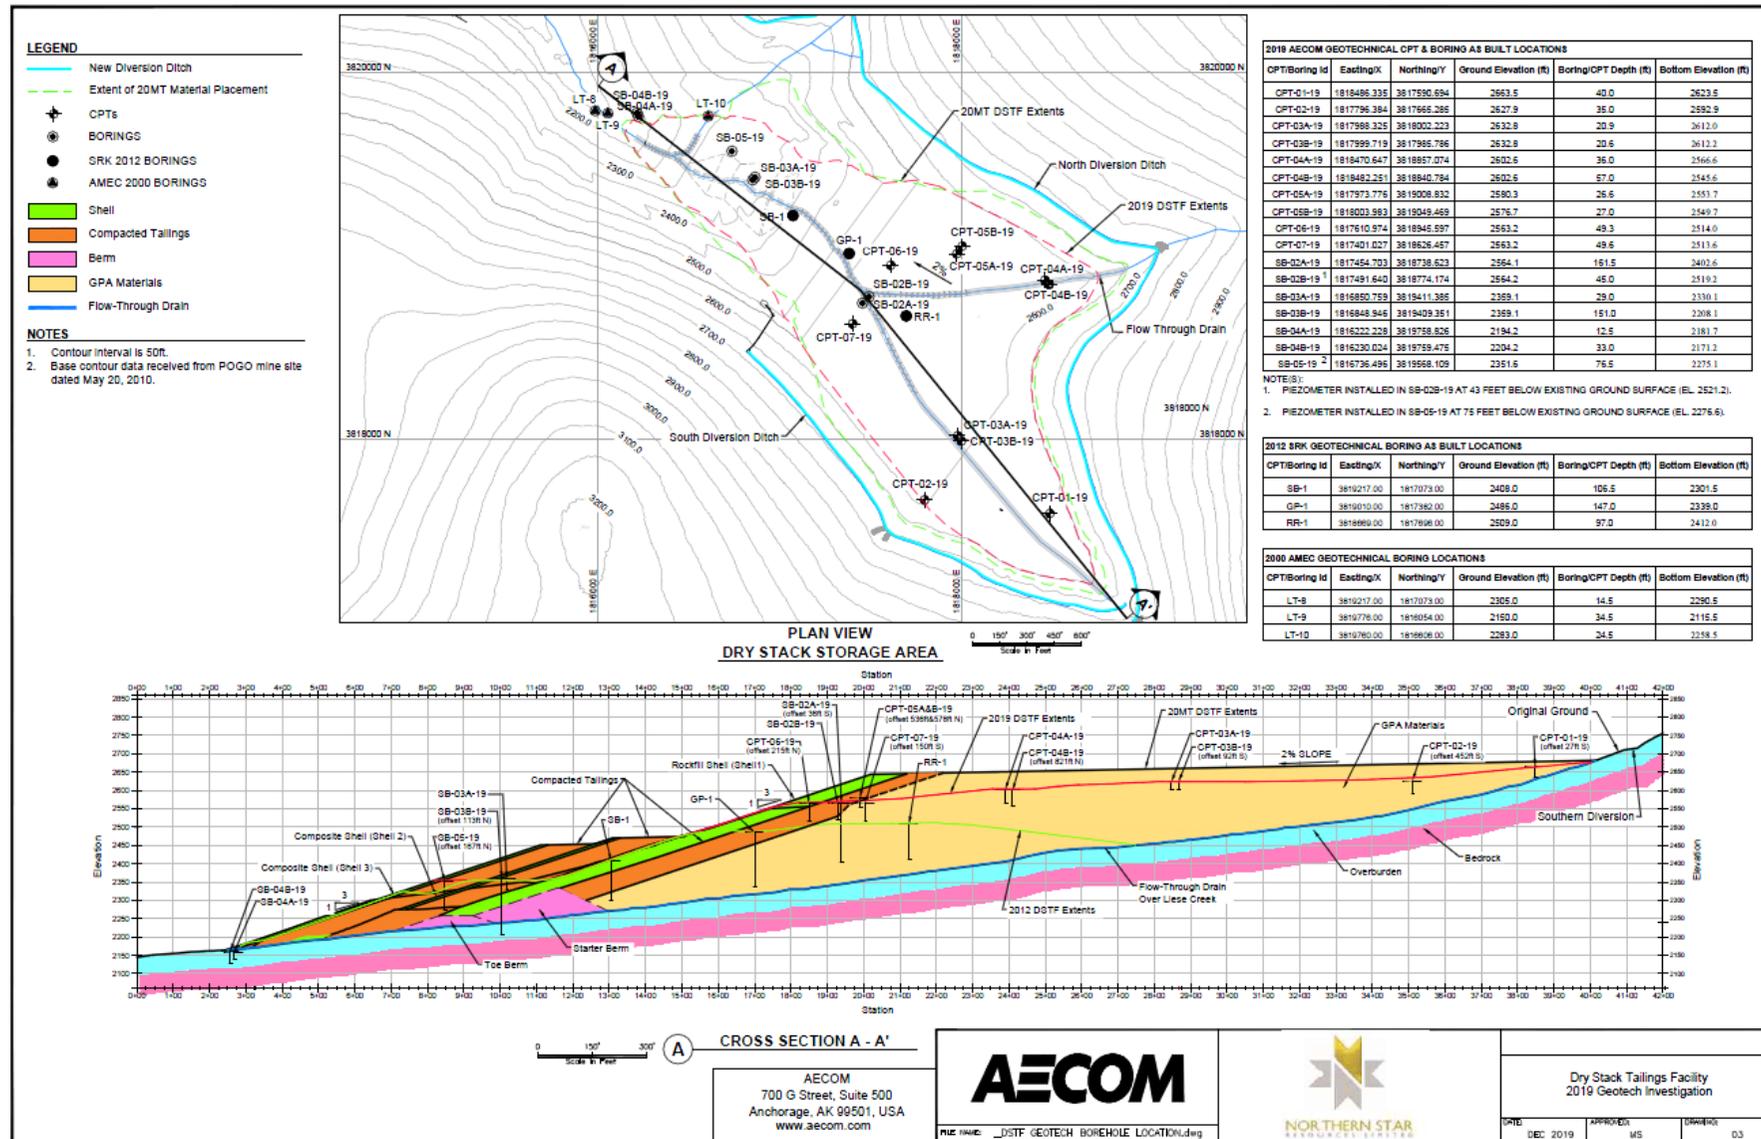
Figure 5: Updated DSTF Configuration Used for Stability Analysis (AECOM, 2019)

- 4) AECOM (AECOM, 2019) used static water levels identified in the SRK (2012) investigation for the slope stability analyses during the 2019 geotechnical investigation. An updated plan view and cross section used for the 2019 stability analysis is shown in **Figure 5**.

- 3) SRK (SRK, 2014b) assumed the phreatic surface presented in Figure 5 based on the following observations:
 - i. The SB-1 deep vibrating wire piezometer (VWP) has consistently reported positive pore pressures since shortly after installation in October 2012; pore pressures measured through October 2013 have ranged up to 6 psi, indicating a maximum recorded phreatic surface elevation of 2,317.5 ft. In addition, wet material was encountered in the bottom 5 ft of the SB-1 borehole during drilling in October 2012.

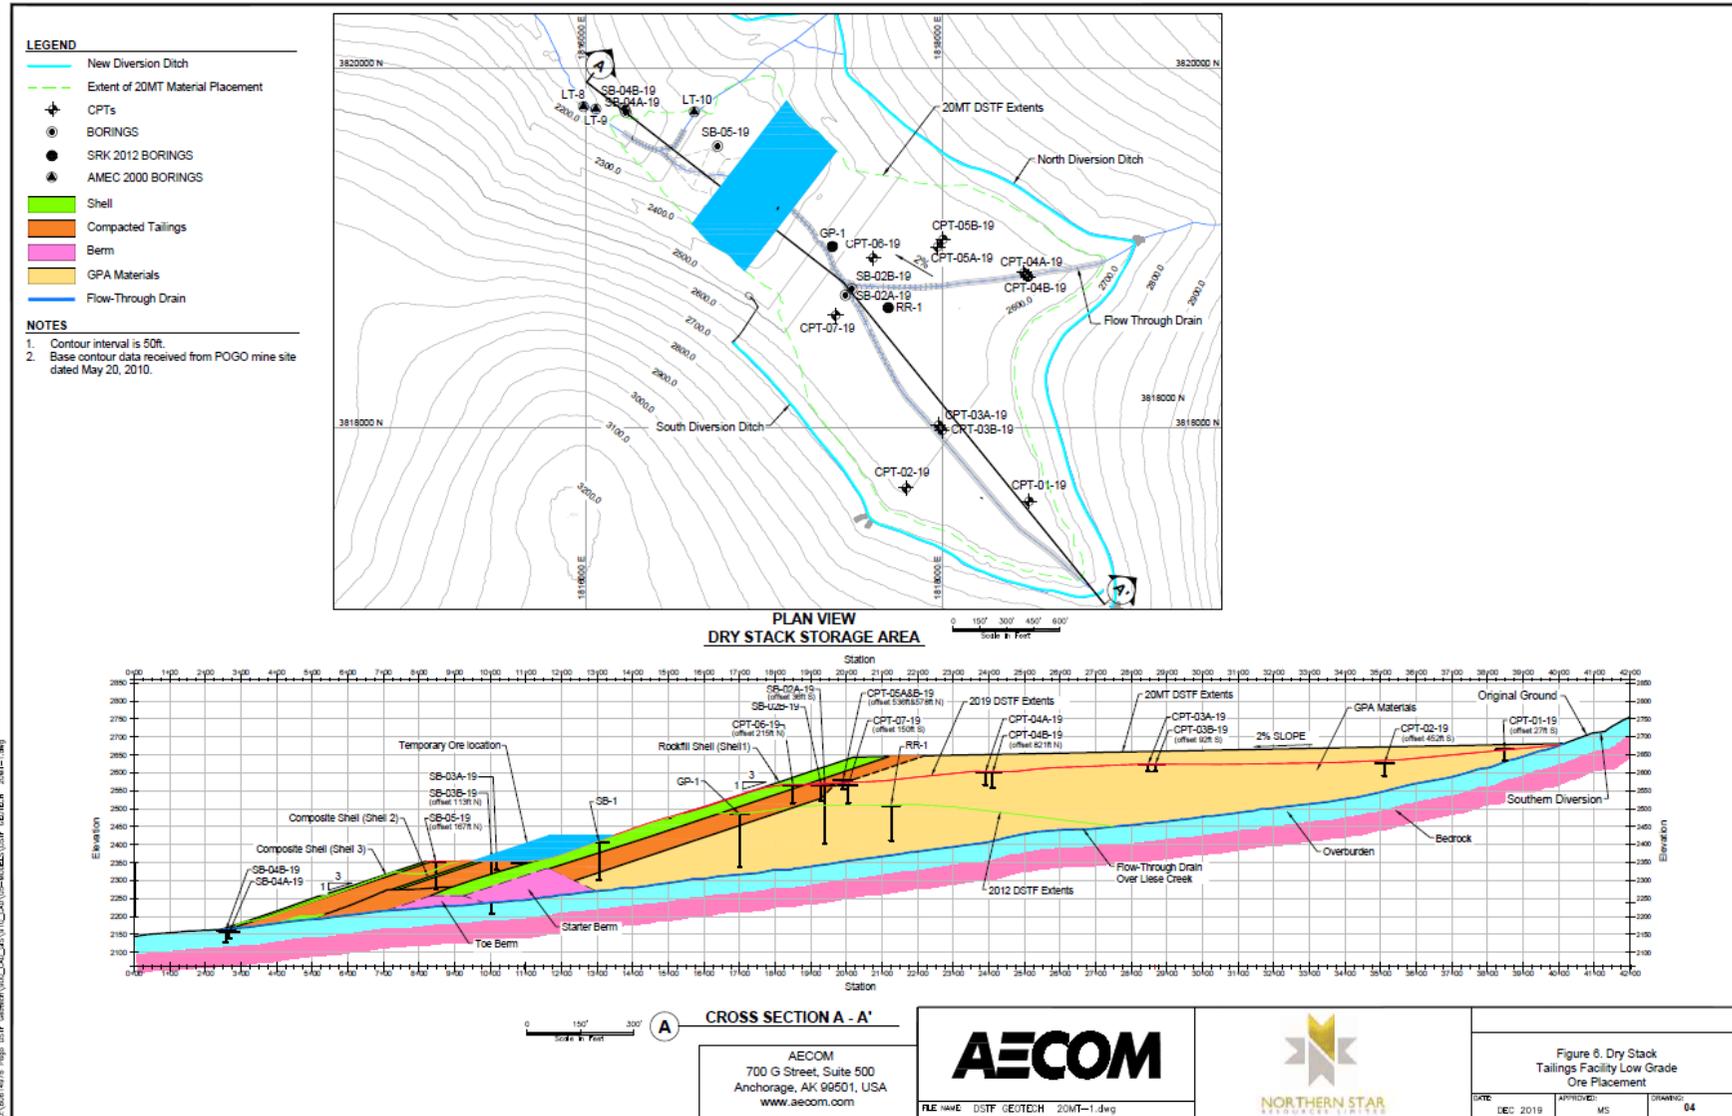
Figure 6: DSTF Low Grade Ore Placement (AECOM, 2019)

Based on a geotechnical investigation in October of 2019 (AECOM, 2019), it was determined that low-grade (LG) ore can be safely placed on Shell 2 up to a total of 1.0 Mton, as shown in Figure 6.

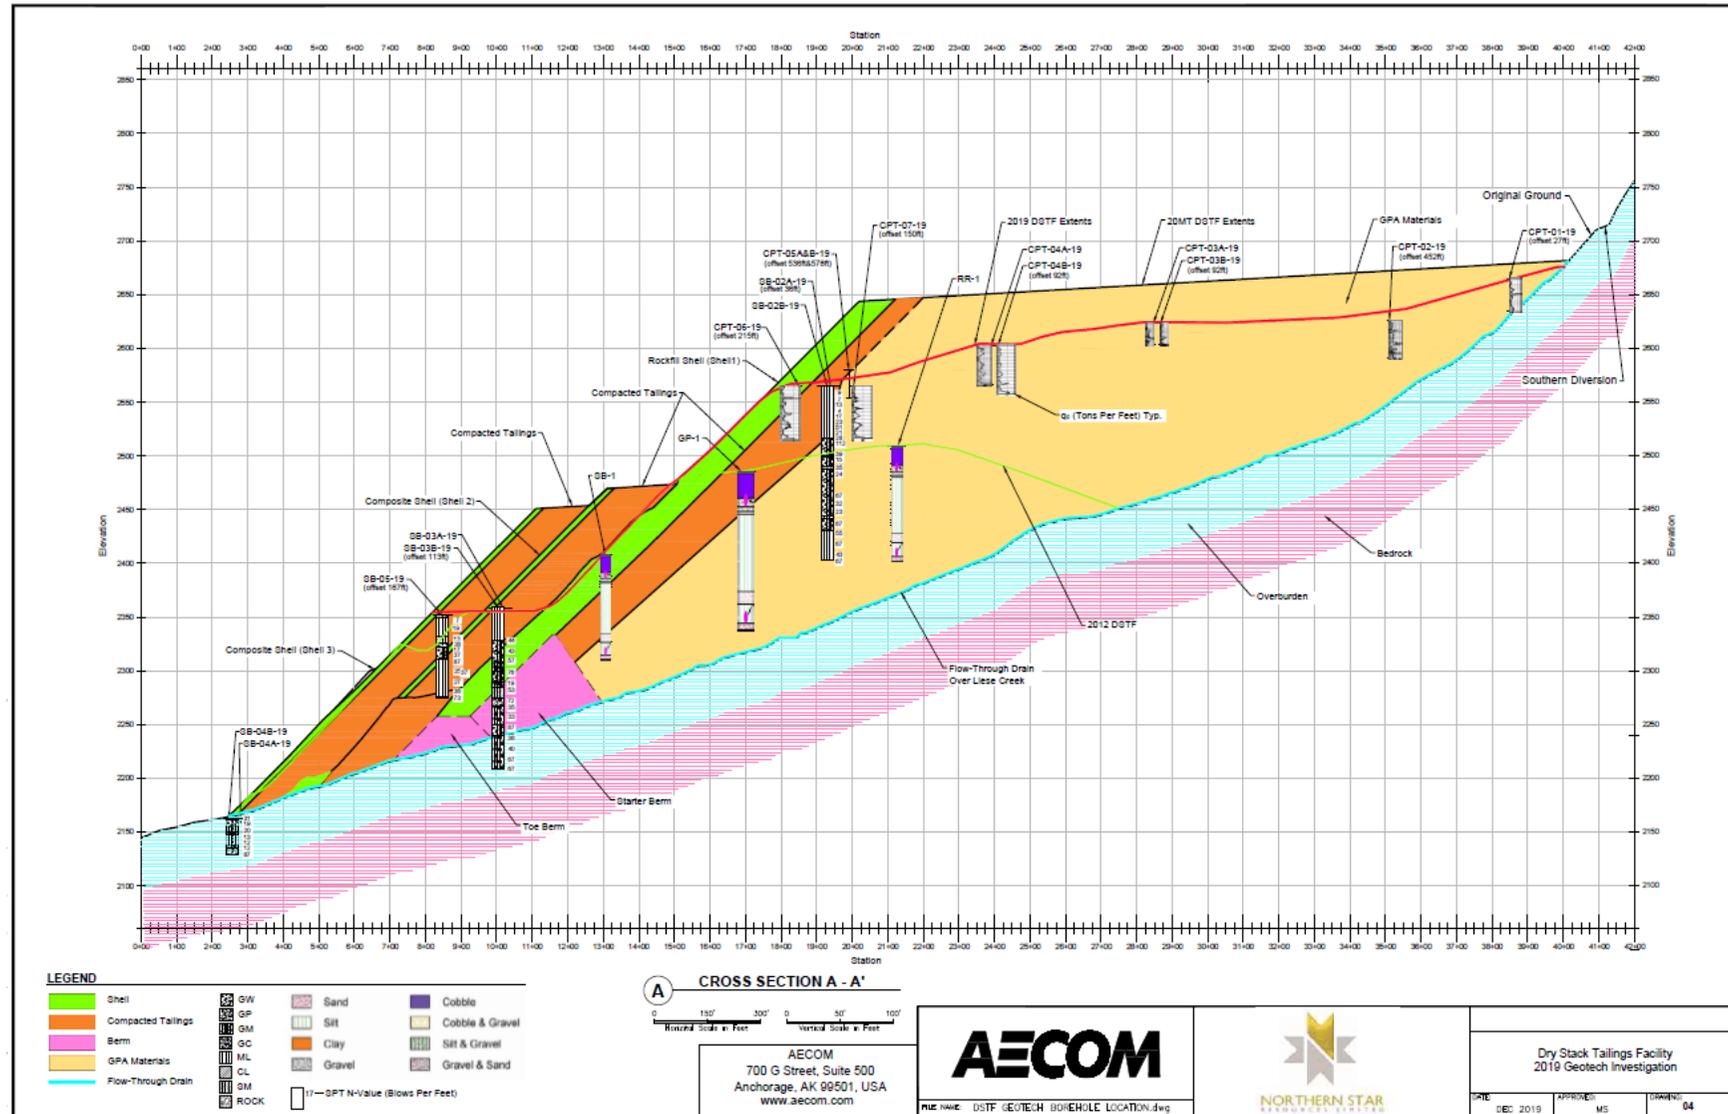
Figure 7: As-Built Borehole and Vibrating Wire Piezometer Locations (AECOM, 2019)

RST vibrating wire piezometers (VWP) are installed in each borehole to evaluate the presence and extent of saturated zones within the DSTF and to monitor changes in pore pressure. DSTF temperatures are also measured using thermistors located within each VWP sensor. The installation depth of each sensor is shown in Figure 7 and presented in Table 9, Summary of Vibrating Wire Piezometer Installation.
