## Independence Mine State Historical Park Preservation Plan

Alaska Division of Parks and Outdoor Recreation Department of Natural Resources 11/21/2014

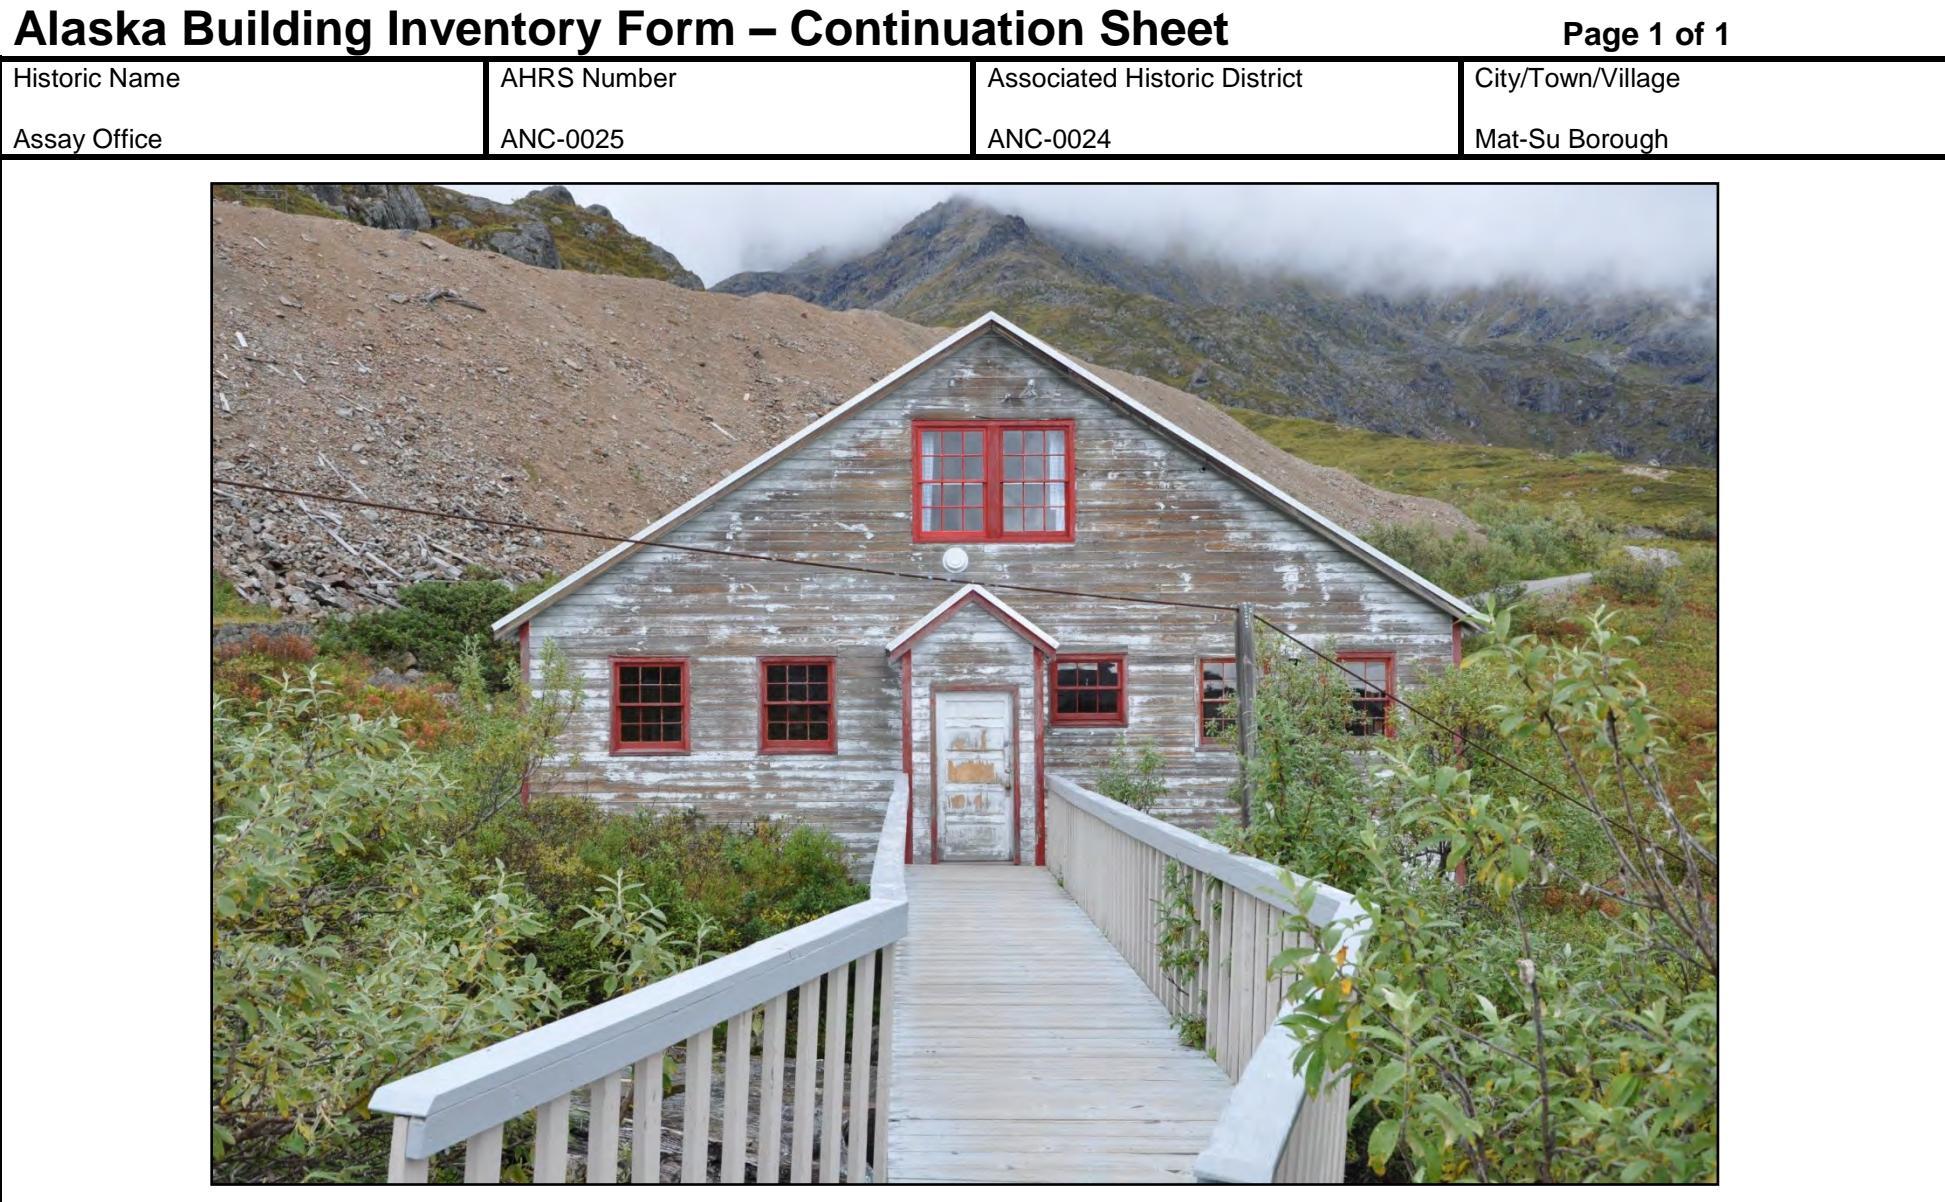
View of the primary (south) façade of the Assay Office (ANC-025).

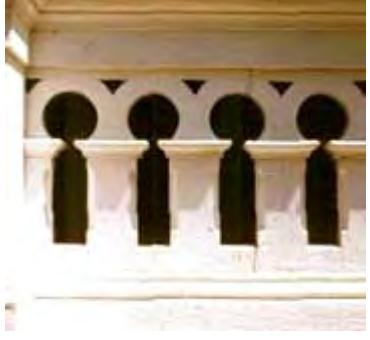
The paint on this exterior decorative feature is sound. Photo: NPS files.

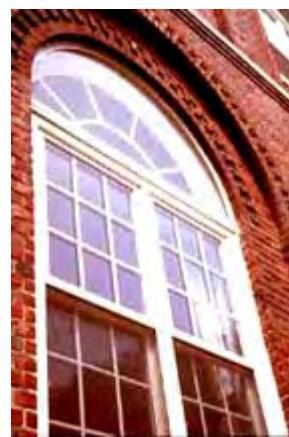
When the paint on the wood windows became too thick, it was removed and the window repainted. Photo: NPS files.

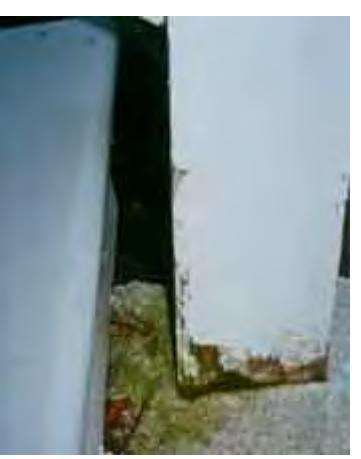
The problem evidenced here by mossy growth and deteriorated wood must be resolved and the wood allowed to dry out before the wood is repainted. Photo: NPS files.

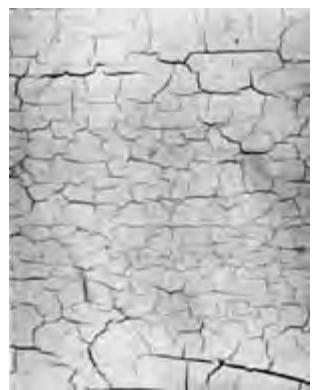
Crazing--or surface cracking--is an exterior surface condition which can be successfully treated by sanding and painting. Photo: Courtesy, National Decorating

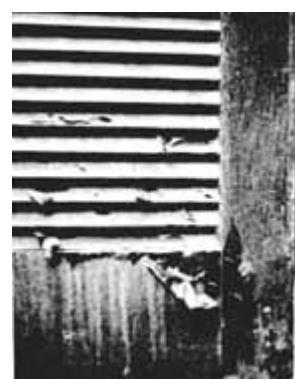
Here, a latex top coat was applied directly over old oil paint, resulting in intercoat peeling. The latex was unable to adhere. If latex is used over oil, an oil-base primer should be applied first. Photo: Mary L. Oehrlein, AIA.

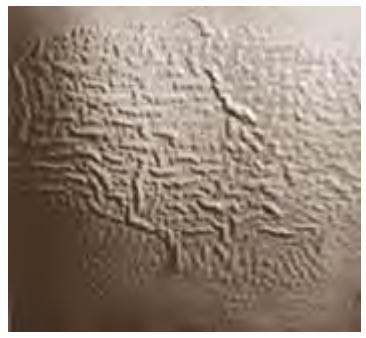
Wrinkled layers can generally be removed by scraping and sanding as opposed to total paint removal. Photo: Courtesy, National Decorating Products Association.

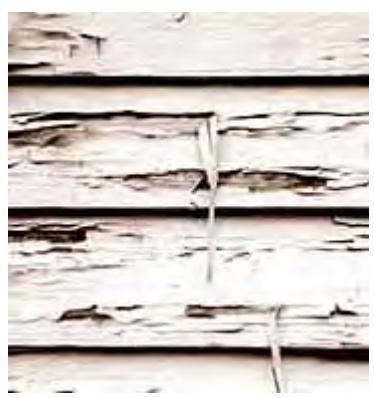
Extensively deteriorated paint needs to be removed to bare wood, then primed and repainted. Photo: NPS files. Peeling to bare wood is most often caused by excess interior or exterior moisture that collects behind the paint film, thus impairing adhesion. Generally beginning as blisters, cracking and peeling occur as moisture causes the wood to swell, breaking the adhesion of the bottom layer.

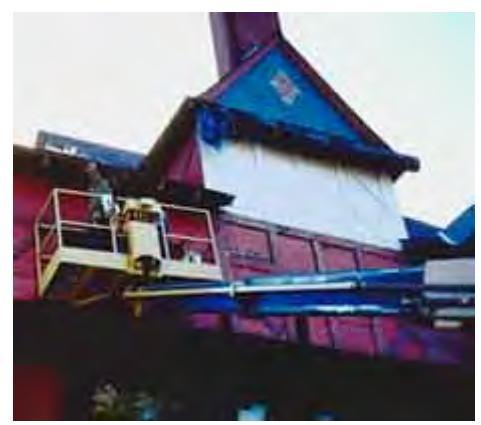
A heat plate was used on the cornice to remove paint. Photo: NPS files.

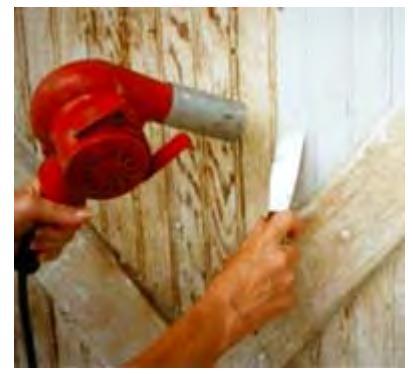
The nozzle on the electric heat gun permits hot air to be aimed into cavities on solid decorative surfaces, such as this carriage house door. After the paint has been sufficiently softened, it can be carefully removed with a scraper. Photo: NPS files.

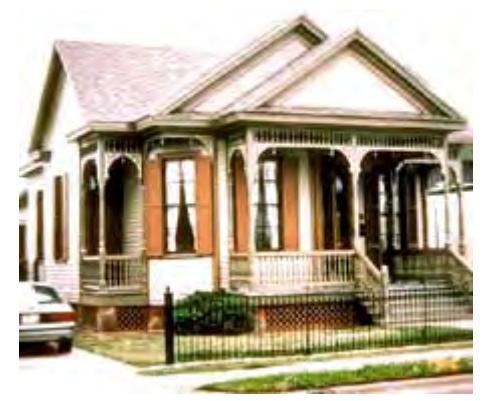
Decorative features were painted with a traditional oil-based paint as a part of the rehabilitation. Photo: NPS files.

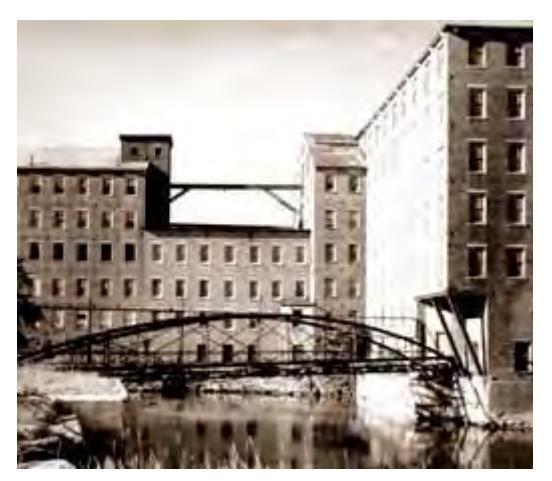
Windows are frequently important visual focal points, especially on simple facades such as this mill building. Replacement of the multi-pane windows with larger panes could dramatically alter the appearance of the building. Photo: NPS files. for example, attempting to conserve energy by closing up or reducing the size of window openings may result in the use of *more* energy by increasing electric lighting loads and decreasing passive solar heat gains.

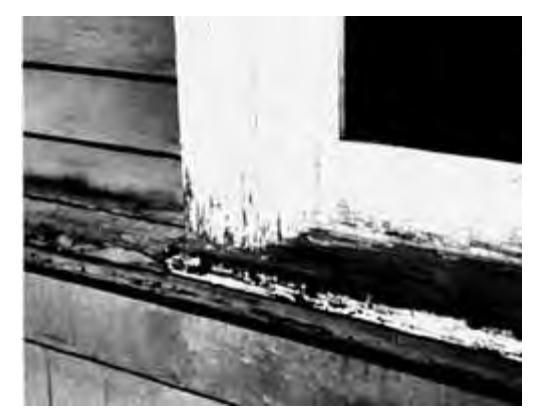
Deterioration of poorly maintained windows usually begins on horizontal surfaces and at joints, where water can collect and saturate the wood. Photo: NPS files.

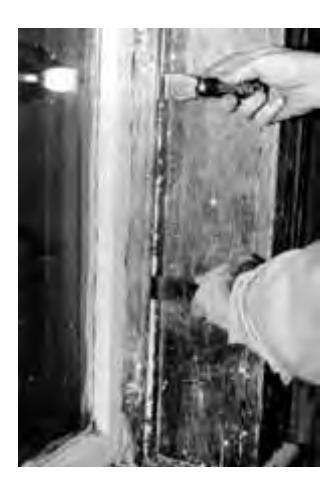
After removing paint from the seam between the interior stop and the jamb, the stop can be pried out and gradually worked loose using a pair of putty knives as shown. Photo: NPS files.

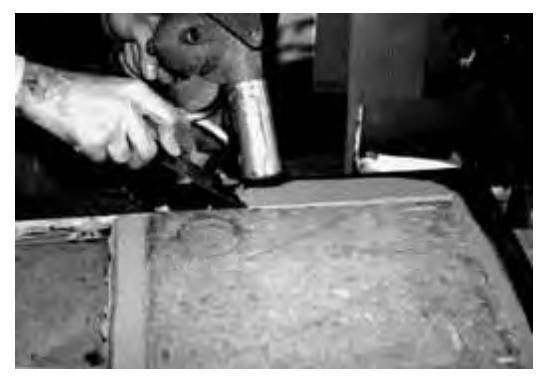
Sash can be removed and repaired in a convenient work area. Pain is being removed from this sash with a hot air gun. Photo: NPS files.

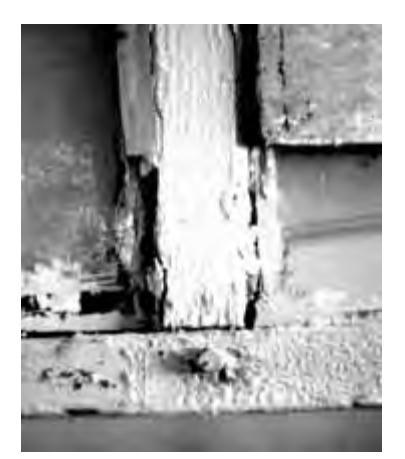
This historic double-hung window has many layers of paint, some cracked and missing putty, slight separation at the joints, broken sash cords, and one cracked pane. Photo: NPS files.

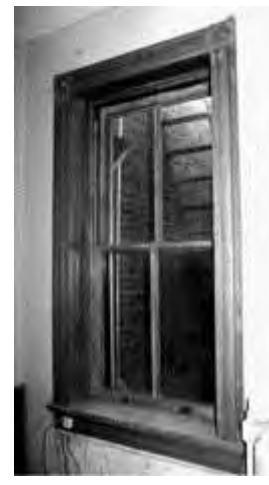
Following the relatively simple repairs, the window is weathertight, like new in appearance, and serviceable for many years to come. Photo: NPS files.

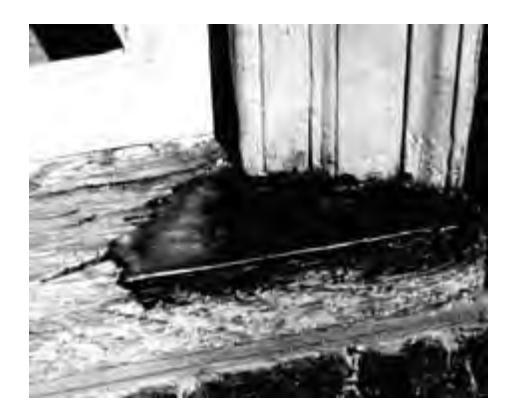
This illustrates a two-part epoxy patching compound used to fill the surface of a weathered sill and rebuild the missing edge. When the epoxy cures, it can be sanded smooth and painted to achieve a durable and waterproof repair. Photo: NPS files.

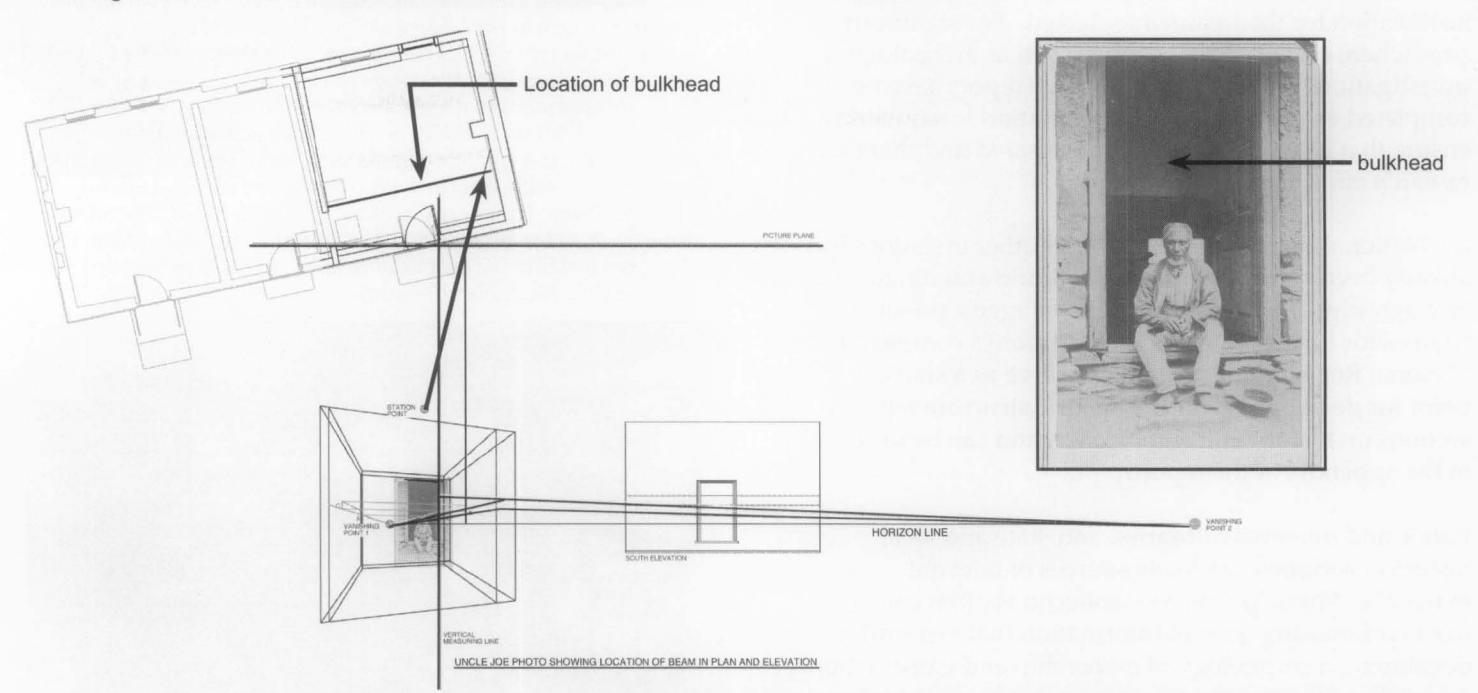
Figure 9. A CADD perspective analysis facilitated study of the location of a long removed interior bulkhead wall. The bulkhead appears in a historic exterior photograph of a man seated in the door entrance to a mid-nineteenth century plantation dependency. Drawing: John Volz & Associates, Inc.; historic photo: National Park Service files.
Archeological investigations can provide information on the locations of building foundations and other sub-grade building elements, and can also assist in developing information on the function of adjacent site areas, building elements, and previously unfinished floor spaces (Fig. 10). The survey may also address the immediate site landscape, if this is not covered in a separate cultural landscape report.

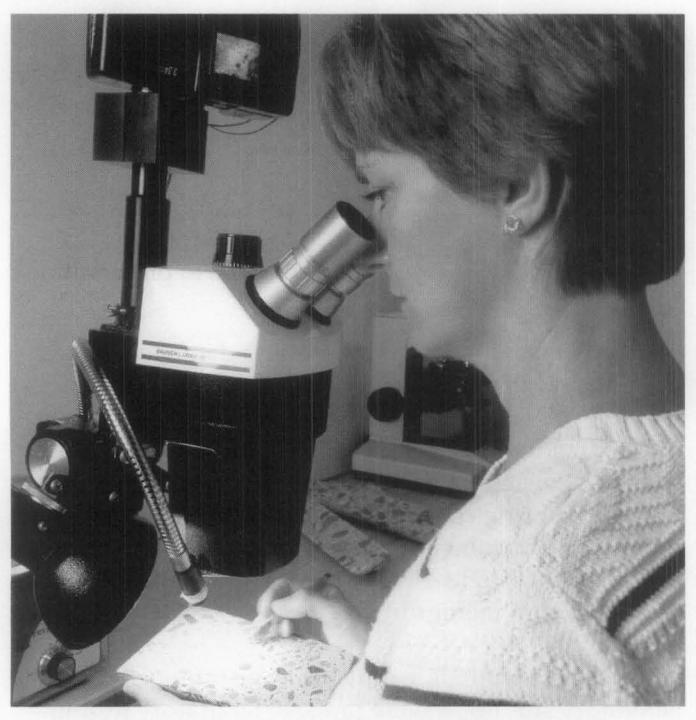
Figure 12. Field and laboratory studies of construction materials may be performed as part of a historic structure report. Laboratory studies of samples removed from the building may include a range of chemical and physical testing and evaluation. Here, a petrographer uses a stereomicroscope to examine concrete specimens. Photo: Wiss, Janney, Elstner Associates, Inc.

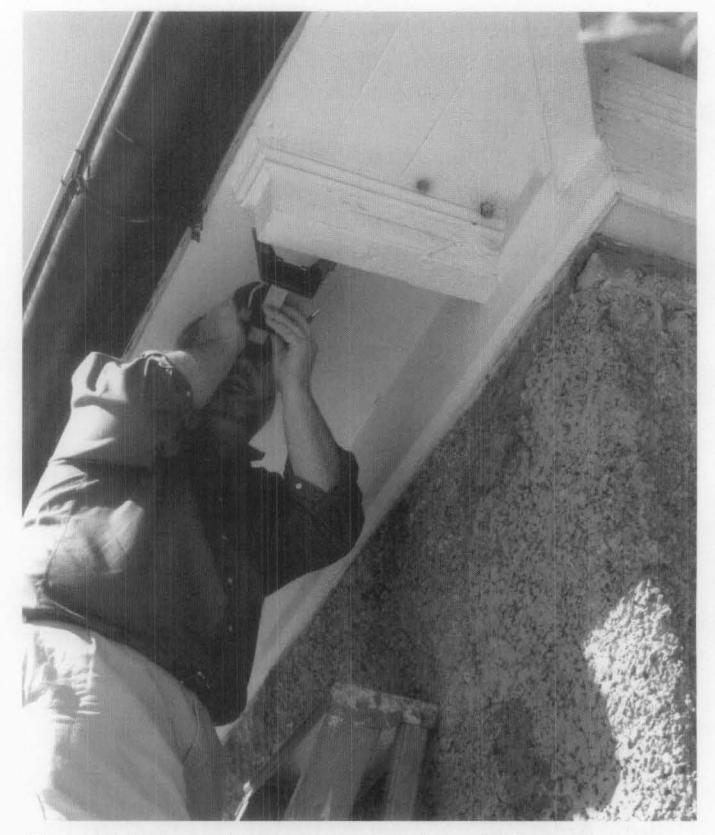
Figure 13. Paint studies may not only help establish the chronology of paints and paint colors used on a building but also may aid in the dating of existing architectural features. Examination of the paint layers on these modillions utilizing a hand-held microscope enabled an investigating team to confirm in the field which modillions were original and which were later replacements. Photo: Charles Fisher, National Park Service.

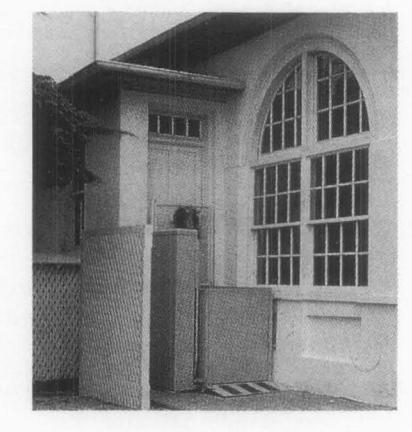
Figure 13. Platform lifts like the one used on this building require minimal space and can be removed without damaging historic materials. Shielded with lattice work, this lift is also protected by the roof eaves. Approach path should be stable, firm, and slip resistant. Photo: Sharon Park.

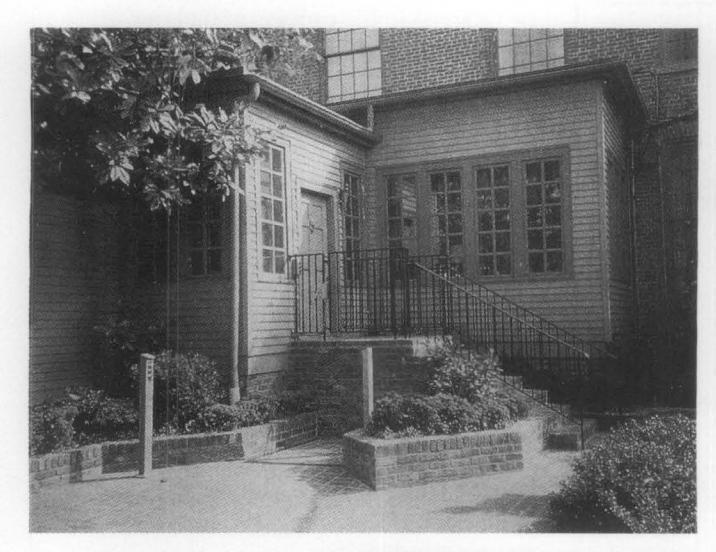
Figure 14. At the Lieutenant Governor's Mansion in Frankfort, Kentucky, a retracting lift (b) was installed to minimize the visual effect on this historic building when not in use (a). Photos: Aging Technology Incorporated.

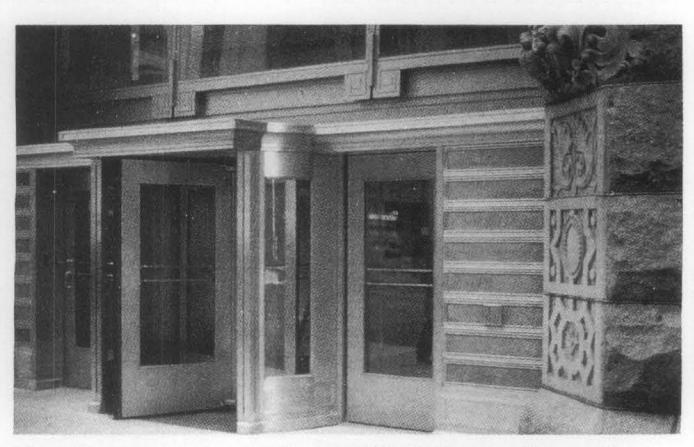
Figure 16. During the rehabilitation of the Rookery in Chicago, the original entrance was modified to create an accessible entrance. Two revolving doors were replaced with a new one flanked by new doors, one of which is operated with a push-plate door opener. Photo: Thomas Jester.

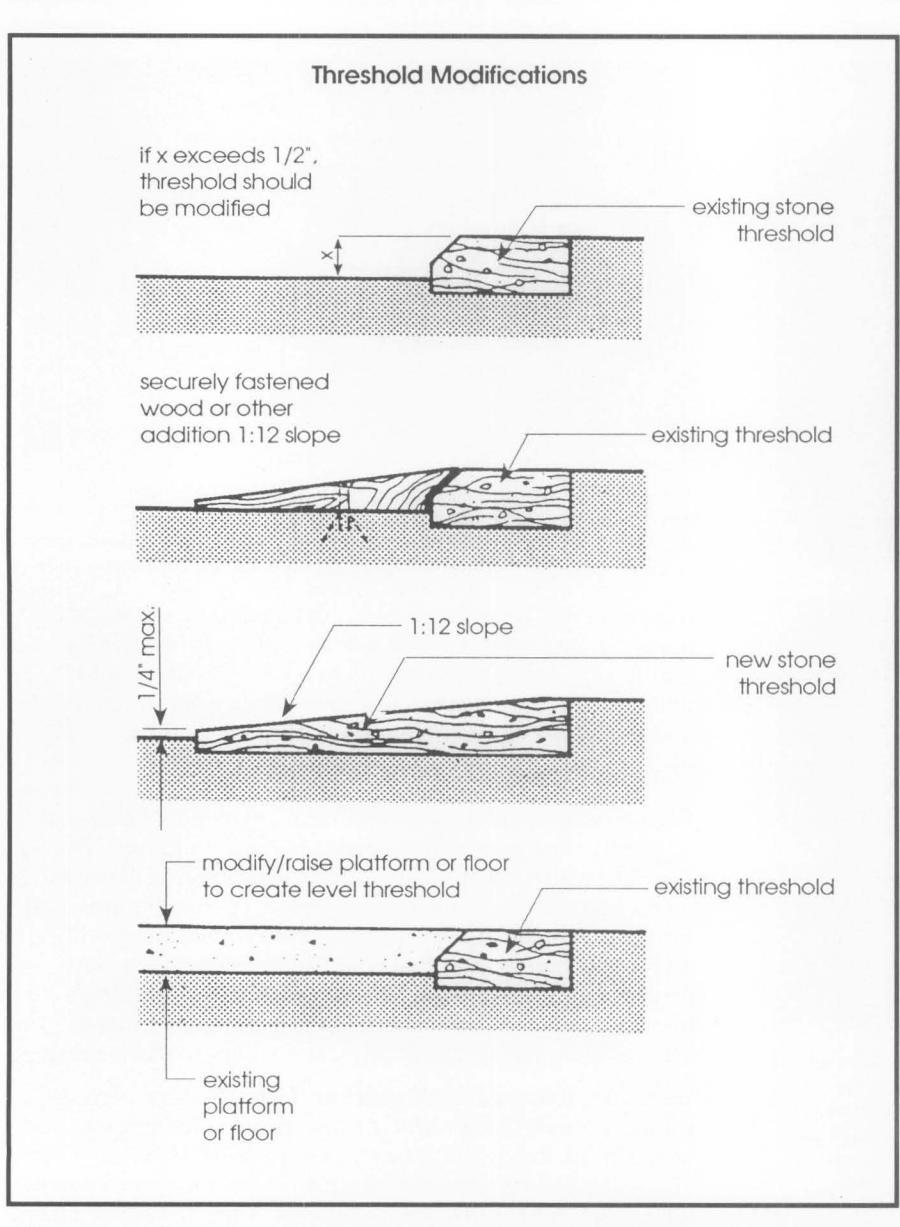
Figure 17. Thresholds that exceed allowable heights can be modified several ways to increase accessibility. Source: Uniform Federal Accessibility Standard (UFAS) Retrofit Manual.

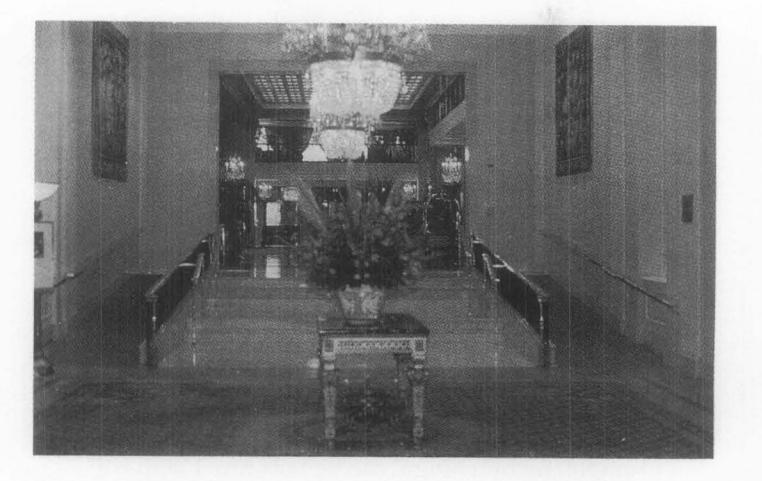
Figure 18. Symmetrical ramps at the Mayflower Hotel in Washington, D.C., provide access to the hotel's lower level. The design for the ramps respects the historic character of this landmark building. Photo: Thomas Jester.

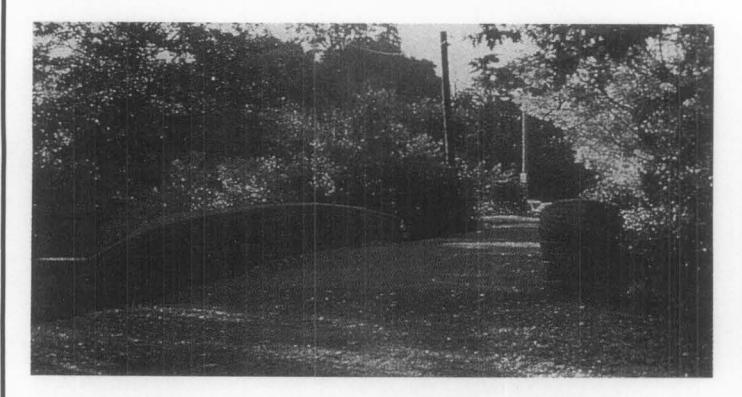
(a.) To improve accessibility in Boston's Emerald Necklace Parks, standard asphalt paving was replaced in selected areas with an imbedded aggregate surface that is more in keeping with the landscape's historic appearance. Photo: Charles Birnbaum.
