Alaska Coastal Revegetation & Erosion Control Guide

By
Stoney J. Wright
and
Philip K. Czapla

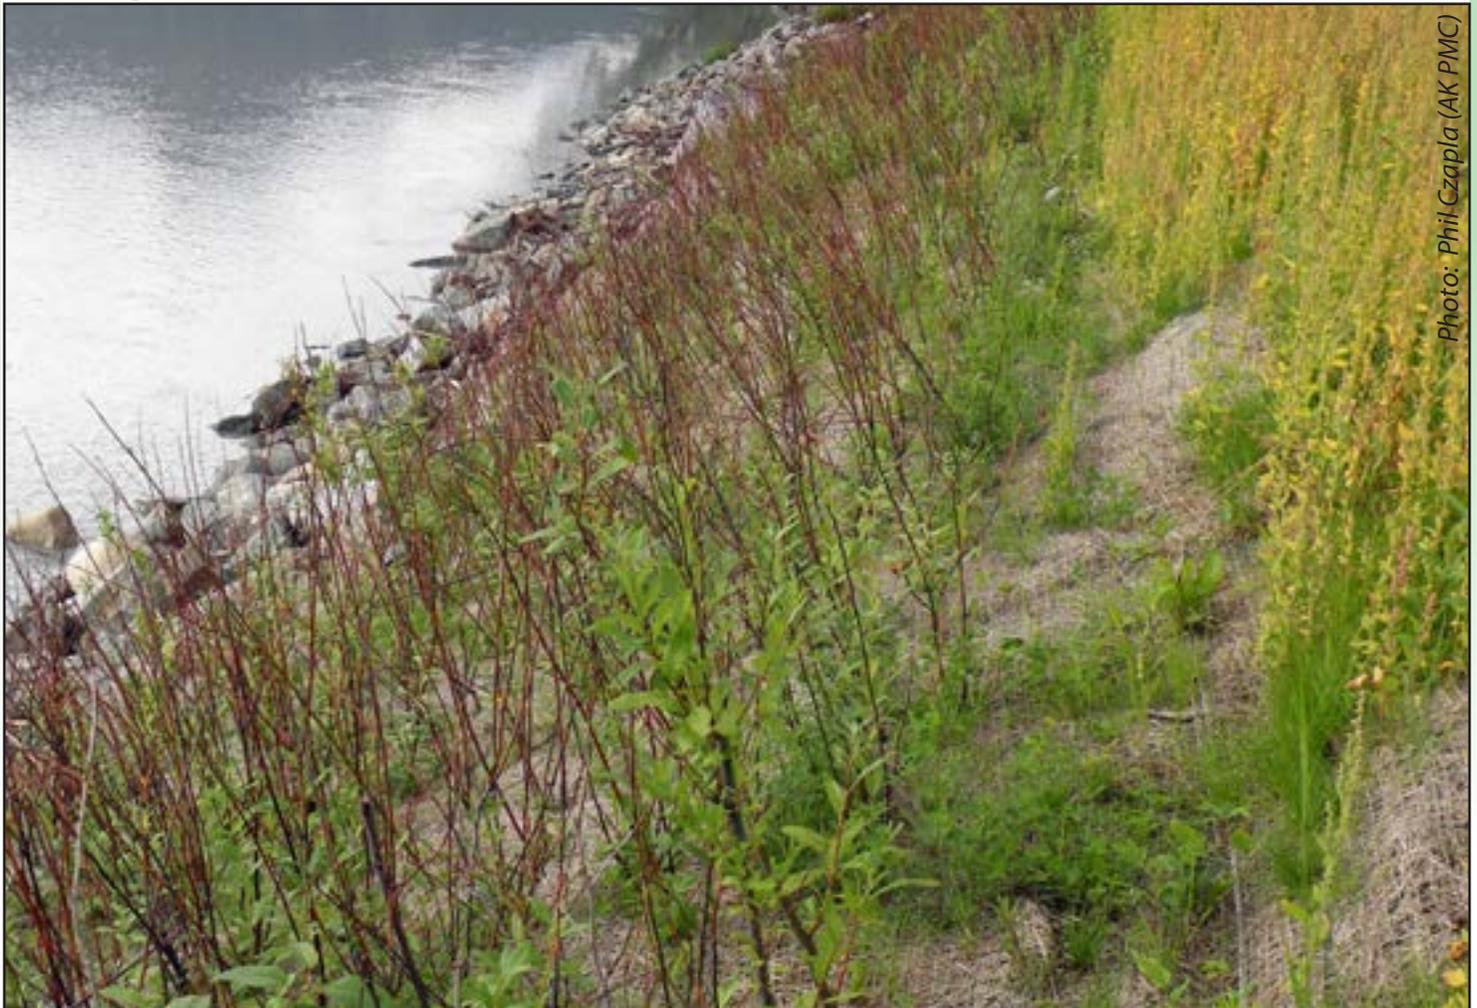
Erosion control fabric supporting willow stakes and seeded plants, along the banks of the Matanuska River

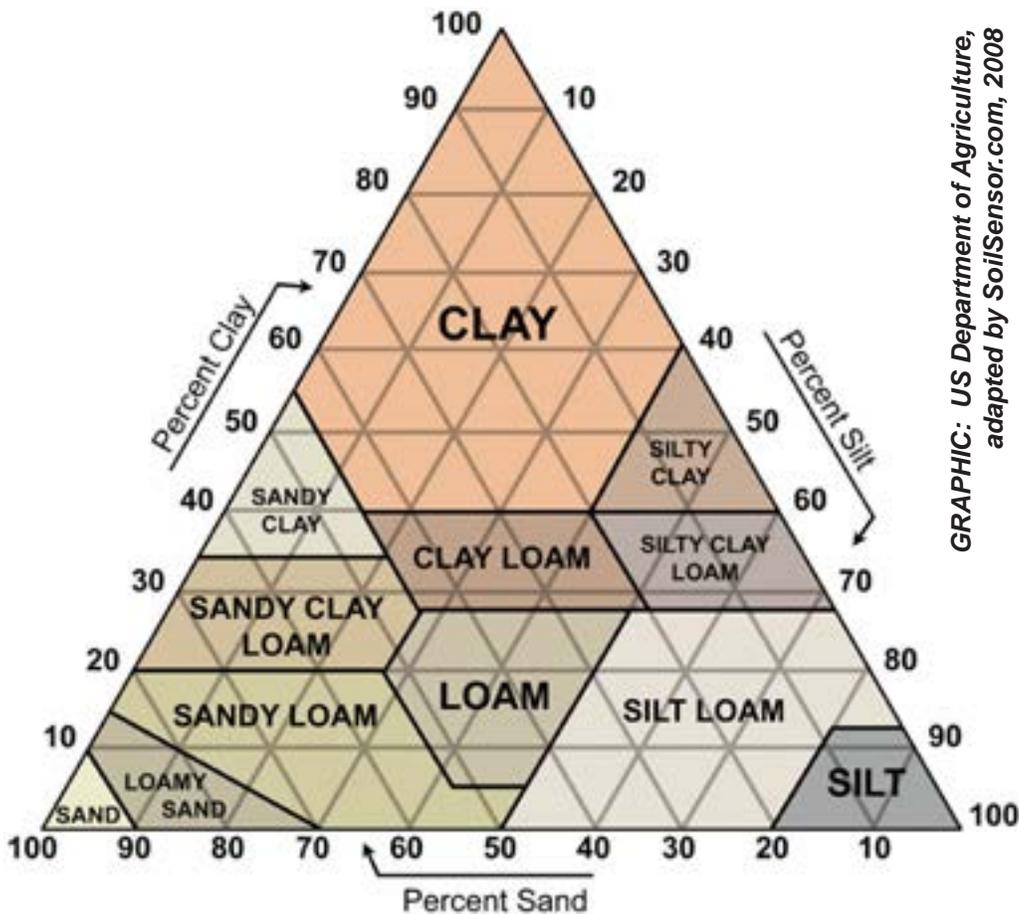
Figure 3: USDA Agronomic Soil Textural Triangle

The Agronomic Soil Textural Triangle (Figure 3, Figure 4) is a tool used to determine the textural type of a soil. Field analysis of soil texture can also be done using the “By Feel Method” (Figure 5). This qualitative method is quick, easy, and fairly reliable. Testing procedure involves wetting a sample of the soil and working the soil between one’s fingers. Water is often used to moisten the soil, but saliva is also suitable. Texture cannot be determined accurately when the soil is dry. Quantitative measures to determine soil texture are also available. Contact the Alaska Plant Materials Center for more information about testing and analysis of soils.

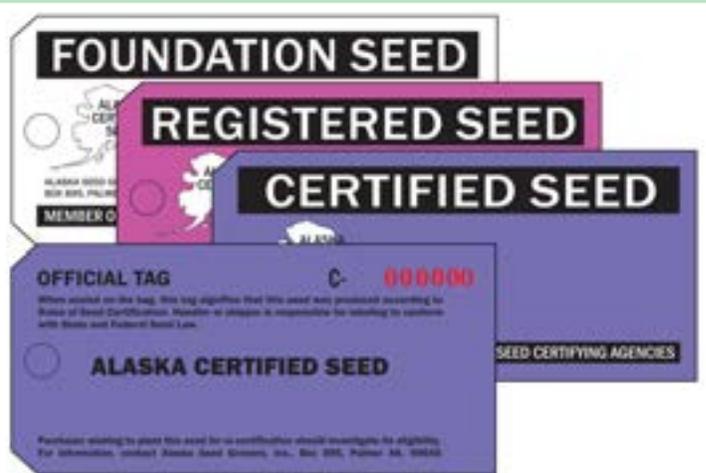
Figure 12: Alaska Certified seed tags

The official use of the term Certified seed (with a capital C) is to describe seed that has been grown under the rules of the Seed Certification Program. Certified seed is the usual commercial category of seed. Its ancestry can be traced back to Registered Class or Foundation Class seed. In addition, the Certified seed must meet variable standards of purity and germination. These standards are a means of verifying authenticity of a seed source. All the Alaska developed seed varieties or cultivars can be sold as either Certified or common.

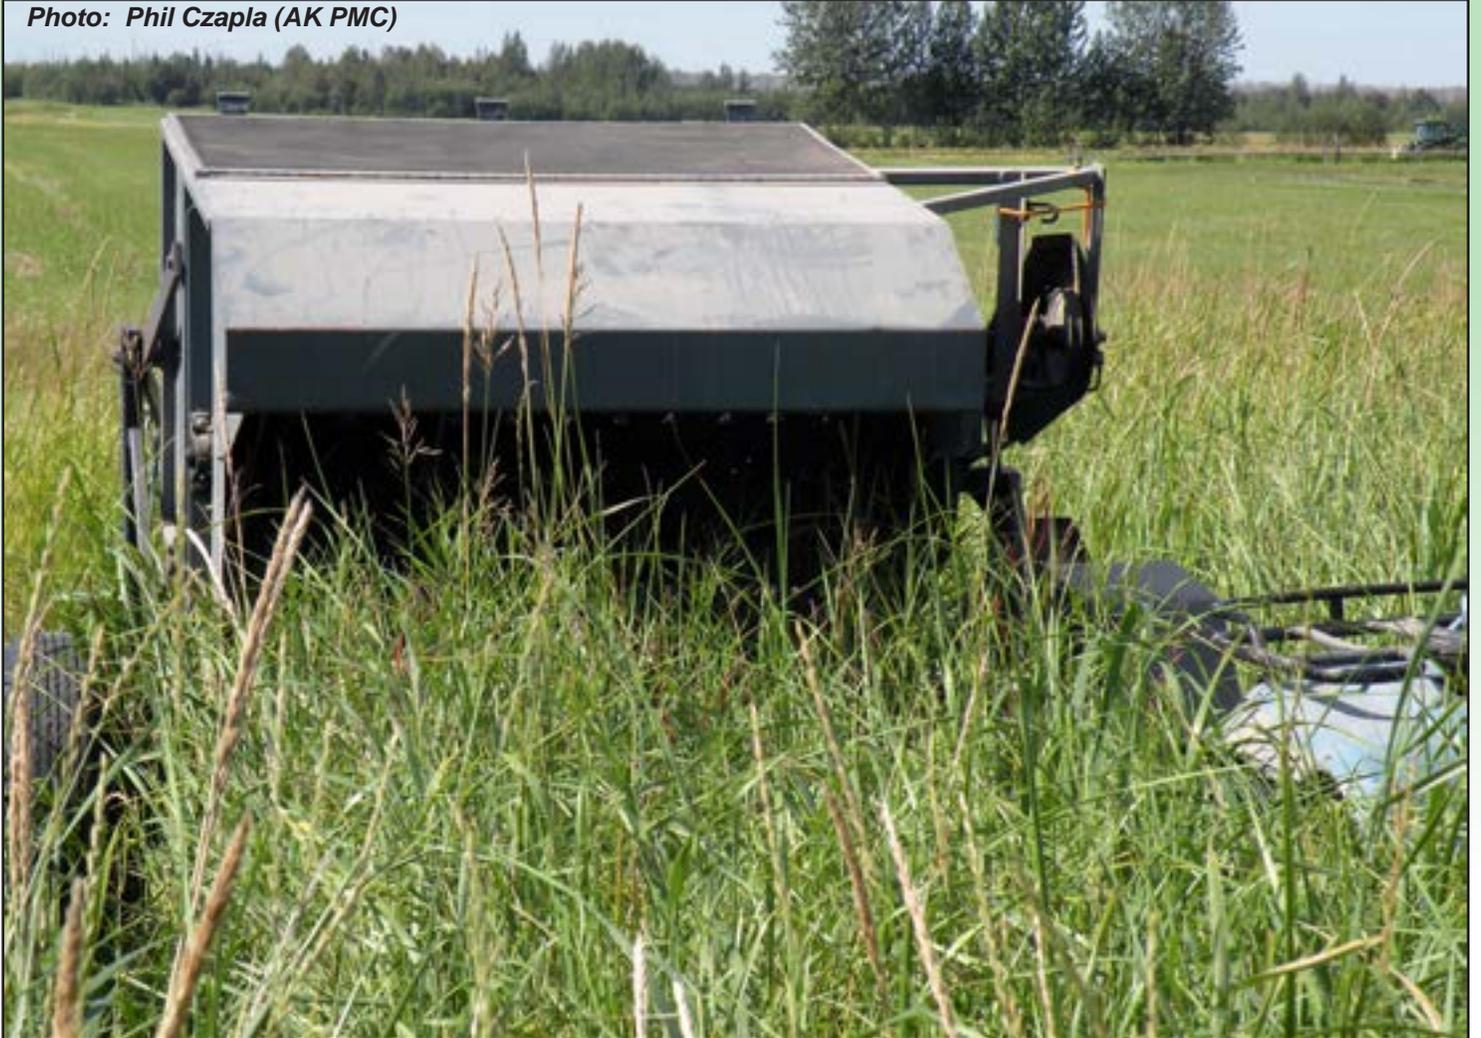
A pull-type seed stripper is an effective means of harvesting collections of wild seed

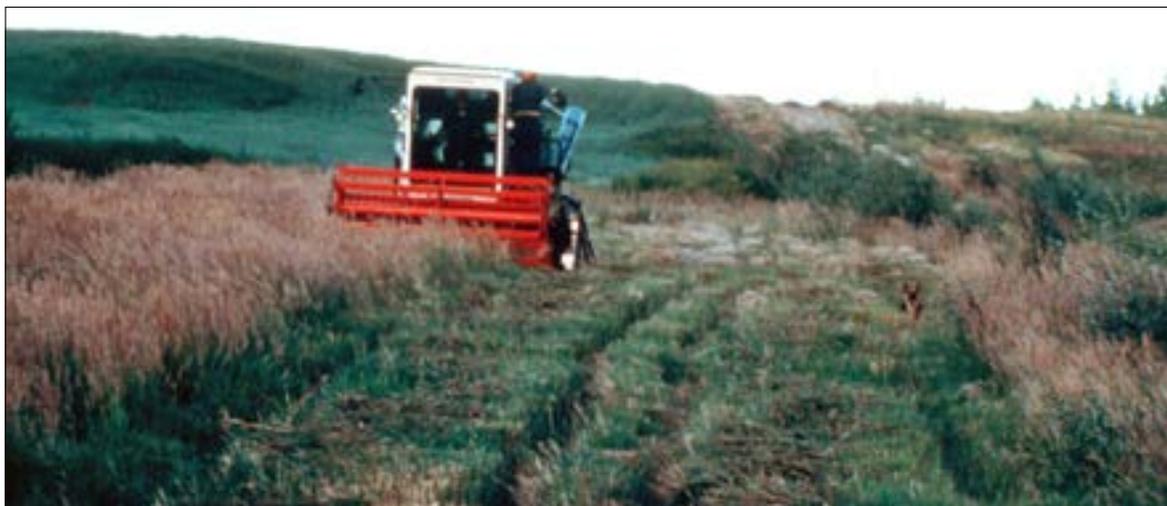
Figure 30: Combine harvesting a wild Bluejoint Reedgrass (*Calamagrostis canadensis*) stand

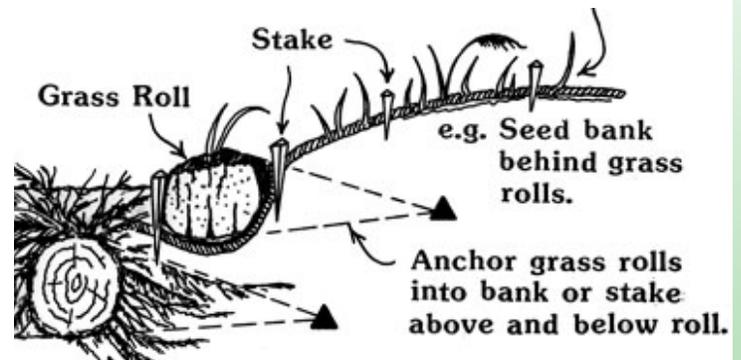
A prepared grass roll, consisting of sod clumps wrapped in an biodegradable fabric, with slits cut in the top for the shoots

Sod clumps are also used in the restoration of erodible stream banks. Grass rolls use sod clumps wrapped in biodegradable fabric to stabilize river banks and quickly establish vegetation cover.

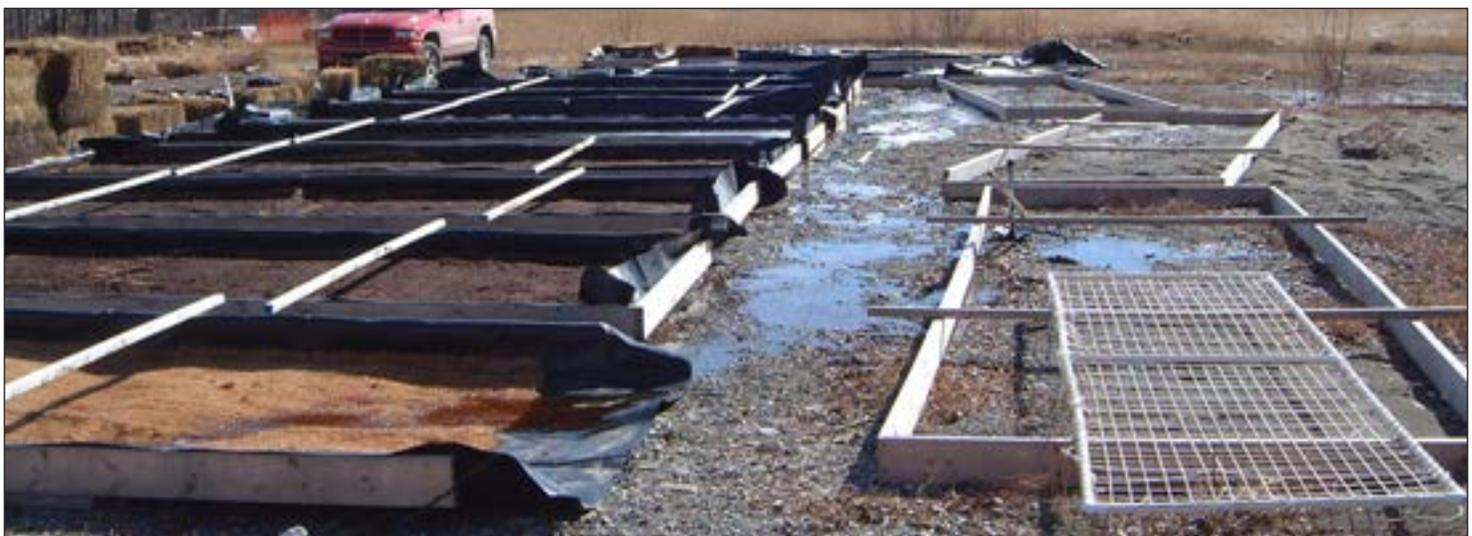
10' x 3' constructed mats framed with dimensional lumber, with thick plastic and erosion control matting used for the base. Only the biodegradable erosion control matting will remain once the mat is deployed.

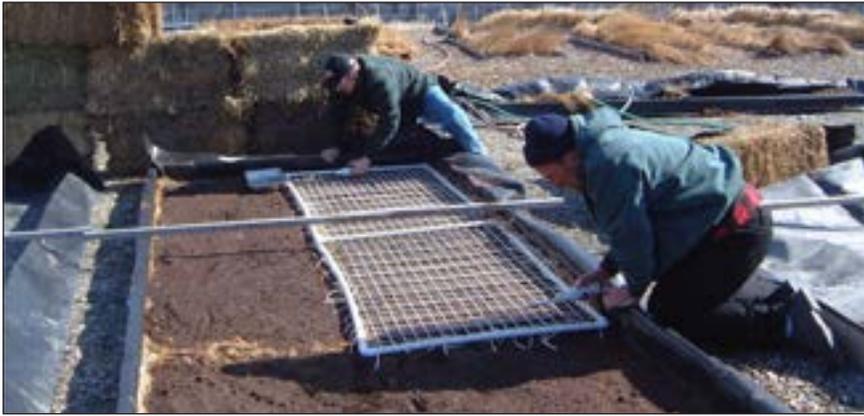
Stratified seeds are sown on a vegetation mat, using hand seeders and a constructed grid to seed at a rate of 1 seed per 2 inch square

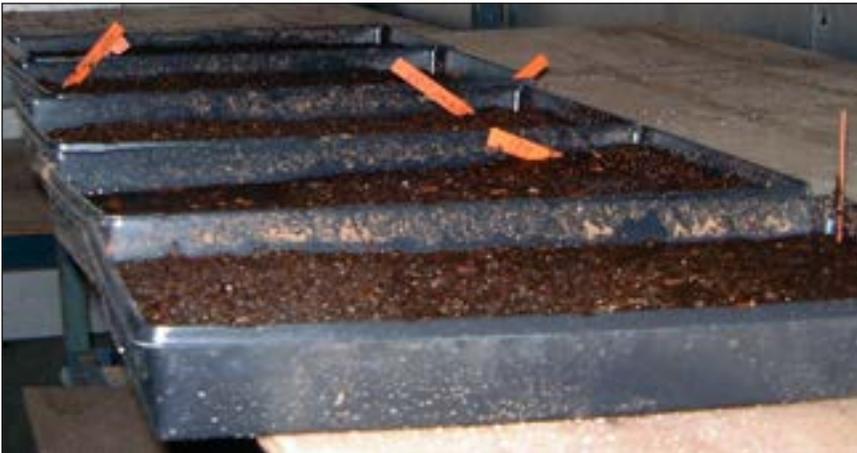
Seeds in flats for cold / moist stratification over the winter. During the stratification process, seeds are placed in cloth bags, with a layer of peat beneath and above them. The cloth around the seeds provide a steady source of moisture.

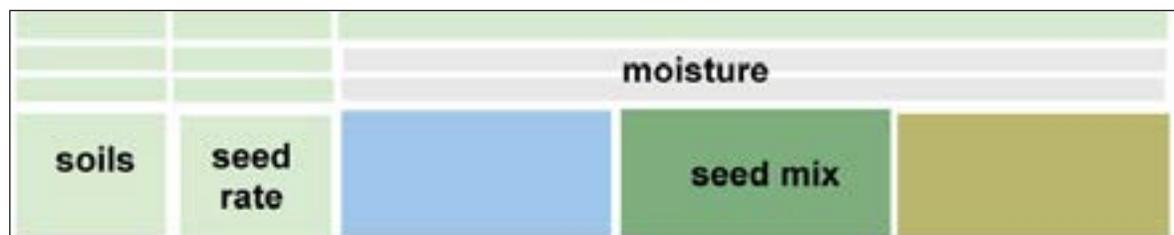
4. Seeding rates for the entire mix are listed in the column "Seed Rate." This number is interchangeable for either lbs / acre or kg / hectare.
5. If the site is determined to be an erosion hazard, add no more than 10% Annual Ryegrass to the previously developed mix. This species, while giving temporary erosion protection, competes for nutrients with long-term perennial species. Also, Annual Ryegrass is a highly palatable forage species that can attract herbivores (i.e. moose and deer). Annual ryegrass cannot be used in conjunction with Alpine Bluegrass (*Poa alpina*). The allelopathic effects of Annual Ryegrass will kill Alpine Bluegrass.

Revegetation Suggestion Chart Structure

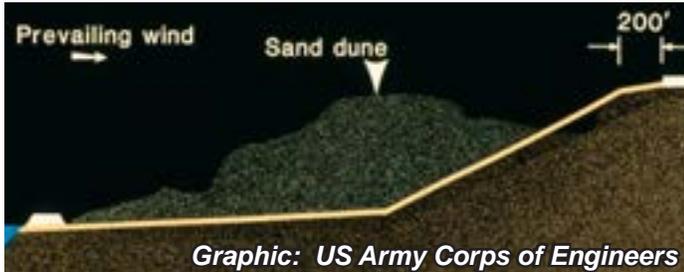
Typical cross-section of Lateral Clear Zone (LCZ)
