Snowshoe Mine Reclamation Project Libby, Montana

Abstract

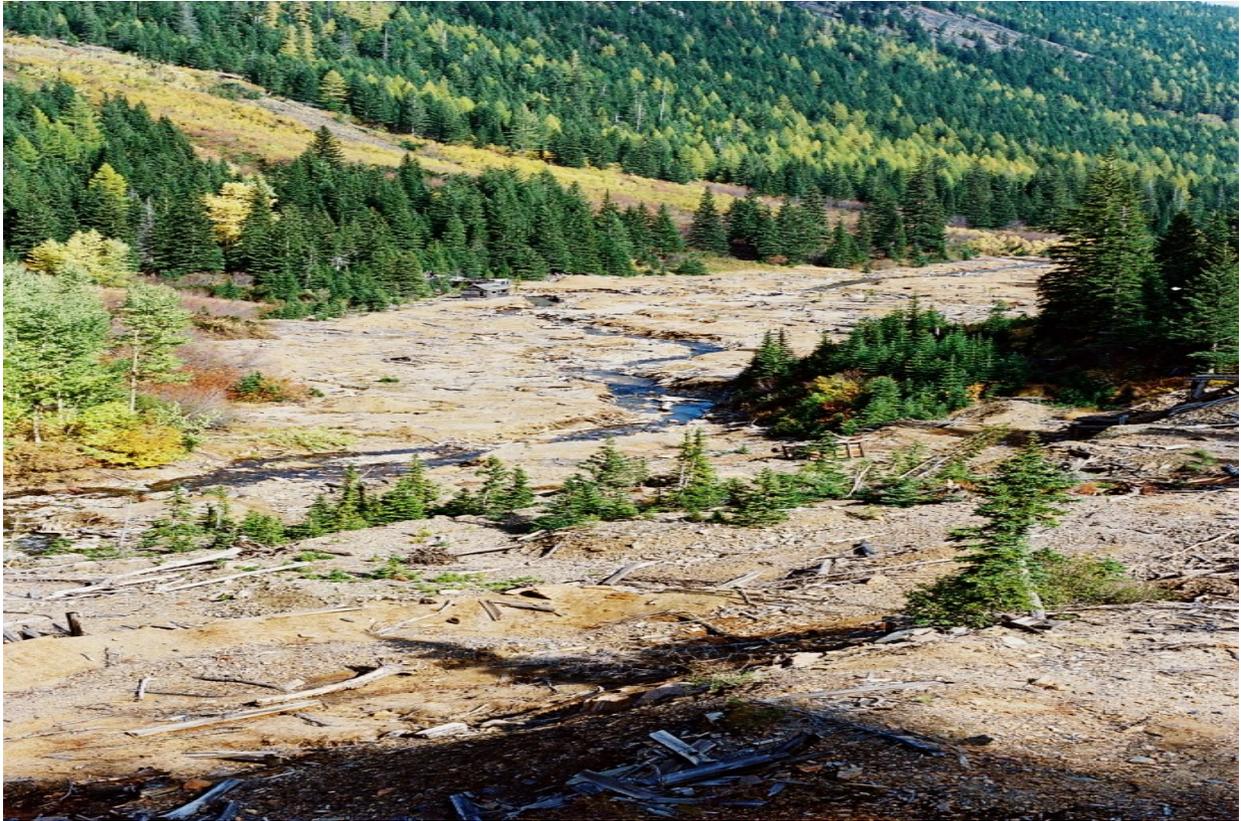
Snowshoe Mine site prior to reclamation (circa 1980's)

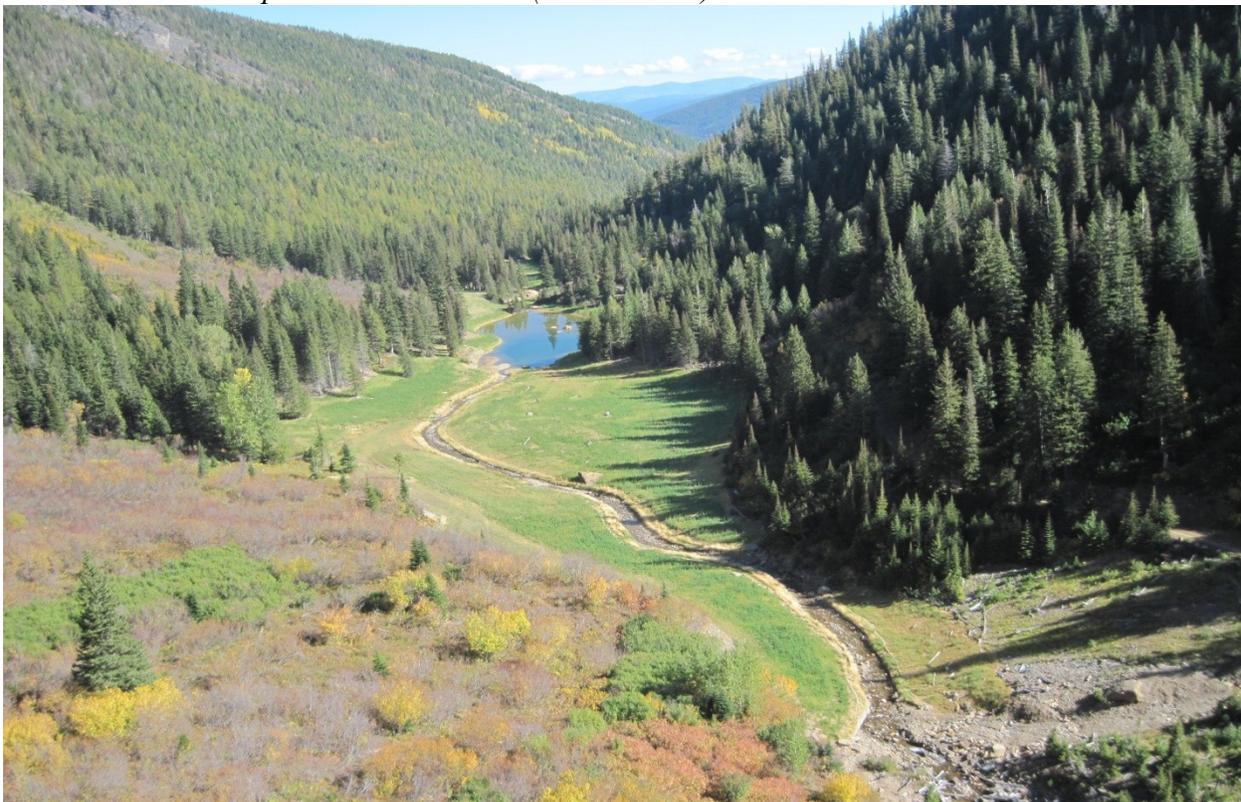
Snowshoe Mine site after successful reclamation (September 2010)

Removal of mine waste materials within the Snowshoe Creek drainage was commenced in September of 2007. The site is located at an elevation of 4,500 feet on the edge of the Cabinet Mountains Wilderness Area. Approximately 2,000 feet of Snowshoe Creek was diverted utilizing a temporary channel to dewater the mine wastes. The waste materials were hauled to a nearby repository location and sealed in place. The repository consisted of a multi-layered impermeable cap. Additionally, two hazardous mine openings located in an avalanche chute were sealed with bat-friendly closures. Clean amended cover soil, which was fertilized, seeded and mulched, was placed within the footprints of the removed wastes. Following waste removal, Snowshoe Creek was reconstructed with coir fabric, grade control structures and check dams and pools throughout the entire disturbed footprint.
