**Mitigation Plan  
for  
Hecla Greens Creek Mining Company  
Greens Creek Mine Stage 3 Expansion**

**March 2014**

ELS Project Number 2039.01

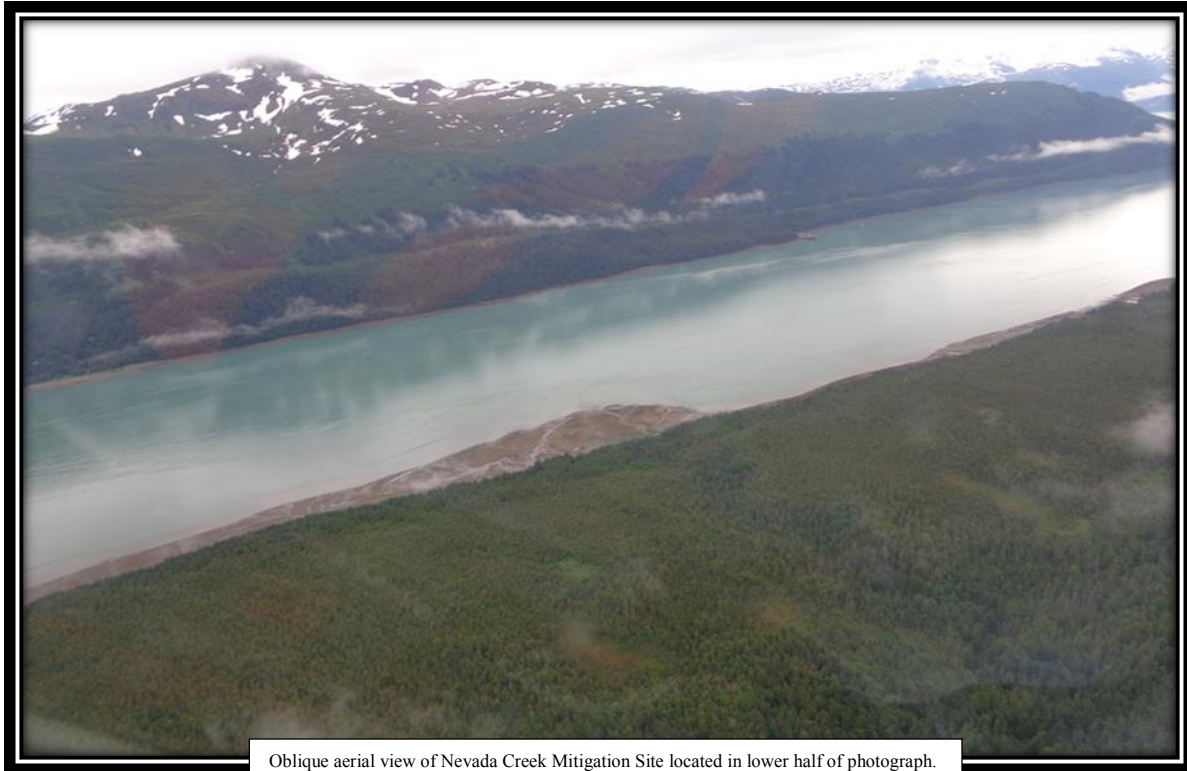
Oblique aerial view of Nevada Creek Mitigation Site located in lower half of photograph.

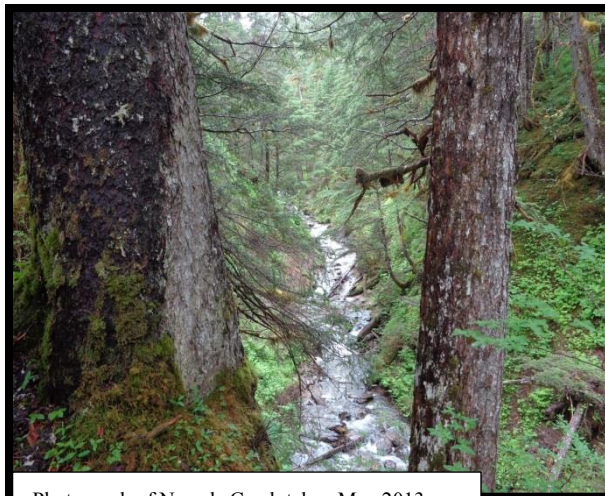
Photograph of Nevada Creek taken May 2013.

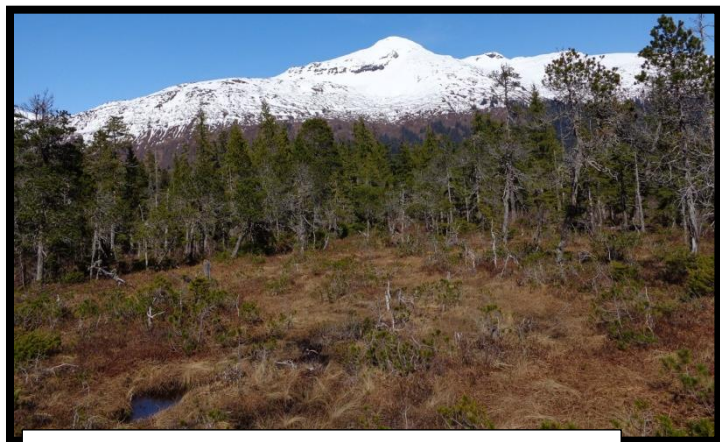
Photograph of Bog fringed by Bog Woodland taken May 2013.

National Wetlands Inventory (NWI) mapping generally captures the full extent of the Bog/Bog Woodland comprised of bogs with emergent and scrub-shrub Cowardin vegetation classes. However, the areas mapped by the NWI as PFO4B coincide with a

larger extent of scrub-shrub bog (PSS4B) as the area mapped as PFO4B is dominated by acid tolerant *Vaccinium* species and stunted trees that generally do not reach heights over 20 feet (Sheet 13; Appendix C).

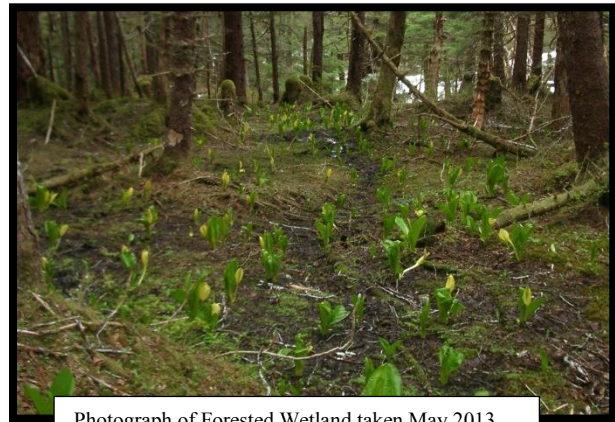
Photograph of Forested Wetland taken May 2013.

The Forested Wetlands are comprised of slope and toe-slope fen wetlands. National Wetlands Inventory (NWI) mapping generally captures the occurrence of the toe-slope fen wetlands. However, the NWI does not capture the forested slope wetlands that occur on the slopes above the wide glaciomarine terrace perched above Gastineau Channel (Sheet 13; Appendix C).

The Forested slope wetland community is comprised of the facultative species western hemlock (*Tsuga heterophylla*, FAC) dominant in the overstory, and Alaska blueberry (*Vaccinium alaskaense*, FAC) and the facultative upland species false azalea (*Menziesia ferruginea*, FACU) dominant in the sparse understory, and obligate wetland species such as American skunk cabbage (*Lysichiton americanus*, OBL) dominant within the herbaceous stratum (Appendix D). The Forested Wetland toe-slope fen community is comprised of facultative species such as red alder (*Alnus rubra*, FAC) dominant in the overstory, with lady fern (*Athyrium filix-femina*, NI) and skunk cabbage dominant in the herbaceous stratum.
