MEMORANDUM

FILE NO: A046113

SUBJECT: Trip Report to Pebble on May
19, 2004

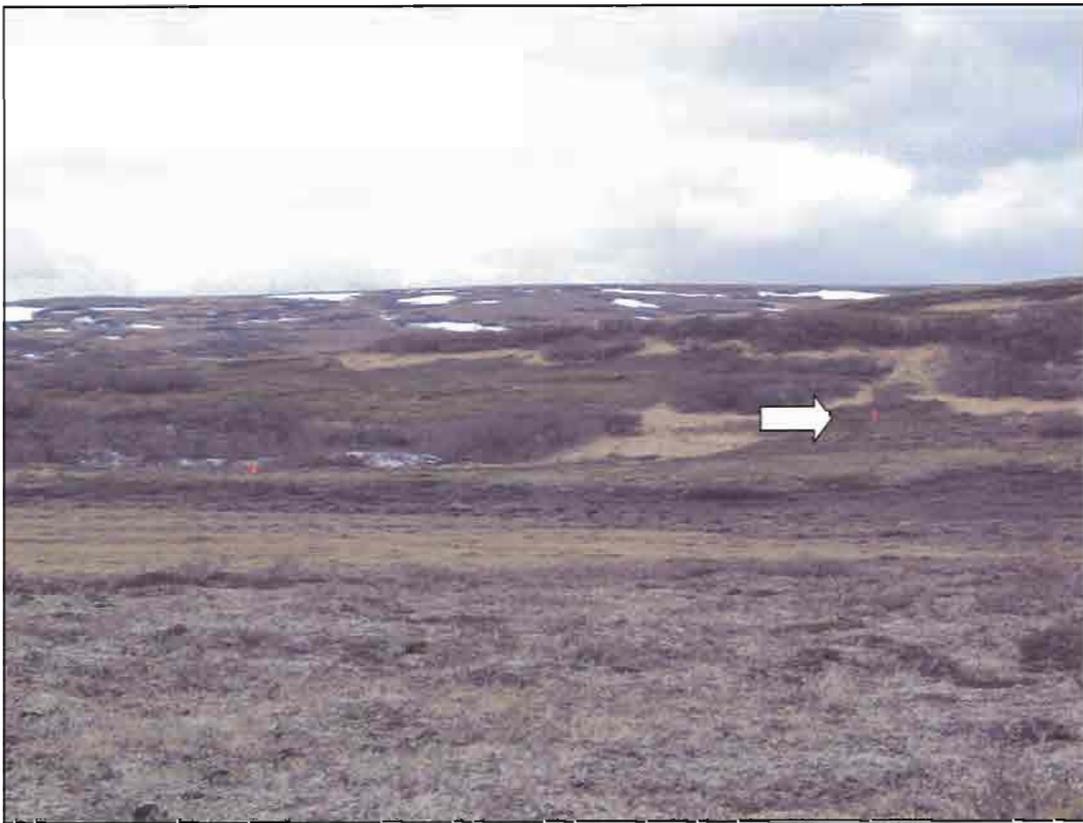
Yesterday, Stan Foo and I flew down to Iliamna and inspected Northern Dynasty's (ND) exploration activity on their Pebble property. ND's APMA indicates they will have five drill rigs operating this year, however upon our visit only two drills were working, while they were mobilizing and moving several others. We inspected the two operating drills and reclamation of the test pits they excavated in 2003. We also inspected several of their 2003 drill sites. Picture 1 below is an example of one of their prior year drill sites marked with an orange post.

Conclusions and Recommendations: Reclamation of drill sites and excavation pits looks good. Disbursement of drilling fluids and mud beyond the sump area at drilling locations in wetland areas needs to be curtailed so that the clay size fraction in the mud does not become disbursed in the wetland environment any more than necessary. This issue was discussed with Rich Moses, ND's exploration manager.

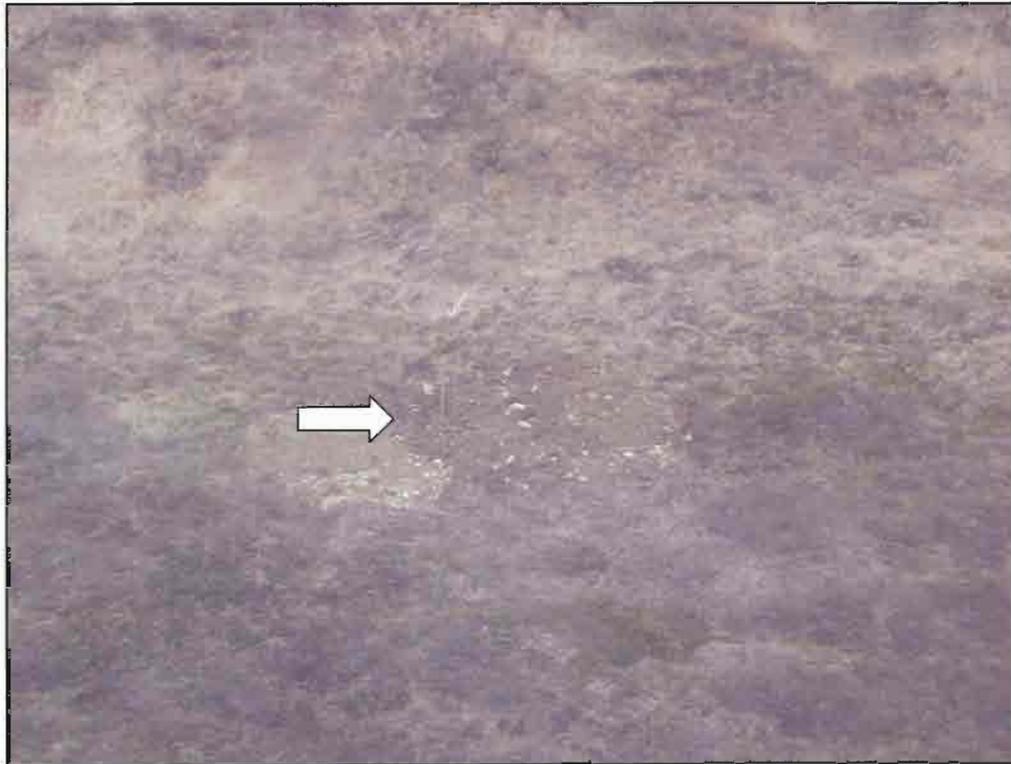
Picture 2 below is an example of one of their reclaimed excavation pits.

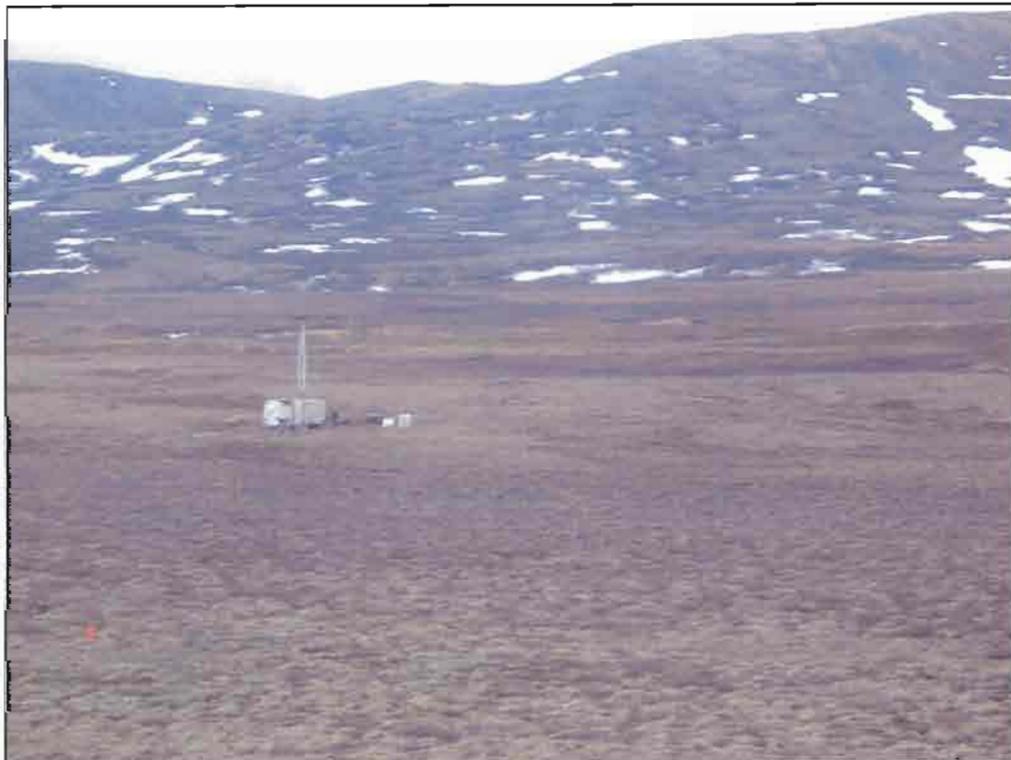
Picture 3

Pictures 3 and 4 below are of a drill site on upland tundra in Township 3 South, Range 35 West, Southeast Quarter of Section 22, Seward Meridian.

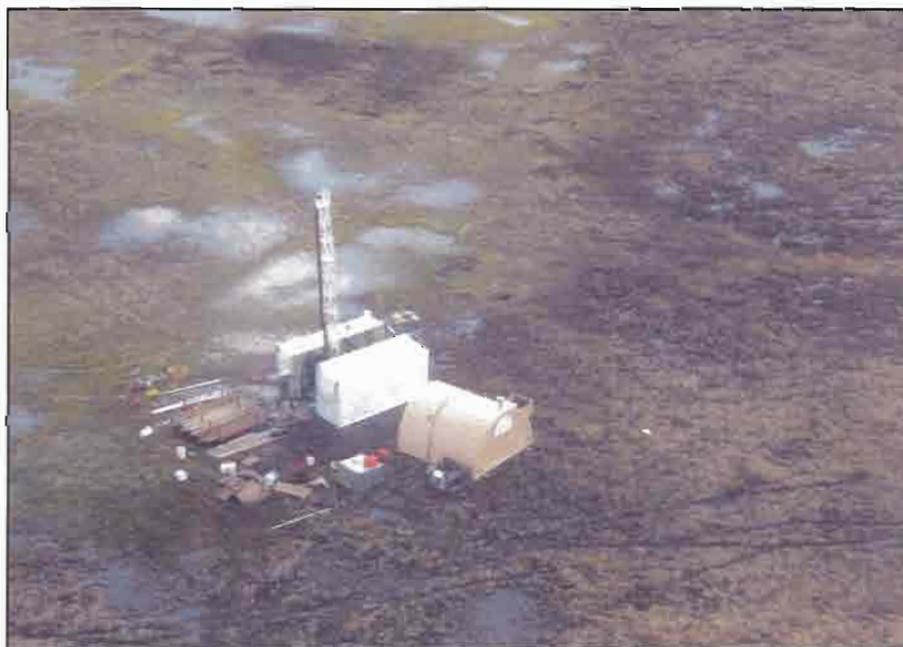
Picture 5

Pictures 5 and 6 below are of a drill site located in a wetland area in Township 3 South, Range 35 West, Section 22, Seward Meridian.
