Kenecott Greens Creek Site Visit November 23, 2004

Kenwyn George, P.E., Environmental Engineer, ADEC-AWQ

This site visit was conducted in conjunction with Laurie Thorpe of the USFS to look at the Tailings facility expansion area, Sulfate Reduction Monitoring Program progress, Site 960 materials removal progress and the present status of Waste Rock Site 23.

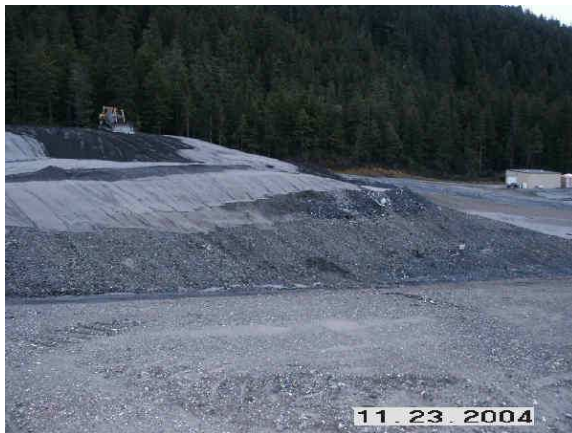
Tails were being placed to the east between the original tailings pile and the new road located on top of the slurry wall on the hillside. At the previous quarry area to the east / southeast of the site, base rock has been placed, a geotextile cover installed and covered in sand, and an initial pass of compacted tails placed. The power line to the waste water treatment plant has been relocated from adjacent to the old tails pile to a location further north on the same latitude as the treatment plant. This will enable expansion of the pile to the north.

East/southeast tailings area

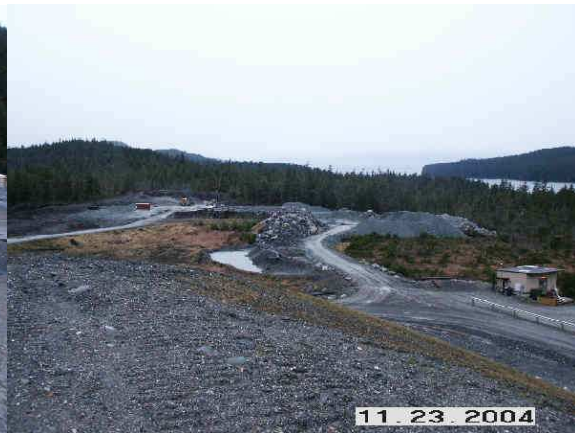
Tailings expansion area

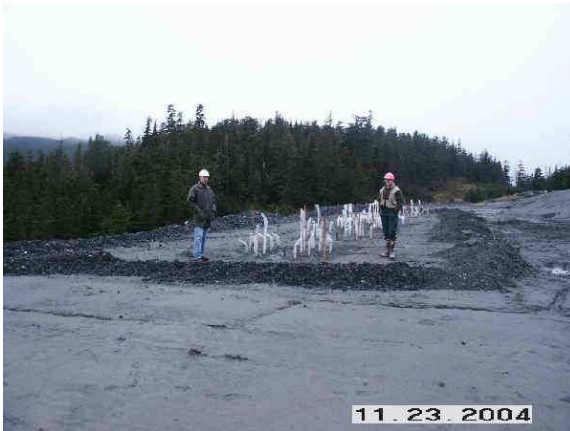
Small "cells" comprised of admixtures within tubes will also be studied in a laboratory during the winter. At the tailings facility, cells 3m x 3m x 4m deep, lined on the sides but not the top or bottom (except for cell No 1 which is an unlined control site) have been installed at the western edge of the top of the existing pile. These cells were set on a small bench in the face of the tailings pile such that they can remain accessible as future tails are placed and the main pile rises higher beside and behind the cells. In each of the 3m x 3m cell sections there are 2 sets of 8 suction lysimeters (16 total), at various depths on opposite sides of each cell. These lysimeters will collect samples from 1.5m deep to 4m deep. In 2005 gas sampling tubes will be installed in each of these cells.

SRMP site at west edge of tails pile

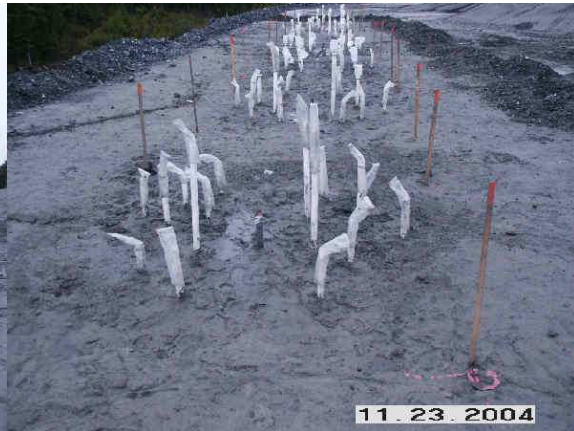
SRMP – lysimeters and sample ports

Tails were excavated from 6 of the 7 cells and carbon sources (local peat, biosolids, & spent brewery grain mash) intermixed with them adjacent to the excavations. The material was then replaced in the cells and compacted to replicate as near as possible the density of the existing tails. Lysimeter sampling points were then hand augered using a power auger (a hard job with all the friction and weight, especially for the deeper holes). Klohn-Krippen had conducted pile stability analyses with the various tails/carbon source mixtures and stated that there should be no greater than 5% by volume of any additive or combination of additives.

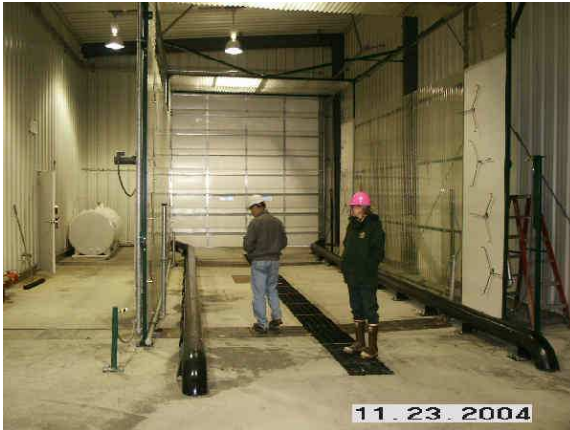
The old truck wash facility is located in the tailings expansion area. This old truck wash station will be removed from the site. Replacing this is a new truck wash facility being constructed at the periphery of the expansion area to the southeast. It is a more sophisticated truck wash that washes the wheels and underside with two sets of upward-pointing jets and side-mounted spray sets.

New truck wash

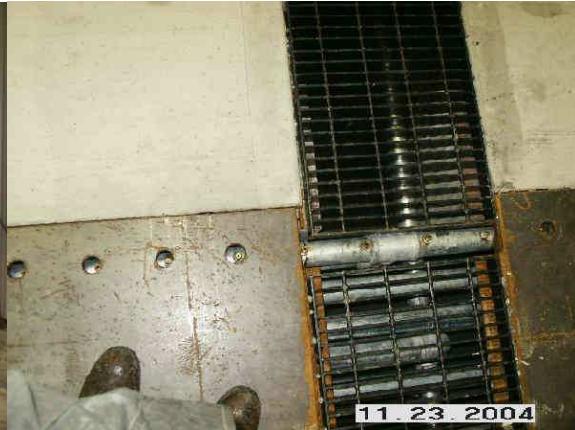
Vertical jets to wash tires & underside of trucks

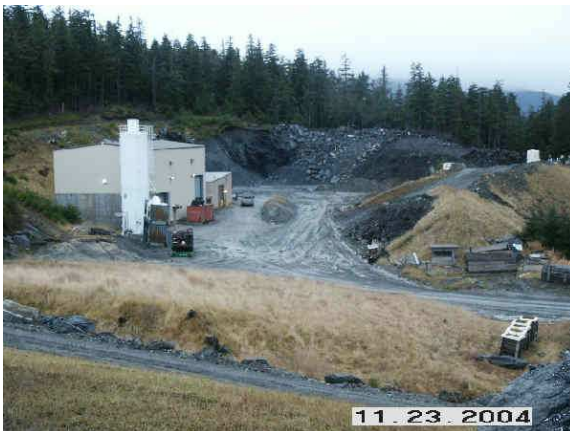
Rock excavation has ceased in this area. There are still rock walls, however the rock will not be quarried for use in locations around the site because it contains too much pyrite; it is better to leave it undisturbed and in place. Eventually tails will fill the pit and will be placed against these rock walls.

Waste Water Treatment Plant and Pit 5

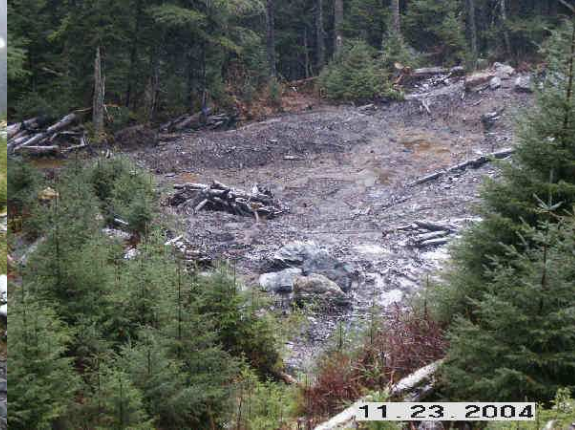
Site 960

Virtually all material has been removed from the site, down to natural clays. There is still acidic run-on from beneath the road above, but that is most likely from natural sources. There is also a stream that runs to the south side of the site, a portion of which now flows onto the excavated area at the lower side. Some original fill material remains in the upper access ramp area; this will be moved after the site has been found stable, and final grading completed with clean-up.
