INSPECTION REPORT GREENS CREEK MINE

Inspection Date: July 31, 2001
Weather: Cloudy, 50-60 °F
Time of Inspection: 2:00 PM - 6:30 PM
Operator Contact: Bill Oelklaus (KGCMC)
Agency Personnel: Steve McGroarty (ADNR); Pete McGee (ADEC); Ed Emswiler (ADEC)
Inspection Objectives: Inspect the "Further Seep" area west of the tailings facility.
Observations:

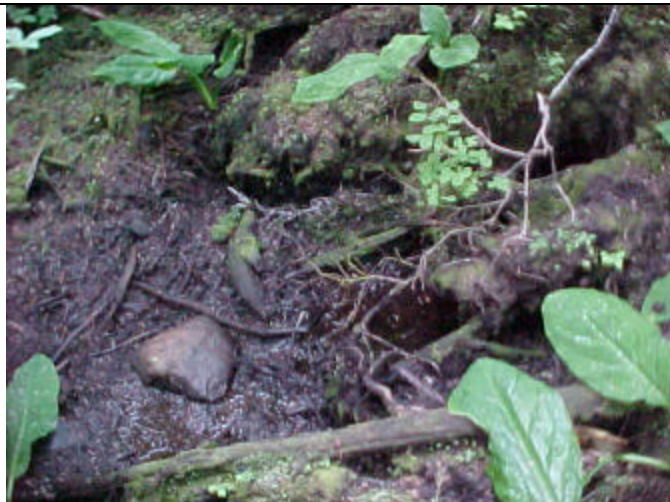
Bill Oelklaus, Pete McGee, Ed Emswiler and I traveled to Hawk Inlet by float plane to allow examination of the area around Further Seep. The seep was not flowing at the time of our observation, but water was present in small pools (Figure 1). A short distance down-slope and off to the south was a set of three nested ground water monitoring stations that had been installed as part of the data collection to support the EIS process (Figure 2). We then walked down the drainage until water was flowing and continued down slope to the beach. There were several locations in the drainage where a sulfur odor was detectable and appeared to be associated with seepage into the creek. There appeared to be an iron-oxide staining on the rocks on the beach where the creek disappeared into the beach gravel (Figure 3).

Figure 1. Location of "Further Seep".

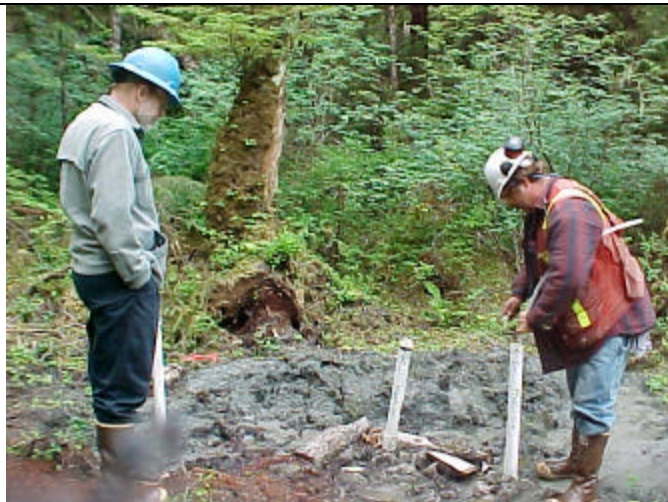
Figure 2. Nested ground water monitoring station located to the west of the tailings facility.

Bill Oelklaus indicated that the company has plans to develop a line of well points on either side of the slurry curtain located along the western edge of the tailings facility to allow determination of the direction of the hydraulic gradient and to compare water quality between the two lines of well points. Dick LeFebvre requested that KGCMC draft a report of the water sampling conducted to date and the company's plans to determine the source of the water in the seep.

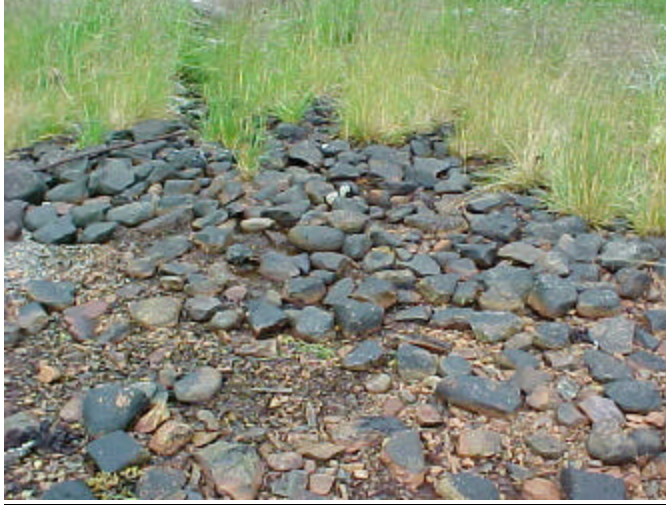
Figure 3. Fe-Ox staining on beach below Further Creek.

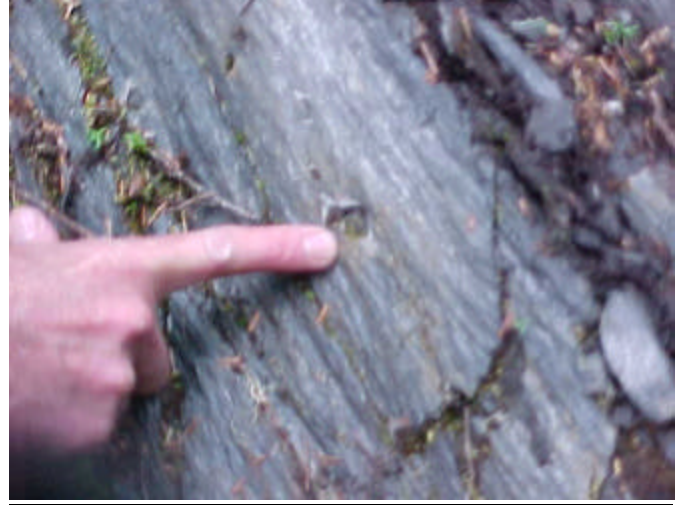
We walked back up the drainage to the group of nested ground water monitoring wells and proceeded approximately 200 feet to the north up the ridge. We encountered another seep and small drainage and suggested that these be sampled if this had not already been done. Bed rock was exposed due to several tree blow-downs. Oxidized pyrite was observed in the exposed bedrock. Cubic shaped cavities; up to 1/2 inch wide; were observed in the exposed bedrock where pyrite cubes have been completely weathered away (Figure 4).

The proximity of the bedrock containing pyrite suggests that consideration be given to the fact that Further Seep may be representative of natural conditions. The proximity of the tailings facility up-gradient of the seep suggests that it is appropriate to continue the efforts to ascertain the source of Further Seep.

Figure 4. Exposed bedrock with cavities from dissolved pyrite.
