Red Dog Mine 2021 Environmental Audit – Final

Teck Alaska Inc.

January 25, 2022

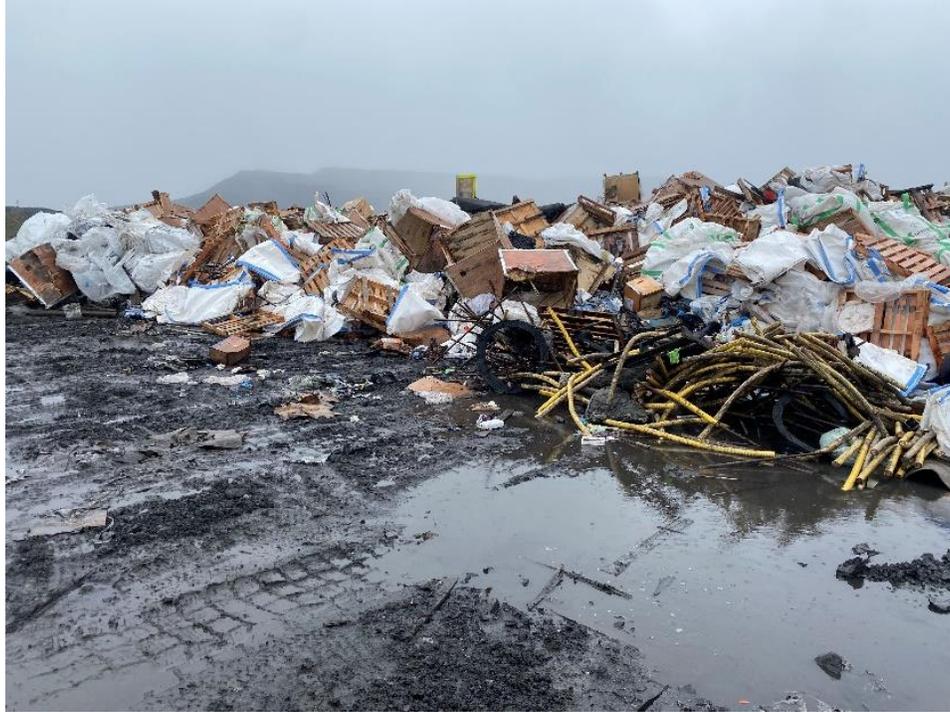
Photograph 1. Class III Landfill Working Face

WMP Section Number	WMP Restriction	TAK Practice	Audit Team Information Resource
2.2.10.15	Ensure that the working face is kept as small as practical to reduce the potential for windblown litter.	The working face was well controlled and was not observed to be overly large as indicated by lack of wind-blown litter.	Field Observation
2.2.10.20	Maintain positive control of all persons who are within the landfill boundaries and that refuse will be deposited in approved locations. Dumping in unauthorized areas violates conditions of this permit.	No persons were observed within the landfill boundary, and there was no indication that waste was being placed in unauthorized areas.	Field Observation

not be considered “trench” (e.g., a long narrow excavation). The current practice at the landfill is that waste is placed on the surface in the active disposal cell then compacted and covered. It is recommended that the Integrated Waste Management Permit be modified to include the surface placement of waste within a disposal cell located lower than the surrounding grade, but still include the option of placing waste in excavated trenches (Appendix A Photographs 1, 2 and 3).

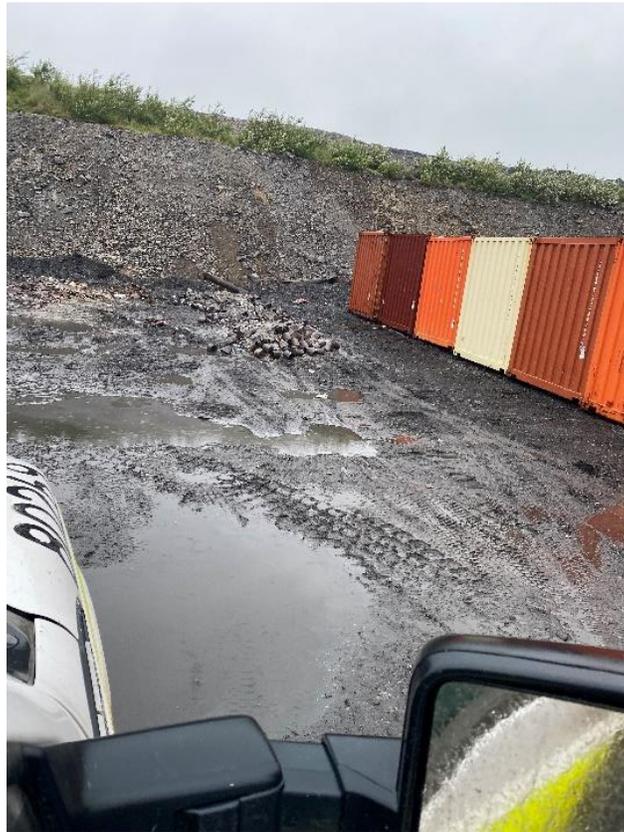
Photograph 2. Incinerator Ash, Placed Away from the Working Face to Cool

The site was being managed to prevent attracting wildlife, and no birds or other wildlife were present at the time of the field audit. The depth of intermediate cover was not verified, the cell observed was “active,” and despite an abundance of rain, auditors observed very little ponded surface water and no obvious signs of runoff from outside of the facility flowing into uncovered waste. The working face was well contained but was beginning to become large enough that intermediate cover should be applied in the near term. Incinerator ash was present on the landfill surface, and it is placed in an area away from the working face to guard against the fire hazard associated with a potential “hot load” of ash material.

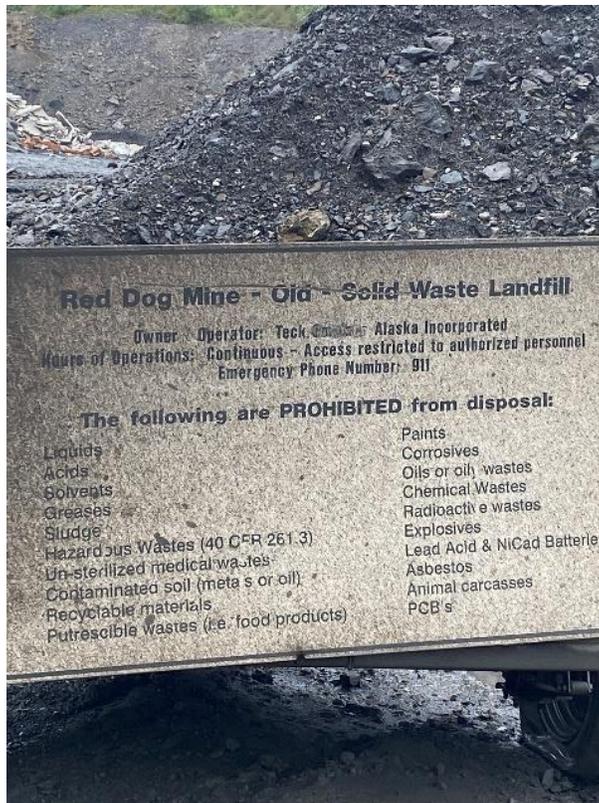
Photograph 3. Landfill Entrance Sign

The Class III (Camp) MSWLF accepts mainly construction debris, wood packing materials (i.e., pallets), used supersacks, and incinerator ash for disposal. At the time of the field audit, a sign was posted at the landfill entrance listing prohibited items. The sign also included the name of the facility, owner/operator name, condition for use, and emergency phone number.

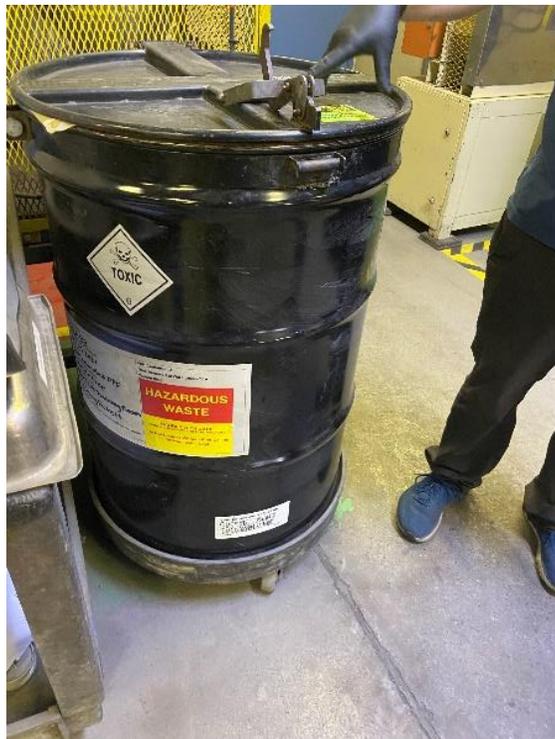
Photograph 6. Hazardous Waste Accumulation Area

- Hazardous wastes will be placed in containers at Satellite Accumulation Areas (HWSAAs) (for less than 55 gallons of waste) or will be placed in appropriately labeled containers and brought directly to a Hazardous Waste Accumulation Area. The Audit Team observed HWSAAs. Appendix A shows the HWSAA at the Assay Laboratory (Appendix A, Photograph 6).

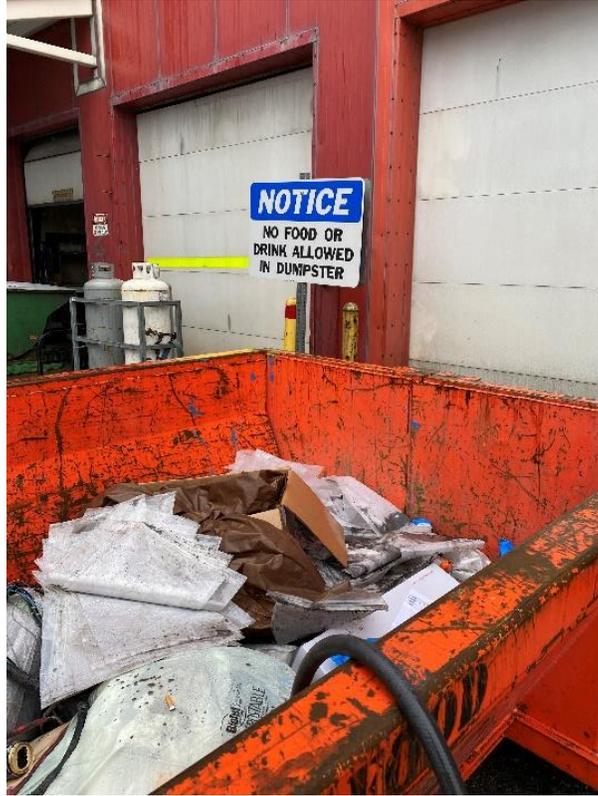
Photograph 7. Dumpster with Signage

- Dumpsters will be marked in a manner such that TAK personnel would be able to distinguish between incinerator and landfill dumpsters. The Audit Team observed that dumpsters onsite are labeled to distinguish between incinerator items or other items per the dumpsters' intended use (Appendix A, Photograph 7).

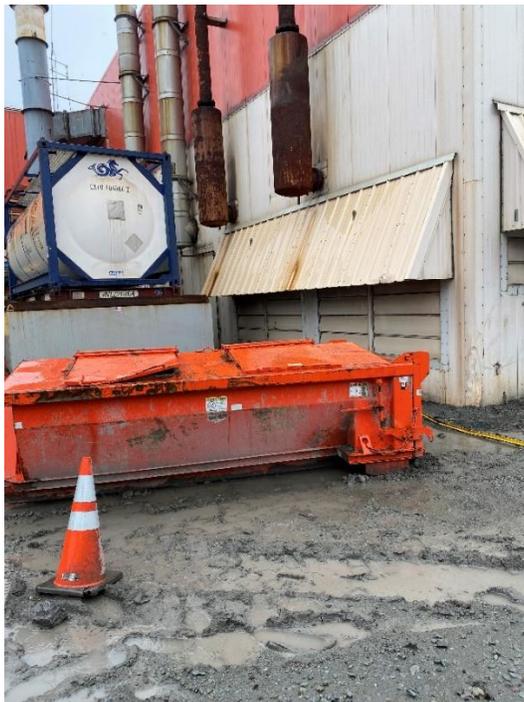
Photograph 8. Covered Dumpster

- Wastes destined for the incinerator (e.g., putrescible food waste, oily waste) will be placed in incinerator dumpsters. These dumpsters would be kept closed to prevent attracting wildlife. The Audit Team observed that most dumpsters onsite have a lid and are labeled in accordance with their intended use. Putrescible food waste is processed in a solid waste incinerator located onsite (Appendix A, Photographs 7 and 8). TAK also conducts random inspections of dumpsters to ensure that waste is being properly segregated (Appendix A, Photograph 9).

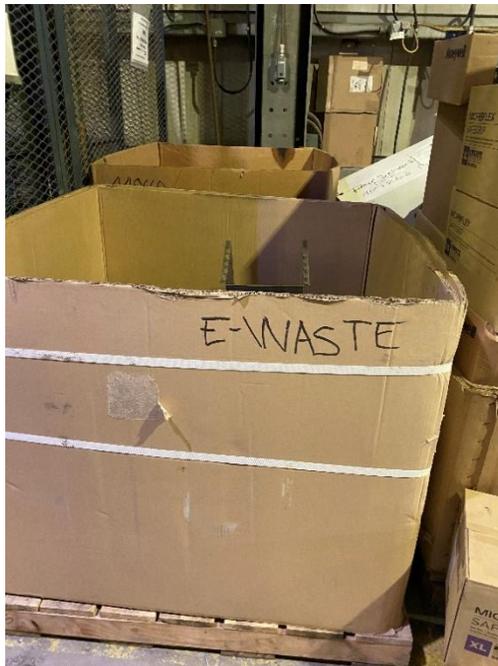
Photograph 10. Electronic Waste Storage Area

- *Materials to be recycled will be placed in segregated containers designated for the specific type of material and managed as outlined in the IWMP.* The Audit Team observed materials such as lead acid batteries, used florescent light bulbs, compressed gas cylinders, and electronic waste in segregated containers that are labeled accordingly (Appendix A, Photograph 10).

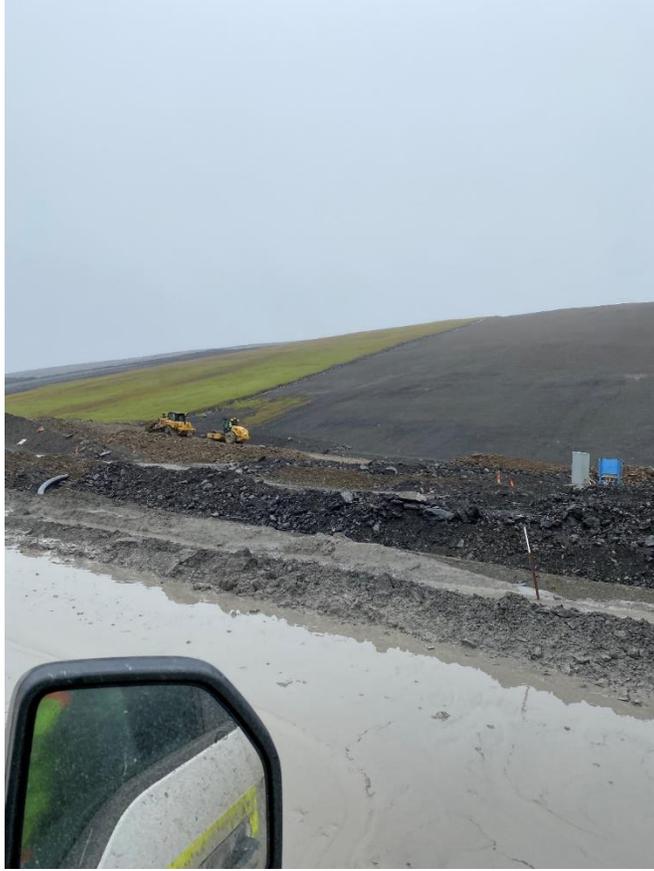
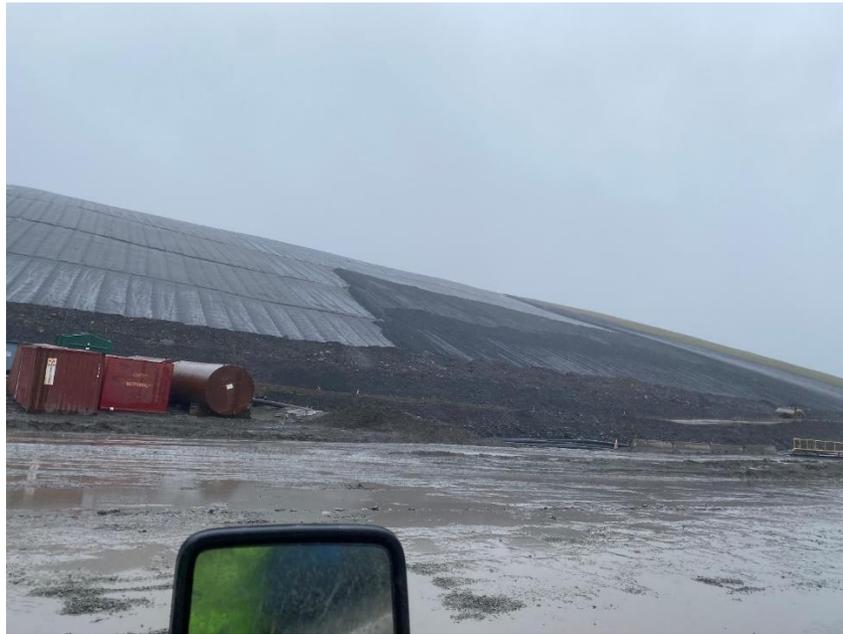
Photograph 11. Closure Activities at the MWD

geomembrane, followed by a geo-composite material, and 2 feet of final cover material was being placed on the surface of the MWD. The side slopes appeared to be 3H:1V (horizontal to vertical); however, an inclinometer measurement was not taken. A test portion of the closure area was well vegetated, with no visual signs of erosion or slope failures.

During the audit, the ongoing closure activities at the MWD were notable. A test section of the geosynthetic liner and soil design was visible, well vegetated, and appeared to be stable, with no evidence of erosion or slump failure. Red Dog crews were working on installing liner material on the side slopes of the facility and covering the liner with soil. Work crews were also installing a draining system at the toe of the sidewall (Appendix A, Photographs 11 and 12). These activities were consistent with the information contained in the amendment request (letter dated July 22, 2019) for modified cover design on the MWD.

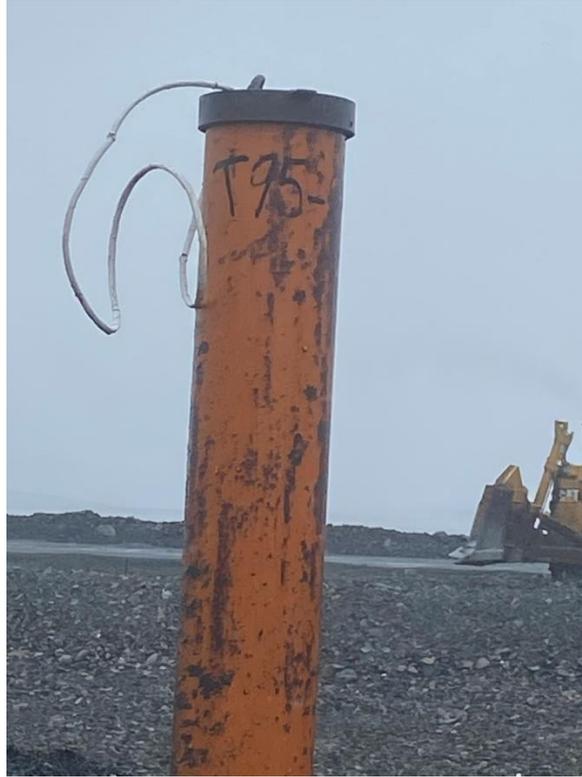
Photograph 13. Thermistor Location

The Audit Team interviewed the Field Technician who collects data, reviewed the monitoring observations in recent monitoring event field data forms, and reviewed annual report data. TAK is performing the monitoring and reporting in accordance with the monitoring program. The Audit Team observed a large number of thermistor readings that were recorded as “Error” on the field data sheet. During the interview with the Environmental Coordinator II, it was explained that TAK uses a consultant to perform the data review, provide TAK a quality control data checklist, provide barometric conversions of the piezometer data, and complete the annual reporting. The third quarter 2021 data checklist confirmed that many of the thermistors have unusable nodes. Of the 16 thermistors, 7 appear to be fully operational. The other nine thermistors have between one and all nodes reporting negative values, indicating an error. Thermistor T-95-004 (Appendix A, Photograph 13) was specifically called out as having had data issues over “past quarters,” implying that an issue has persisted. The thermistor data indicates that numerous nodes had problematic readings (like for T97-28, T96-13, and T96-23). The Audit Team asked if there was a SOP or QAPP for the data validation, data management, and data quality objectives for this monitoring program. The Environmental Coordinator II said there were not; however, the annual reports refer to quality assurance/quality control (QA/QC) measurements and data review checklists, so it appears that some form of QA is being performed. A QA program that lines out data review, identification of issues, and at what point equipment maintenance or replacement is required is recommended to keep the monitoring program operating as intended.

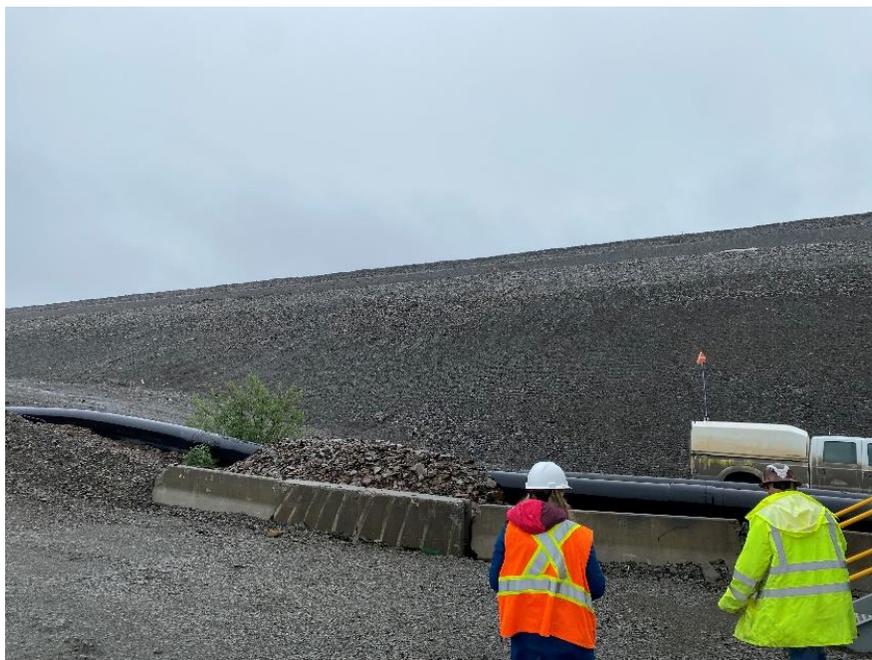
Photograph 13. Tailings Storage Facility, Main Dam

Photographs 13 through 19 in Appendix A depict observations of the dams and appurtenances taken during the Red Dog field visit.
