## TECHNICAL MEMORANDUM

**Reference No.** 31405631.1516-006-TM-0

### NITROGEN SOURCE CONTROL OUTFALL 002 – TASK 2 IMPLEMENTATION AND EVALUATION

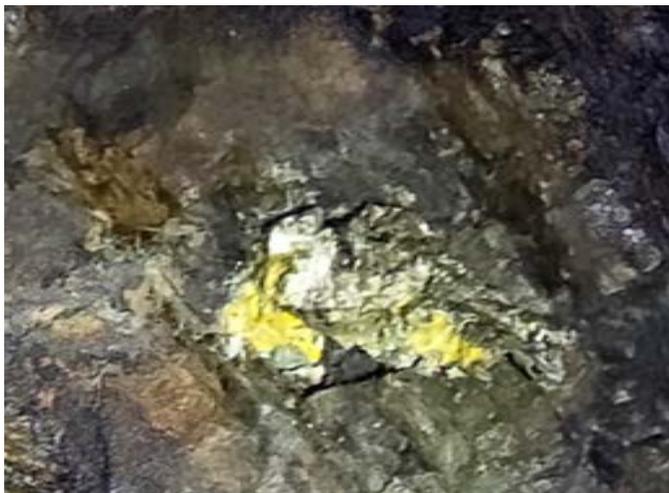
**Figure 2.8. Undetonated Emulsion Chub in Boot**

Kensington personnel load development headings with stick powder in wet holes to decrease the chance of explosive seepage. This is done with a trace detonating cord that runs along the length of the hole to ensure detonation of all sticks. Despite this appropriate technique, multiple post-blast inspections had signs of misfires and partial detonation. These signs included partially detonated stick powder, as shown in Figure 2.8.

The application of a detonating cord trace with stick powder to allow water flow in holes was negated by tamping of the powder. Tamping will disallow water flow and increase the likelihood of stick separation in the powder column and causing undetonated explosives to be left following as a blast, as shown in Figure 2.8.

- Limit the effect of water pressure in holes:
  - Holes observed by loading crews to have water flowing should be loaded with stick powder and a detonating cord tracer along the length of the hole. The detonating cord tracer should be matched to the stick explosive based on manufacturer recommendations. Detonating cord that is too small will only damage the emulsion, causing wastage, rather than detonate the stick.

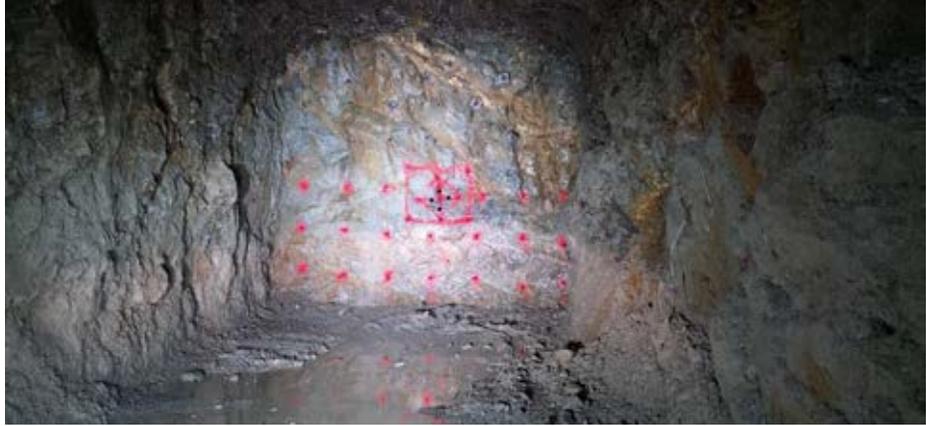
<p><b>PHOTO 4</b> Location: 2 Type: Development</p> <p>Drill pattern on development heading. Well drilled and evenly spaced pattern.</p>

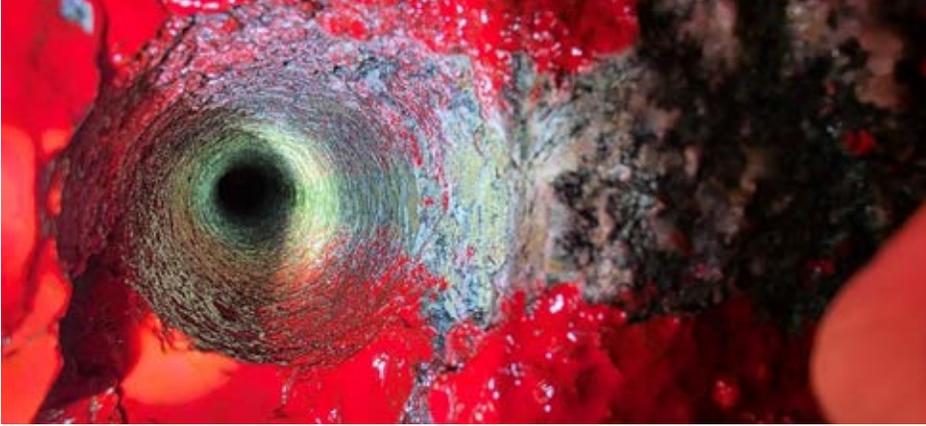
<p><b>PHOTO 5</b> Location: 2 Type: Development</p> <p>Downhole view of borehole showing clean boundaries.</p>

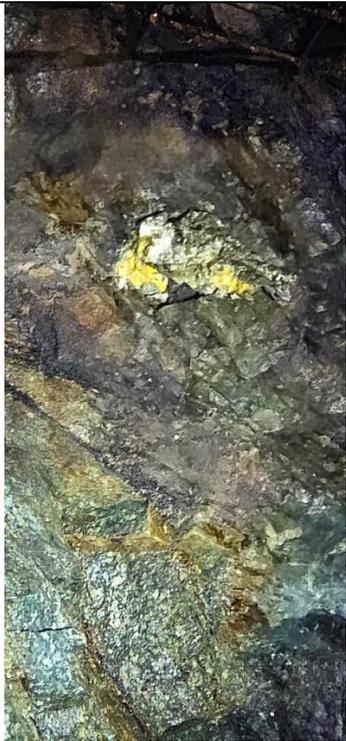
<p><b>PHOTO 9</b> Location: 3 Type: Development</p> <p>Leftover emulsion chub in upper right corner of heading</p>

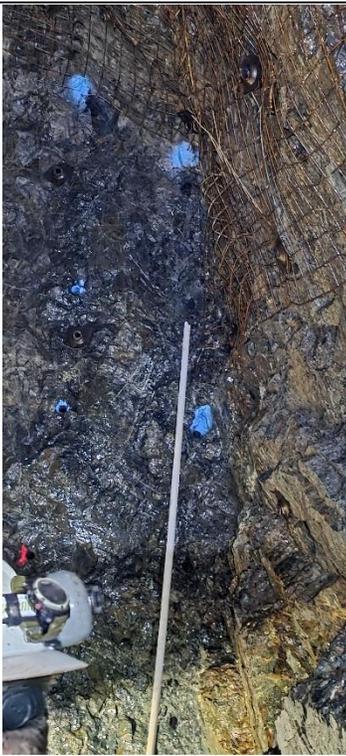
<p><b>PHOTO 10</b> Location: 3 Type: Development</p> <p>Right rib showing excessive water</p>

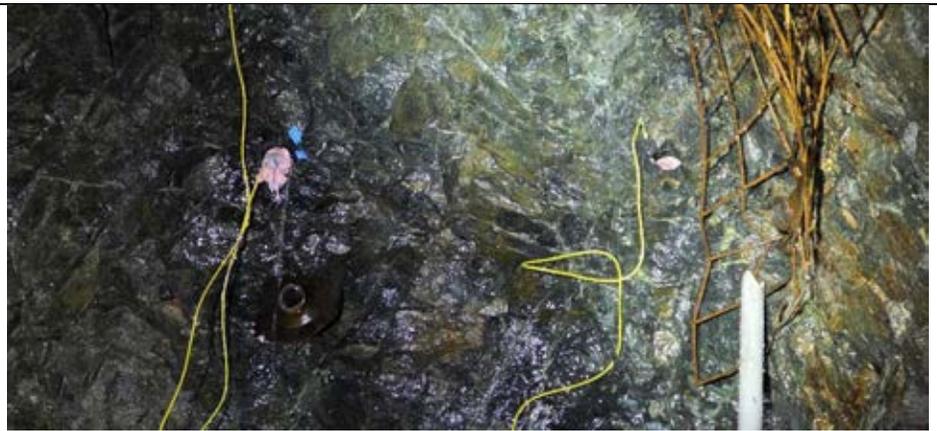
**PHOTO 14**  
Location: 3  
Type: Development

Upper hole 1 displaying emulsion seepage

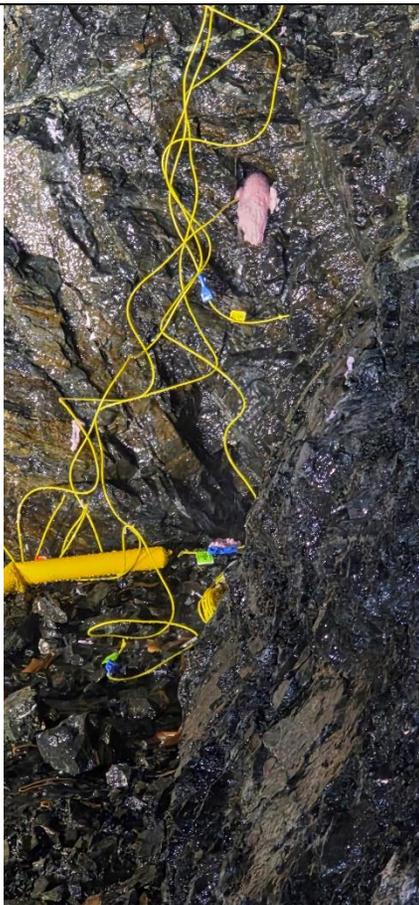
**PHOTO 15**  
Location: 3  
Type: Development

Hole 2 showing emulsion seepage and the powder has fallen from the collar

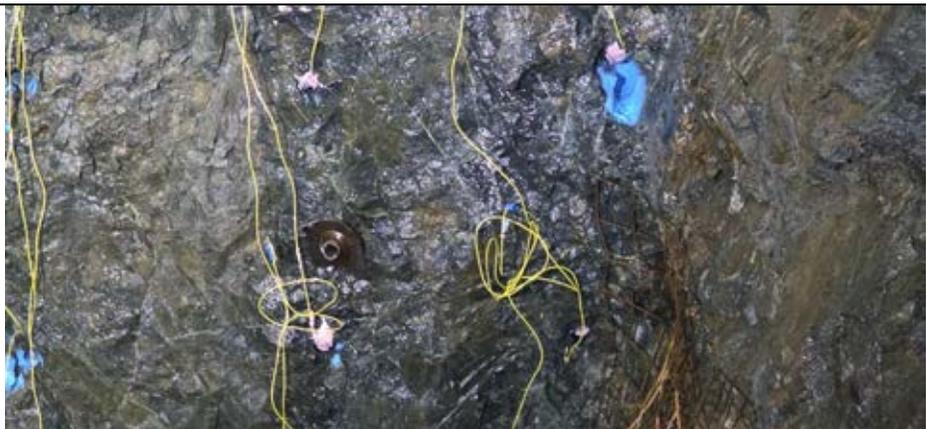
**PHOTO 16**  
Location: 3  
Type: Development

Upper hole 1 displaying emulsion seepage

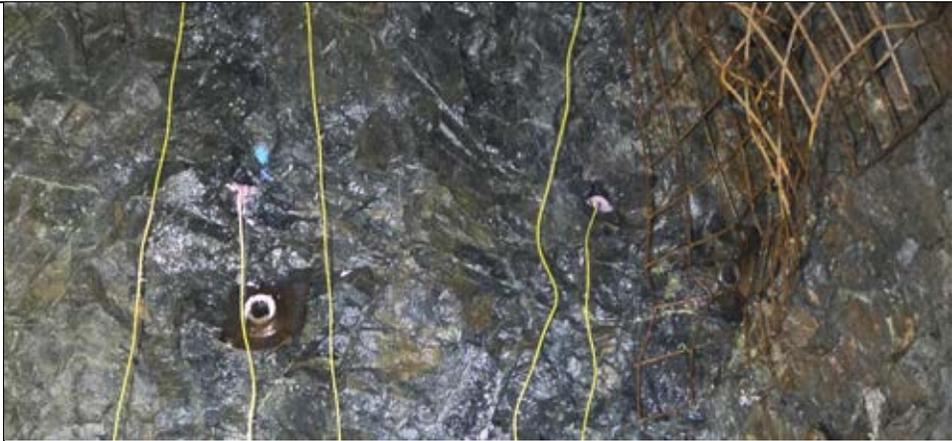
**PHOTO 17**  
Location: 3  
Type: Development

Upper hole 1 displaying emulsion seepage

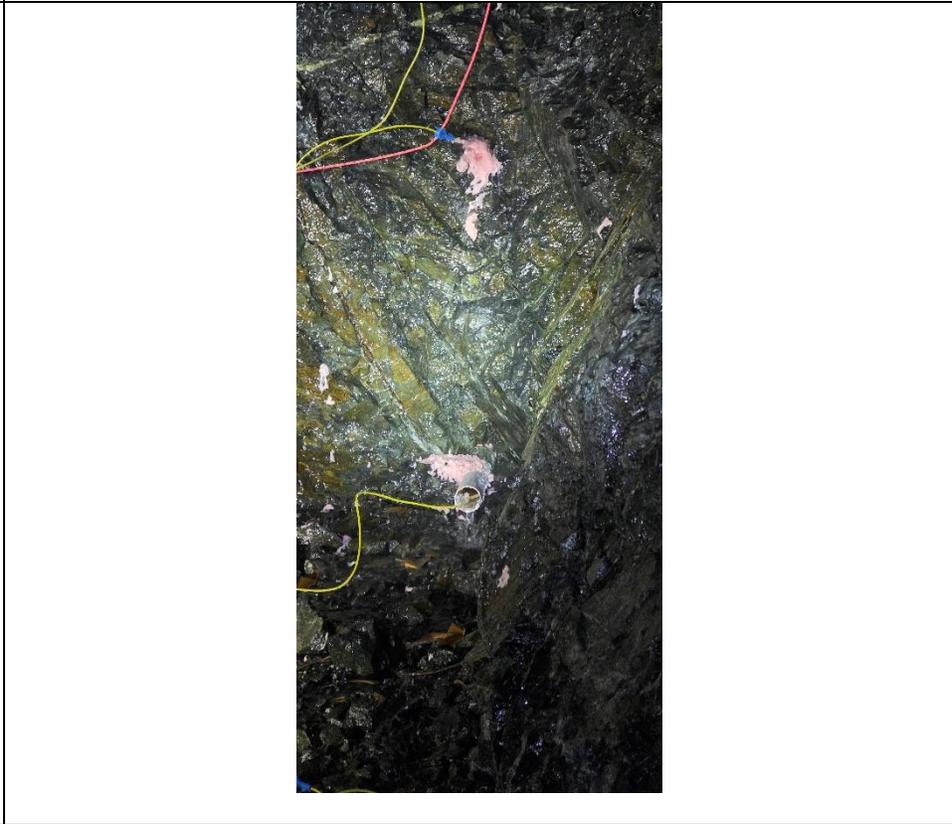
**PHOTO 18**  
Location: 3  
Type: Development

Hole 2 showing emulsion seepage and the powder has fallen from the collar

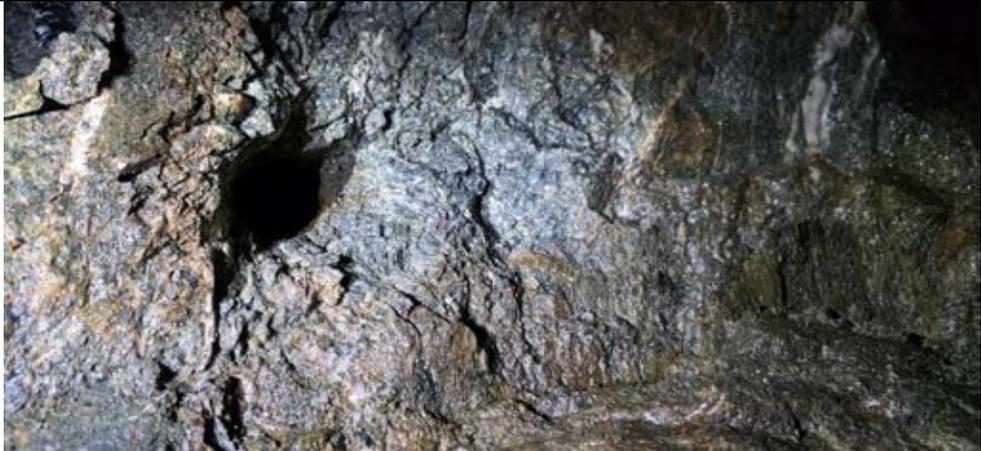
A close-up photograph of a rock surface. A bright red paint is applied to a section of the rock, which appears to be a boot or a specific area of interest. A yellow cable or wire runs horizontally across the image, passing over the red-painted area. The rock surface is dark and shows signs of crushing and fracturing.
<p><b>PHOTO 4</b> Location: 2495-246 Type: Development</p> <p>Boot that shows significant crushing and slight radial fracturing</p>

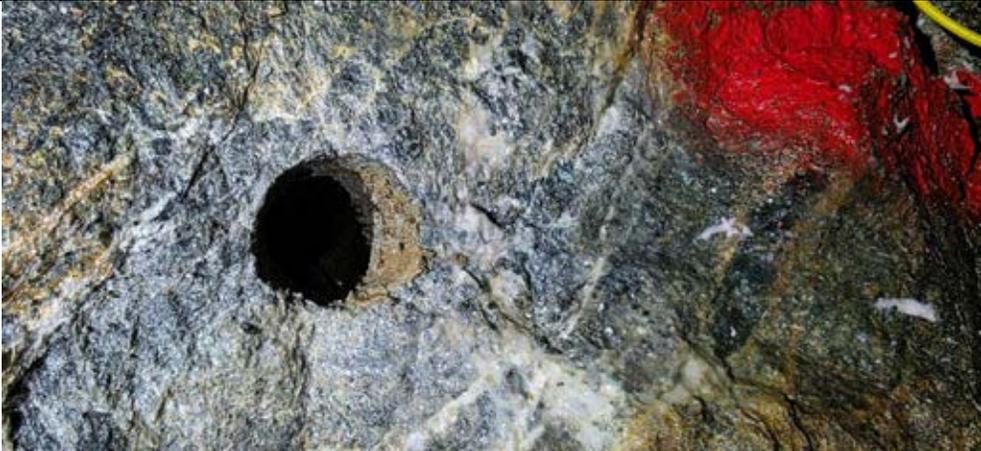
A close-up photograph of a rock surface. A dark, circular hole is visible in the center of the frame. The rock surface is dark and shows signs of crushing and fracturing. The lighting is somewhat dim, highlighting the texture of the rock.
<p><b>PHOTO 5</b> Location: 2495-246 Type: Development</p> <p>Boot that shows significant crushing and slight radial fracturing</p>

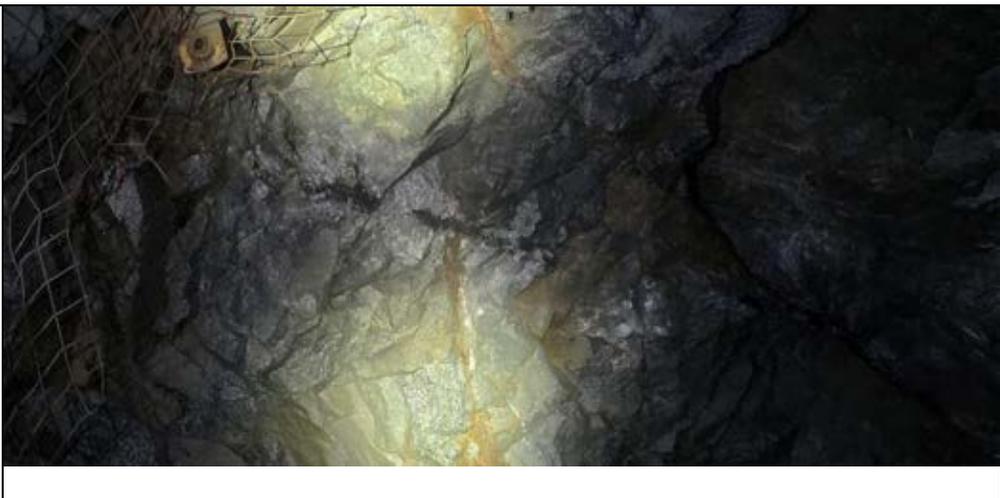
**PHOTO 8**  
Location: 2720  
Type: Development

Carbon Staining in  
Upper Corners

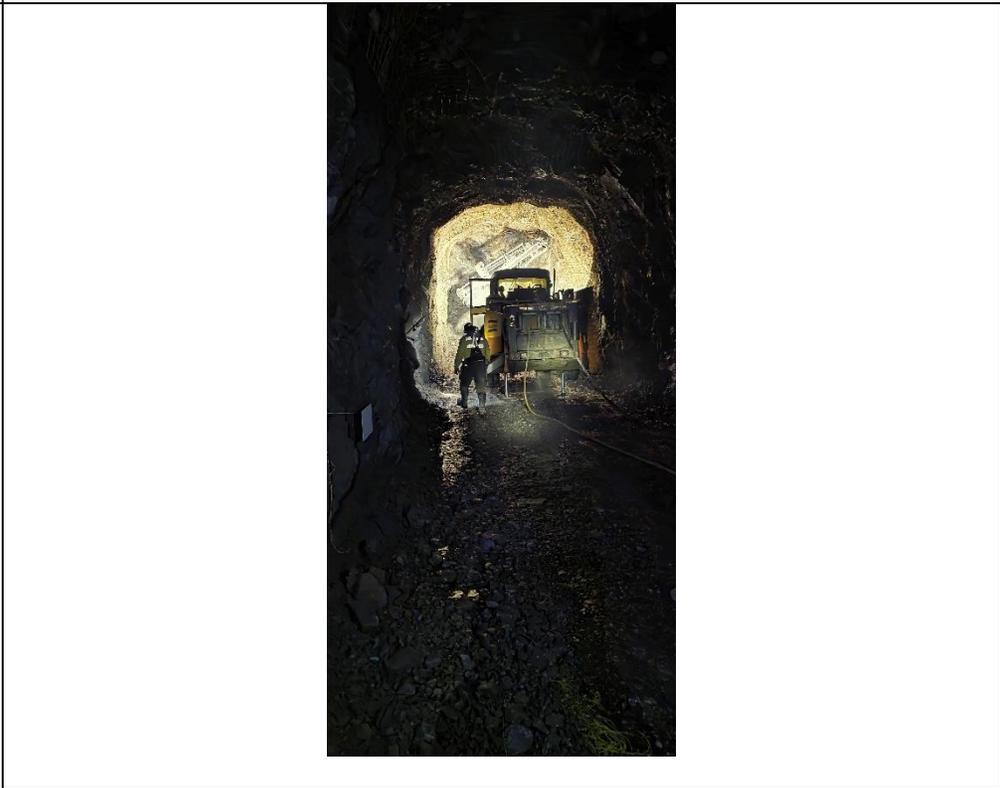
**PHOTO 8**  
Location: 3  
Type: Development

Bolter Set-up

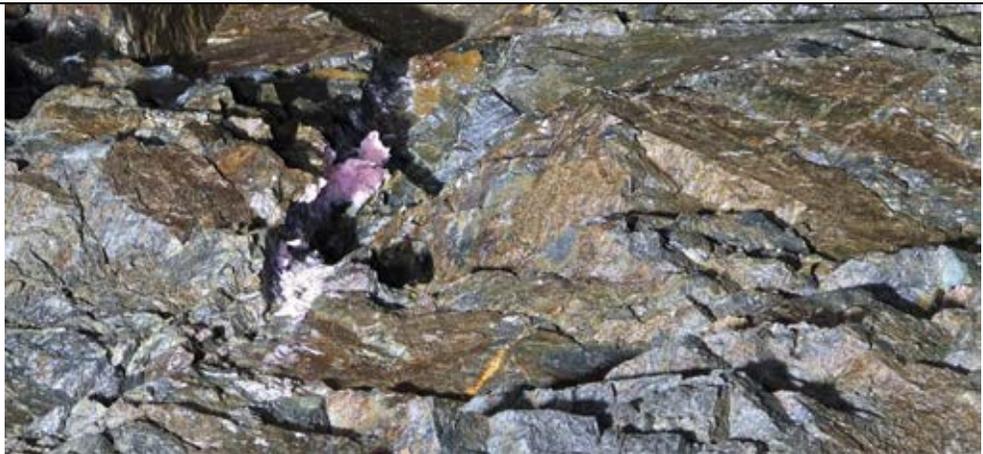
**PHOTO 8**  
Location: 3  
Type: Development

Misfired emulsion in  
Half barrel

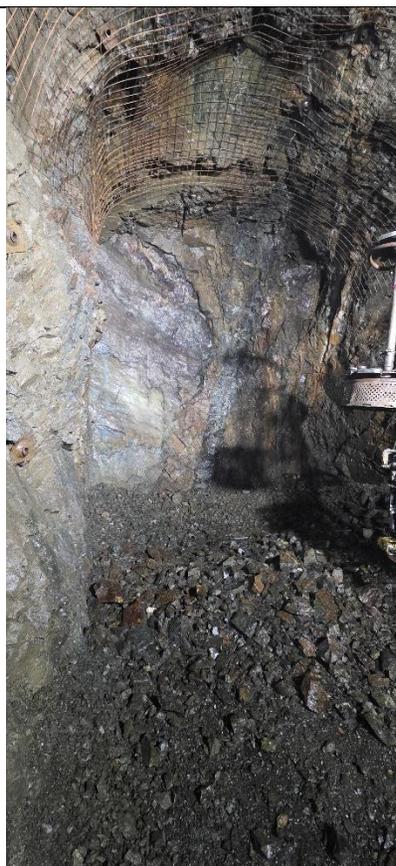
**PHOTO 9**  
Location: 3  
Type: Development

Full Round view

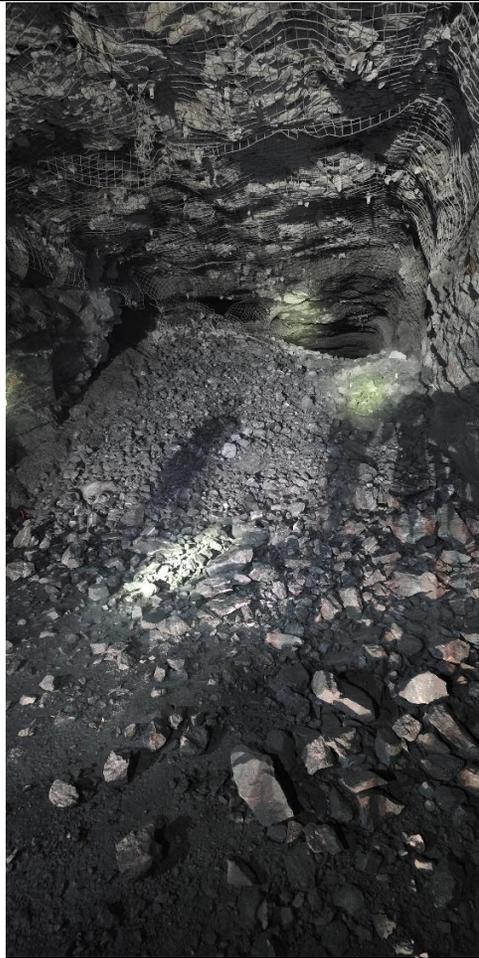
**PHOTO 1**  
Location: K1555-083  
Type: Bottom of Stope

Fragmentation pile on upper side. Well fragmented and loose appearance

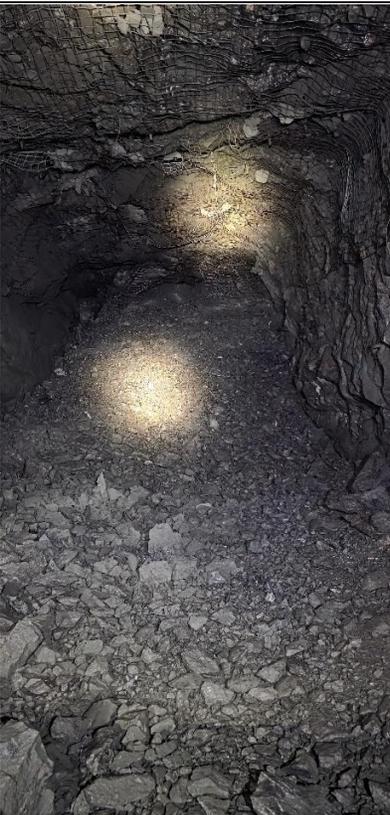
**PHOTO 2**  
Location: K1555-083  
Type: Bottom of Stope

Fragmentation pile on upper side. Well fragmented and loose appearance

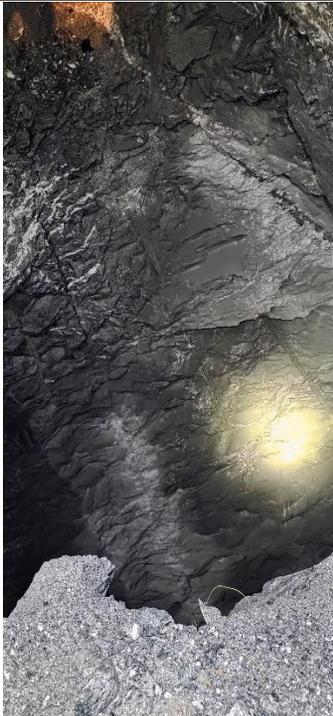
A vertical photograph of a dark, rocky stope. A bright yellow light source illuminates a large, dark, irregularly shaped object (a half barrel) embedded in the rock. The surrounding rock surface shows some carbon staining and varied textures. A person in a red shirt is visible in the lower left corner for scale.
<p><b>PHOTO 5</b> Location: K1555-083 Type: Top of Stope</p> <p>3 half barrels in R1 showing varied crushing and disappearance into unbroken material.</p>

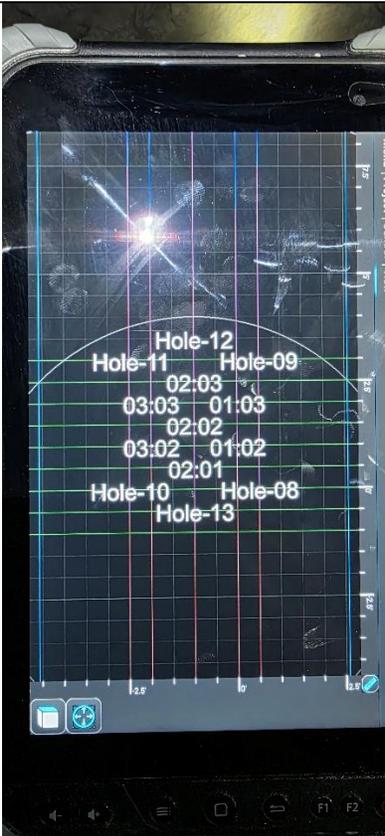
<p><b>PHOTO 1</b> Location: E1180-202 Type: Stope</p> <p>Boretrak hole Locations</p>

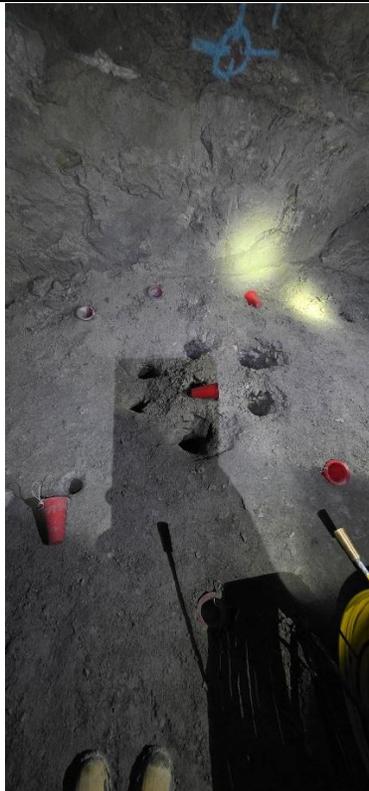
<p>The image shows a smartphone screen displaying the Boretrak application. The screen features a grid overlay on a dark background. A semi-circular arc is drawn across the grid. Text labels for various holes and their corresponding times are displayed within the grid. The labels include: Hole-12, Hole-11, Hole-09, Hole-10, Hole-08, and Hole-13. Times listed are 02:03, 03:03, 01:03, 02:02, 03:02, 01:02, and 02:01. The application interface also shows a scale at the bottom with markings for 12.5 and 25.0.</p>
<p><b>PHOTO 2</b> Location: E1180-202 Type: Stope</p> <p>Boretrak hole Locations</p>

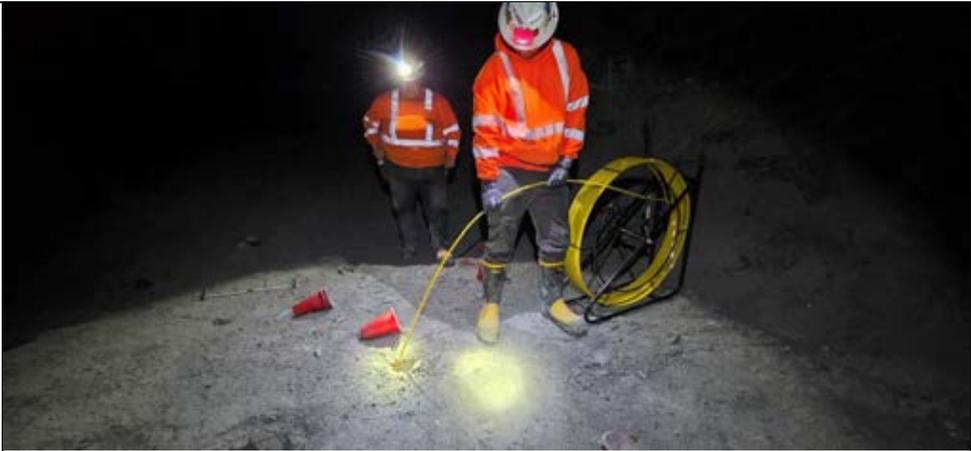
**PHOTO 3**  
Location: E1180-202  
Type: Stope

Boretrak operation

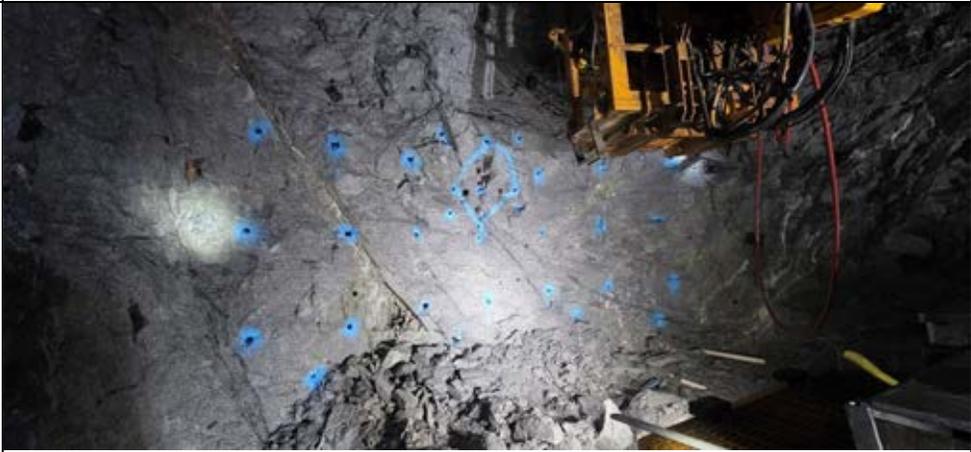
**PHOTO 4**  
Location: KN200  
Type: Development

Drillhole locations painted

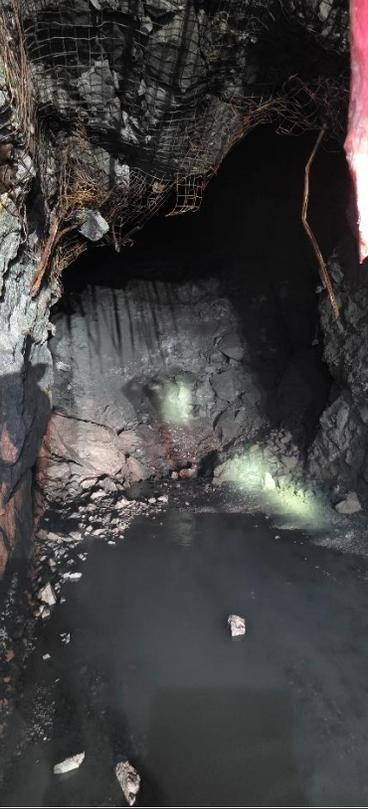
<p><b>PHOTO 1</b> Location: 1625-098 Type: Bottom of Stope</p> <p>Tight muckpile varied fragmentation</p>

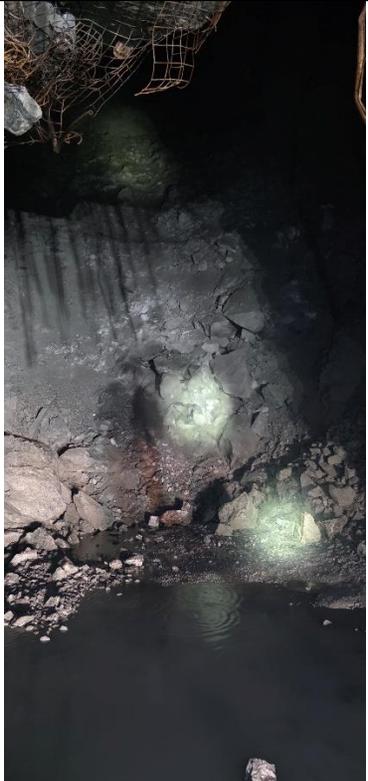
<p><b>PHOTO 2</b> Location: 1625-098 Type: Bottom of Stope</p> <p>Tight muckpile varied fragmentation</p>

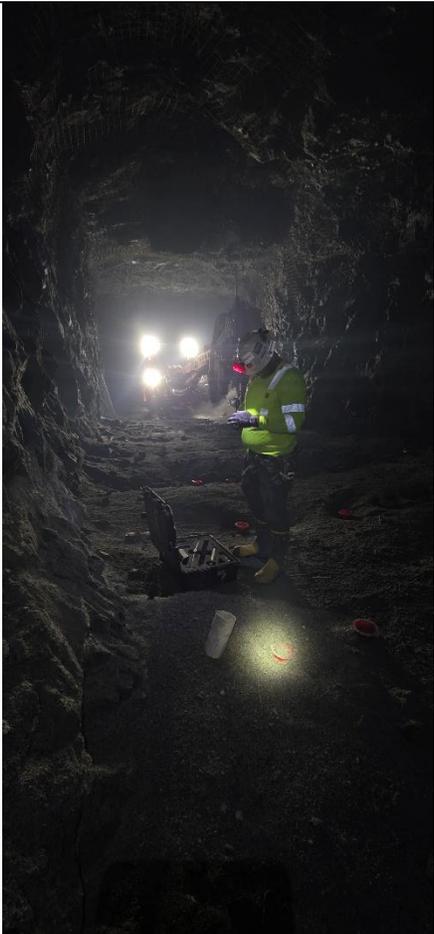
<p><b>PHOTO 3</b> Location: 2345-262 Type: Stope  Boretrak set-up</p>

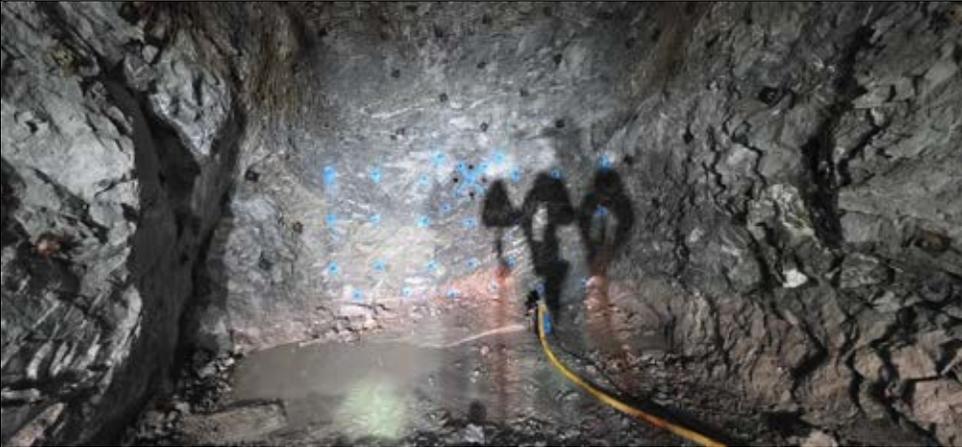
<p><b>PHOTO 4</b> Location: KN200 Type: Development  Drillhole locations painted</p>

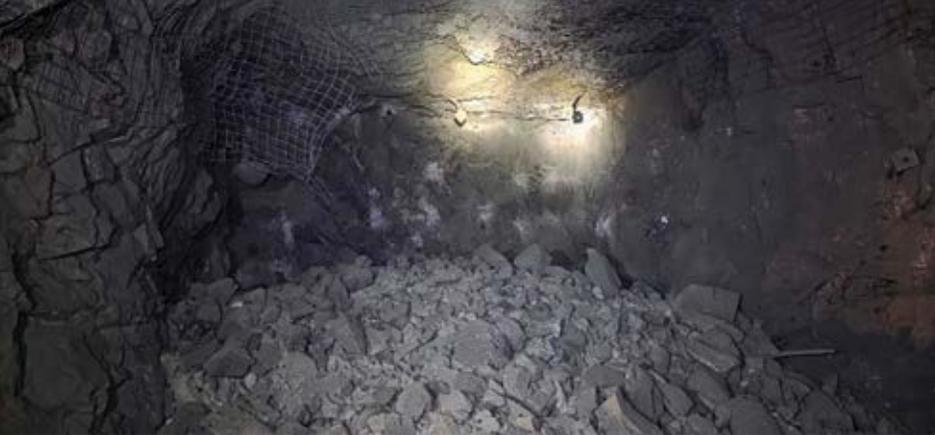
<p><b>PHOTO 1</b> Location: 2720-1 Type: Development</p> <p>Crushing around borehole boots indicating proper detonation</p>

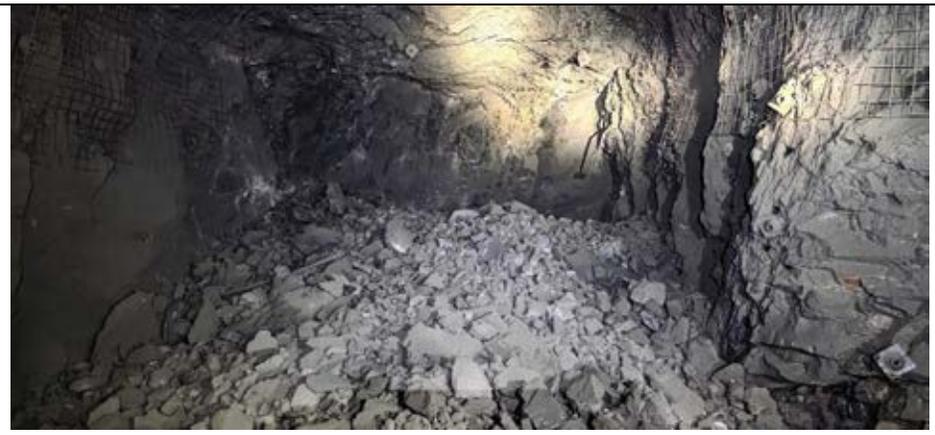
<p><b>PHOTO 2</b> Location: 2720-2 Type: Development</p> <p>Crushing around borehole boots indicating proper detonation</p>

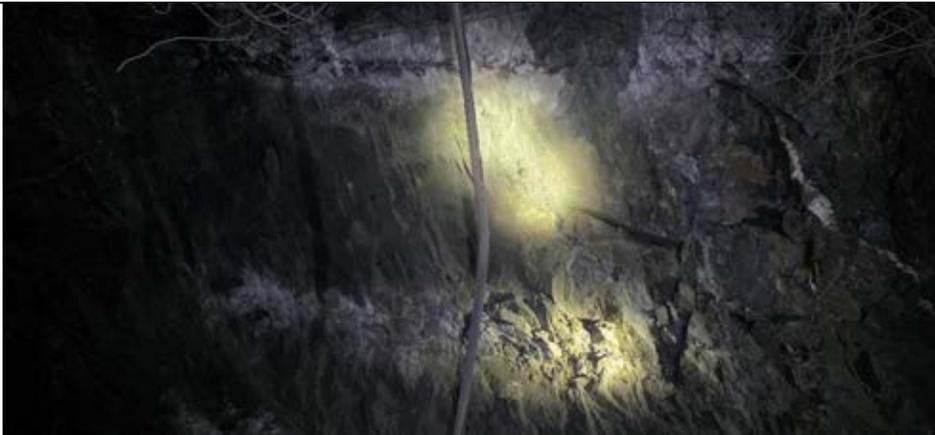
<p><b>PHOTO 3</b> Location: 2795-slab Type: Development</p> <p>Crushing around borehole boots indicating proper detonation</p>

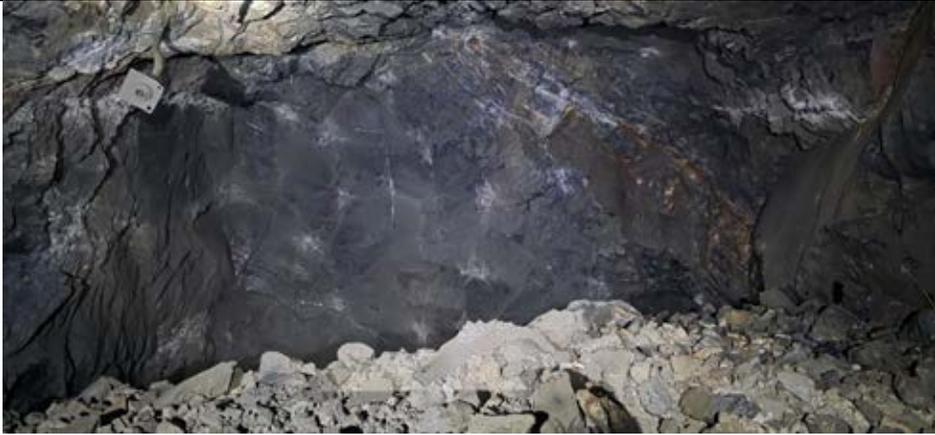
<p><b>PHOTO 4</b> Location: 2795-1  Type: Development  Crushing around borehole boots indicating proper detonation</p>

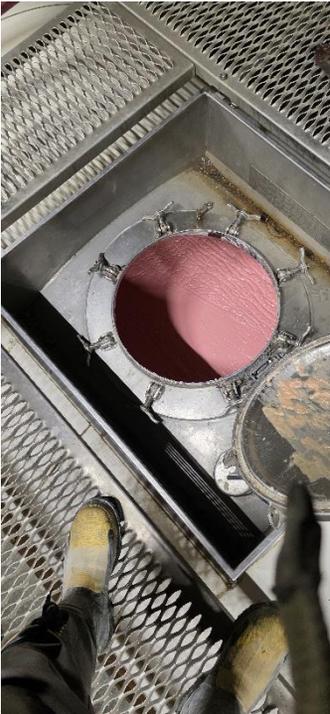
<p><b>PHOTO 5</b> Location: Emulsion Magazine Type: Tank  Homogenous Mixture displayed</p>

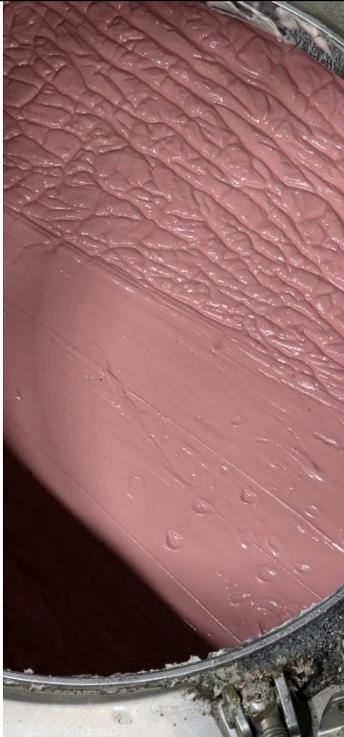
<p><b>PHOTO 6</b> Location: Emulsion Magazine Type: Tank</p> <p>Homogenous Mixture displayed</p>
