PEBBLE PROJECT

2021 Reclamation Report

MLUP No. 6118

DECEMBER 2021

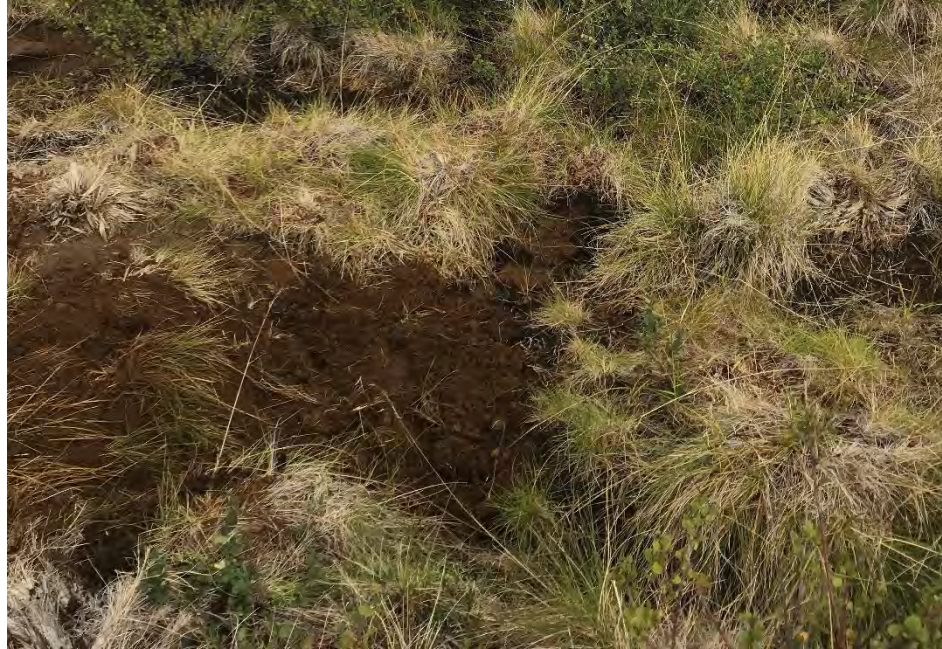
1. Borehole 4209

Borehole previously plugged to surface. Above-ground casing removed in 2021.

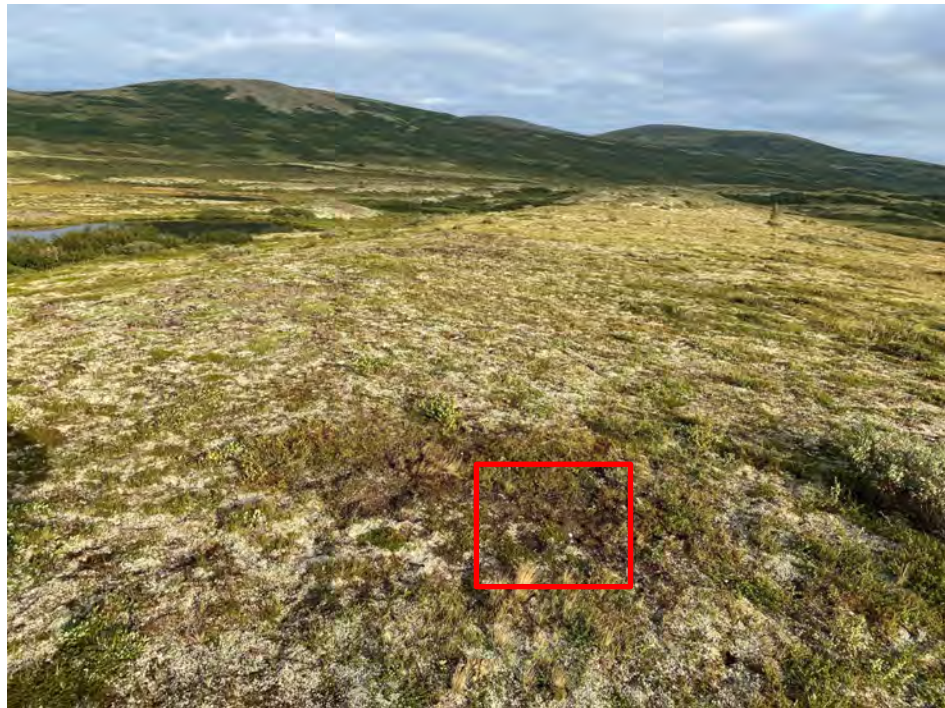
2. Borehole 4210

Post-closure.
