DIVISION OF MINING, LAND AND WATER

## Field Inspection of the Pebble Copper/Gold Project

July 26-27, 2007

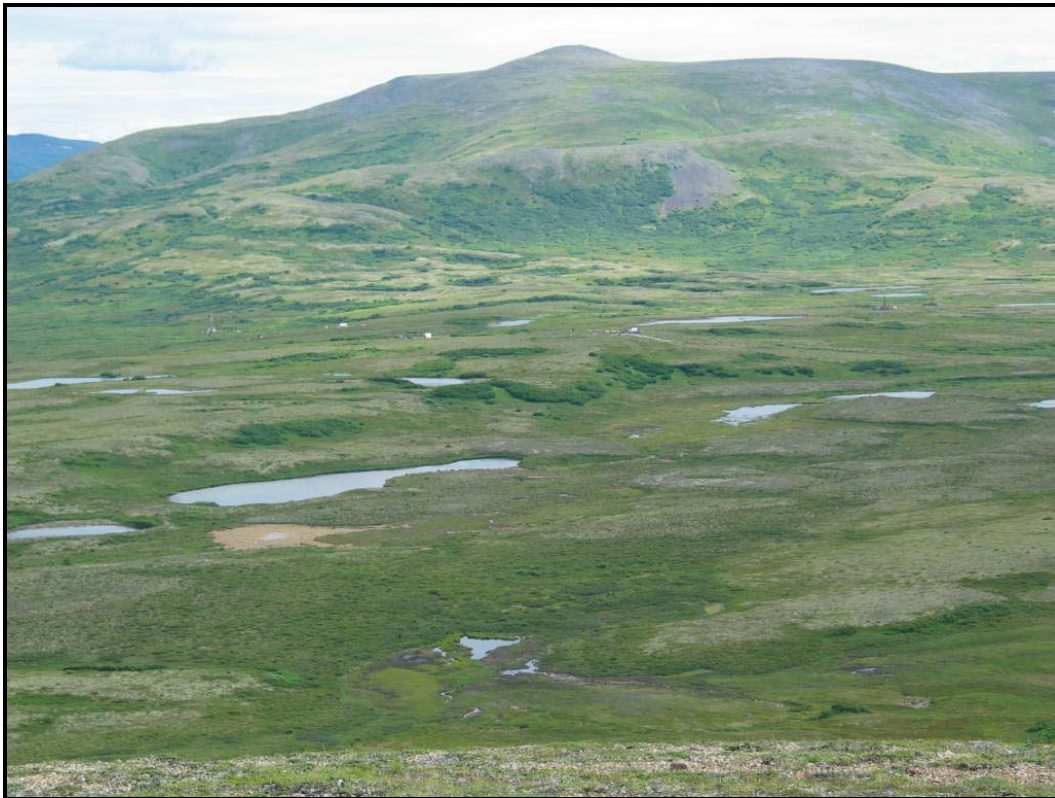
Photo #1. View from west side of the Pebble Deposit, looking east across the valley.

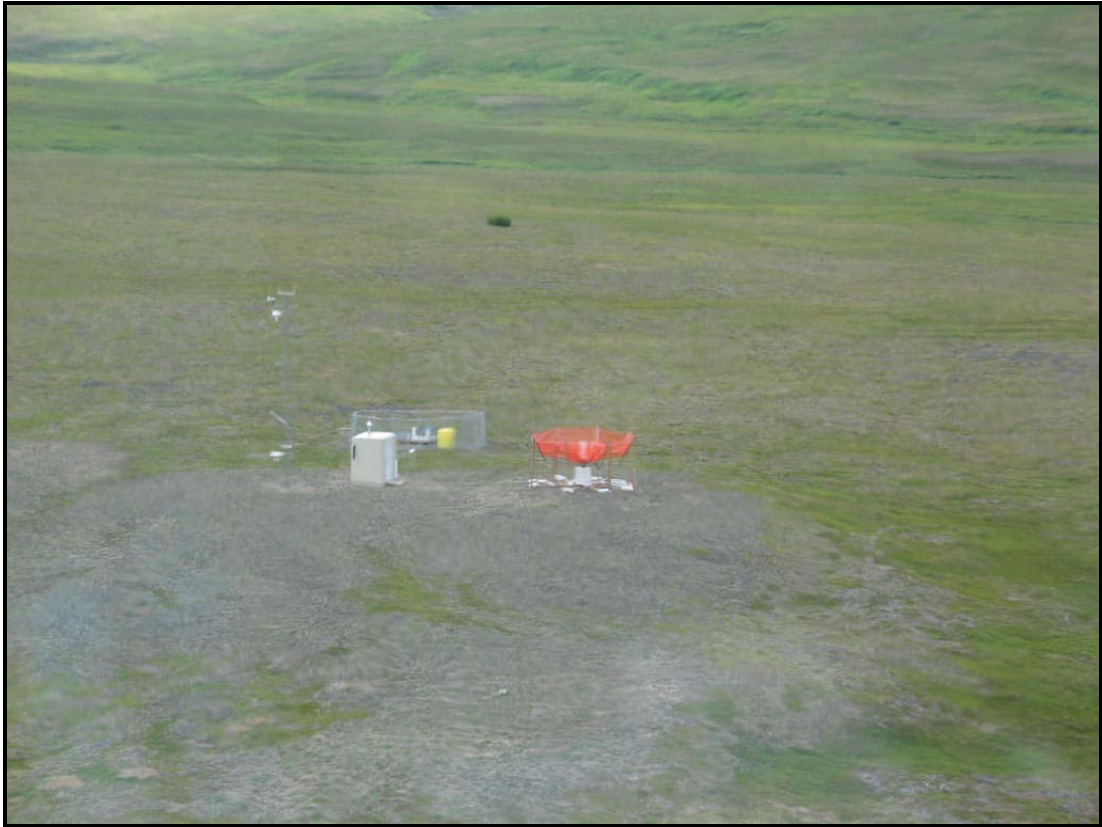
Photo #4. Weather station on ridge at proposed millsite. Drainage in the background is within the proposed tailings pond.

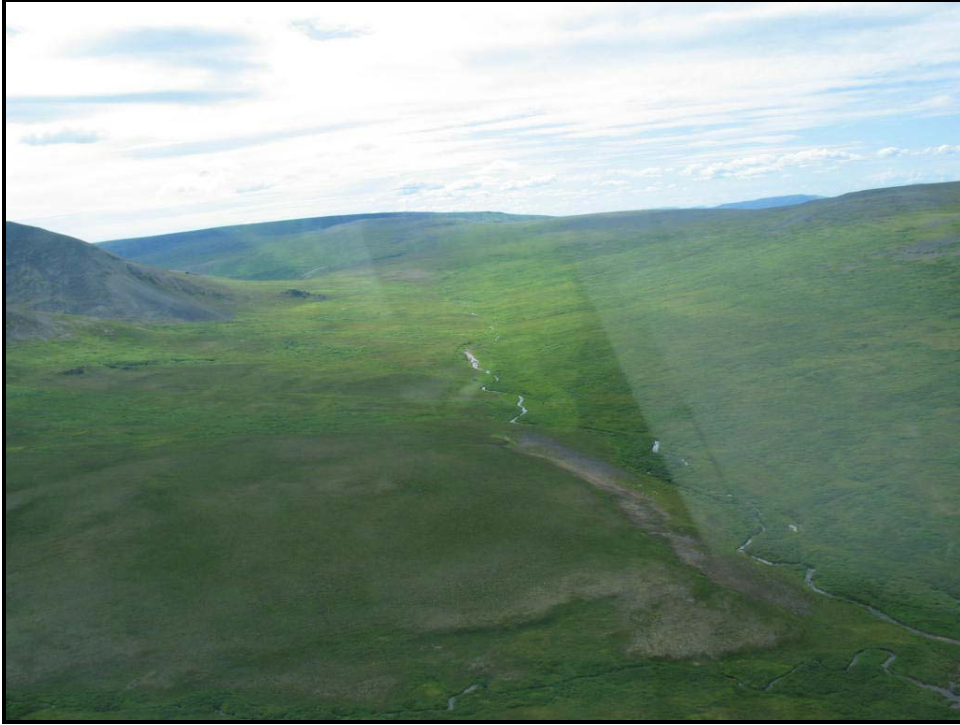
Photo #5. Aerial view looking south up the drainage where tailings pond is planned. A second dam would be required, probably somewhere around the curve in the distance.

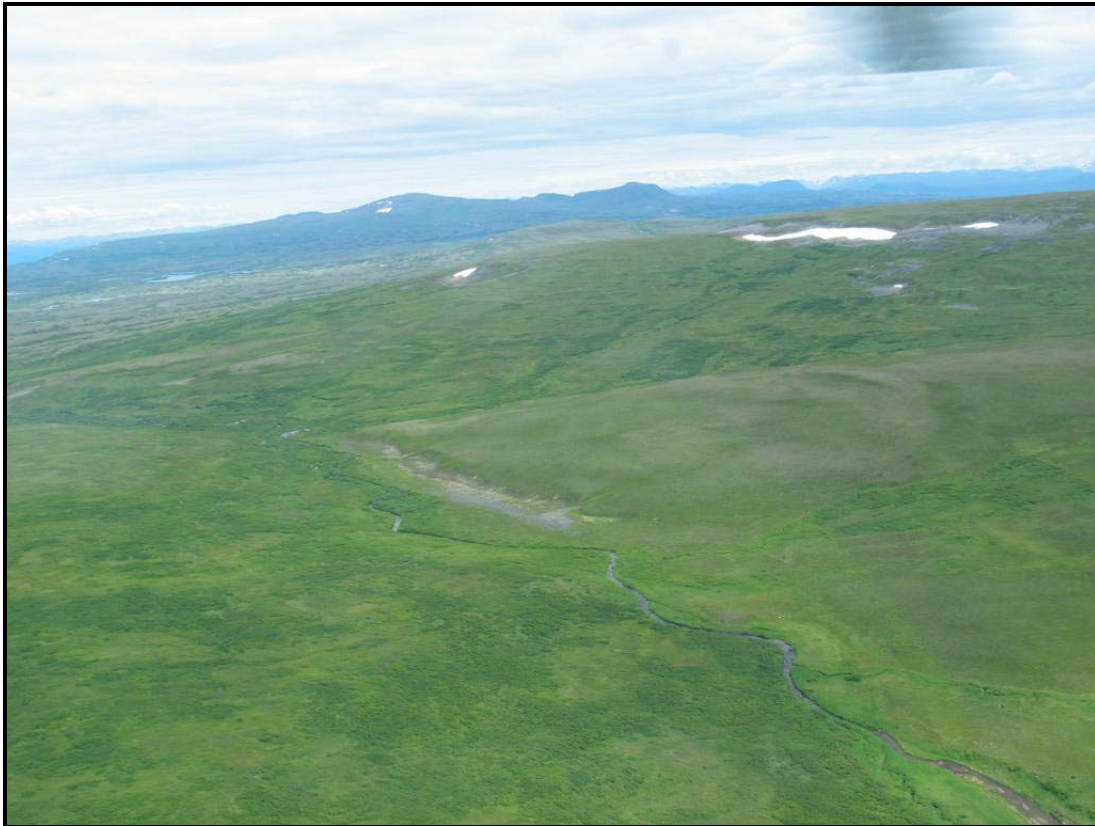
Photo #7. North end of the proposed tailings pond area. The dam would be in the middle distance, approximately where the ridgeline steepens to the left.

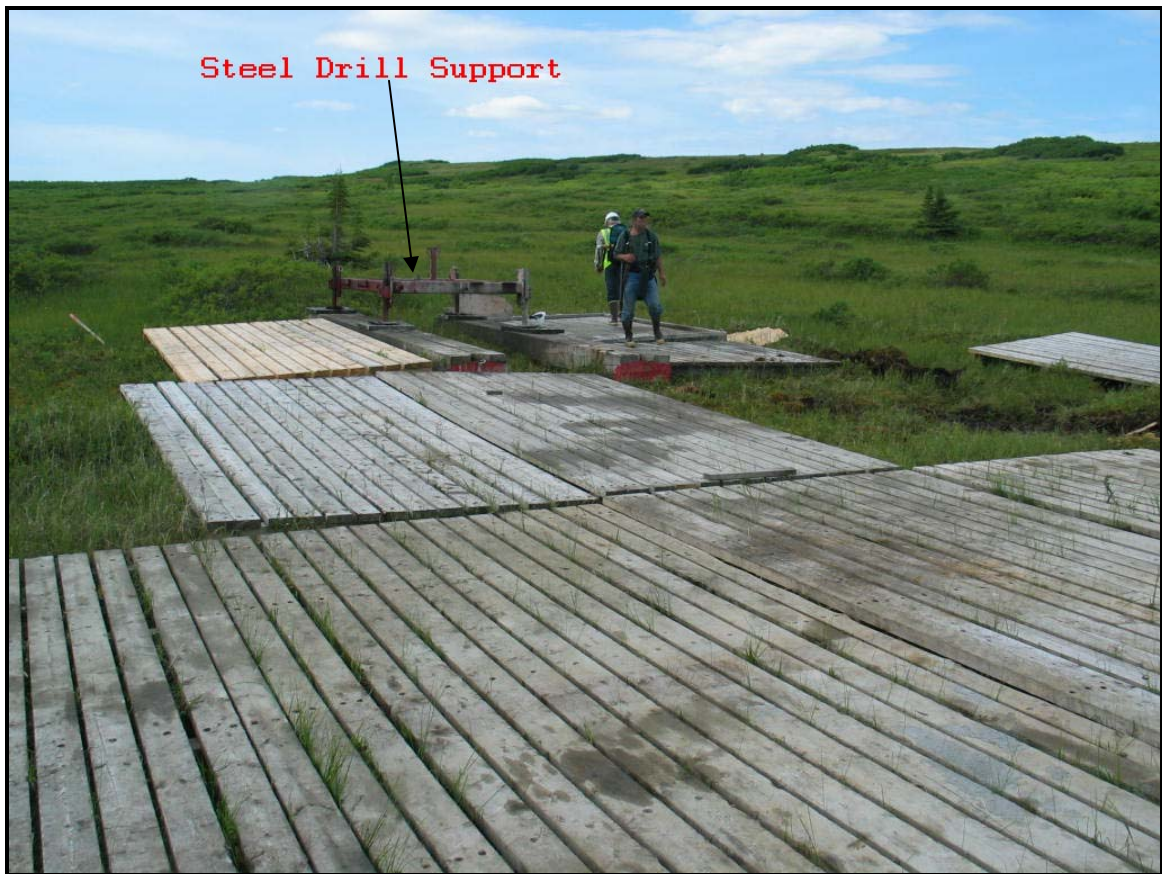
Photo #11. New drill site ready for the drill.

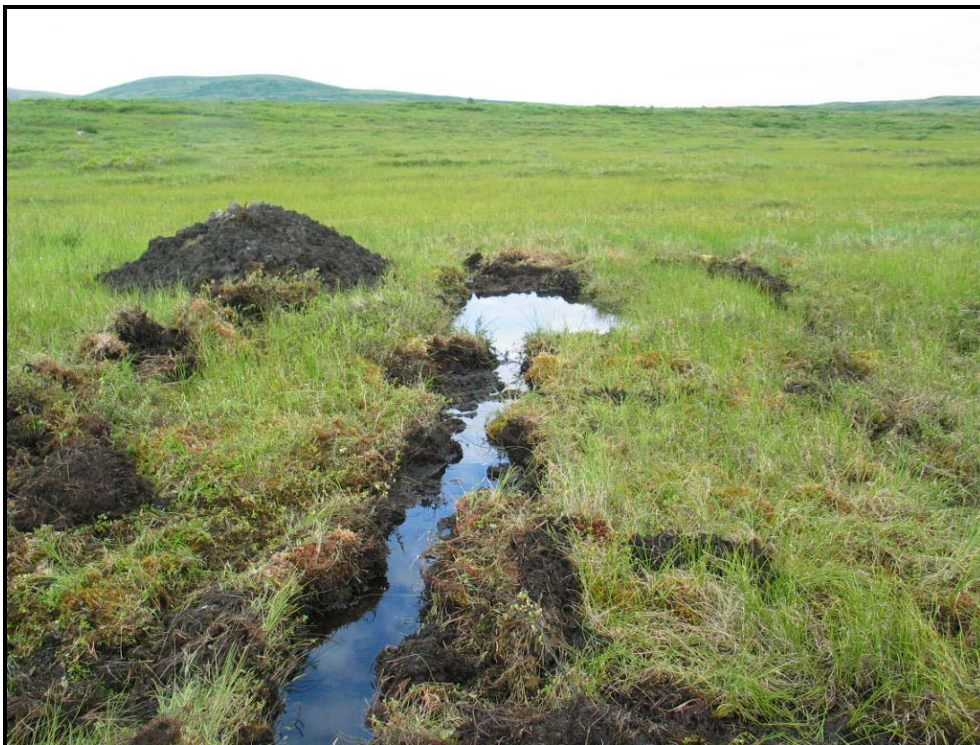
Photo #12. Drainage ditch and sump at new drill site.

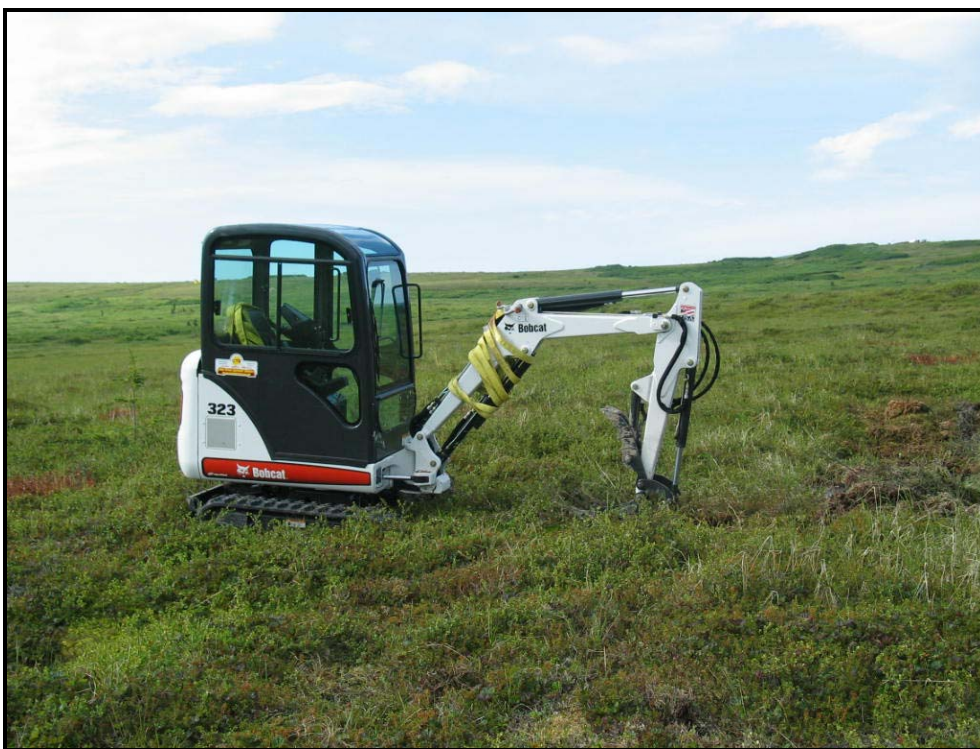
Photo #13. Small backhoe used for digging sumps. The backhoe is air lifted between sites.

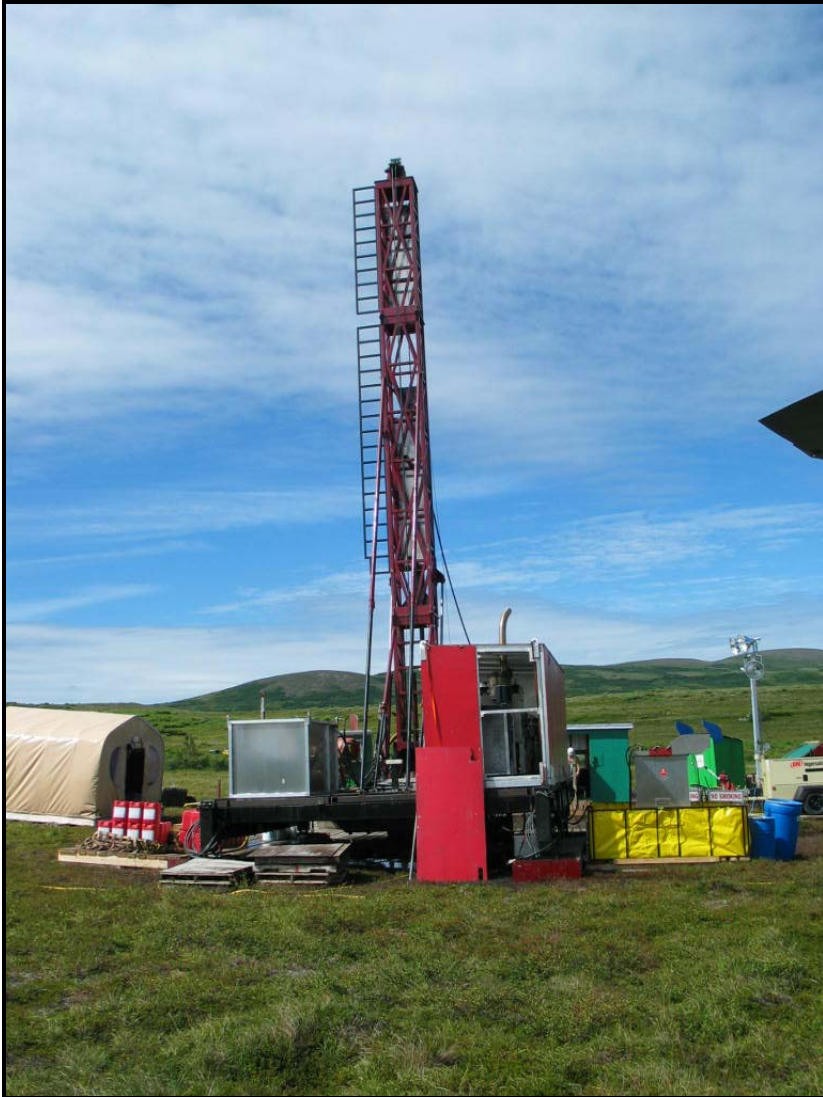
Photo #15. Drill #6.

- Crew quarters, for shelter and safety in the event that weather prevents the helicopters from changing worker shifts. The crews have sufficient food and heating fuel for several days. (Photo #16)
- Storage structure – usually a Quonset hut. (Photo #15, Tan colored structure)
- Tundra matting – discussed above.

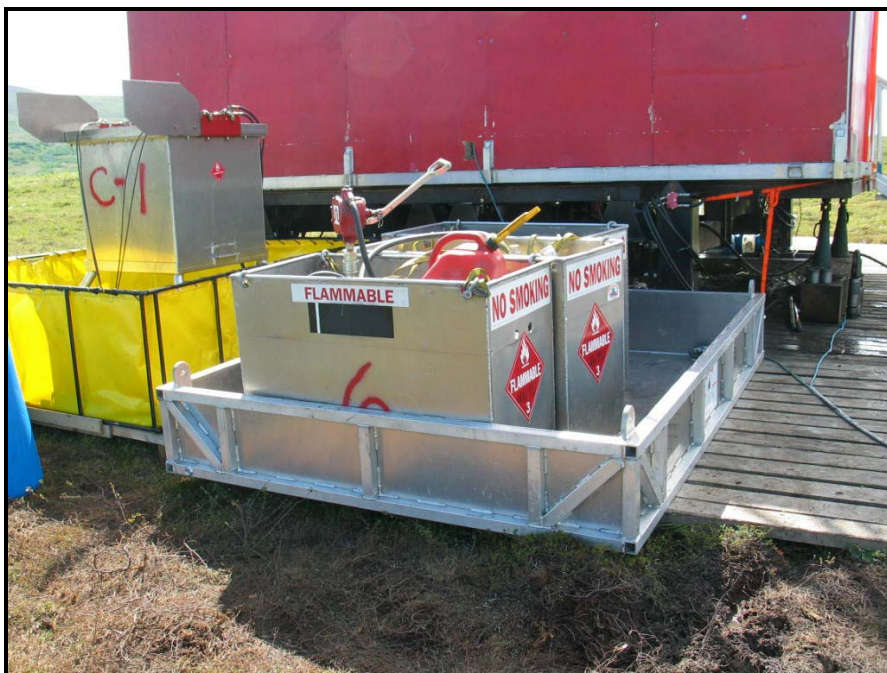
- Fuel is slung to the drills in 118 gallon, double walled aluminum tanks. The tanks are placed in a large, heavy aluminum container, then the fuel is pumped into the main fuel storage tank. The purpose of the aluminum container is to eliminate the risk of tearing the plastic containment liner. (Photo #17)

Photo #17. Double walled, 118 Gal. fuel transport tanks in aluminum containment.

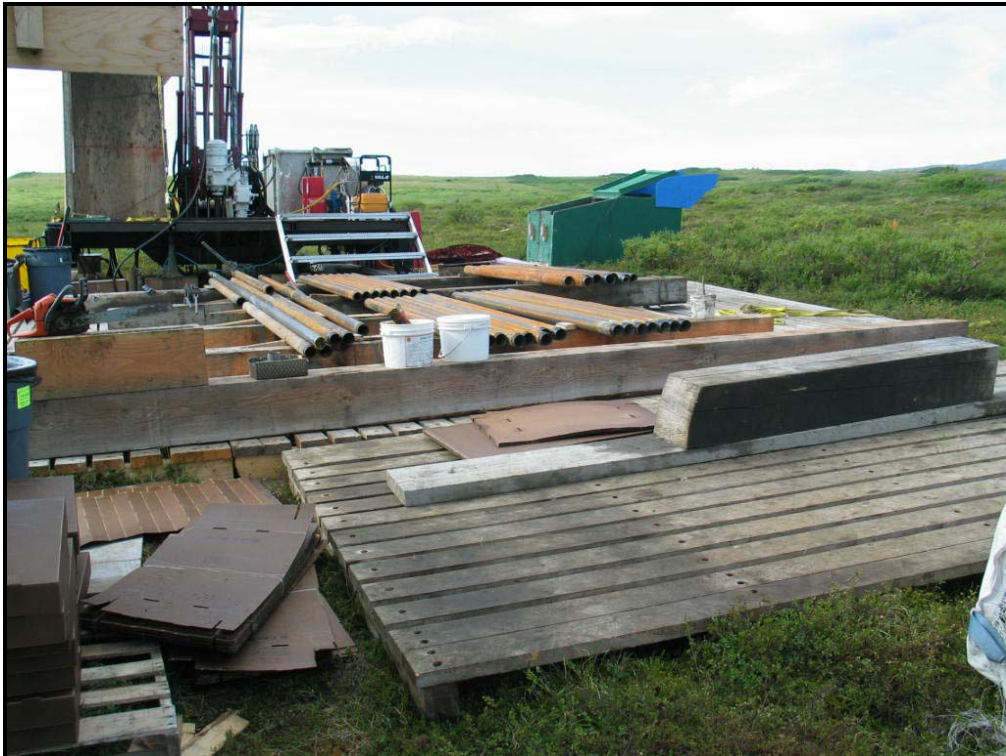
Photo #21. Drill #7.

Drill #7 (See photo #21) was operating in a lowland about 300 yards south of Upper Talarik Creek, close to a wetlands. The drilling return was being pumped about 150 yards up hill away from the wetland. The water seeps into the ground over a short distance. (See photos #24-26.)

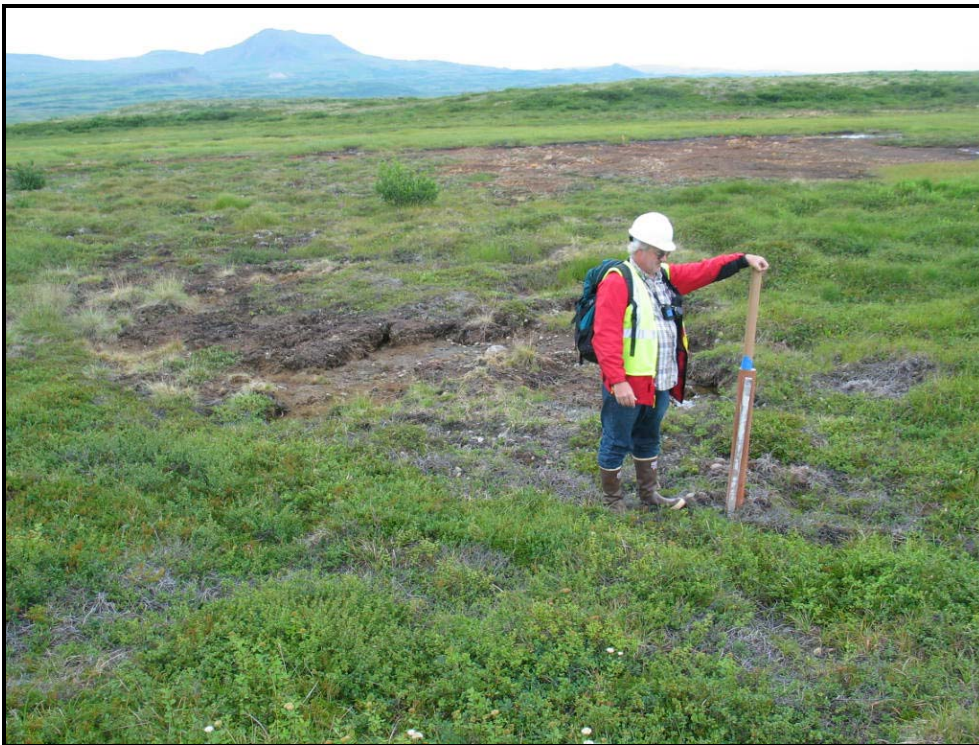
Photo #34. Jeff Rogers of DMLW at DDH 4214. Metal oxides associated with the discovery outcrop can be seen in background.

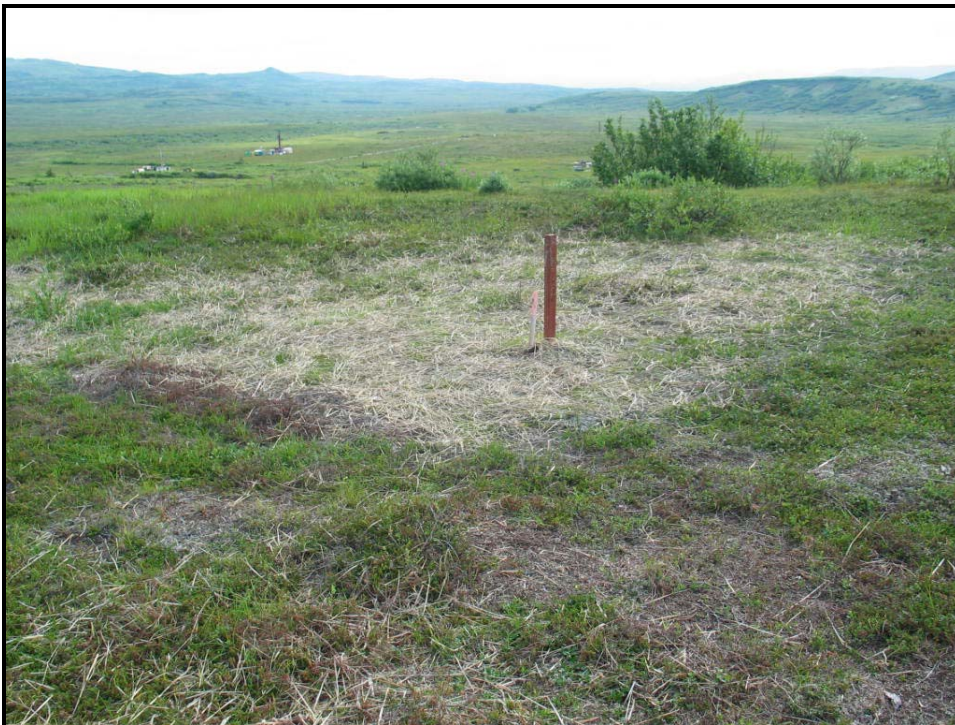
Photo #40. Reclamation at DDH 7362.

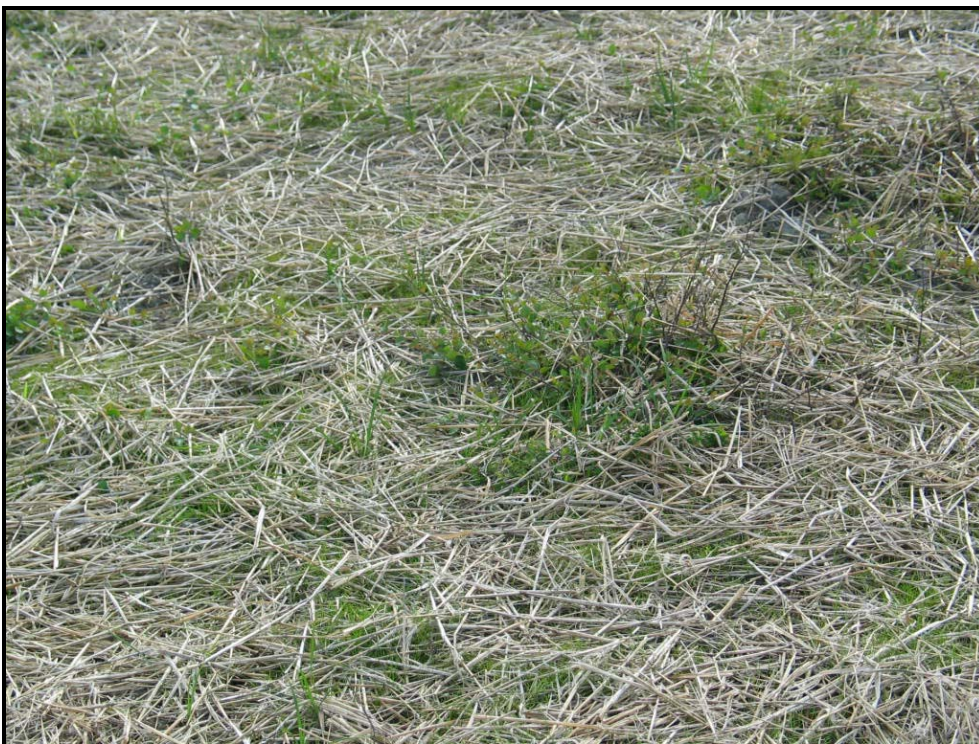
Photo #41. Reclamation at DDH 7362.

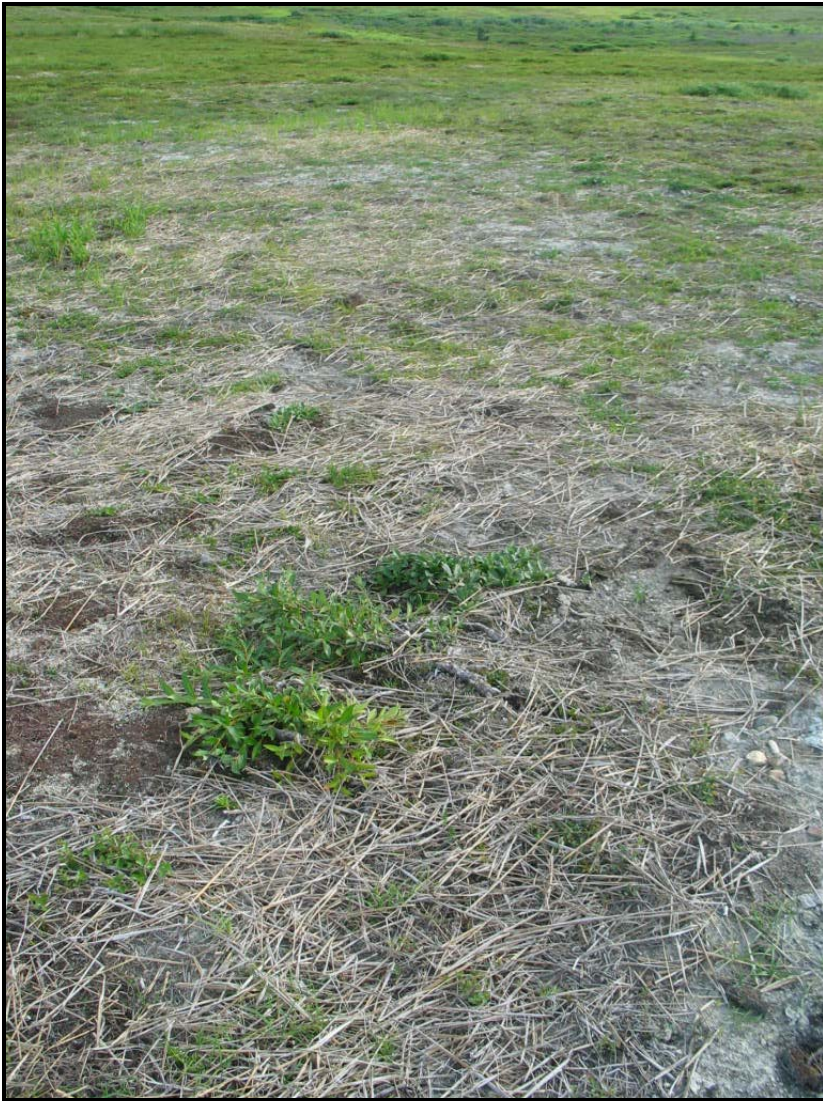
Photo #43. Reclamation at DDH 7361

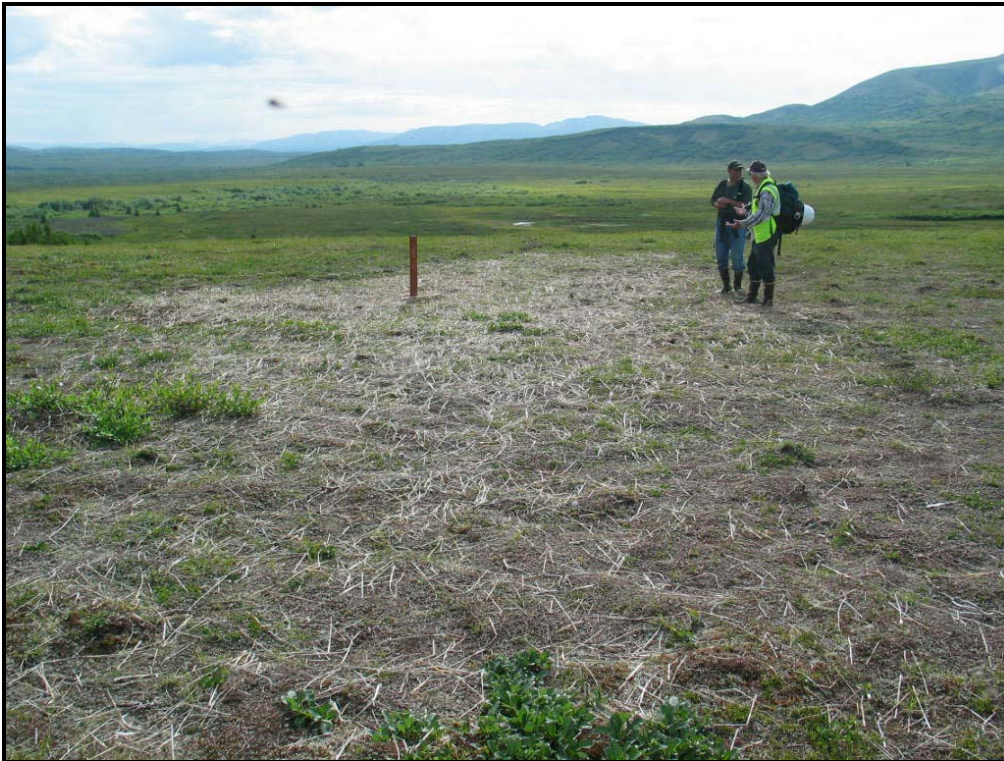
Photo #44. Reclamation at DDH 7367

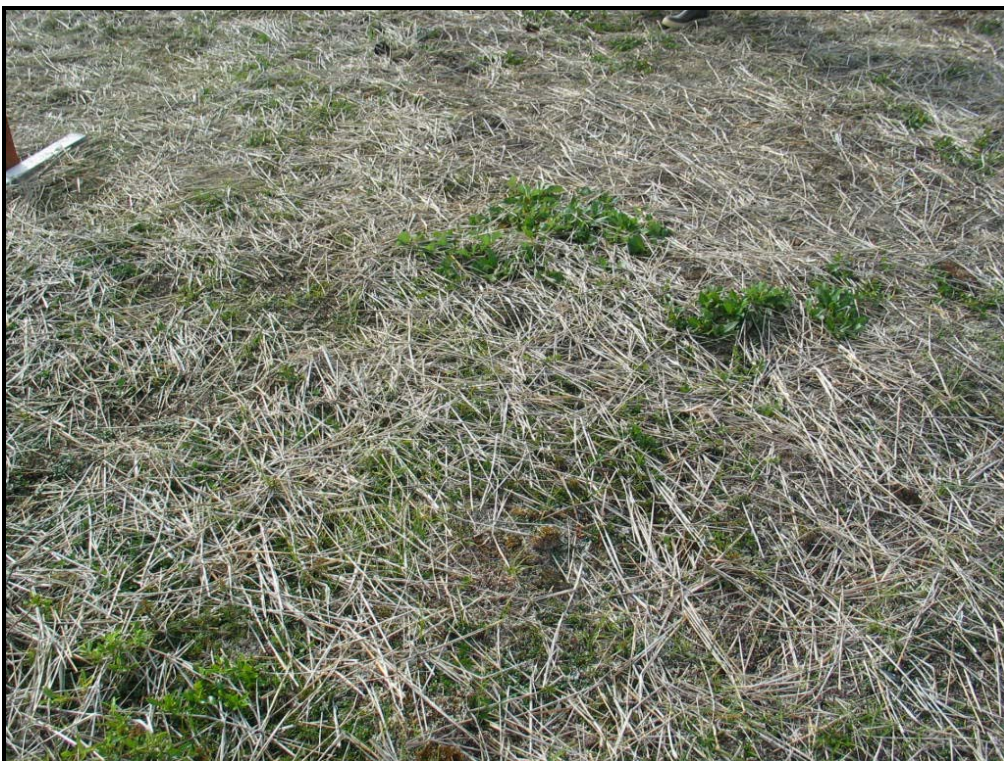
Photo #45. Reclamation at DDH 7367

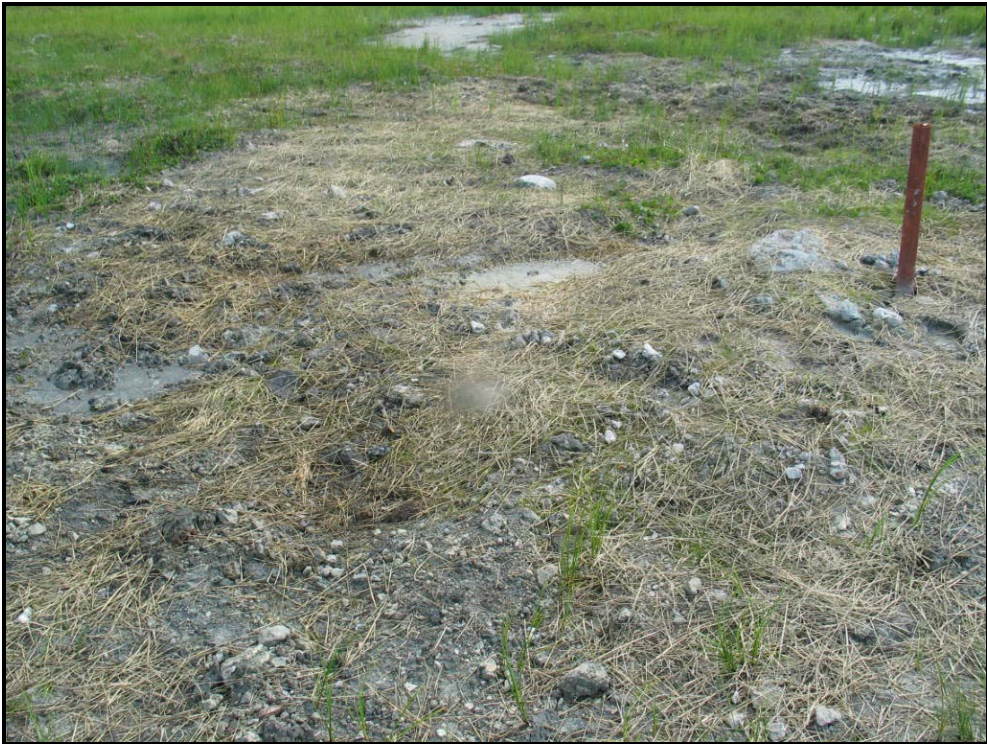
Sumps could not be dug for some of the holes drilled this past winter and spring (fewer than 10) because the ground was frozen. (See photos 46 and 47 in Part II of this report.) Cuttings and drilling fluids from these holes were discharged directly onto the ground. This is a customary practice, and is generally allowed. However, Lena Brommeland, of Northern Dynasty, has informed me that they are currently working to identify drill locations for the coming winter and dig appropriate sumps in advance. This should result in few, if any holes having their cuttings deposited directly onto the tundra.

Photo #47. Reclamation at DDH 7358

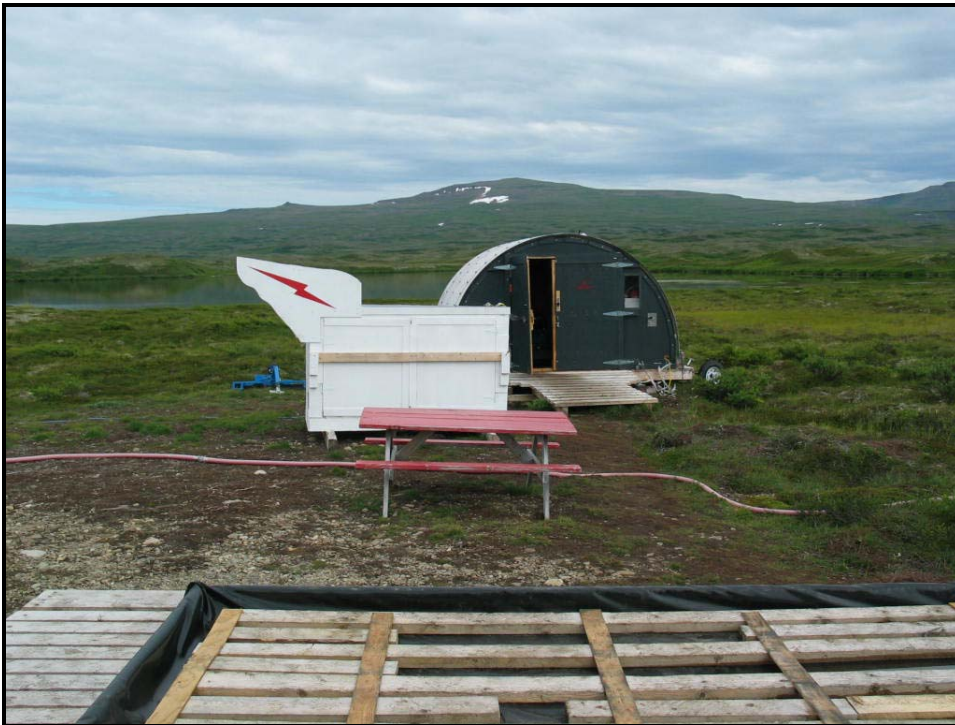
Photo #51. Quonset hut and white container filled with spill materials. Big Wiggly Lake is in the background.

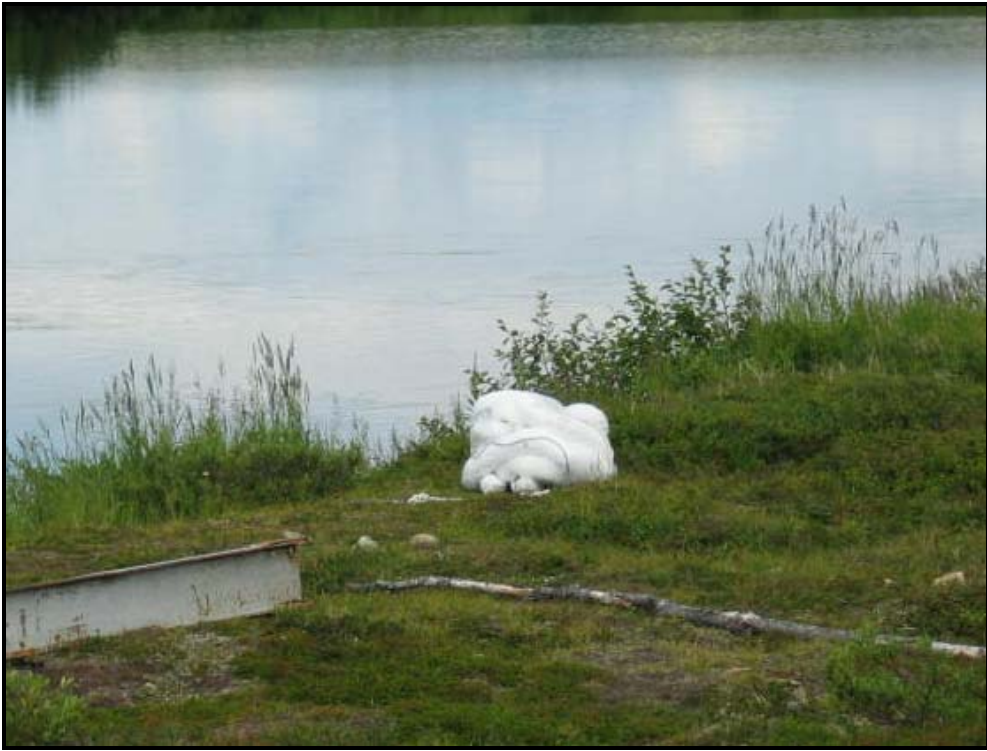
Photo #52. One of two float booms for containing fuel spills on Big Wiggly Lake.

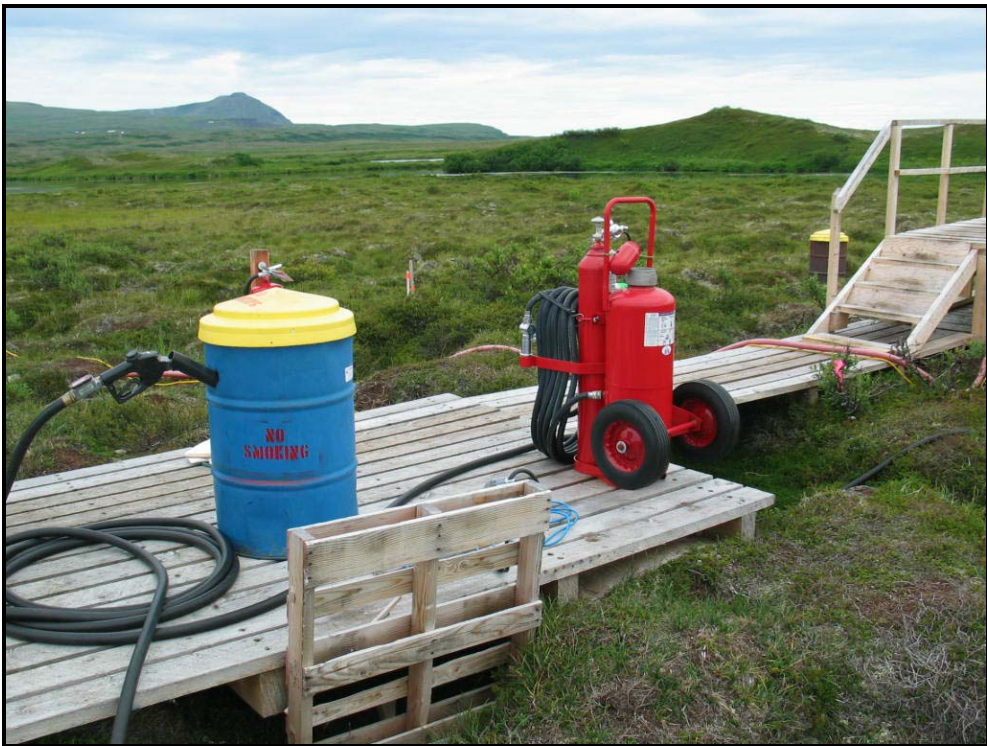
Photo #53. Large fire extinguisher at Big Wiggly fuel storage facility.

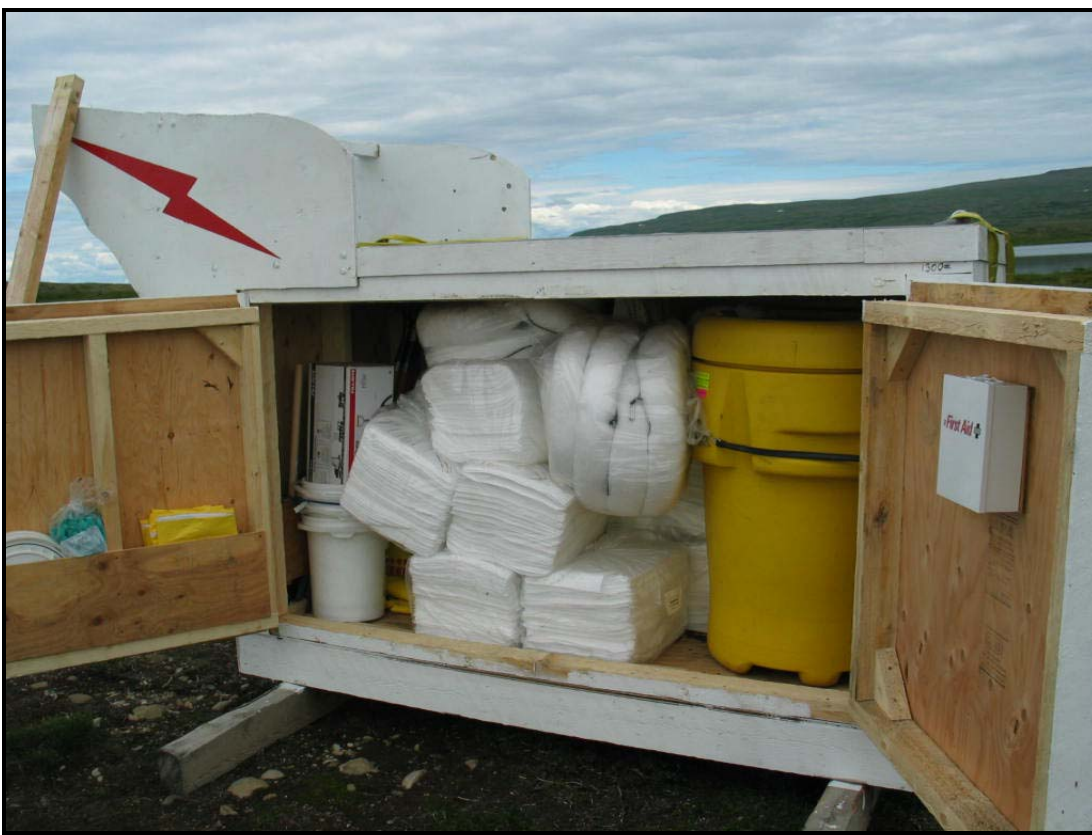
Photo #54. White container full of spill equipment. A first aid kit is on the door to the right.

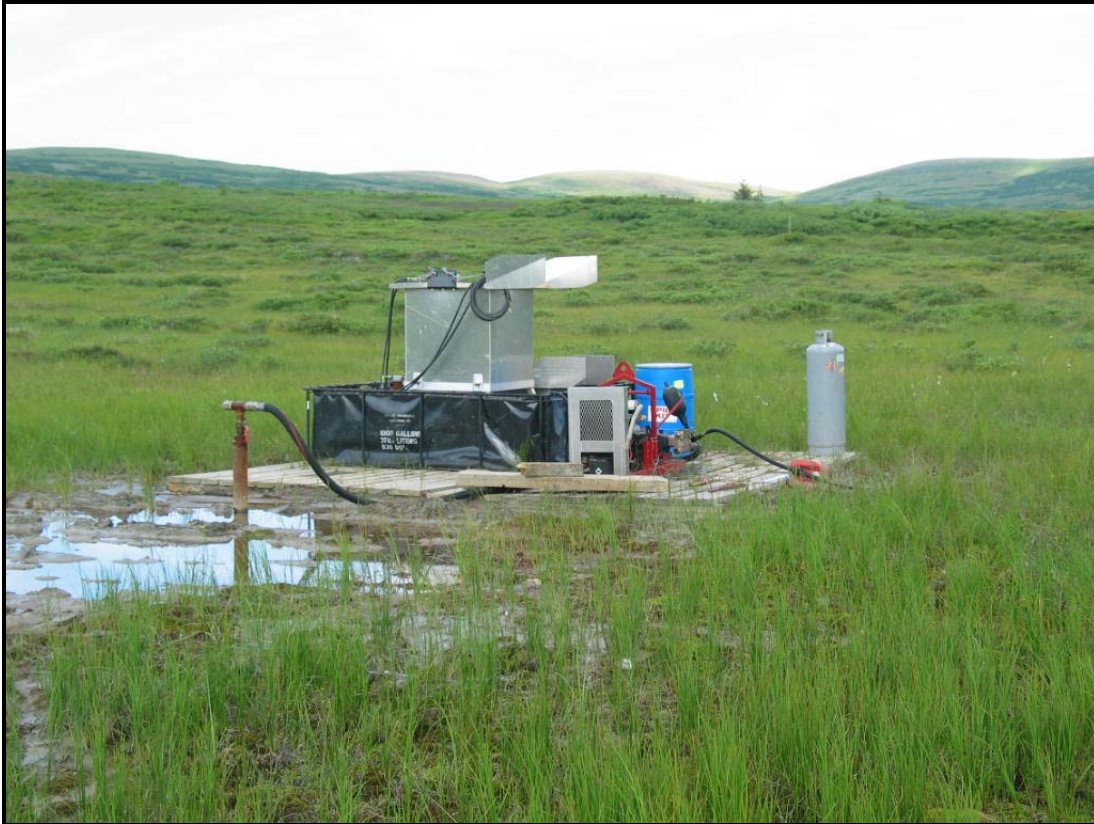
Photo #56. Water pumping facility taking water from a recently drilled hole.

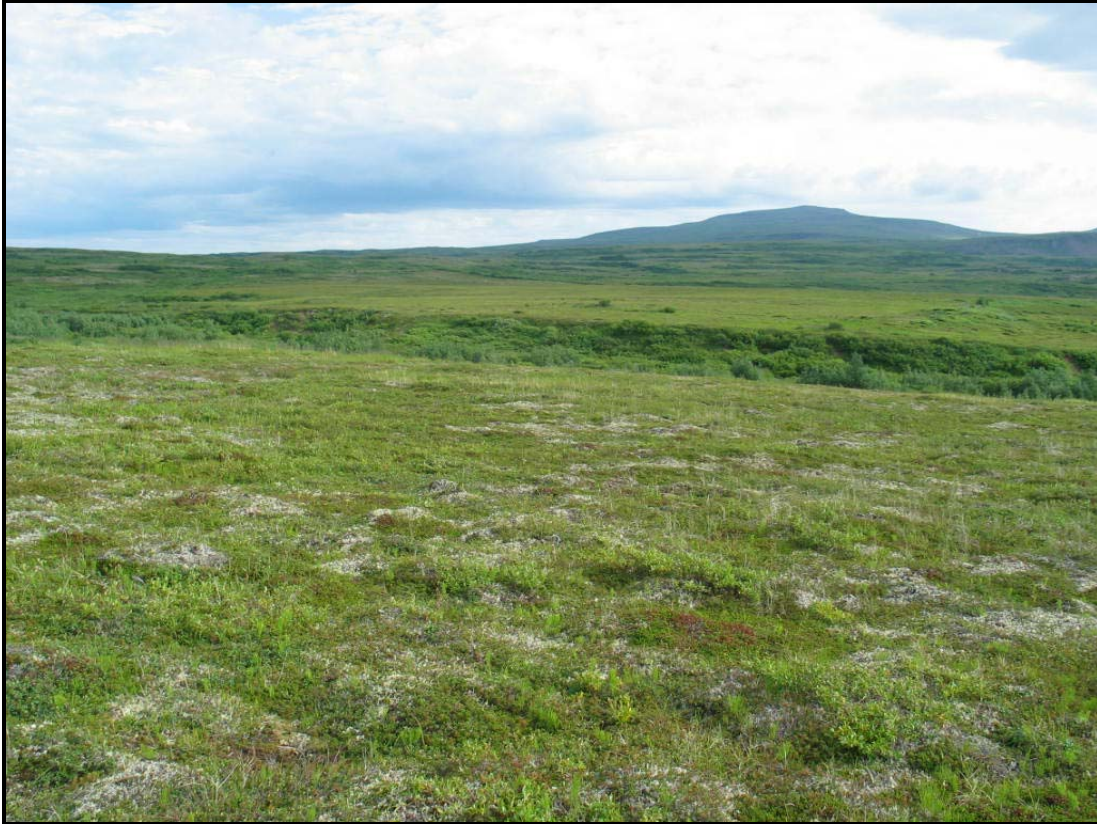
We spent part of the second day walking the Upper Talarik Creek area. We walked down to the creek near where its uppermost tributaries come together. We generally followed the drainage downstream for roughly a half mile, past the area of the May spill. (See photos #59-61.) We saw no inappropriate substances, such as diesel fuel or drilling fluids, in or near the creek. We did not see any fish or large wildlife. There were, however, obvious signs of beaver activity. (See photo #61.)

Photo #59. Uppermost Upper Talarik Creek drainage.

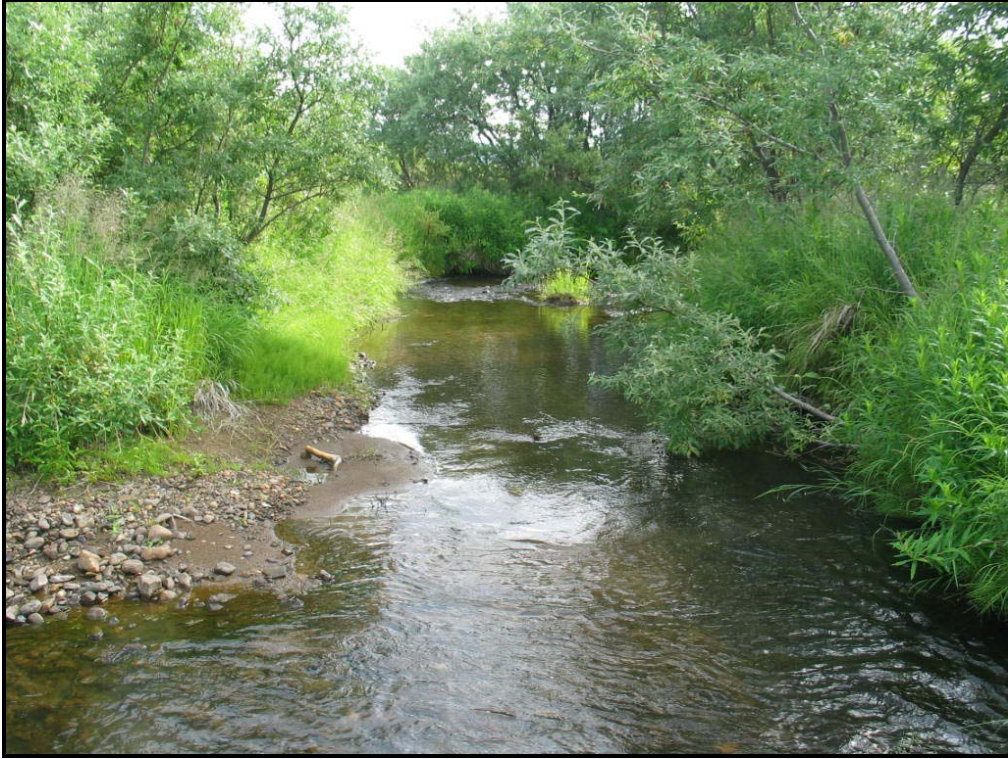
Photo #60. Upper Talarik Creek.

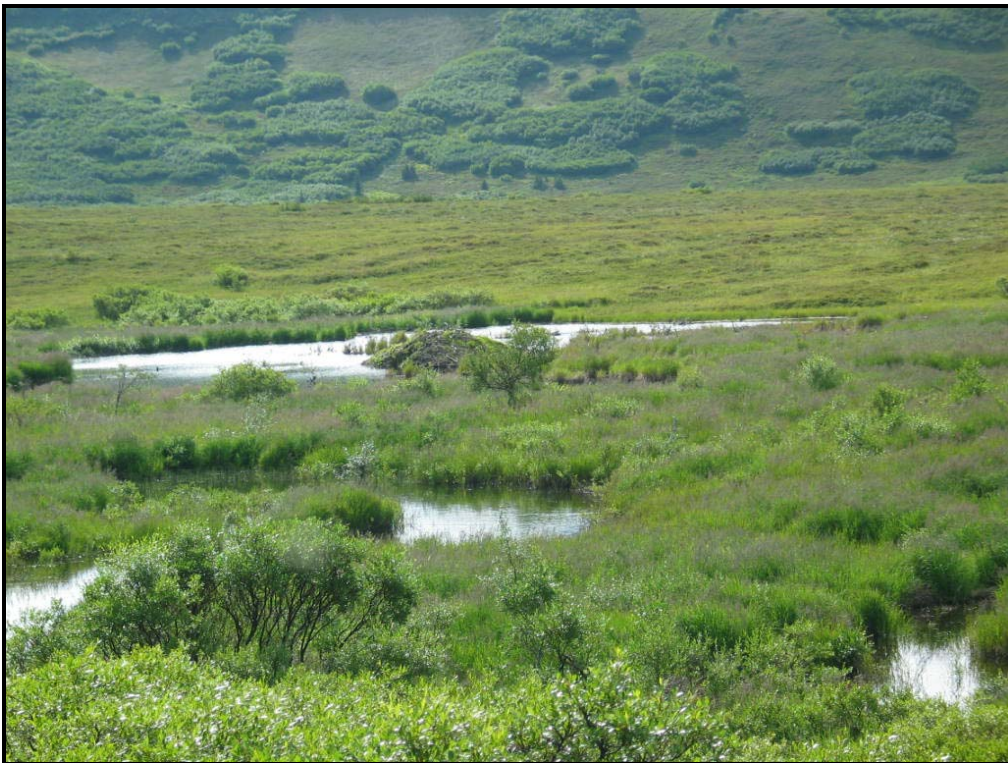
Photo #61. Beaver lodge and dam on Upper Talarik Creek.

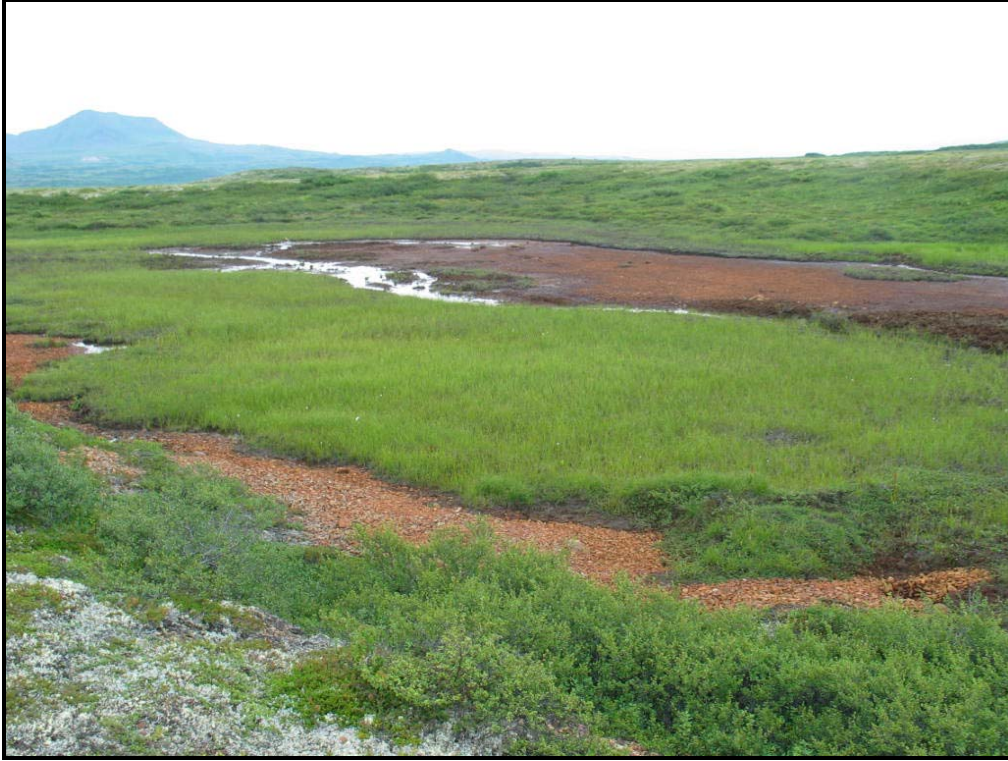
For the most part, the Pebble mineralization does not crop out at the surface, but there is a discovery outcrop located in a wetland area over the West Orebody. It is about 200 yards north of the old exploration camp which is now being used for storage. (See photos #62 and 63.) This outcrop was first sampled by Phil StGeorge of Tec Cominco in the early 1980's. There is heavy iron oxide staining on colluvium over a north-south trending wetland for several hundred feet. (See photos #64 and 65.) There is a small area of broken outcrop toward the south end of the metal oxide stained area. The rock is heavily silicified and veined, with strong clay alteration as well. There are a lot of iron oxides after sulfides, with some cavities after sulfide minerals. (See photo #66.)

Photo #63. Discovery outcrop and wetland.

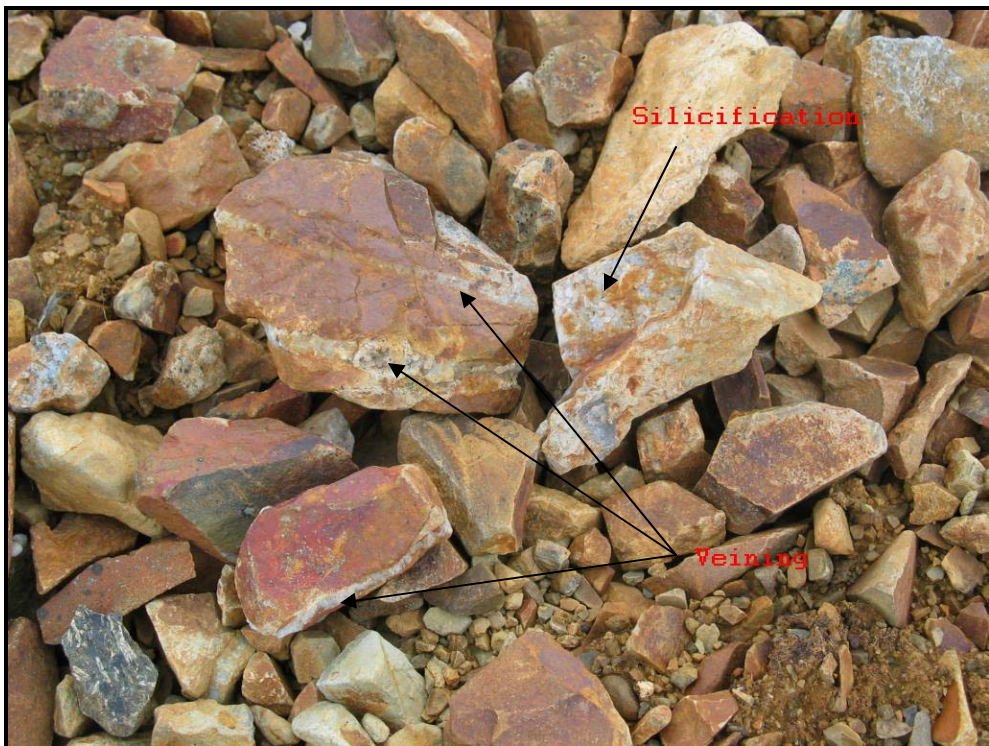
Photo #66. Alteration and veining in outcrop.
