DIVISION OF MINING, LAND AND WATER

## Field Inspection of the Pebble Copper/Gold Project

July 26-27, 2007

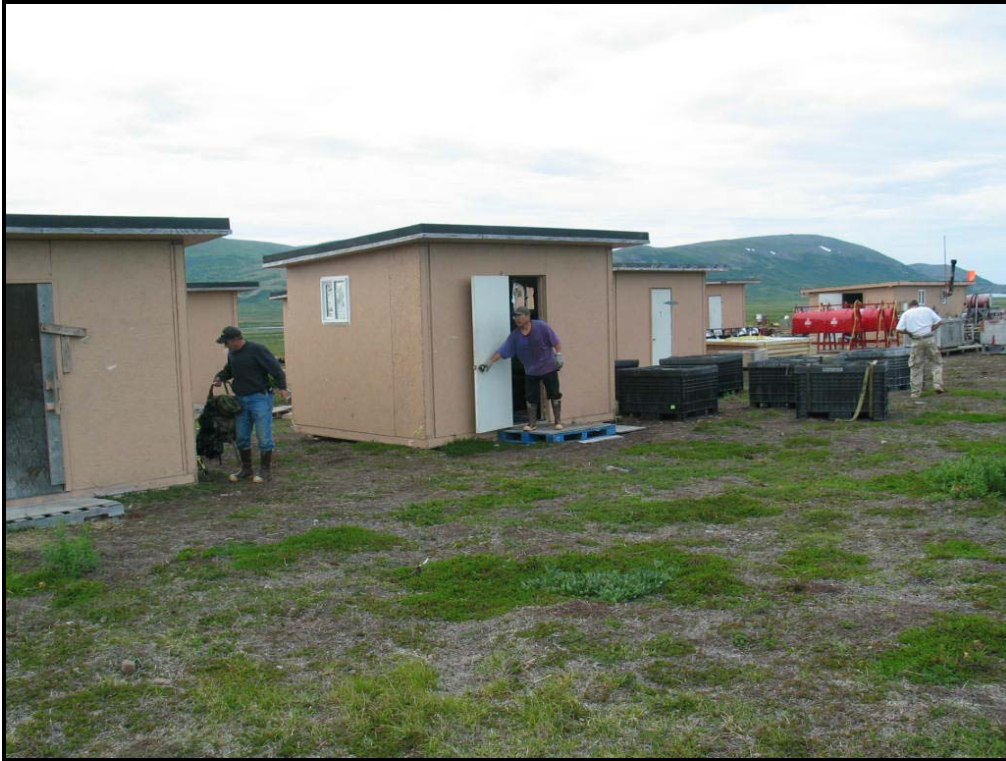
We briefly visited the old exploration camp which is now being used for materials storage and as a possible emergency shelter. Northern Dynasty has a lot of materials stored in the old camp, particularly drill steel. The site is quite active, with helicopters slinging equipment in and out regularly. (See photos #68 and 69.)

Photo #68. Old camp and storage facility over West Orebody.

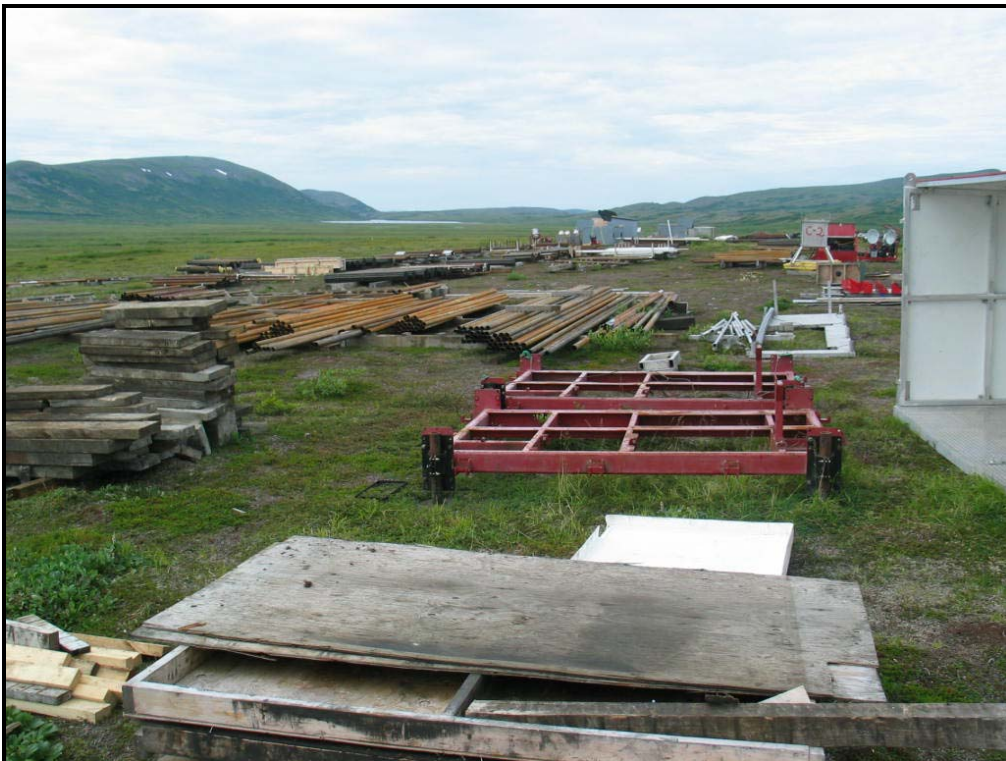
Photo #69. Drill steel stockpiled at old camp.

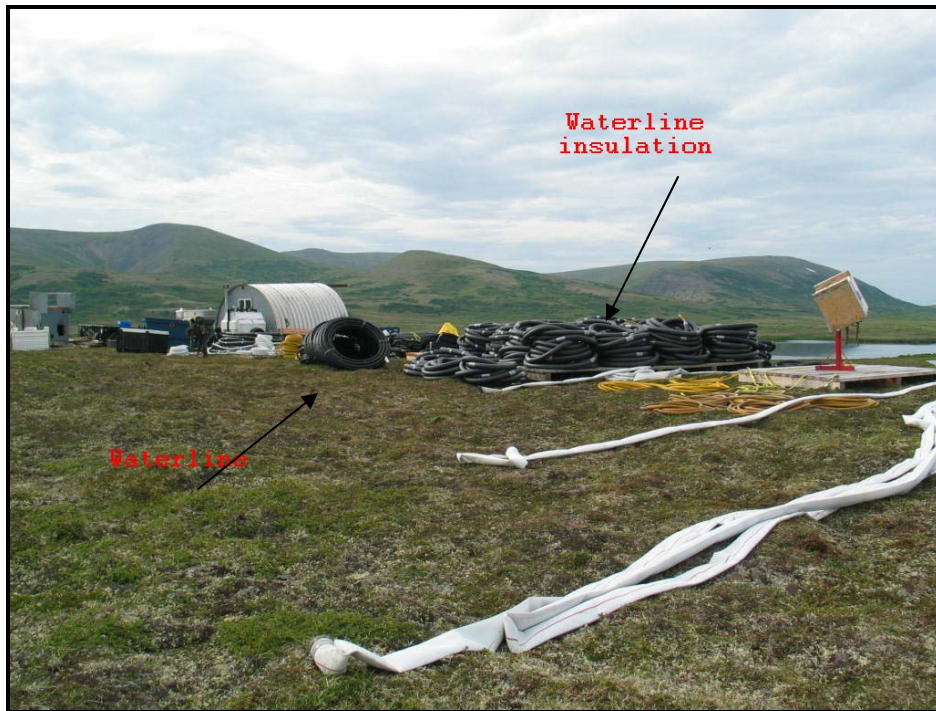
Photo #70. Waterline storage area.
