## RED DOG MINE INSPECTION REPORT

<b>Inspection Date:</b>	July 25 through July 27, 2016
<b>Weather:</b>	July 25: Sunny-overcast, 69 °F; July 26: sunny, overcast 66 °F; July 27: rain, wind 53 °F
<b>Time of Inspection:</b>	July 25 1:30PM to July 27 noon
<b>Operator Contact:</b>	Chris Eckert (Teck Alaska Incorporated)
<b>Agency Personnel:</b>	ADNR – Carolyn Curley
<b>Inspection Objectives:</b>	General Site Inspection and observation of construction activities.
<b>Documentation:</b>	Photos and field book notes may be reviewed at the Northern Regional Office of ADNR

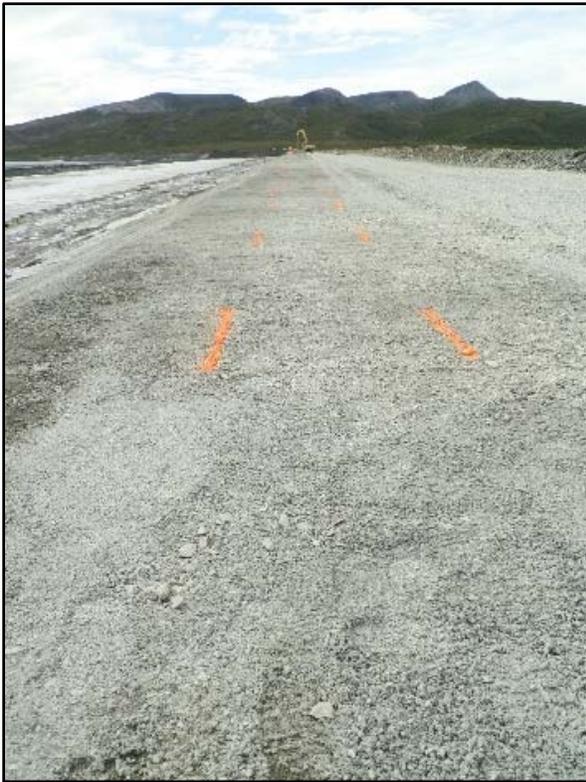
Figure 4: Markings for anchor trench on Red Dog Mine Tailings Main Dam crest. View is looking west.

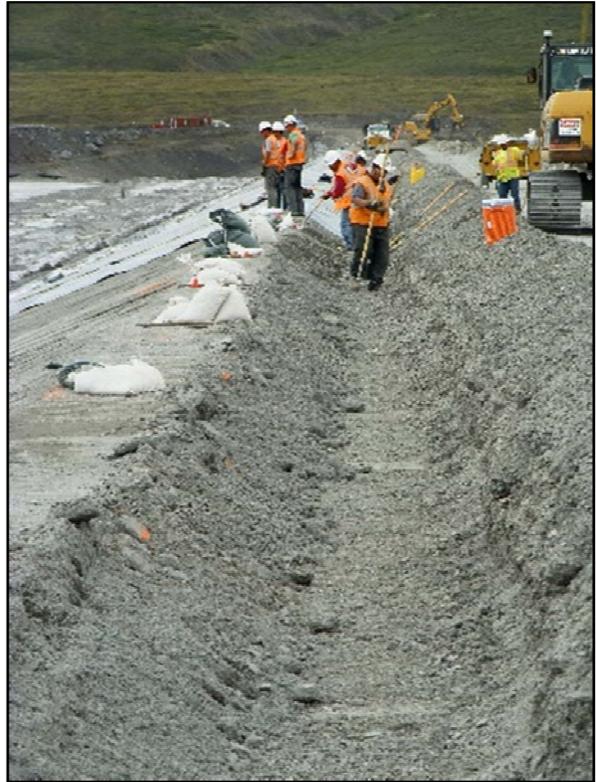
Figure 5: Crew prepares anchor trench for installation of a liner panel.

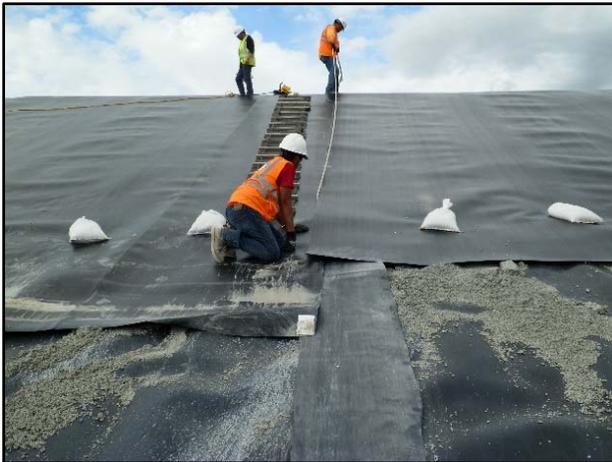
Figure 11: Crew preparing panels 149 and 150 for the seam fusion weld.

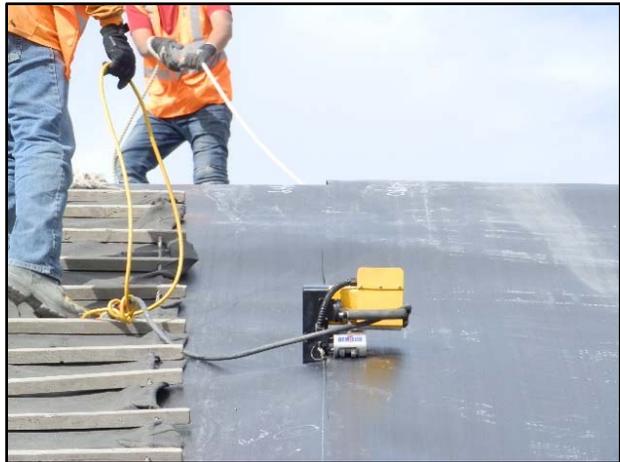
Figure 12: Close-up photo of seam fusion welder.

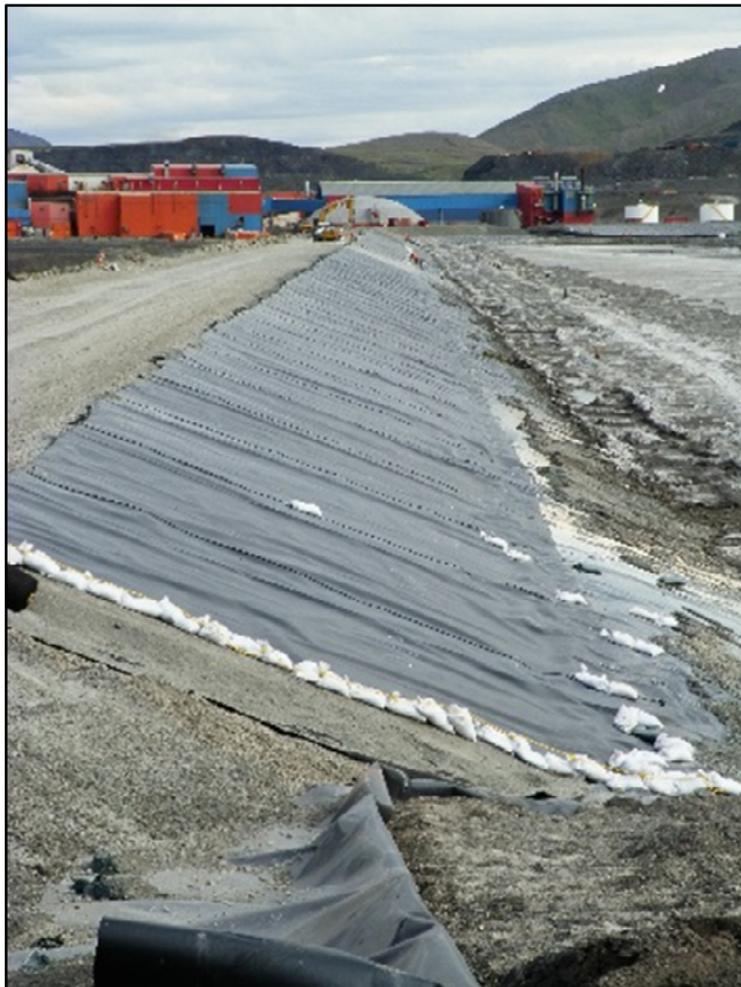
Figure 17: Looking east along the upstream face of the Red Dog Mine Tailings Main Dam.

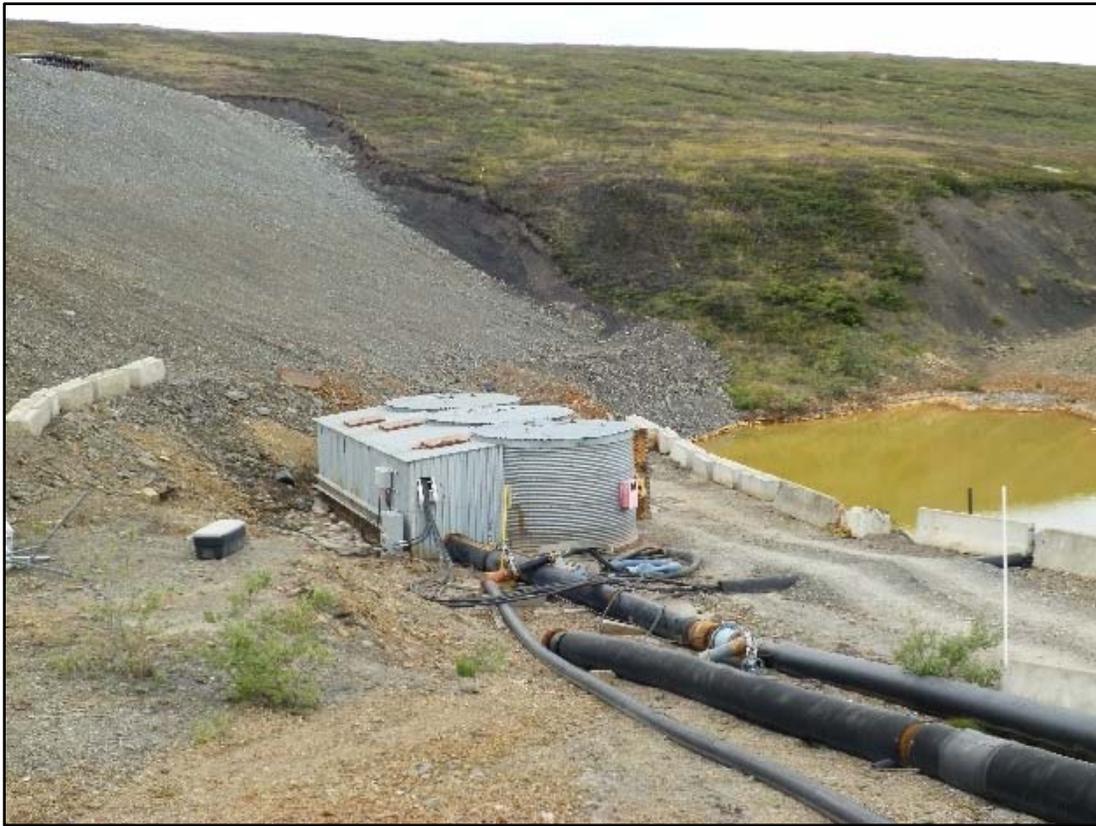
Figure 20: Seepage pumpback system and pond downstream from Red Dog Mine Tailings Main Dam.

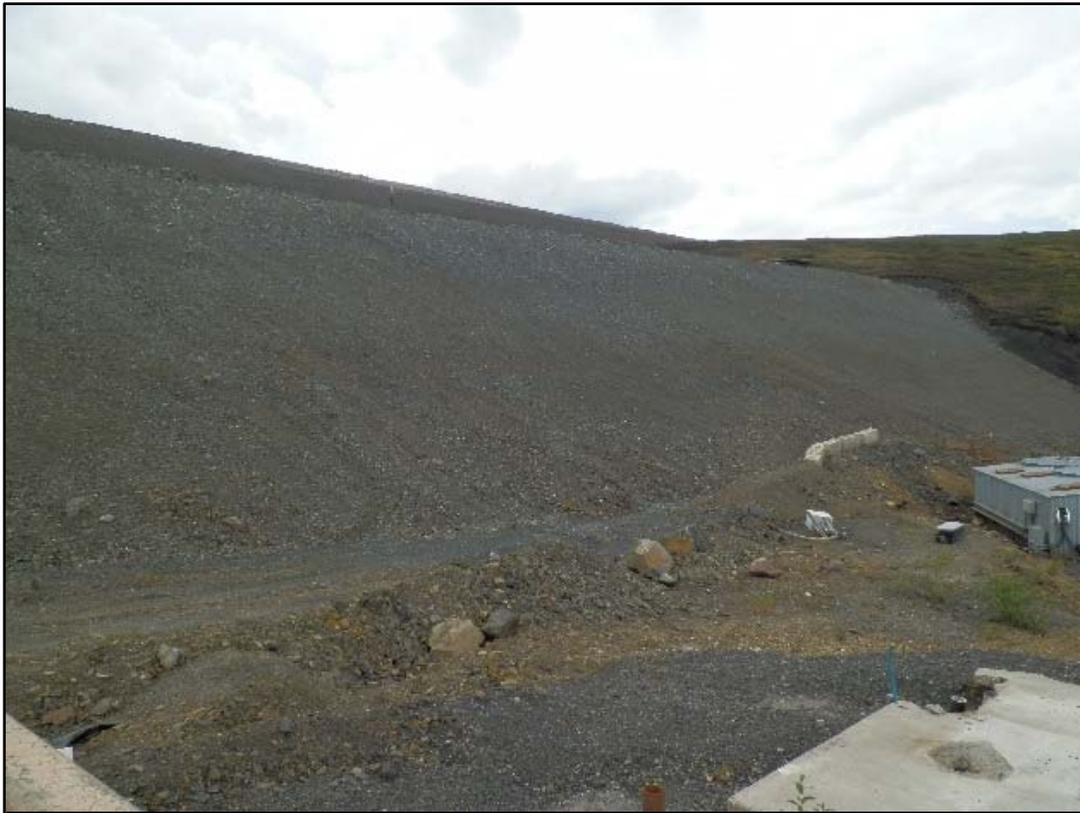
Figure 22: Red Dog Mine Tailings Main Dam, west side downstream face.

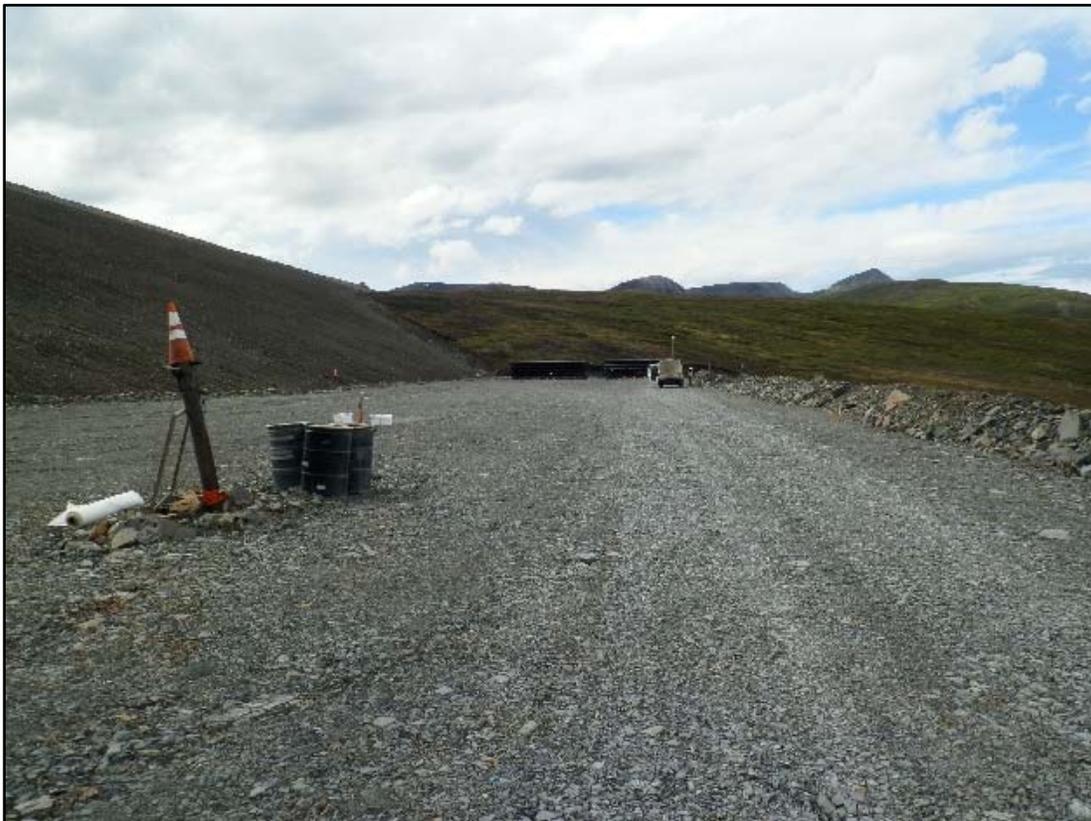
Figure 23: Monitoring station on Red Dog Mine Tailings Main Dam downstream face looking to the west.

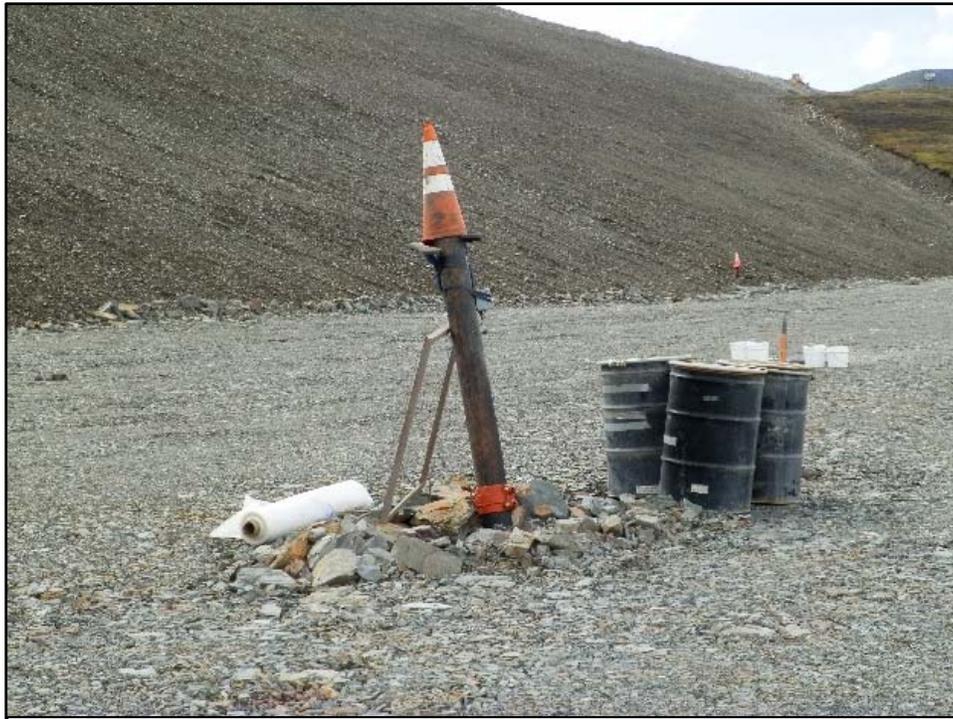
Figure 24: Close-up view of monitoring station set-up.

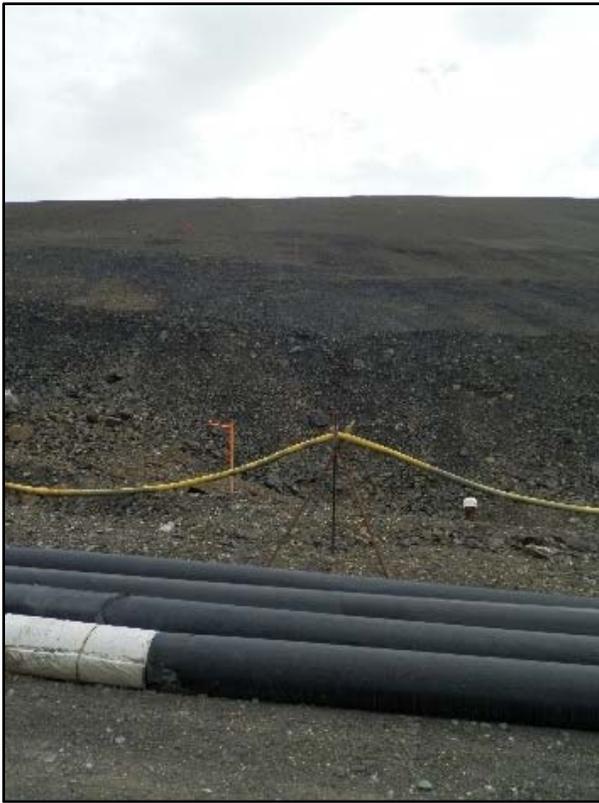
Figure 28: Flags set for new cover test by MS 15.

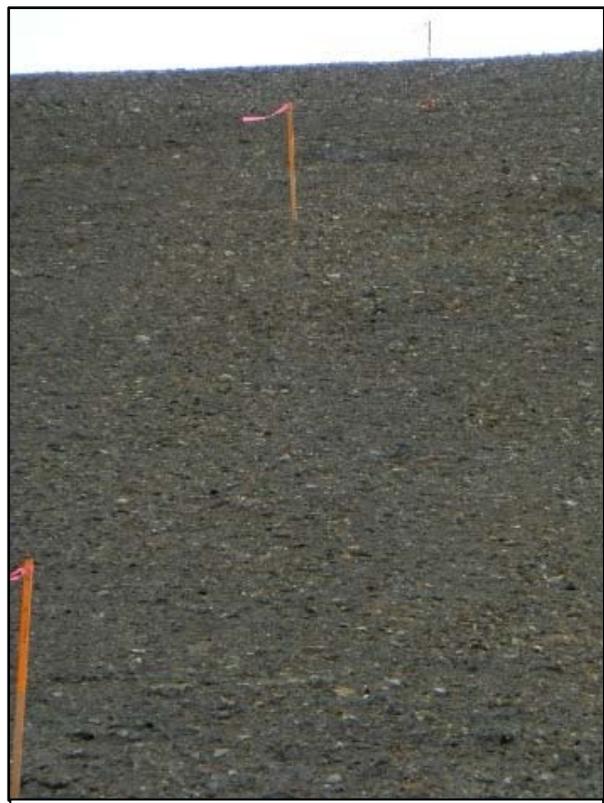
Figure 29: survey flags extend height of waste rock dump for new cover test.

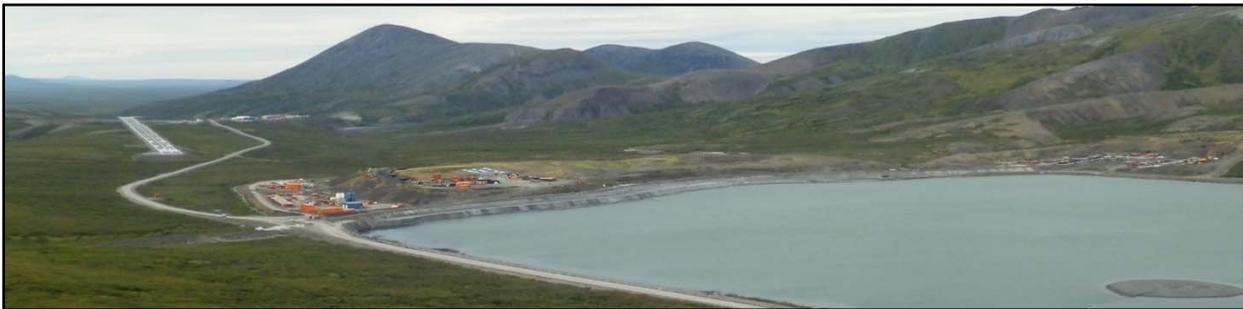
Figure 30: Back Dam viewed from Qanaiyaq Dump.

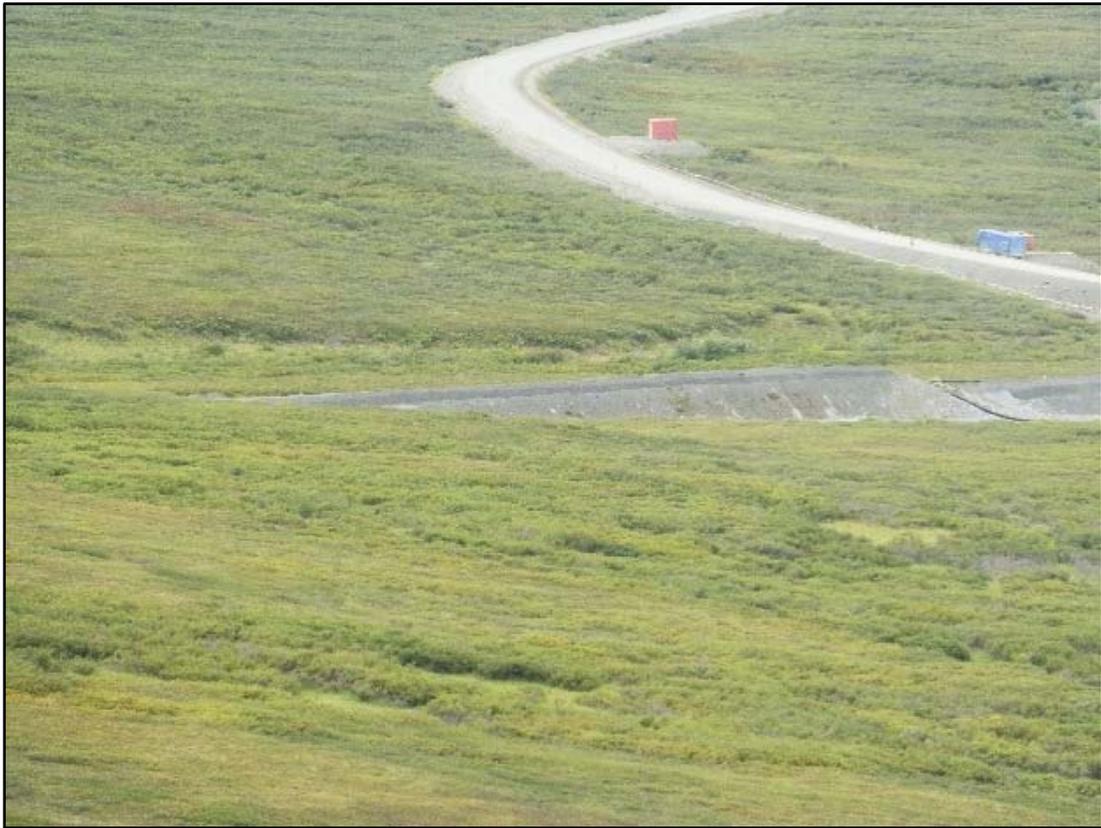
Figure 31: View of east abutment from Qanaiyaq Dump.

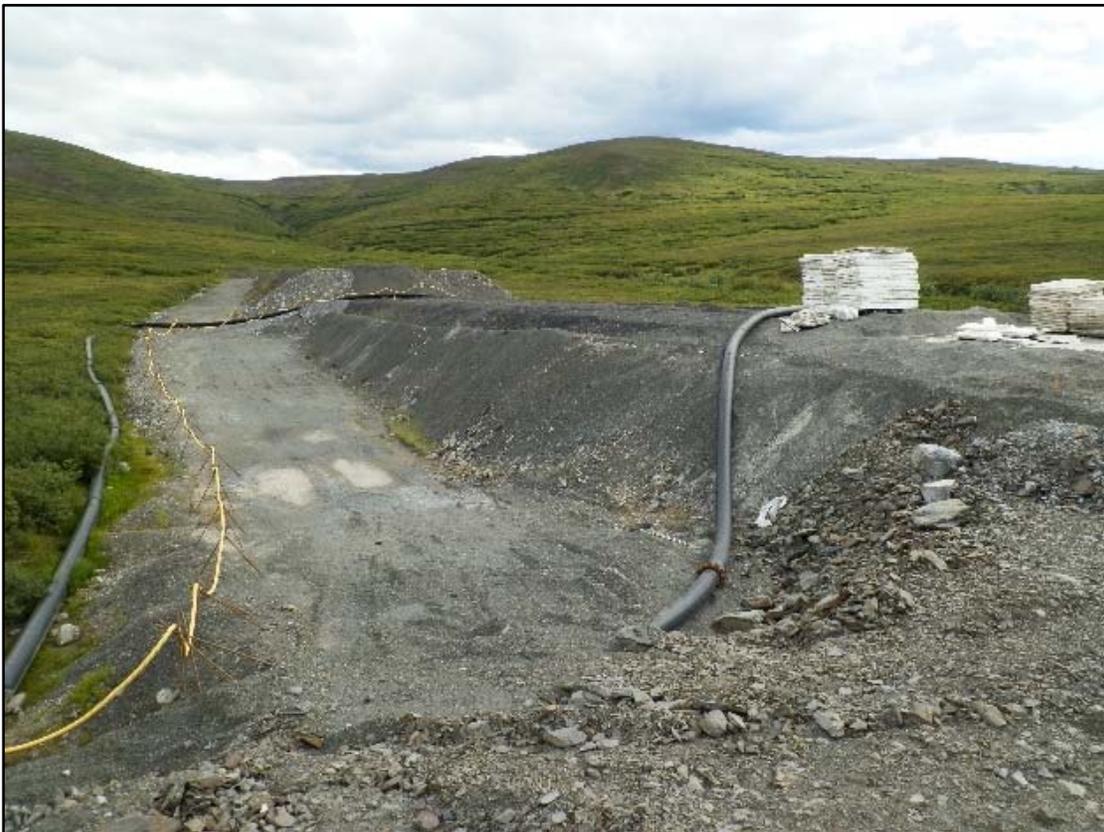
Figure 32: View of the north side of the east abutment from the haul road.

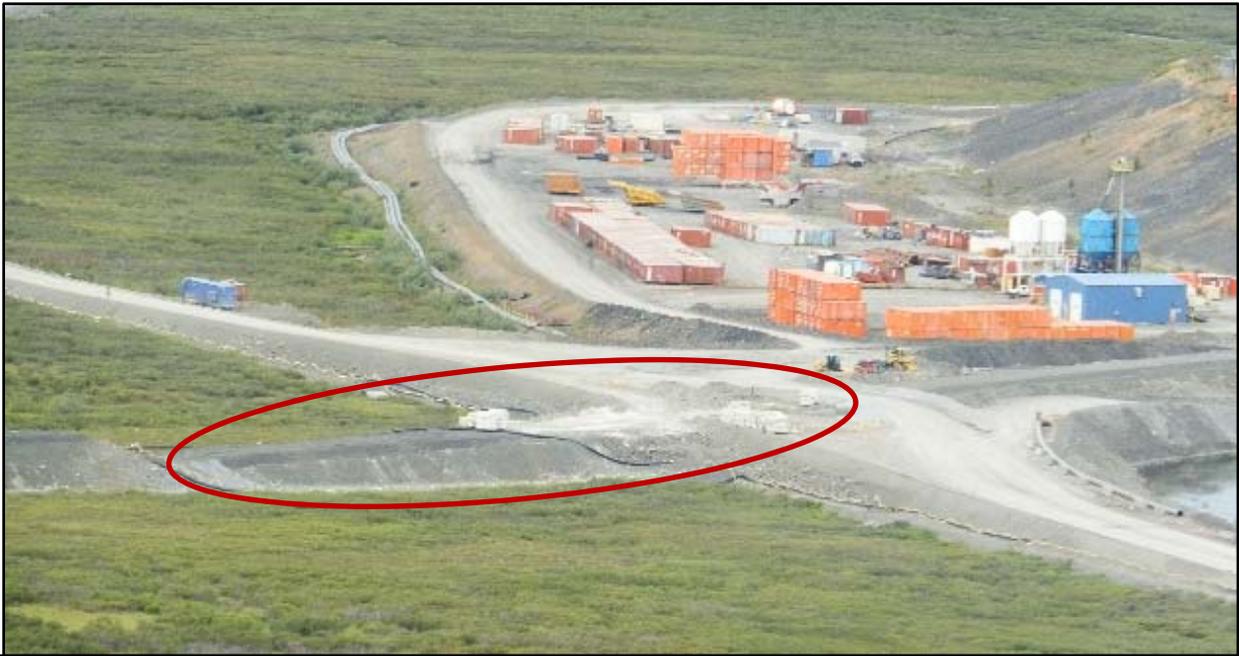
Figure 33. Location of work on the east abutment Red Dog Tailings Back Dam.

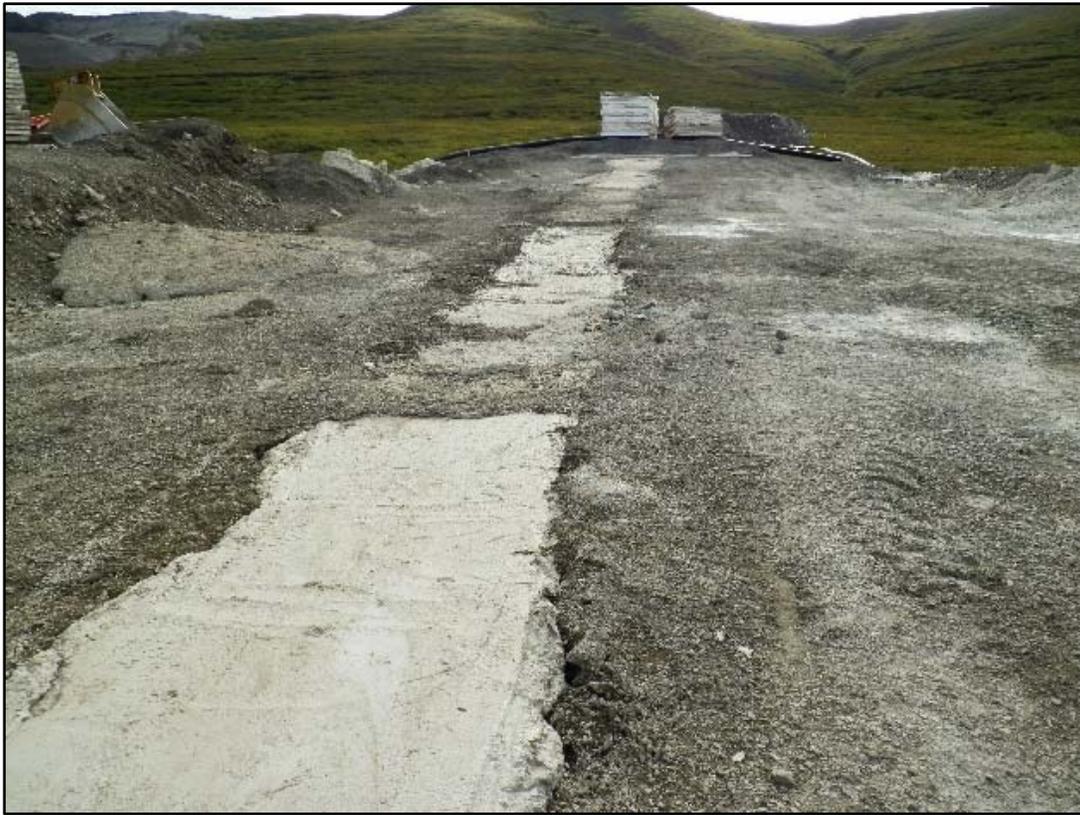
Figure 35: Insulation waiting to be placed.

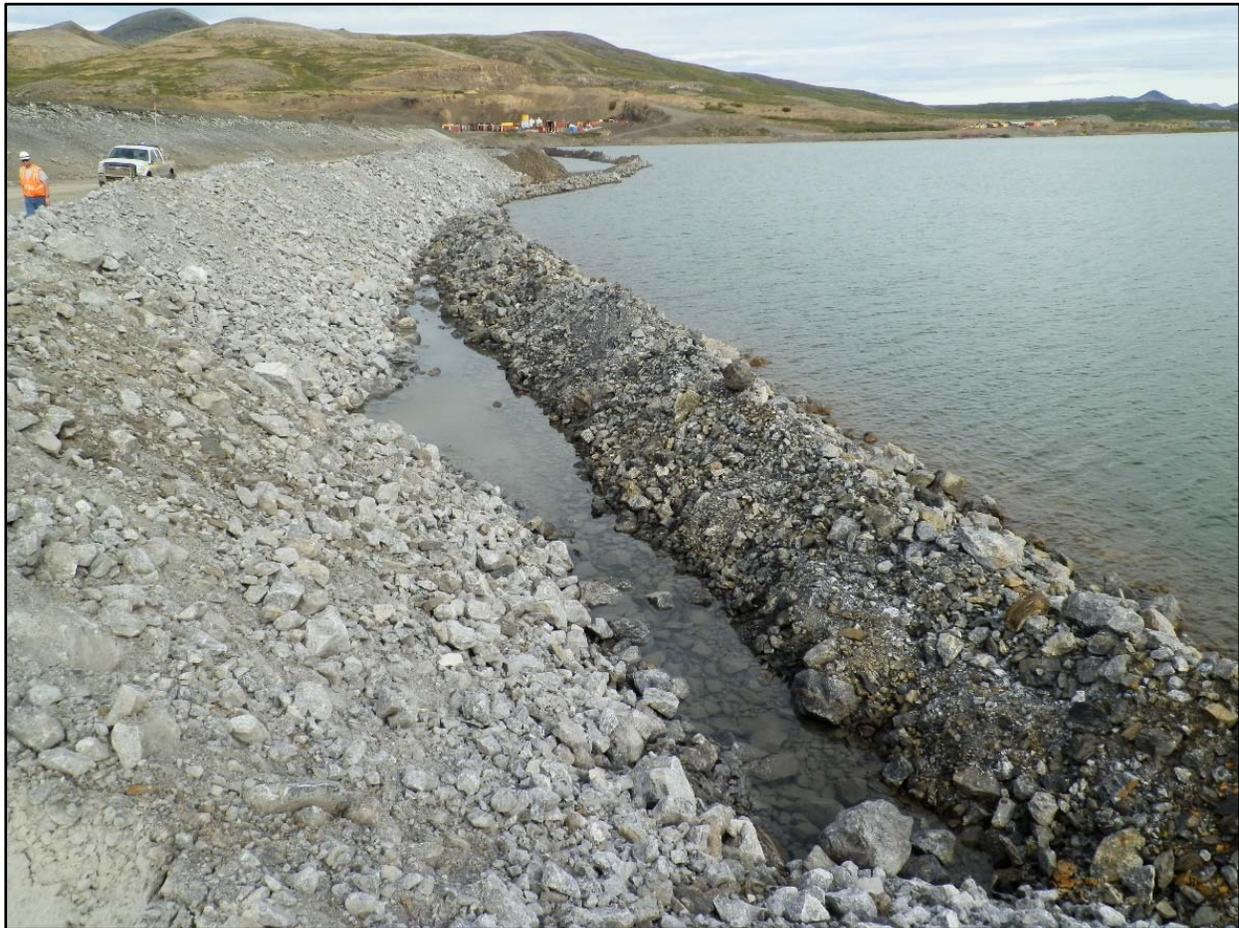
Figure 38: View from east end of Red Dog Tailings Back Dam looking west along the north side.

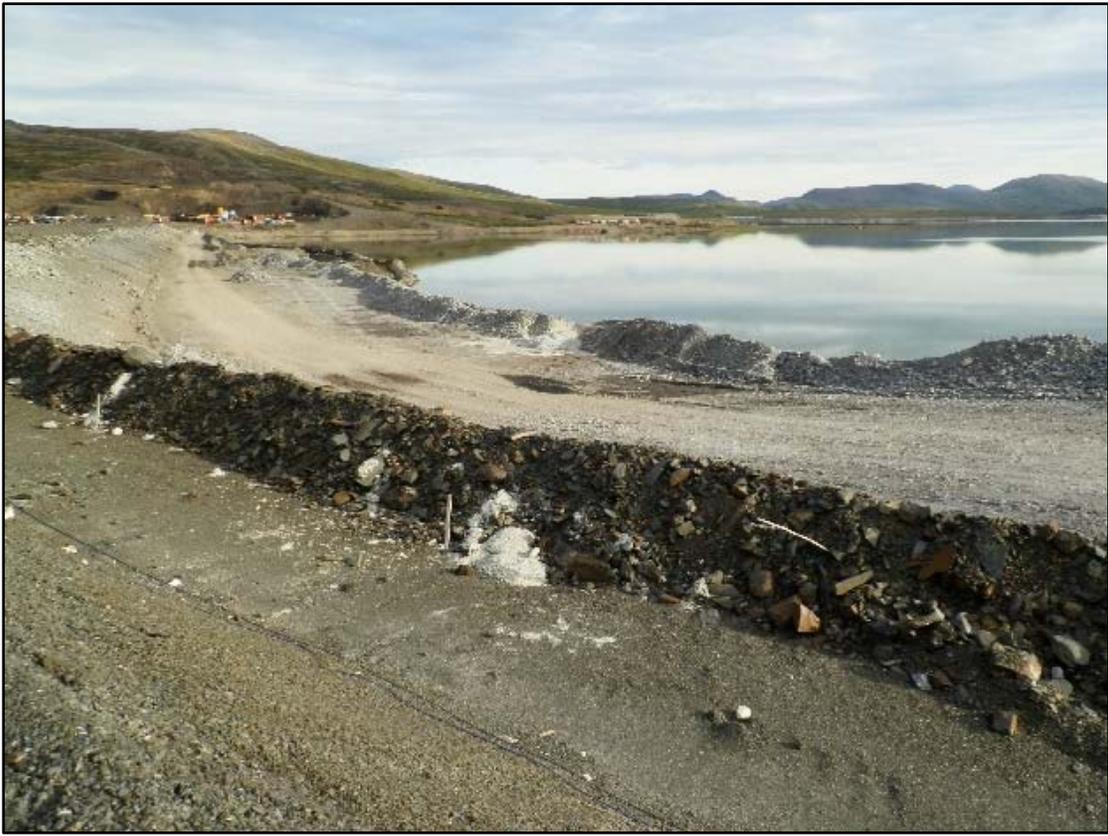
Figure 41: View of the north side Red Dog Tailings Back Dam from frost cap. View is looking toward the west.

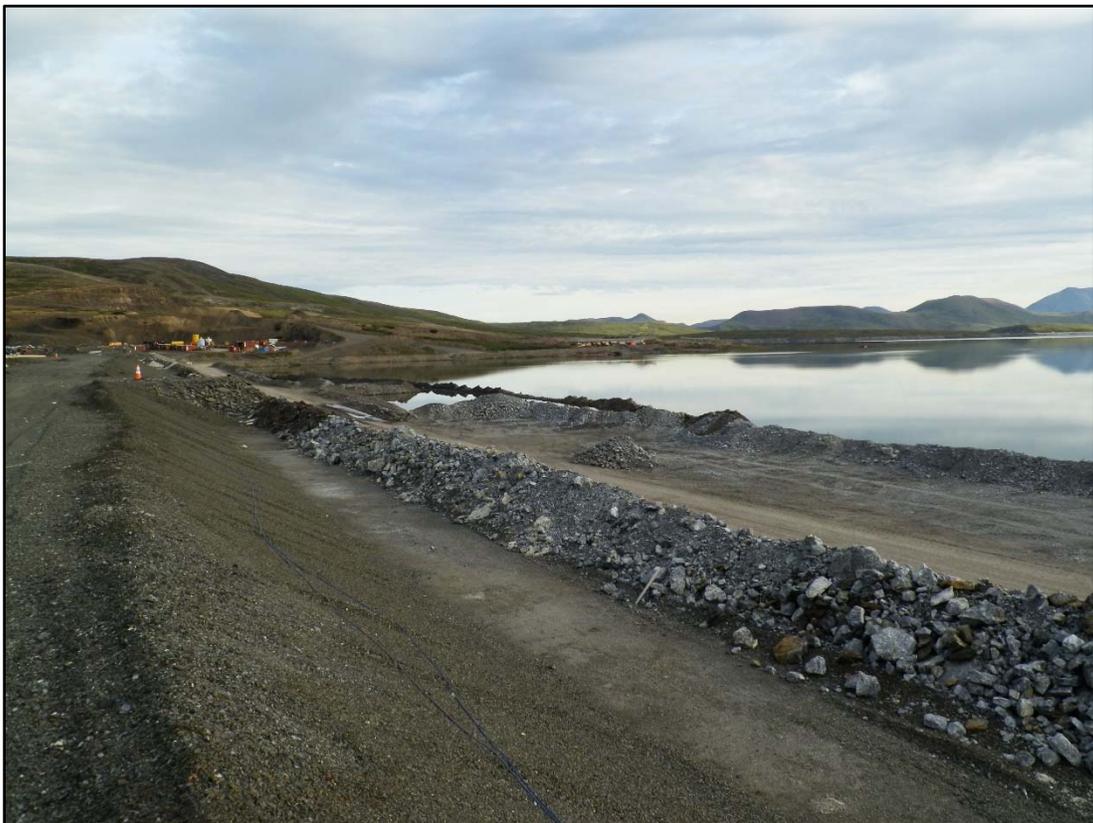
Figure 42: North side of the Red Dog Tailings Dam looking west from approximate center.

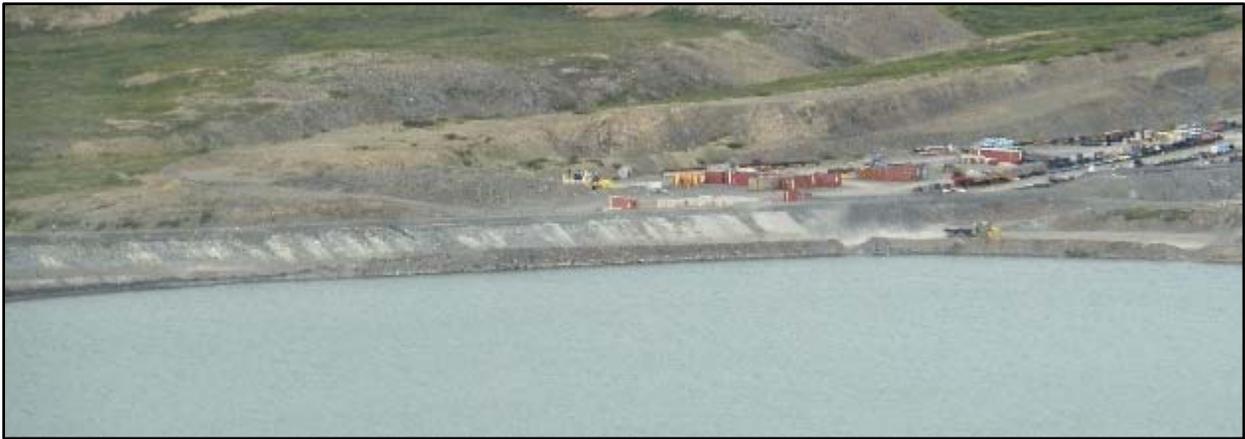
Figure 43: West end of the Red Dog Tailings Back Dam as viewed from the Qanaiyaq Dump.

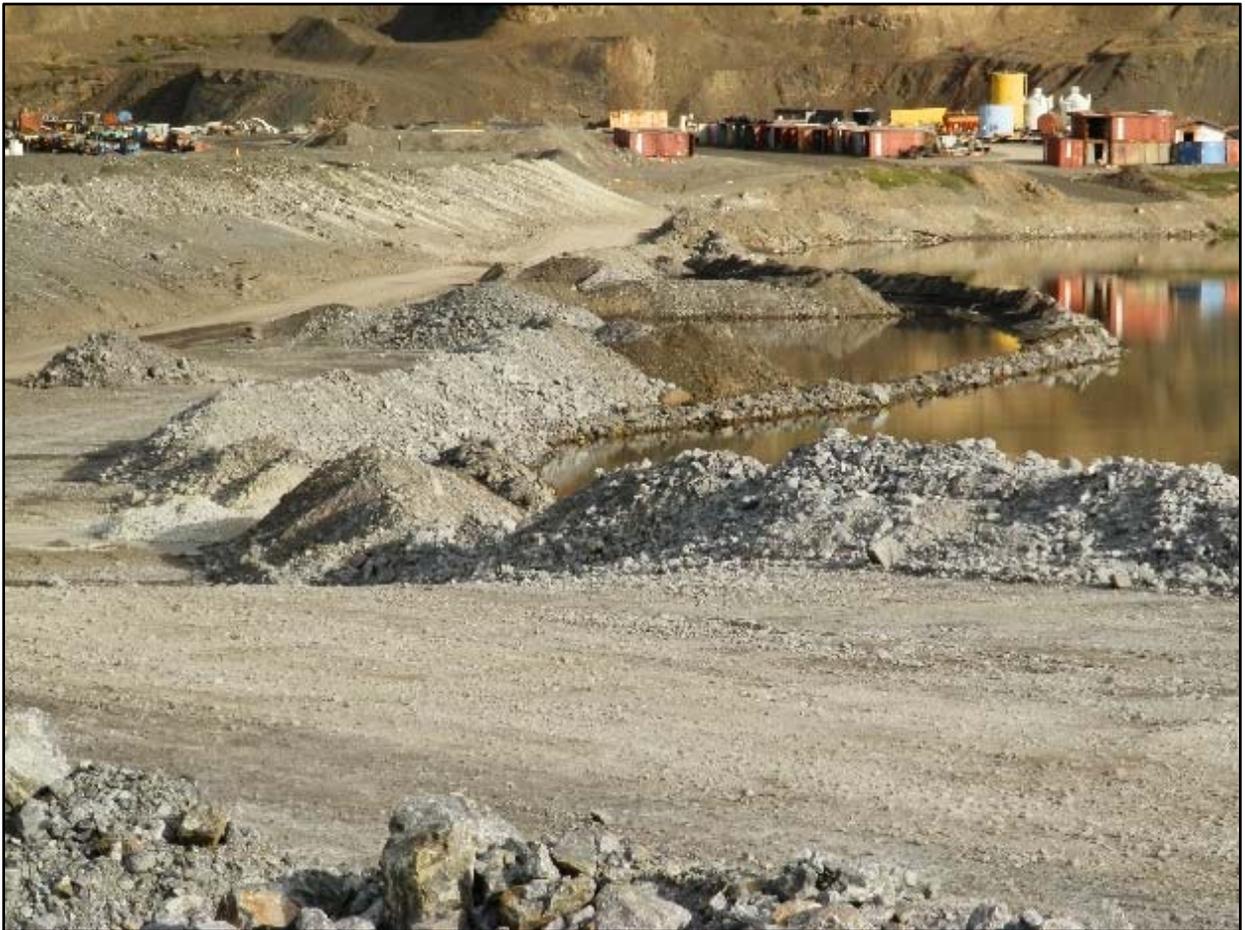
Figure 44: View of the northwest end of the Red Dog Tailings Back Dam

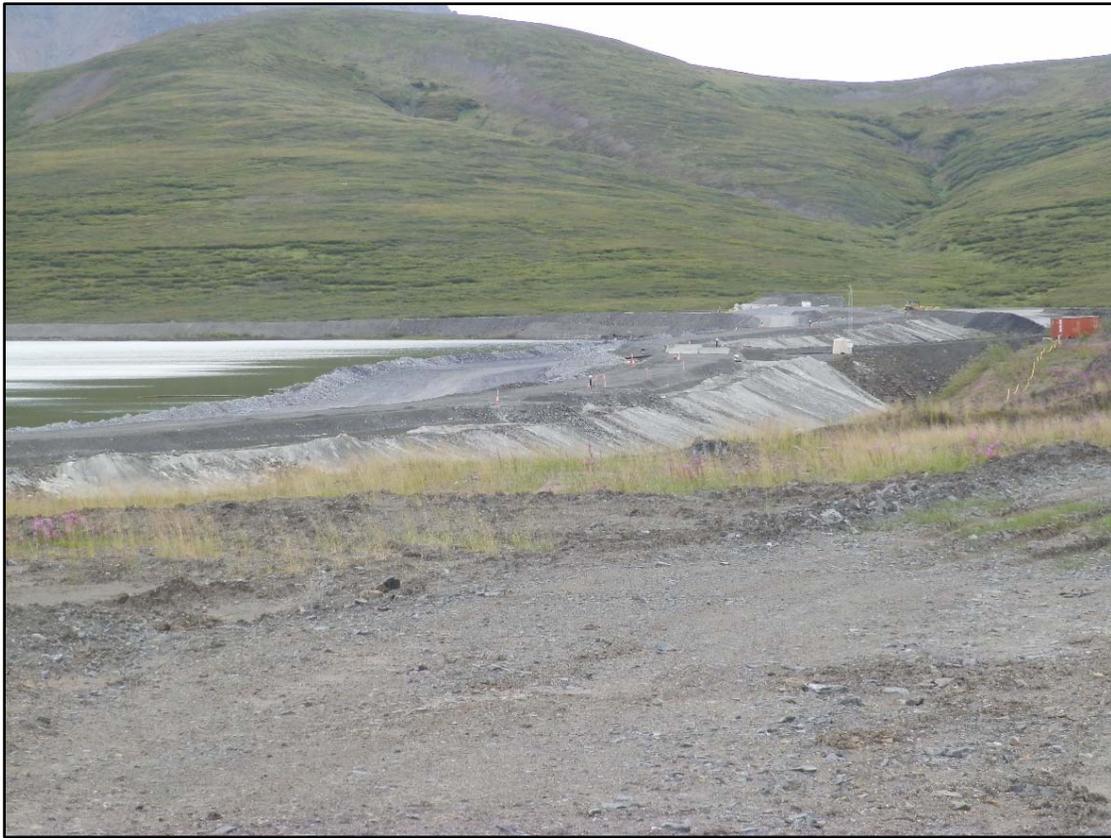
Figure 45: Red Dog Tailings Back Dam viewed looking east along the south side.

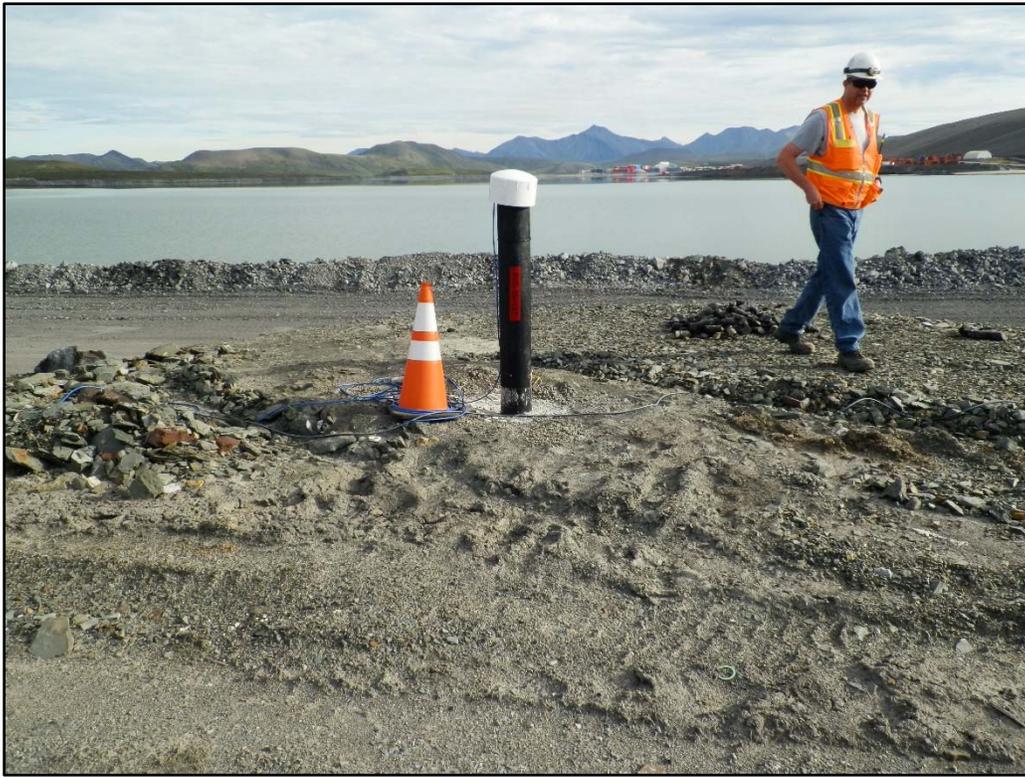
Figure 47: Example of typical instrument casing on Red Dog Tailings Back Dam.

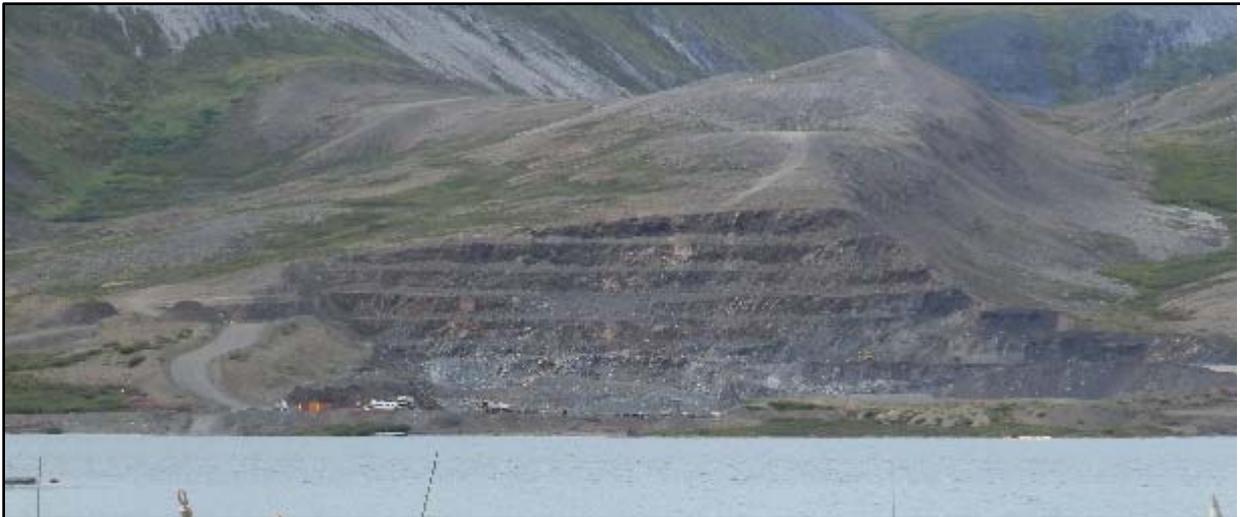
Figure 49: DD2 Quarry viewed from haul road across the Tailings Storage Facility.

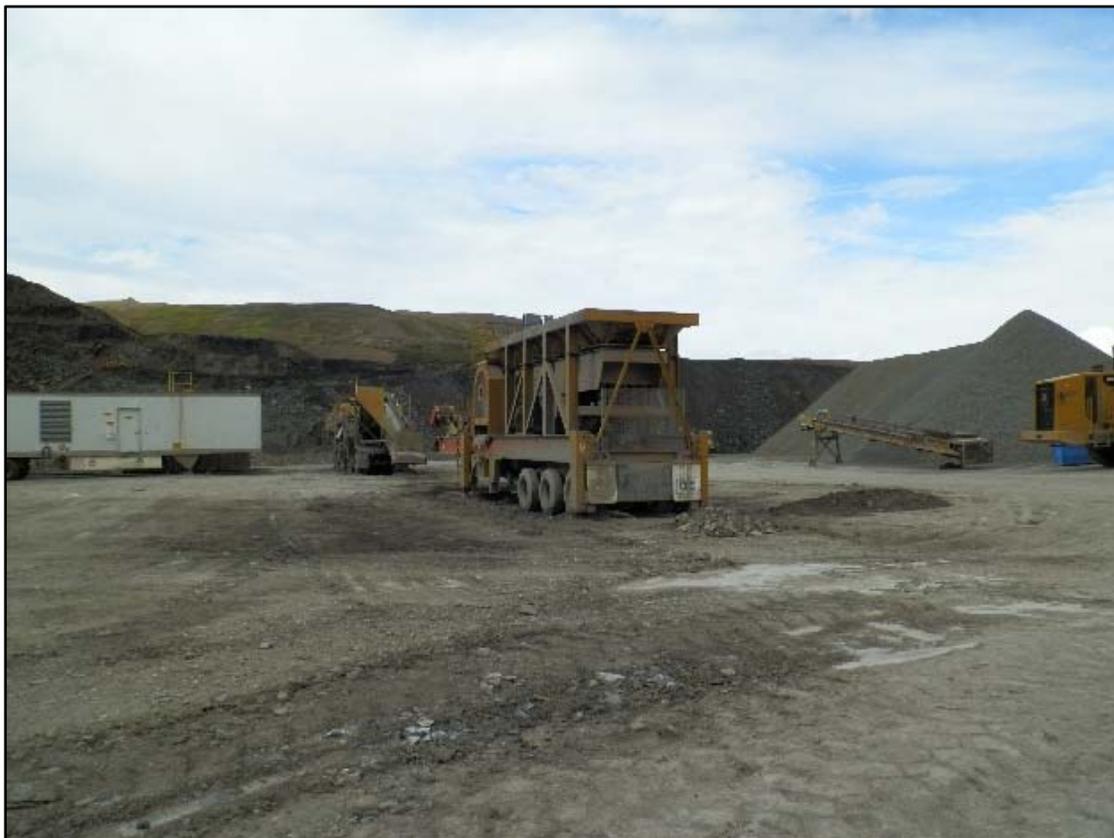
Figure 50: Equipment on the floor of DD2 Quarry.

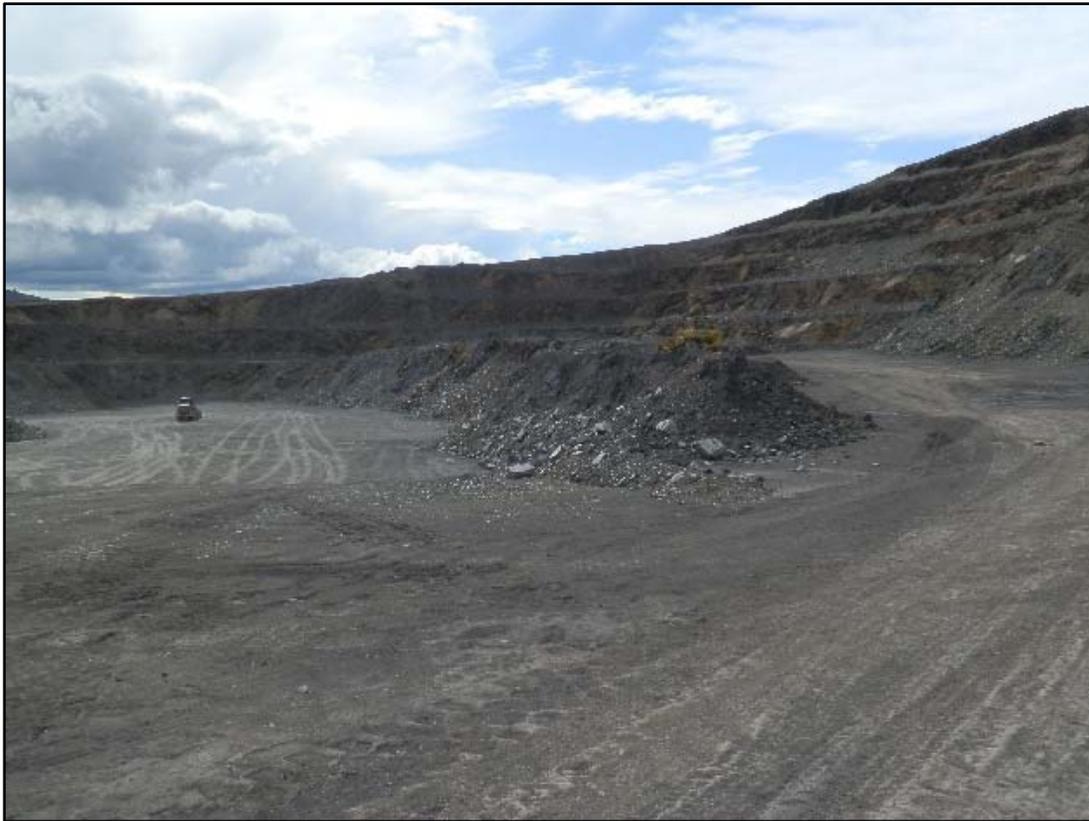
Figure 51: Looking south into the active working of DD2 Quarry.

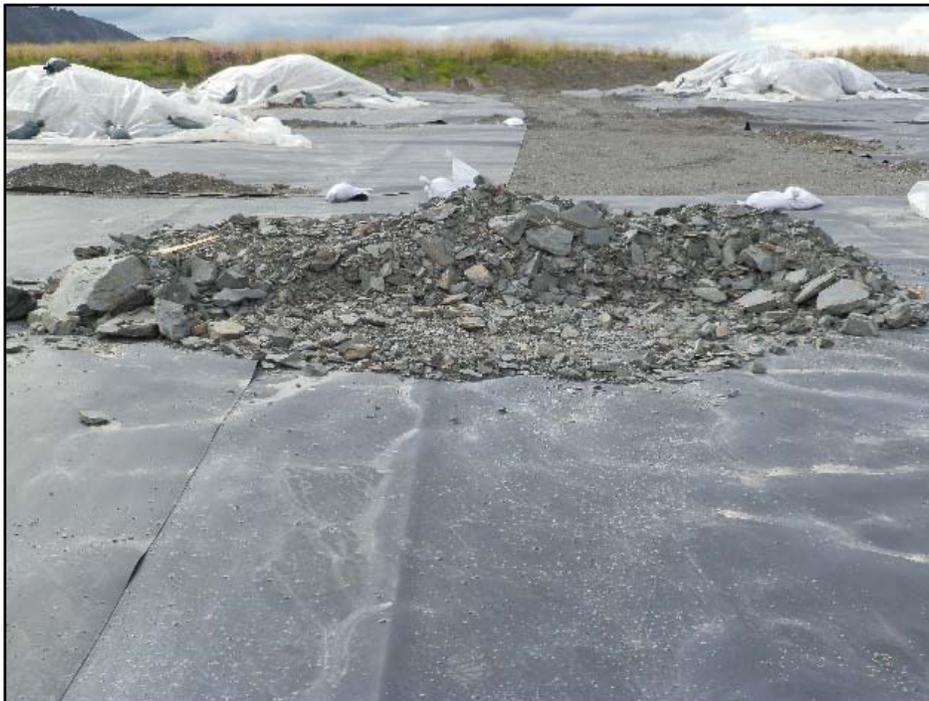
Figure 55: Sample collection in progress for gradation test.

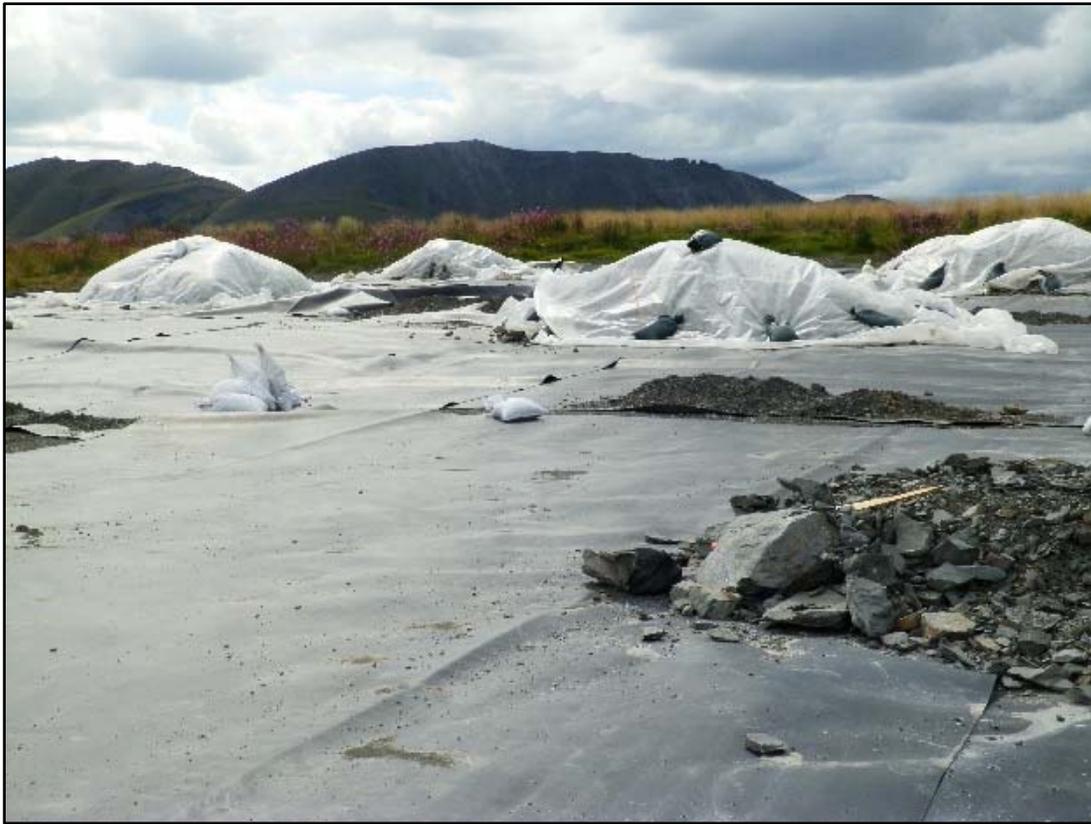
Figure 56: Samples for gradation testing are separated, covered, and labeled.

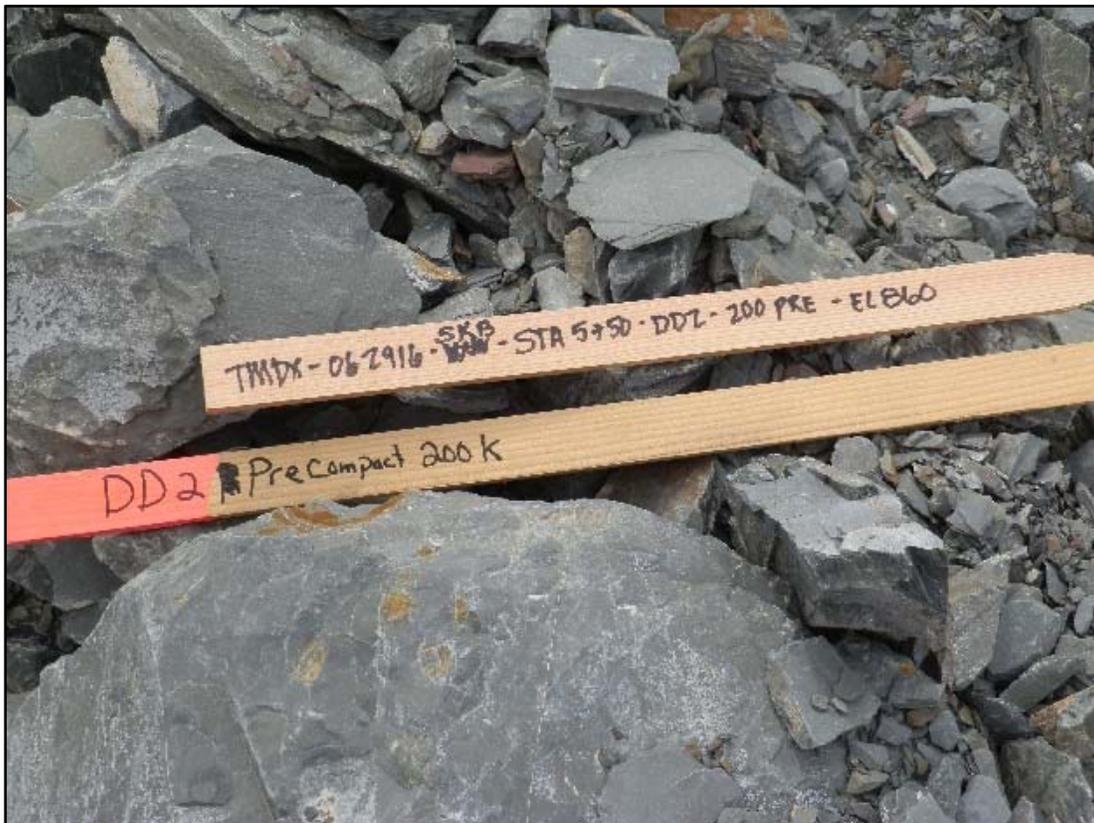
Figure 57: Example of labeling for the gradation test stockpiles.

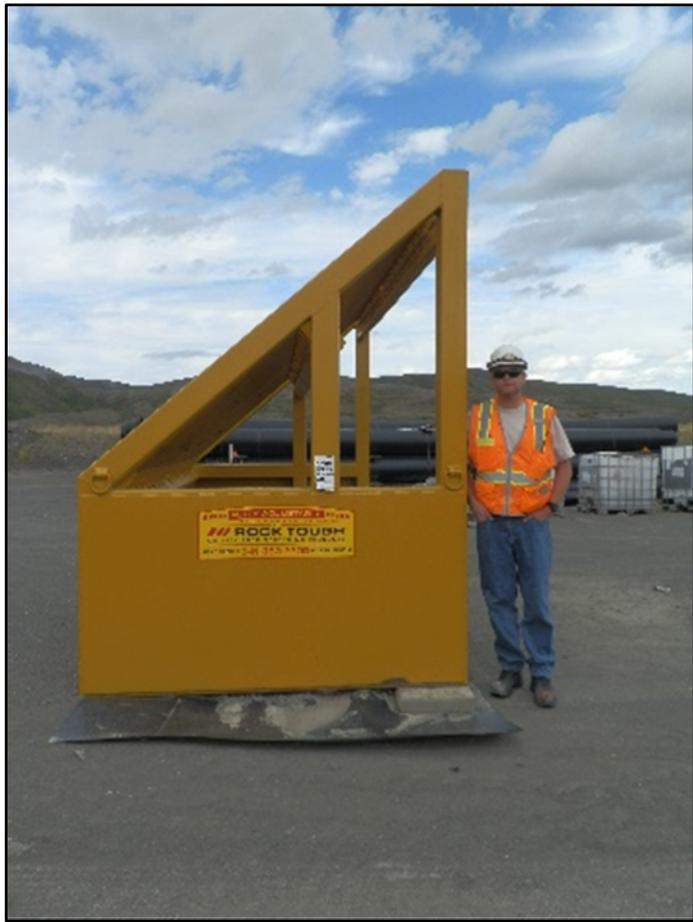
Figure 58: Side view of the equipment on site for the gradation test.
