## RED DOG MINE INSPECTION REPORT

<b>Inspection Date:</b>	July 25 through July 27, 2016
<b>Weather:</b>	July 25: Sunny-overcast, 69 °F; July 26: sunny, overcast 66 °F; July 27: rain, wind 53 °F
<b>Time of Inspection:</b>	July 25 1:30PM to July 27 noon
<b>Operator Contact:</b>	Chris Eckert (Teck Alaska Incorporated)
<b>Agency Personnel:</b>	ADNR – Carolyn Curley
<b>Inspection Objectives:</b>	General Site Inspection and observation of construction activities.
<b>Documentation:</b>	Photos and field book notes may be reviewed at the Northern Regional Office of ADNR

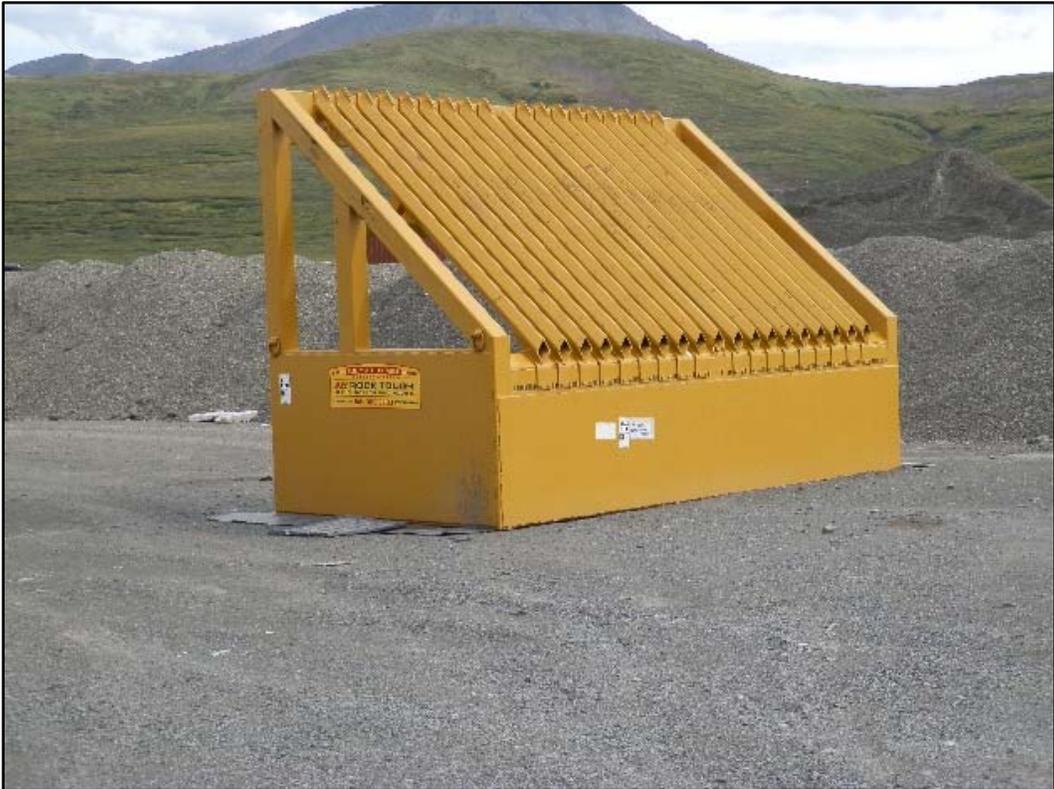
Figure 59: Custom-built equipment on site for the gradation tests of DD2 Quarry material.

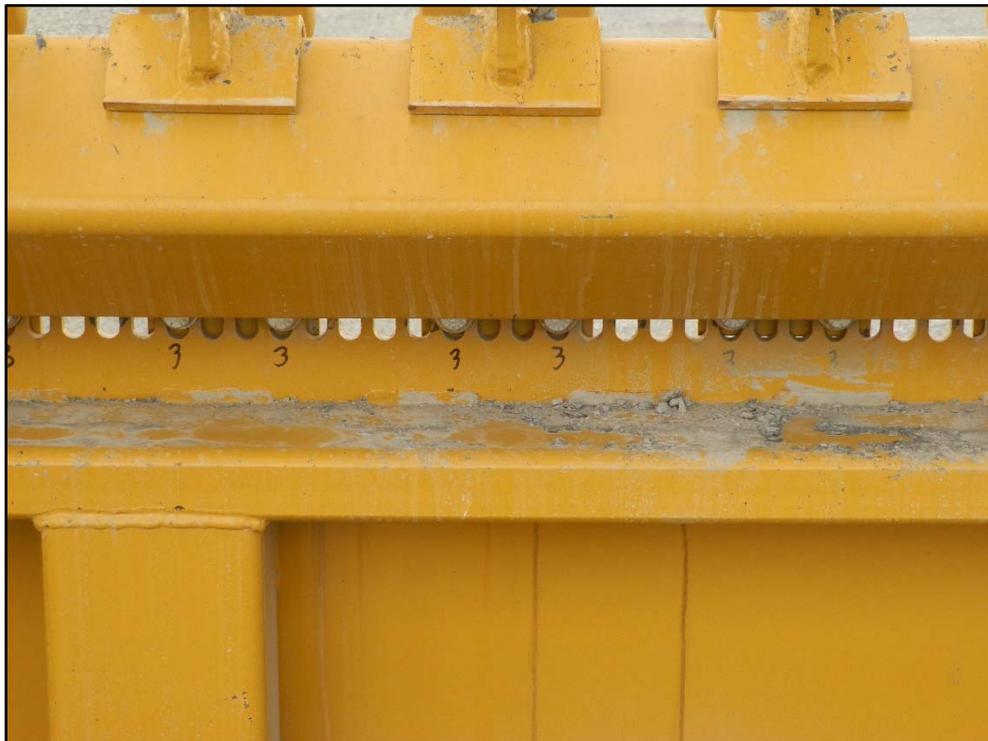
Figure 61: Marking inside the equipment for the gradation tests.

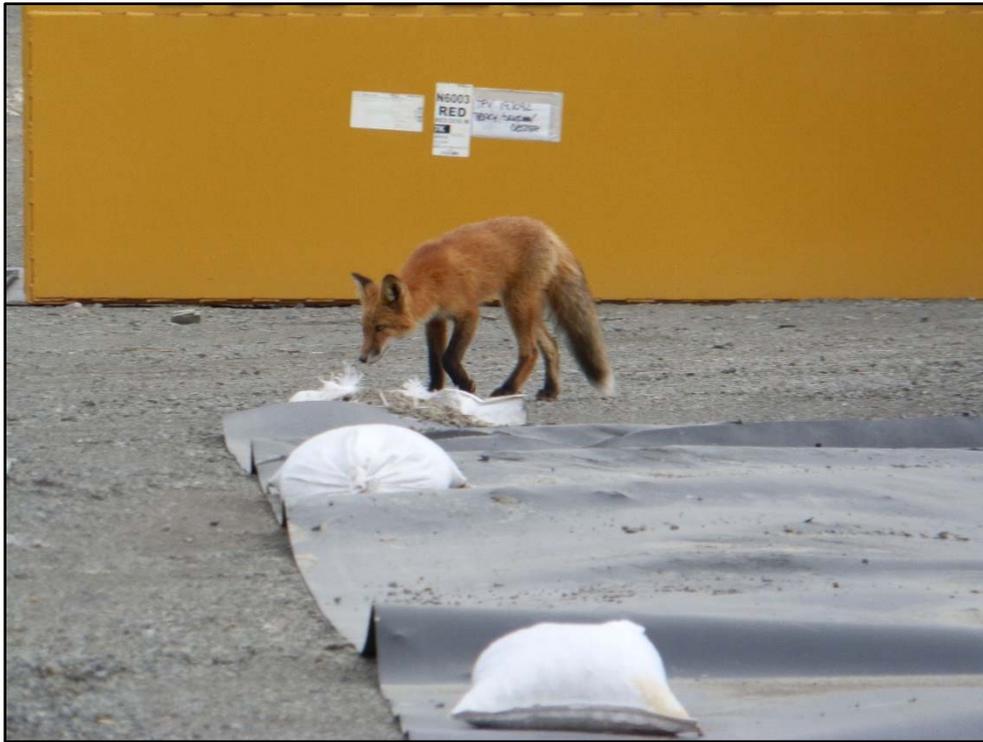
Figure 62: Red fox investigating stockpiles.

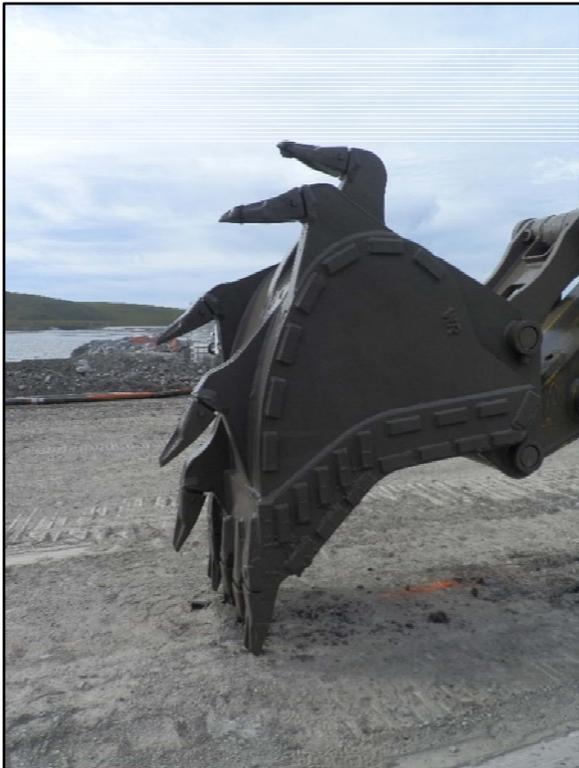
Figure 63: Side view of excavator bucket for wing wall construction.

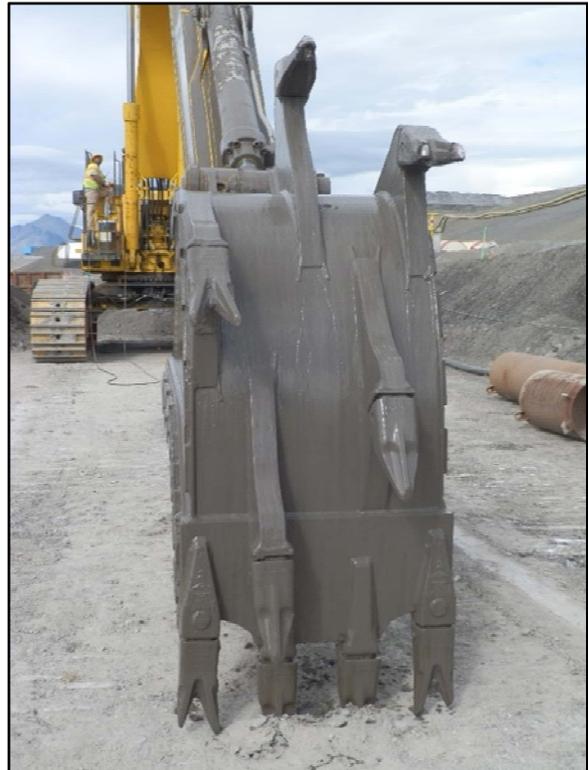
Figure 64: Front view of the excavator bucket for wing wall construction.

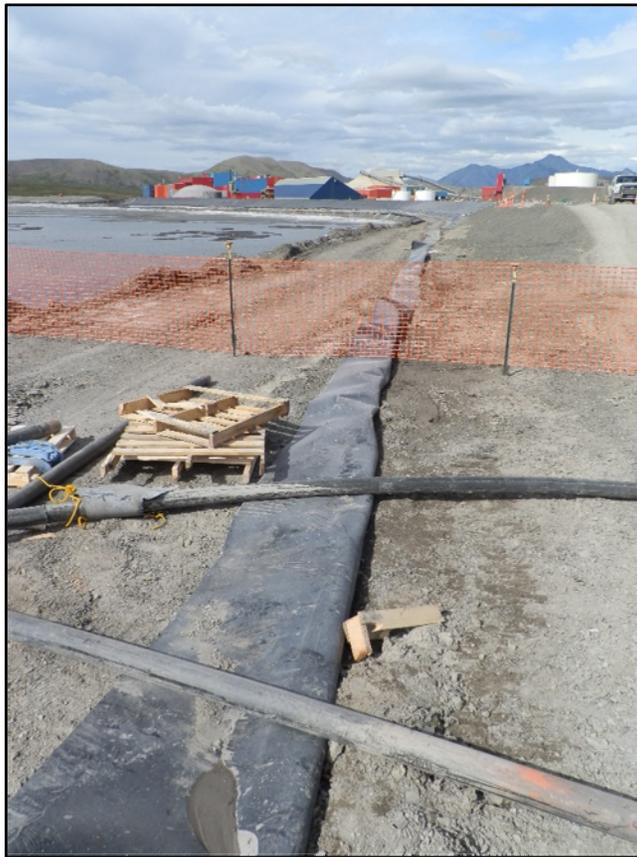
Figure 65: Tie-in to existing wing wall.

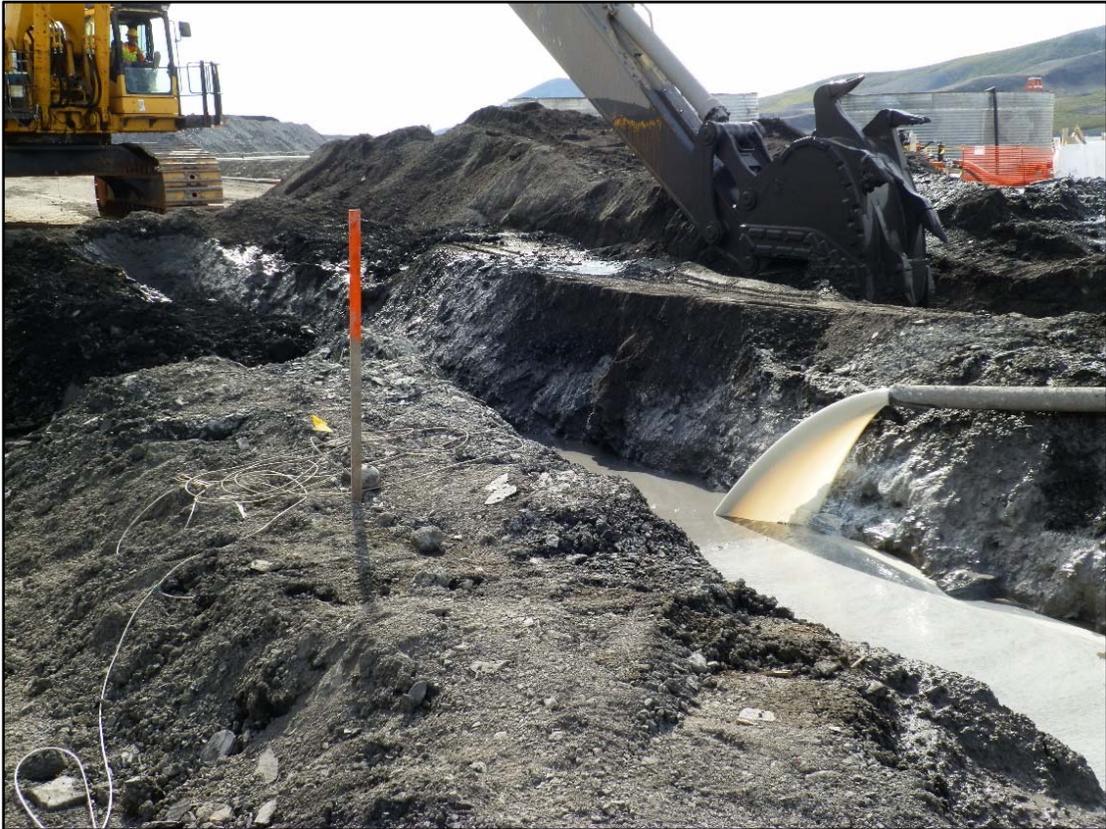
Figure 66: Beginning trench for slurry wing wall construction.

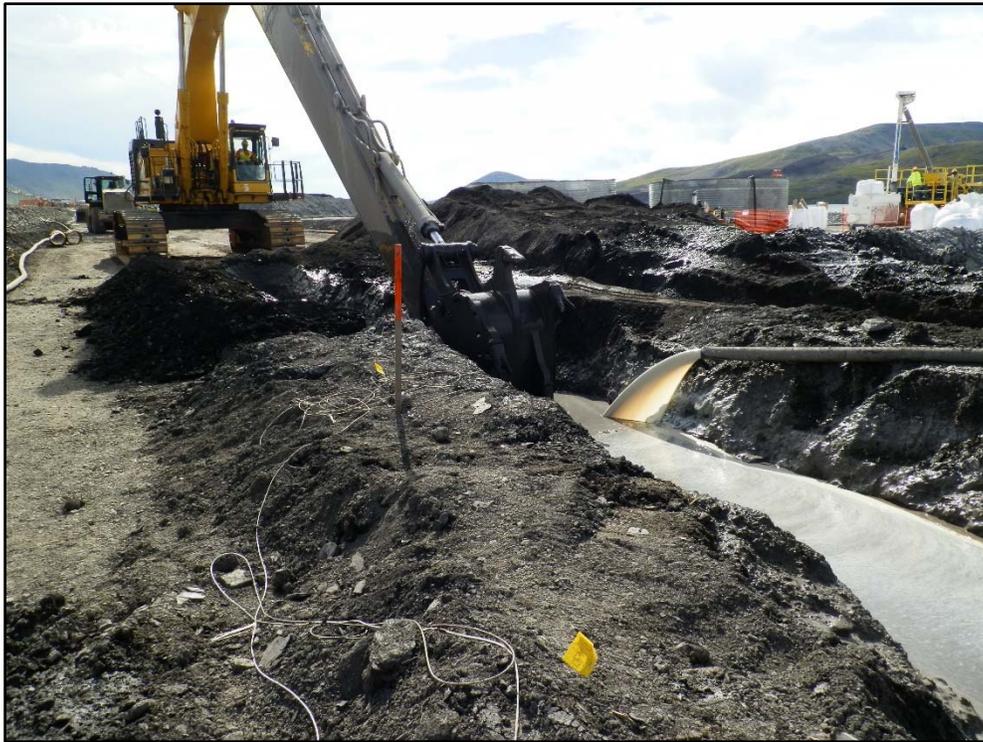
Figure 67: Excavator digging the trench for the wing wall.

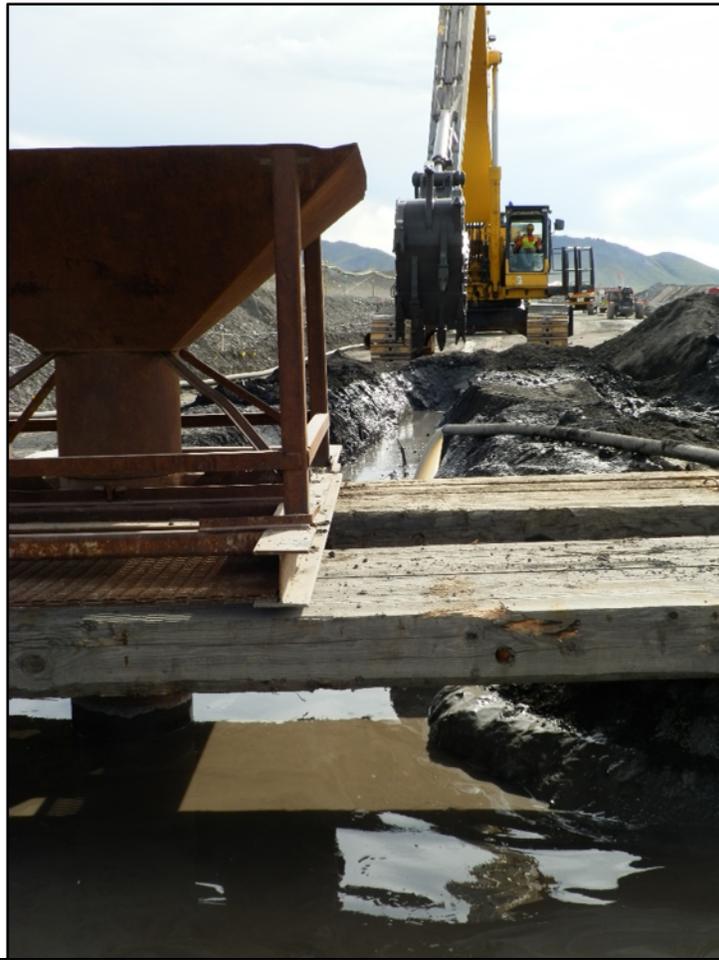
Figure 68: Set-up for material; deposition for the slurry wing wall construction.

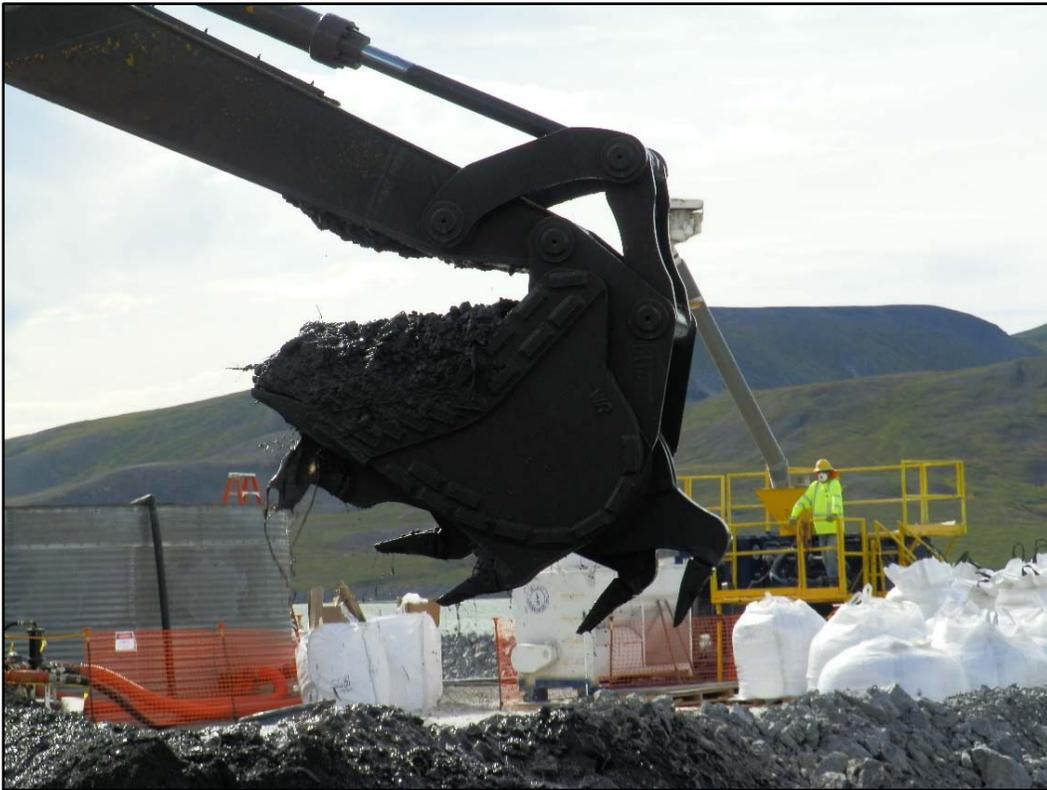
Figure 69: Excavator bucket removing material from trench.

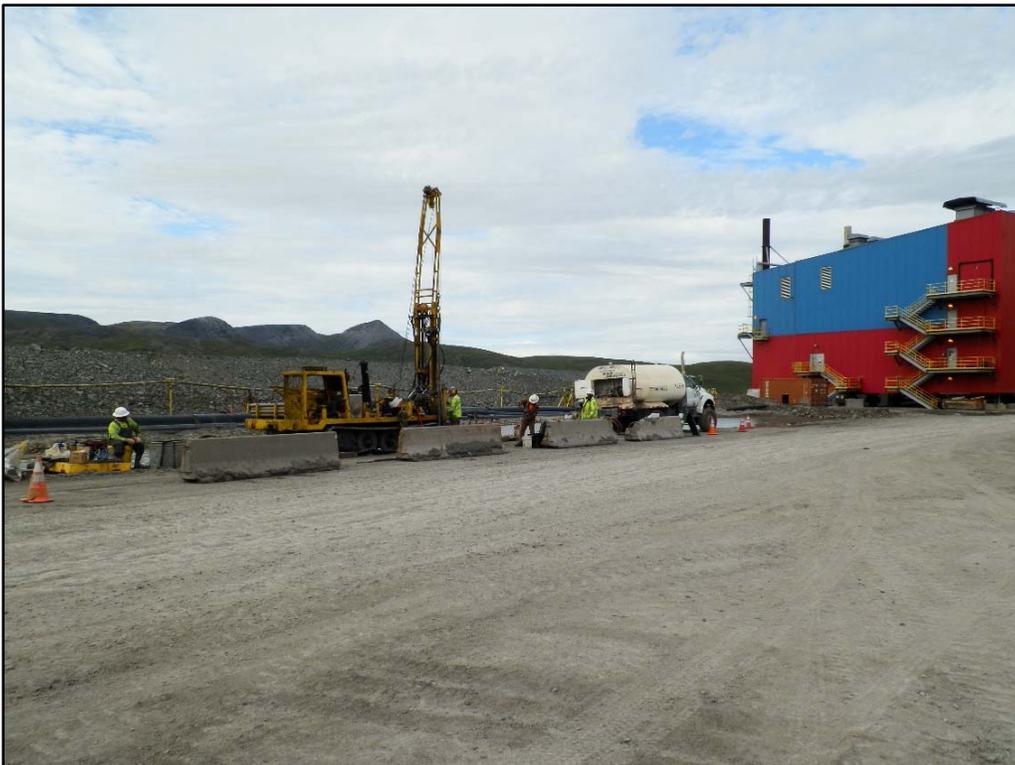
Figure 70: Drill rig set to begin geotechnical drill hole.

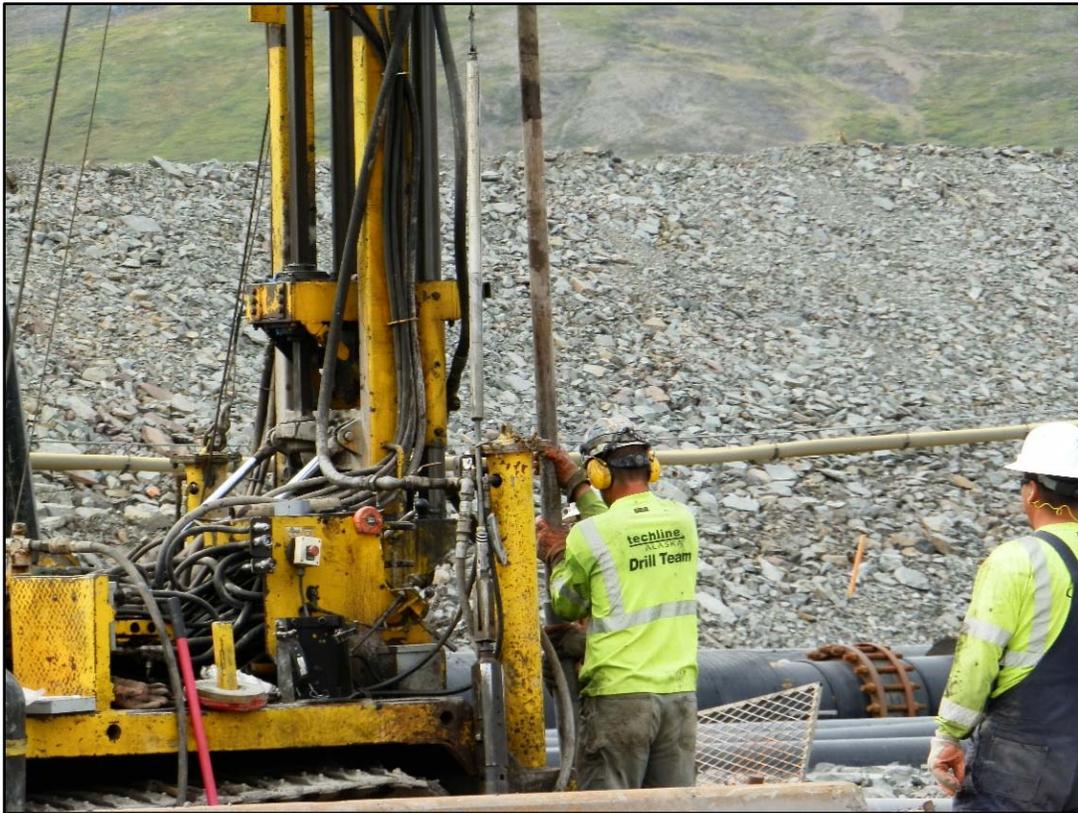
Figure 71: Packer test was observed.

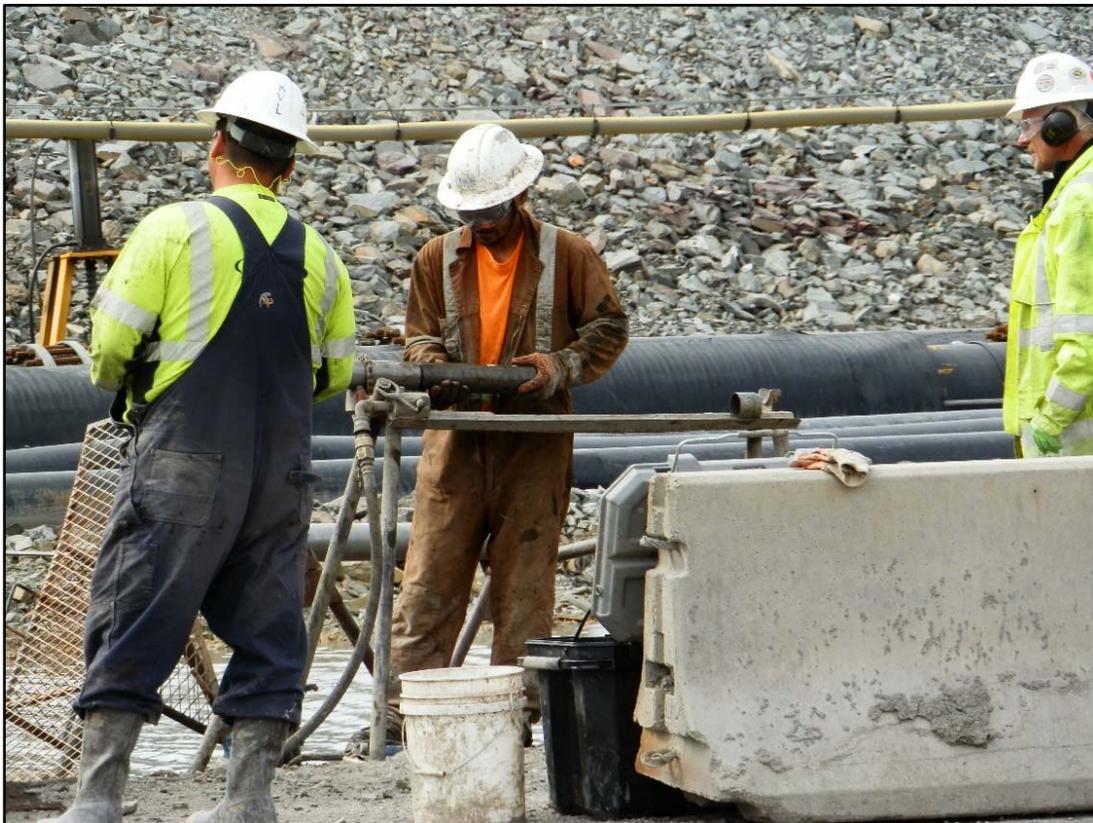
Figure 72: Core samples were removed and logged.

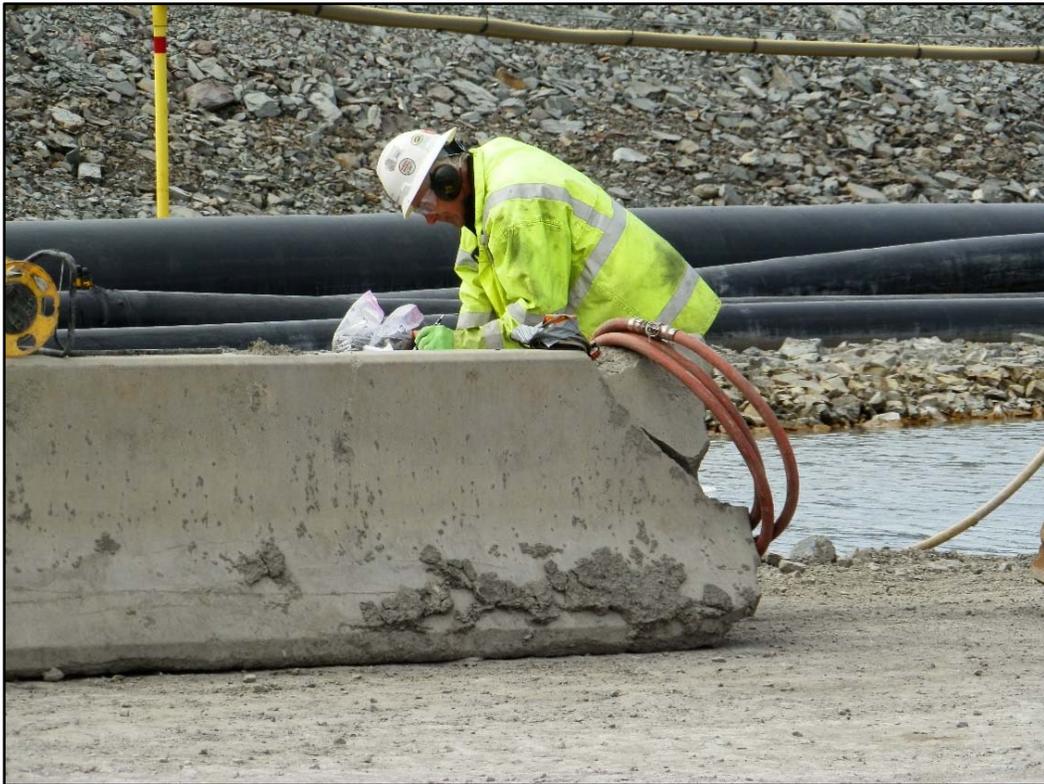
Figure 73: Notes and measurements taken in the field by crew.

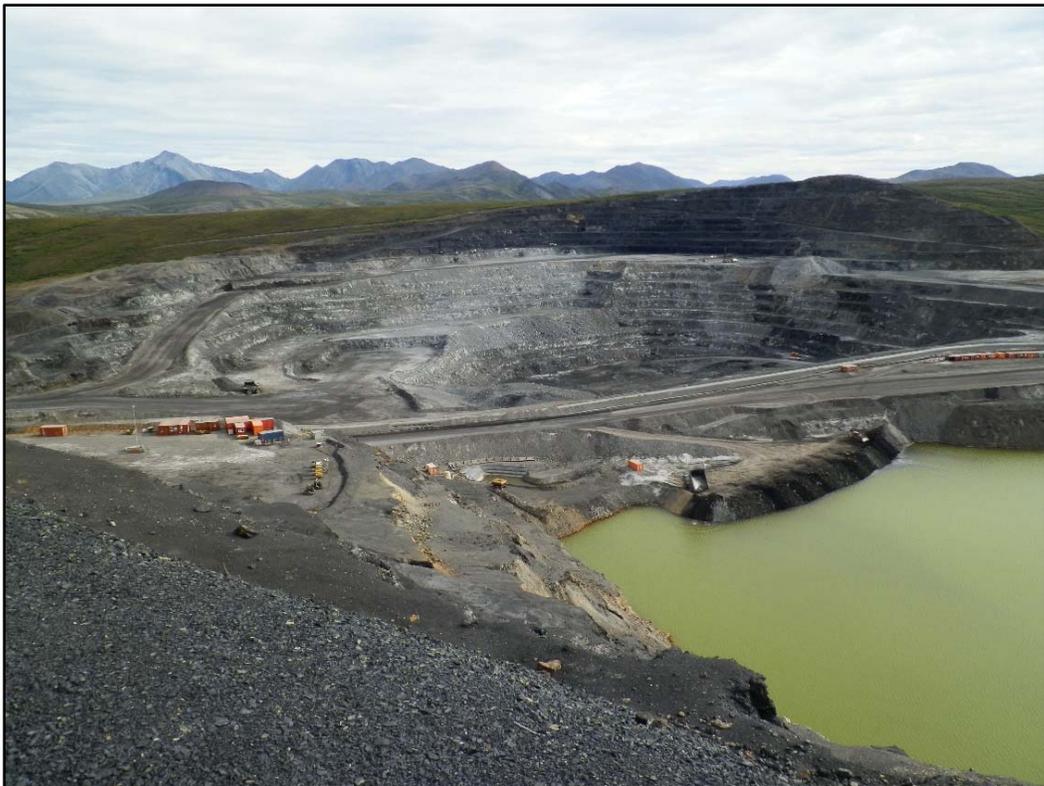
Figure 74: Aqqaluk Pit and Main Pit Dump viewed from the Boulder Overlook.

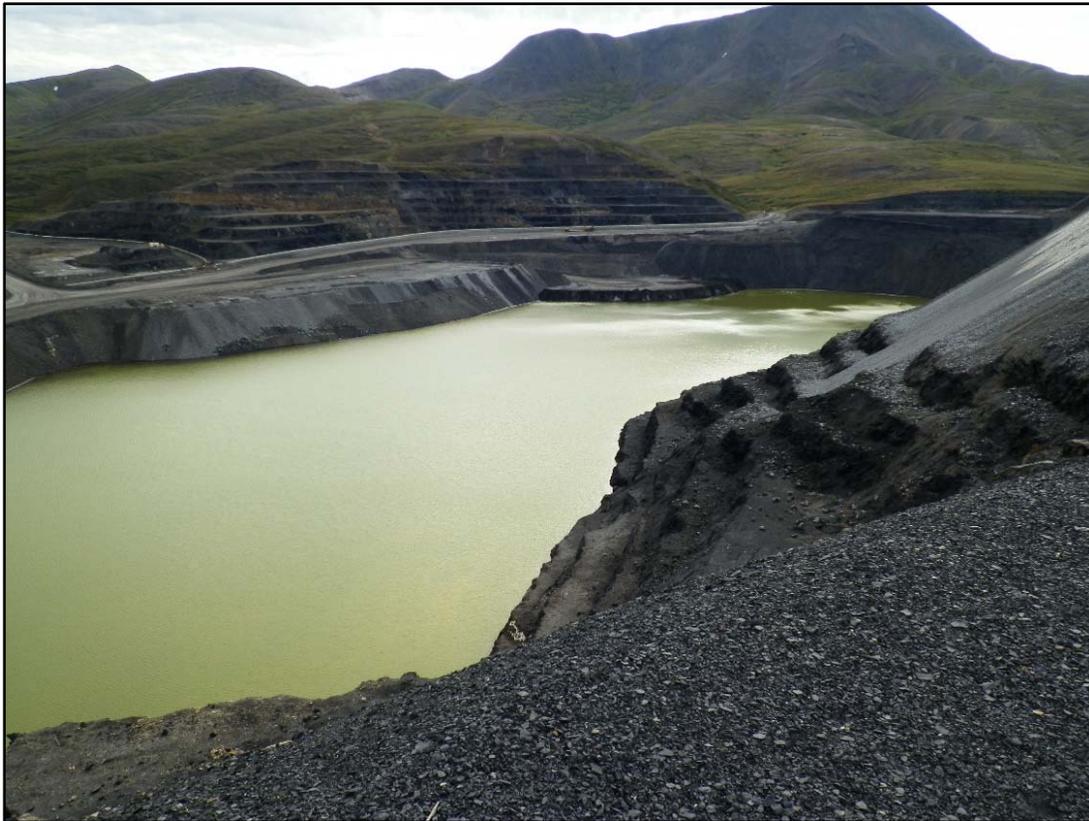
Figure 75: View of Main Pit as seen looking east from the Boulder Overlook.

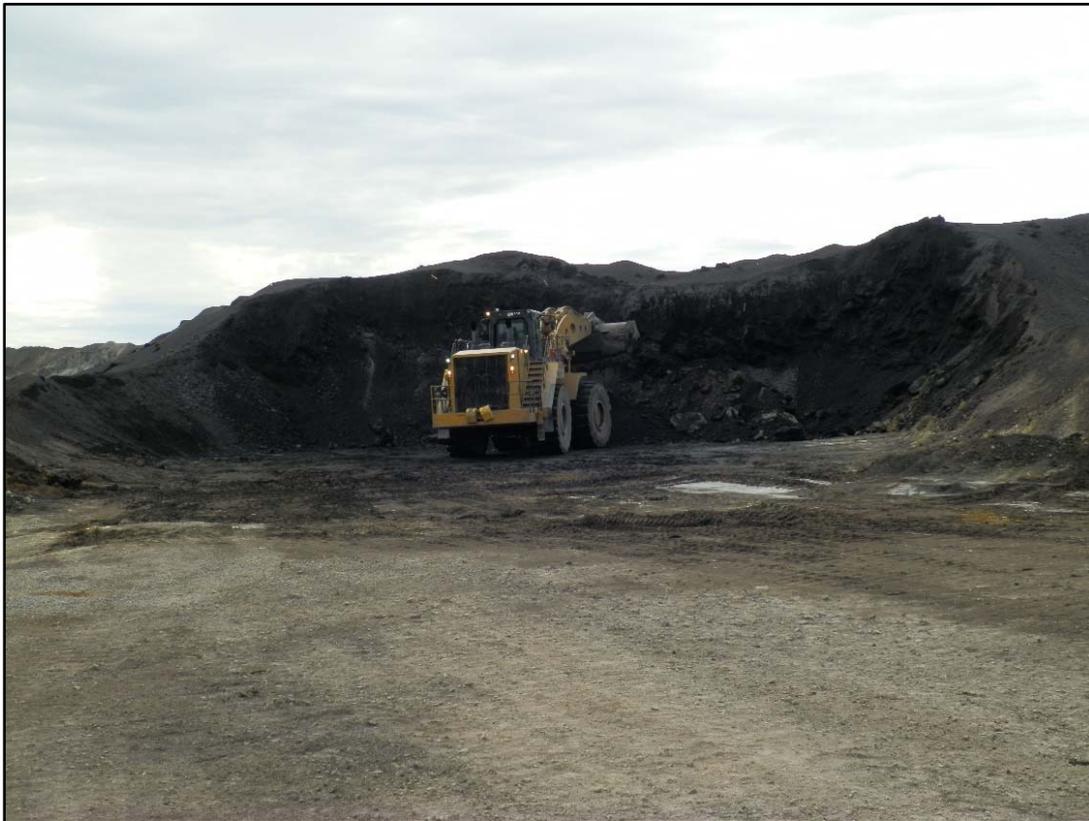
Figure 76: Qanaiyaq Pit working face.

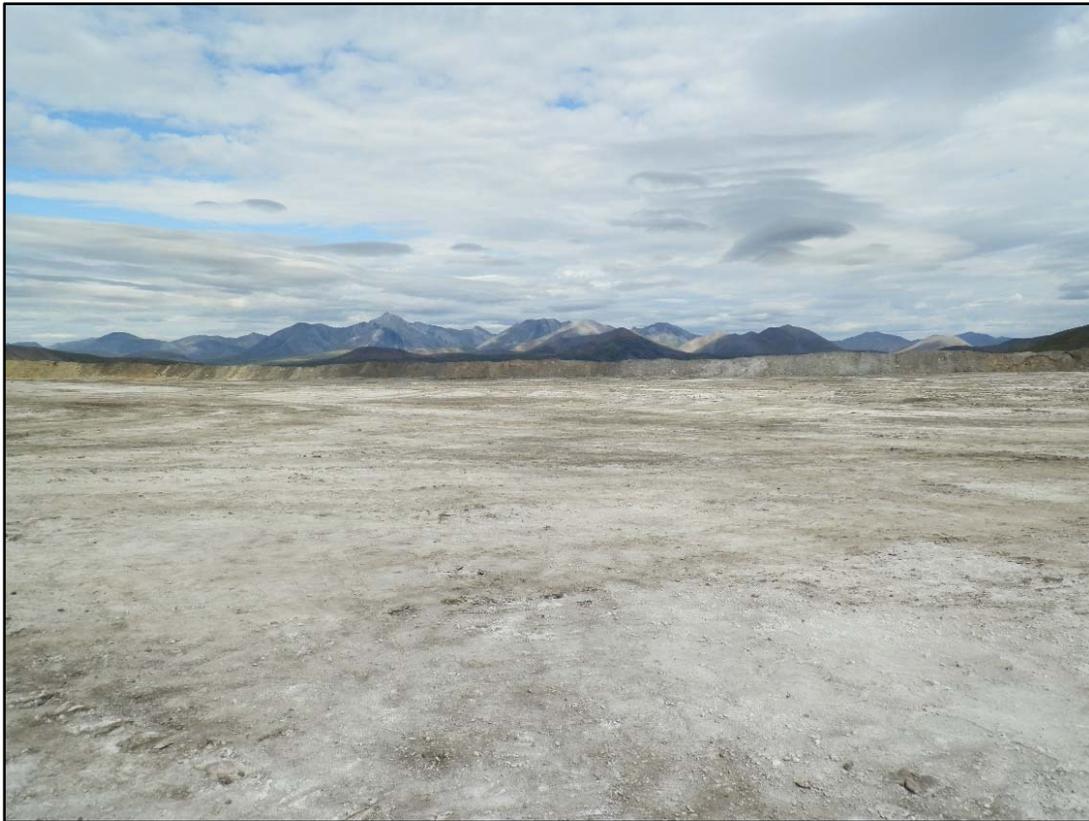
Figure 77: Qanaiyaq Pit floor looking north east

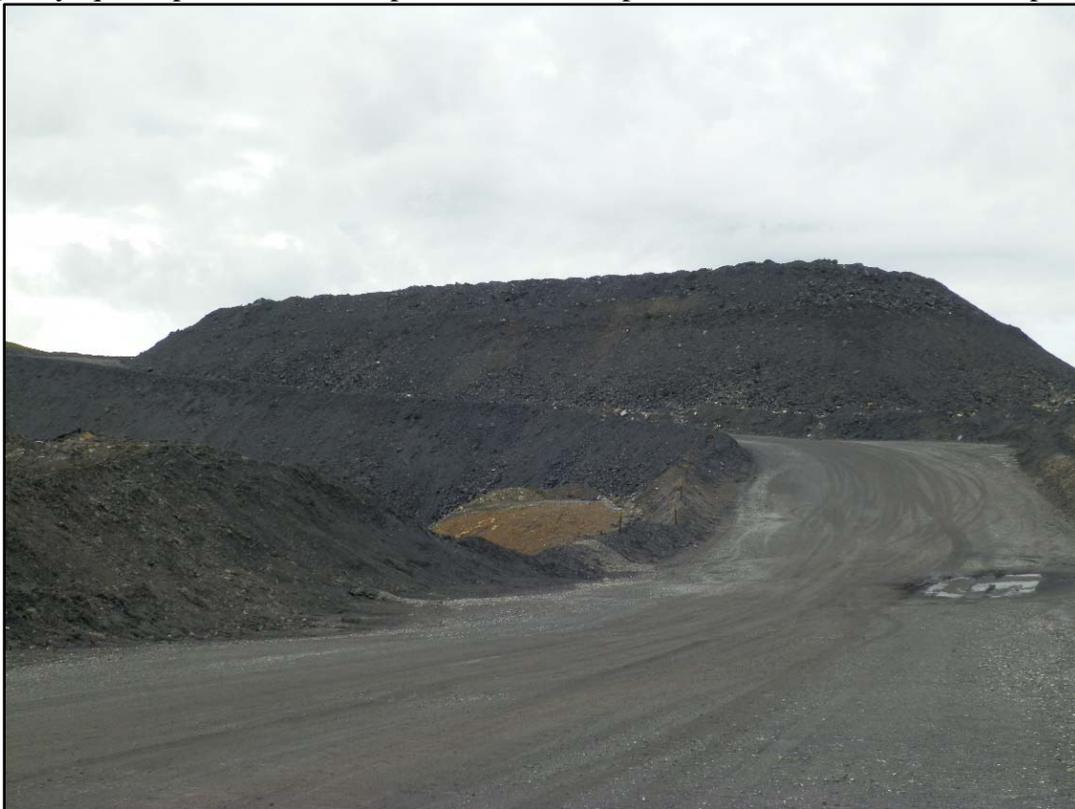
Figure 78: The Qanaiyaq Dump as seen heading south on the haul road on the Oxide Dump.

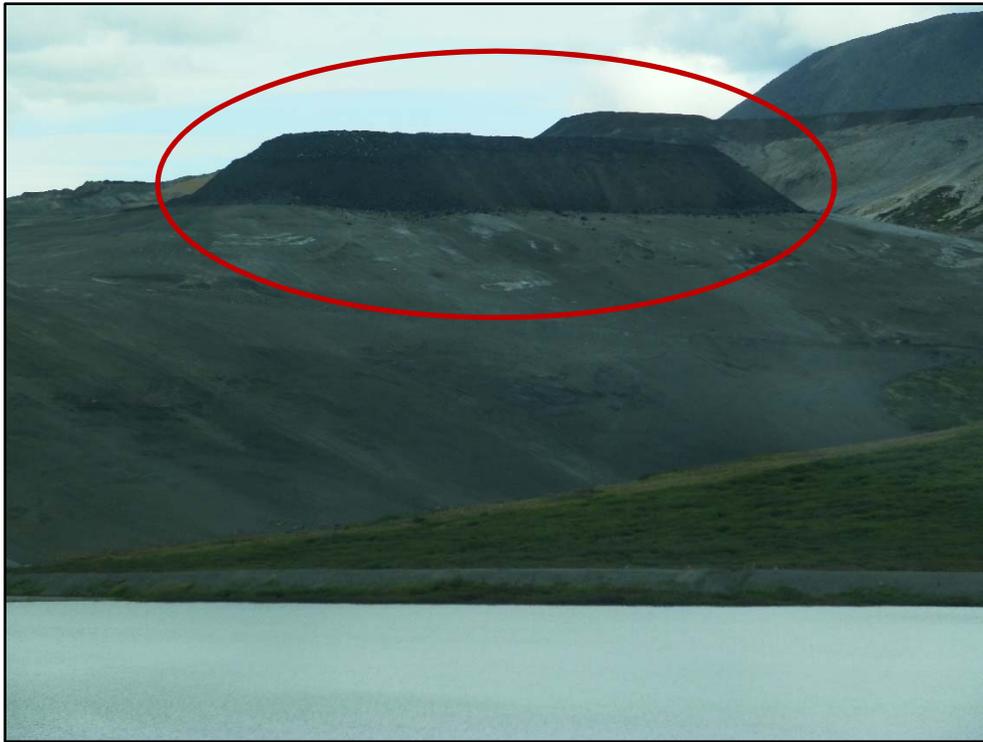
Figure 79: The Qanaiyaq Dump located on the Main Waste Dump.
